**Tri-State Home Inspections
Bedford/Goffstown NH
Inspector: Joseph M. Griffin
NH License # 00005**

**Smith, Margaret
555 Oak Lane
Oaksville, NH**

Inspected 12/14/19 8:30 AM Client present at inspection, Weather heavy rain, cold

Inspection Summary

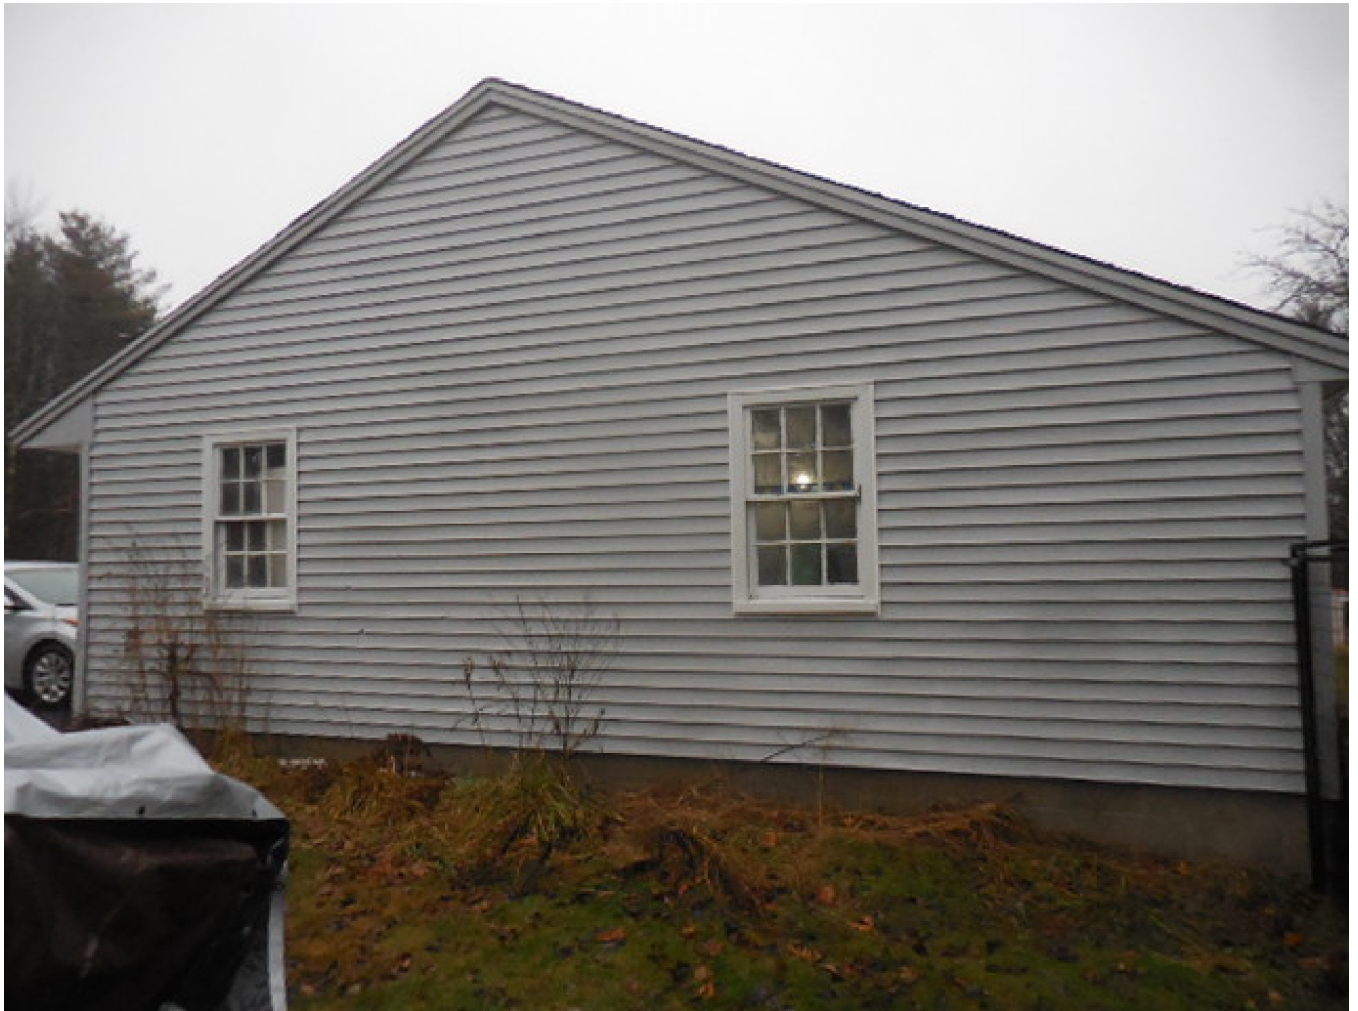
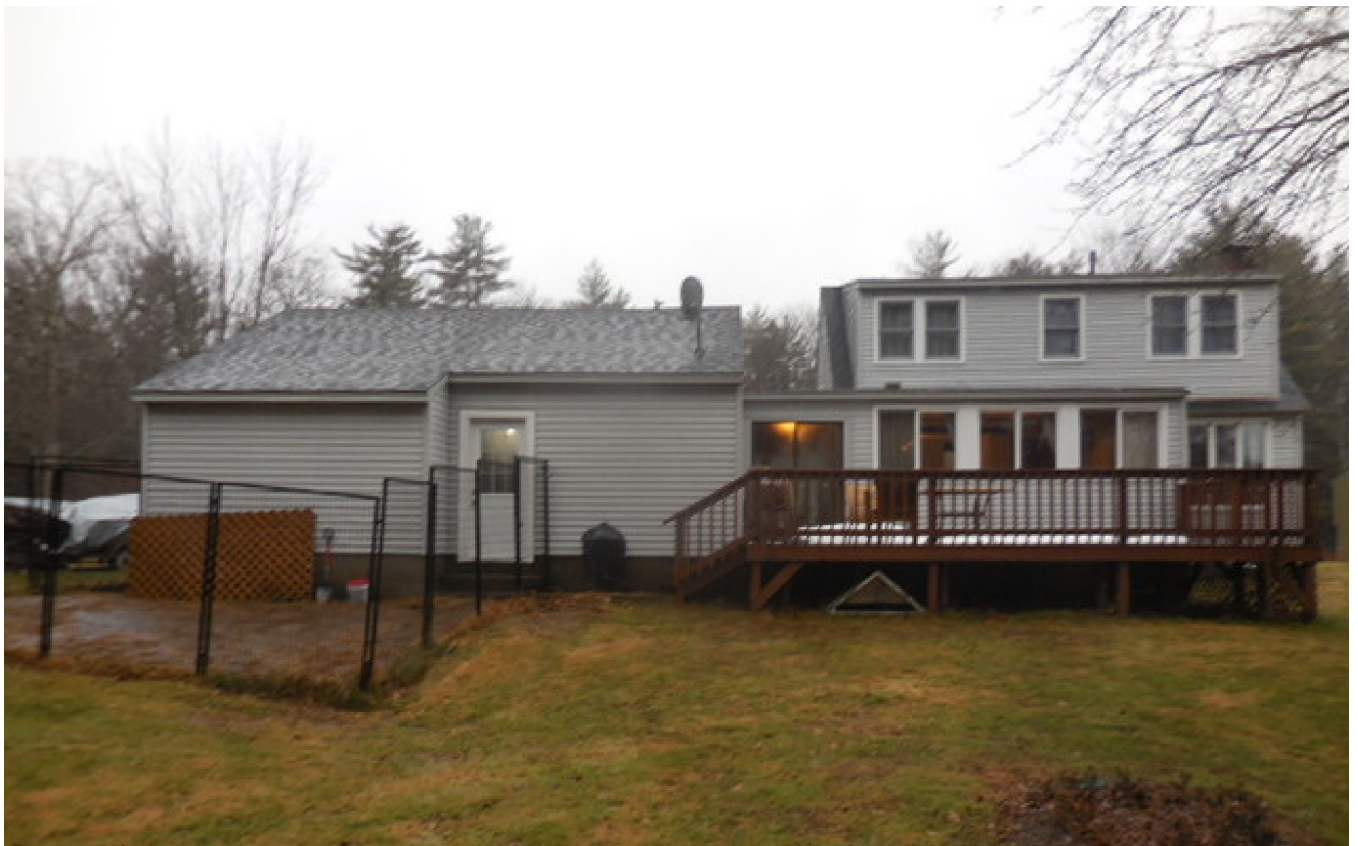
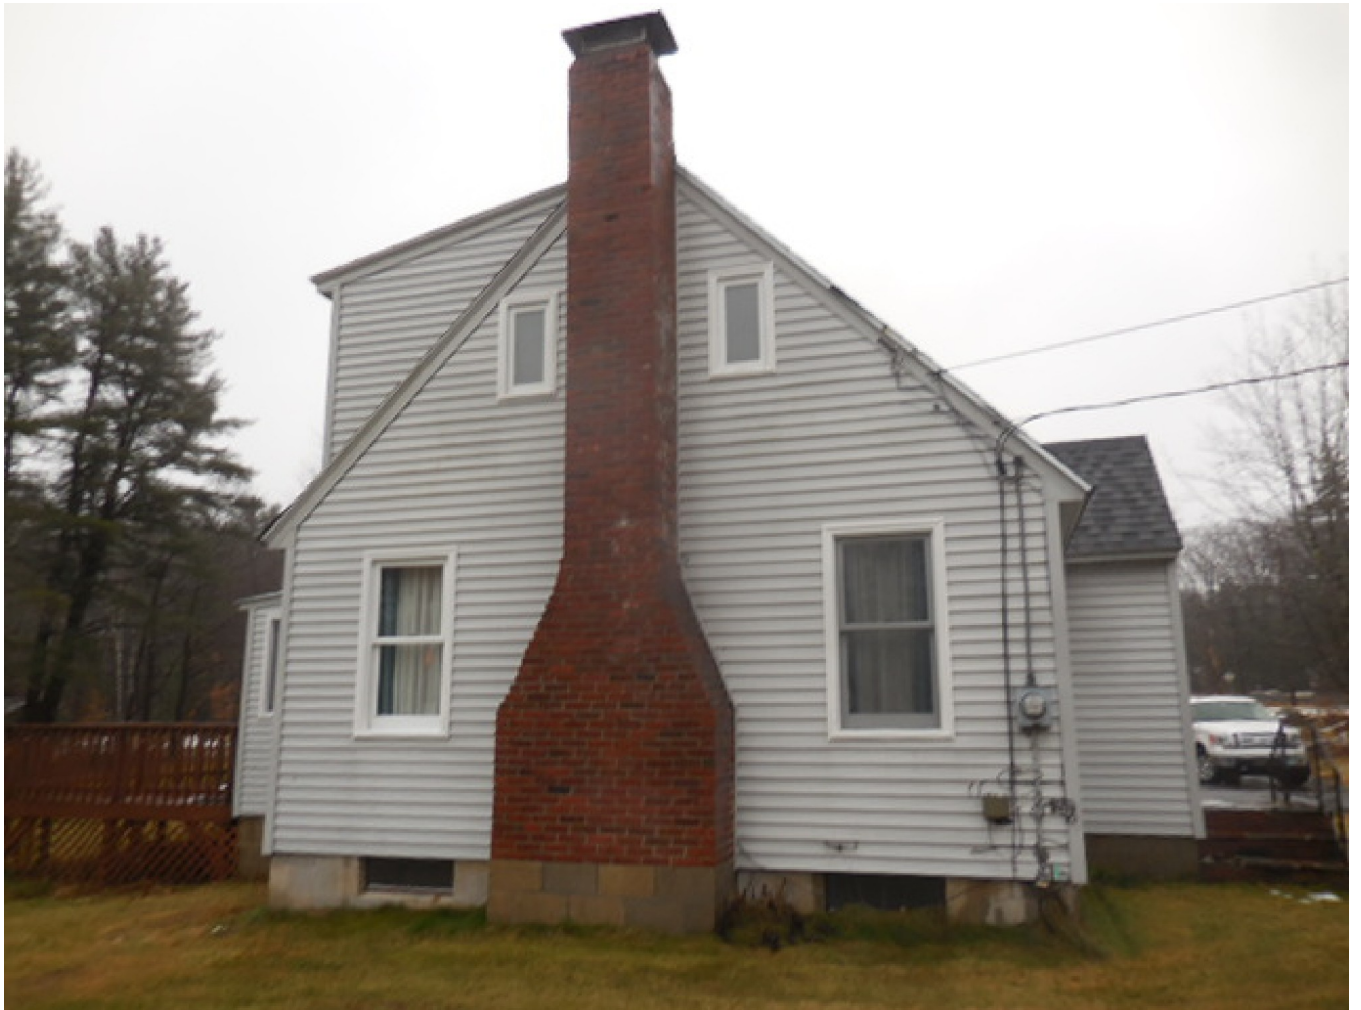
Addition photo

Informational photo only- No repair needed

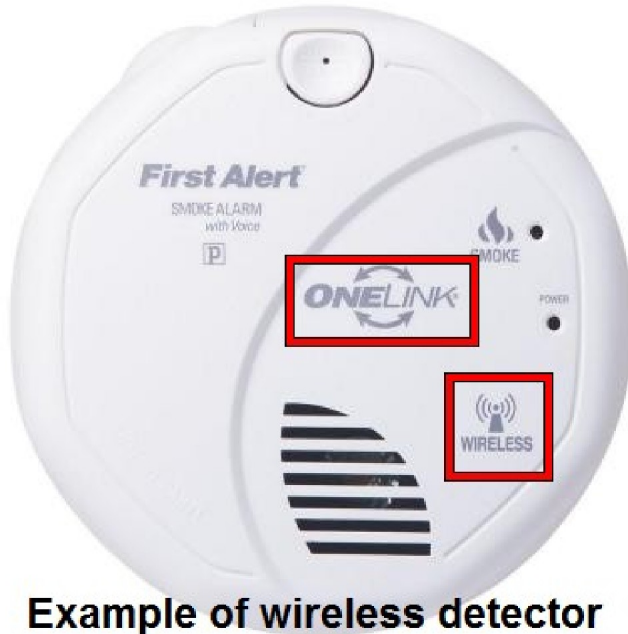
Example of newer Combo detector

Smoke detectors should be checked on the day home is occupied.
Older and few (by today's standards) smoke detectors noted. (See photo)
50/50 detectors are available now at most home centers.
Strongly suggest adding all new smoke detectors at move-in (Photo-electric type) in common hallways, inside and outside of sleeping areas, and at least one on every level of the home.
Hardwired detectors with battery backup if possible. If not, a dual 9v battery type is recommended.
Strongly suggest adding carbon monoxide detectors, one on each level, especially inside/outside sleeping areas.
Just having one in the basement may not protect you as it will be hard to hear through closed doors.
New technology is available today in a combo detector. (See example photo)
These detectors can detect high Carbon Monoxide levels in addition to Smoke detection.
They are recommended to be hard wired with a 9v battery backup for safety.

If battery powered only, make sure the detectors can ALL communicate wirelessly.
It is recommended to buy all the detectors together, and from the same manufacturer.

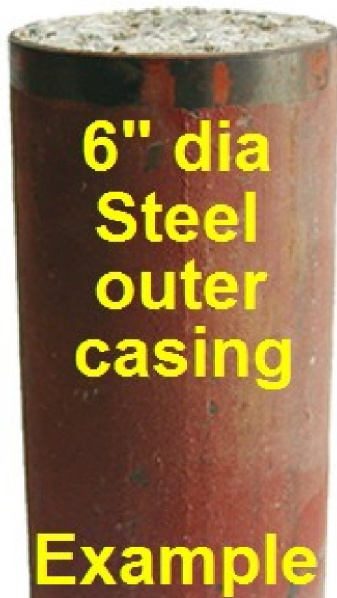
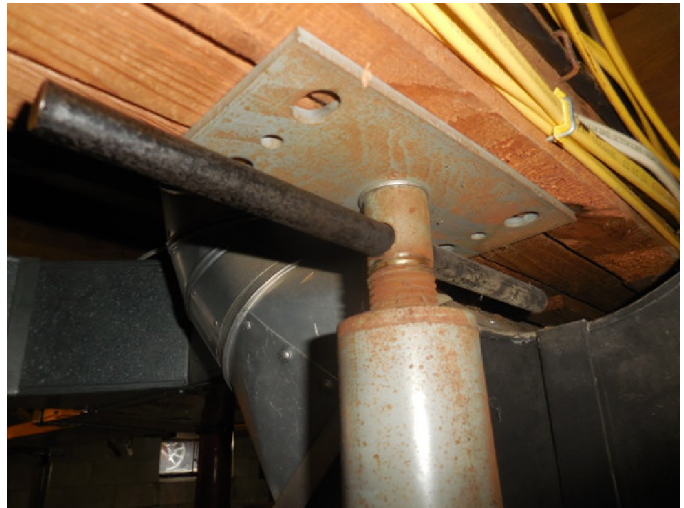
Concrete filled

Temporary hollow jackscrew type support columns noted. See photo-repairs needed.

These types of jackscrew supports are meant for TEMPORARY support only, and not meant to carry the full bearing loads long-term. Steel-cement filled lally columns are recommended. See example photo.

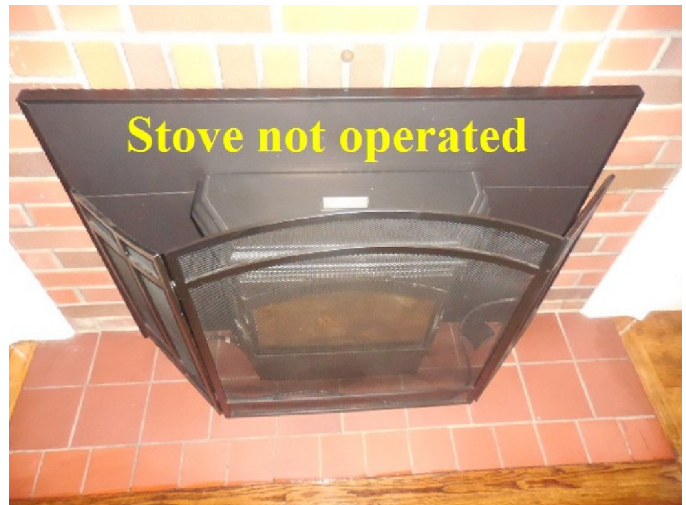
Woodstoves are not part of the inspection. It is strongly recommended that the stove flue is cleaned regularly. Informational photo only- No repairs needed

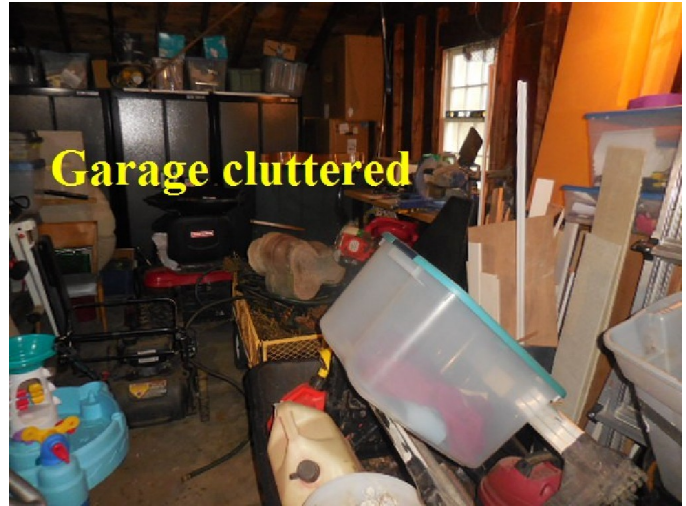
The garage inspection was limited due to stored items. See photo.

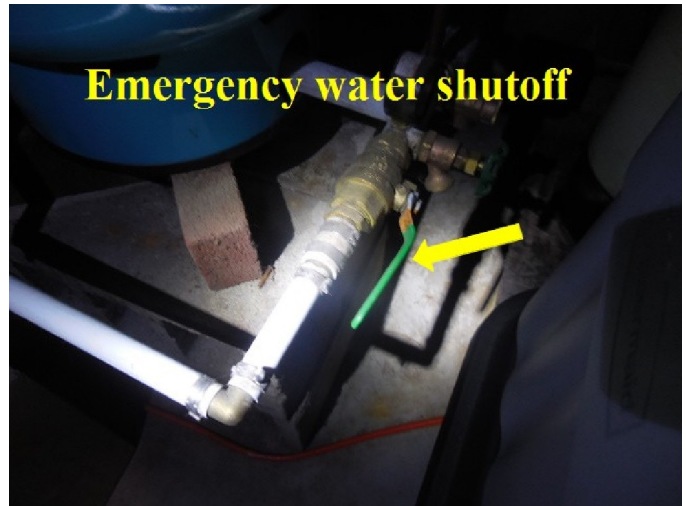
Main Water Shut Off

Turn water off in flooding emergencies. Location: See photo.

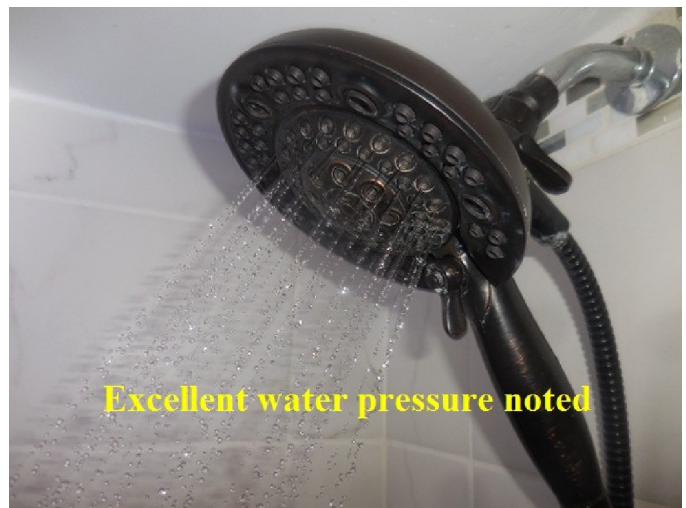
Water pressure

Excellent pressure/flow noted at fixtures. Informational photo only- No repairs needed

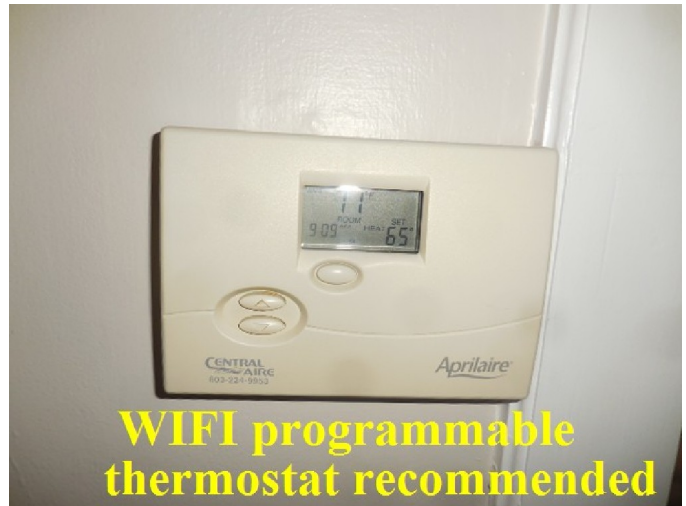
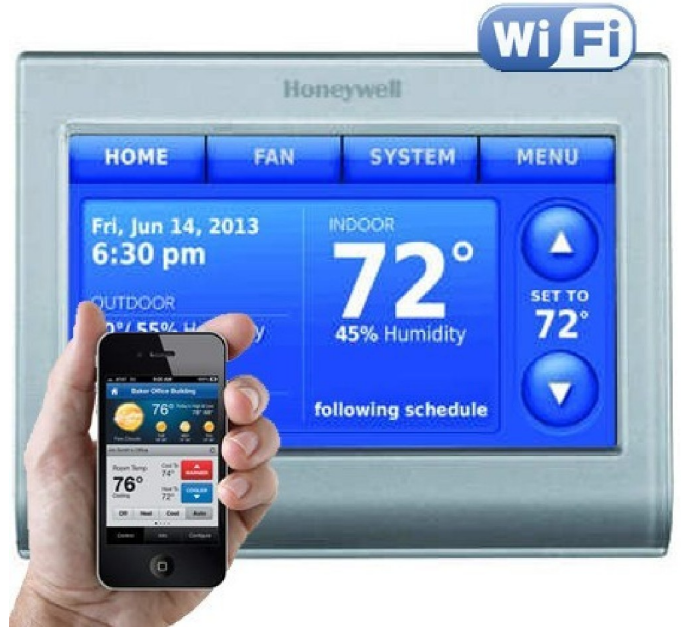
Thermostat

Programmable WIFI thermostat recommended for better energy efficiency. Informational photo only- No repairs needed

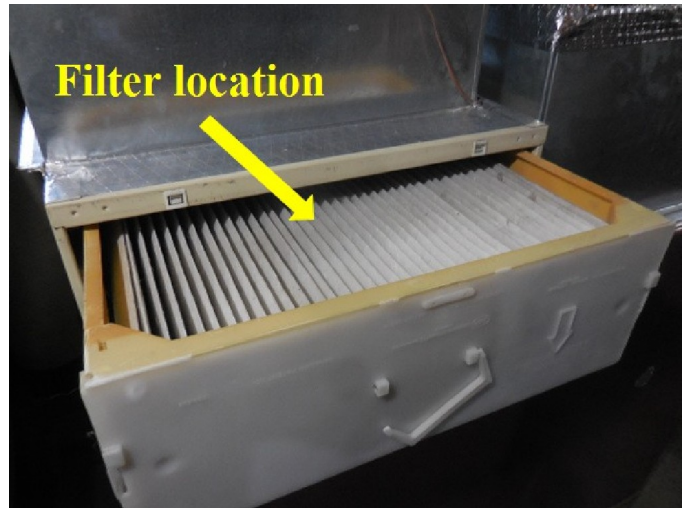
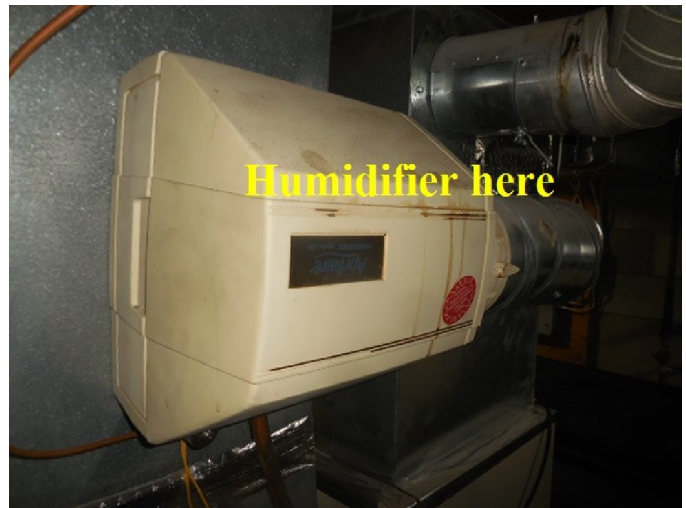
Filter System

Informational photo only- No repairs needed
The filter should be looked at/replaced every 6-8 months.
