# Briar Lake

## Unit Owners' Association

Inspected: May 31, 2024 • Revised on: September 9, 2024  
Lebanon, PA

FULL RESERVE STUDY

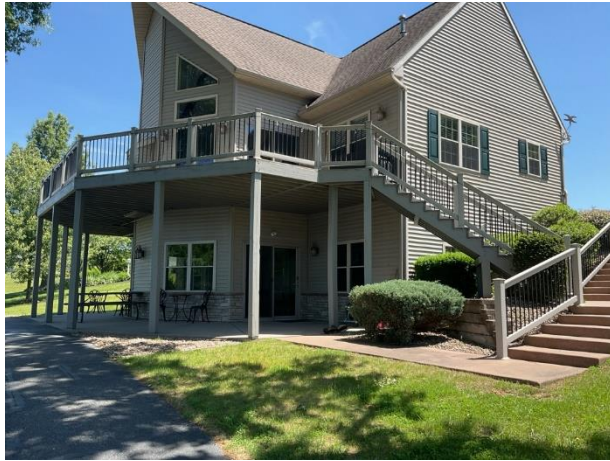
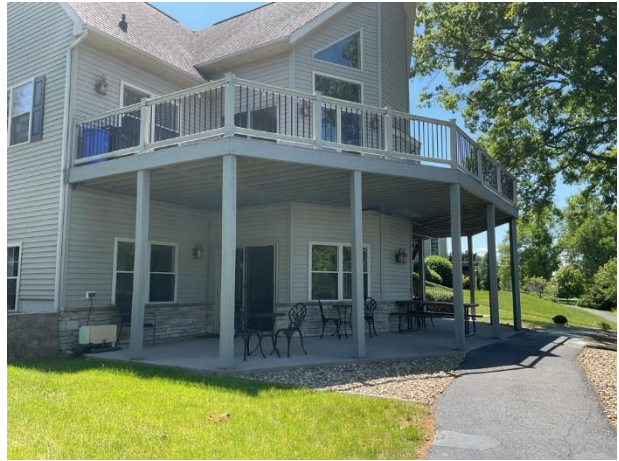
**Condition:** Fair overall with finish deterioration noted at the composite decking and vinyl railings.

Deck overview

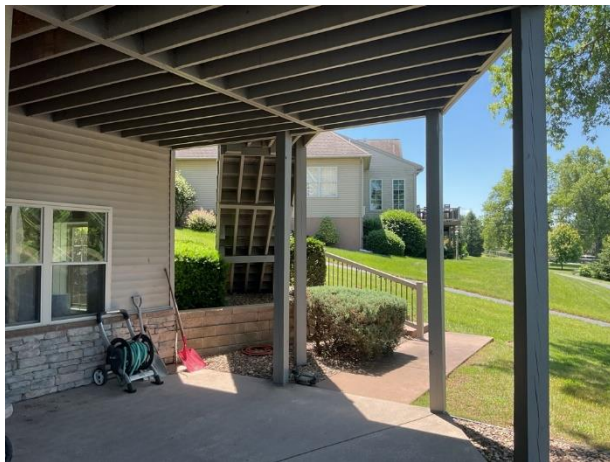
Structure detail

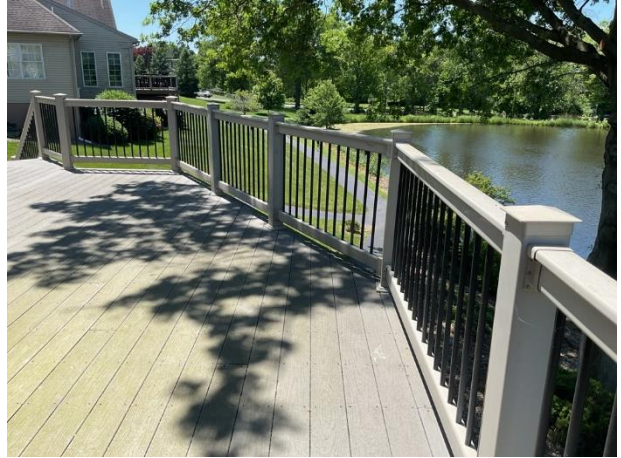
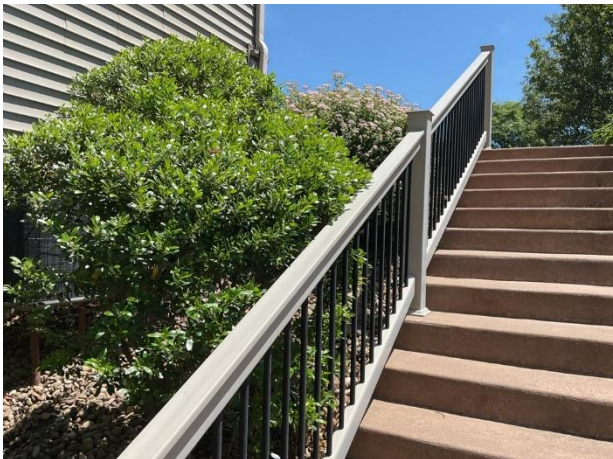
**Vinyl railings overview**

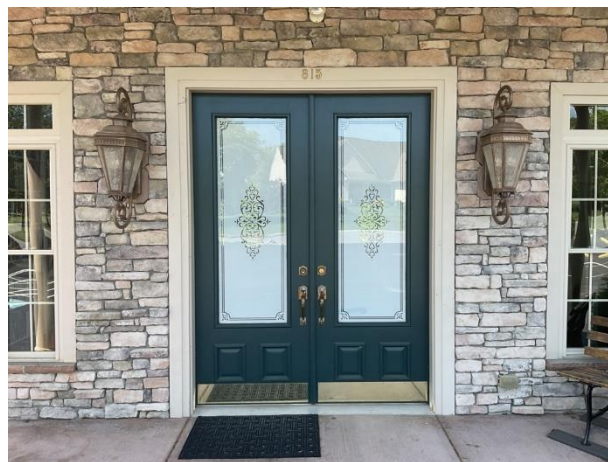
**Condition:** Good to fair overall

**Entrance doors**

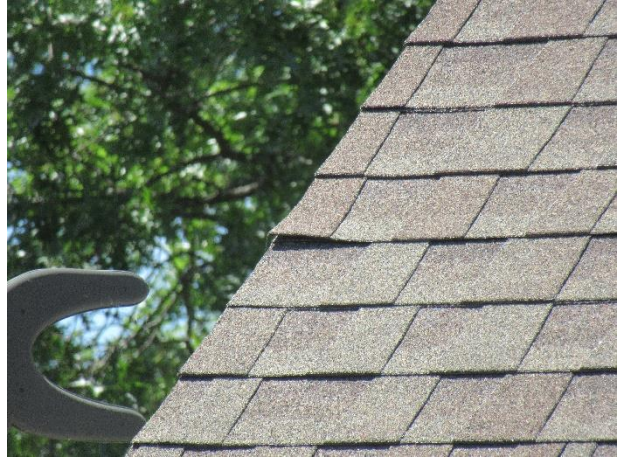
**Isolated shingle lift**

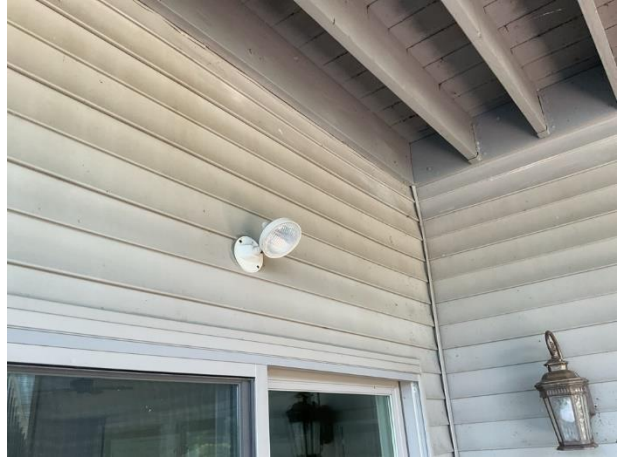
**Condition:** Good to fair overall with isolated organic growth, bulged siding and finish deterioration

**Bulged siding**

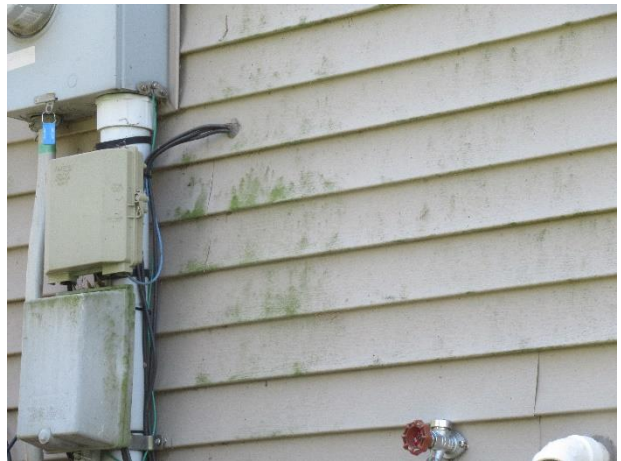
**Organic growth**

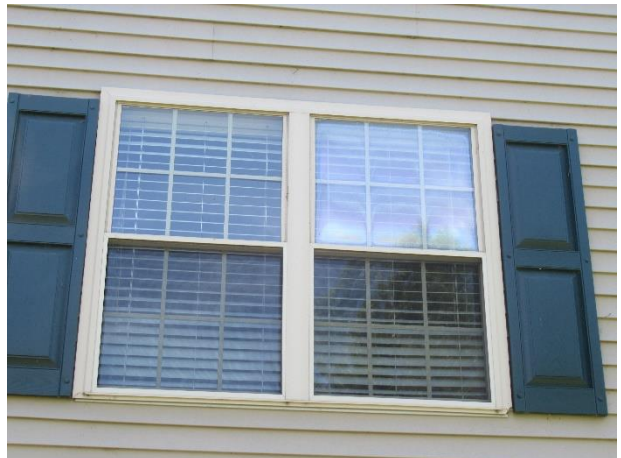
**Fogged glass**

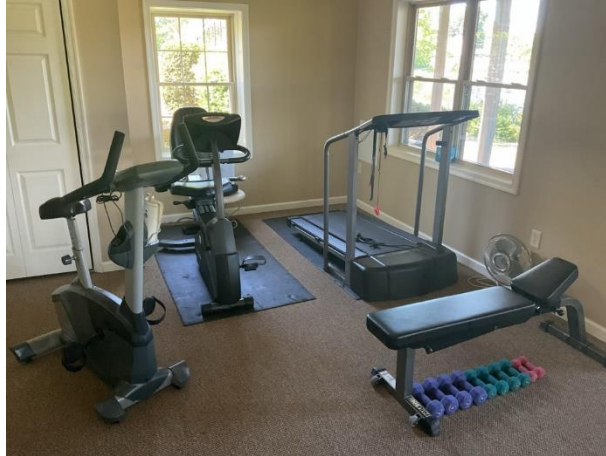
**Conditions:** Good to fair overall. The Board did not report operational deficiencies.

**Exercise equipment**

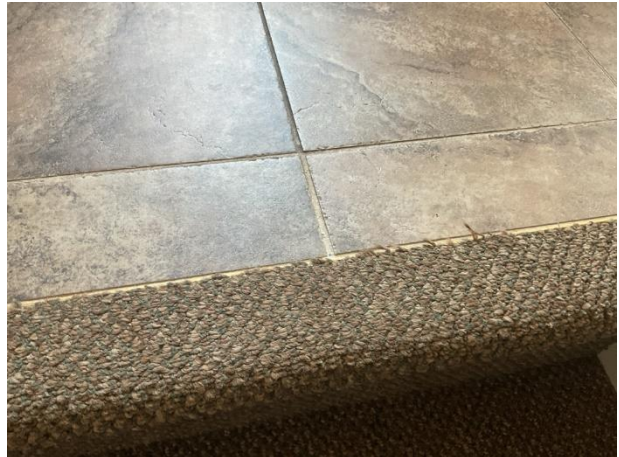
**Carpet fray**

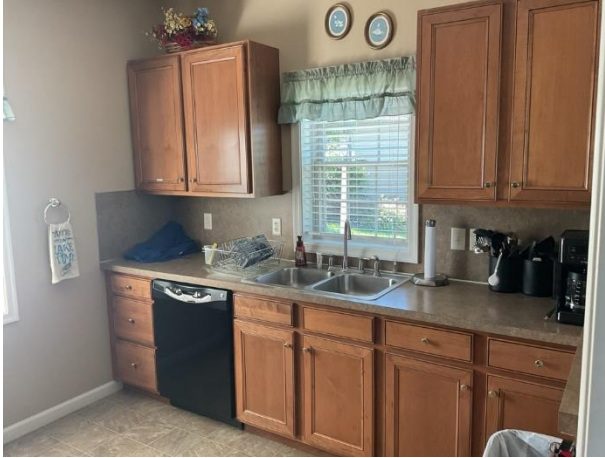
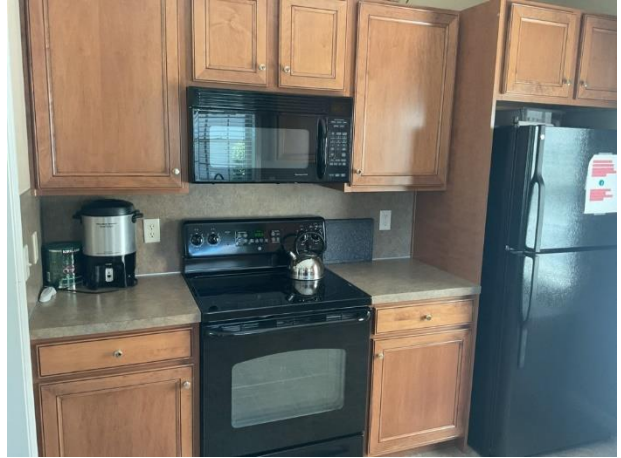
**Condition:** Good to fair overall. We have deferred the renovation of the kitchen past our stated useful life due to its good overall condition.

**Kitchen overview**

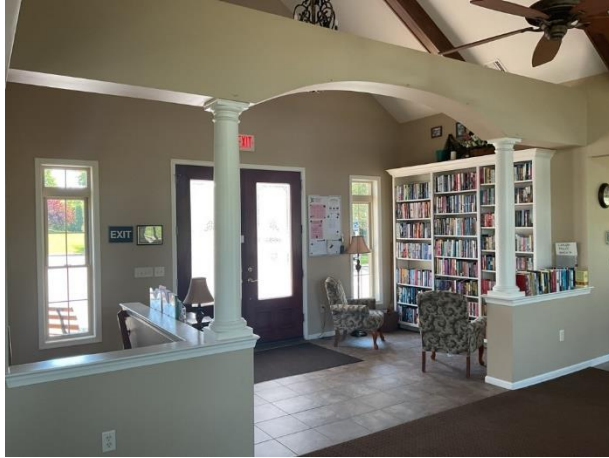
**Condition:** Good to fair overall with isolated damaged paint evident. We have deferred the repainting of the walls and ceilings at the clubhouse interior due to their good overall condition.

**Paint finishes overview**

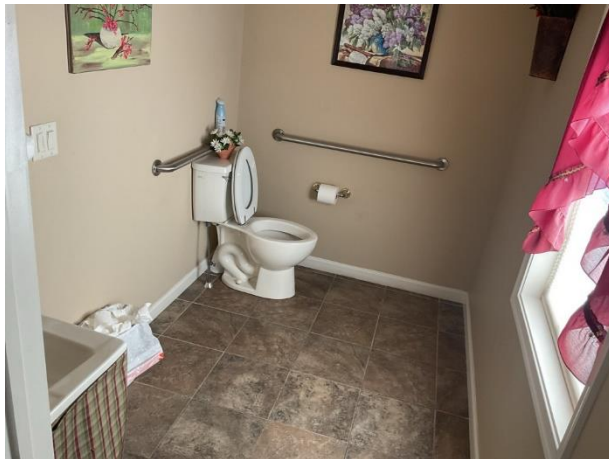
**Condition:** Good to fair overall. We have deferred the renovation of the restrooms past our stated useful life due to their good overall condition.

Rest room overview

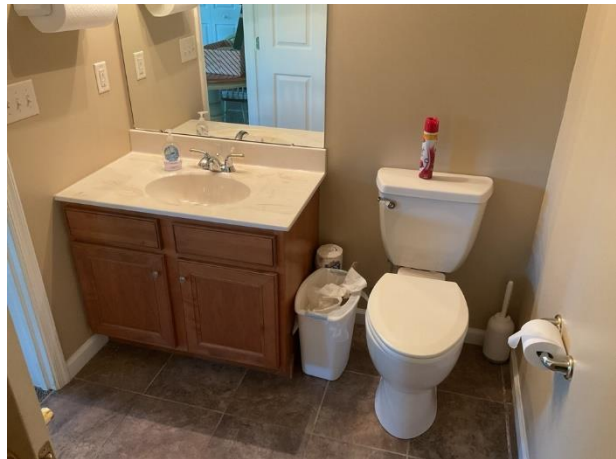
Rest room overview

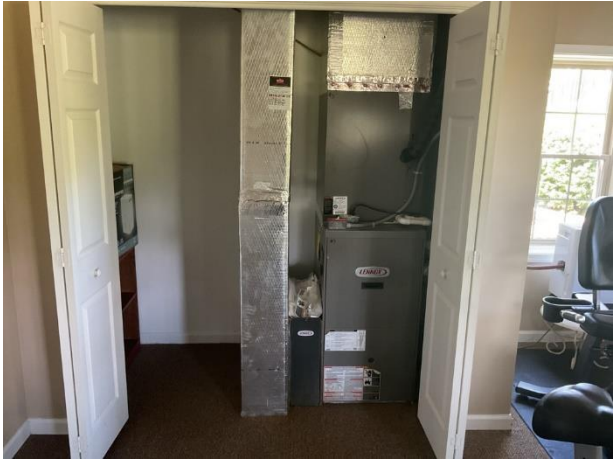
**Condition:** Reported satisfactory without operational deficiencies

**Split system air handling unit**

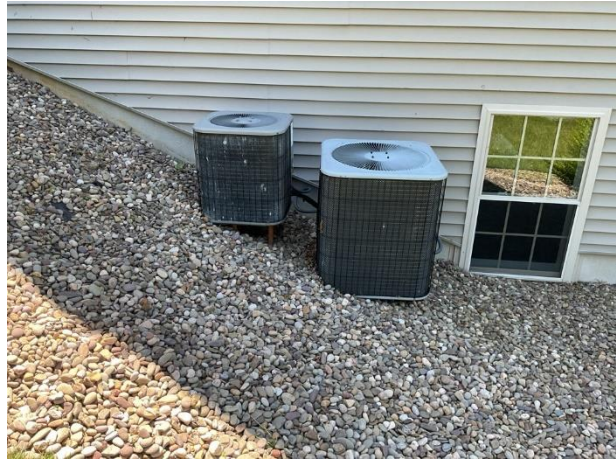
**Split system condensing units**

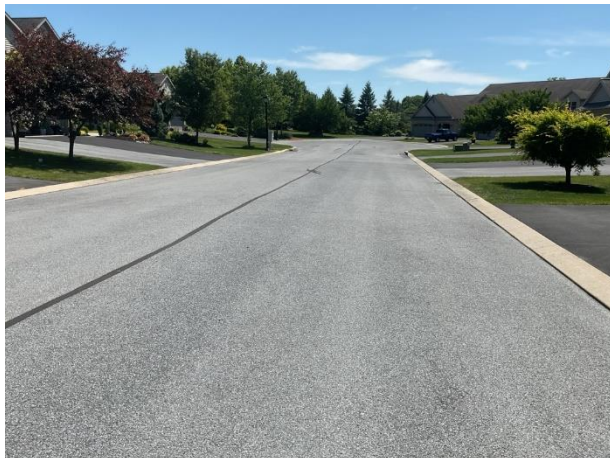
- Streets paved in 2020: Good to fair overall condition
- Streets paved in 2022: Good overall condition
- Original streets: Good to fair overall condition with periodic cracks and patches evident
- Parking Area: Good to fair overall condition with periodic cracks evident. We have deferred the total replacement of the parking area due to its good overall condition

**Pavement overview - Remaining**

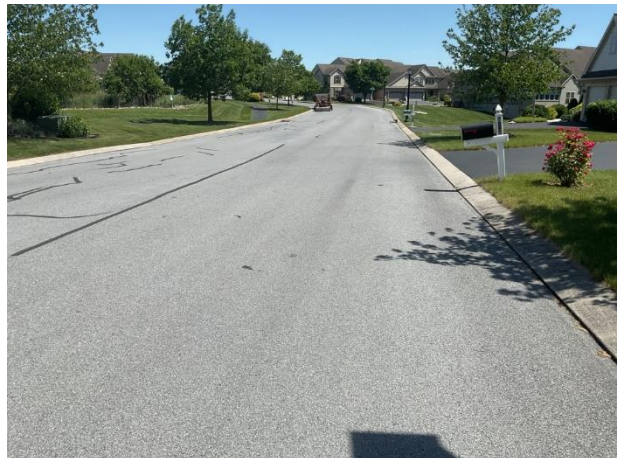
**Pavement overview - Remaining**

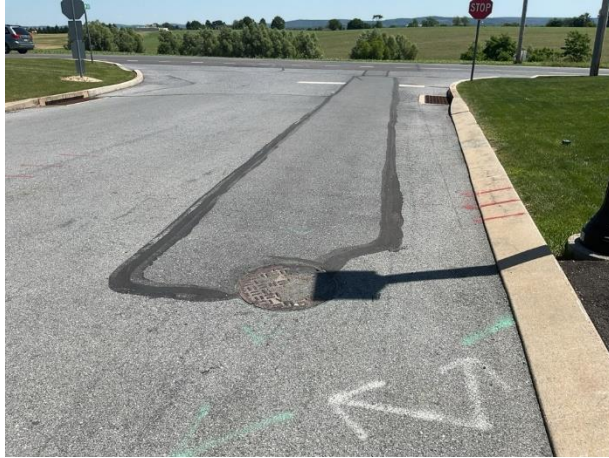
- Approximately 4,800 square yards comprised of Lantern Drive and Briar Edge Court have not been repaved and are estimated to have received a topcoat of asphalt in 2013. We noted previous crack repairs and patching at these streets.

**Pavement patch – Lantern Drive**

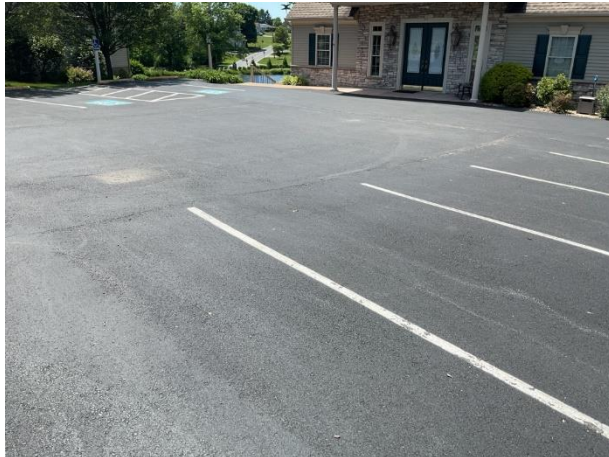
**Pavement overview – Parking area**

The manner of repaving is either a mill and overlay or total replacement. A mill and overlay is a method of repaving where cracked, worn and failed pavement is mechanically removed or milled until sound pavement is found. A new layer of asphalt is overlaid atop the remaining base course of pavement. Total replacement includes the removal of all existing asphalt down to the base course of aggregate and native soil followed by the application of two or more new lifts of asphalt. We recommend mill and overlayment on asphalt pavement that exhibits normal deterioration and wear. We recommend total replacement of asphalt pavement that exhibits severe deterioration, inadequate drainage, pavement that has been overlaid multiple times in the past or where the configuration makes overlayment not possible. Based on the apparent visual condition and configuration of the asphalt pavement, we recommend the mill and overlay method for initial repaving followed by the total replacement method for subsequent repaving at the streets at Briar Lake. We recommend the total replacement method for the parking area.

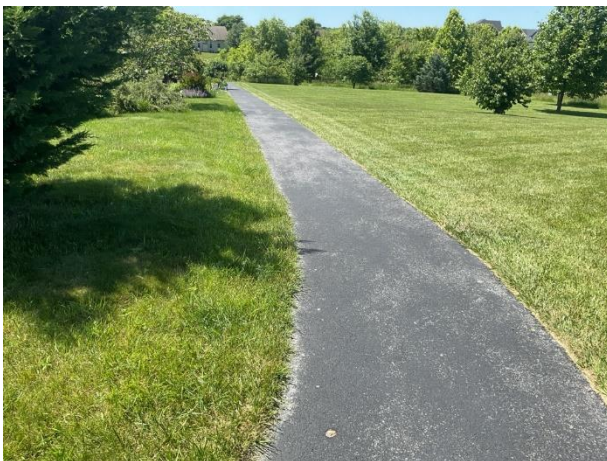
**Condition:** Good to fair overall with periodic cracks, settlement, patches and previous repairs evident. In isolated areas, we also noted sunken/settled areas that have resulted in standing water atop the walking paths.

**Asphalt pavement walking path**

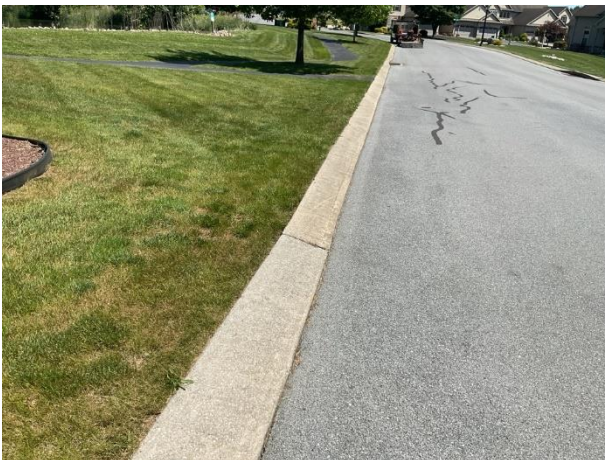
**History and Condition:** Good to fair overall with isolated cracks and spalled concrete evident. The Board does not report a history of repairs or replacements

Concrete curb overview

**Expenditure Detail Notes:** Expenditure timing and costs are depicted in the **Reserve Expenditures** table in Section 3. We estimate that up to 1,950 linear feet of curbs, or twenty percent (19.9%) of the total, will require replacement during the next 30 years.

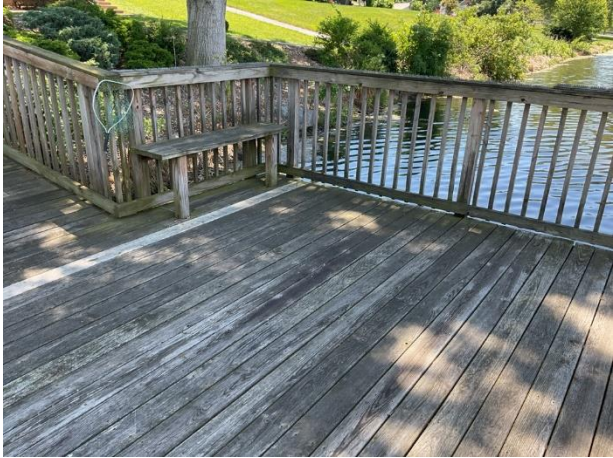
**Condition:** Fair overall with wood deterioration and organic growth evident

**Dock overview**

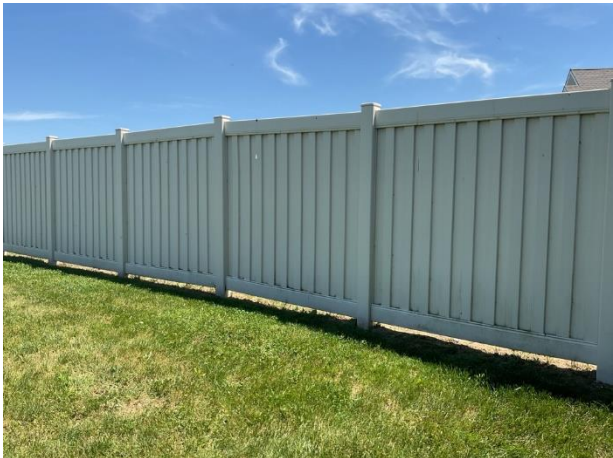
**Condition:** Fair overall with finish deterioration and isolated damage evident

Common vinyl fence

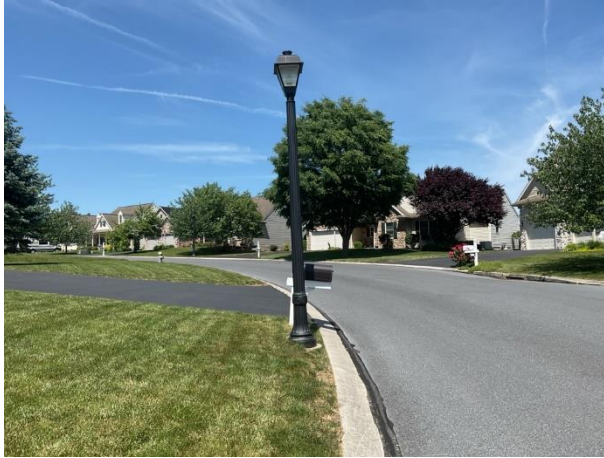
**Light pole and fixture - Note leaning pole**

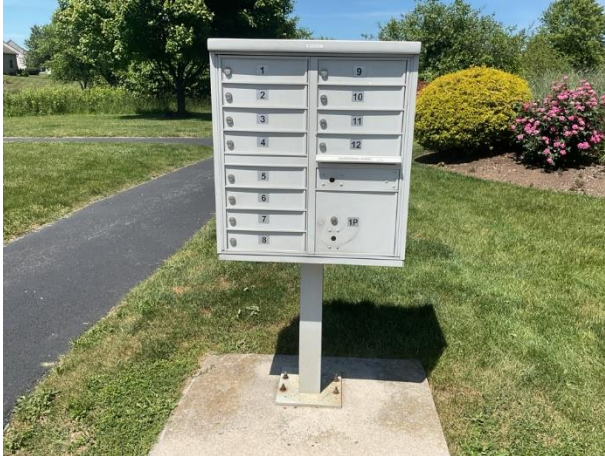
**Condition:** Good to fair overall with fastener rust and finish deterioration evident.

**Mailbox stations**

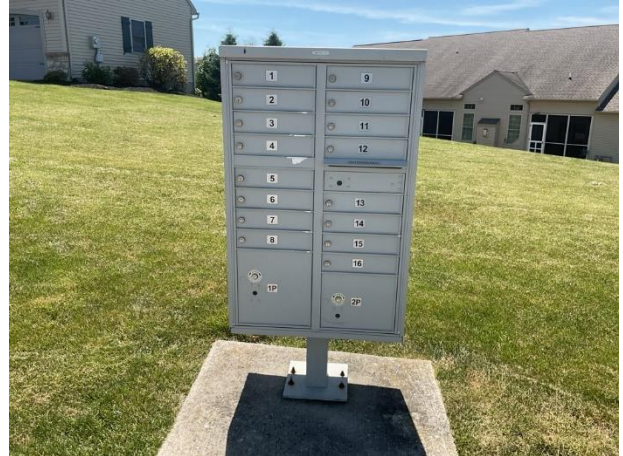
**Mailbox stations**

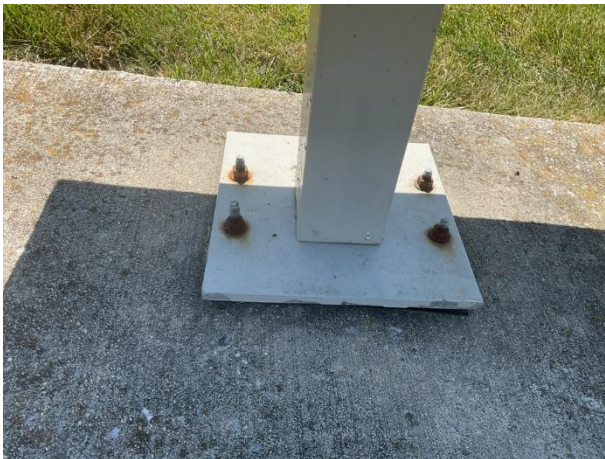
**Mailbox station fastener rust**

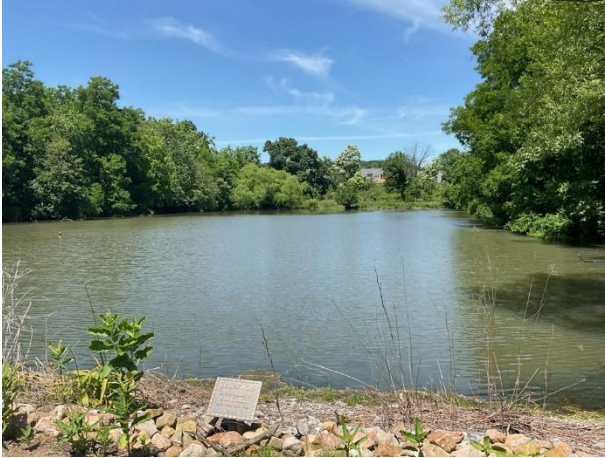
**Condition:** The main Lake is in good to fair overall condition. The Farm pond and upper pond are in fair overall condition with algae bloom and shoreline overgrowth noted.

**Upper pond overview**

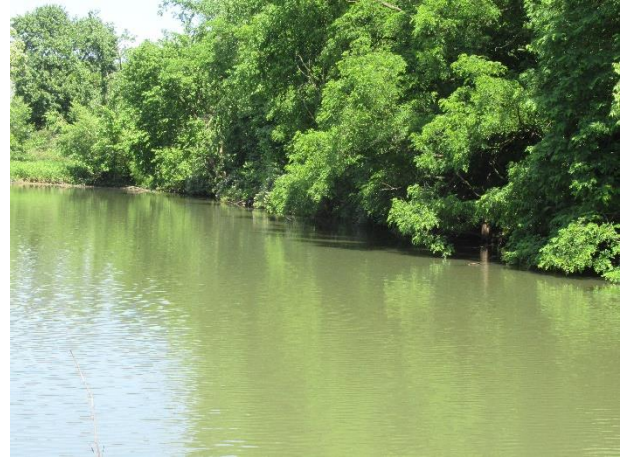
**Upper pond shoreline overview – Note overgrowth**

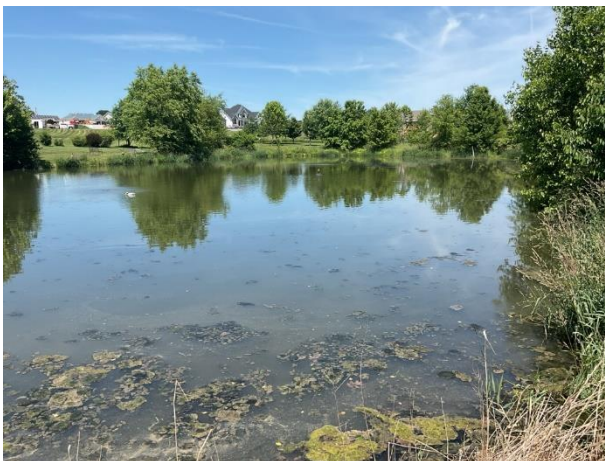
**Farm pond overview – Note algae bloom**

**Expenditure Detail Notes:** Expenditure timing and costs are depicted in the **Reserve Expenditures** table in Section 3. We recommend the Association plan to install a combination of plantings and rip rap around the ponds along 115 linear feet of the Farm pond, 420 linear feet around the Main Pond and 165 linear feet around the upper pond, or approximately fifteen percent (15%), of each pond's shoreline per event.

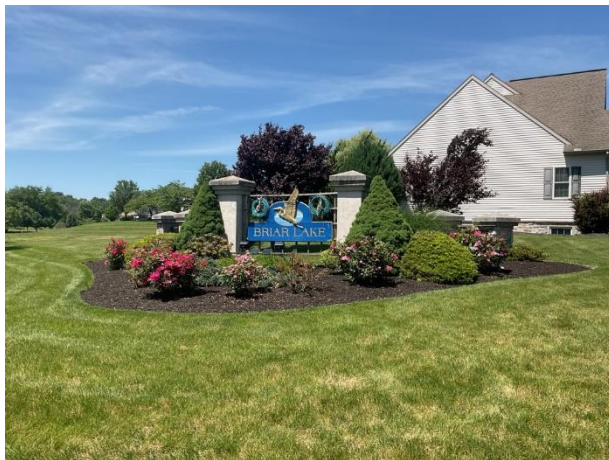
**Condition:** Fair overall deterioration noted at the sign and wood fencing

Entrance monument overview

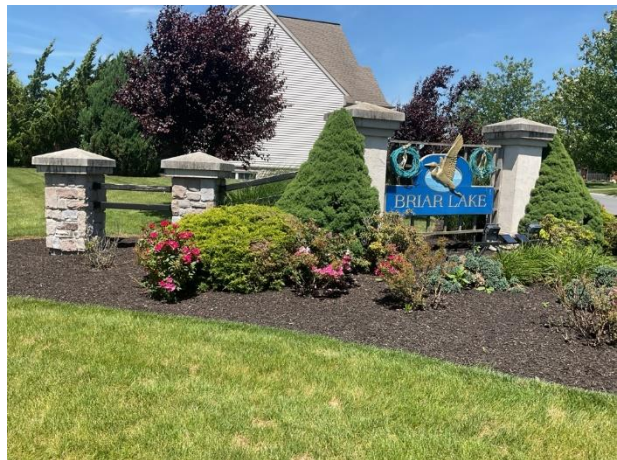
Entrance monument overview

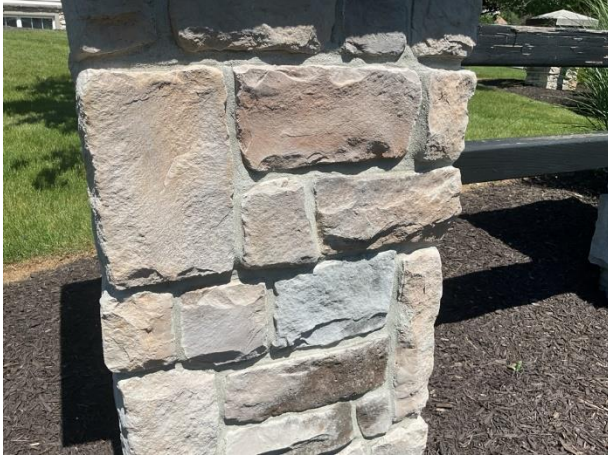
**Masonry overview**

**Expenditure Detail Notes:** Expenditure timing and costs are depicted in the **Reserve Expenditures** table in Section 3. Our cost for renovation includes repairs to the masonry and replacement of the remaining components listed above.

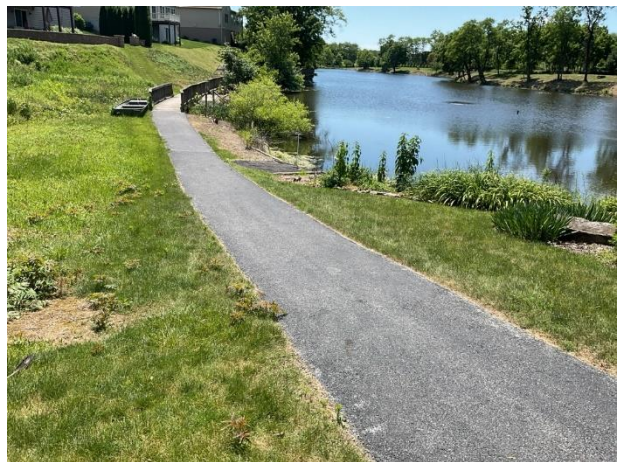
Asphalt walking path

- Removal of approximately 100 linear feet of the wood deck walking path at the Northeast corner of the main lake
- Installation of asphalt walking path (Including subbase, riprap and a culvert)
- Installation of railings
- Replacement of the Boat ramp
- Repair of the depression along North Eighth Avenue

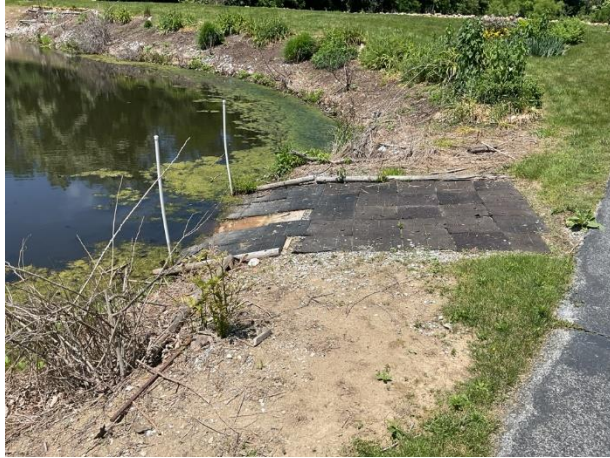
**Boat ramp**

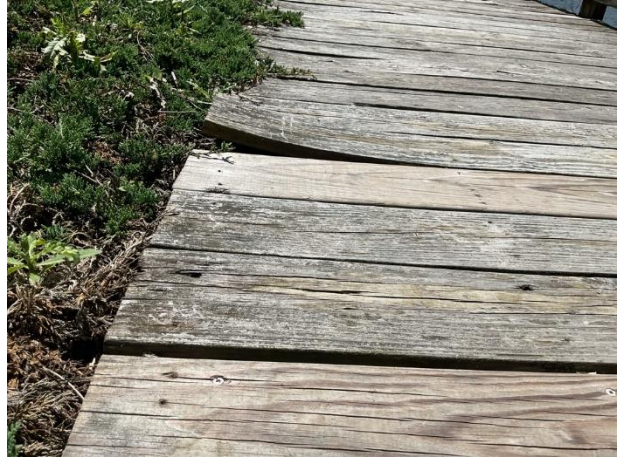
**Condition:** Fair to poor overall with wood deterioration, loose deck boards, and deterioration evident

**Lifted deck board**

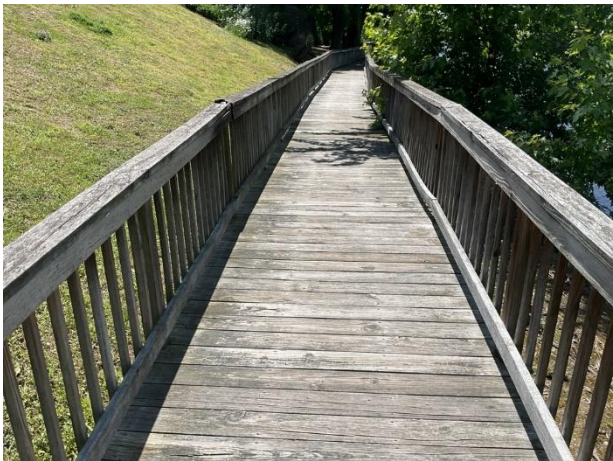
**Condition:** Fair to poor overall with wood deterioration, wood rot, loose deck boards, railing lean and organic growth evident

**Wood deck walking path**

- Replacement of the composite decking
- Replacement of up to fifty percent (50%) of the wood structure
- Partial replacement and repairs to the railings as needed

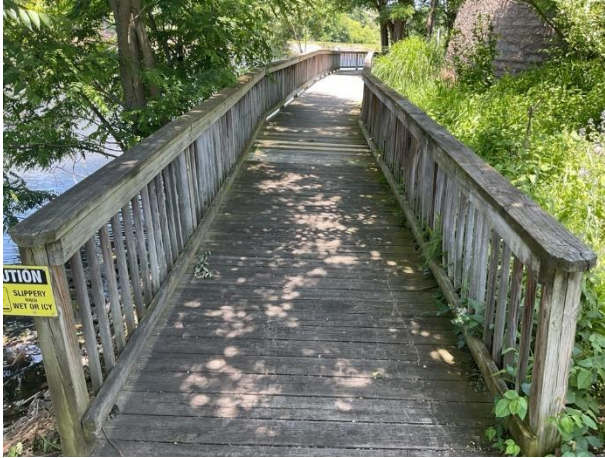
**Wood deck walking path**

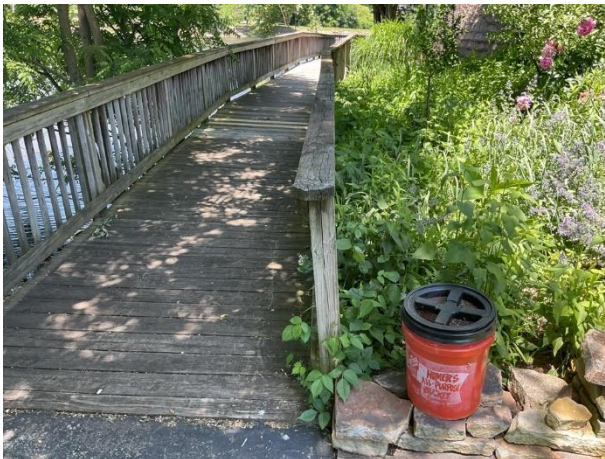
**Railing lean**

- Annually:
  - Inspect to identify and correct any unsafe conditions
  - Secure loose fasteners and replace deteriorated fasteners
  - Replace deteriorated wood components
  - Check railing stability and fasteners
- Every three years:
  - Power wash with algaecide and application of sealer/stain if applicable
