Up Close Inspections

Home Inspection Report

Property Address:

Inspected on Fri, Jan 1 2021 at 12:00 PM

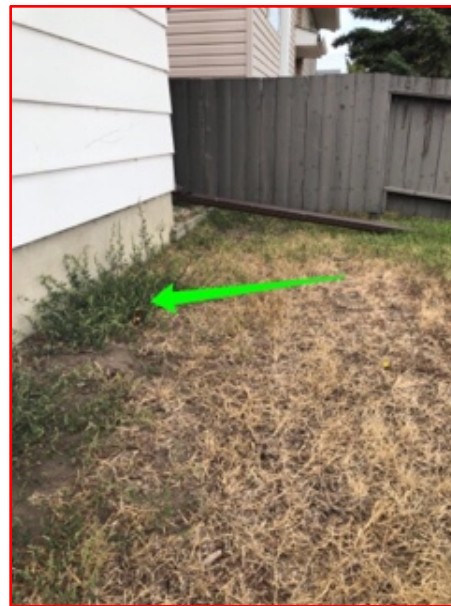
Figure 1-2

1) Observed some areas around foundation had negative grade. Recommend raising grade to facilitate water drainage away from foundation. Recommend repair

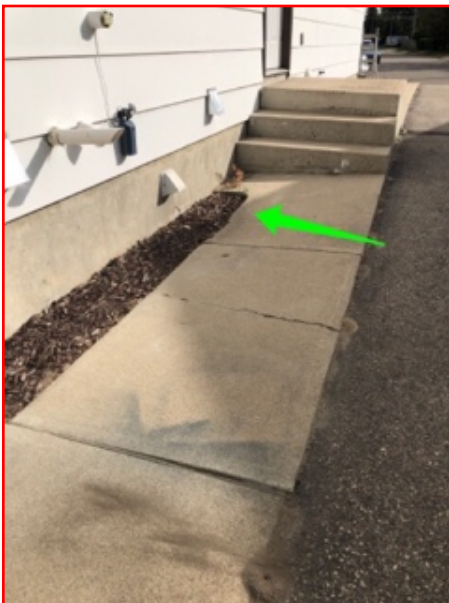
Figure 4-1

2) Observed two sections of concrete walkway appear to be sinking towards the foundation. Recommend raising to facilitate water drainage away from foundation.

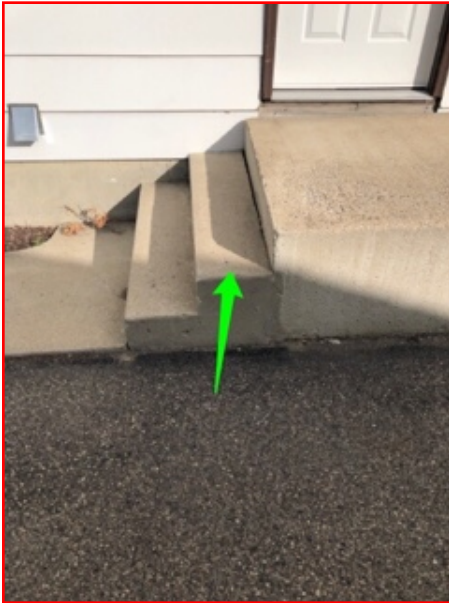
Figure 5-1

3) Observed concrete step at side of home has multiple cracks and appears to have had two risers added. Risers appear to be sinking and pulling away from main step. Recommend repair.

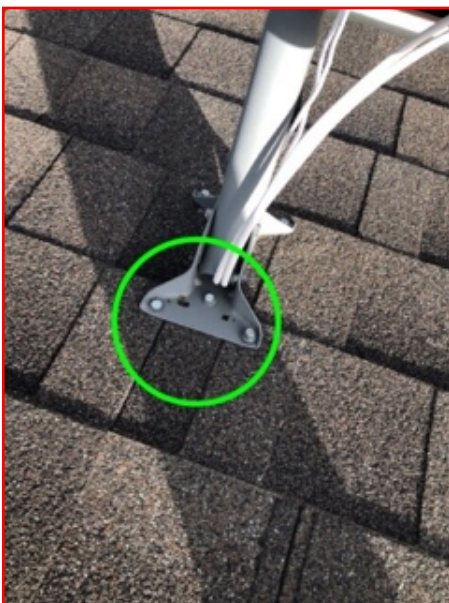
Figure 6-1

4) Observed some roof fasteners have missing and deteriorated caulking. Recommend ensuring all fasteners have adequate caulking installed.

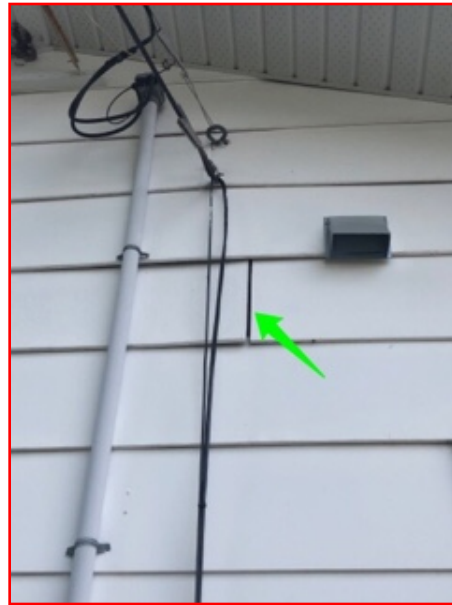
Figure 8-2

5) Observed several minor repairs required to exterior siding. Recommend repair

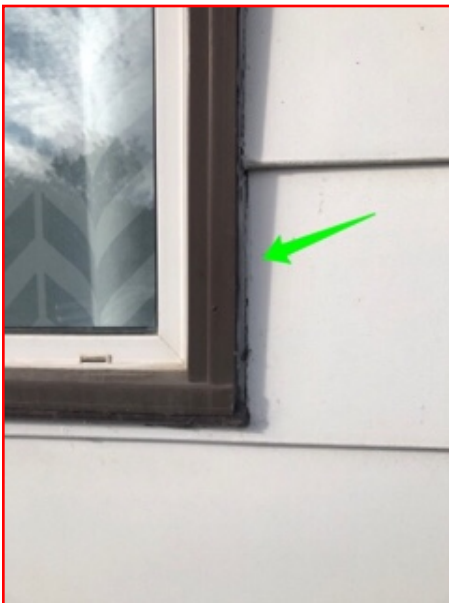
Figure 11-1

8) Observed some missing and deteriorated caulking around all windows and doors.
Recommend repair

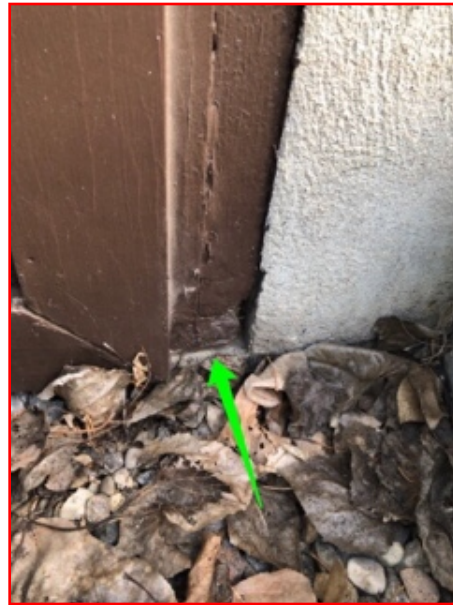
Figure 12-2

9) Observed wooden basement windows require maintenance and repair. Observed deteriorated wooden window frame. Recommend repair.

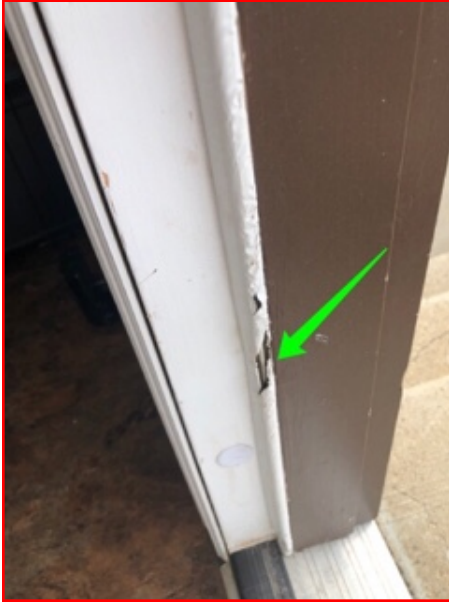
Figure 13-1

10) Observed side entry door has damaged and short weatherstripping. Recommend repair

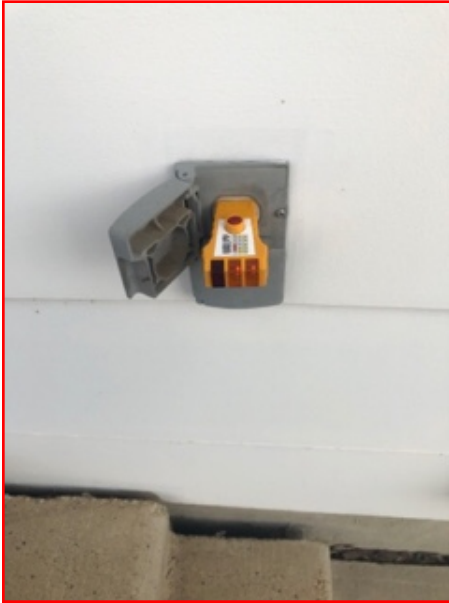
Figure 16-1

11) Observed exterior house plug is not GFI protected. Recommend repair

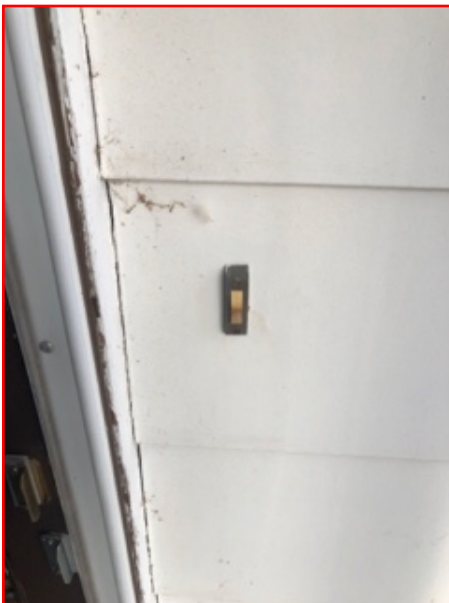
Figure 17-1

12) Observed front doorbell does not work. Recommend repair

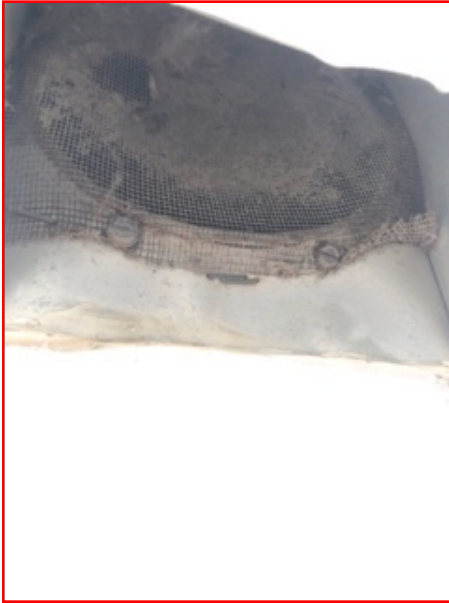
Figure 18-1

13) Observed exterior air intake hood requires maintenance. Recommend cleaning

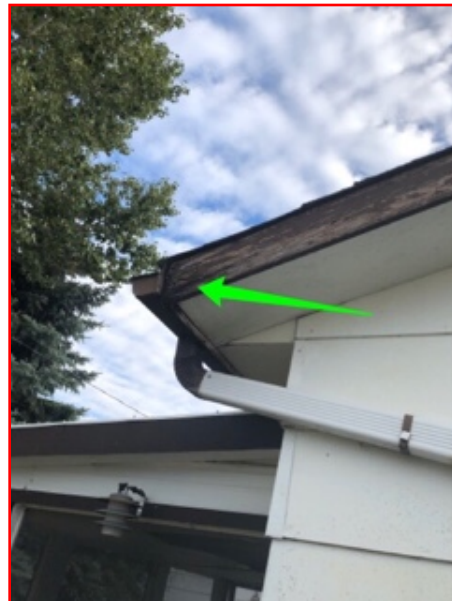
Figure 19-2

14) Observed wooden fascia on garage shows signs of visible deterioration, particularly above metal roofing addition. Recommend maintenance and repair.

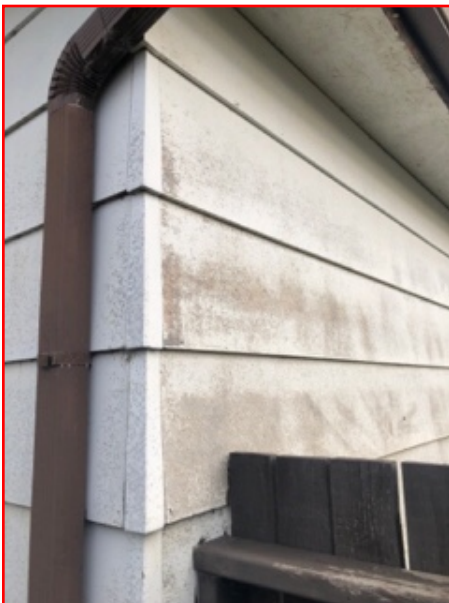
Figure 21-1

16) Observed maintenance is required on exterior siding of garage. Recommend repair

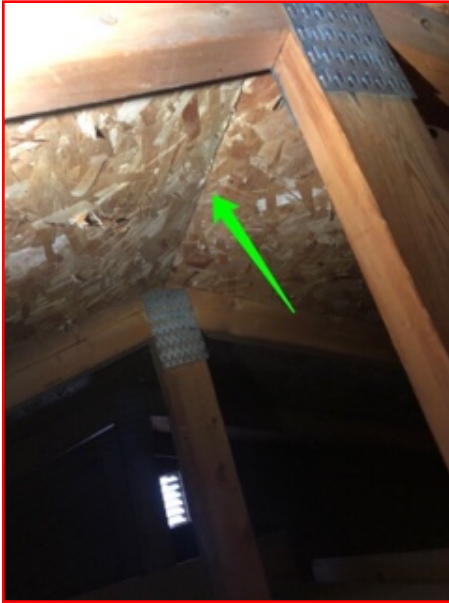
Figure 23-1

17) Observed garage roof trusses have missing ridge blocking. Recommend repair

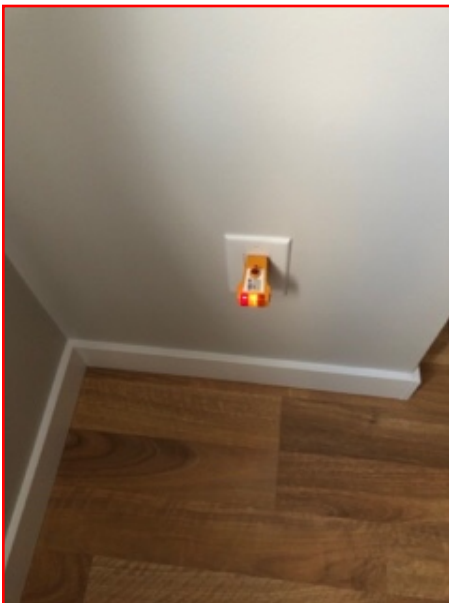
Figure 30-1

20) Observed multiple electrical plugs in living room have hot and neutral reversed.
Recommend repair

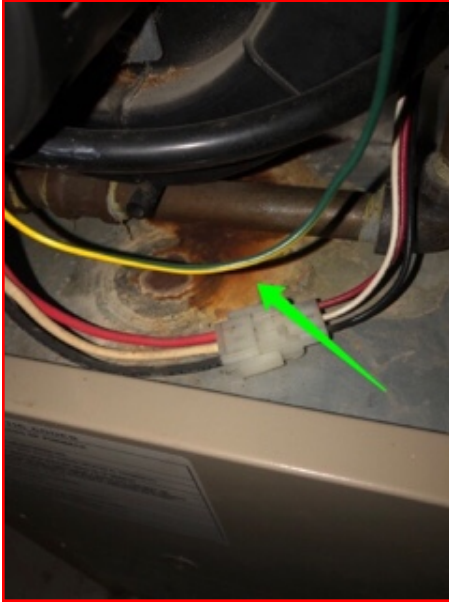
Figure 31-1

21) Observed some rust in furnace cabinet. Appeared dry at time of inspection.
Recommend monitoring

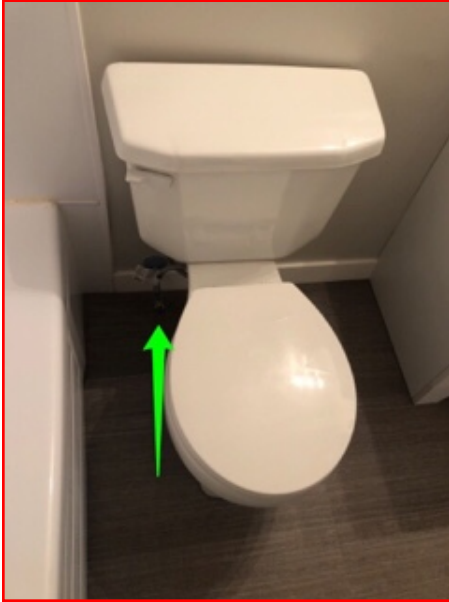
Figure 38-1

25) Observed main floor bathroom toilet is loose and water supply to toilet does not appear to turn on. Recommend repair

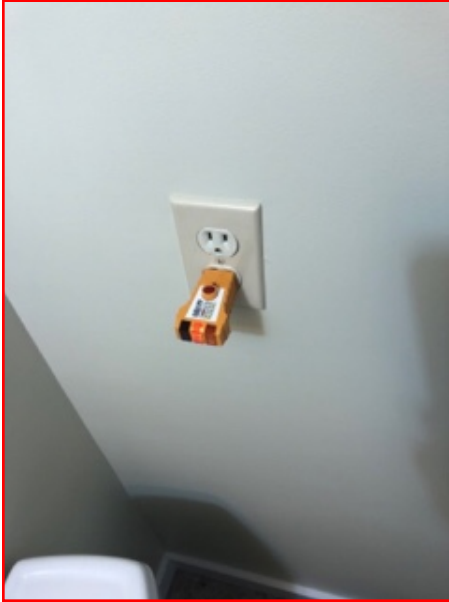
Figure 43-1

27) Observe basement bathroom electrical plug is not GFI protected and is not wired correctly. Recommend repair

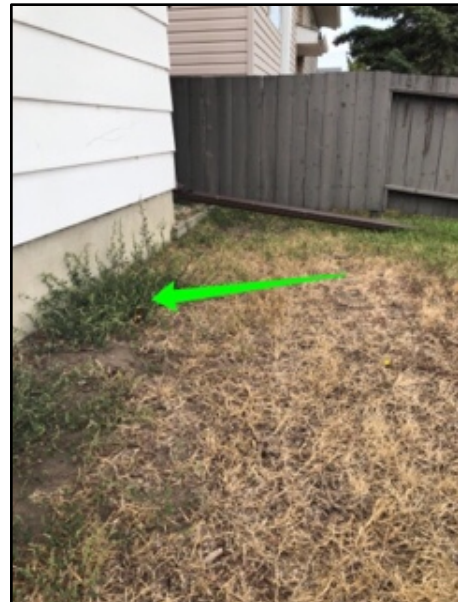
Figure 1-2

Observed some areas around foundation had negative grade. Recommend raising grade to facilitate water drainage away from foundation. Recommend repair

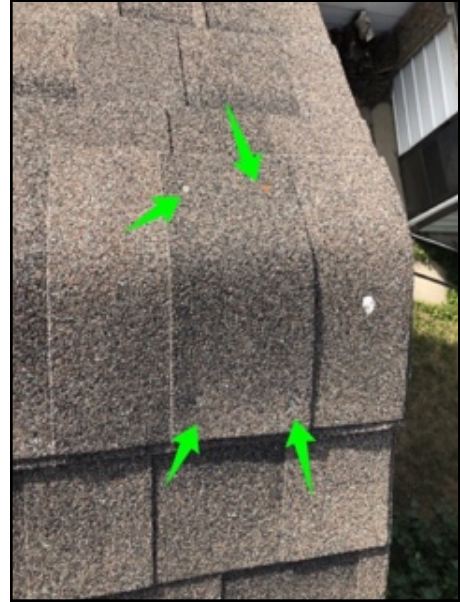
Figure 6-2

Observed some roof fasteners have missing and deteriorated caulking. Recommend ensuring all fasteners have adequate caulking installed.

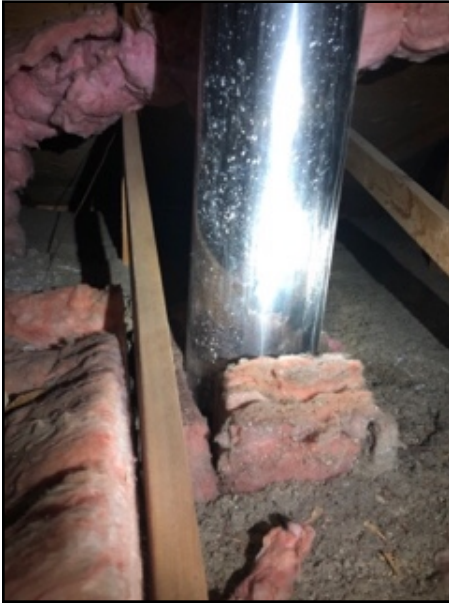
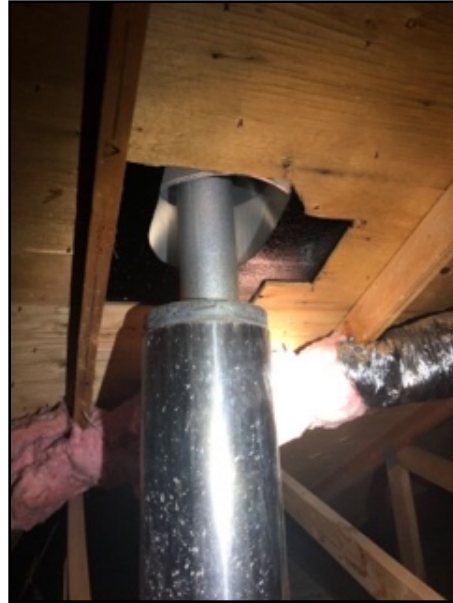
Comment 7:

Observed metal chimney has excess caulking installed. Some physical deterioration. Recommend monitoring and maintenance.

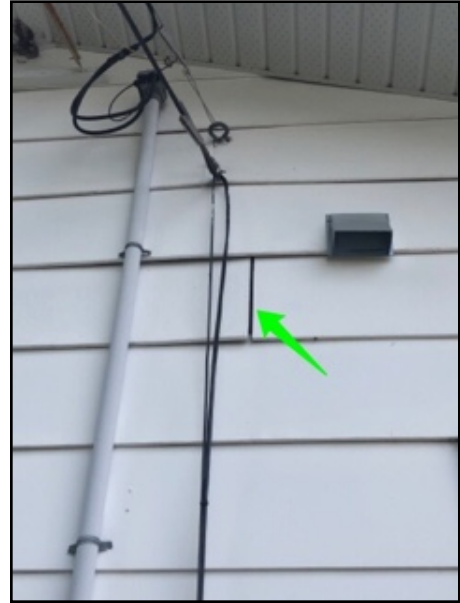
Figure 8-2

Observed several minor repairs required to exterior siding. Recommend repair

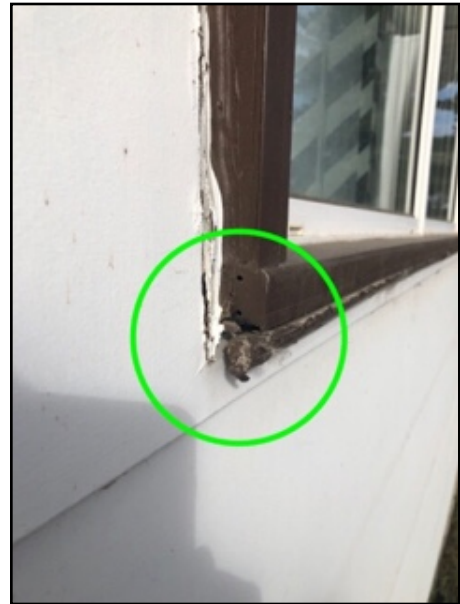
Figure 11-2

Observed some missing and deteriorated caulking around all windows and doors. Recommend repair

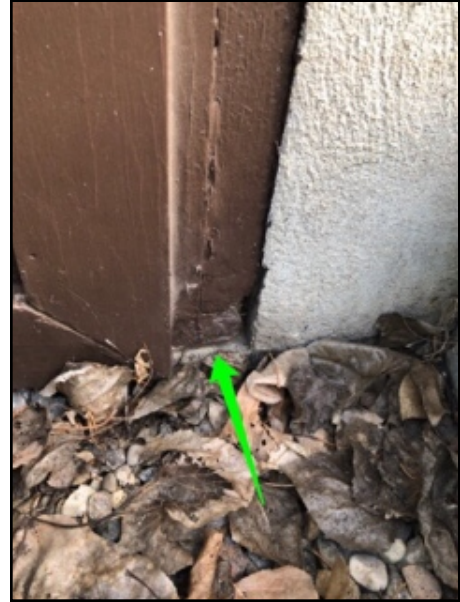
Figure 12-2

Observed wooden basement windows require maintenance and repair. Observed deteriorated wooden window frame. Recommend repair.

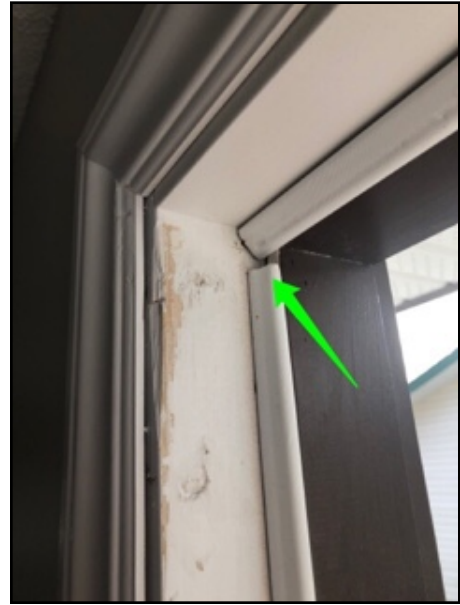
Figure 13-2

Observed side entry door has damaged and short weatherstripping. Recommend repair

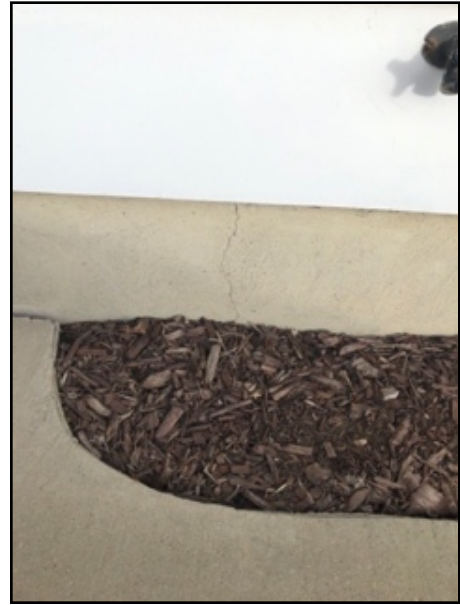
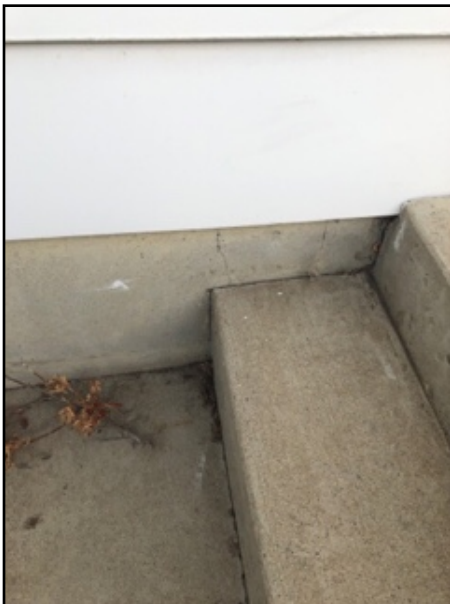
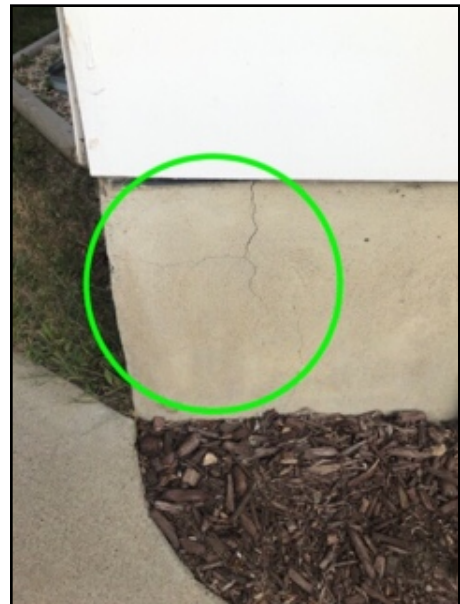
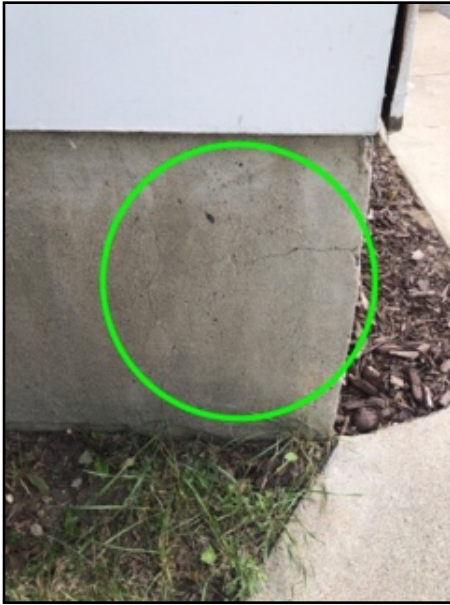
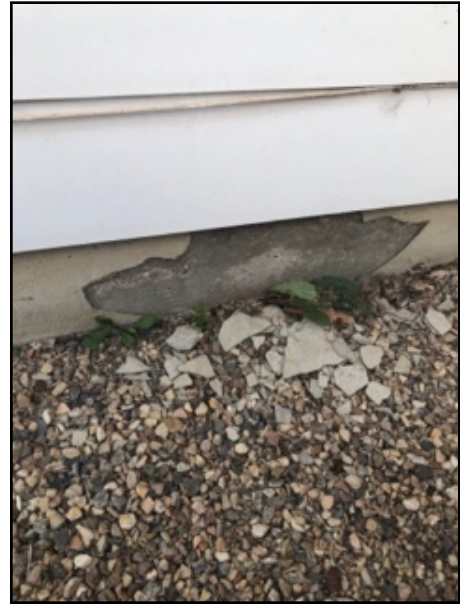
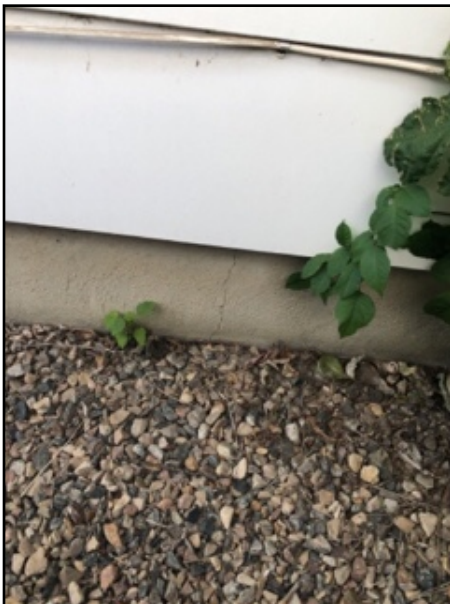
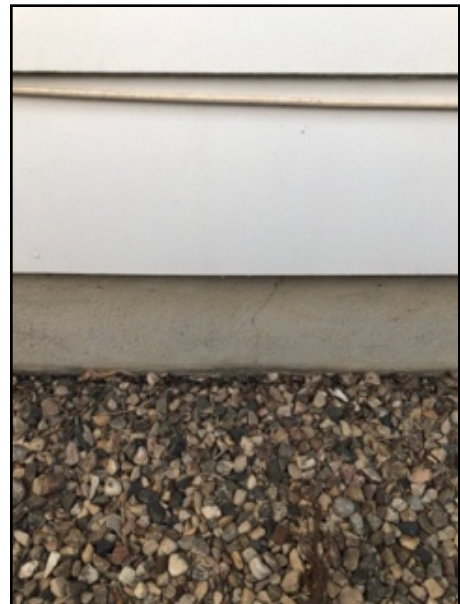
Observed multiple minor cracks in exterior foundation and foundation coating.
Recommend monitoring

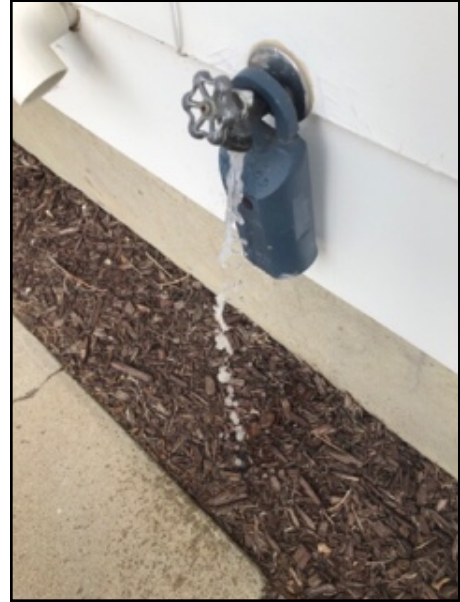
Figure 15-2

Observed exterior water faucets are not freeze proof. Recommend winterizing before the winter season.

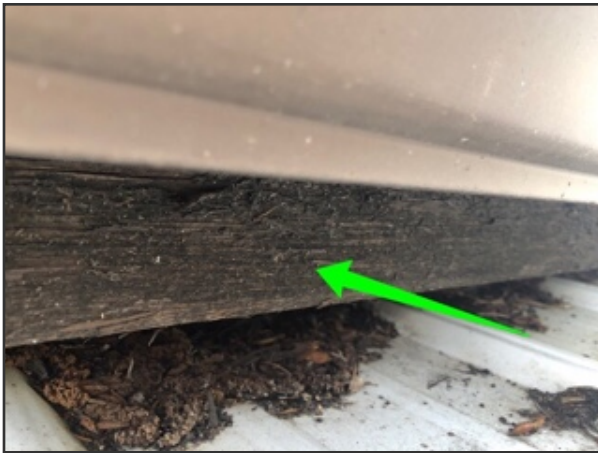
Figure 19-1

Observed wooden fascia on garage shows signs of visible deterioration, particularly above metal roofing addition. Recommend maintenance and repair.

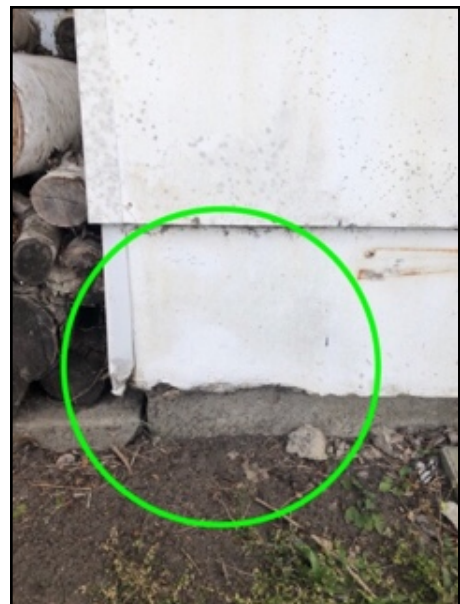
Figure 21-2

Comment 21:
Observed maintenance is required on exterior siding of garage. Recommend repair

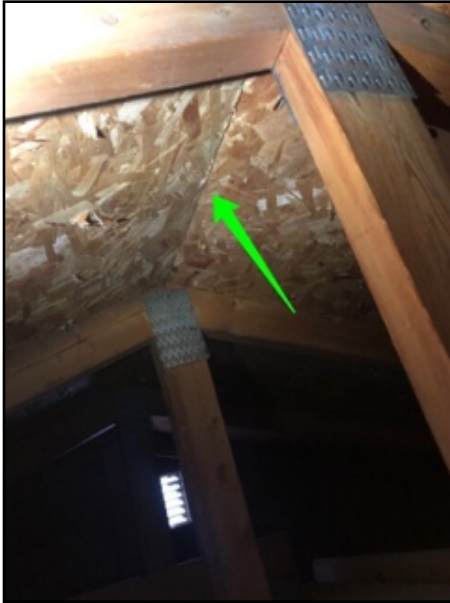
Figure 23-1

Observed garage roof trusses have missing ridge blocking. Recommend repair

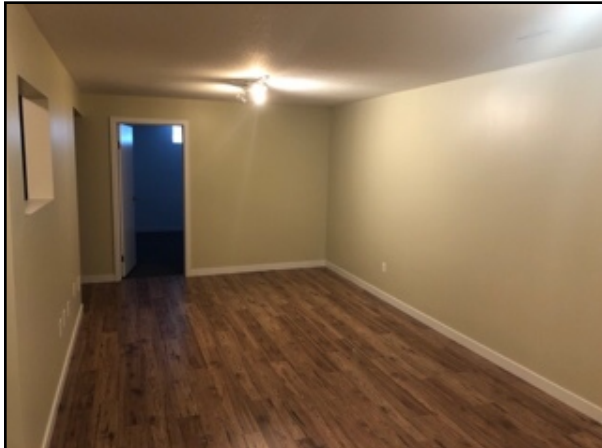
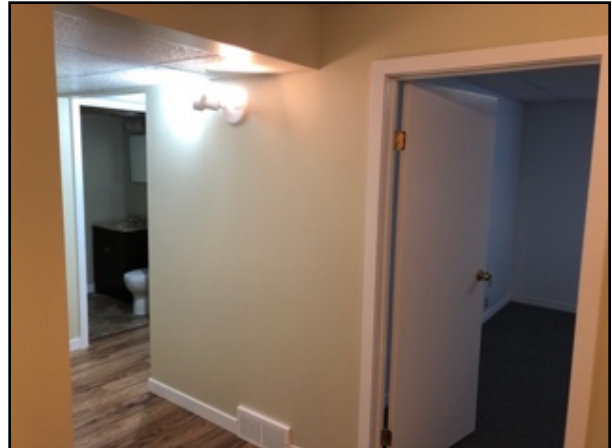
Comment 26:

Observed the basement appears to be fully developed. Unable to inspect interior of foundation, concrete floor, or wood floor system.

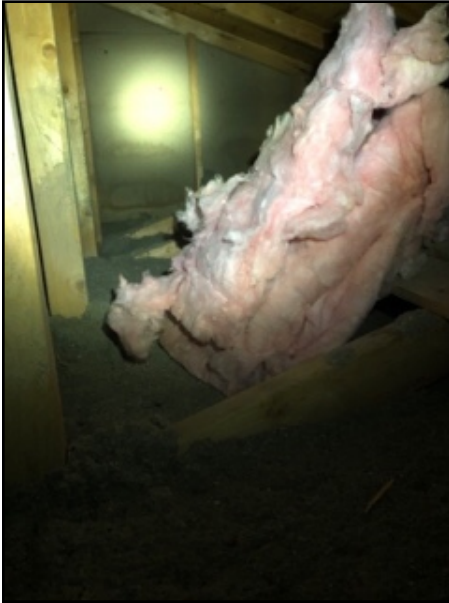
Observed attic insulation appears minimal for Canadian winters. Recommend additional insulation.

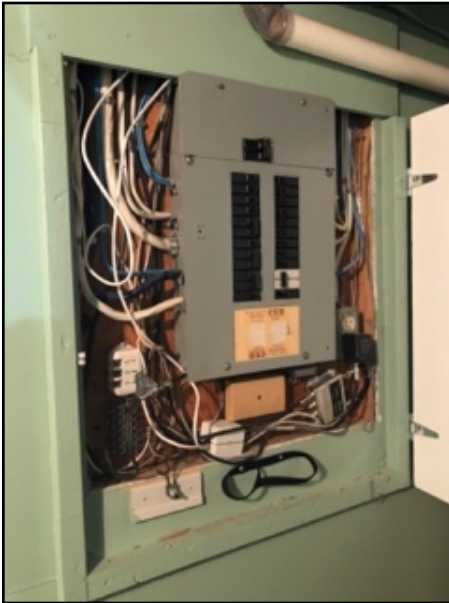
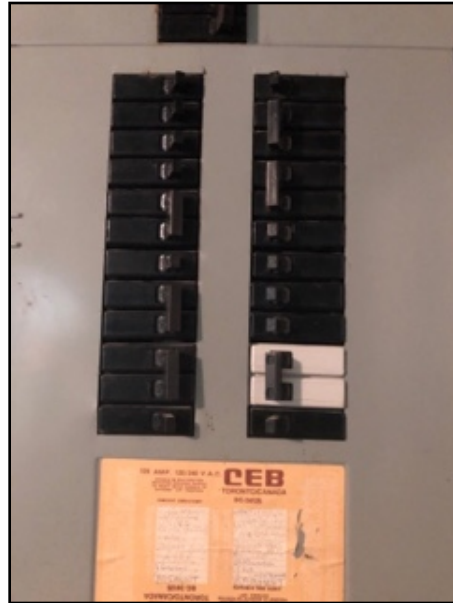
Comment 29:

Observed minor rust and some water marks at electrical panel main breaker. Observed panel appears to be dated. Recommend having electrical panel inspected by qualified contractor.

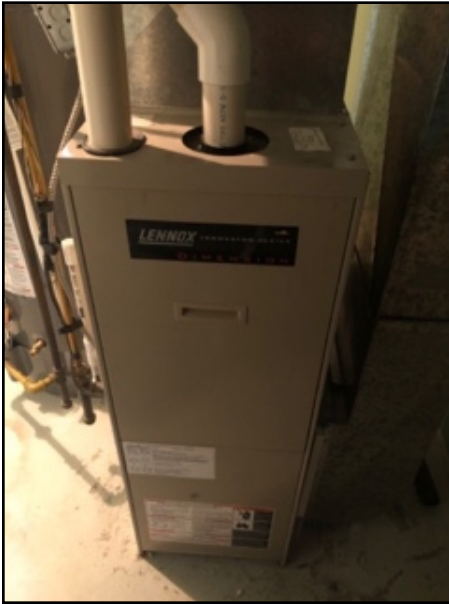
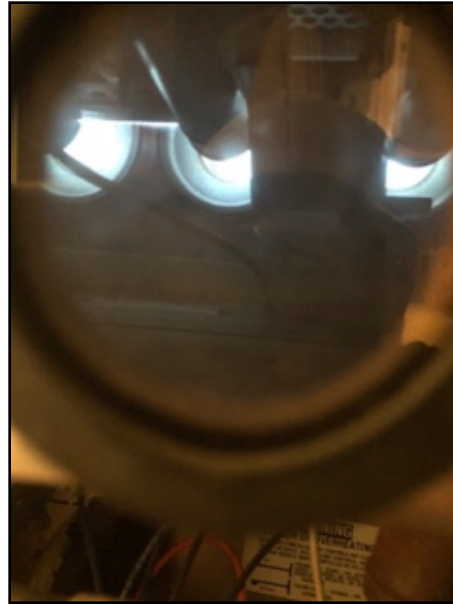
Comment 31:

Observed some rust in furnace cabinet. Appeared dry at time of inspection.
Recommend monitoring

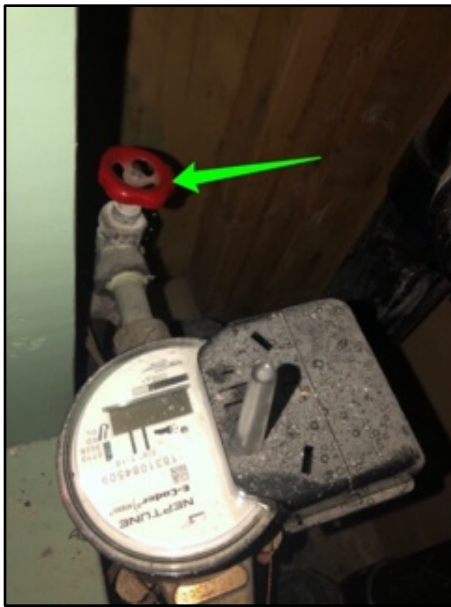
Figure 34-1

Comment 34:
Main water shut off valve.

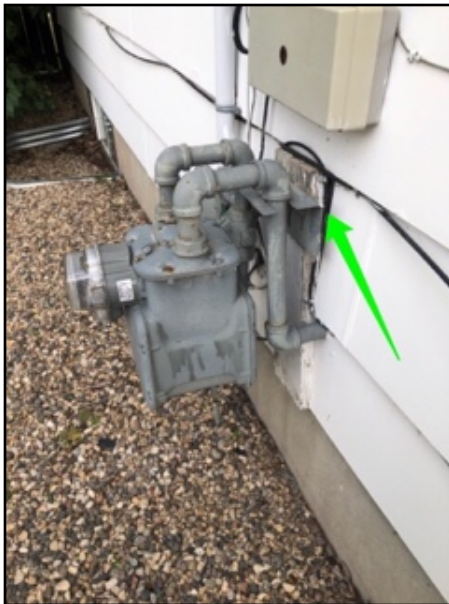
Comment 35:

Observed natural gas meter appears to be pulling away from the structure. Recommend contacting the utility service provider for repair.

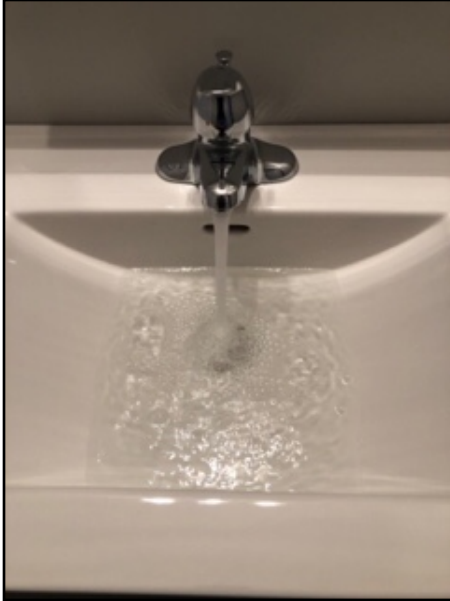
Comment 37:

There were no visible leaks in main floor bathroom at time of inspection.

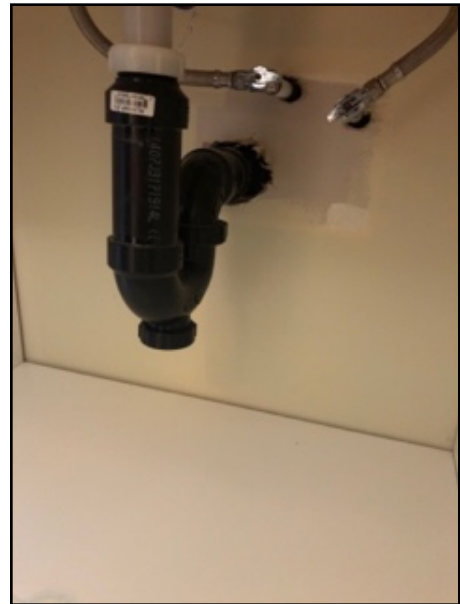
Comment 41:

There were no visible leaks in basement bathroom at time of inspection.

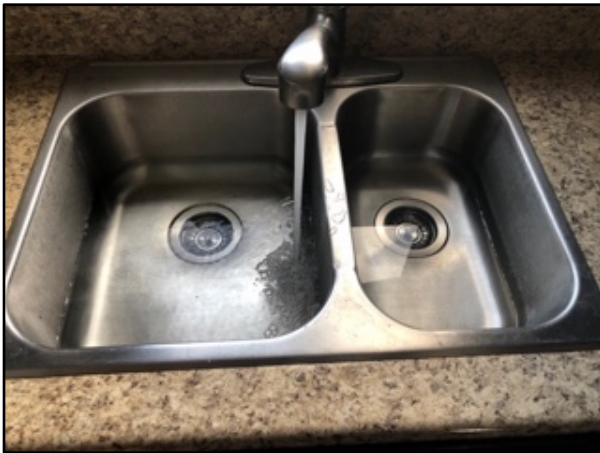
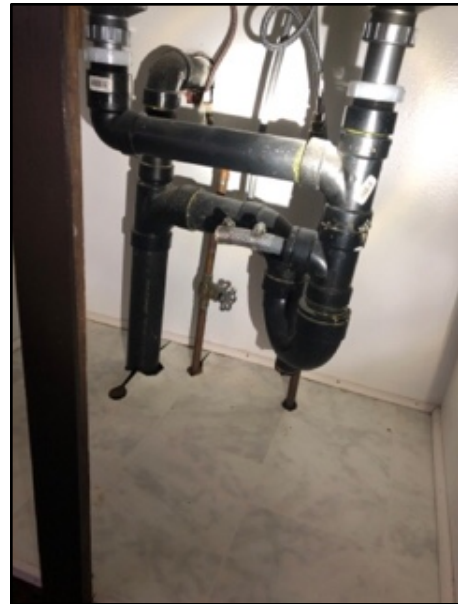
Figure 44-1

Comment 44:
There were no visible leaks in the kitchen at time of inspection.

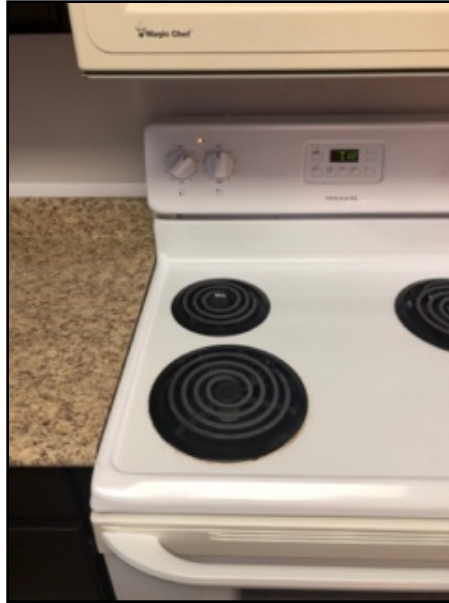
Oven:

Frigidaire
Condition: Satisfactory

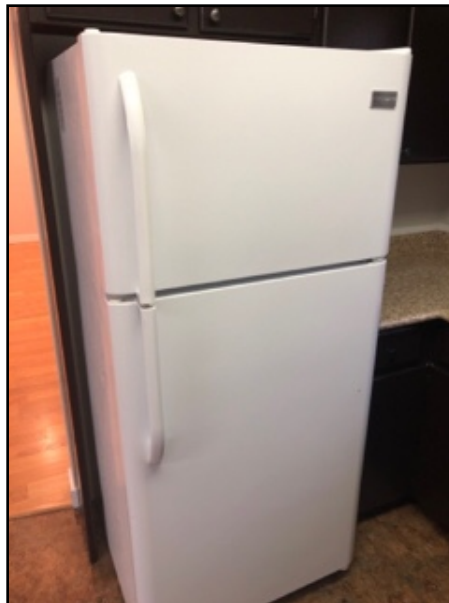
Refrigerator:

Frigidaire
Condition: Satisfactory

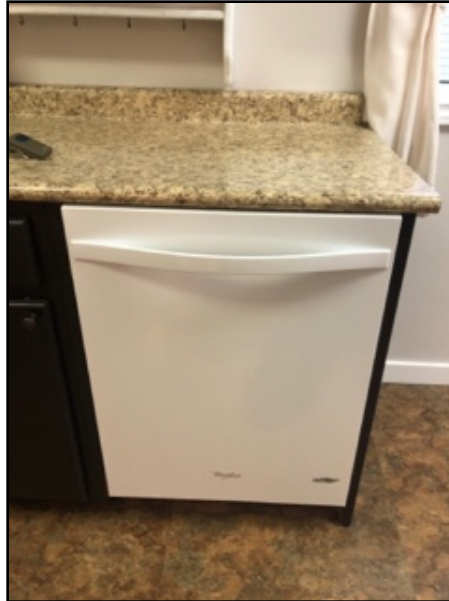
Dishwasher:

Whirlpool
Condition: Satisfactory

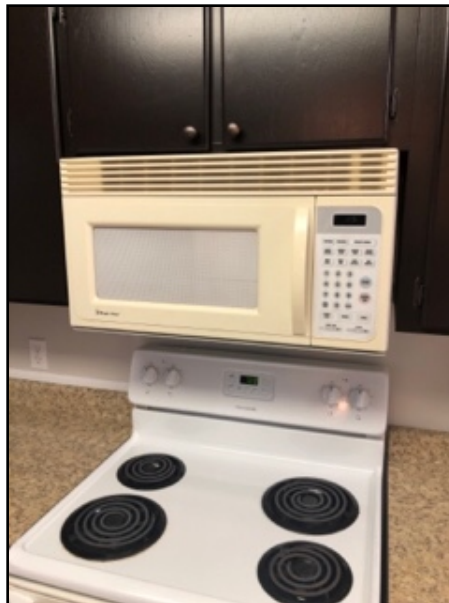
Microwave:

Magic Chef
Condition: Satisfactory

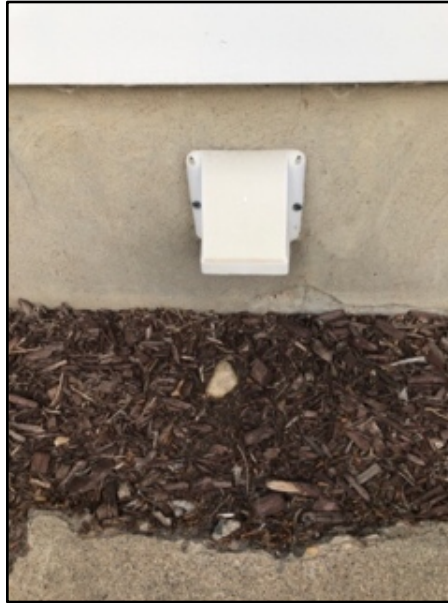
Dryer Venting:

To Exterior

Condition: Satisfactory

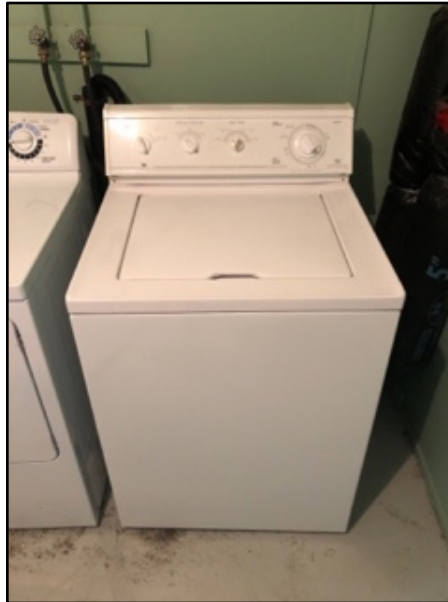
White-Westinghouse

Condition: Satisfactory

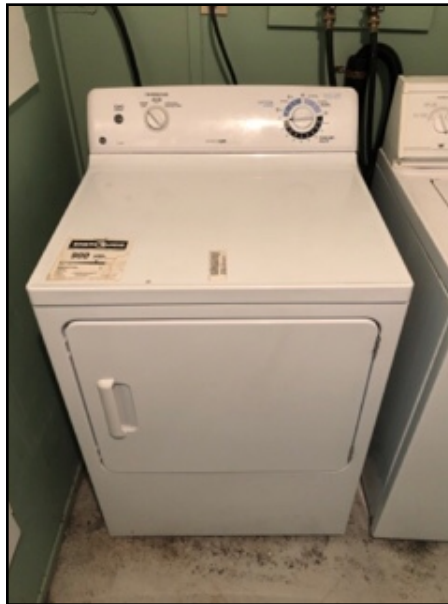
Dryer:

General Electric
Condition: Satisfactory

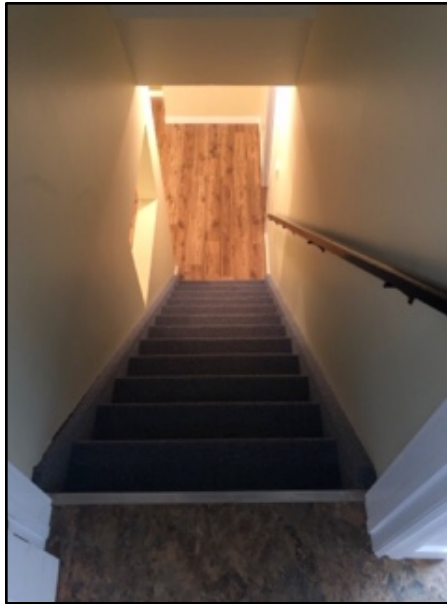
Window Types:	Casement, Sliders, Fixed
	Condition: Satisfactory
Window Materials:	Wood, Vinyl
Fireplace:	Not Present
Stairwell:	Handrail
	Condition: Satisfactory
