Evaluation of Sanitary Sewers and Manholes

**City of Panorama Park
Scott County, Iowa
February 2020**

Project No. 19924000

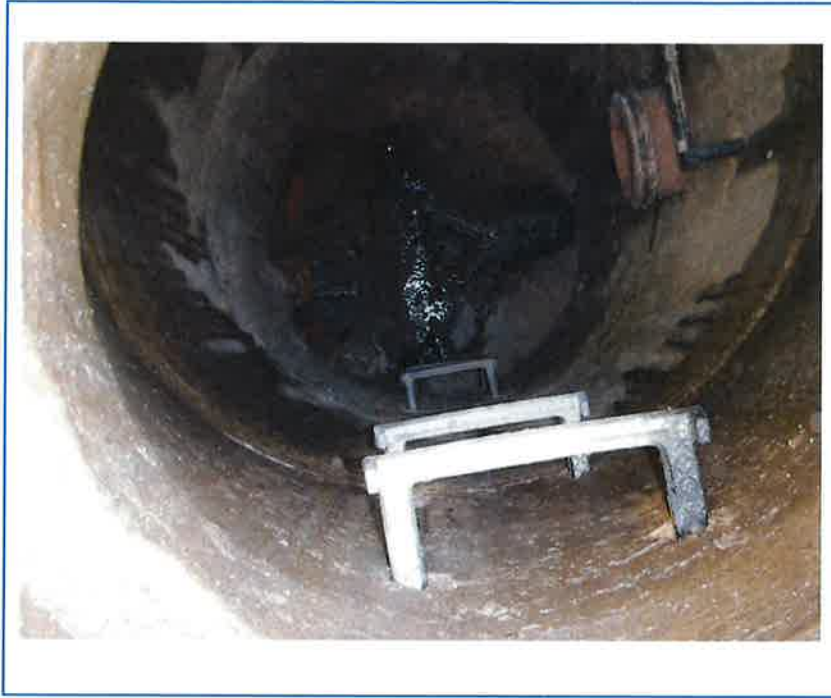
Picture Number 1

NOTE: BRING TO GRADE

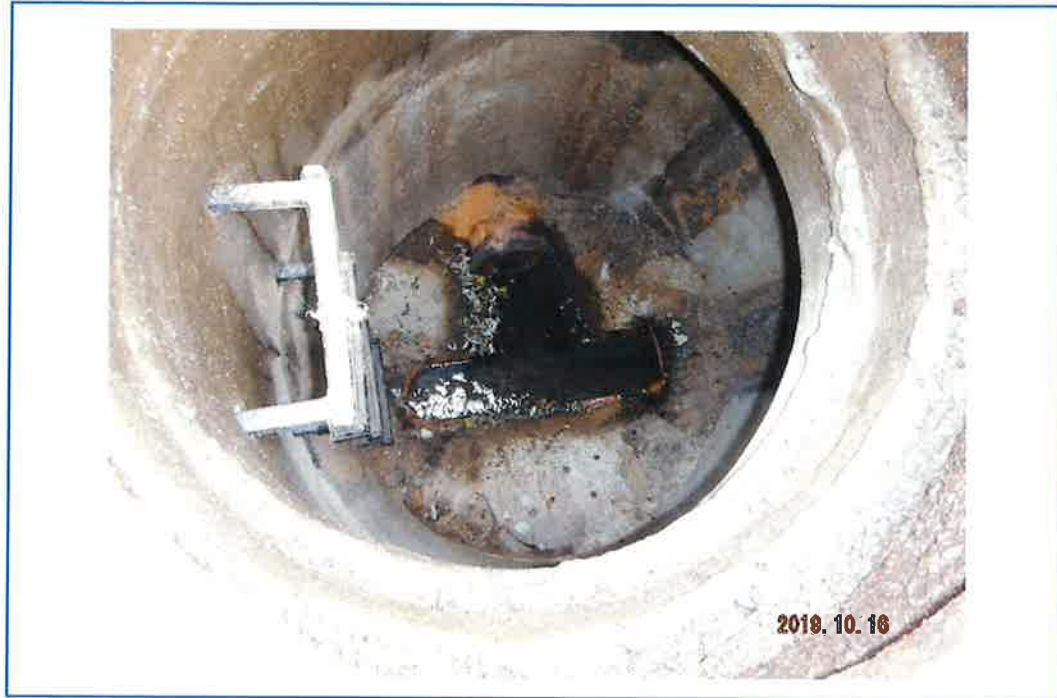
Picture Number 1

NOTE: BRING TO GRADE

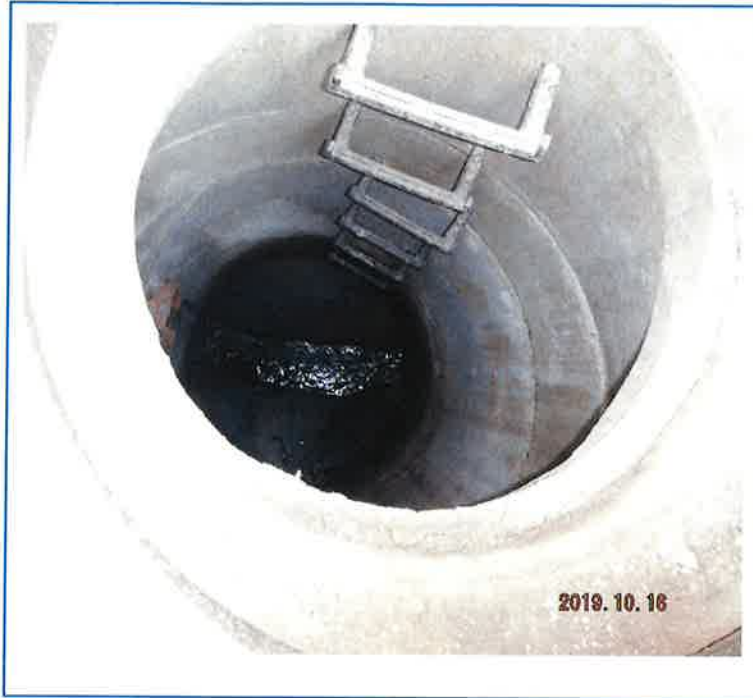
Picture Number 1

DROP MANHOLE

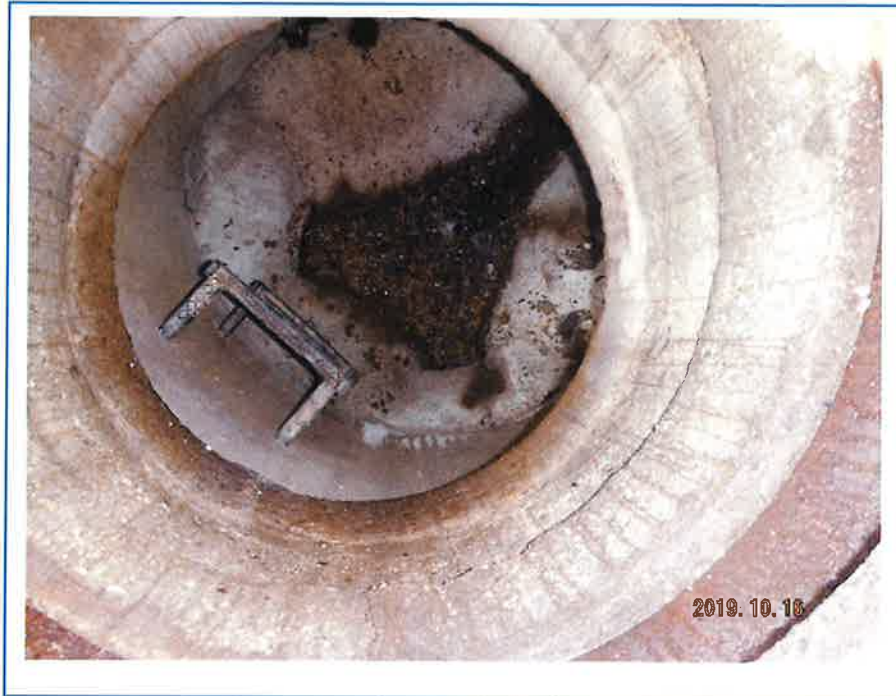
Picture Number 1

NOTE: BRING TO GRADE
