Property Inspection Report

**PROSPECTOR
HOME INSPECTIONS**

**757 Main St.
Inspection Prepared For: Mary Doe
Agent: Support - Home Inspector Pro**

**Date of Inspection: 12/5/2022
Home Age: 22 Size: 1448**

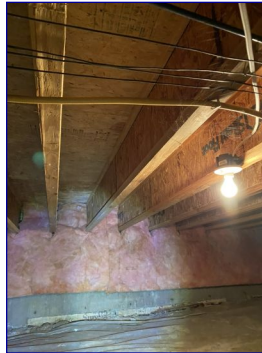
Joists

The floor joists do not have any insulation in them. The radiant heat is attempting to heat the uninsulated crawl space as well as the house. I recommend installing insulation for increased energy efficiency.

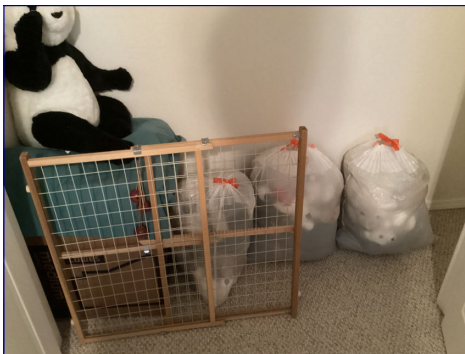
The owners belongings are blocking access to this area and other areas throughout the house. For this reason, some areas could not be fully inspected.

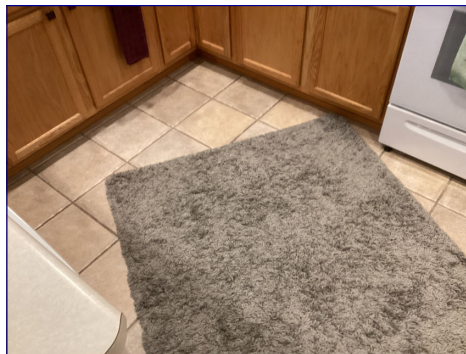
The area rug in the kitchen was taped to the floor. This limited my inspection of the floor tiles.

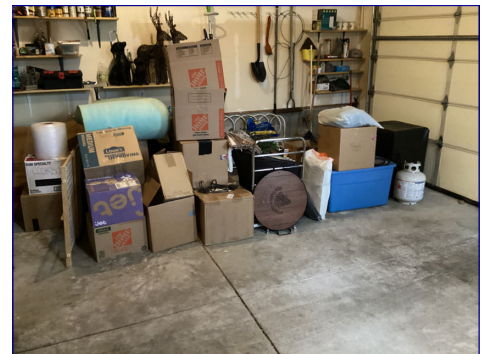
The owners belongings are blocking access to this area. For this reason, the area could not be fully inspected.

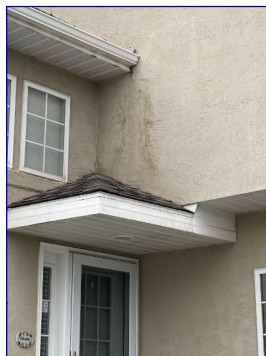
This photo shows additional water staining on the exterior siding. I recommend a licensed roofer evaluate the roof system.

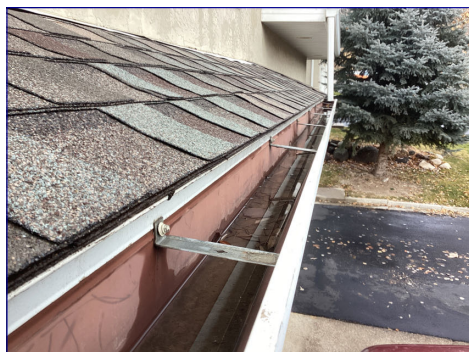
Gutters

The gutter over the garage door had pooling water in it. The gutter needs to be adjusted to drain the standing water.

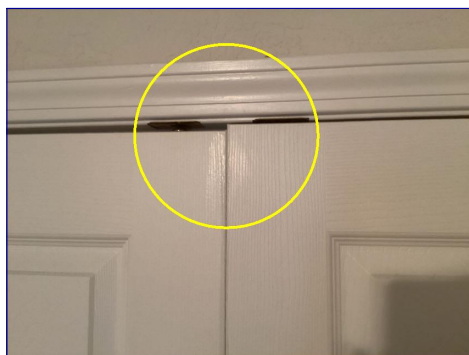
Door

The left closet door is slightly out of alignment. The closet doors rubbed a little bit at the top.

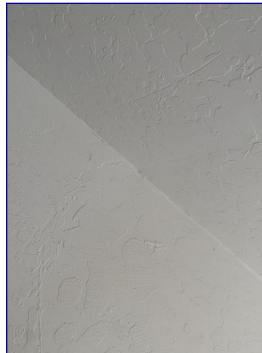
There are small cracks along the seam above the stairs.

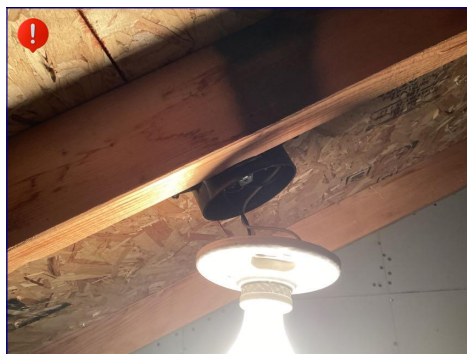
Electrical

The light fixture needs to be secured to the housing.

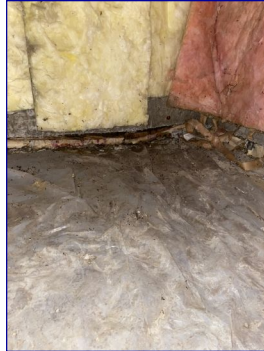
Insulation

The foundation walls were insulated. The insulation prevented me from viewing the foundation walls in the crawl space. The foundation walls were not inspected.

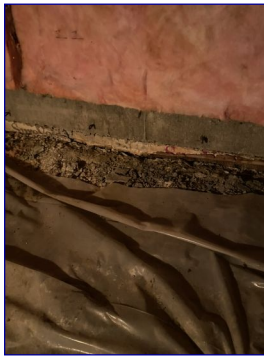
Vapor Barrier

The vapor barrier is present in the crawl space. I recommend repairing and relaying the vapor barrier so it will perform it's intended purpose.

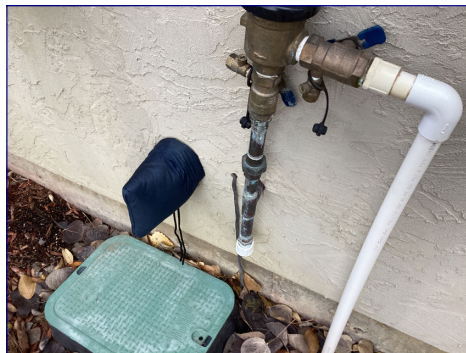
Hose Bibs

Exterior hose bib was winterized. I removed the exterior cover to determine it is an anti-siphon valve. I did not remove the interior cover because of how it was secured. For this reason, the hose bib was not tested.

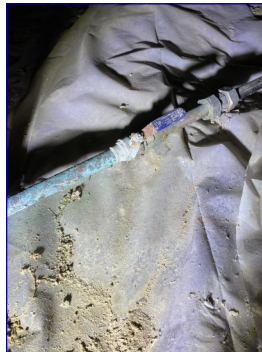
Water Entry Piping

The main water valve into the house is located in the crawl space. I recommend having a licensed plumber evaluate the old corroding valve. This will ensure it works when needed. This is a minor issue because there is the other shutoff valve behind the water softener.
