**Illuminating real estate  
investment decisions since 1999**

1568 Sample Street , Any City, CA  
Inspection prepared for: Sample Client  
Date of Inspection: 3/26/2022

Inspector: Scott Schildknecht  
ASHI Certification # 252268  
1485 Maria Avenue , Concord , CA 94518  
Phone: (707)649-8700  
Email: [scott@northbayinspection.com](mailto:scott@northbayinspection.com)  
[Northbayinspection.com](http://Northbayinspection.com)

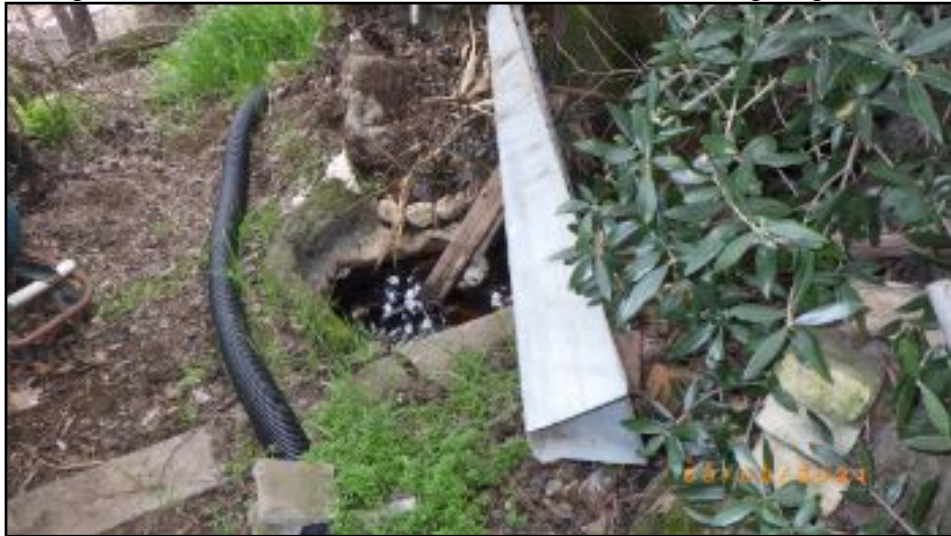
pond at the rear

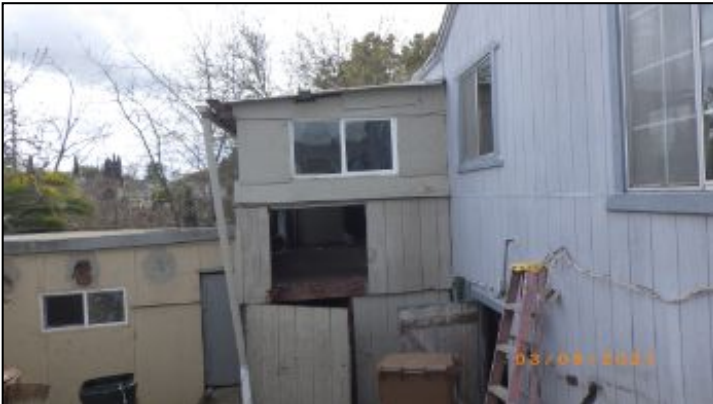
attached structure

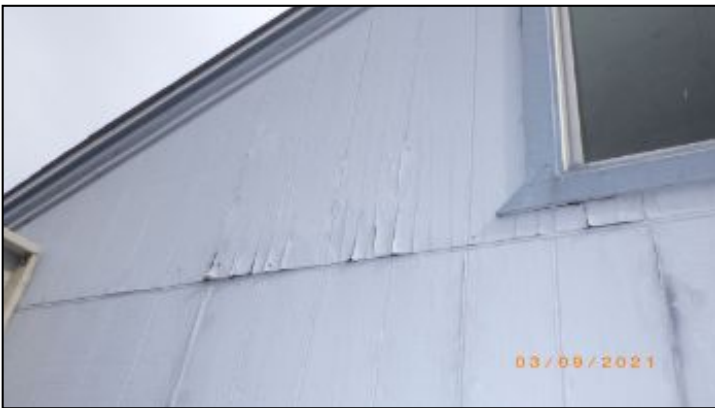
delaminated siding

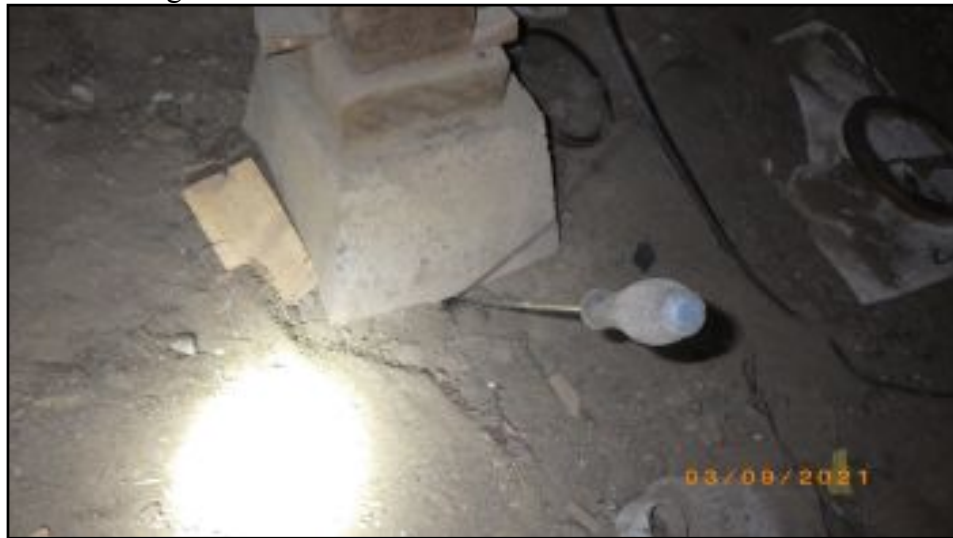
no footings

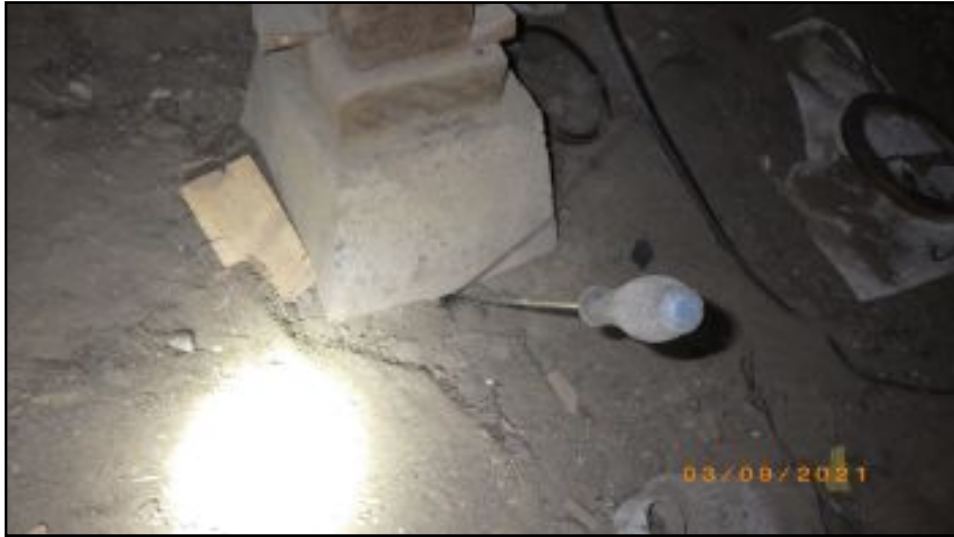
no footings

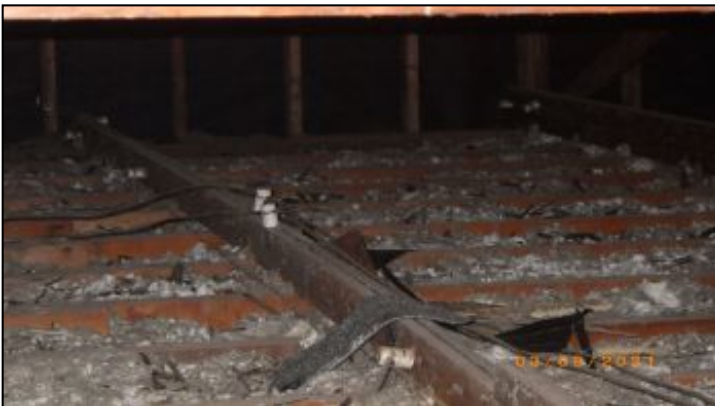
knob and tube wiring

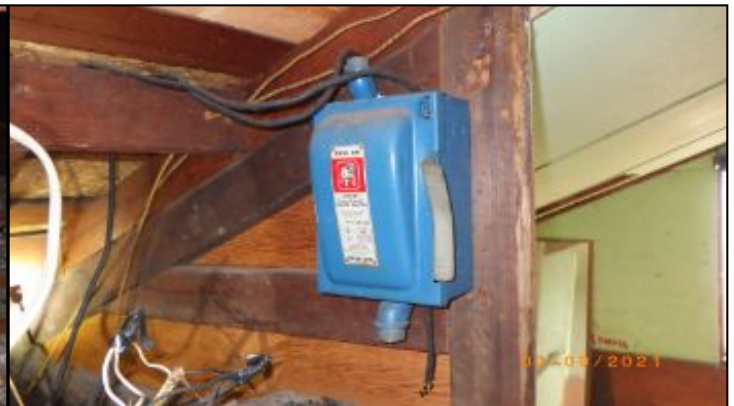
abandoned wiring

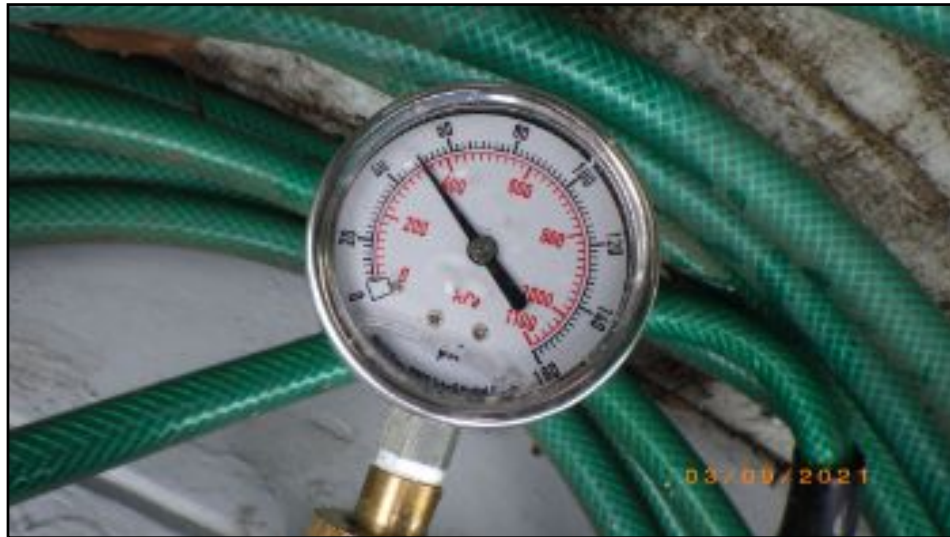
normal pressure

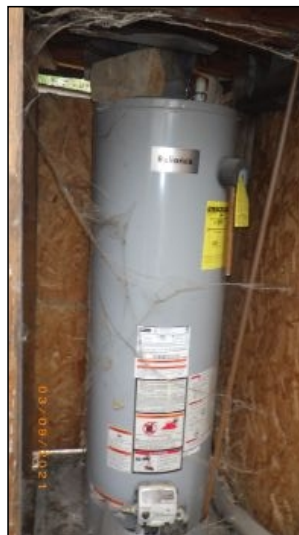
The water heater is missing seismic restraints. We recommend installing approved restraints on this water heater. Note: The California State Architect is the determiner for minimum standards for Department of Real Estate (DRE) requirements. About Seismic Restraints: The best braces are rigid and support the water heater both top and bottom; plumber's tape, aluminum straps, inlet/outlet supports, and other non-approved restraints are no longer considered adequate restraints according to the guidelines of the California Seismic Safety Commission and the California State Architect Guidelines. As of January 1 1997, home sellers in California are required to certify that this water heater complies with current guidelines upon sale of the property.

Several aspects of the water heater and/or its installation are improper. Please read the entire plumbing section for more information.

several aspects bad

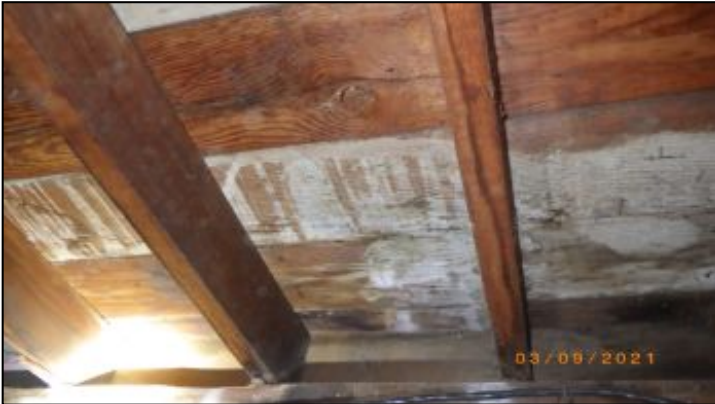
**The framing beneath the ground floor of this home is inadequate at the addition. This may allow excessive deflection of floor framing that results in sloped or bouncy floors and can potentially result in failure of the floor system under extreme conditions. We recommend further inspection and repairs by a qualified contractor.**

outdated framing

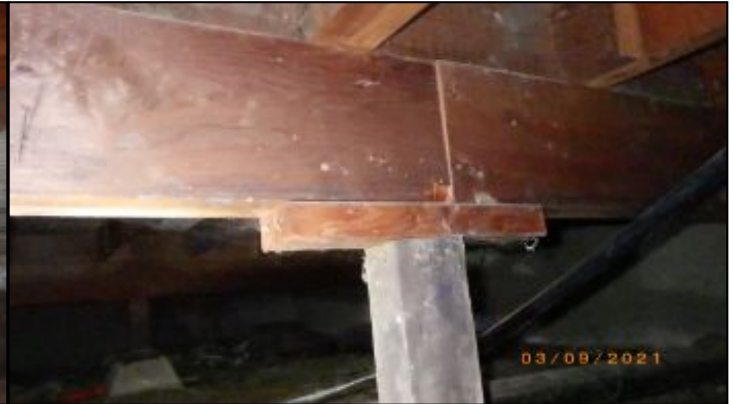
framing observations

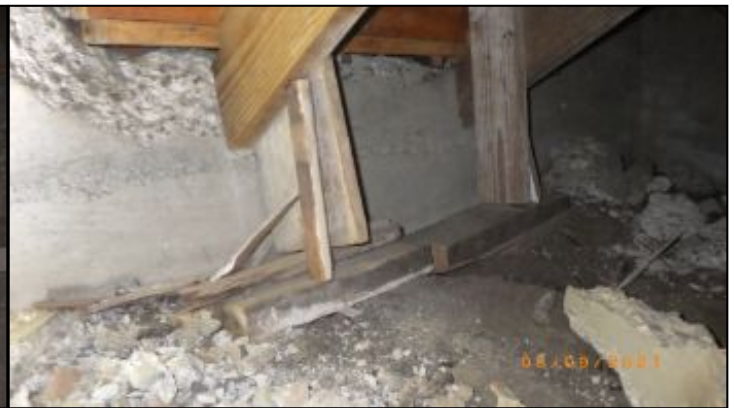
in contact with soil

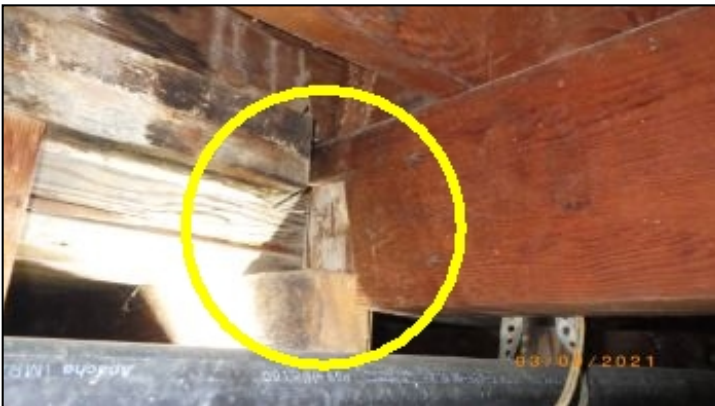
bad framing

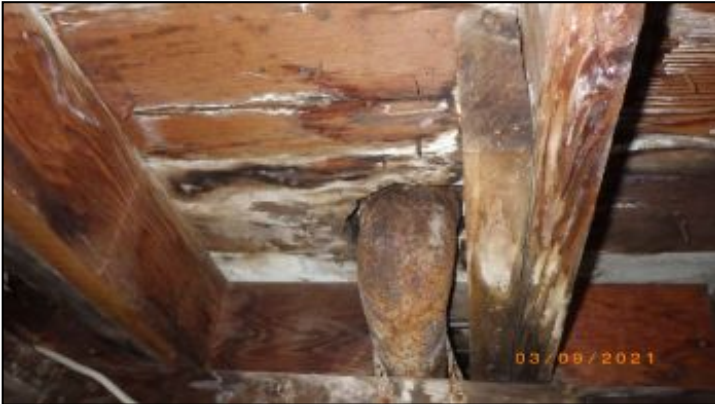
water stains
