This **Summary Report** is meant to organize any **Moderate Recommendations** and **Significant and/or Safety Concerns** into a shorter, straight to-the-point format. It does not, however, include **Upgrade/Maintenance** recommendations or Informational data that can be found in the Full Report.

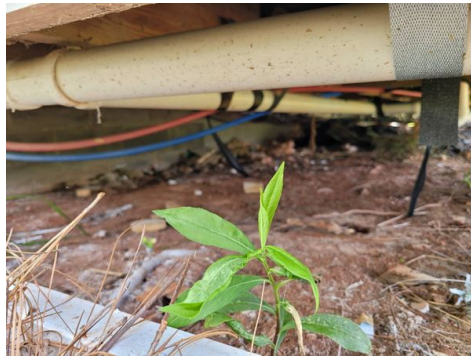
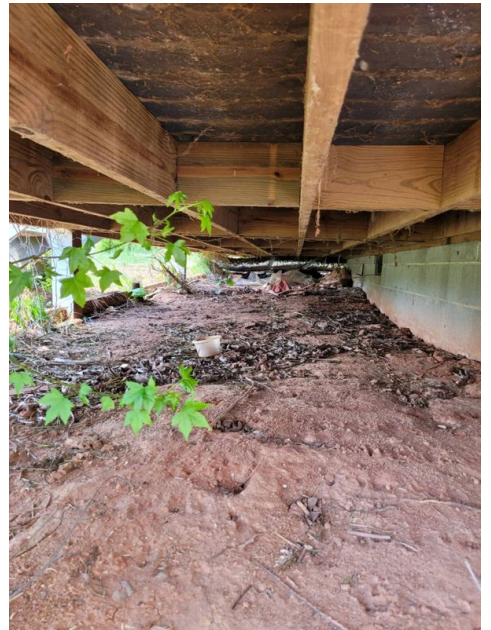
Master Bath & middle rear room bumpout

One or more additions to the home were added above an existing porch. In addition to plumbing, wiring, and ductwork being exposed to the elements, this may also be of structural or safety concerns. Recommend further evaluation by a qualified contractor in addition to asking for permits in reference to the additions.

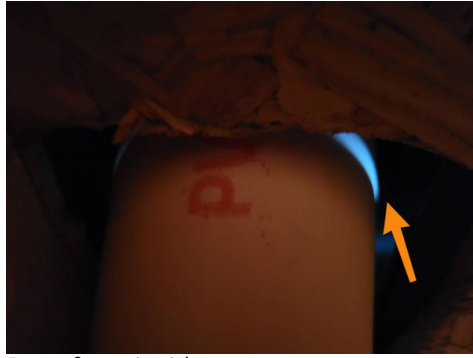
One or more plumbing vents were damaged. Recommend repair.

Boot from inside

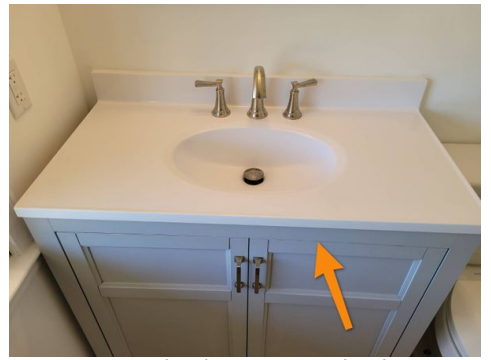
Front center bedroom attached bathroom

Countertop was not completely fastened to the cabinets.
