Water Penetration Forensic Investigation

FINAL – 5-5-21

## Glazing Inspection Report

[REDACTED]  
[REDACTED]  
**Tallahassee, Fl 32312**  
**FINAL - Report date 5-5-20**

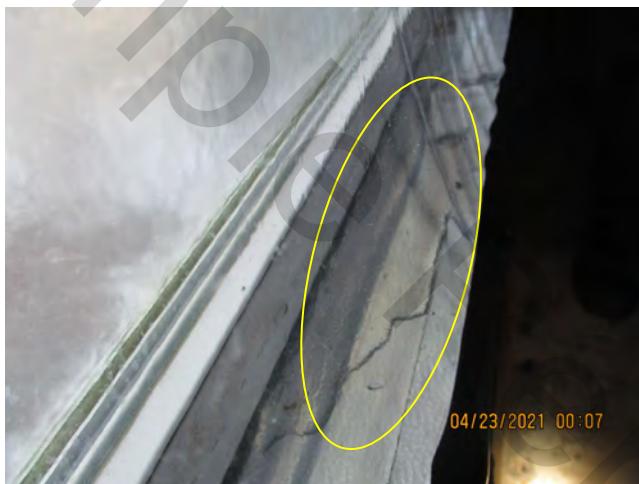
Water penetration was witnessed at the sill frame member of window systems tested by the ASTM E-1105 field test.

Water Penetration witnessed at window sill – unit 216 – spec 1

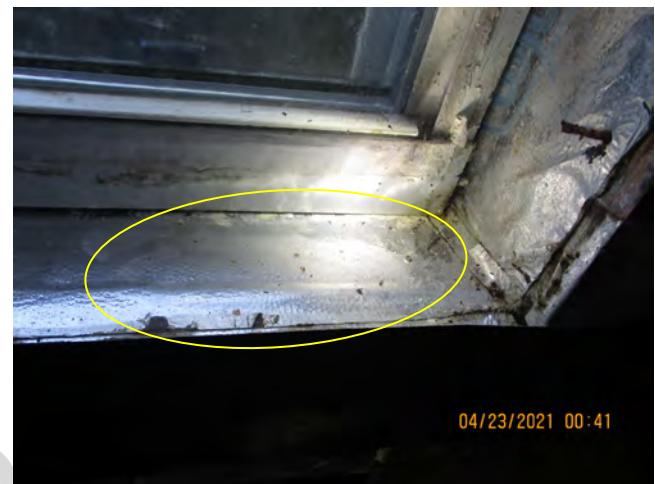
Water Penetration witnessed at window sill – unit 216 – spec 2

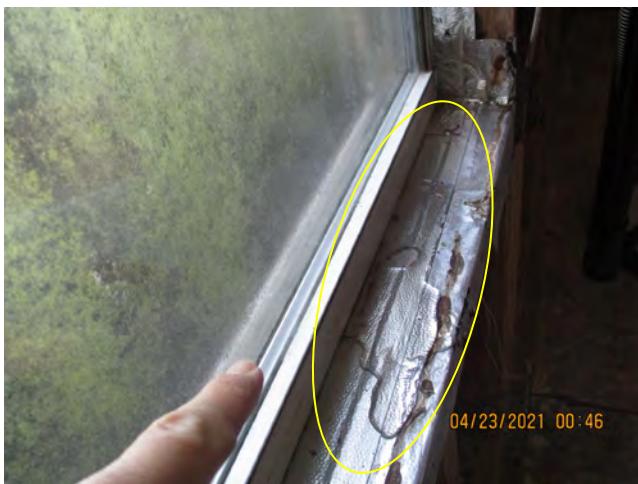
Water Penetration witnessed at window sill – unit 216 – “untested system adjacent to spec 2”

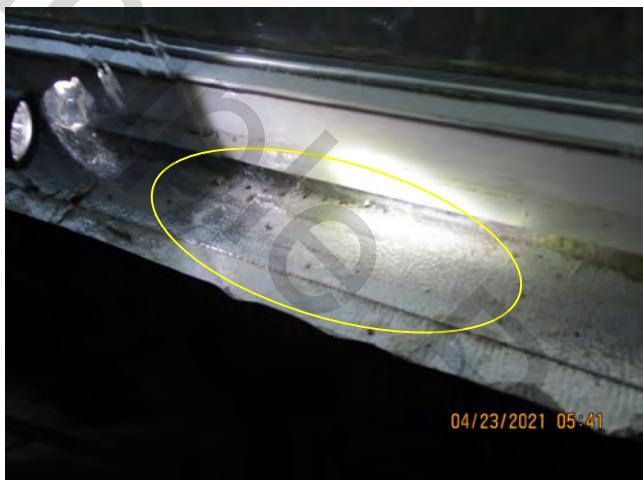
Water penetration was witnessed at the interlocking frame member and sill frame member of window systems tested by the ASTM E-1105 field test.

Water Penetration witnessed at window sill – unit 311 – spec 1

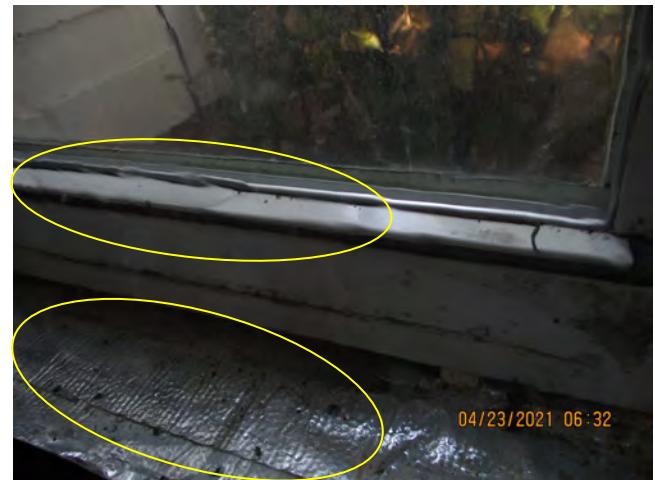
Water Penetration witnessed at window sill – unit 311 – spec 2

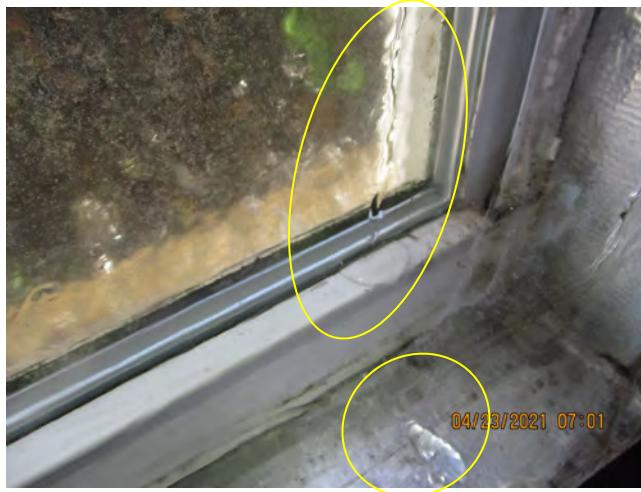
Water Penetration witnessed at interlock and sill – unit 311 – spec 3

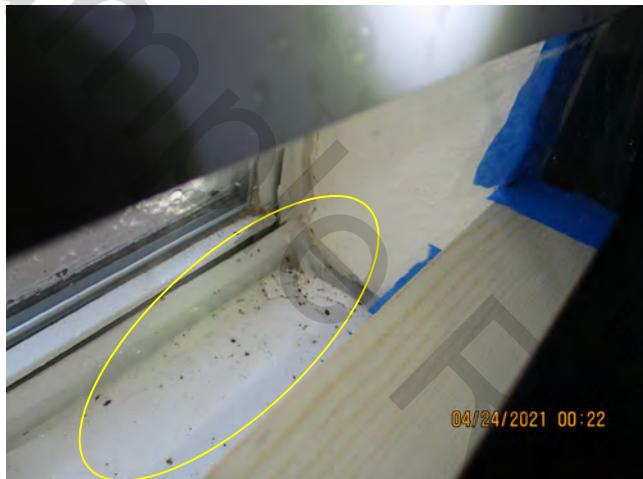
Water penetration was witnessed at the interlocking frame member and sill frame member of window systems tested by the ASTM E-1105 field test.

Water Penetration witnessed at window sill – unit 917 – spec 1

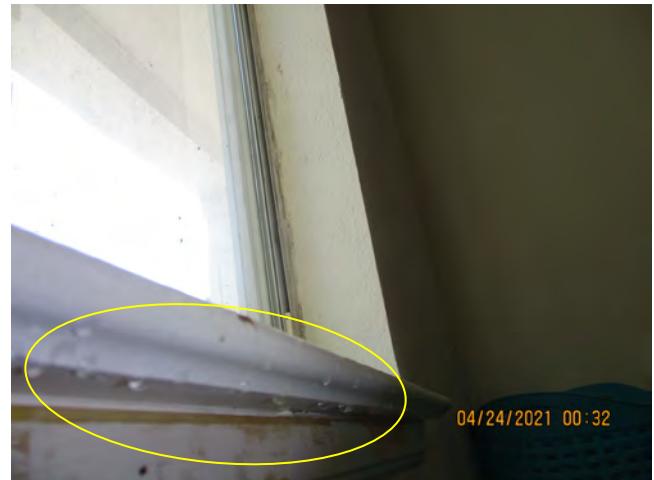
Water Penetration witnessed under the window sill – unit 917 – spec 1

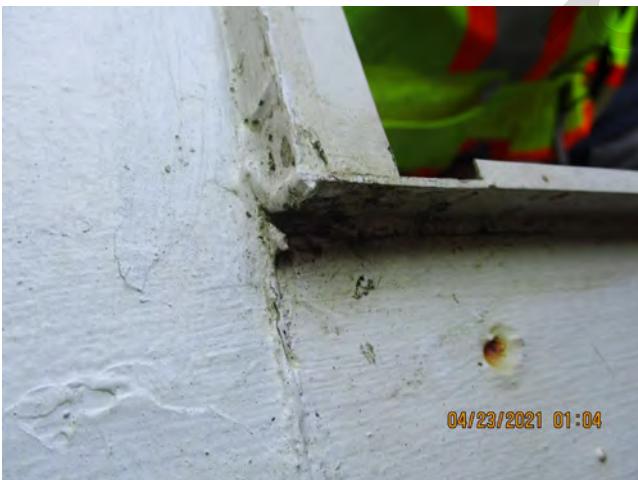
Sources of Water Penetration  
Identified – Unit 216

1. Before a Remedial Sealant protocol is started, we recommend that a qualified contractor remove the exterior casing/trim around the window systems and inspect the condition of the Exterior Flashing, Nailing Fin, and the windows adherence to the OSB Substrate. Repair any issues found that may be an underlying cause of Water Penetration.

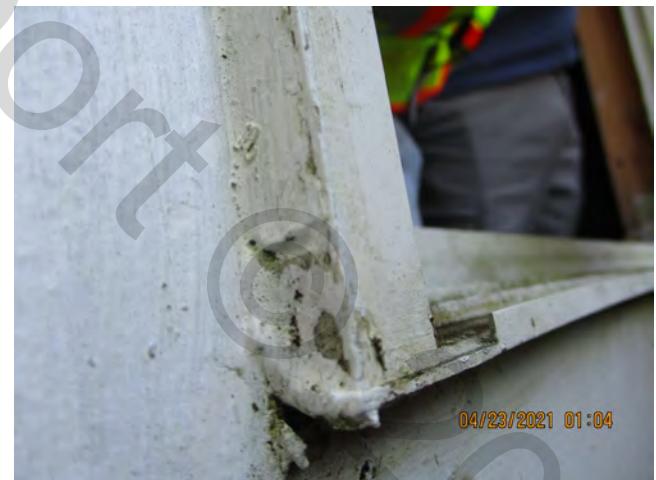
Sources of Water Penetration  
Identified – Unit 216

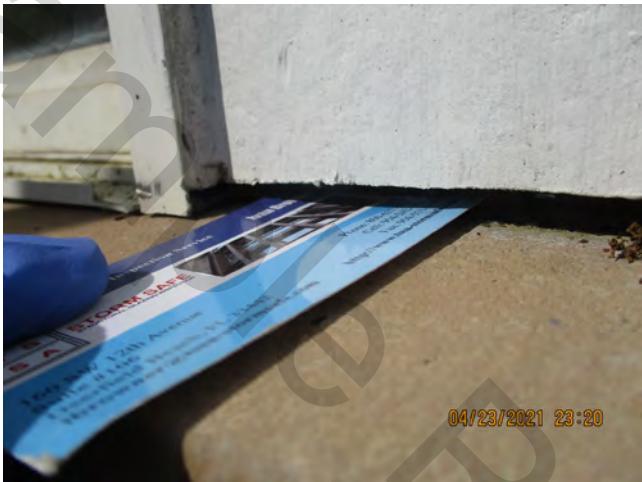
Sources of Water Penetration  
Identified – Unit 917

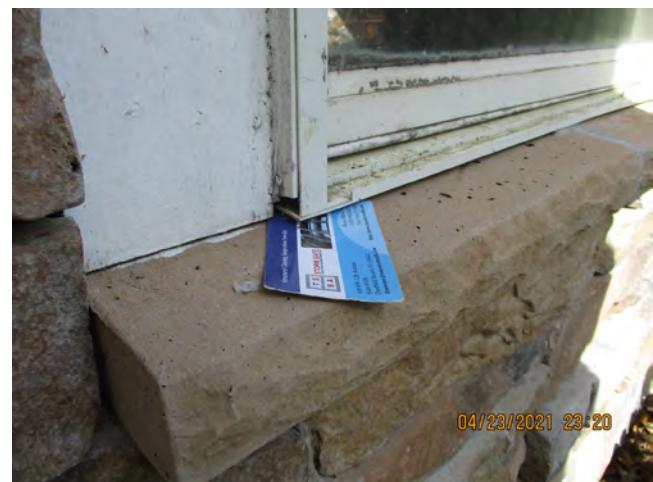
Sources of Water Penetration  
Identified – Unit 917

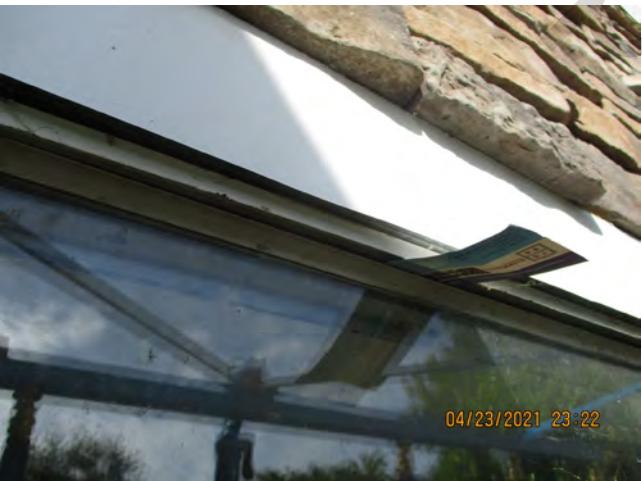
Sources of Water Penetration  
Identified – Unit 917

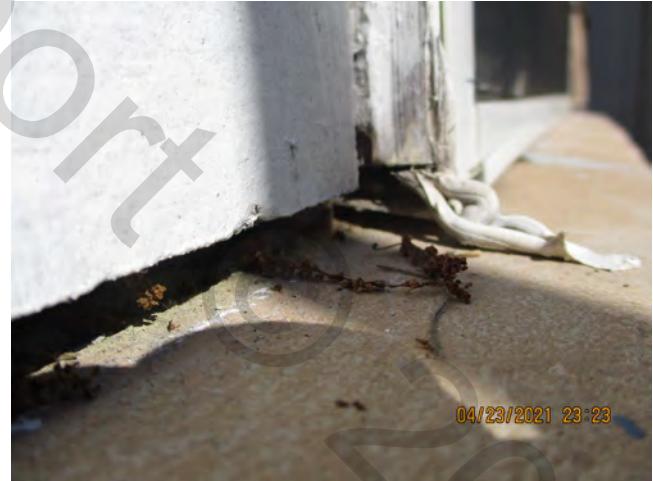
Sources of Water Penetration  
Identified – Unit 917

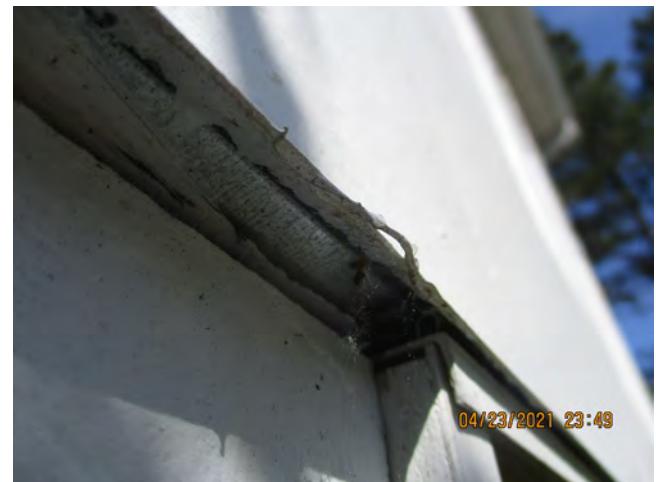
Sources of Water Penetration  
Identified – Unit 917

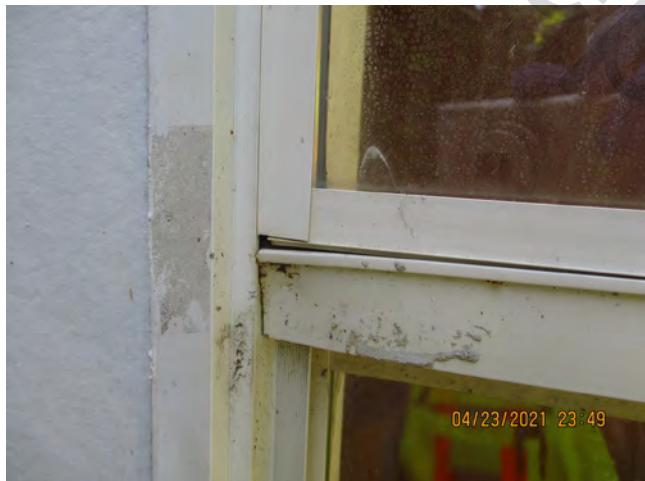
Sources of Water Penetration  
Identified – Unit 917

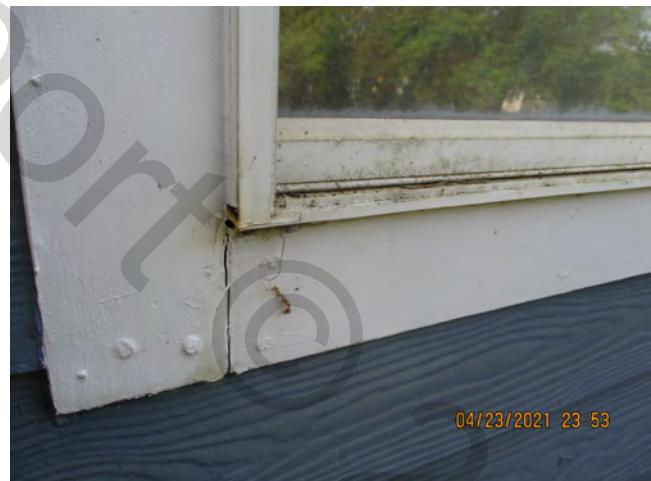
Sources of Water Penetration  
Identified – Unit 917

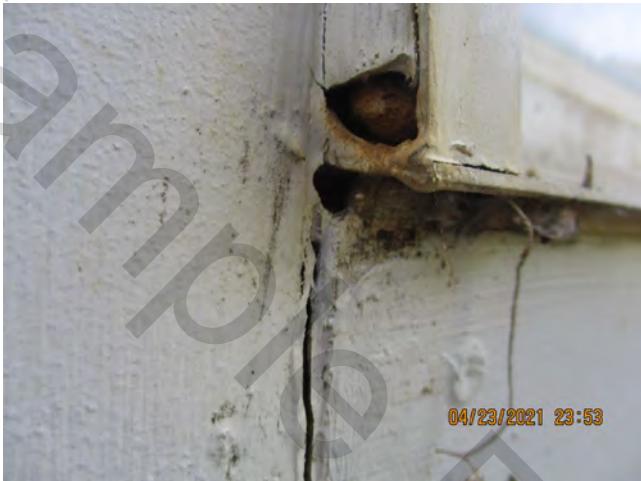
Sources of Water Penetration  
Identified – Unit 917

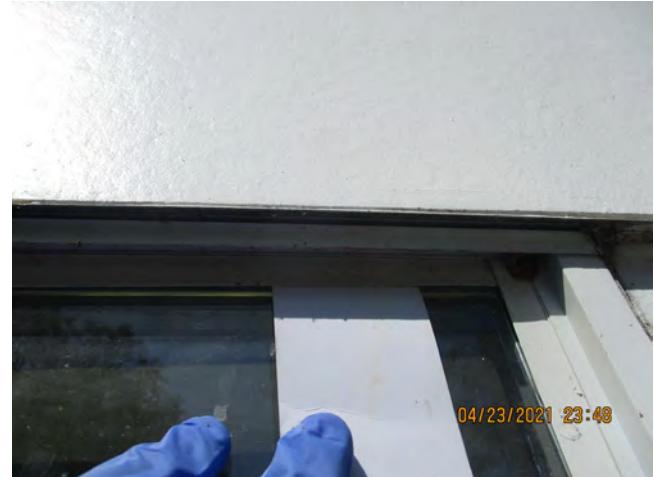
Sources of Water Penetration  
Identified – Unit 917

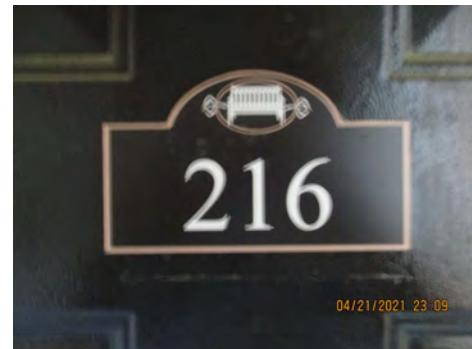
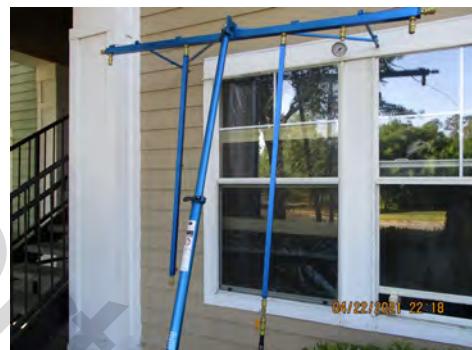
Building 2 – Unit 216  
Specimen 1

Cycle 2 – (Failure) 3:28 min  
Water Penetration witnessed  
at Sill Frame Member

Cycle 2 - Water  
Infiltration witnessed  
in IGU of Non-  
Operational Sash

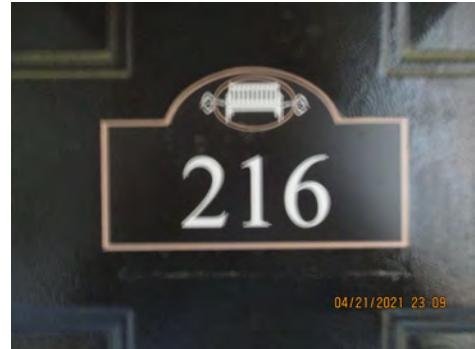
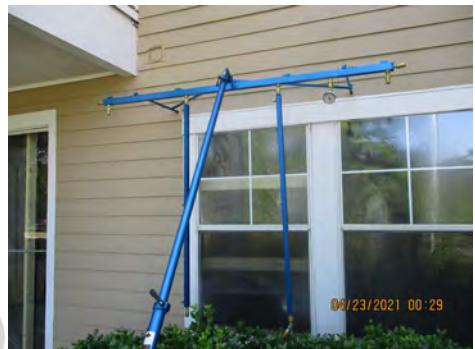
Building 2 – Unit 216  
Specimen 2

Note – Incidental moisture penetration occurred at window next to this specimen from over spray of our spray rack. This second window did not have a vacuum being created during the time of failure.

Cycle 1 – (Failure) 4:54 min  
Water Penetration witnessed  
at Sill Frame Member

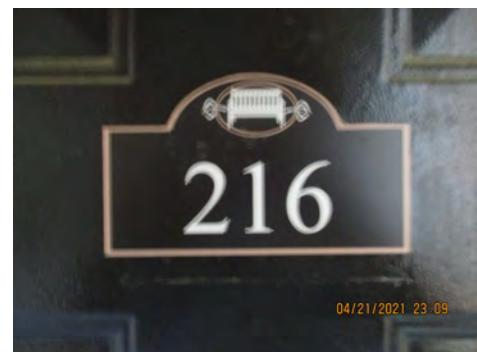
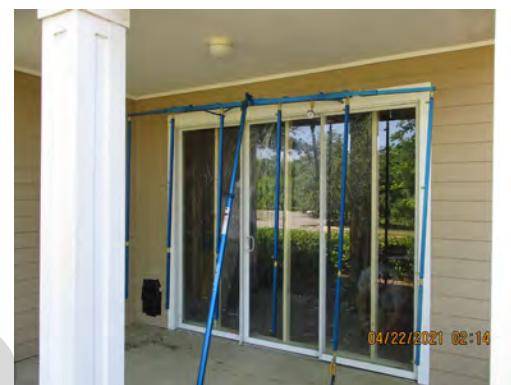
Building 2 Unit 216 spec 3

NA – The final result of one of the systems tested, "Sliding Glass Door" (Building 2 – unit 216 – spec 3), was inconclusive due to the fact that TSSA Storm Safe DAC Inc. inspectors were not able to create a strong enough vacuum pressure within our constructed testing chamber.

This was because there was a great deal of uncontrollable Air Infiltration between the installed Sliding Glass Door System and the Fenestration it was installed within.

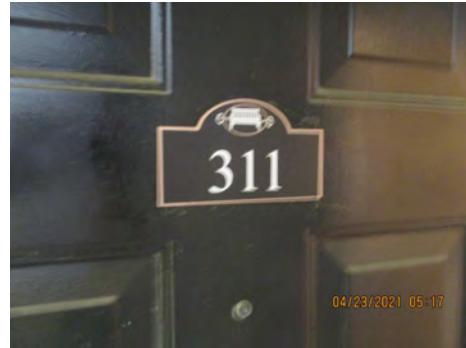
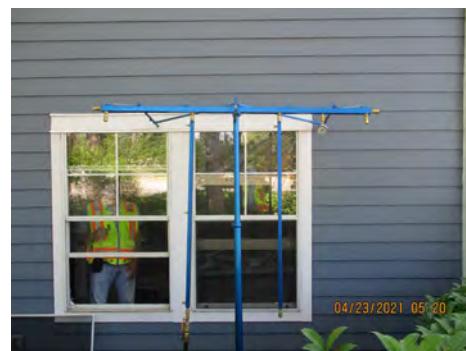
Building 3 Unit 311 spec 1

Cycle 2 – (Failure) 3:31 min  
Water Penetration witnessed  
at Sill Frame Member

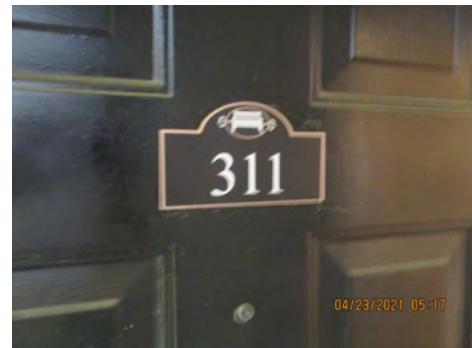
Building 3 Unit 311 spec 2

Cycle 1 – (Failure) 4:59 min  
Water Penetration witnessed  
at Sill Frame Member

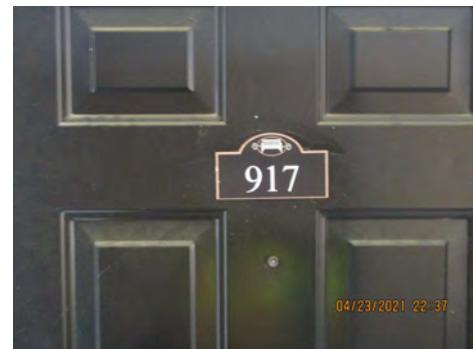
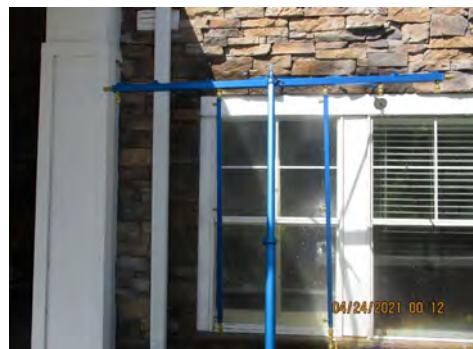
Building 9 Unit 917 spec 1

Cycle 2 – (Failure) 1:44 min  
Water Penetration witnessed  
at Sill Frame Member

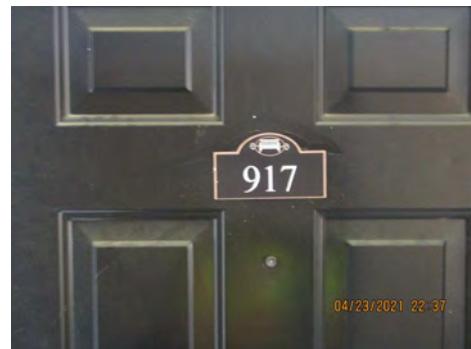
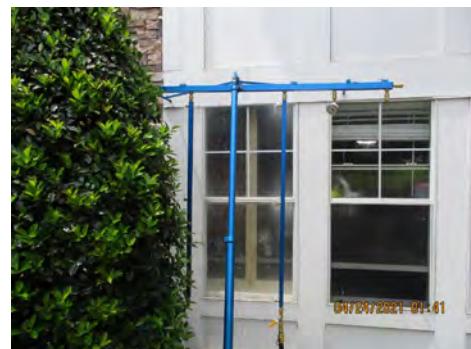
Building 9 Unit 917 spec 2

Cycle 2 - Water  
Infiltration witnessed  
at Interlocking  
Meeting Rail

Cycle 2 – (Failure) 2:26 min  
Water Penetration witnessed  
at Sill Frame Member

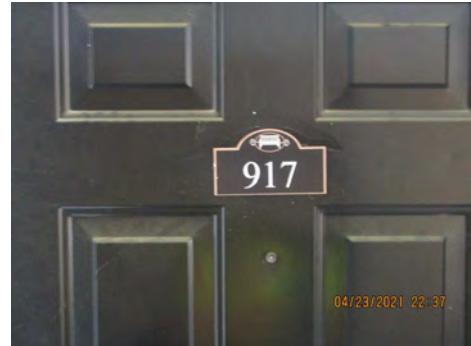
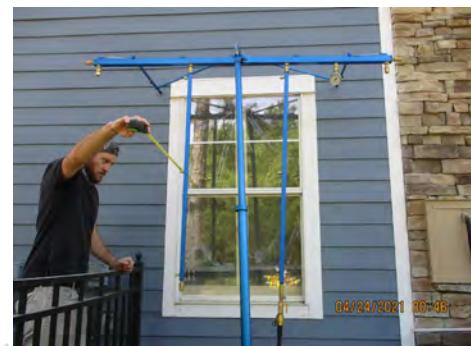
Building 9   Unit 917   spec 3

Note – This Specimen is a Pass  
No moisture penetration was witnessed  
during each of the three testing cycles.

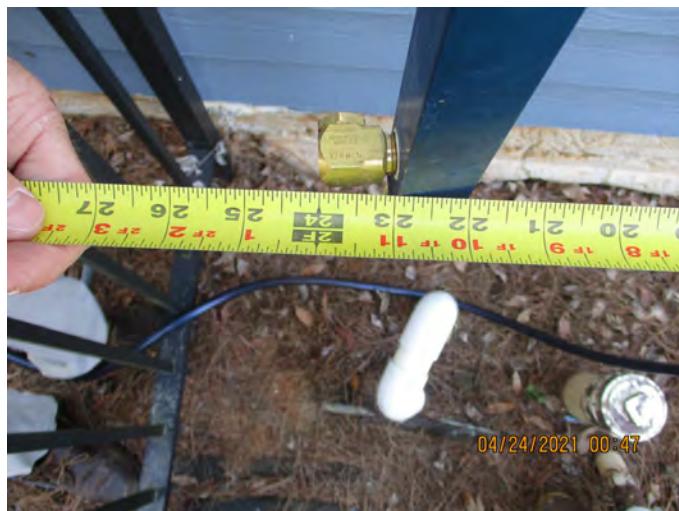
Testing Chamber on Interior of test specimen

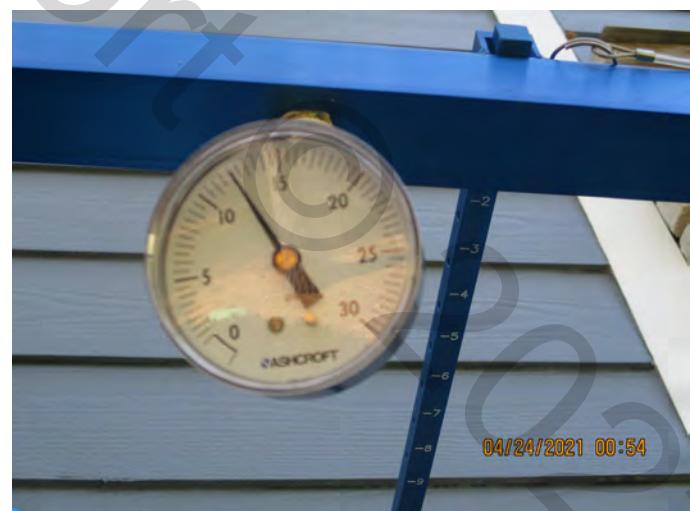
Cycle 1 – Chamber Pressure Achieved

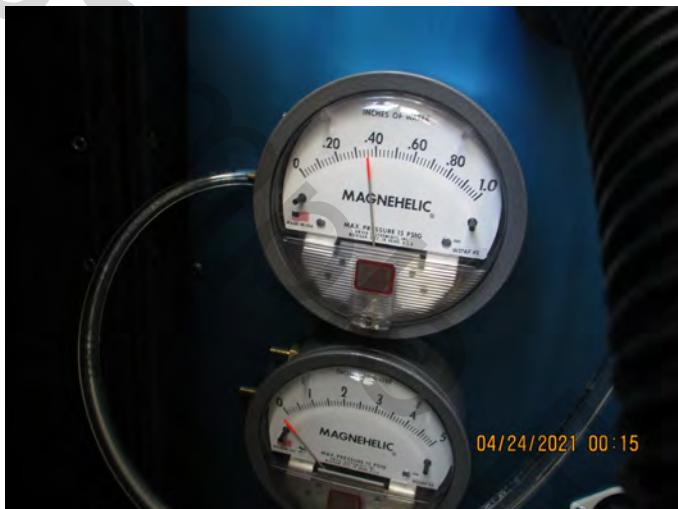
Cycle 2 – Chamber Pressure Achieved

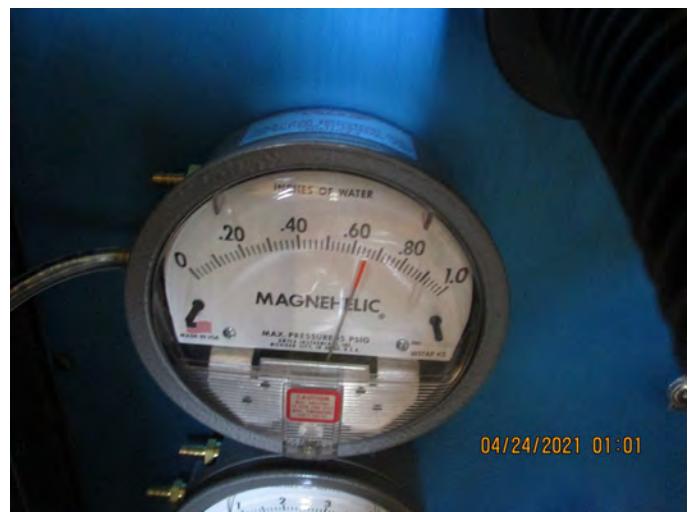
Cycle 3 – Chamber Pressure Achieved

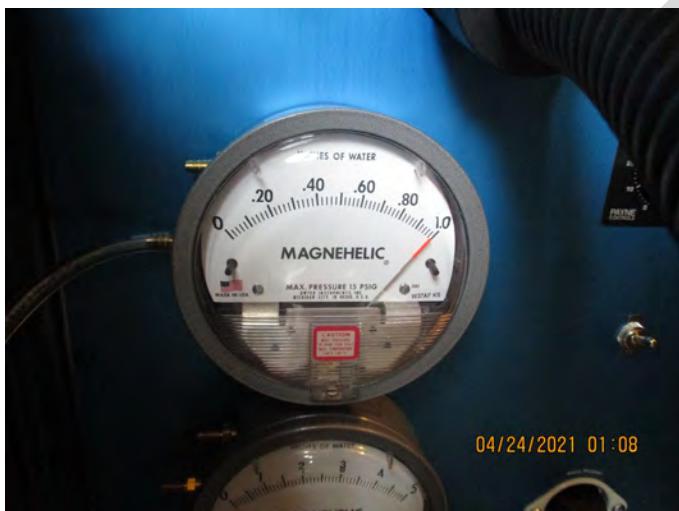
Checking for Water Penetration
