Mrs. [REDACTED] [REDACTED] Residence  
[REDACTED] Beach, Florida  
Installation Verification Inspection  
FINAL – 3-25-22

**Re: Installation Verification and Testing Structural Glazing Assessment**

TSSA Project # [REDACTED] - Installation Verification/Testing [REDACTED]  
[REDACTED] Beach - 2022-2-23

Final Report Version – 3/25/2022

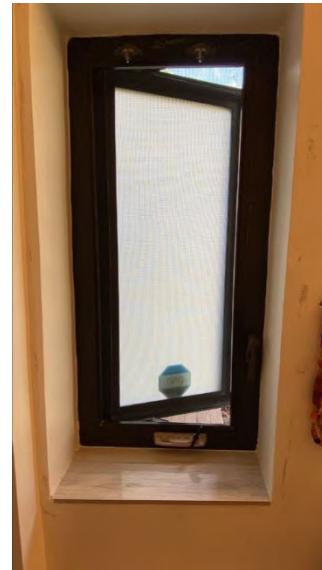
## Window Map Location - 1

Tapcons are correct size and manufacturer based on NOA

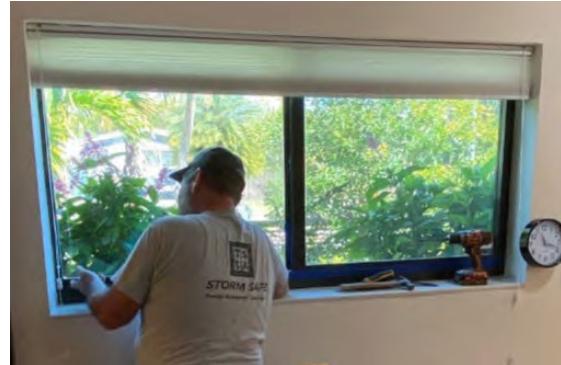
## Window Map Location - 2

Tapcons are corrected size and manufacturer based on NOA  
System operates smoothly

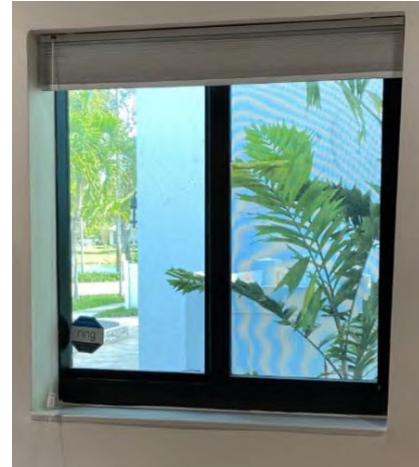
## Window Map Location - 3

Tapcons are corrected size and manufacturer based on NOA  
Frame Engulfed by the interior reveal

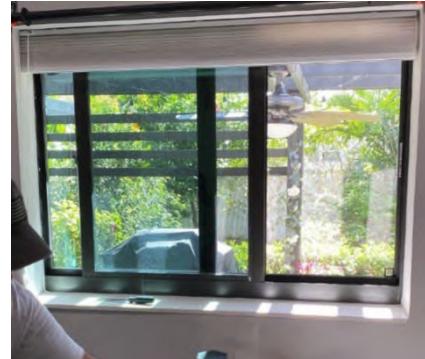
## Window Map Location – 4

Multiple types and manufacturers of Tapcons are used in the installation  
 Tapcons are corrected size based on NOA  
 Frame Engulfed by the interior reveal

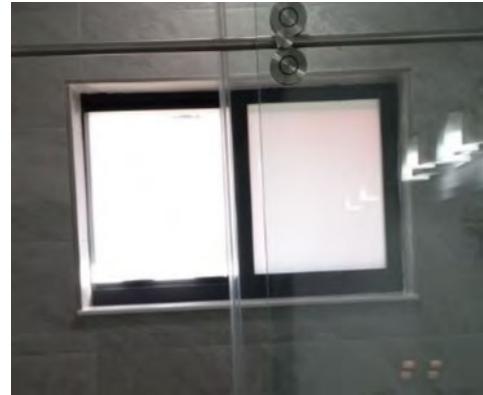
## Window Map Location - 5

Tapcons are corrected size and manufacturer based on NOA  
Tile Return

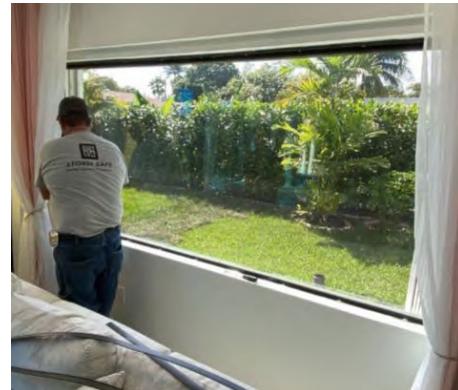
## Window Map Location - 7

Tapcons are corrected size and manufacturer based on NOA

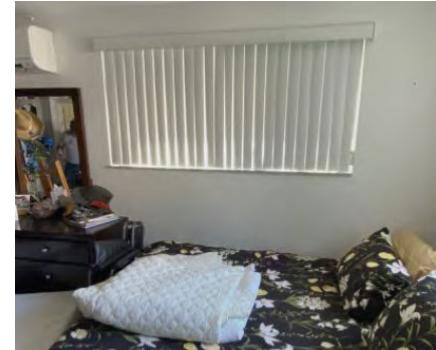
**Window Map Location - 8**

Interior Not Accessible during the inspection

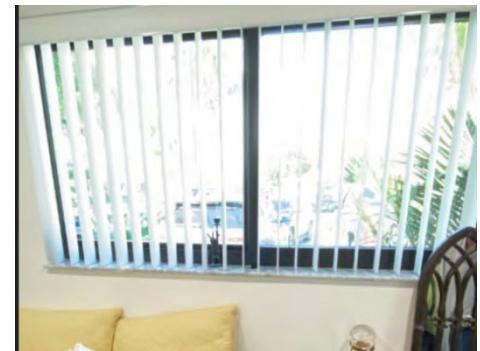
## Window Map Location - 9

Interior Not Accessible during the inspection

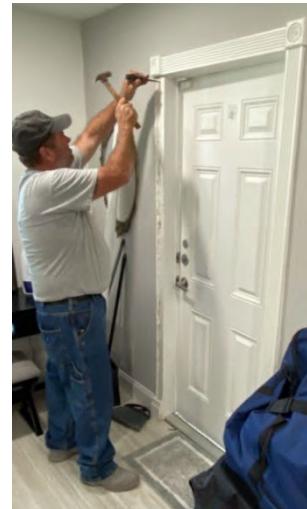
## Window Map Location - 6

Jamb is double bucked

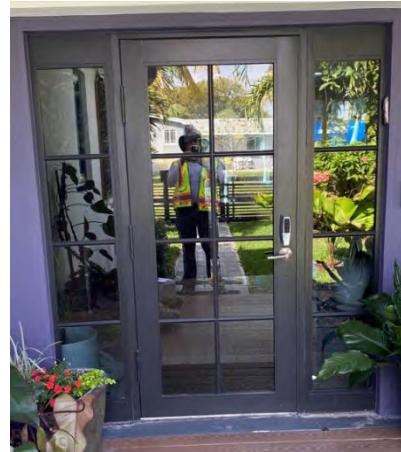
### Window Map Location - 13

Wood Substrate around the entire door

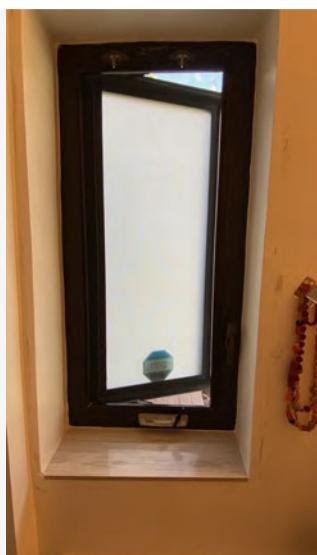
3

## Specimen has impaired operation

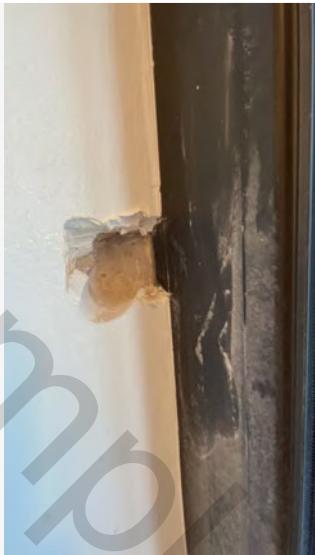
4

NOTE - this Reveal is Plaster over Concrete not Drywall

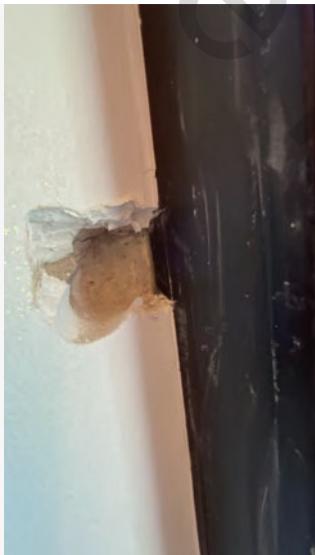
5

NOTE - this Reveal is Plaster over Concrete not Drywall

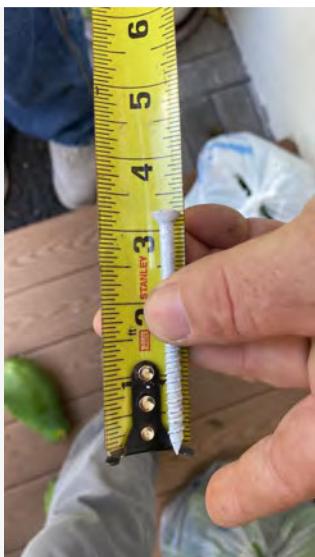
9

Correct Fastener as per NOA

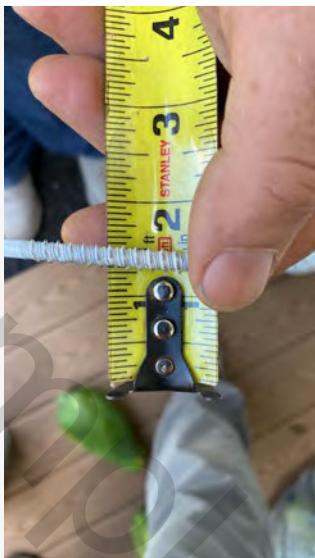
10

Correct Fastener as per NOA

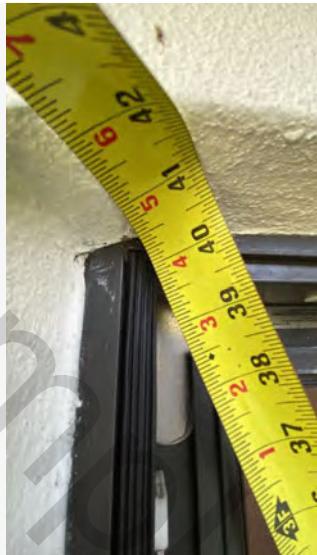
16

Window is installed out of square

The professional recommendation of TSSA Storm Safe DAC Inc. is that incorrectly installed and damaged PGT windows need to be removed from their openings and re-installed based on manufacturer instructions and industry best practices as put forth by FGIA/AAMA and ASTM.

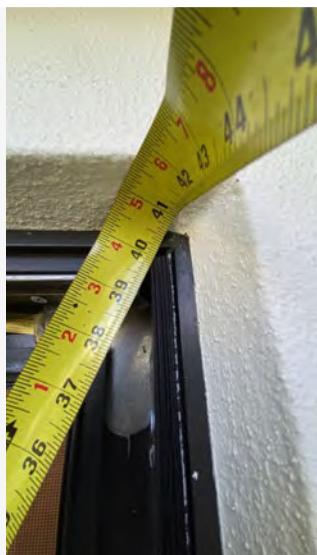
18

Window is installed out of square

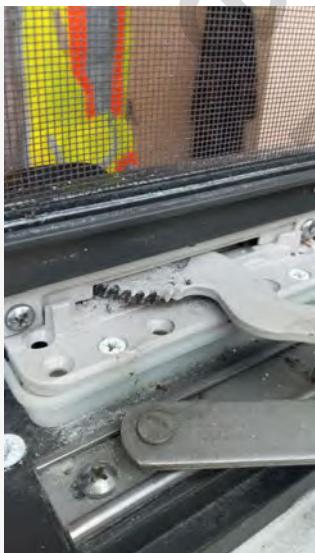
Inspecting Casement Split Arm operator and casement hinge for proper operation

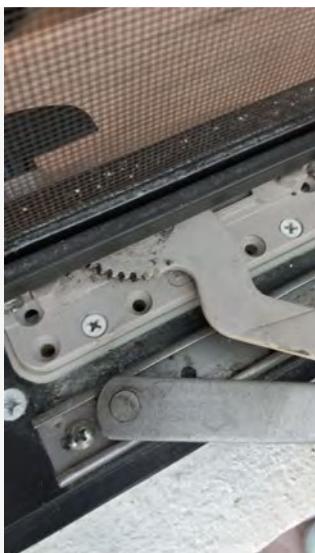
Inspecting Casement Split Arm operator and casement hinge for proper operation

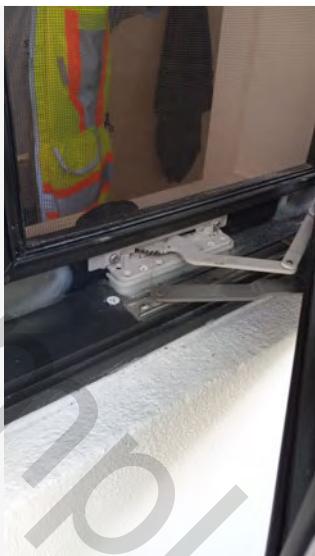
Casement Operation was impaired

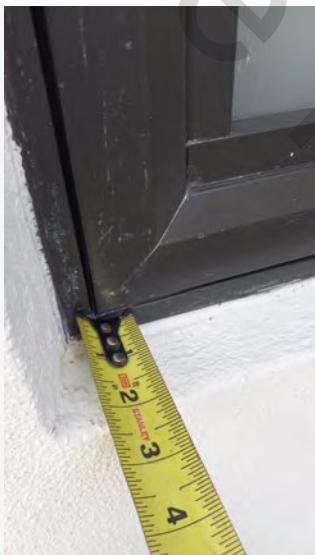
Casement Vent was visibly bowed

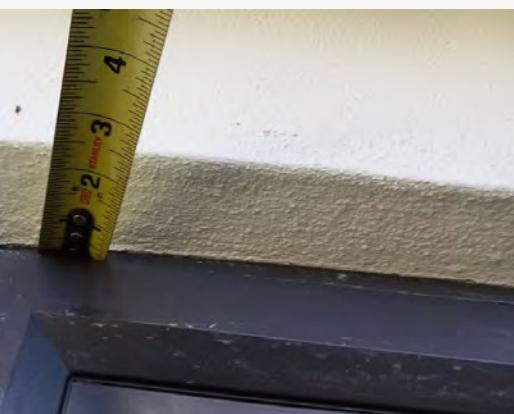
Casement Vent was visibly bowed

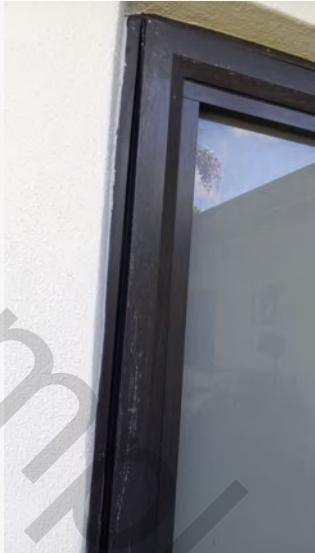
Casement Vent was visibly bowed

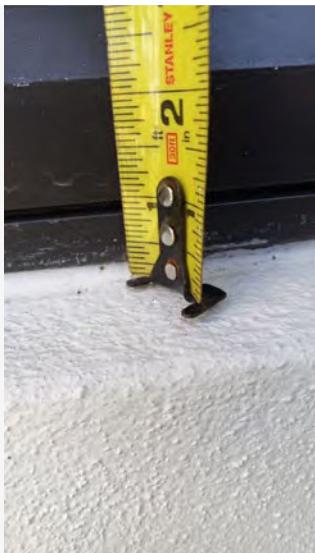
Casement Vent was visibly bowed

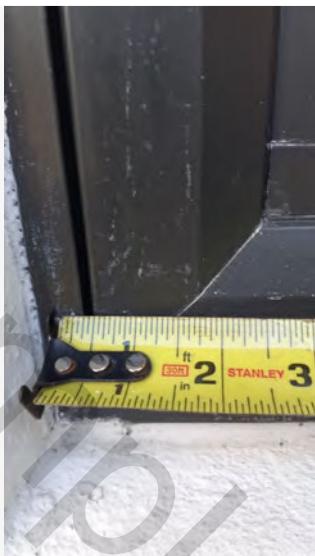
Casement Vent was visibly bowed

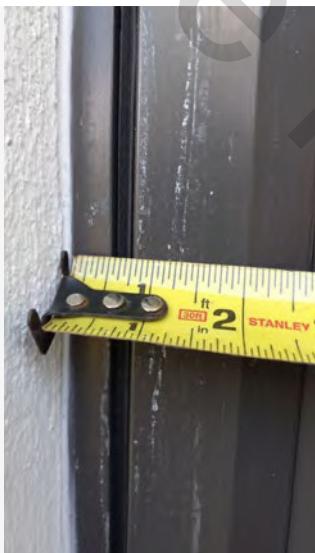
Casement Vent was visibly bowed

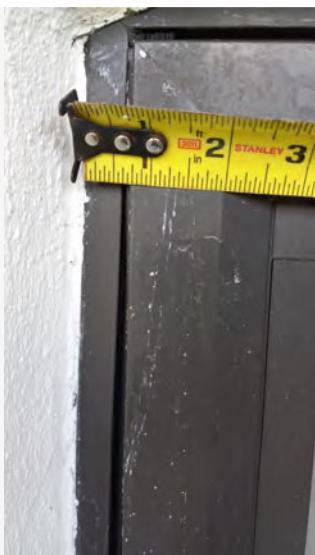
Casement Vent was visibly bowed

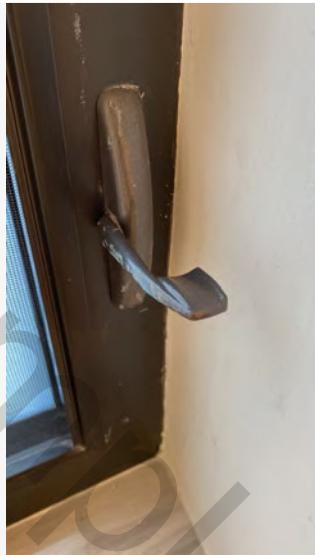
Flip Lock operation is impaired

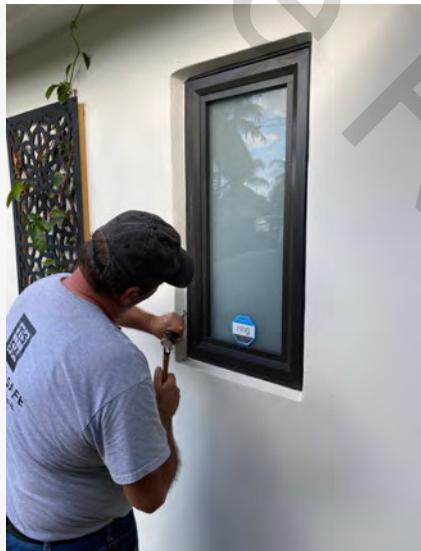
Removing exterior Stucco Reveal to inspect window installation

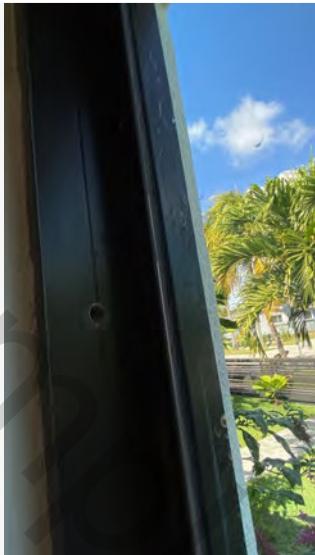
System Frame Fastener Hole does not have a conical to receive the fastener head

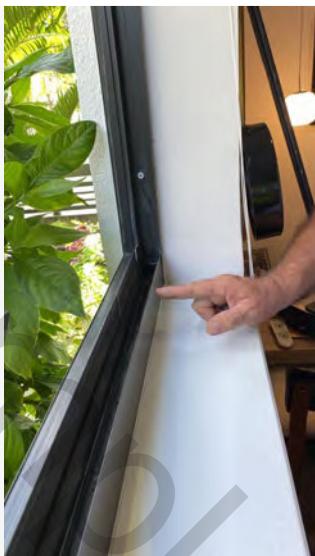
inspecting Weeping system

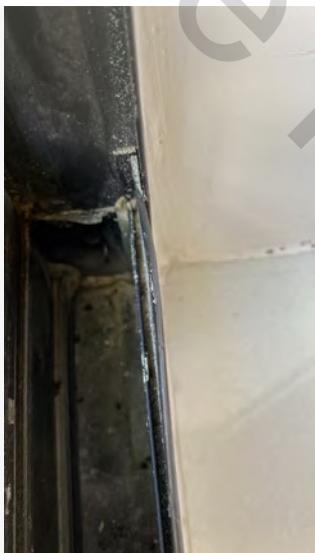
Weeping system was rendered un-functional from the interior of the sill track with Cementous material

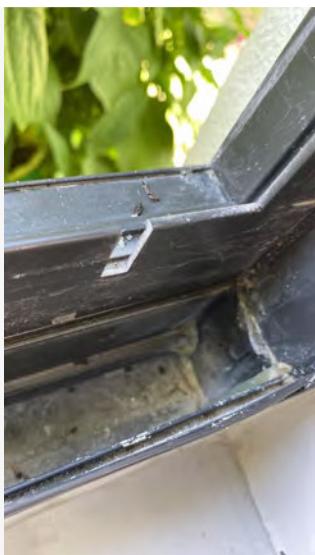
Weeping system was rendered un-functional from the interior of the sill track with Cementous material

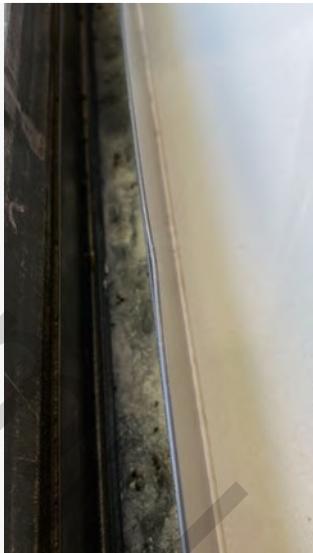
Weeping system was rendered un-functional from the interior of the sill track with Cementous material

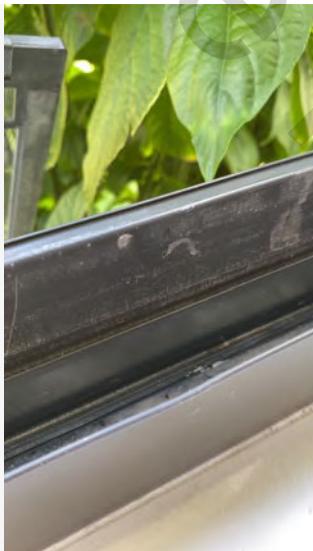
Weeping system was rendered un-functional from the interior of the sill track with Cementous material

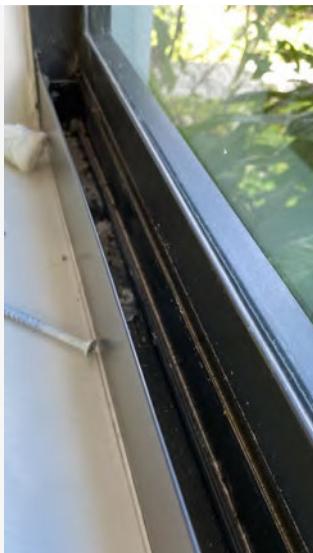
Sill Fastener Head appears to be covered with a hard dense plastic material not specified sealant as per best practices

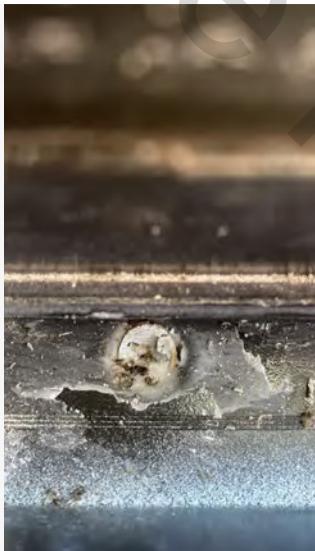
Sill Fastener Head appears to be covered with a hard dense plastic material not specified sealant as per best practices

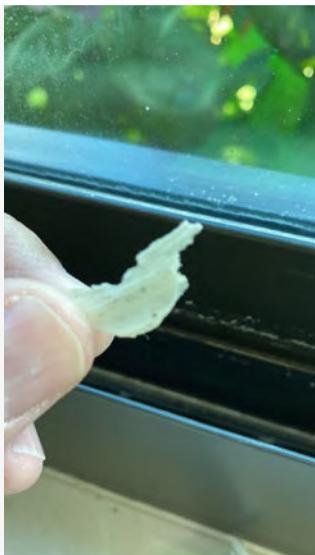
Sill Fastener Head appears to be covered with a hard dense plastic material not specified sealant as per best practices

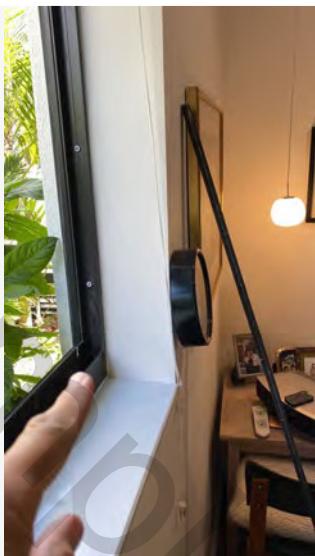
Sill Riser is bent and separated from its installed positions

Sealant Disruption is witnessed at the sill riser to jamb connection point

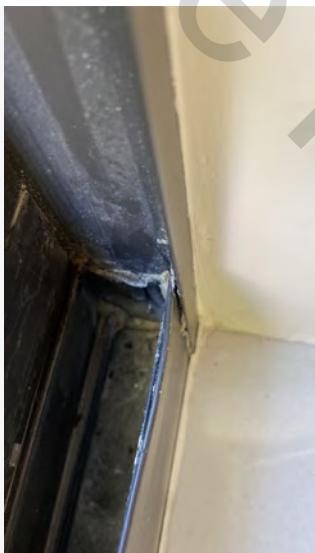
Sill Riser is bent and separated from its installed positions

Sealant Disruption is witnessed at the sill riser to jamb connection point

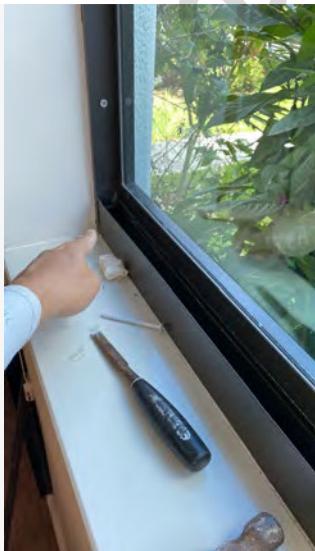
29

Sill Riser is bent and separated from its installed positions

Sealant Disruption is witnessed at the sill riser to jamb connection point

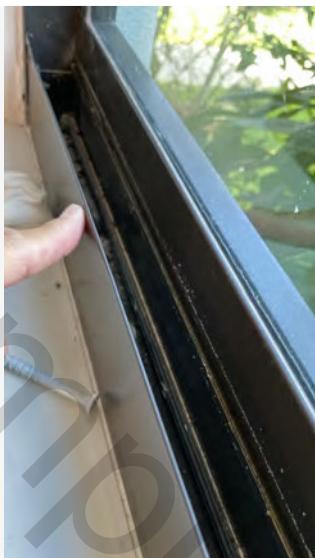
31

Sill Track and Operational Panel is removed to perform an inspection of the Sill Fasteners and Installation Methods

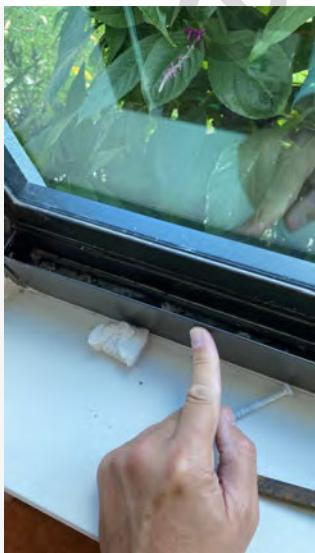
32

Sill Track and Operational Panel is removed to perform an inspection of the Sill Fasteners and Installation Methods

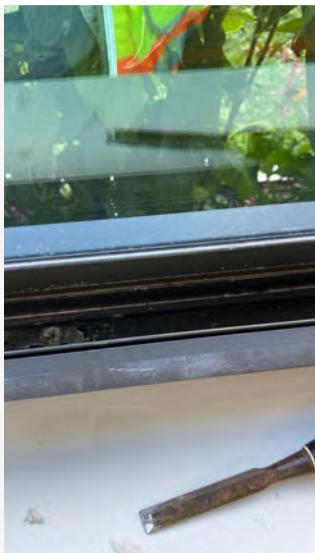
36

Straight Edge placed against Sill Riser to demonstrate the degree of bending the Sill Riser has been subjected to during the Installation Process

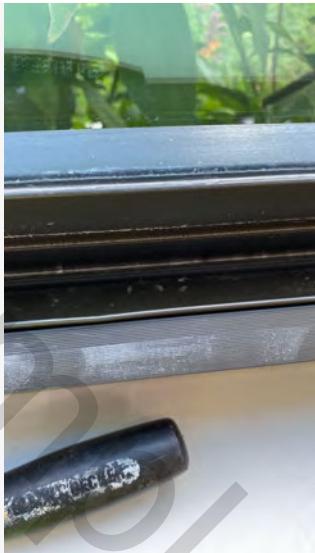
37

Straight Edge placed against Sill Riser to demonstrate the degree of bending the Sill Riser has been subjected to during the Installation Process

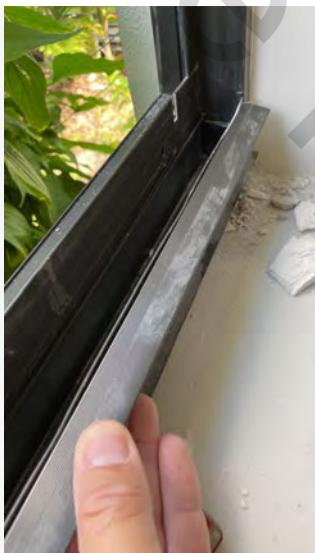
38

Straight Edge placed against Sill Riser to demonstrate the degree of bending the Sill Riser has been subjected to during the Installation Process

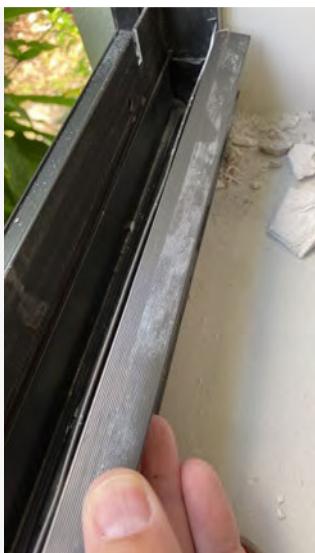
39

Straight Edge placed against Sill Riser to demonstrate the degree of bending the Sill Riser has been subjected to during the Installation Process

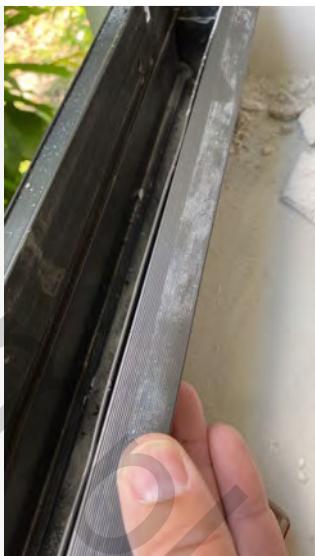
40

Straight Edge placed against Sill Riser to demonstrate the degree of bending the Sill Riser has been subjected to during the Installation Process

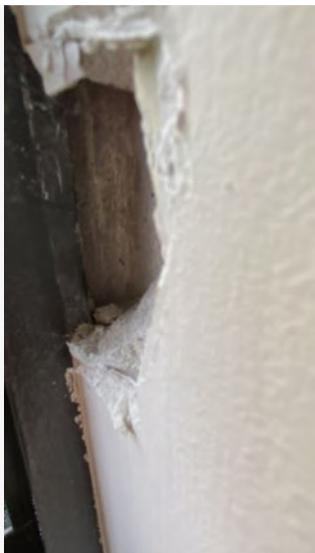
42

inspection shows that no bucking was used and the frame is not completely supported

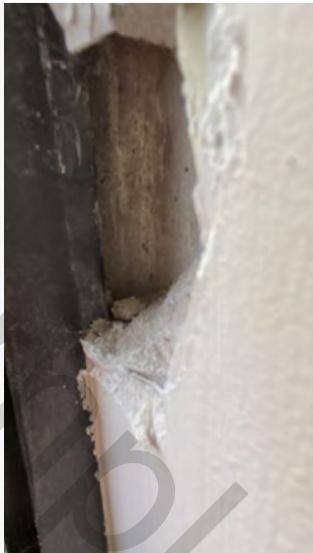
43

inspection shows that no bucking was used and the frame is not completely supported

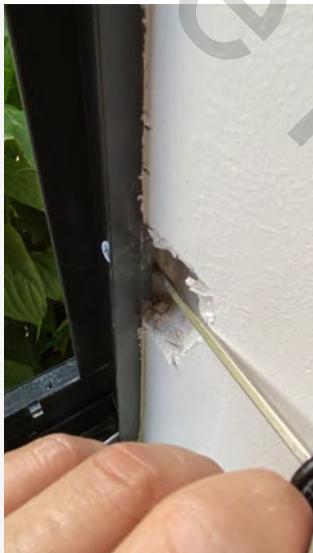
44

inspection shows that no bucking was used and the frame is not completely supported  
No Shims were witnessed

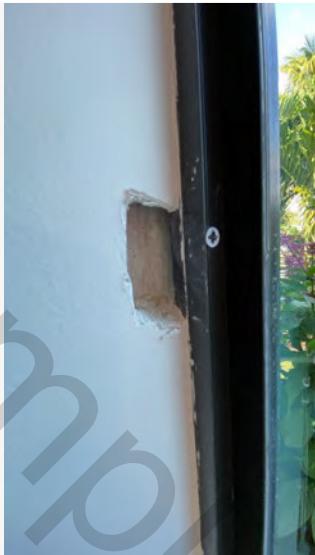
46

inspection shows that no bucking was used and the frame is not completely supported  
No Shims were witnessed

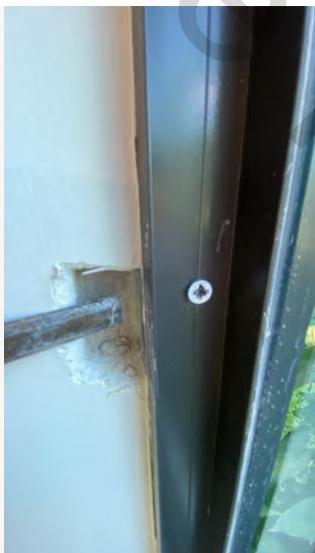
47

inspection shows that no bucking was used and the frame is not completely supported  
No Shims were witnessed

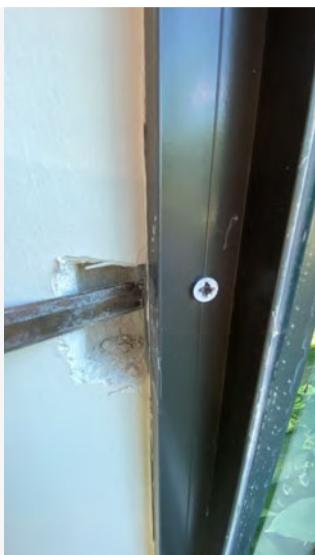
48

inspection shows that no bucking was used and the frame is not completely supported  
No Shims were witnessed

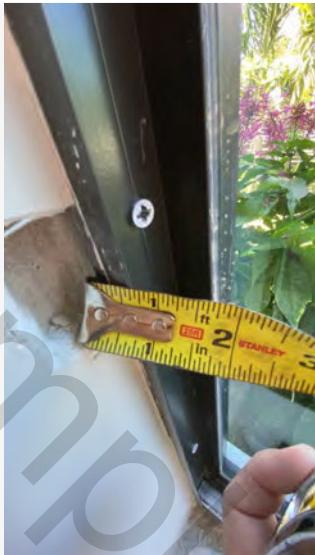
49

inspection shows that no bucking was used and the frame is not completely supported  
No Shims were witnessed

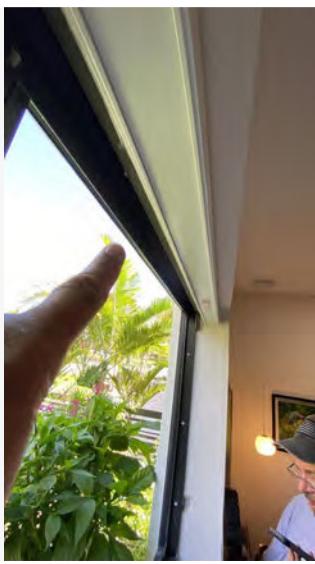
51

Anti Lift Adaptor was not installed as per NOA

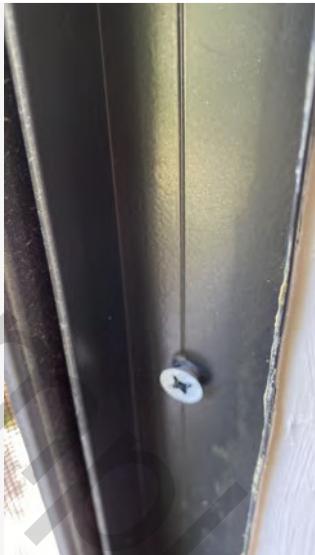
4

Fastener Not fully seated in Conical

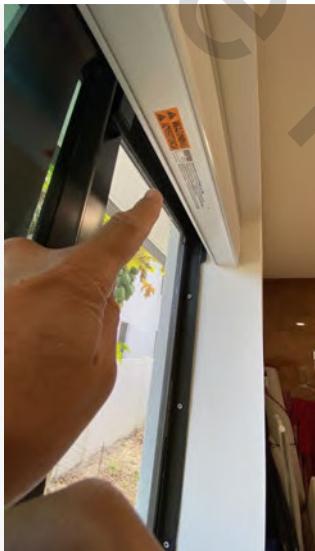
5

Anti-Lift device not installed as per NOA

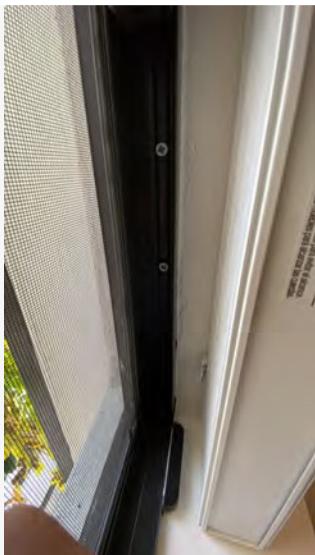
6

Fasteners installed at an angle

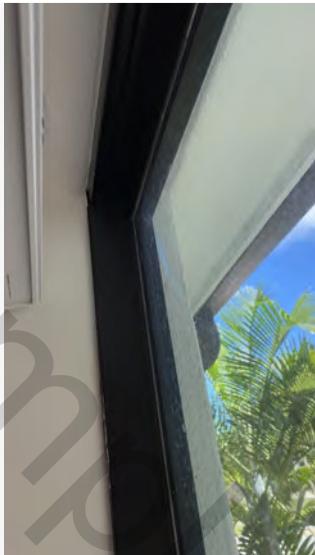
7

System Framed engulfed by Plaster reveal

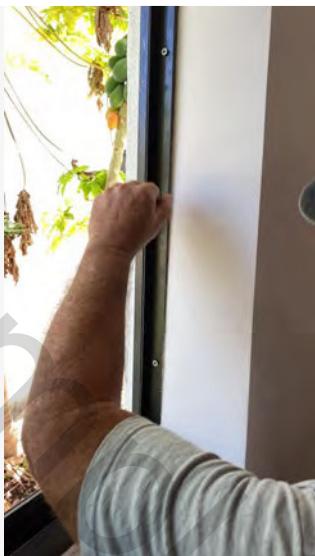
19

Fasteners were turning by fingertips only

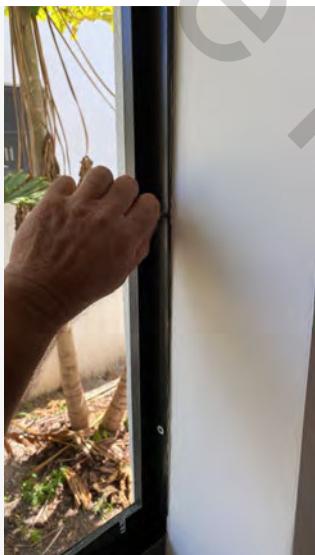
20

Fasteners were turning by fingertips only

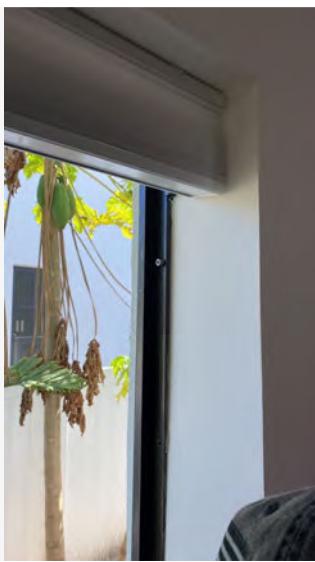
21

Fasteners were turning by fingertips only

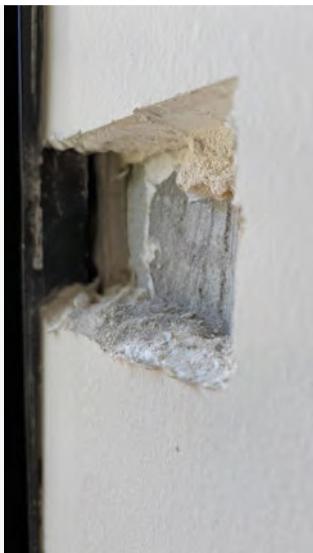
24

Frame is not completely supported  
No Bucking was installed between substrate and aluminum frame  
No Shims were used during installation

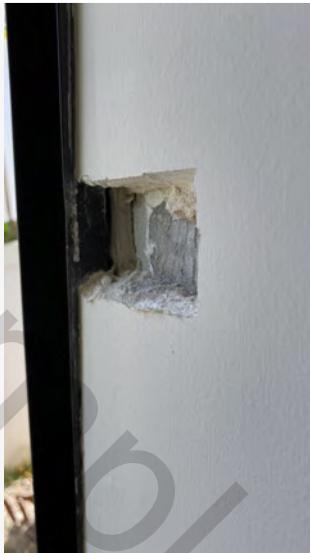
25

Frame is not completely supported  
No Bucking was installed between substrate and aluminum frame  
No Shims were used during installation

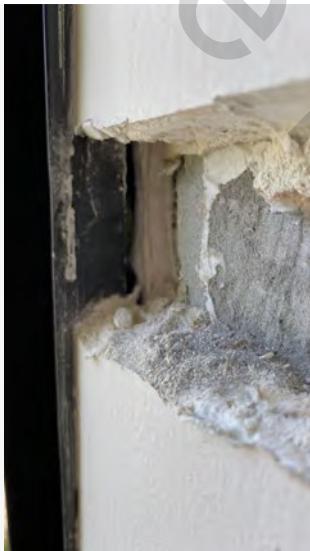
26

Frame is not completely supported  
No Bucking was installed between substrate and aluminum frame  
No Shims were used during installation

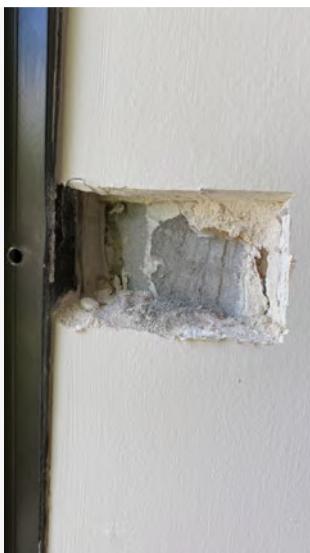
27

Frame is not completely supported  
No Bucking was installed between substrate and aluminum frame  
No Shims were used during installation

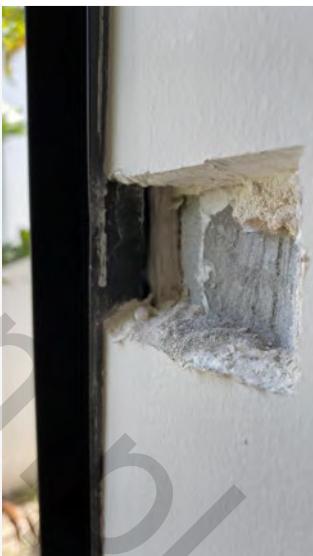
28

Frame is not completely supported  
No Bucking was installed between substrate and aluminum frame  
No Shims were used during installation

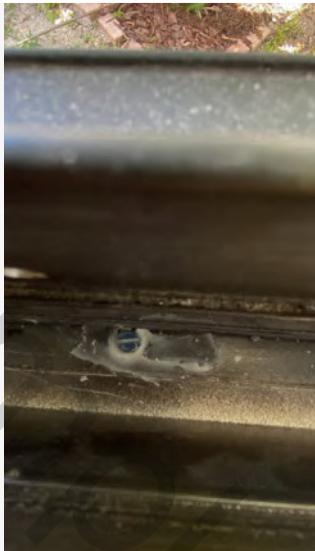
31

Sill Fastener Head appears to be covered with a hard dense plastic material not specified sealant as per best practices

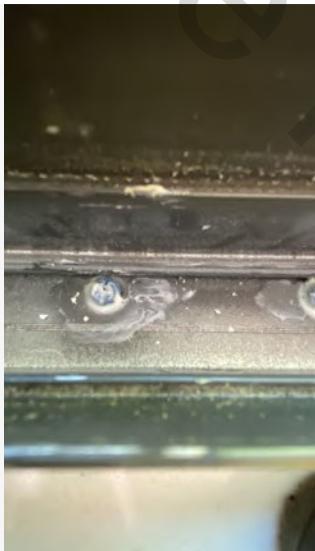
32

Sill Fastener Head appears to be covered with a hard dense plastic material not specified sealant as per best practices

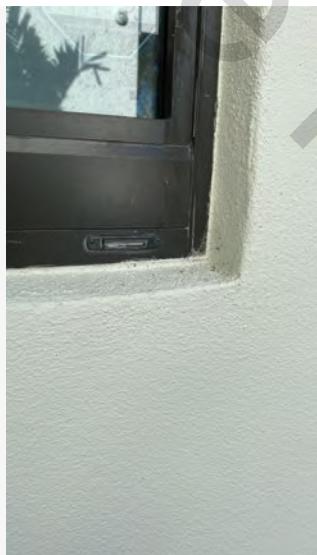
2

Weeping system was rendered un-functional from the interior of the sill track with Cementous material

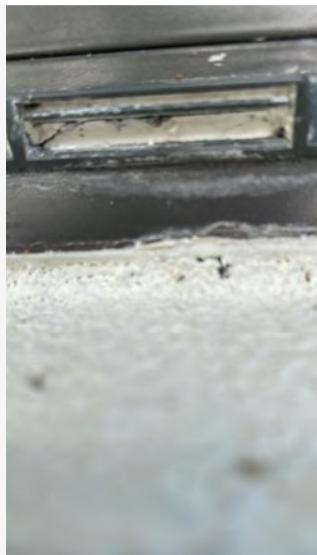
3

Weeping system was rendered un-functional from the interior of the sill track with Cementous material

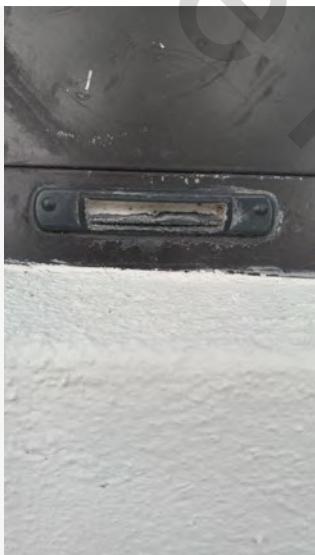
5

Weeping system was rendered un-functional from the interior of the sill track with Cementous material

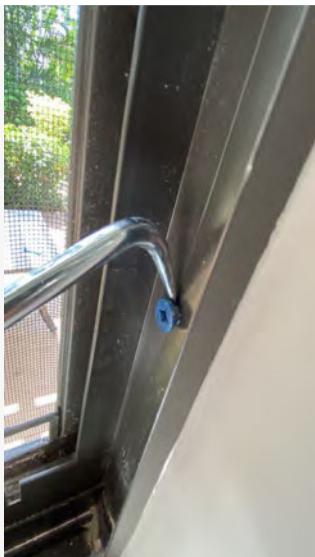
9

Fastener not fully seated in conical

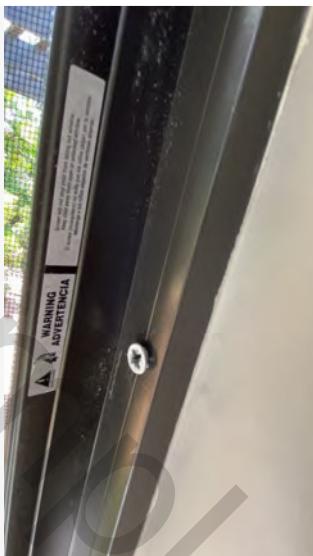
10

Fastener not fully seated in conical

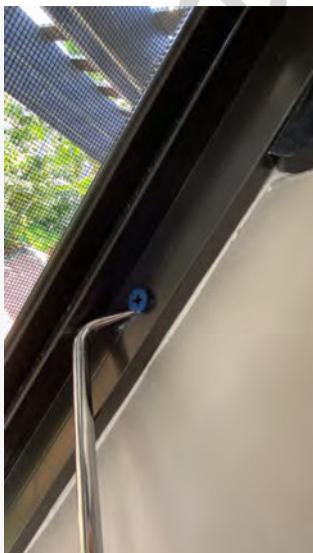
11

Fastener not fully seated in conical

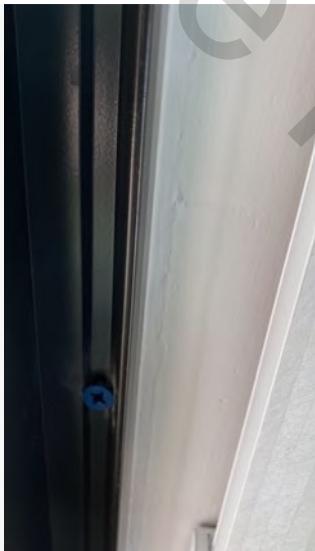
17

fastener not fully seated in conical

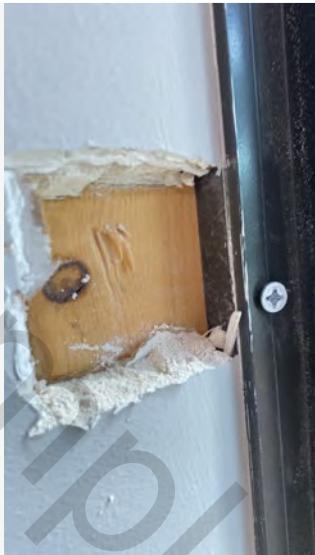
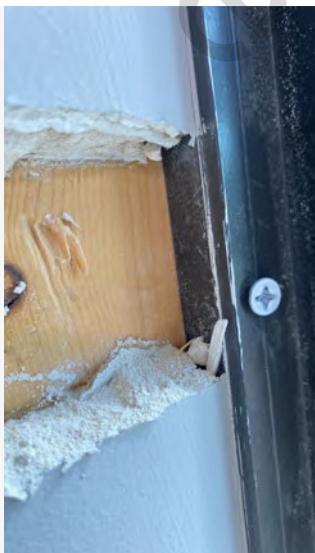
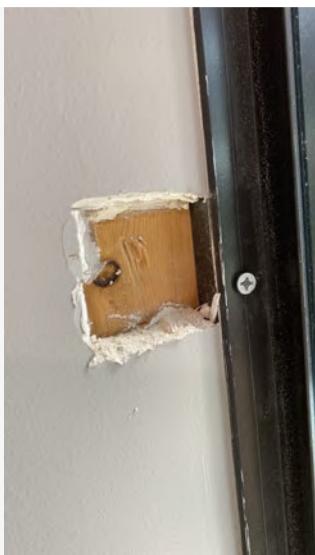
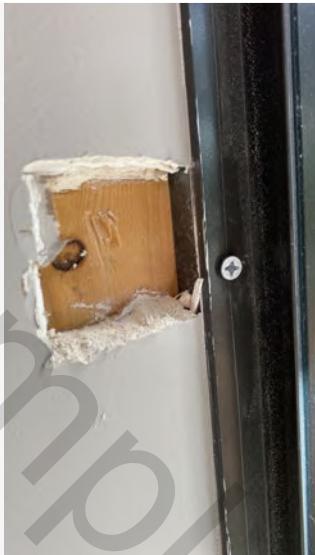
Left Jamb is bucked with a NON-Pressure Treated white wood 2 x. Installer used to make the opening smaller

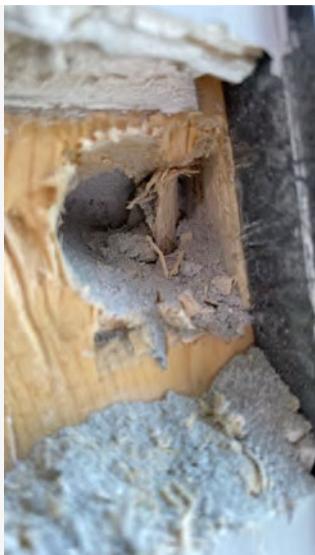
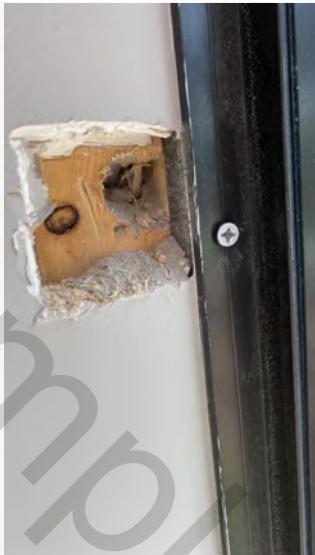
Buck was installed against concrete

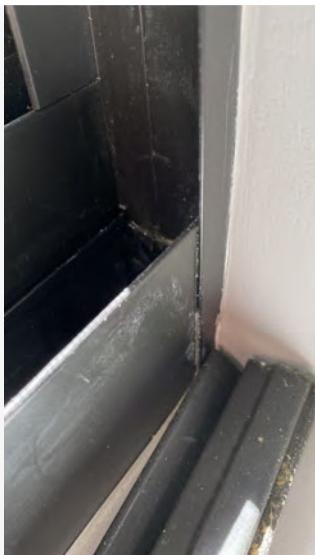
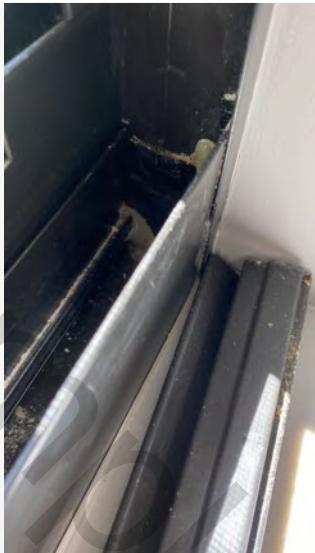
Sealant Disruption is witnessed at the sill riser to jamb connection point  
Sill Riser is bent and shows signs of being hammered back into position.

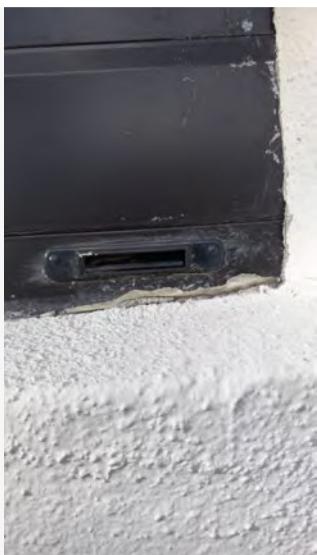
## Weeping System is clean and open from Exterior

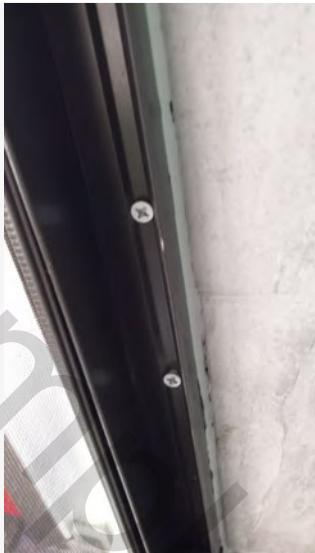
Fasteners not fully seated

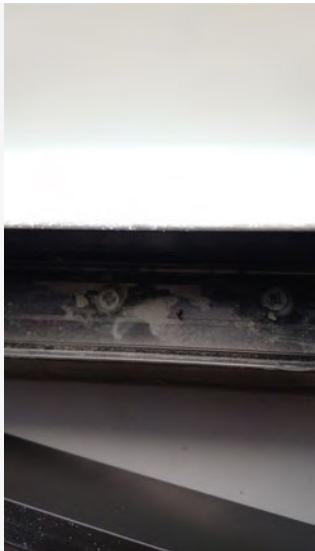
Sill Fastener Head appears to be covered with a hard dense plastic material not specified sealant as per best practices

Weeping system was rendered un-functional from the interior of the sill track with Cementous material

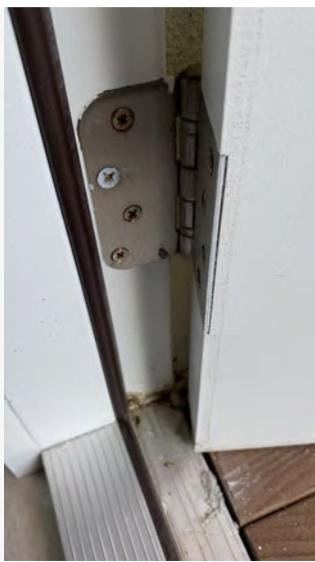
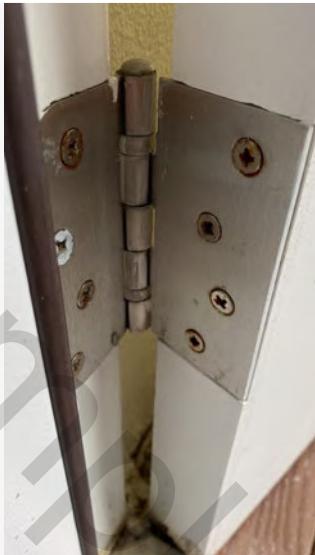
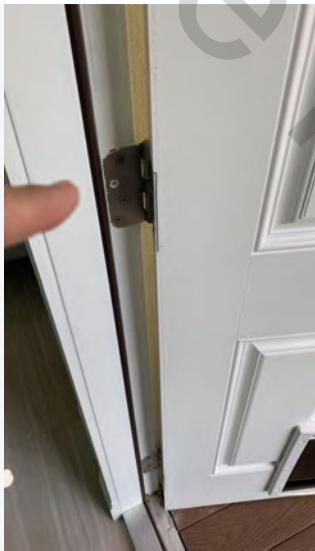
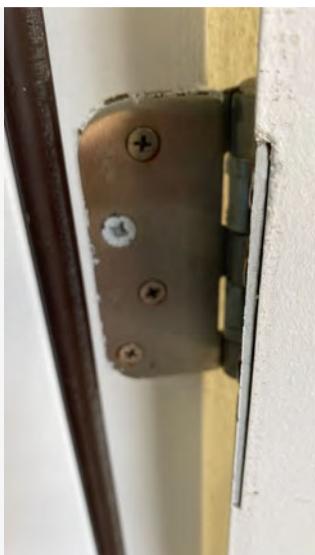
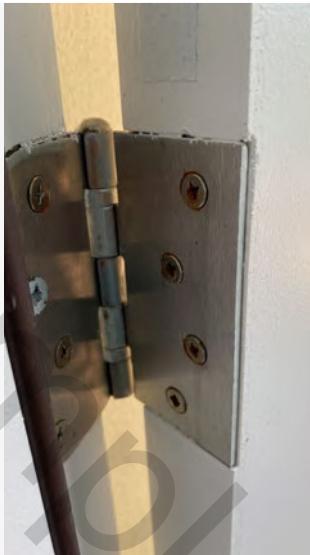
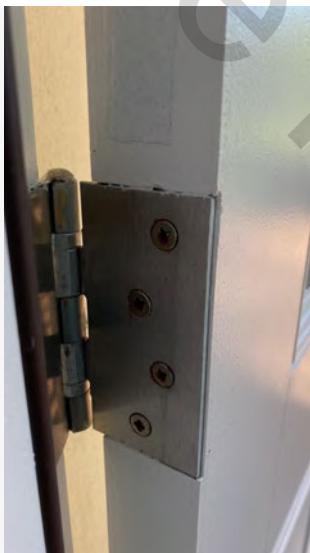
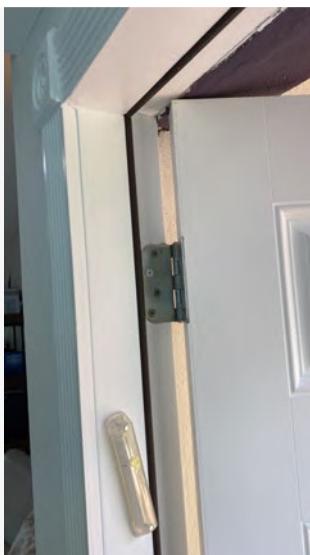
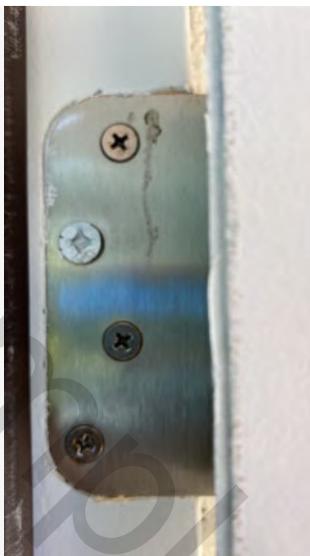
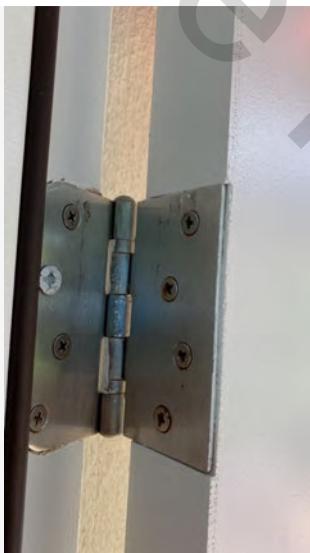
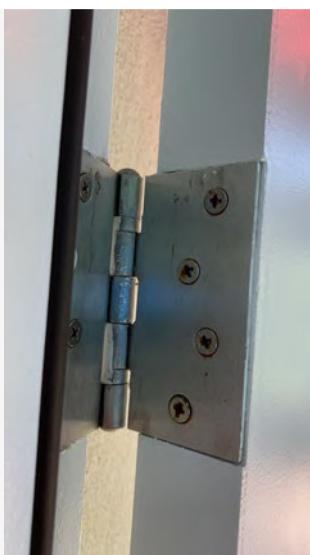
## Hinge Fastener cluster installed correctly

Hinge Fastener cluster installed correctly

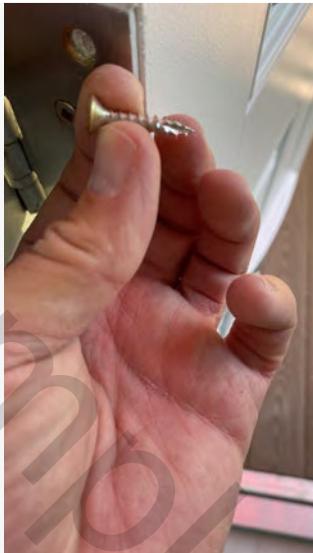
13

hinge fastener

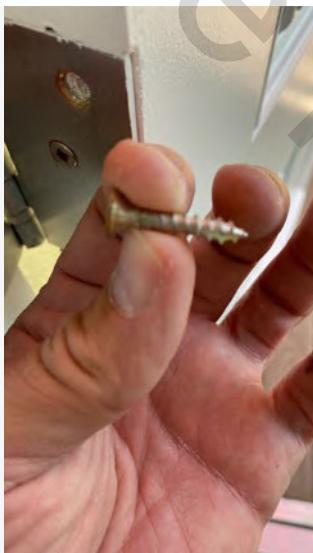
14

Hinge Fastener cluster installed correctly

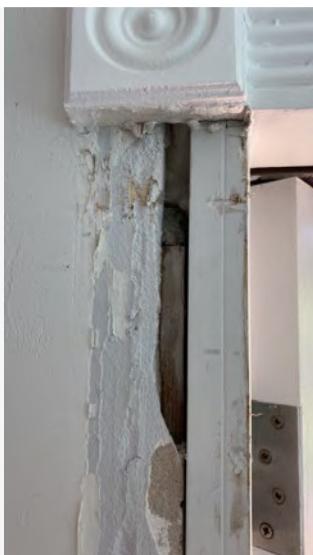
15

Left Jamb Bucking does not go all the way to the top of the jamb

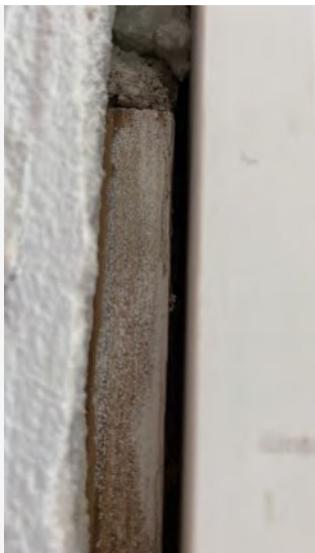
18

Door Not Fully Supported by Bucking

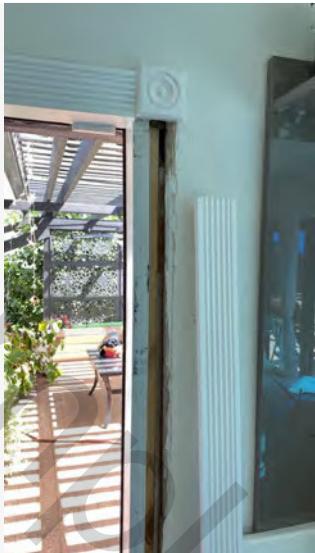
19

Right Jamb is double bucked ( $\frac{1}{4}$  in buck &  $\frac{3}{4}$  in additional buck)  
additional buck does not support frame all the way to the head.

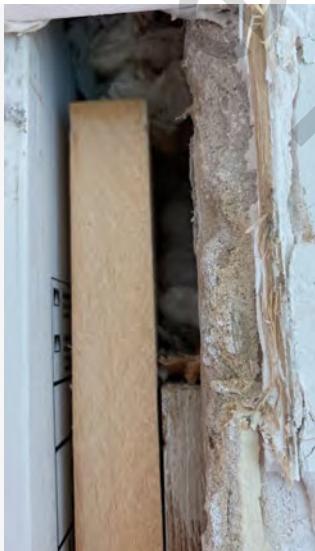
20

Right Jamb is double bucked ( $\frac{1}{4}$  in buck &  $\frac{3}{4}$  in additional buck)  
additional buck does not support frame all the way to the head.

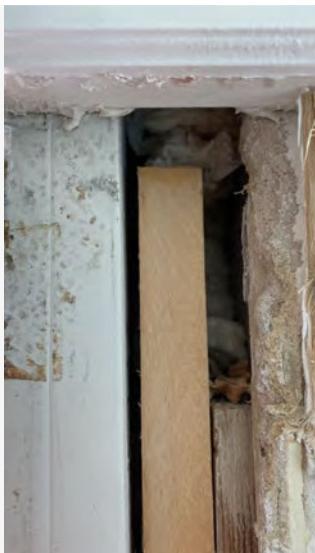
21

Right Jamb is double bucked ( $\frac{1}{4}$  in buck &  $\frac{3}{4}$  in additional buck)  
additional buck does not support frame all the way to the head.

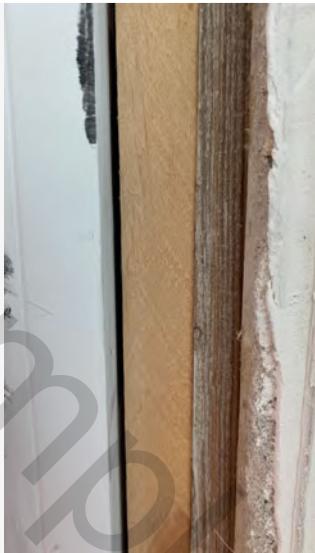
22

Right Jamb is double bucked (1/4 in buck & 3/4 in additional buck)  
additional buck does not support frame all the way to the head.

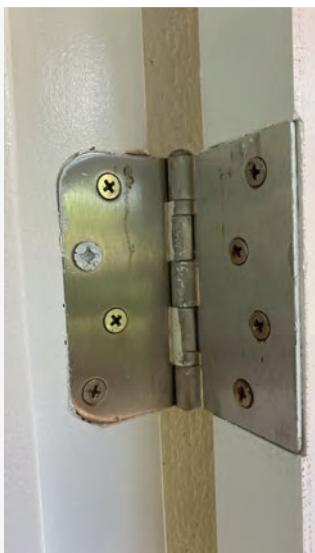
24

Hinge Fastener cluster installed correctly

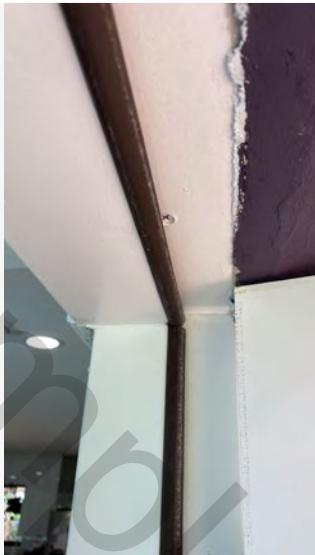
25

Anchors at the Header are installed through the thinnest part of the door.

As Per the NOA they should be installed through the thickest part of the door.

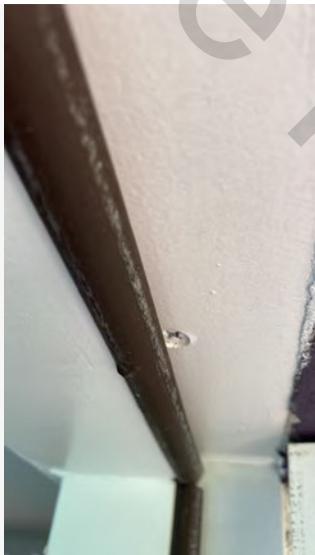
26

Anchors at the Header are installed through the thinnest part of the door.

As Per the NOA they should be installed through the thickest part of the door.

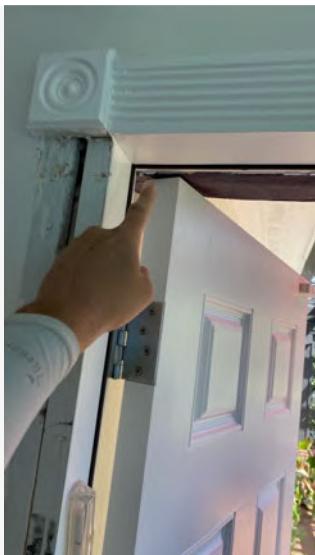
27

Anchors at the Header are installed through the thinnest part of the door.

As Per the NOA they should be installed through the thickest part of the door.

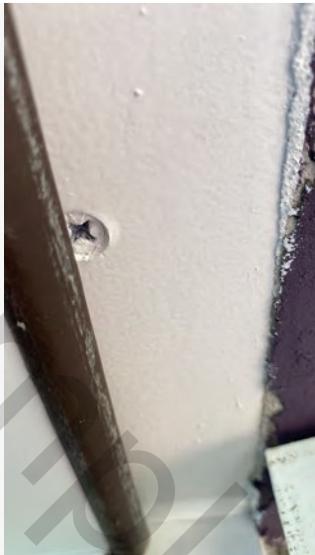
28

Fastener witnessed at Head

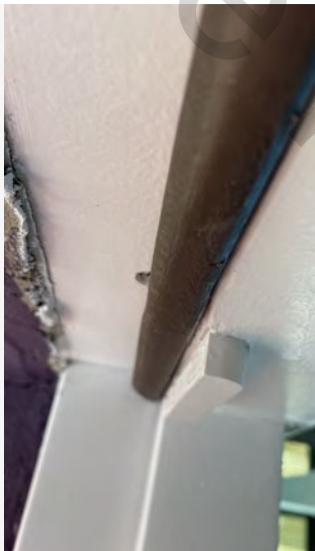
29

Fasteners at Head Frame

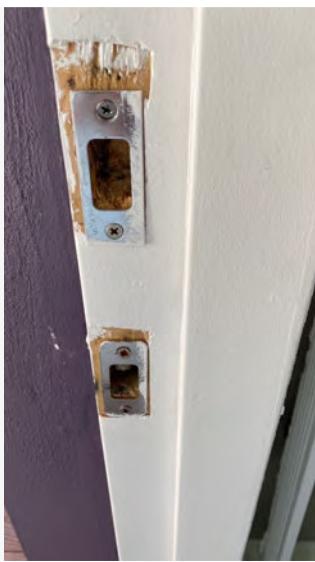
30

Striker plate is incorrect  
Mortise for Lock Plate and Striker Plate is very poor

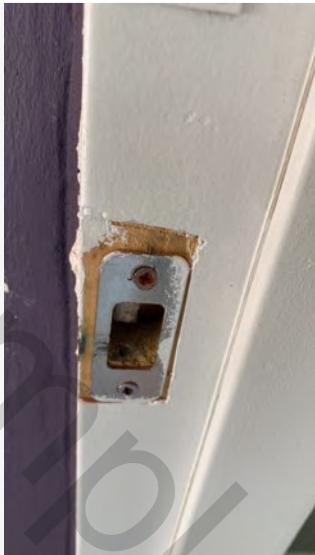
31

Striker plate is incorrect

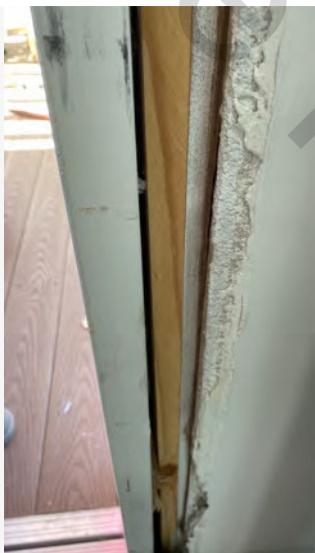
32

no shim witnessed at fastener

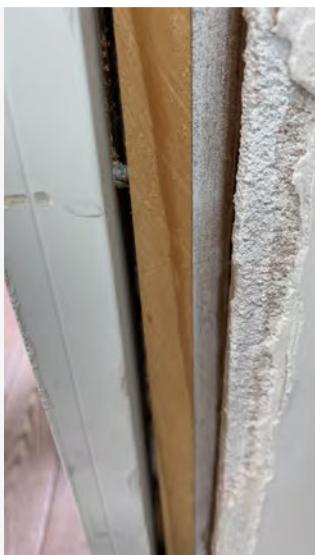
33

No Shim Witnessed at Fastener

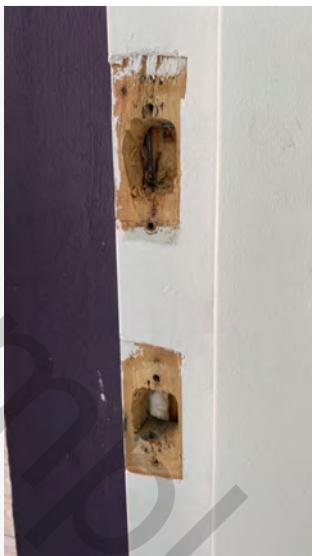
34

Mortise for Lock Plate and Striker Plate is very poor
