Mrs. [REDACTED] [REDACTED] Residence  
[REDACTED] Beach, Florida  
Installation Verification Inspection  
FINAL – 3-25-22

**Re: Installation Verification and Testing Structural Glazing Assessment**

TSSA Project # [REDACTED] - Installation Verification/Testing [REDACTED]  
[REDACTED] Beach - 2022-2-23

Final Report Version – 3/25/2022

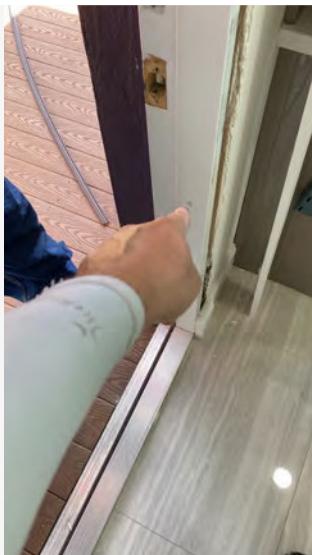
36

fastener inspection

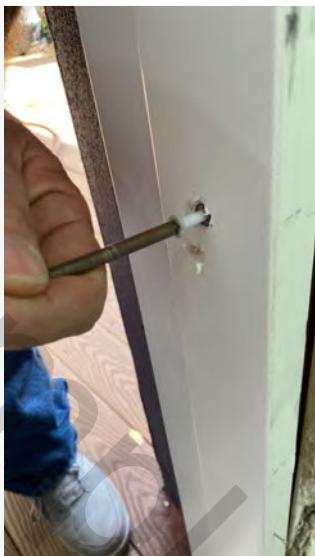
37

removing fastener to check embedment

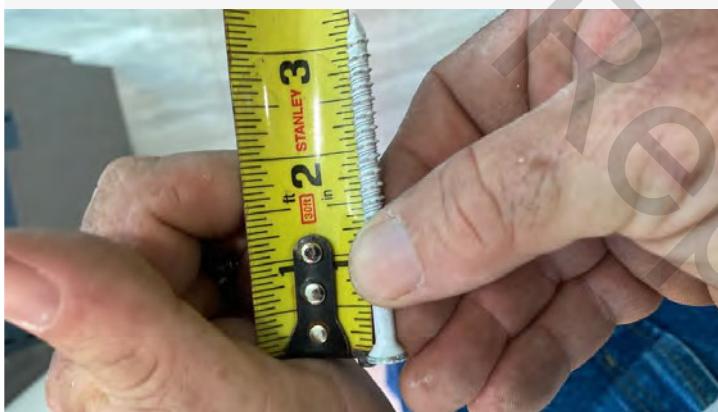
38

Tapcons are corrected size based on NOA

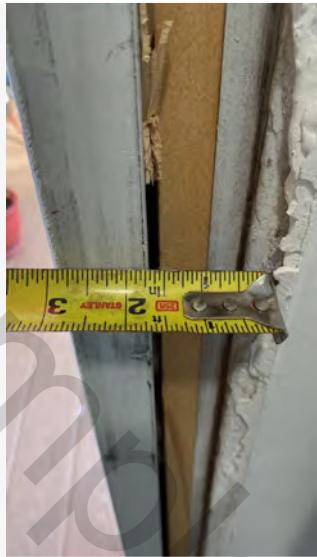
40

Proper embedment achieved with NOA Approved Fastener

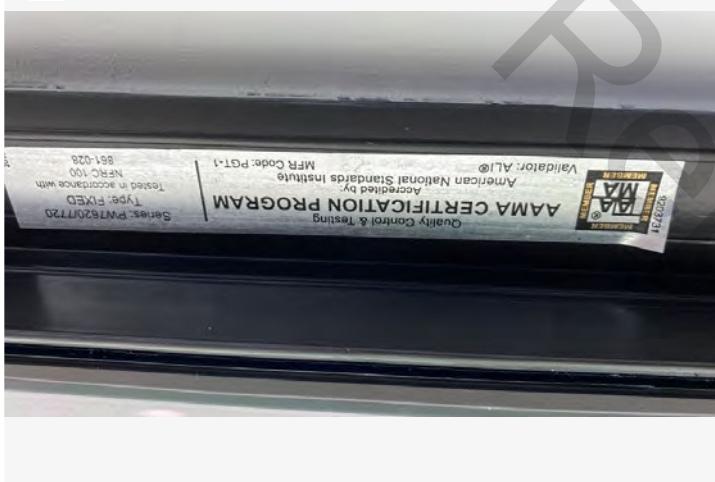
5

Manufacturer Sticker identifying system design pressure, thermal properties, size and installation location

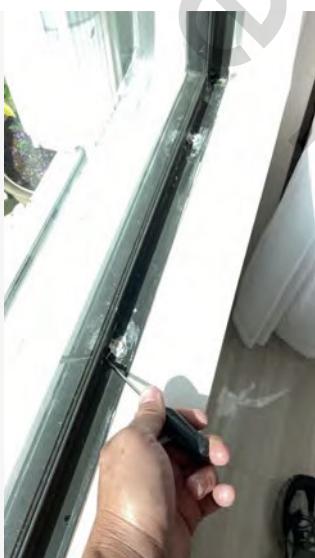
8

Sill Fastener Head appears to be covered with a hard dense plastic material not specified sealant as per best practices

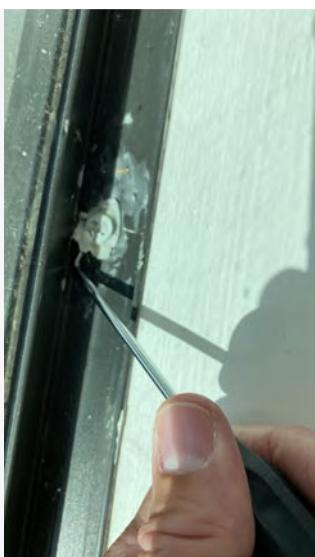
9

Sill Fastener Head appears to be covered with a hard dense plastic material not specified sealant as per best practices

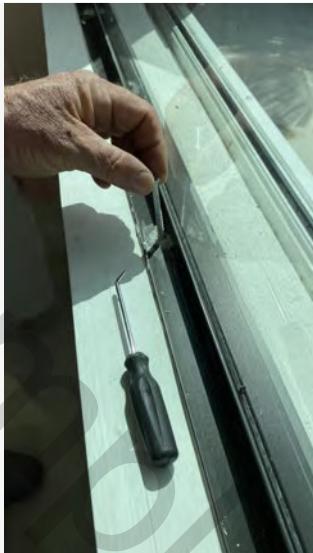
10

Removing Sill Fastener during inspection

Sill Fastener Head appears to be covered with a hard dense plastic material not specified sealant as per best practices

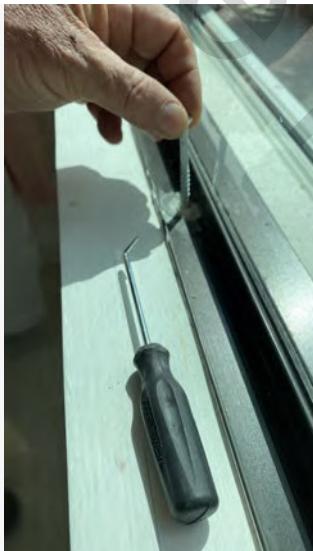
11

Removing Sill Fastener during inspection

Sill Fastener Head appears to be covered with a hard dense plastic material not specified sealant as per best practices

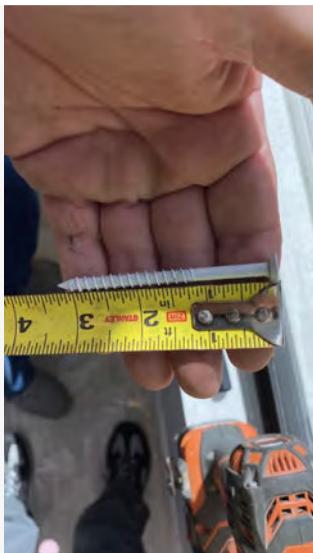
12

Correct Fastener as per NOA for installation into Bucking and Masonry

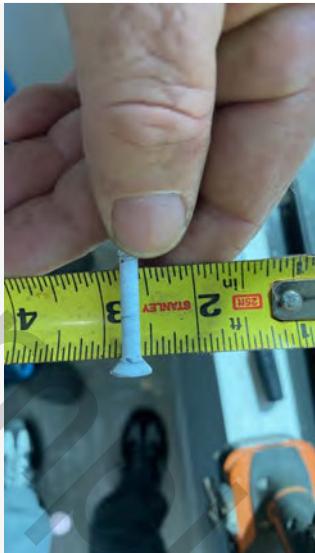
13

Correct Fastener as per NOA for installation into Bucking and Masonry

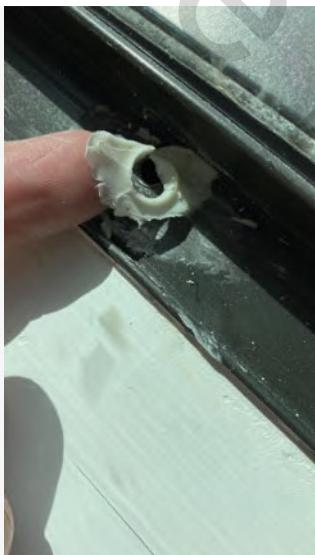
14

Sill Fastener Head appears to be covered with a hard dense plastic material not specified sealant as per best practices

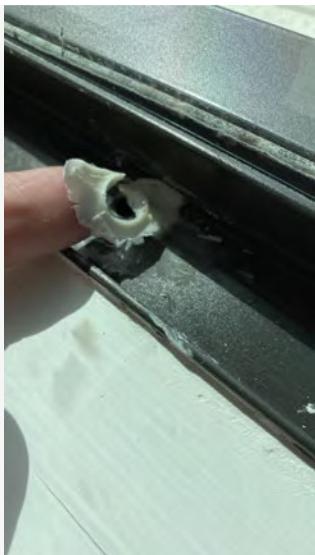
15

Sill Fastener Head appears to be covered with a hard dense plastic material not specified sealant as per best practices

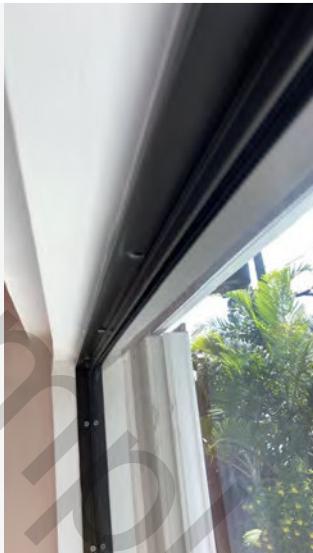
16

No Shims witnessed between Head Frame and Yellow Pine

Frame was Torqued due to no Shims being used to the point of effecting the glazing leg pulling the frame member away from the installed glass lite.

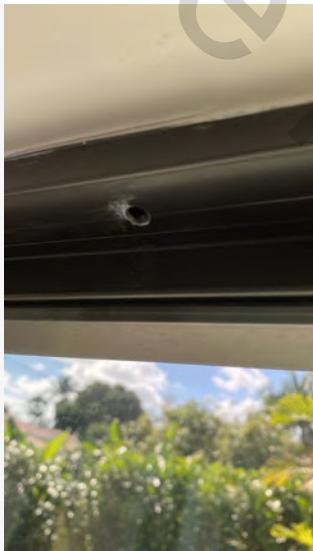
17

No Shims witnessed between Head Frame and Yellow Pine

Frame was Torqued due to no Shims being used to the point of effecting the glazing leg pulling the frame member away from the installed glass lite.

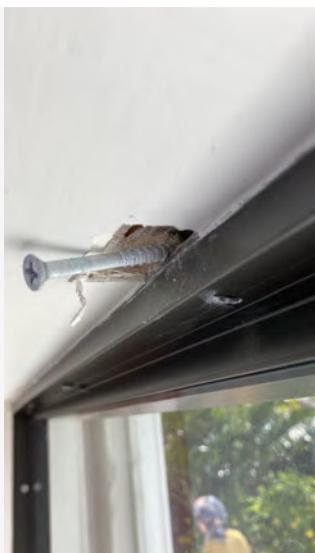
22

Fastener being used to demonstrate the amount of space between the system frame and the Yellow Pine Substrate

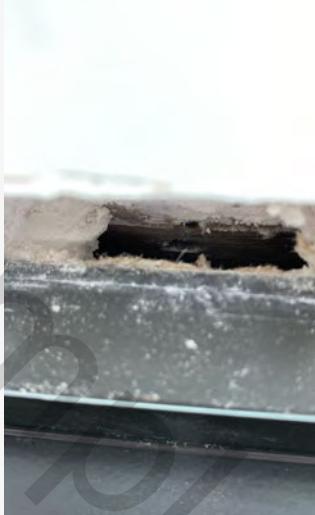
23

A photo demonstrating the amount of space between the system frame and the Yellow Pine Substrate

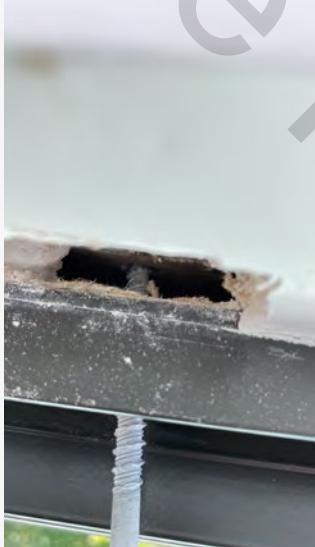
24

No Shims witnessed between Head Frame and Yellow Pine

A photo demonstrating the amount of space between the system frame and the Yellow Pine Substrate

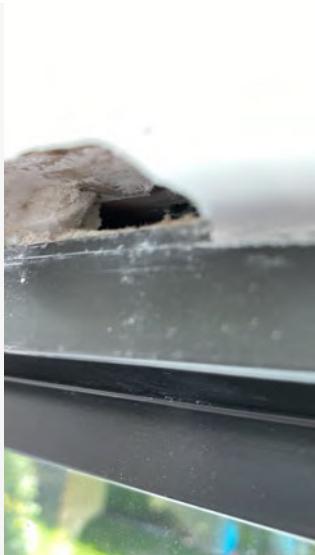
25

No Shims witnessed between Head Frame and Yellow Pine

A photo demonstrating the amount of space between the system frame and the Yellow Pine Substrate

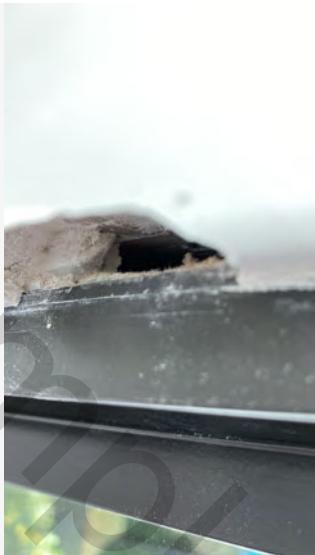
26

No Shims witnessed between Head Frame and Yellow Pine

A photo demonstrating the amount of space between the system frame and the Yellow Pine Substrate

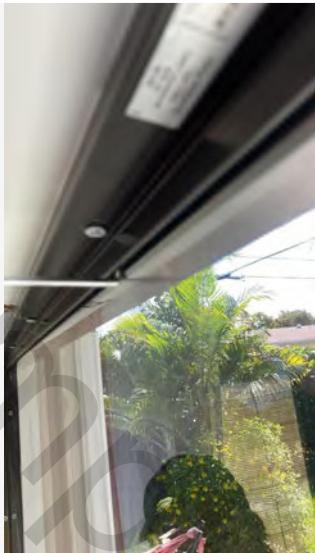
35

Frame was Torqued due to no Shims being used to the point of effecting the glazing leg pulling the frame member away from the installed glass lite.

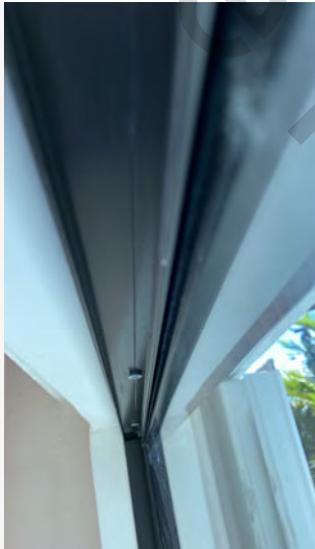
36

Frame was Torqued due to no Shims being used to the point of effecting the glazing leg pulling the frame member away from the installed glass lite.

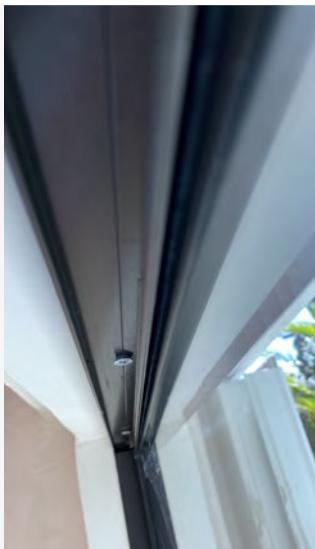
Frame was Torqued due to no Shims being used to the point of effecting the glazing leg pulling the frame member away from the installed glass lite.

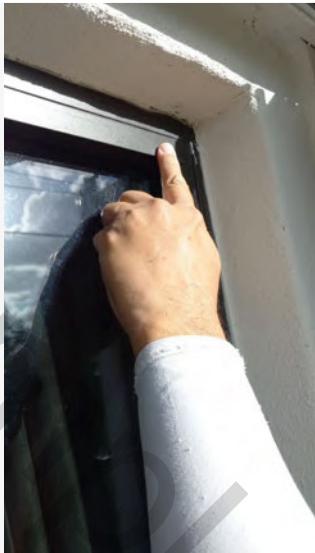
Frame was Torqued due to no Shims being used to the point of effecting the glazing leg pulling the frame member away from the installed glass lite.

Frame Bowing visually evident.

Glass stop disruption caused be frame bowing

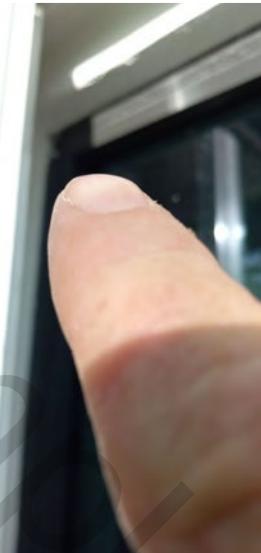
Frame was Torqued due to no Shims being used to the point of effecting the glazing leg pulling the frame member away from the installed glass lite.

Frame Bowing visually evident.

Glass stop disruption caused be frame bowing

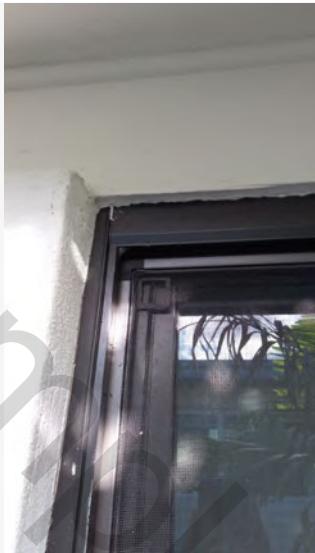
5

Original 2 x 6 Wood Header. The installer only blocked up to the original header and installed stucco over the original wood header.

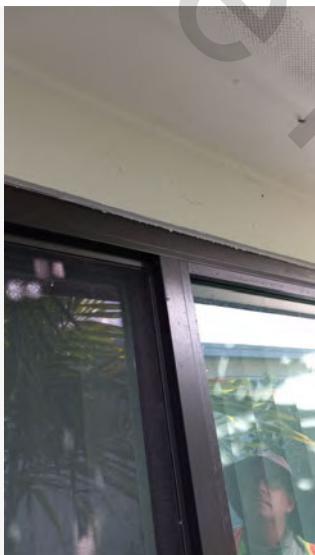
Original 2 x 6 Wood Header. The installer only blocked up to the original header and installed stucco over the original wood header.

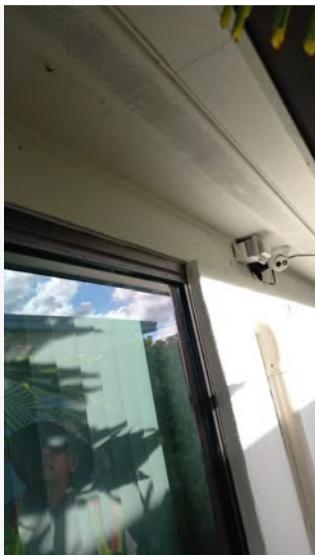
Original 2 x 6 Wood Header. The installer only blocked up to the original header and installed stucco over the original wood header.

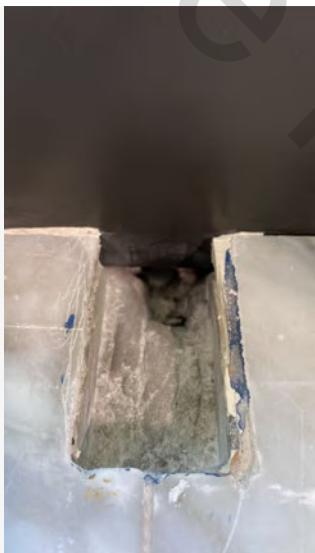
6

A notch in the Marble Sill from previously installed Mull Bar allowed for a visual inspection under the sill.  
No wood was witnessed under the sill of the new system.

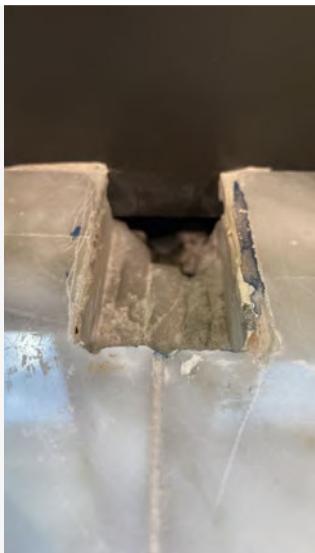
A notch in the Marble Sill from previously installed Mull Bar allowed for a visual inspection under the sill.  
No wood was witnessed under the sill of the new system.

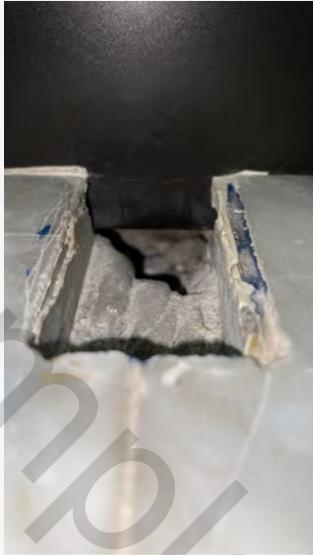
7

A notch in the Marble Sill from previously installed Mull Bar allowed for a visual inspection under the sill. No wood was witnessed under the sill of the new system.

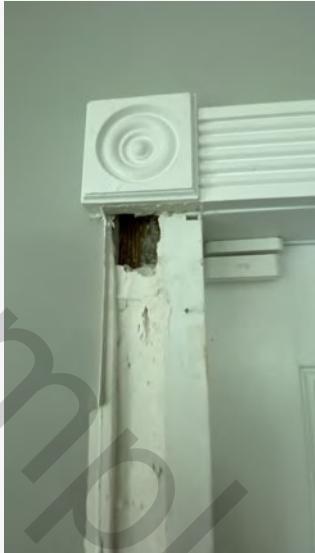
4

Frame is not completely supported  
Installer Filled Void between Door with Drywall Mud  
Fastener Inspection is difficult because of presence of  
Drywall Mud

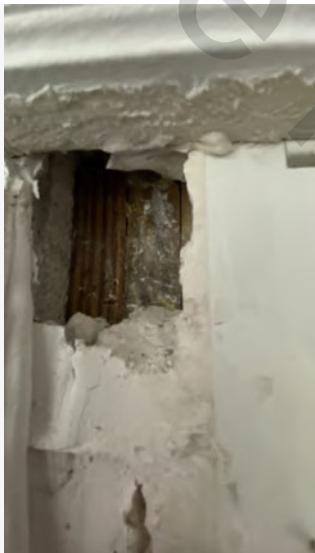
5

Frame is not completely supported  
Installer Filled Void between Door with Drywall Mud  
Fastener Inspection is difficult because of presence of  
Drywall Mud

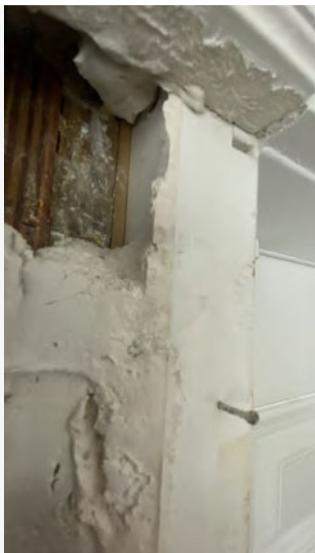
6

Frame is not completely supported  
Installer Filled Void between Door with Drywall Mud  
Fastener Inspection is difficult because of presence of  
Drywall Mud

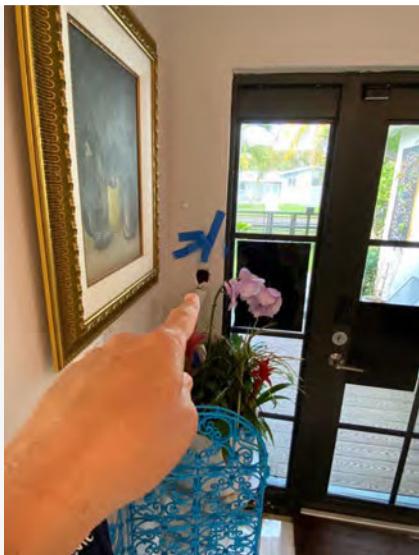
3

loose Electric Socket was removed to inspect bucking and installation

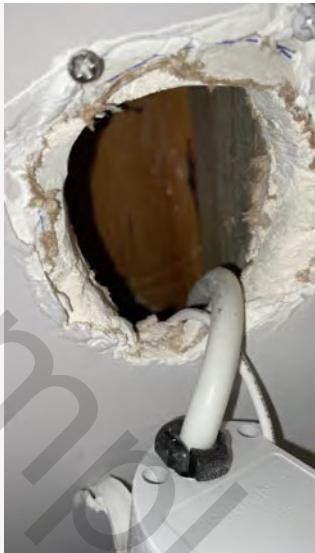
2 x 4 stud with a 1 x 4 attached to it

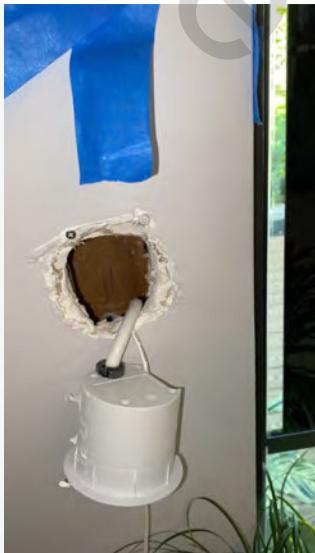
5

2 x 4 stud with a 1 x 4 attached to it

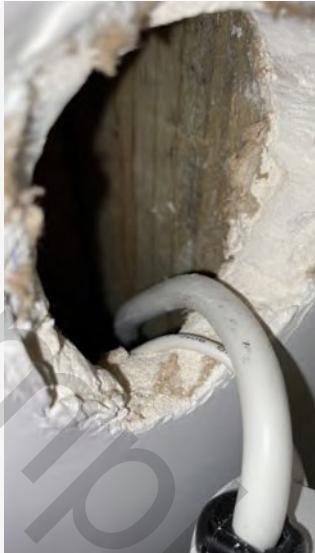
7

2 x 4 stud with a 1 x 4 attached to it

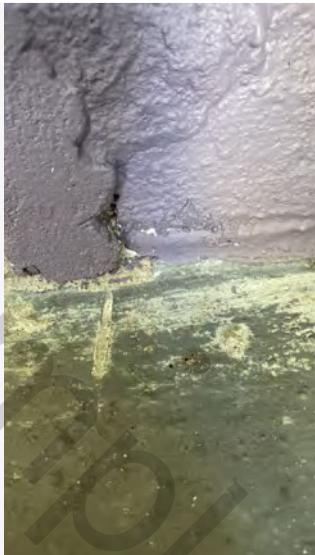
10

Crack witnessed in footer

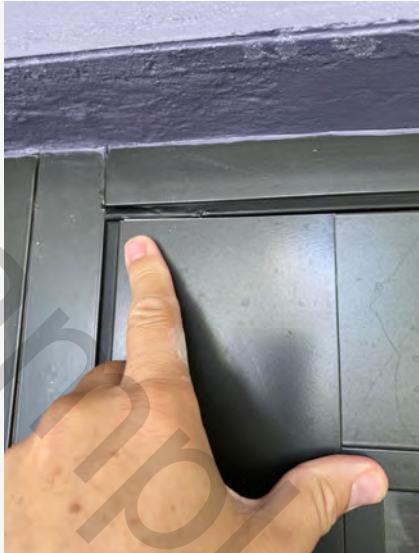
13

Door out of Plum, Level and True

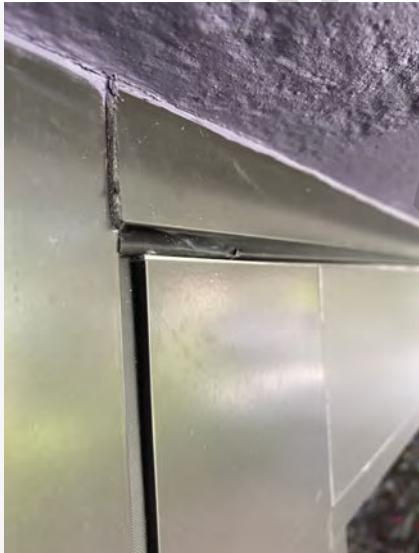
14

Door out of Plum, Level and True

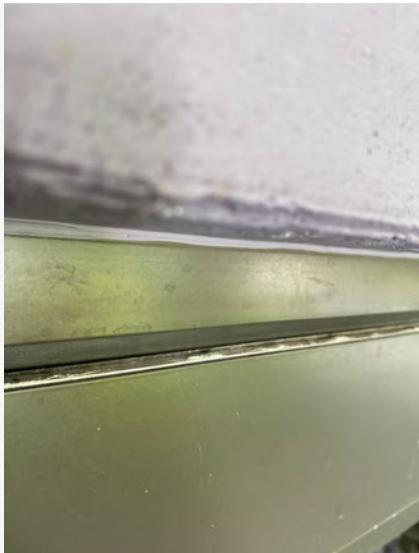
15

Door out of Plum, Level and True

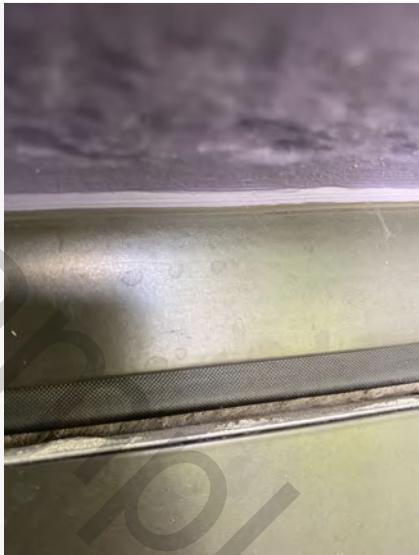
16

Door out of Plum, Level and True

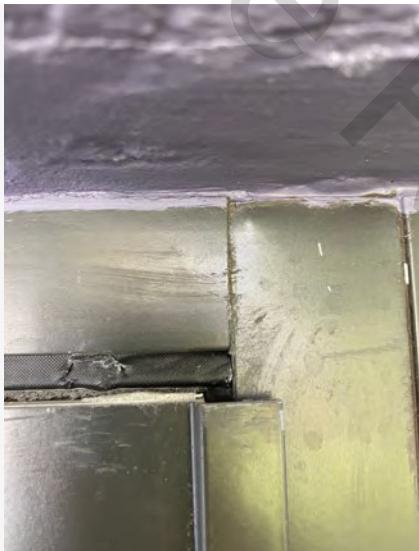
17

Door out of Plum, Level and True

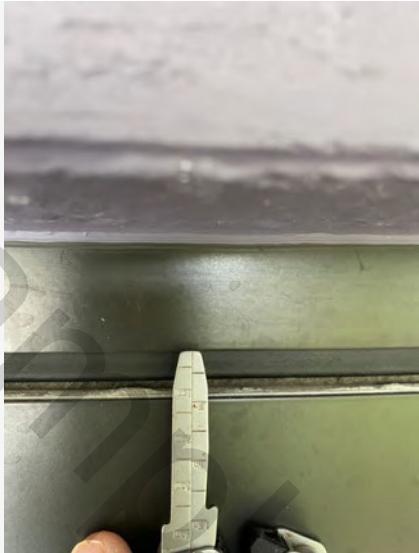
19

Door out of Plum, Level and True

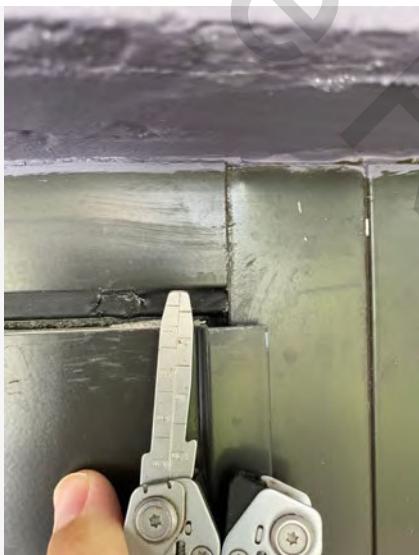
20

Door out of Plum, Level and True

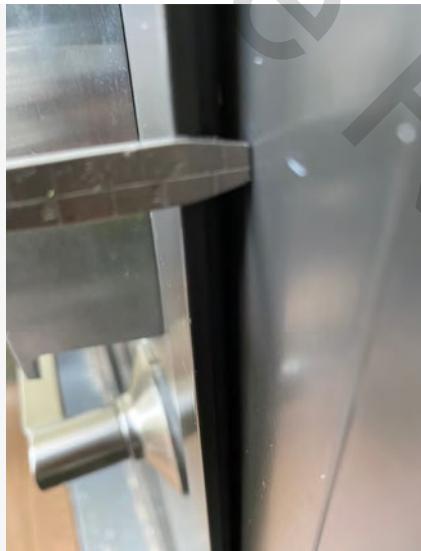
23

Door out of Plum, Level and True

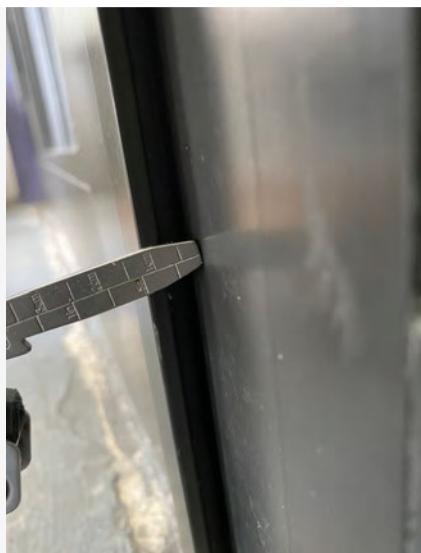
24

Door out of Plum, Level and True
