Big Bear Home Inspectors

Property Inspection Report

1111 Sample Avenue, "Lower Moonridge", Big Bear Lake, CA 92315
Inspection prepared for: Sample Sample
Real Estate Agent: Default AAA -

Date of Inspection: 7/29/2018 Time: 10:00am
Age of Home: Built in 1947 71 Years Size: A,B,C=1,330 SqFt
Weather: Clear & Warm
There will be 3 Reports Made A B C. This is Report For Building A
Inspection Report was Paid For In Full at the Time Of The Inspection. 7-29-2018
Chk#124
****PLEASURE DOING BUSINESS WITH YOU****

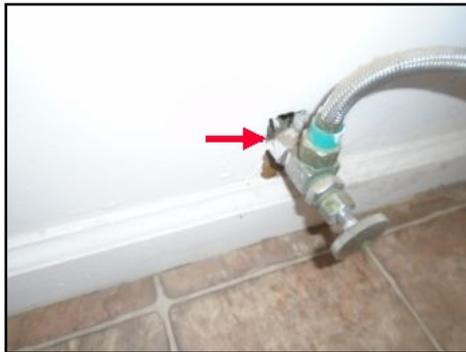
| Page 13 Item: 12 | Plumbing | • Area where Plumbing enters the wall should be sealed up. |

Seal Hole around the Pipe

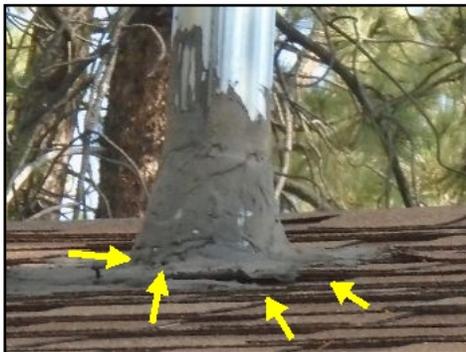
Page 25 Item: 5

• The 1 Stack and Flashing Sealant work should be looked at.

Sealant is Questionable

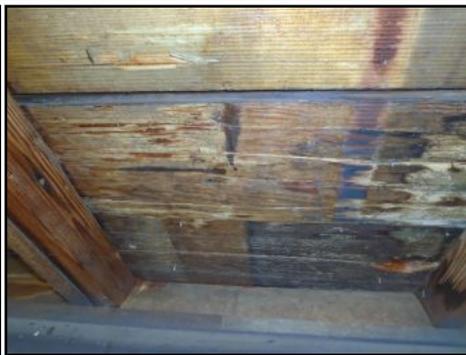
Exterior Areas Eaves & Fascia

Broken Fascia Board

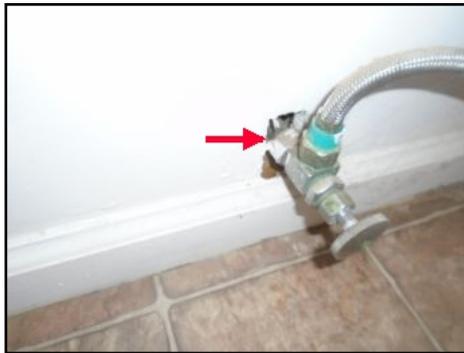
Observations:
 • Area where Plumbing enters the wall should be sealed up.

Seal Hole around the Pipe

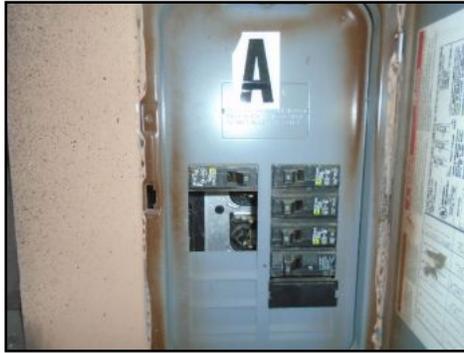
- **Sub-Panel "A" Knockouts need snap-in caps inside panel box. Should be installed to keep mice out of panel box and to avoid potential electrocution hazard.**

Sub Panel for Building "A"

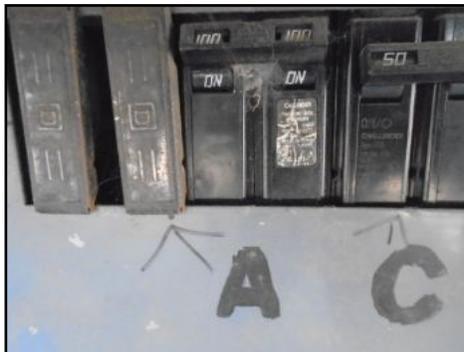
Building "A" Main is 100 Amp

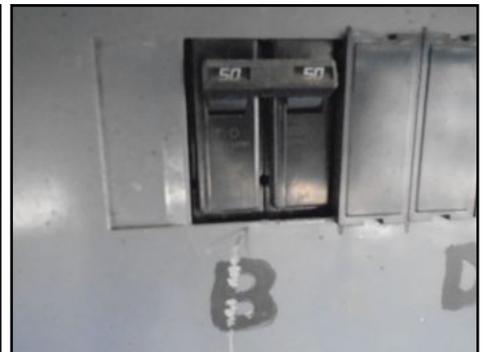
Building "B" Main Breaker is 50 Amp

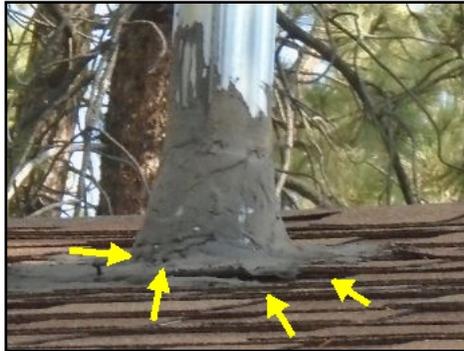
- The 1 Stack and Flashing Sealant work should be looked at.

Sealant is Questionable

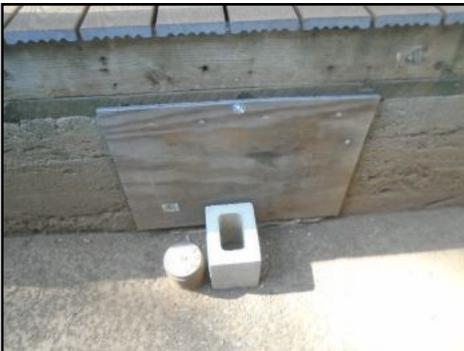
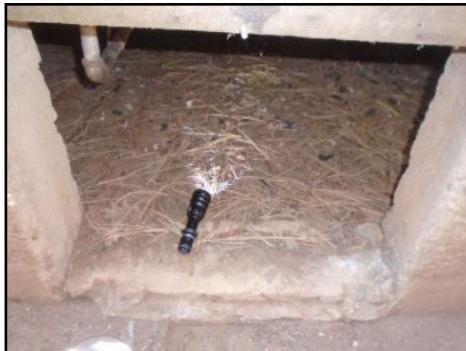
Entrance Under Deck

Observations:
 • The foundation access panel installed and functional during the inspection.
 • Limited inspection from the access area only.
 • Recommend at least 18 inches of clear access to gain entry.
 • The exterior crawlspace access was missing a cover. We recommend installing a cover with a screen to assist in ventilating the space.
 • Could not access the crawlspace, there was limited space for entry.

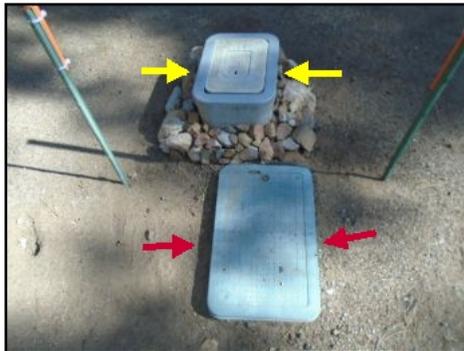
- City water Main Valve Appeared to be working Correctly At The Time Of The inspection

(Red Arrow) City Water Main (Yellow Arrow) Stop & Waste

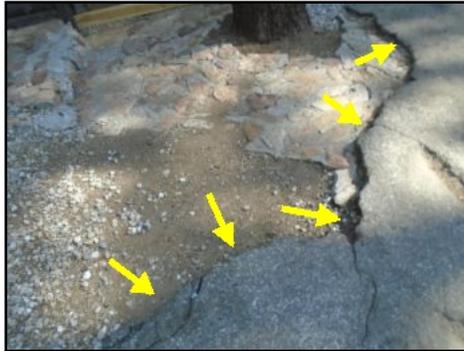
- Driveway in good shape for age and wear. Some oil staining. Clean and seal to extend life.
- Gravel driveways need ongoing maintenance. Repair as needed.
- **Uneven Asphalt at the driveway. This is a Tripping Hazard**

Possible Tripping Hazard

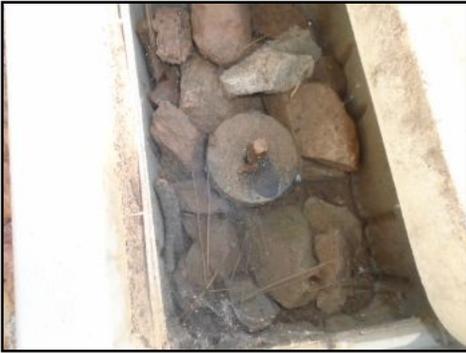
For Entire Property

- Stop & Waste Functioned Correctly During the Time Of The inspection
- Multiple Stop & Wastes on Property

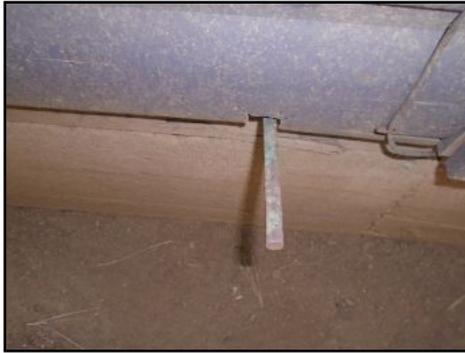
Materials: In Front of the City main Left Front Corner of the Property • Also another one coming out the Rear West Corner of the Building to what looks like it is for Draining Water Heater. But Valve sticking out of the Wall could be a Safety hazard. Recommend further evaluation by a Handyman

To drain Water Heater

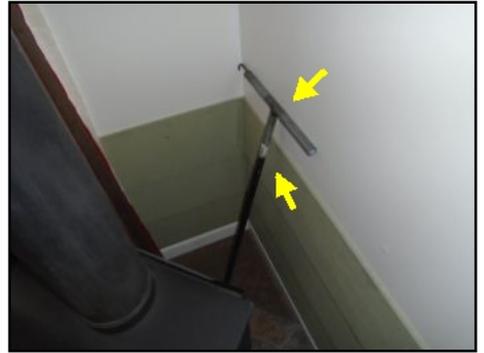
Key For Outside Stop & Waste

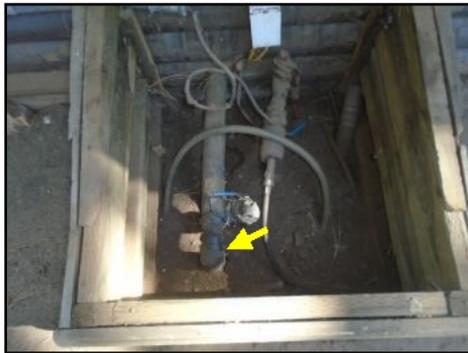
- Appears to be No Issues with the Grounds Plumbing

Water Main For Building A

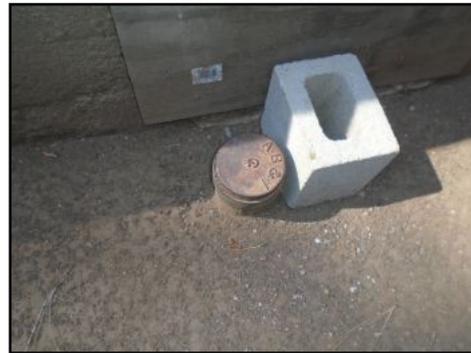
Main Line Clean Out
