Water Transmission Main Condition Assessment

March 6, 2024

City of Elyria Water System

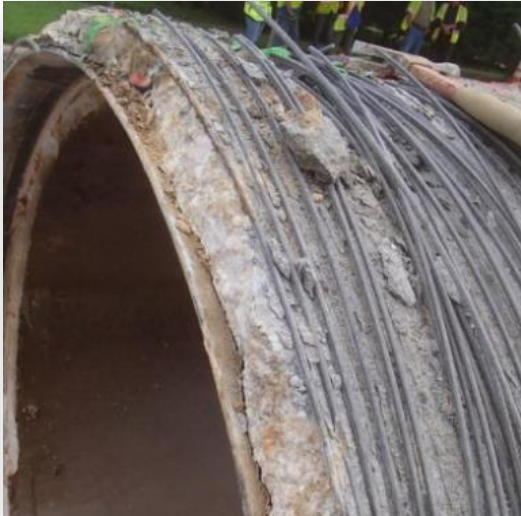
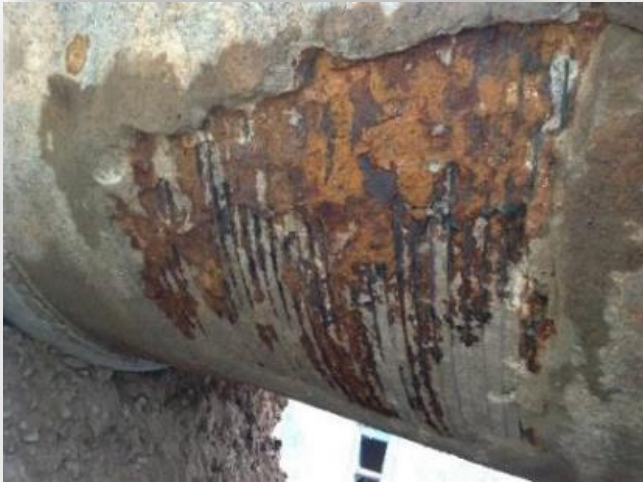
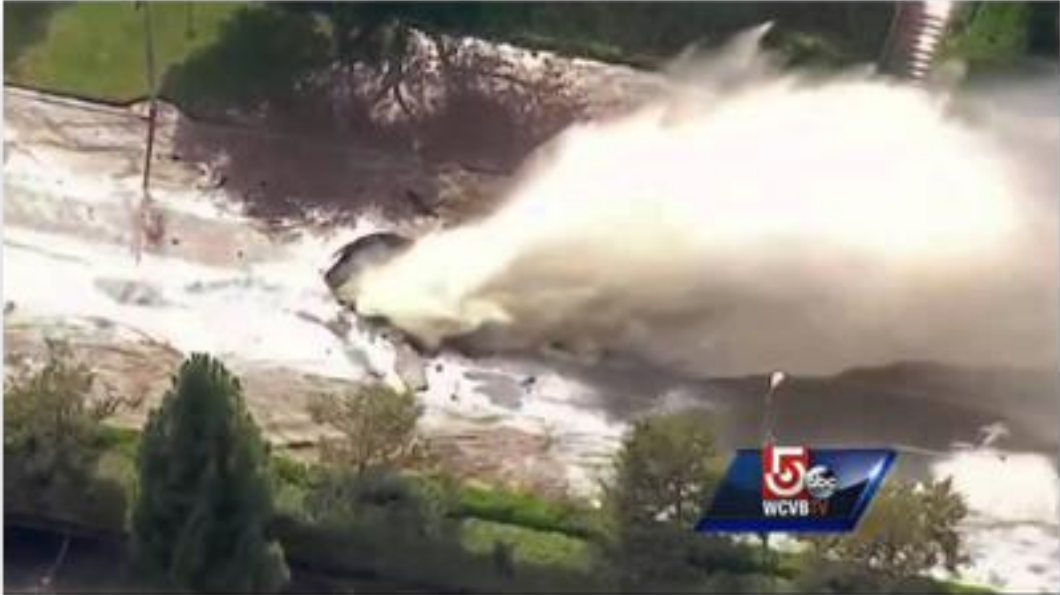
PCCP Failure

PCCP failures begin with wire breaks

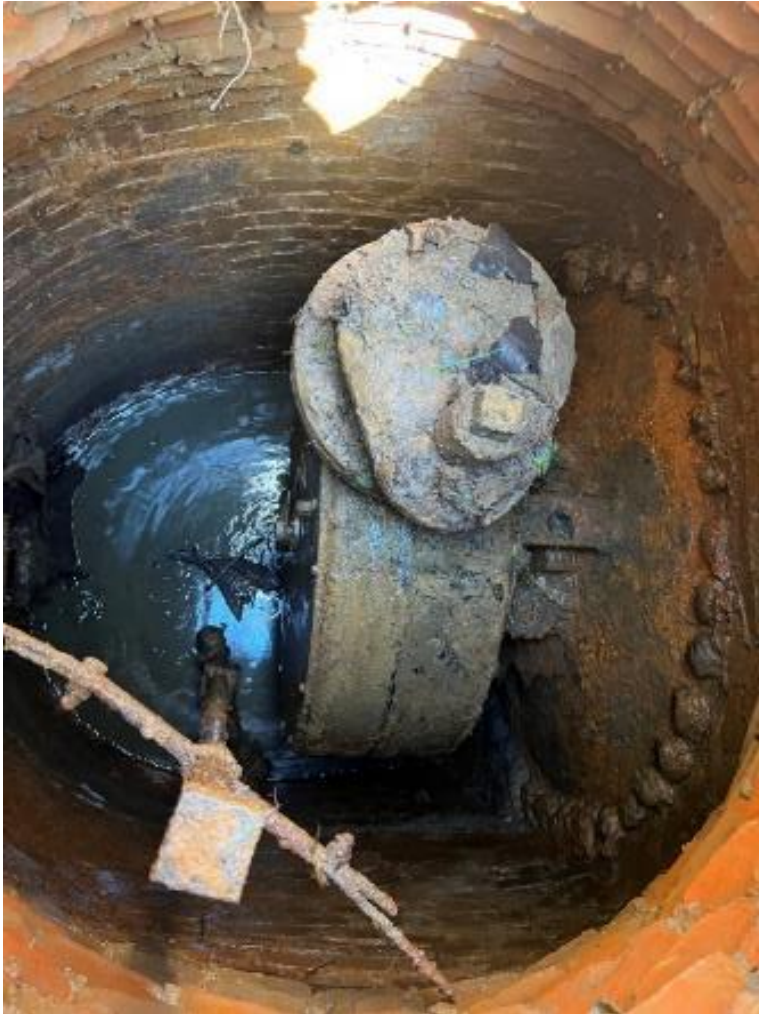
48" PCCP Main –
Mainline Cone Valves

All cone valves operated very well and were in great condition.

- **No action needed prior to inspection**

- Continue to monitor performance of valves and exercise valves on a scheduled program.

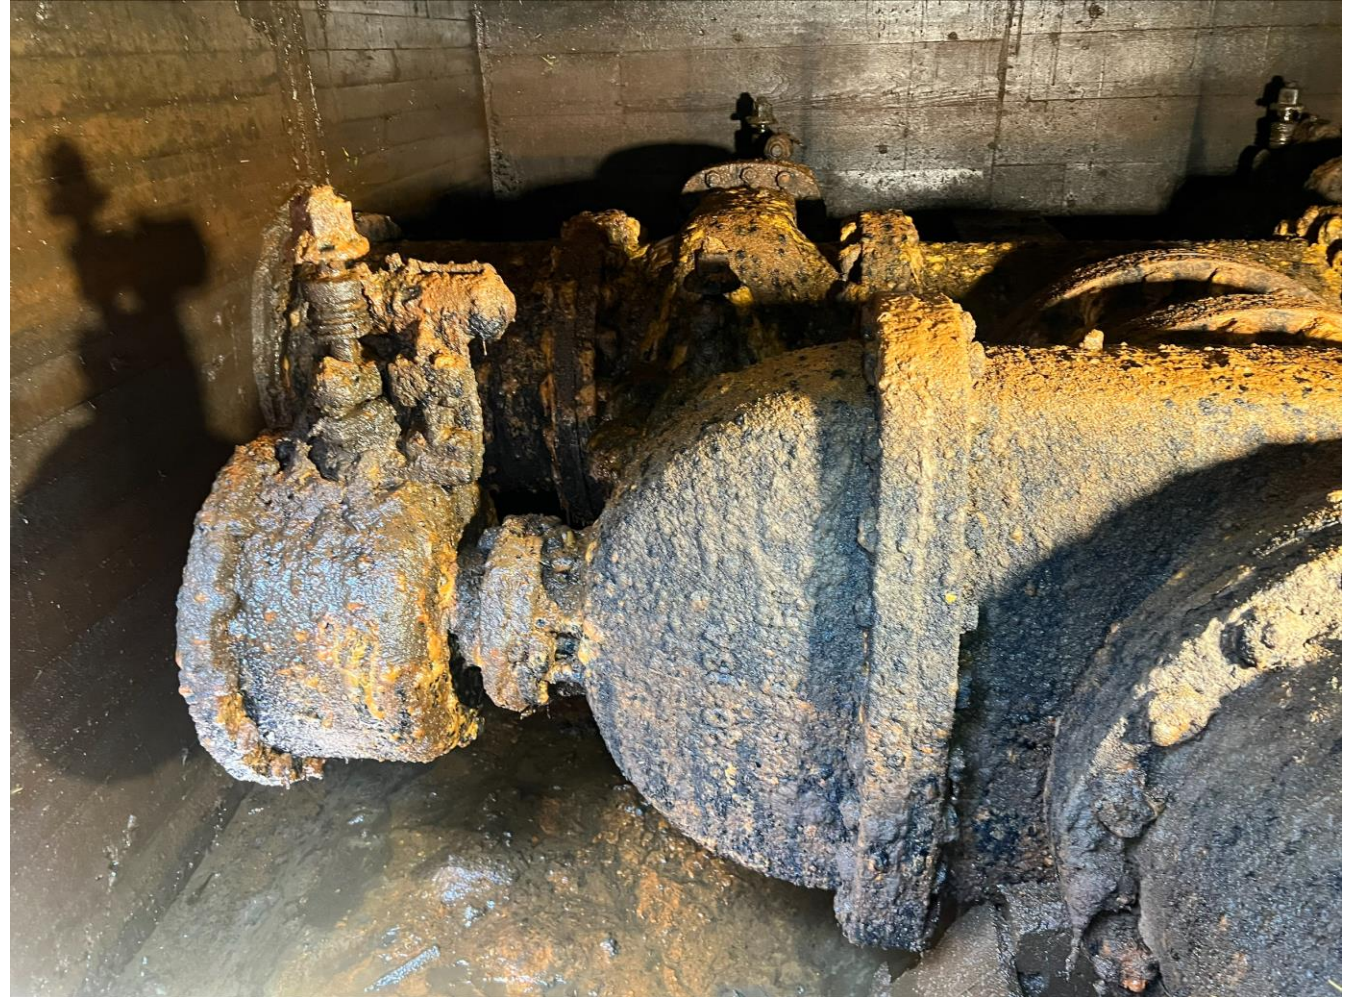
20" & 30" CIP Main –
Mainline Gate Valves

Valves were very corroded

Valves struggled to exercise 25% often

Some exposed gear boxes on the 20-inch CIP valves in very poor condition – did not exercise

- Continue to exercise valves in operable condition
- Avoid exercising high risk valves identified in TM
- Replace all valves including air valves and drain valves during pipeline rehabilitation project or within 10 years.

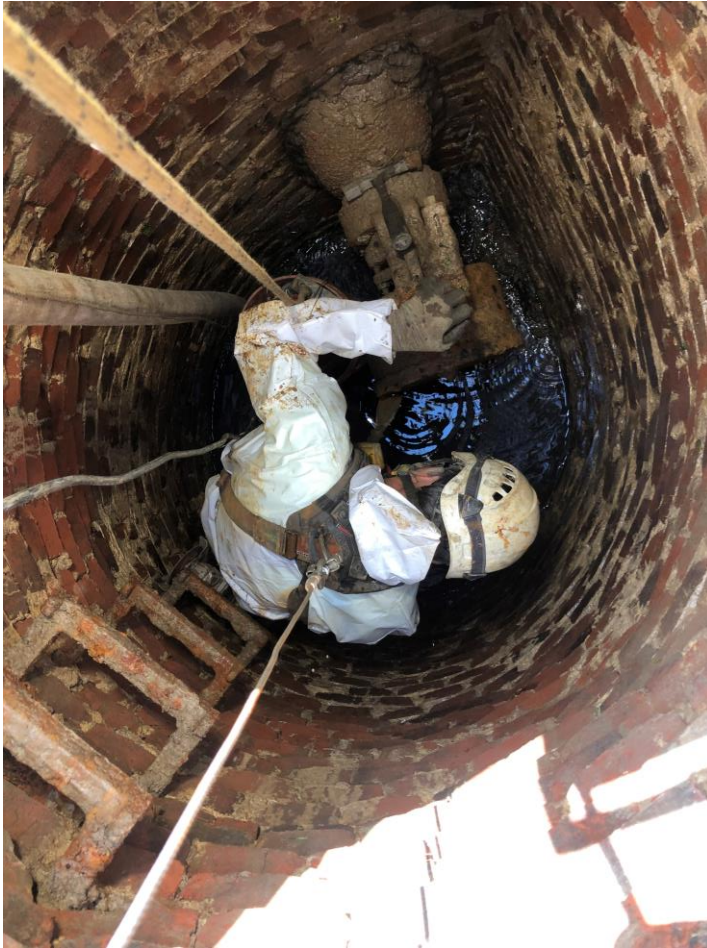
48" PCCP to 30" CIP Cross
Connection Gate Valves

48 – 30-inch Cross-connection gate valves also operated well

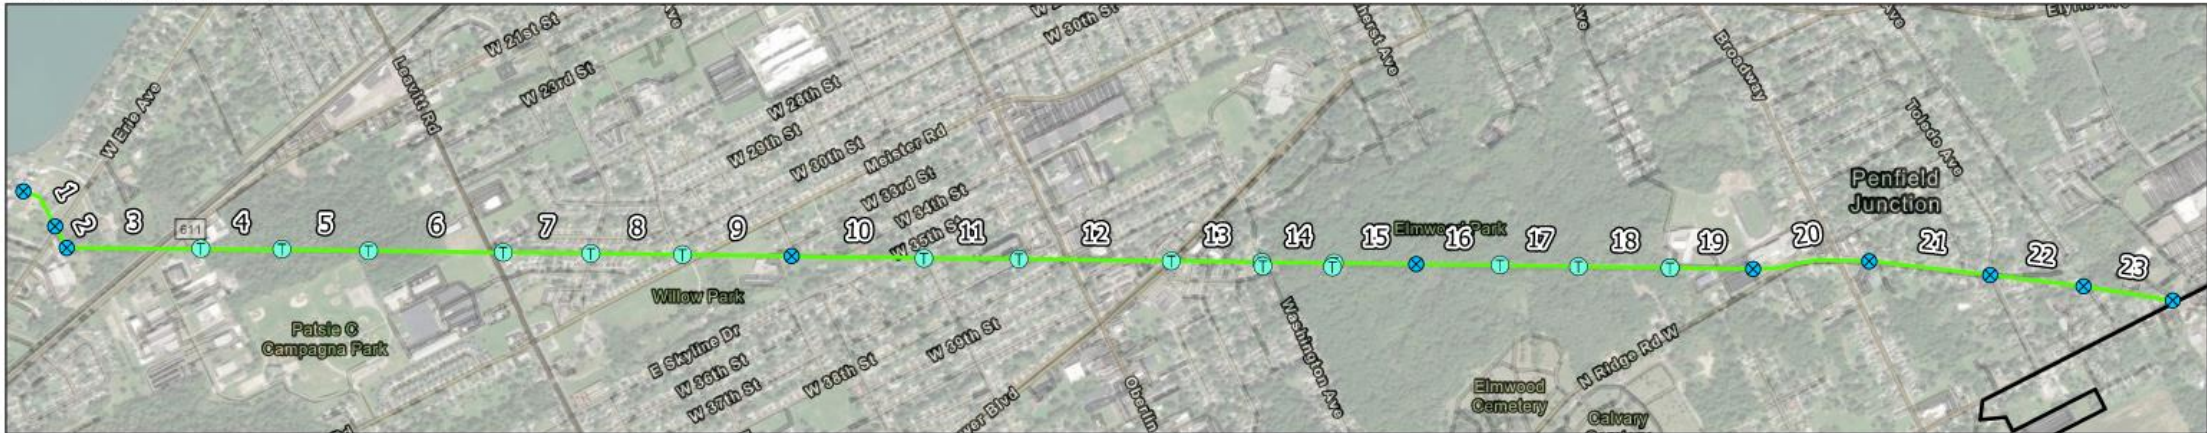
FIGURE 1: 23,000-LF, 20-inch Phase

23 Phases Completed ~22,000 LF Inspected
