# Wolverine Home Inspection LLC

## Home Inspection Report

**Birch Run , MI**

Inspected on Fri, Aug 23 2019 at 10:37 AM

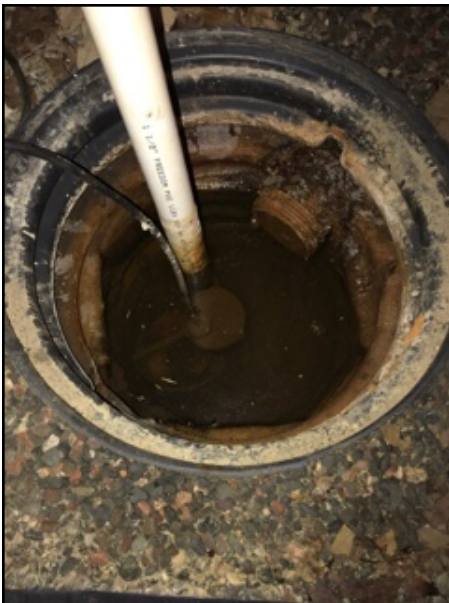
Figure 12-1

Sump pump on north side of crawlspace is dead .

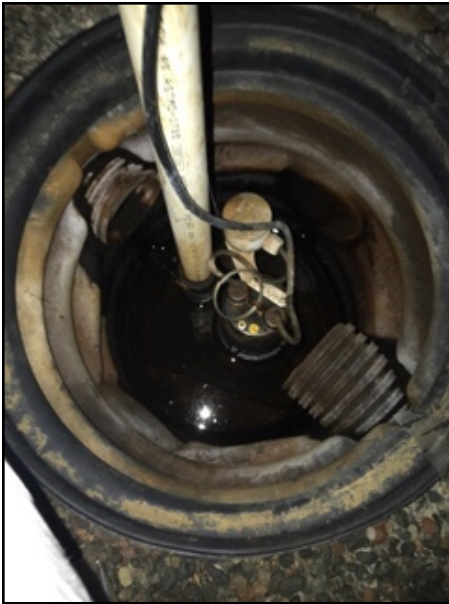
Figure 14-1

Both sump pumps bad. Power confirmed going to pump

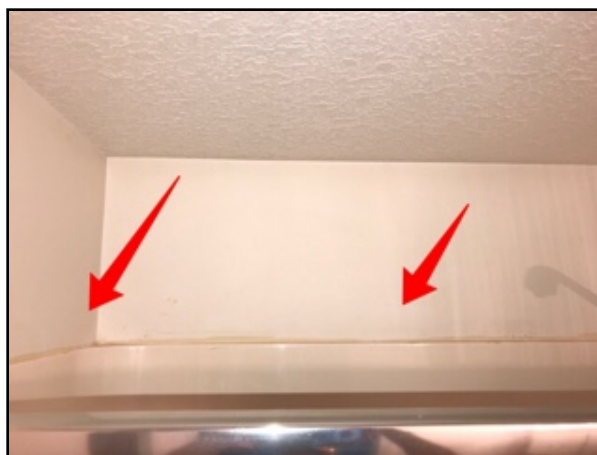
Figure 23-2

Recommend sealing top of shower enclosure to prevent water intrusion behind enclosure .

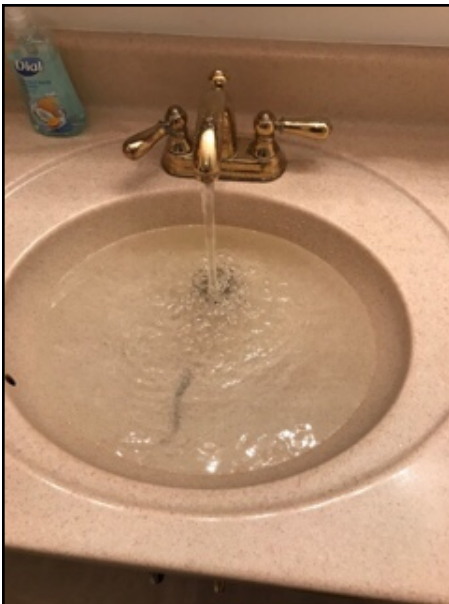
Figure 26-1

Comment 26:  
sink is draining slow .

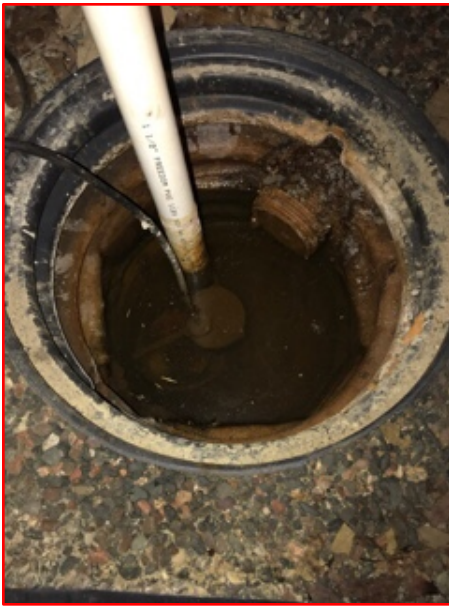
Figure 12-1

- 1) Sump pump on north side of crawlspace is dead .

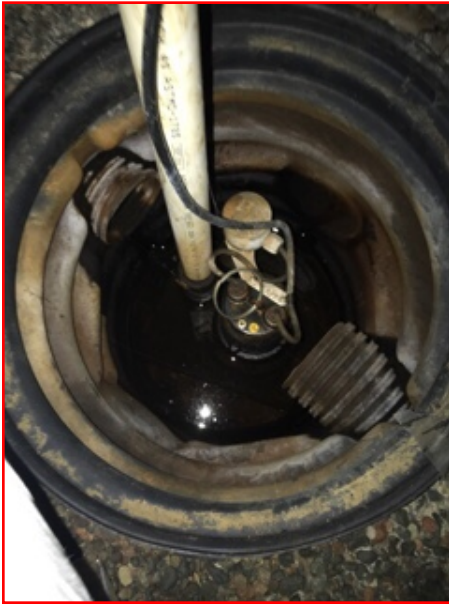
Figure 14-1

- 2) Both sump pumps bad. Power confirmed going to pump

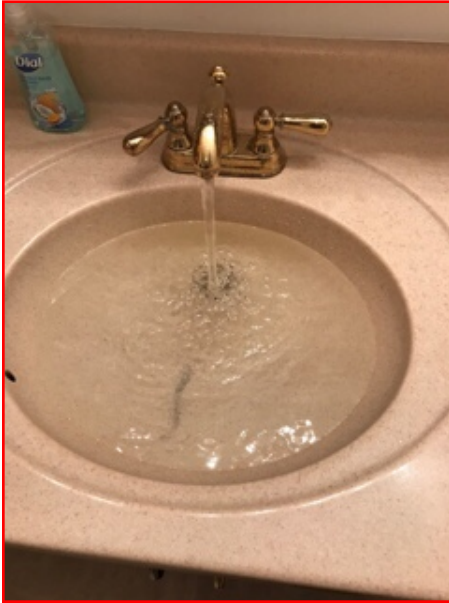
Figure 26-1

5) sink is draining slow .
