INDY PRECISION HOME INSPECTIONS

PROPERTY INSPECTION REPORT

**123 Anystreet Drive
Inspection Prepared For: John Homeowner
Agent: No Agent On File -**

**Date of Inspection: 1/1/2023
Year Built: 1998 Size: 1143 Square Feet
Weather: Sunny / 36 Degrees Fahrenheit**

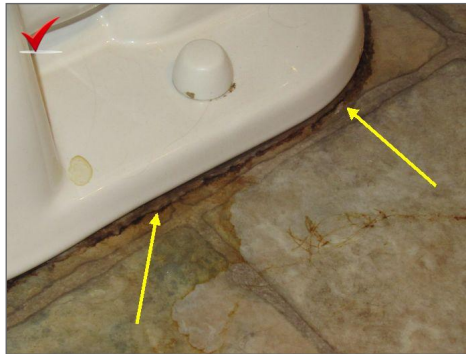
Page 44 Item: 5	Toilet	<ul style="list-style-type: none"> There is evidence of leaking at the base of the toilet which indicates the presence of a failing wax ring. Recommend a qualified contractor evaluate and repair.
-----------------	--------	--

Evidence of a failing wax ring observed on bathroom toilet, recommend repair

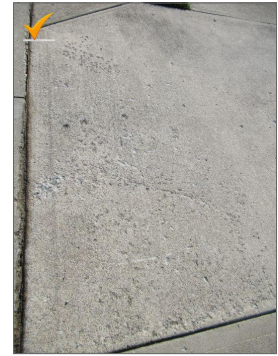
The driveway has areas of spalling, in most cases, the defect does not affect the slab's service life if untreated

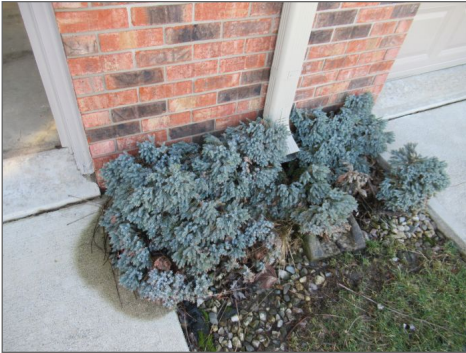
Trees/vegetation in contact with the home, recommend trimming back trees/vegetation

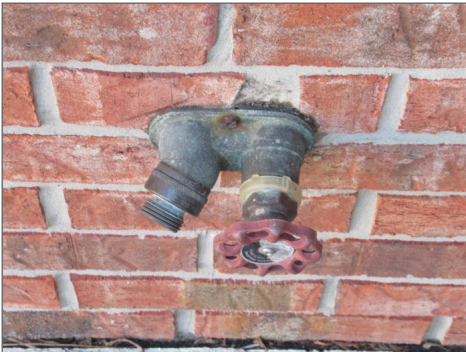
Hose faucet was shut-off and not tested

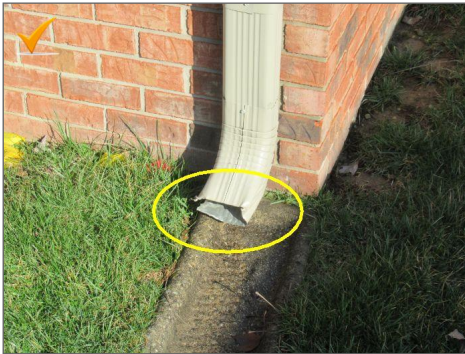
The gutter downspouts had some visible damage, recommend a professional contractor repair

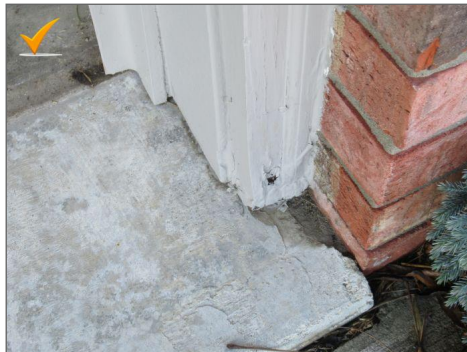
- Trim was damaged/wood rot in areas. Recommend repair or replacement of damaged exterior trim by a licensed contractor.

Trim was damaged/wood rot in areas, recommend repair or replacement of damaged exterior trim by a licensed contractor

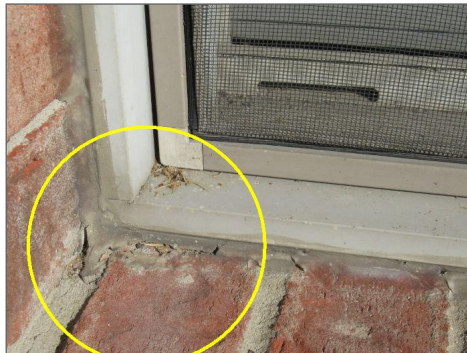
The caulking is dried and cracked, recommend a professional contractor to remove and replace the caulking

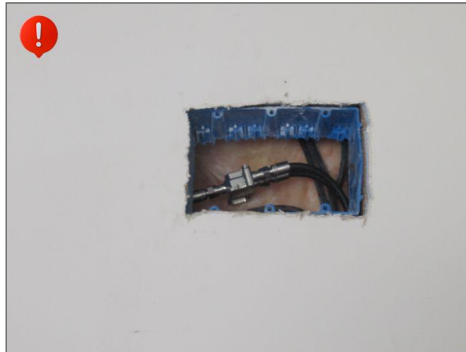
One or more holes and or penetrations were present at the garage firewall, recommend repair

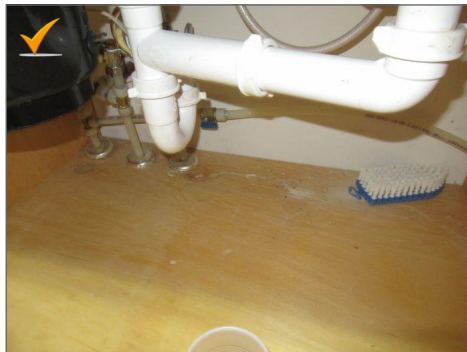
- Some kitchen cabinet hinges and pulls are loose. Recommend hinges and pulls be tightened.
- The kitchen cabinet floor has some old moisture stains. No active moisture was observed during the inspection. Recommend monitoring and repairing as needed.

Old moisture stains observed under kitchen sink, recommend monitoring

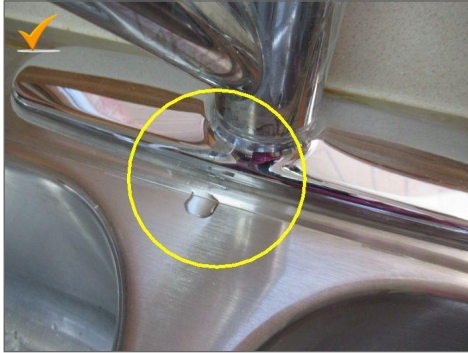
- Water flow from the kitchen sink sprayer is low (see video below). Recommend cleaning and re-testing.
- The kitchen faucet shows evidence of leaking when in use. Recommend a licensed plumber repair.

Slight leak from faucet observed, recommend repair

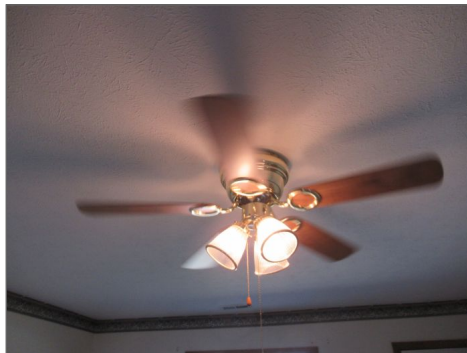
- No representation can be made to the proper installation of ceiling fans. Recommend monitoring and adjust/repair as needed by a qualified contractor.
- The ceiling fan emitted a grinding/clicking sound when in operation. Recommend monitoring and repairing/replacing as needed.

No representation can be made to the proper installation of ceiling fans

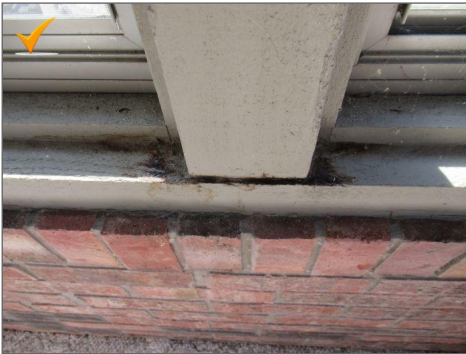
- There are moisture stains on the walls. This sun room is an unconditioned space and will require proper ventilation to prevent mold and mildew growth. Monitor and repair as needed.

There are moisture stains on the walls, recommend maintaining proper ventilation and repair as needed

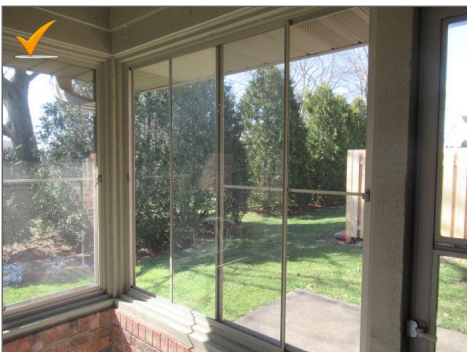
- All windows were tested and operational, however some are difficult to open/close. Recommend cleaning and lubricating track to allow for easier operation.
- One or more window screens are damaged/torn/missing. Recommend repair by a licensed contractor.

Windows are all functional, but difficult to operate, recommend cleaning/lubricating

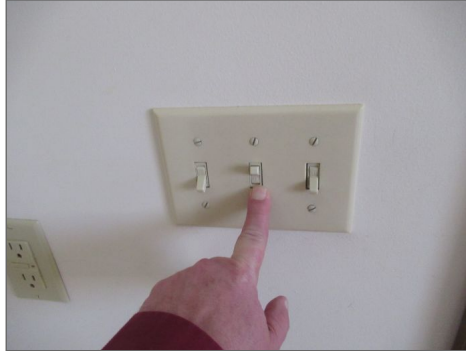
- One or more switches do not operate anything apparent. This could be due to being wired to a light fixture/ceiling fan that is not installed or to a receptacle that is blocked by homeowner possessions. Recommend verifying proper operation with the seller.

Switch(s) shown do not operate anything apparent, recommend verifying proper operation with seller

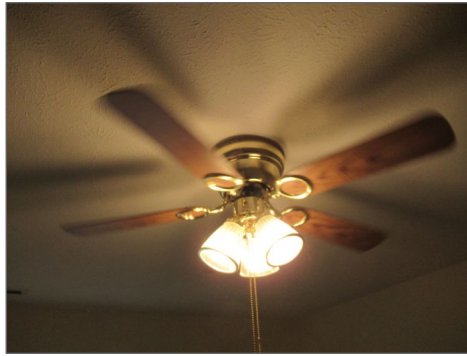
- No representation can be made to the proper installation of ceiling fans. Recommend monitoring and adjust/repair as needed by a qualified contractor.

No representation can be made to the proper installation of ceiling fans

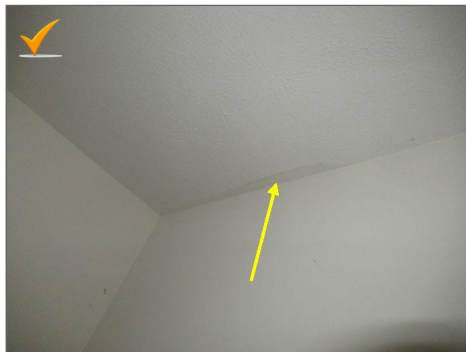
- There is moisture staining on the bedroom closet ceiling. There was no current moisture at the time of the inspection. Monitor and repair as needed.

There is staining on the closet ceiling, there was no current moisture at the time of the inspection, monitor and repair as needed

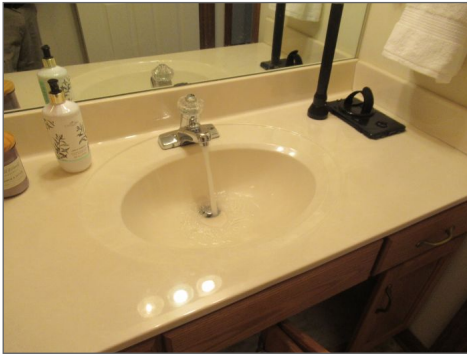
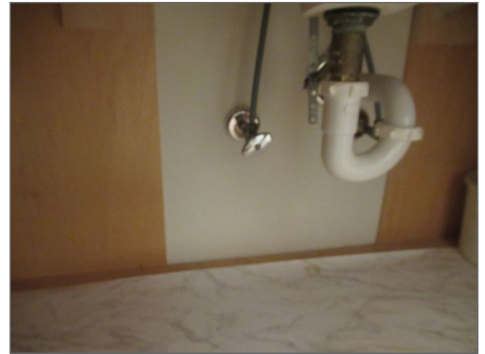
- Faucet leaks: Yes
 - Pipes leak: No
- Observations:
- The bathroom faucet shows evidence of leaking when in use. Recommend a licensed plumber repair.
 - There was previous moisture staining and damage present under the bathroom vanity cabinet. Recommend monitoring. Repair or replace as needed.

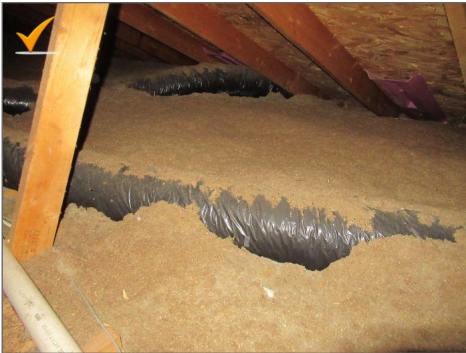
- Recommend additional insulation

- The attic insulation is not sufficient for current building standards. Recommend a licensed professional add additional insulation.

The attic insulation is not sufficient for current building standards, recommend a licensed professional add additional insulation

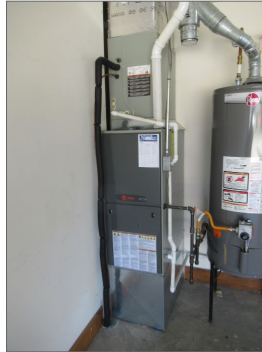
Trane furnace

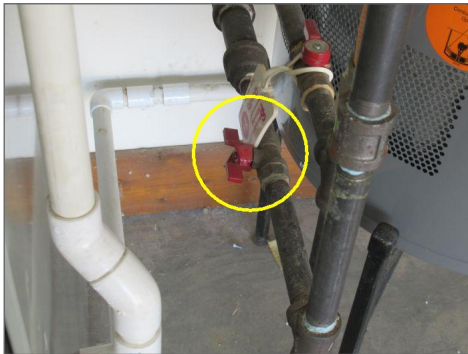
Fuel shutoff valve

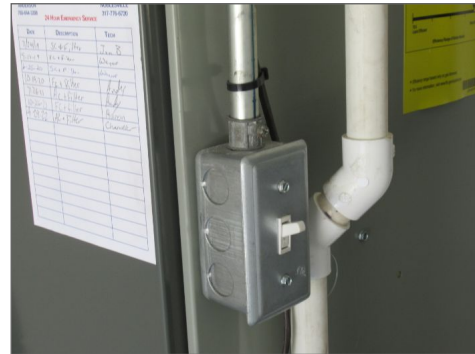
Electrical safety/service disconnect

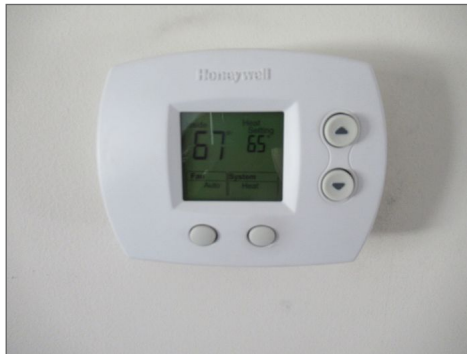
Thermostat located in living room

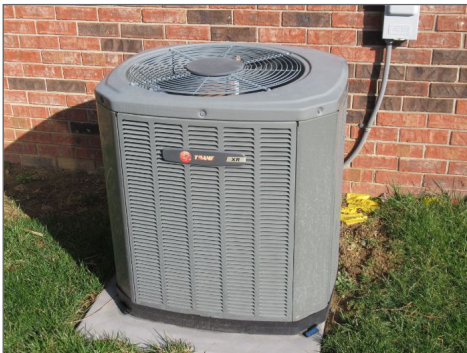
The exterior **A/C** unit

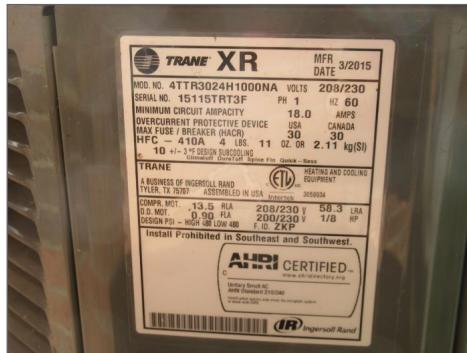
The exterior A/C unit data tag
(mfr.date: March 2015)

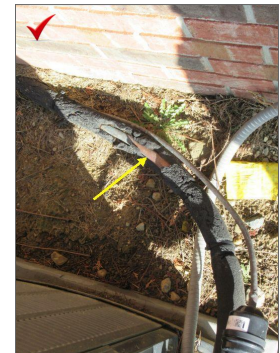
- Location: South
 - Brand: Trane
 - Manufacture Date (According to Data Plate): March 2015, 8 years old at time of inspection.
 - Energy source: Electric
 - Unit Type: Air cooled
 - Outside disconnect: Yes
 - Maximum fuse/breaker rating (amps): 30
 - Maximum fuse/breaker installed (amps): 20
 - Level: Yes
 - Insulation: Replace
 - Improper clearance (air flow): No
- Observations:
- Model #4TTR3024H1000NA
 - Serial #15115TRT3F
 - There is damaged and/or missing insulation on the air conditioner refrigerant line. Recommend replacing insulation.

The exterior A/C unit refrigerant line
insulation, recommend replacing

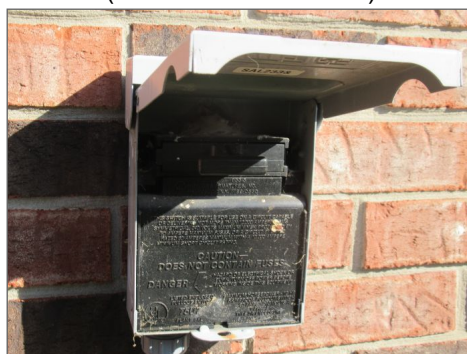
The exterior A/C unit service disconnect

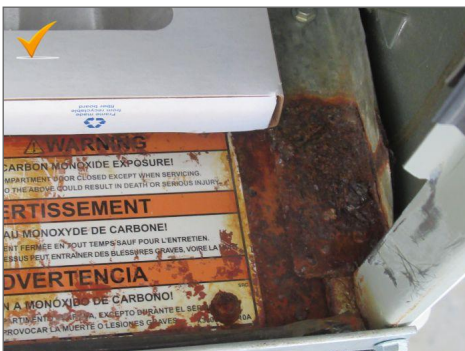
Rust in cabinet observed, recommend monitoring and repairing as needed

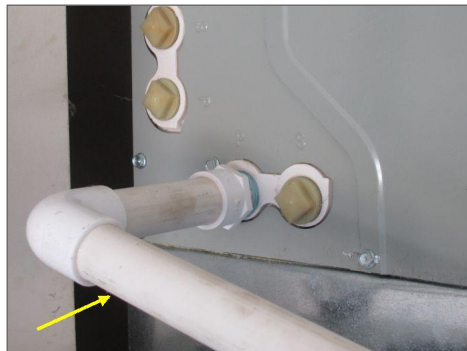
Condensate drip line

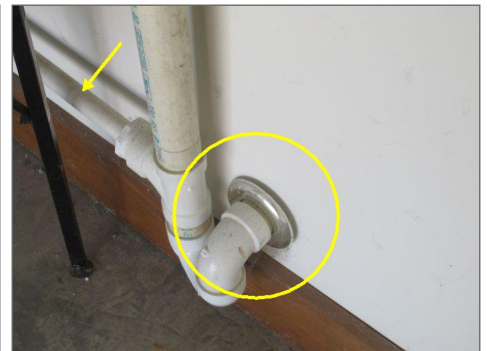
Condensate drip line terminates to drain

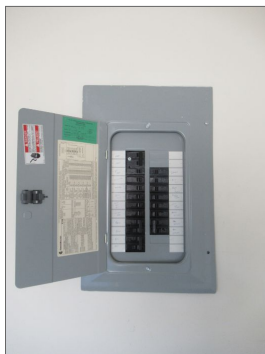
The main electrical service panel

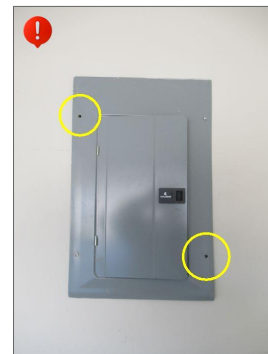
- The main electrical panel dead cover is missing two installation screws, which is a safety hazard. Recommend a licensed electrician install proper non-pointed screws.

Main electrical dead cover is missing 2 screws which is a safety concern, recommend replacing

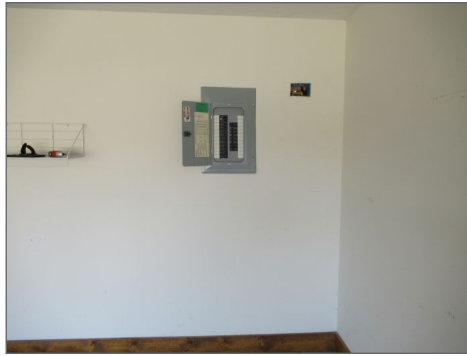
Main electrical panel located in the garage
