Inspection report for the property at  
**2108 Bienvielle, Monroe, LA**

This report is prepared exclusively for **Sue Kuruvilla**  
On: **2022-07-30**

QED Service

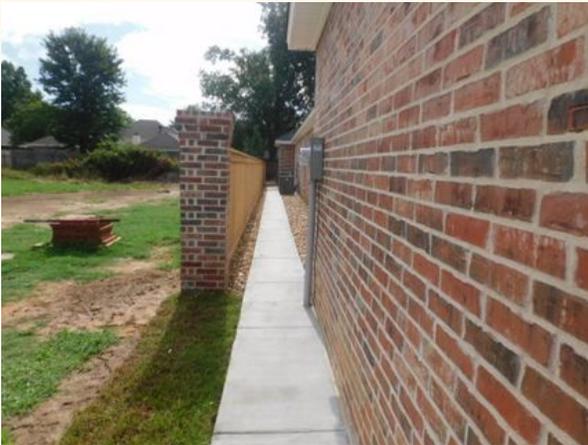
**(G-3) Review:** gate not installed at time of inspection.

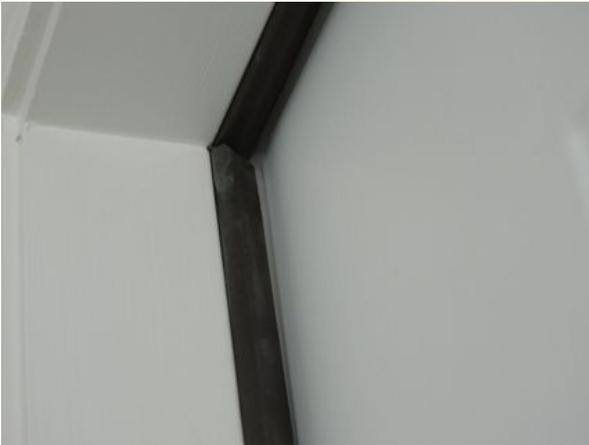
🔧 (ED1-5) Review: Doors not properly closing and engaging the door seals.

🔧 (ED1-6) Review: Doors appear to be out of square or not properly installed. This is based on the visual gapping around the door at seal.

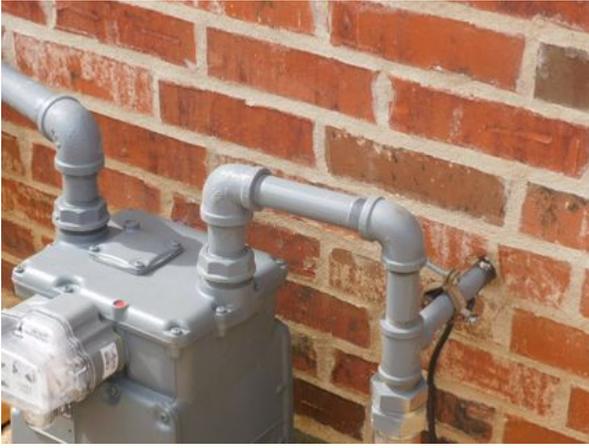
**(FSD-1) Note:** gas shut off valve located at meter on side of home.

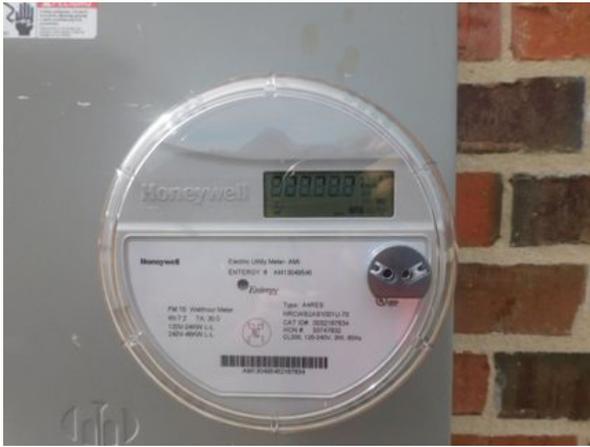
**(ES1-1) Note:** meter base

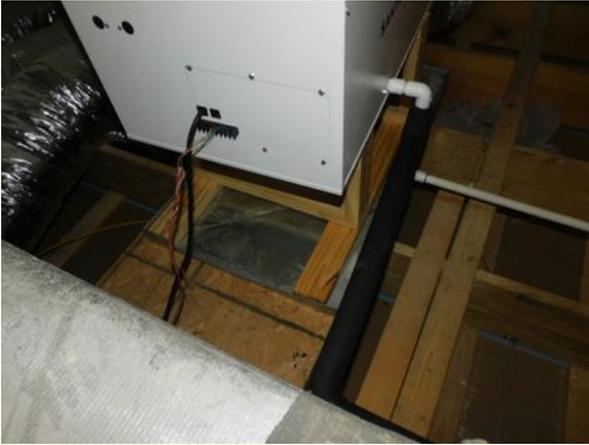
(HCFV-1) **Improve:** lumber in pans by be limiting or blocking need drainage in overflow pans.

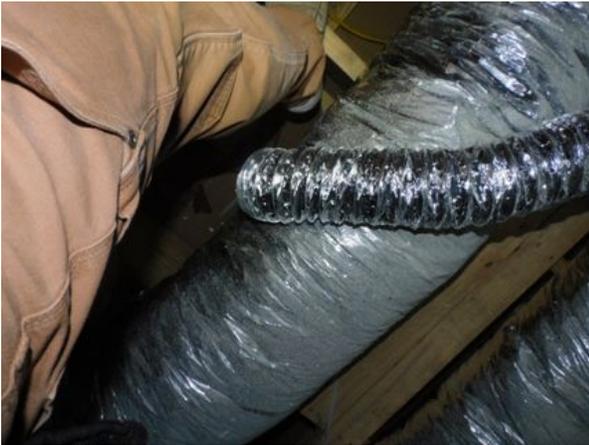
🔧 (HCFV-2) **Review:** Flex ducting being crushed in attic in various locations.

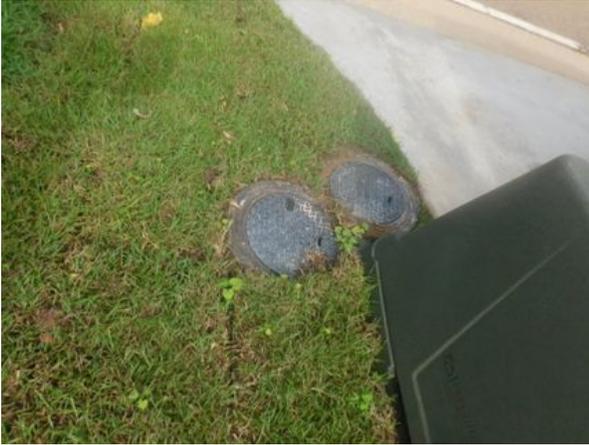
Location of Water Meter Note, front of home

↗ **(P2-1) Note:** This shows the location of the water meter at the street side of the house.

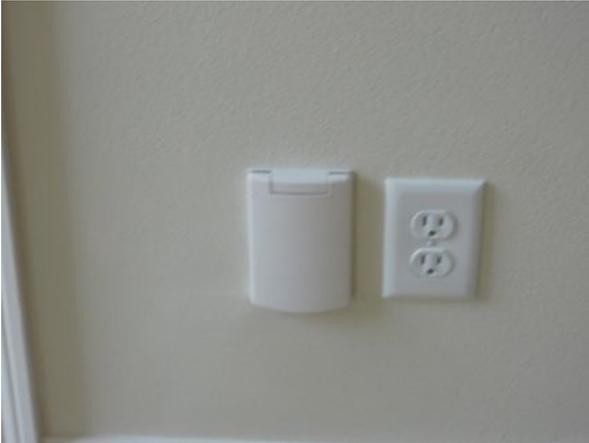
🔍 **(AP-1) Due Diligence:** The central vacuum system was not tested during inspection. These systems are beyond the scope of this inspection. I recommend inquiring with the seller for any additional information:

- Is this system functioning?
- Are there recommended maintenance or servicing tips for keeping the system clean and functioning?
- Some of these system have a filter that requires cleaning and others require replacing a bag.

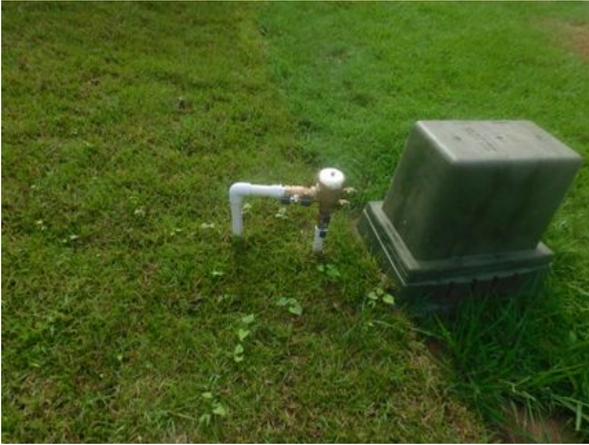
🔗 **(AP-3) Note:** Irrigation system not part of the home inspection. Recommend having owner demo the system before purchase.

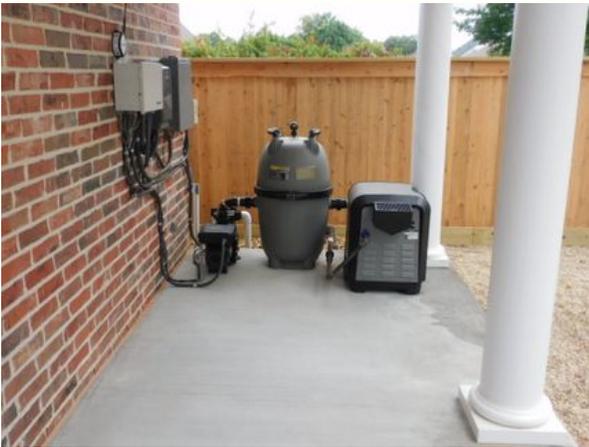
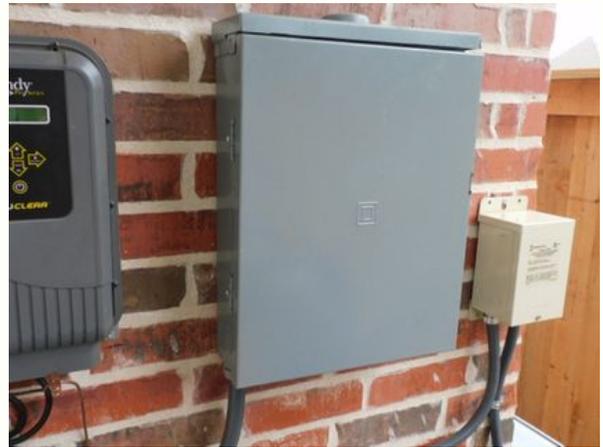
⚡ (AP-8) Note: present but not part of the home inspection.

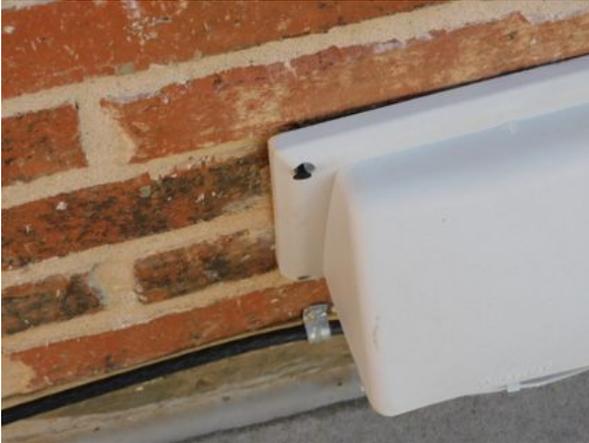
🔧 (LF-2) **Review:** Caulk and seal dryer vent to wall.

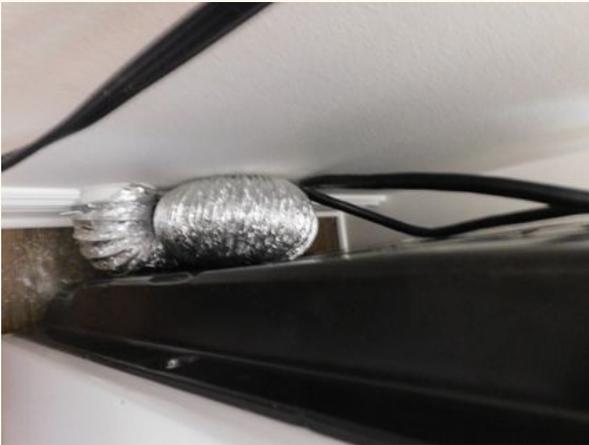
🔧 (LF-3) **Review:** dryer vent duct faulty.

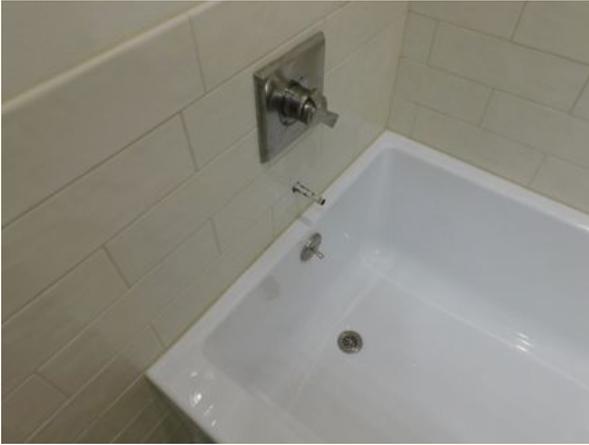
**🔧 (B-5) Review:** Tub spout not installed.

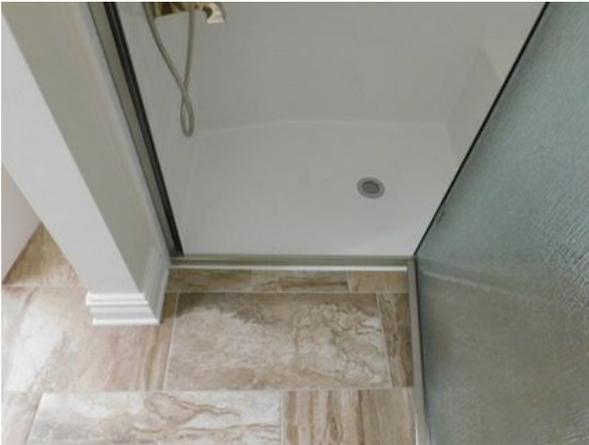
✦ (B-3) Note: Flooring sloped entering the shower.

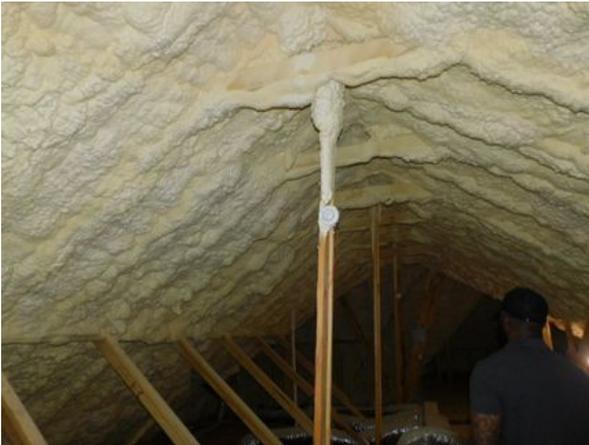
🔍 (A-2) Note: Spray foam insulation noted.

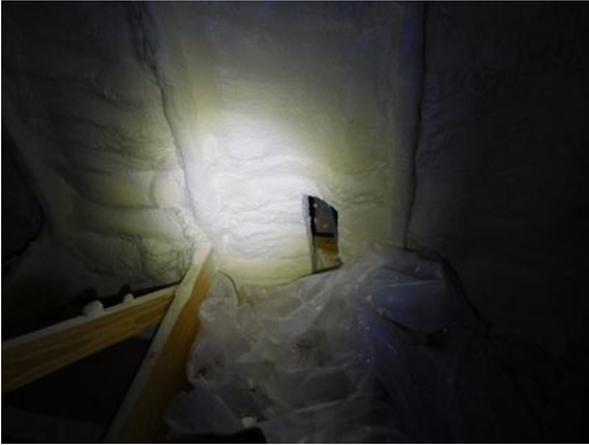
🔍 (A-3) Review: Holes cut into spray foam insulation in various locations.
