Inspection report for the property at
2708 Bramble Drive, Monroe, LA 71201

This report is prepared exclusively for **Michael & Holly Gray**
On: **2022-08-02**

QED Service

Inspector: Michael Burroughs : LA State License #LHI 10044,

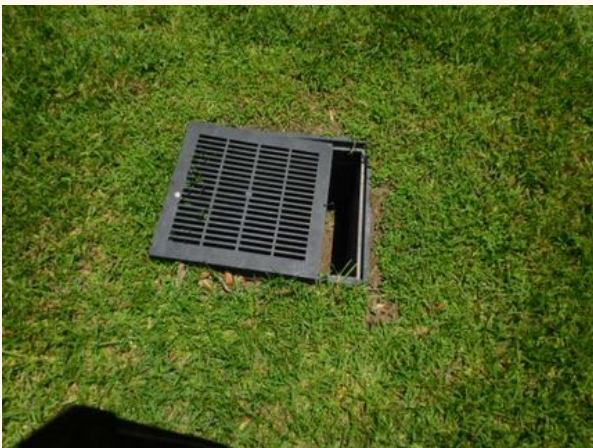
(G-2) Review: Site drain covers appear to be improperly installed.

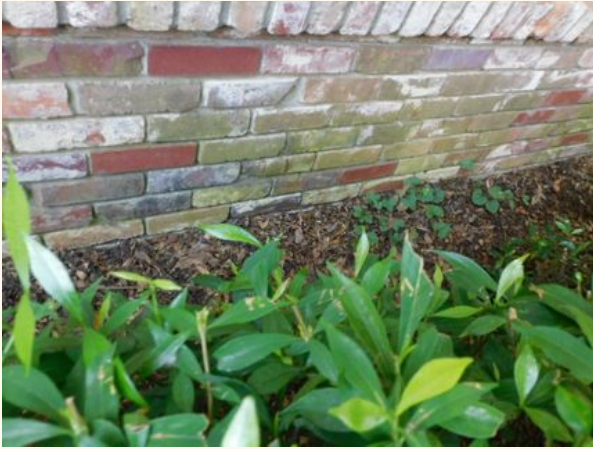
🔧 (G-3) Review: Earth against siding.

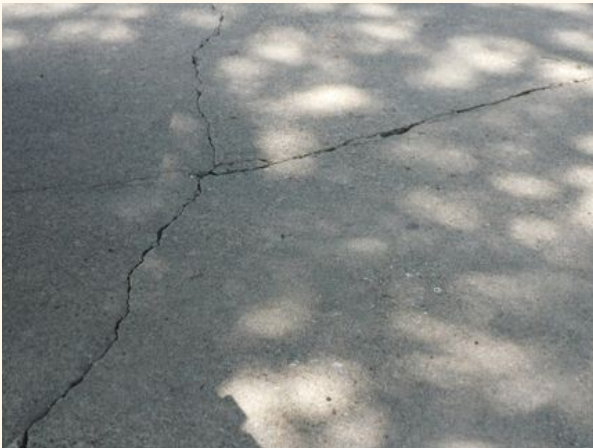
🔧 (G-4) Review: Concrete cracks noted in Driveway. Refer to line 0210 of the Uniform Building Inspection Report Binder.

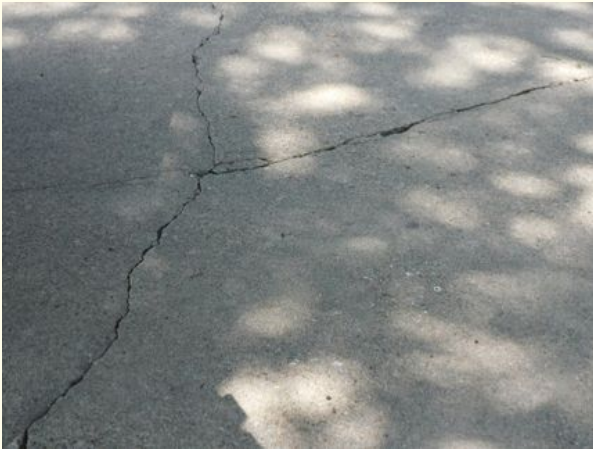
**(G-5) Improve:** Uneven walkways and driveway concrete. The settlement appears to have created a possible tripping hazard. Refer to line 0230 of the uniform building inspection report binder.

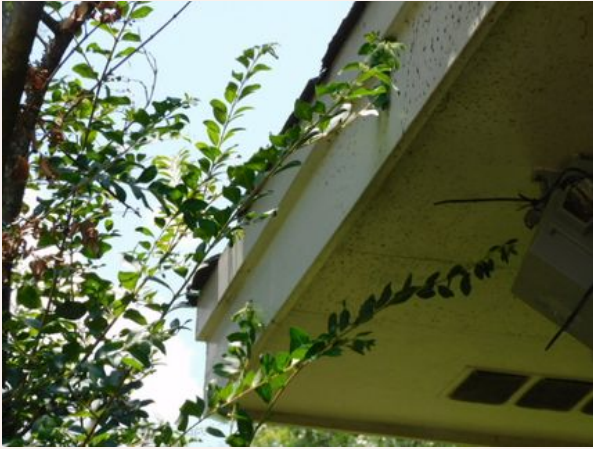
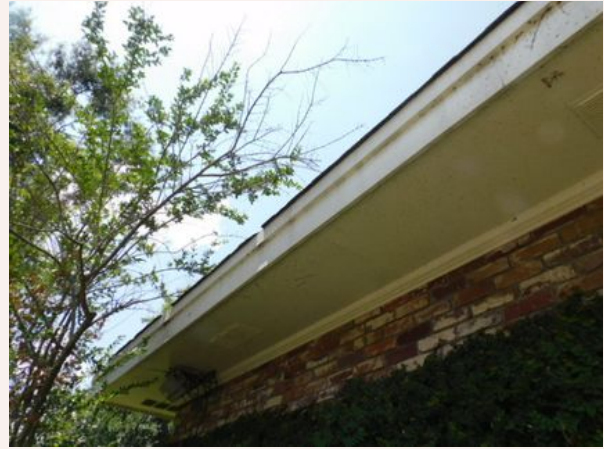
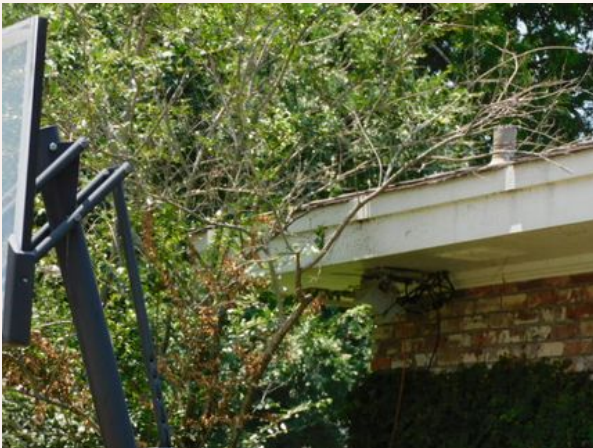
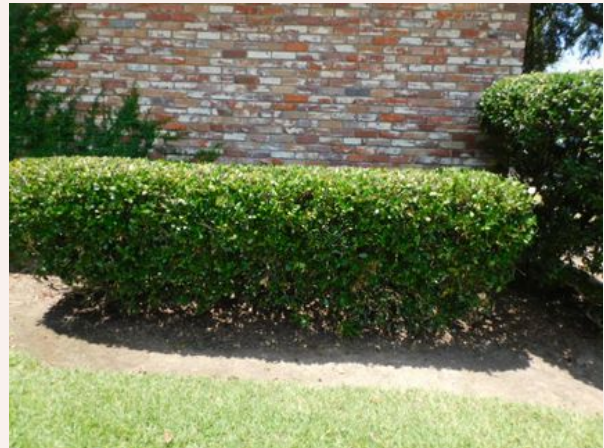
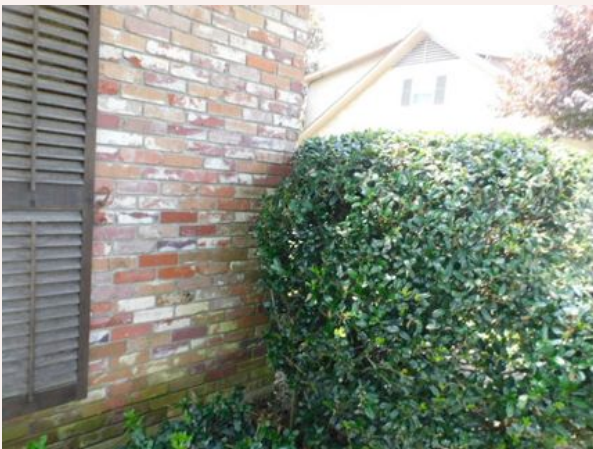
✂️ **(G-6) Recommended Preventive Maintenance:** Pruning trees, branches and vegetation away from the house is recommended. Where trees, branches and large shrubs can provide rodent access to the roof, a minimum 6-foot clearance is recommended as many rodents can jump 6-feet. All vegetation, including smaller landscaping such as grasses, flowers and shrubs should be kept 1-foot off the house to eliminate contact which could trap moisture against the building.

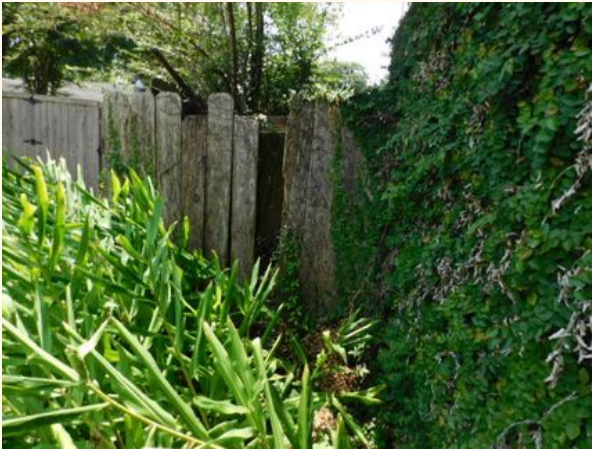
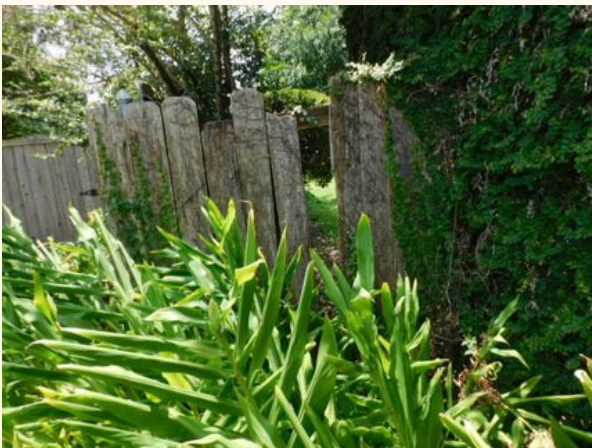
🔧 **(G-10) Review:** Localized damage was noted to the fencing - see west side. Implement carpentry repairs as needed.

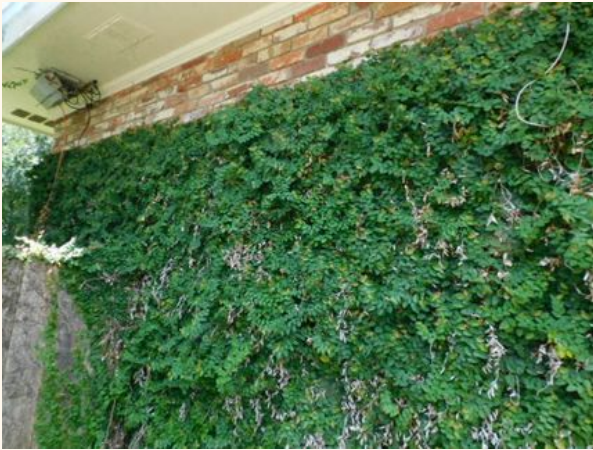
🔍 (ED1-1) Review: Ivy or vines covering masonry siding.

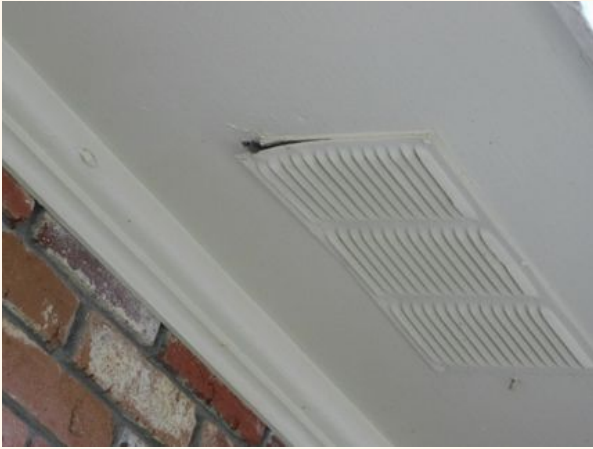
🔍 (ED1-2) Review: Soffit vents loose.

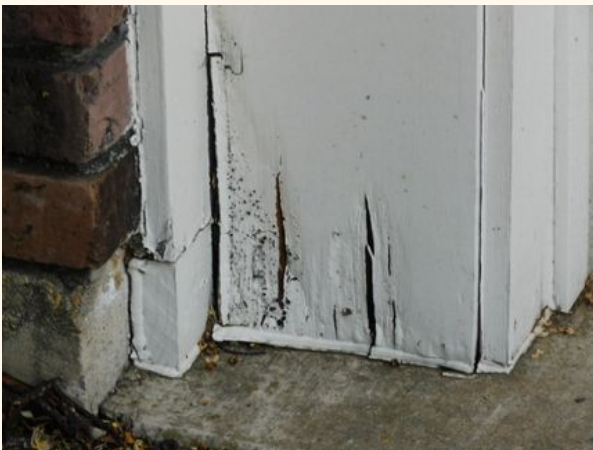
**(ED1-4) Review:** Garage door trim damaged.

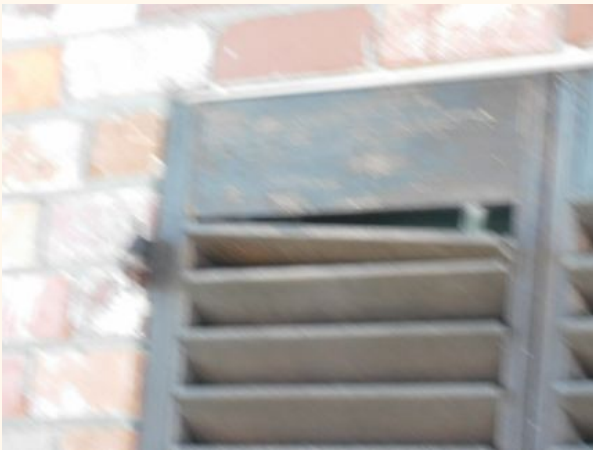
🔑 (ED1-7) Review: Window shutters damaged.

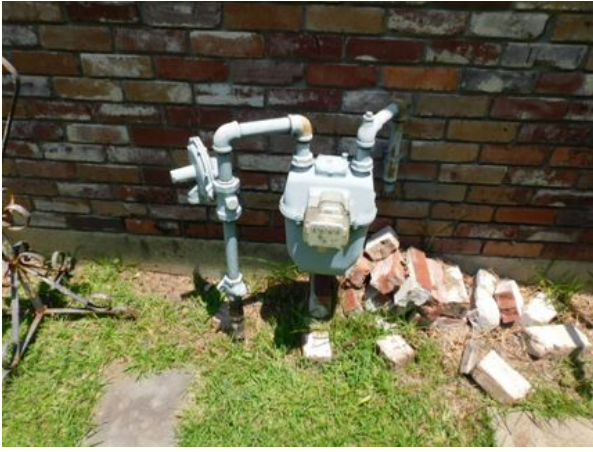
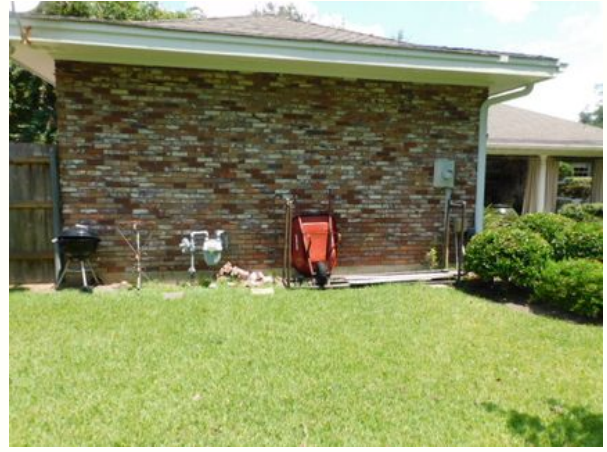
📌 **(FSD-1) Note:** Main gas shut off at meter on side of the home.

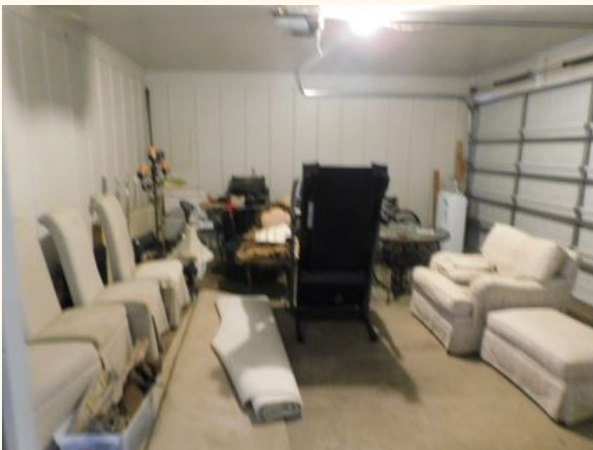
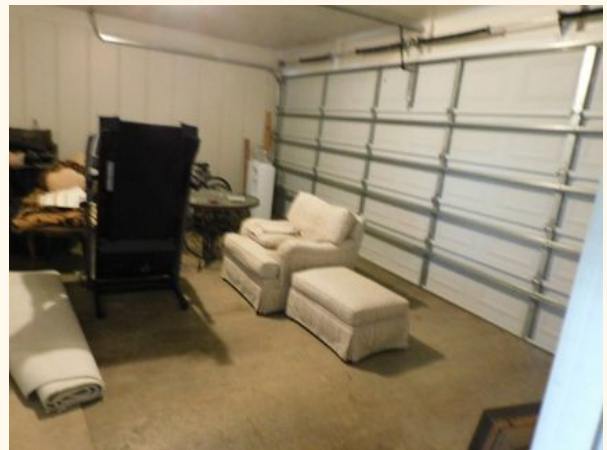
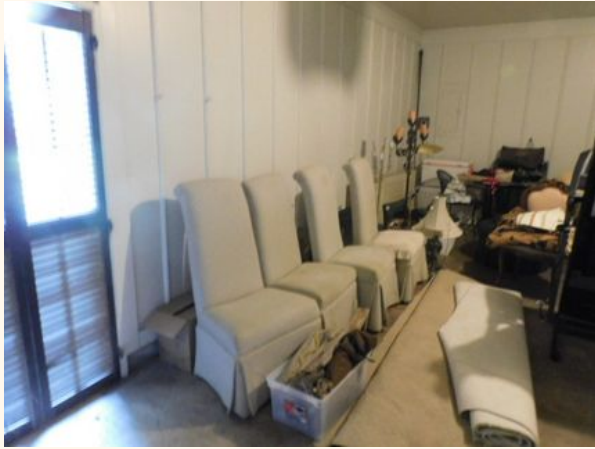
🔑 (G2-1) Review: storage items limited access and view of inspector.

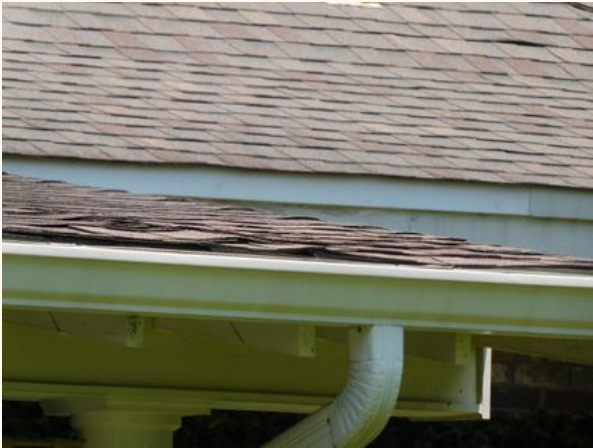
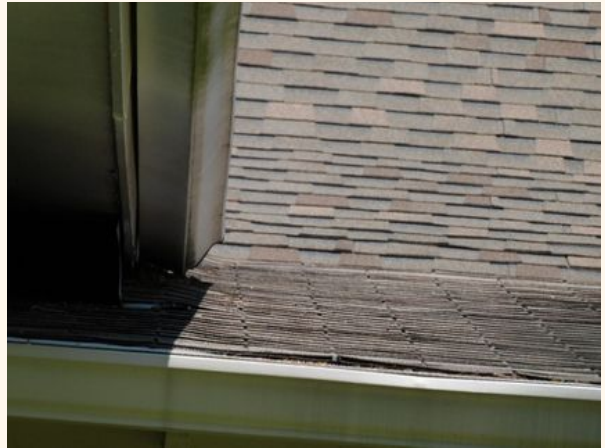
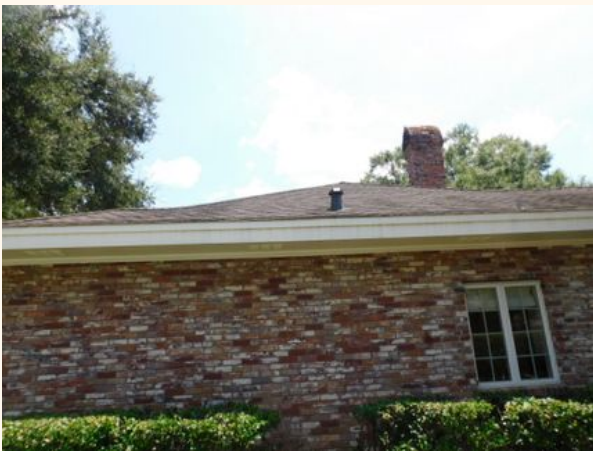
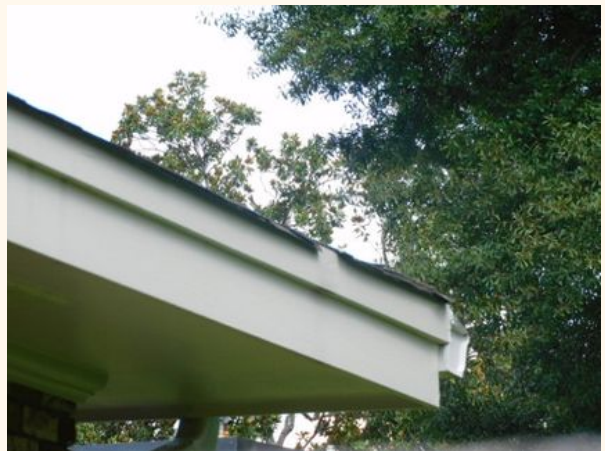
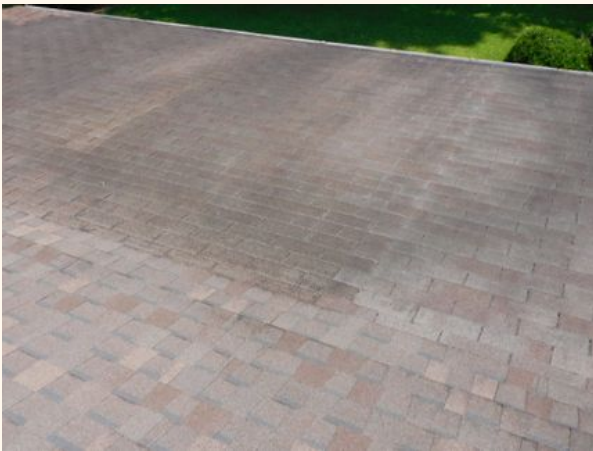
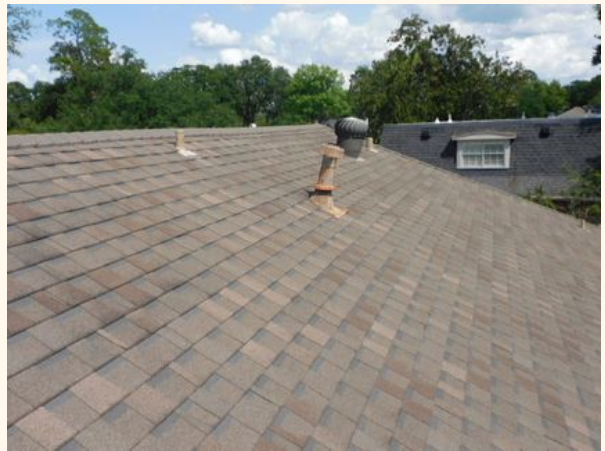
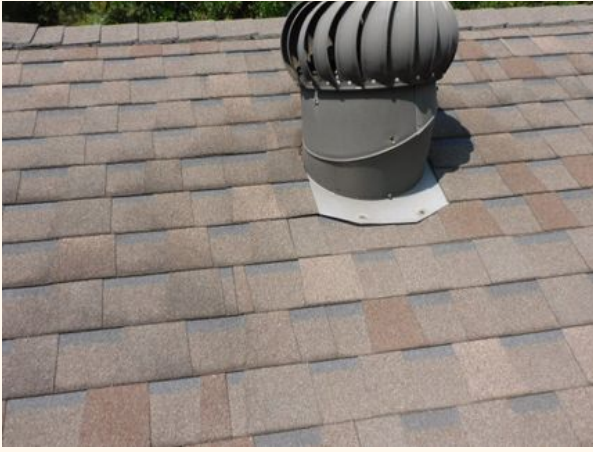
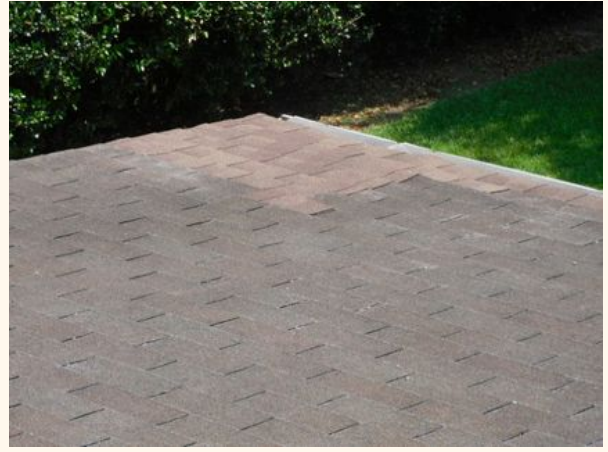
🔗 (RCG2-1) Review: Roof appears to be at the end of its useful life.

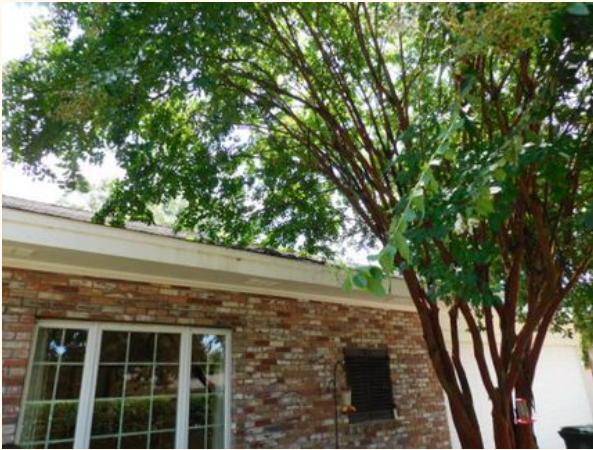
🔧 (RCG2-2) Review: Tree limbs in contact with roofing materials.

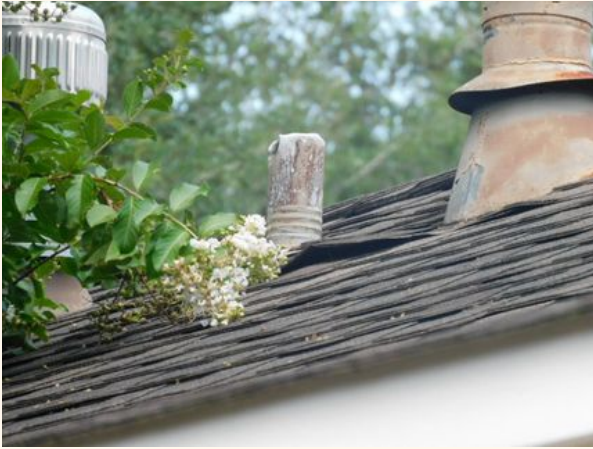
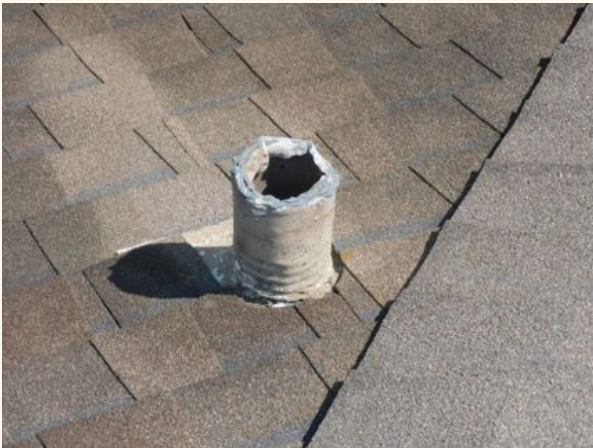
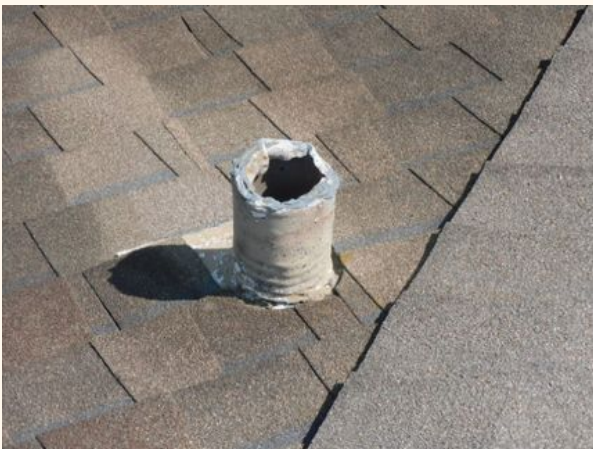
🔧 (RCG2-3) Review: Flashings damaged and lifting off of roof.

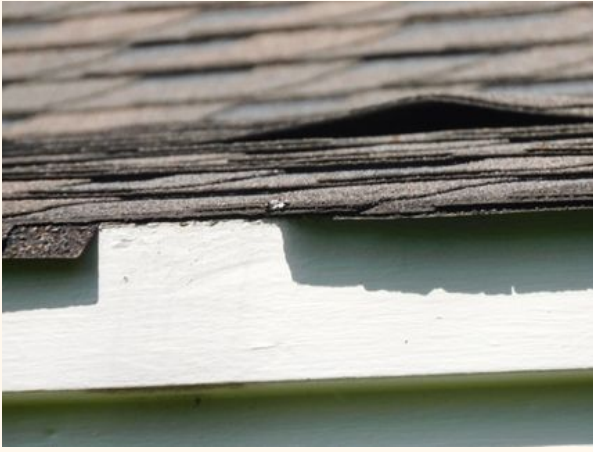
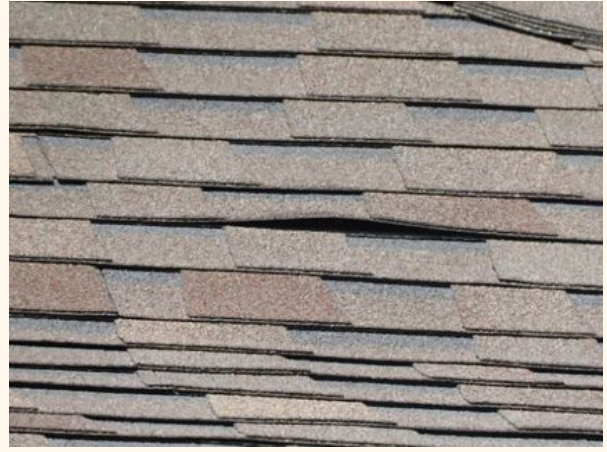
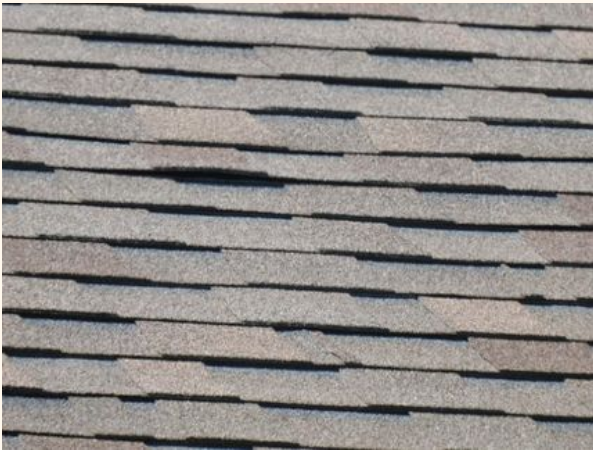
🔧 (RCG2-4) Review: Shingles lifted off of deck.

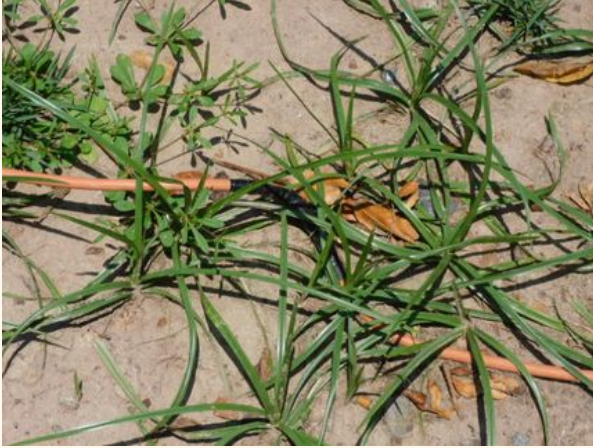
🔧 **(EDFW-1) Review:** Extension cords on earth in rear yard. Cord damaged noted by the electrical tape applied.

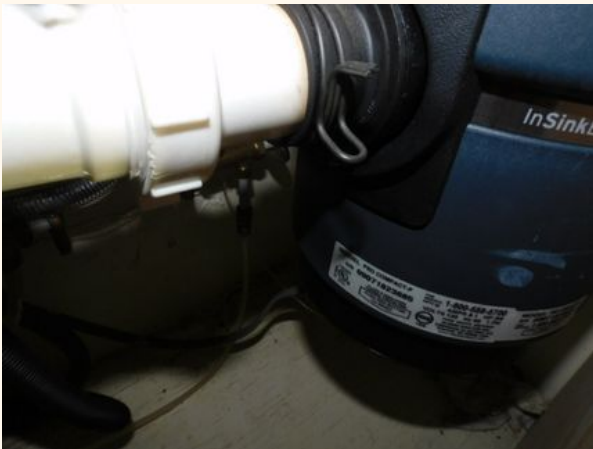
🔧 **(EDFW-2) Review:** The wiring to the kitchen sink disposer is done running nonmetallic sheathed cable to a plug. This is non-standard and a potential safety hazard. Have this wiring further evaluated and repaired by a licensed electrician.

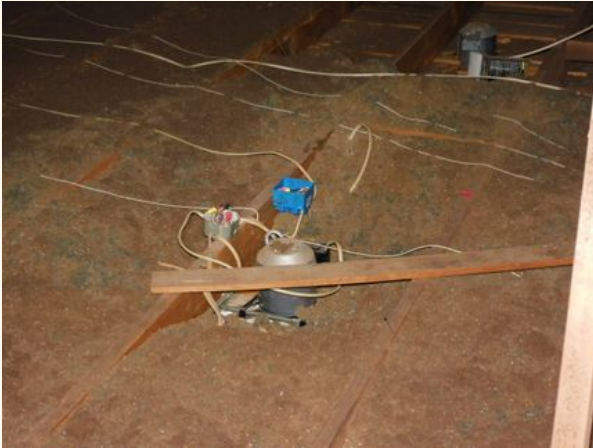
🔧 **(EDFW-3) Review:** The open electrical junction box in the garage and attic needs to be covered for improved safety. This is as simple as installing a cover plate over the box to protect the wiring. Sometimes, an extension ring is needed if finishes are covering the box. Repair as needed for improved safety.

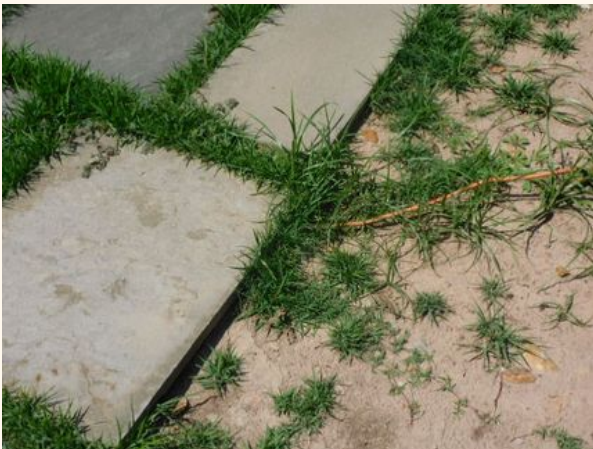
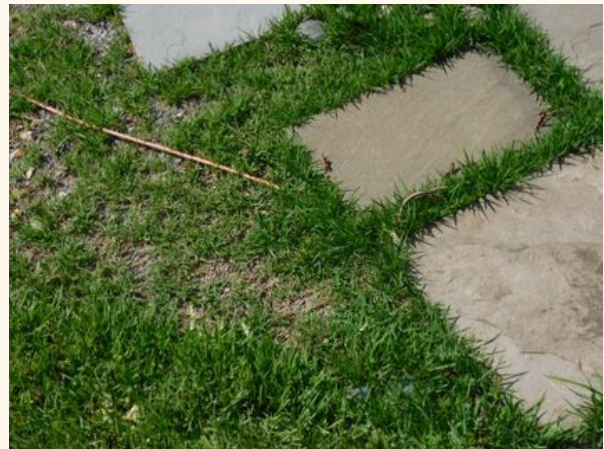
🔗 (EDFW-4) Review: Extension cord on earth in rear yard.

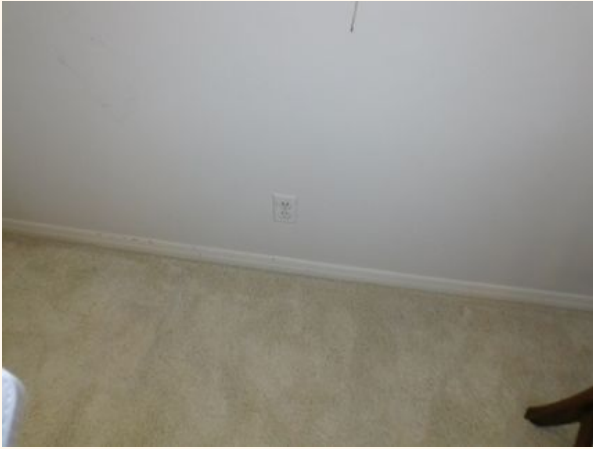
🔧 (EDFW-7) Review: Outlet in bedroom - fail to test - tester did not show any power.

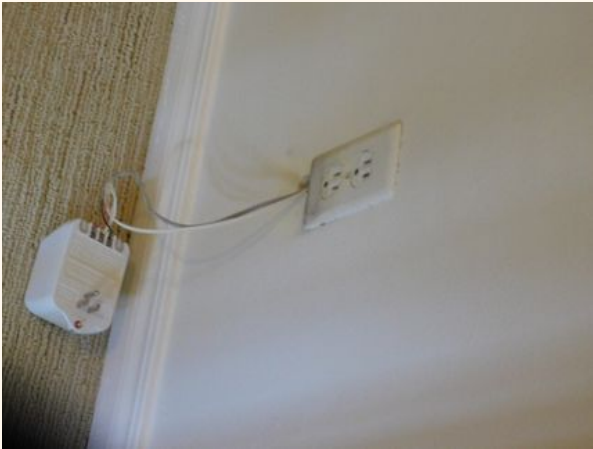
🔧 (EDFW-8) Review: Low voltage wiring passing through outlet connected to plug in.

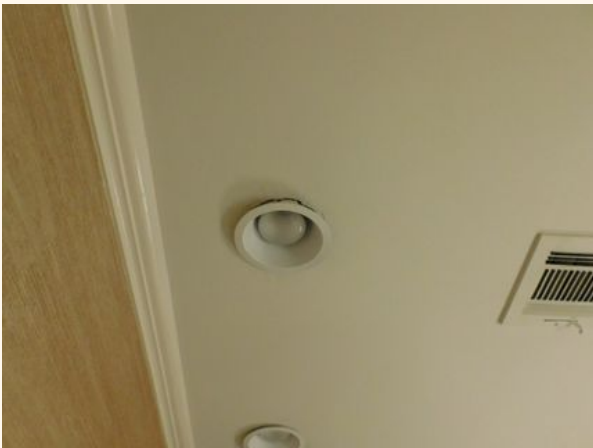
🔧 (EDFW-9) Review: Light fixture lights fixture not flush with ceiling.

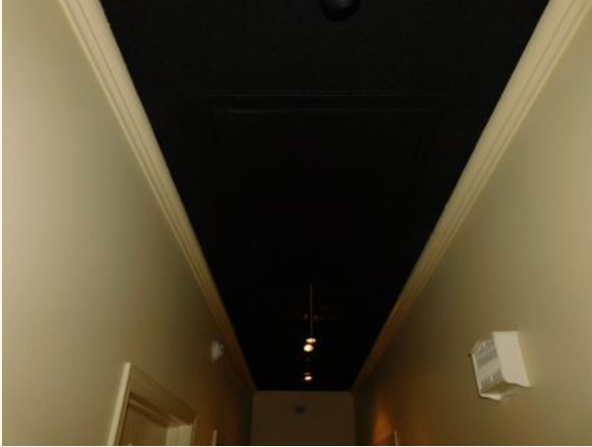
🔧 (EDFW-10) Review: Multiple inoperative lights were noted: This is likely due to bulbs being burned out, but could be due to an inoperative fixture, circuit or switch. Replace bulbs or repair lights as needed. Noted in hallway and on the rear porch wall mounted lights. Hall light fixtures appear to show signs of smoke damage.

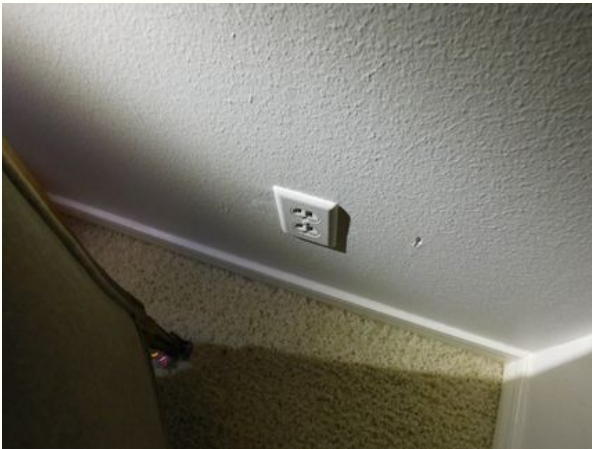
🏠 (EDFW-5) Improve: Exterior outlets are not GFC protected. Refer to 5760 in the Uniform Building Inspection Report Binder.

⚡ (EDFW-6) Note: Several outlets could not be tested due to stored items or blocked access to the device.

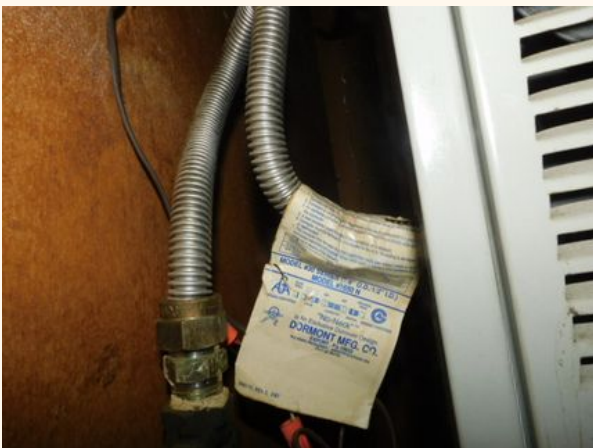
⚠ (HCFV-1) Review: Flex gas line enters the heating unit - this line should be hard pipe through the wall.

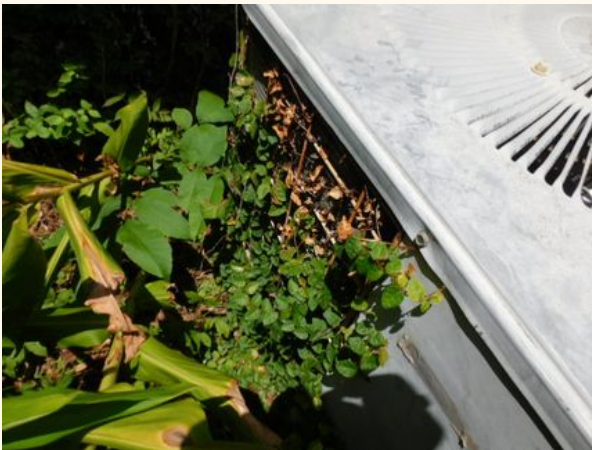
🔍 (HCFV-3) **Review:** condenser clearance from plants questionable.

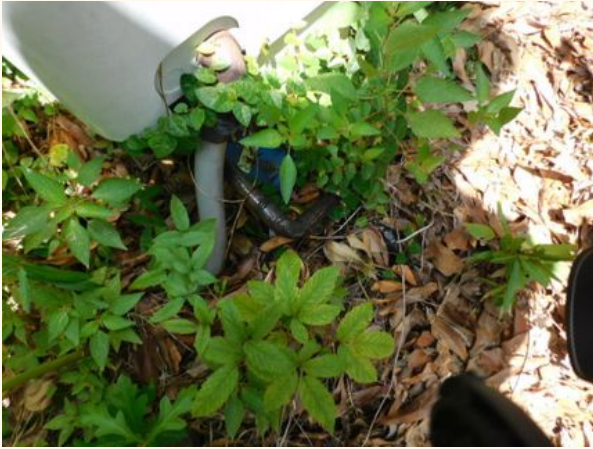
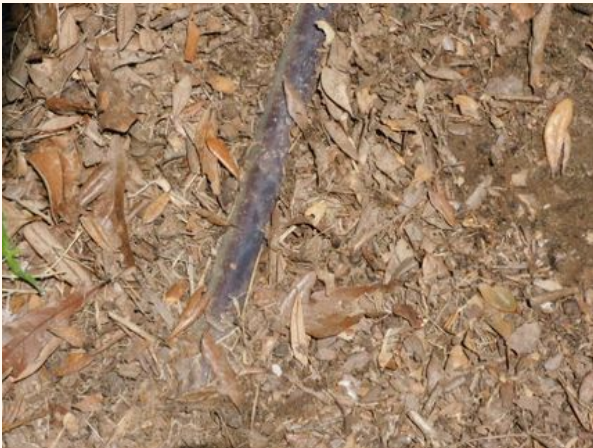
🔍 (HCFV-4) **Review:** Refrigerant line insulation damaged / missing at condenser.

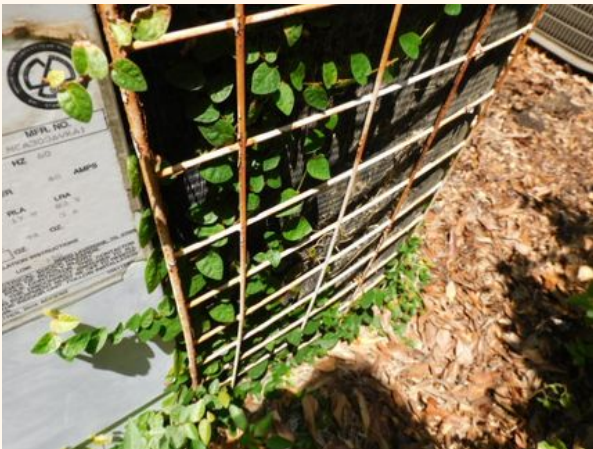
🔧 (HCFV-6) Review: IVY growing into and on the condenser.

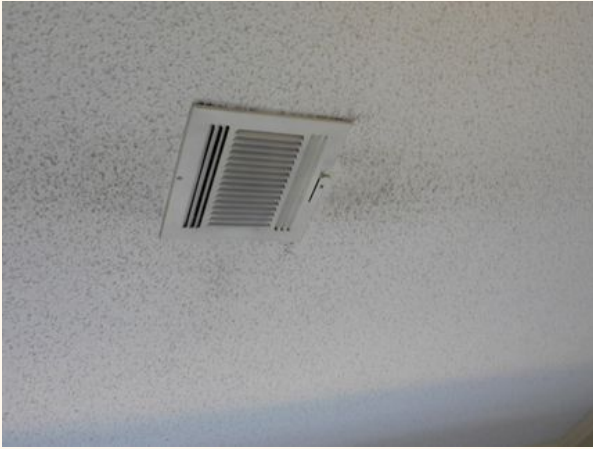
🔧 (HCFV-8) **Review:** a/c register dirty and need cleaning.

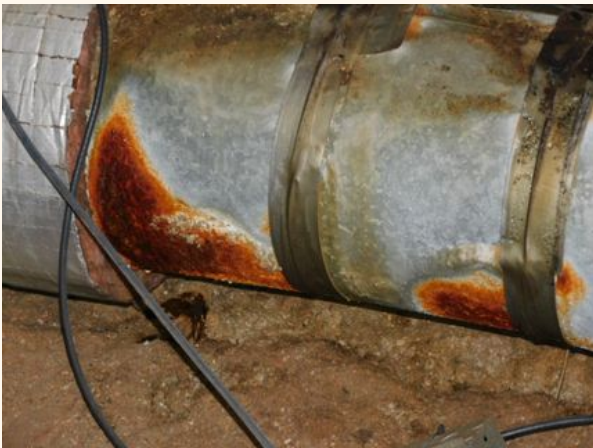
🔗 (HCFV-10) Review: Duct system insulation and metal ducting damage, missing, rusting, condensate and leaking noted.

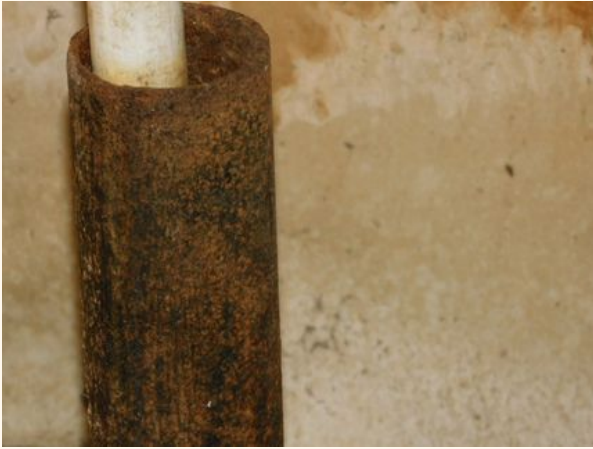
🔍 (HCFV-11) Review: Condensation drain connection improper.

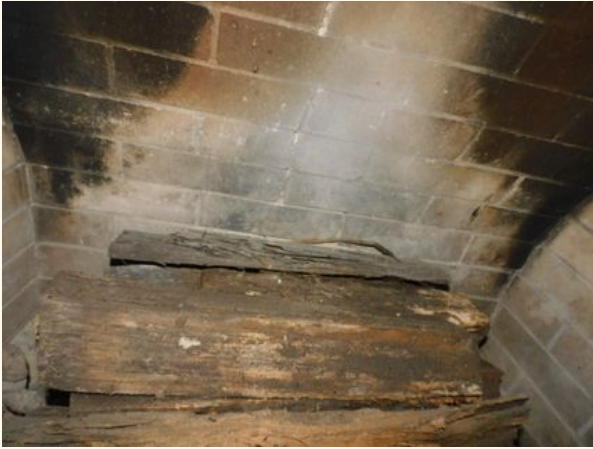
🔧 (HCFV-14) Review: Cracked brick were noted in the back wall of the fireplace firebox. This can make the fireplace unsafe for fires. Hire a mason or chimney sweep to further evaluate this condition and repair as needed to insure safe and reliable performance from the fireplace. Firebox repairs need to be made using firebrick and proper refractory mortars designed for high temperatures.

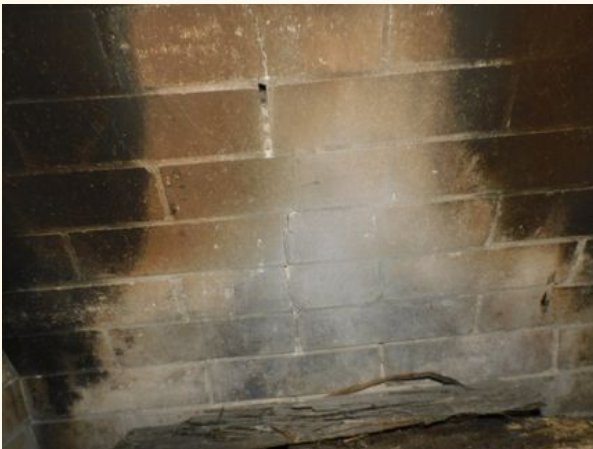
🔧 (HCFV-15) Review: Failing / missing masonry mortar was noted in the fireplace firebox. This can make the fireplace unsafe for fires. Hire a mason or chimney sweep to further evaluate this condition and repair as needed to insure safe and reliable performance from the fireplace. Firebox repairs need to be made using firebrick and proper refractory mortars designed for high temperatures. Mortar repairs are often referred to as tuck pointing.

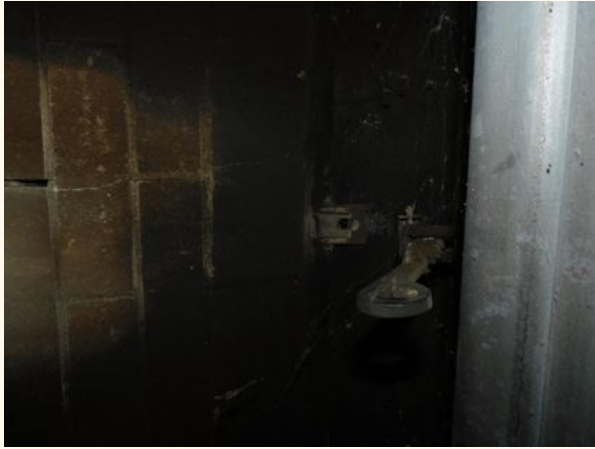
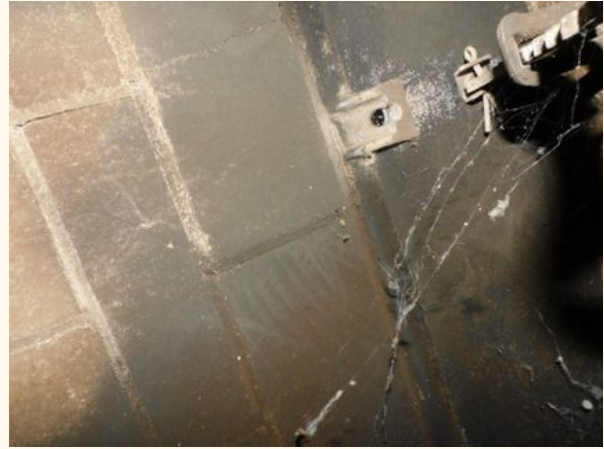
🔧 (HCFV-16) Review: Chimney needs cleaning and service

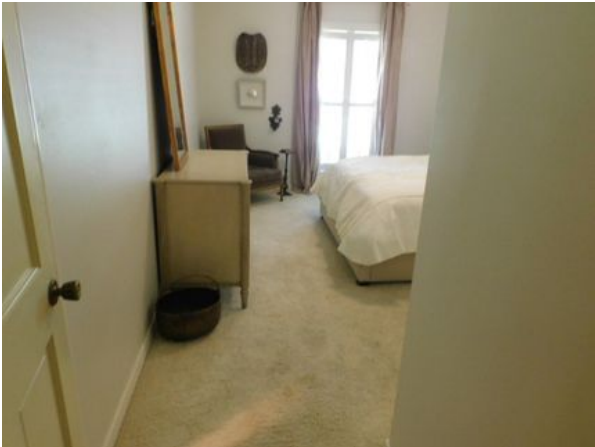
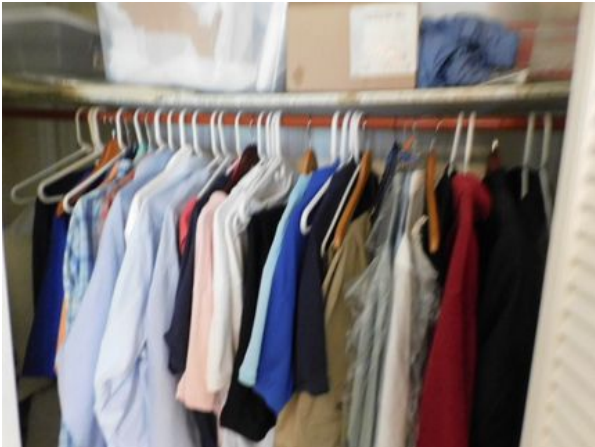
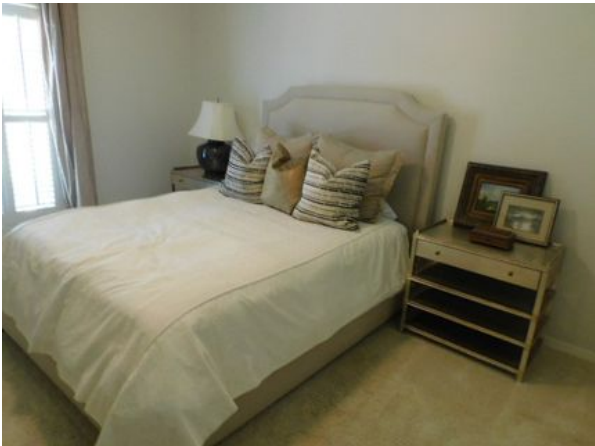
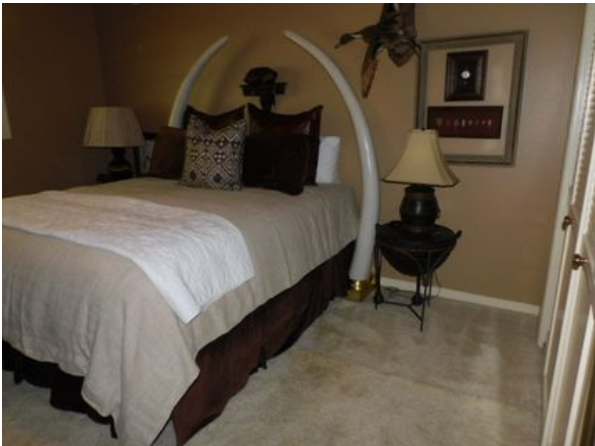
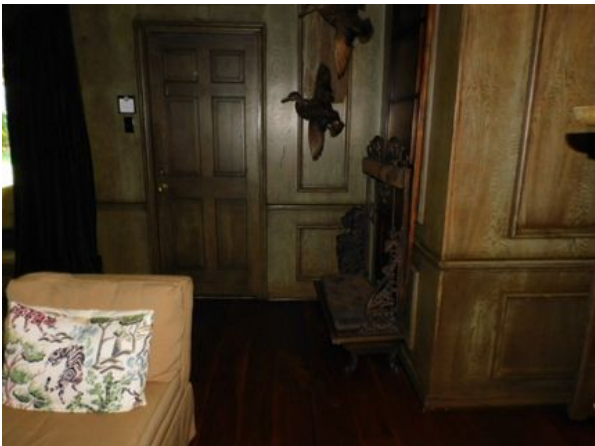
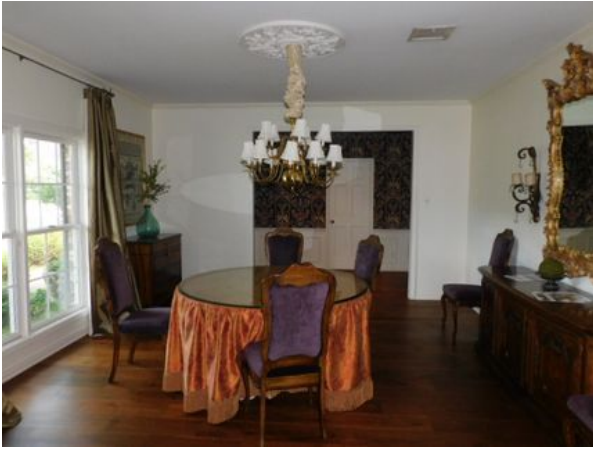
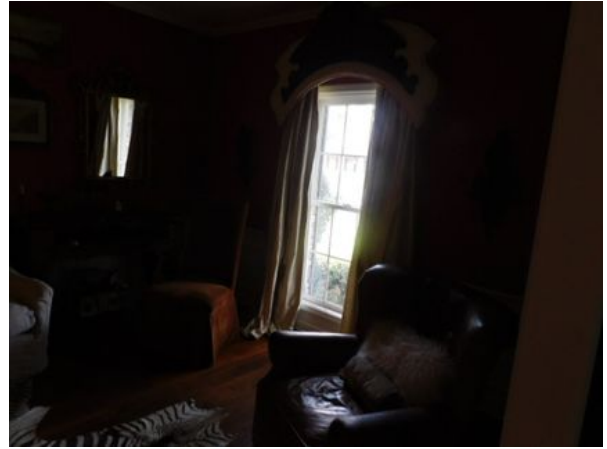
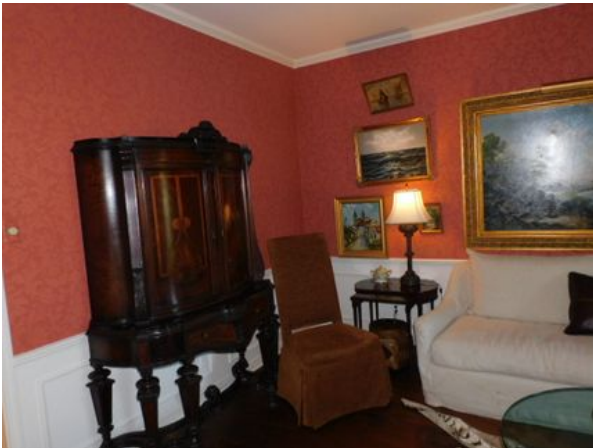
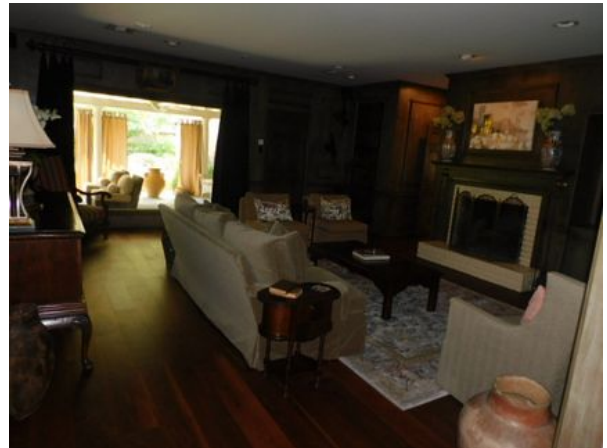
Access impaired by homeowners furniture blocking view in numerous areas.

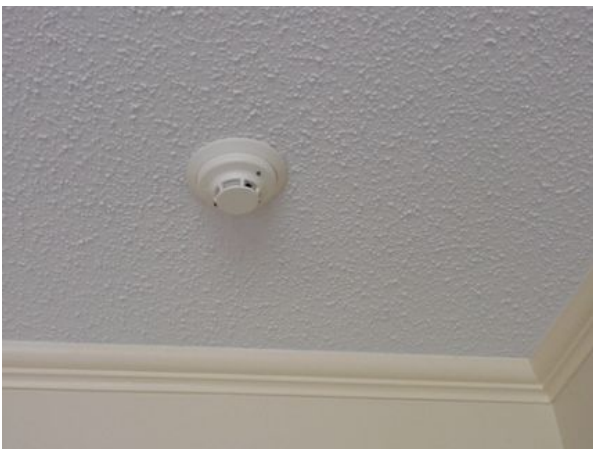
Alarms sensors present but not tested by inspector.

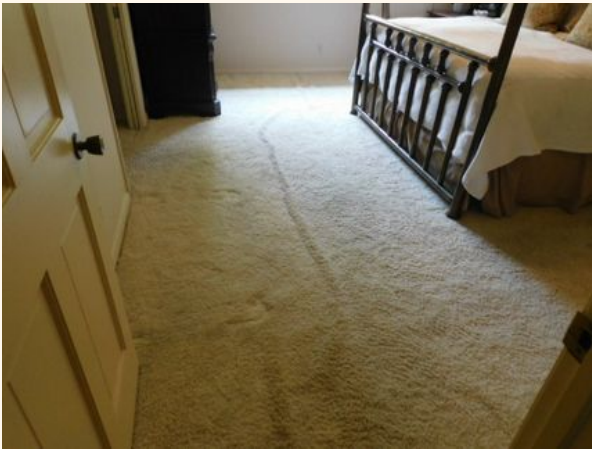
(I-3) Review: Carpet loose in numerous locations in the home.

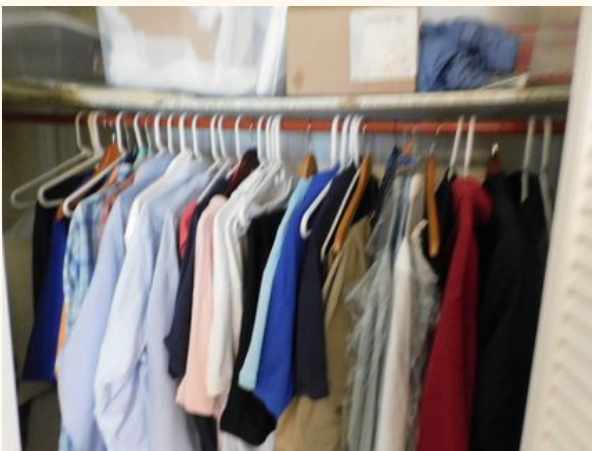
(I-4) Review: Closets full limiting inspector's view of areas.

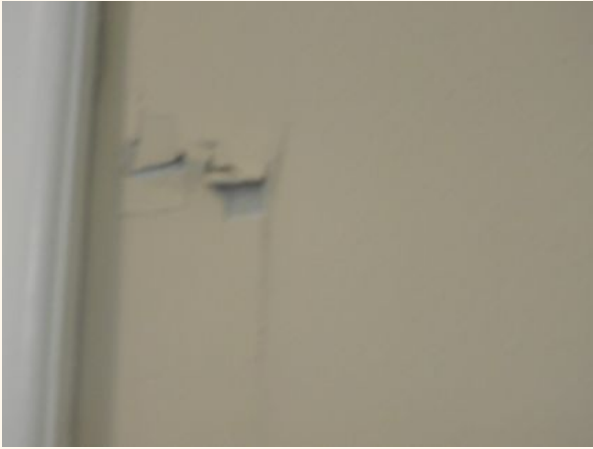
🔧 (I-6) Review: Tape joint damaged and peeling noted in kitchen

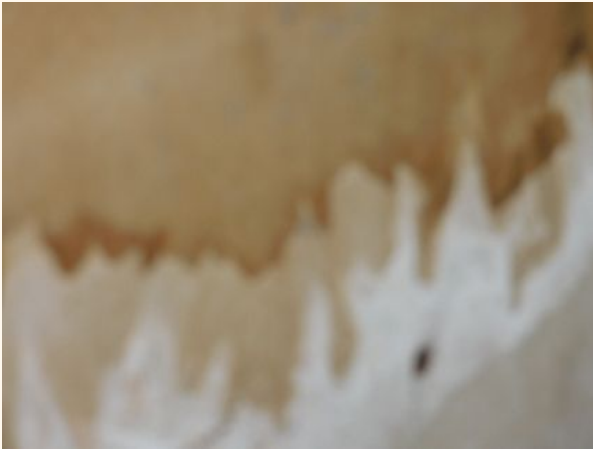
🔧 (I-7) Review: walls of return air chamber water stained and damaged.

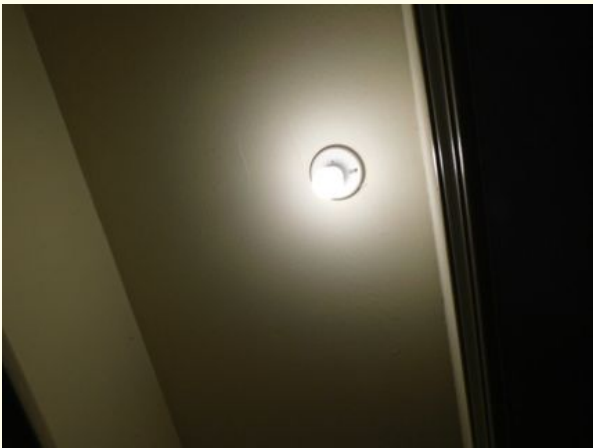
🏠 (I-5) Improve: Exposed light bulbs in closet.

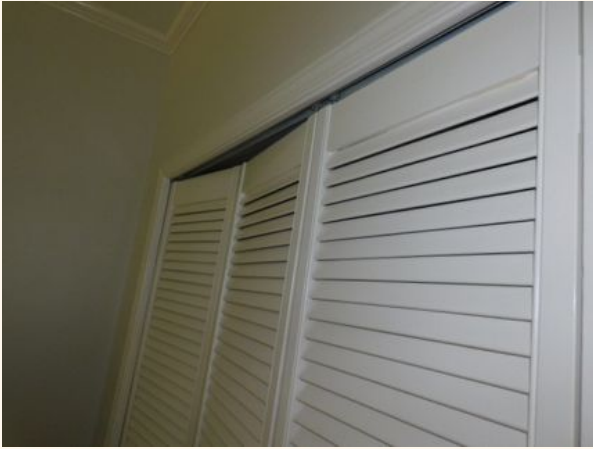
🔧 (I-8) **Review:** Doors dragging on carpet in bedrooms. Improper return air under door.

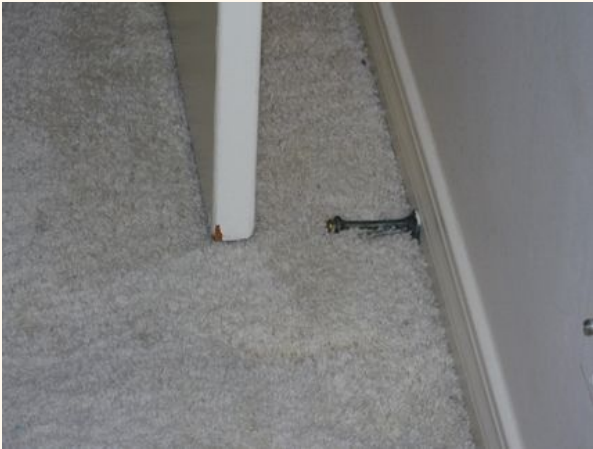
🔧 (I-9) Review: The door stop system for the home is incomplete. I recommend systematically installing door stops to protect doors and wall finishes.

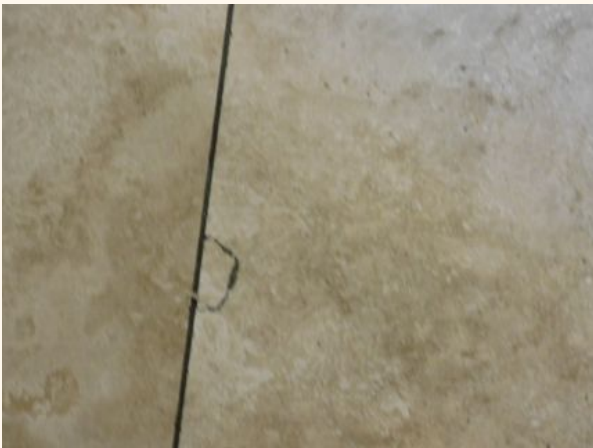
🔧 (I-10) Review: Floor tiles damaged

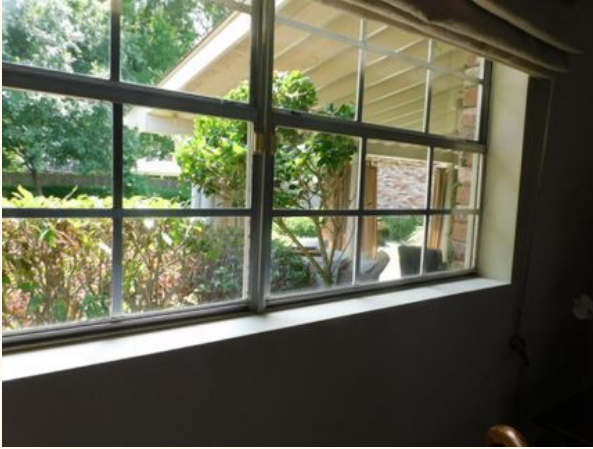
🔍 (I-11) Review: windows faulty.

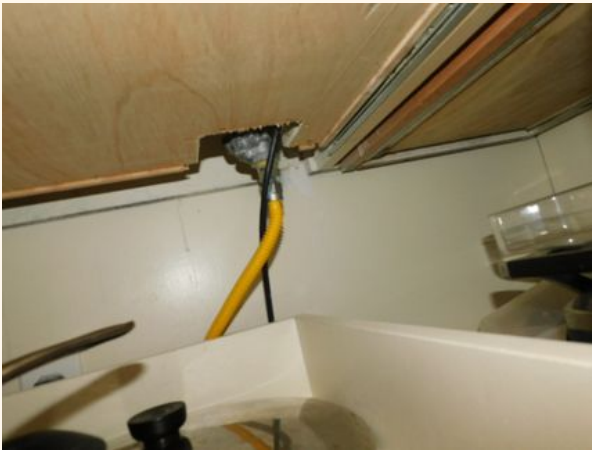
⚠ (K-6) Review: Electric lines in contact with gas lines.

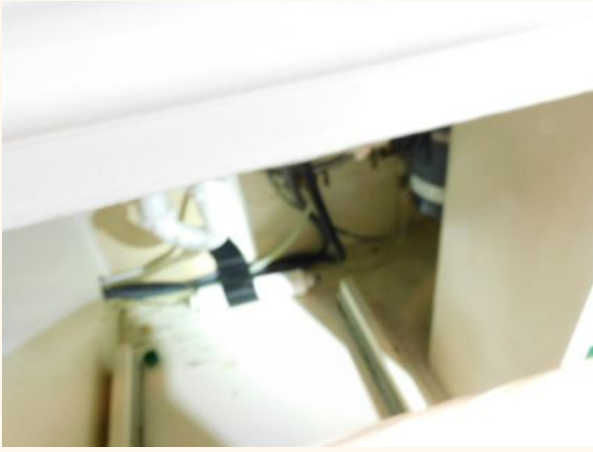
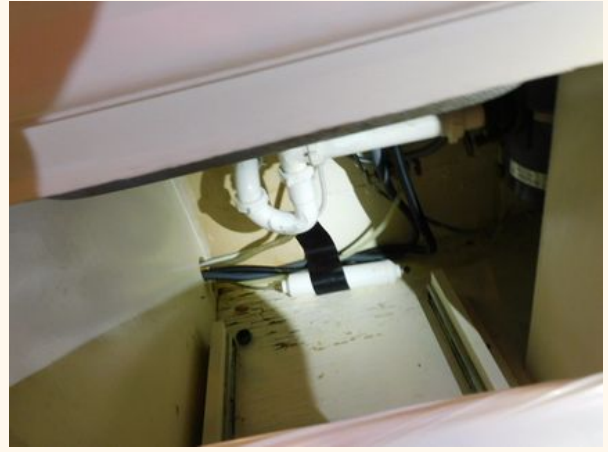
⚠ (K-7) Review: Disposal wiring questionable.

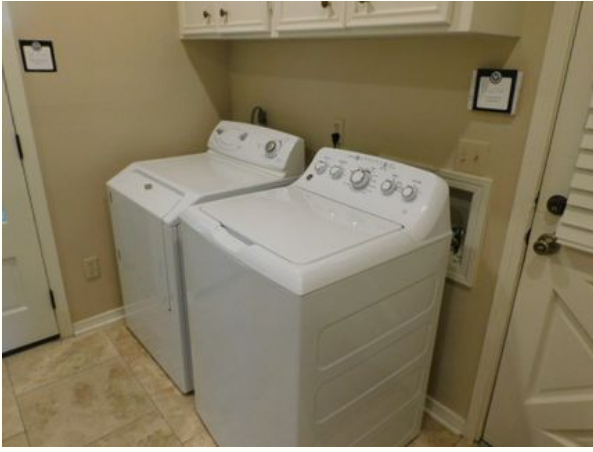
✦ (LF-1) Note: Laundry equipment present but not tested.

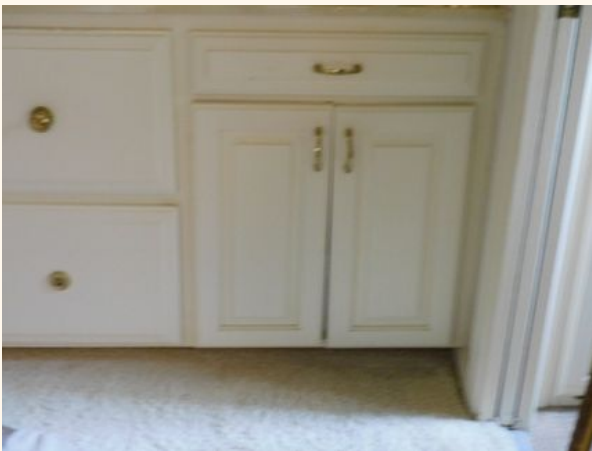
🔧 (B-2) Review: bathroom cabinet doors and drawers need adjustment or repairs.
