Inspection report for the property at
2708 Bramble Drive, Monroe, LA 71201

This report is prepared exclusively for **Michael & Holly Gray**
On: **2022-08-02**

QED Service

Inspector: Michael Burroughs : LA State License #LHI 10044,

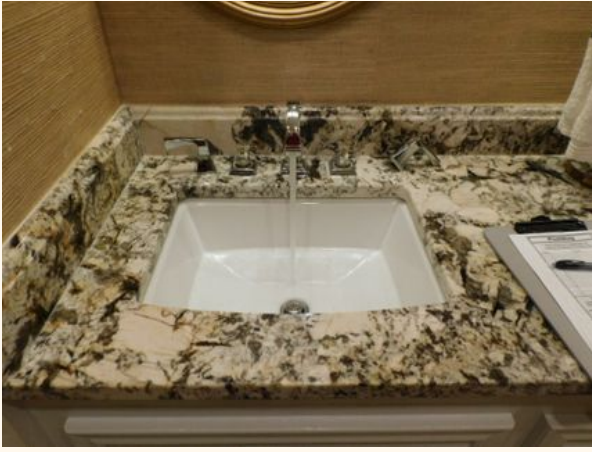
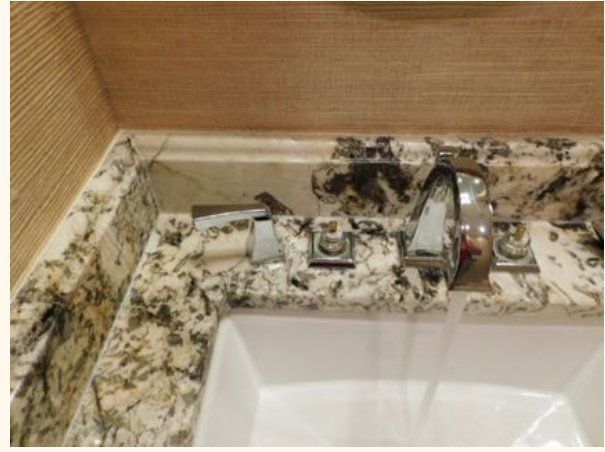
🔧 (B-3) Review: Sink faucet handles not secured.

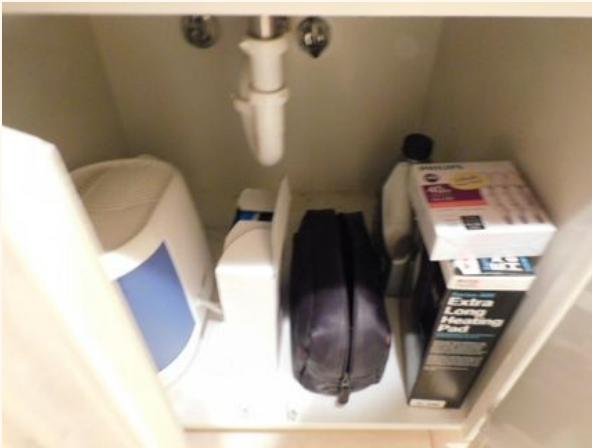
**(B-5) Review:** Access impaired under sink.

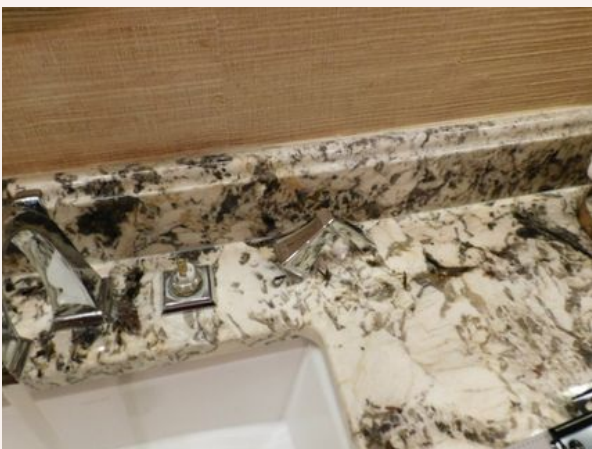
**(B-4) Recommended Preventive Maintenance:** The backsplash behind the master bathroom sink is not adequately sealed to the countertop and could allow water to get behind the countertop. Seal with caulking.

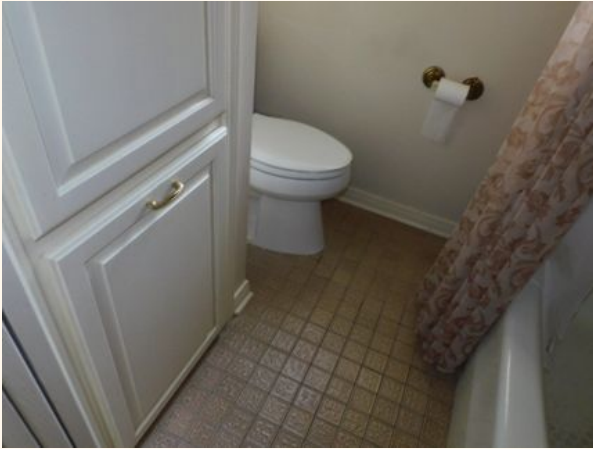
🔧 (B-6) Review: commode loose on floor.

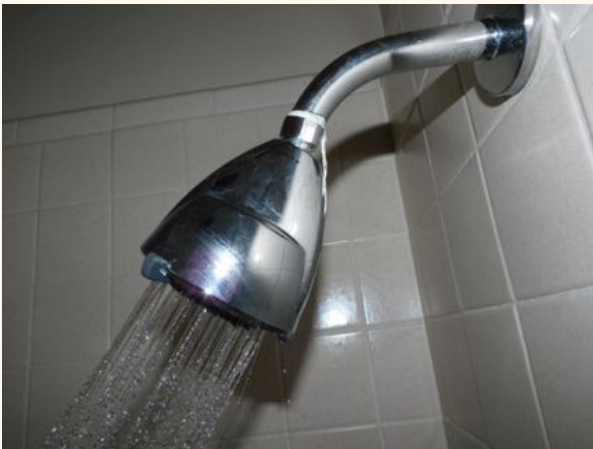
🔧 (B-7) Review: The shower head in the main bath is leaking and requires repair. Leaky shower heads are common and not a significant concern. Adjust as needed to prevent leakage at the shower head.

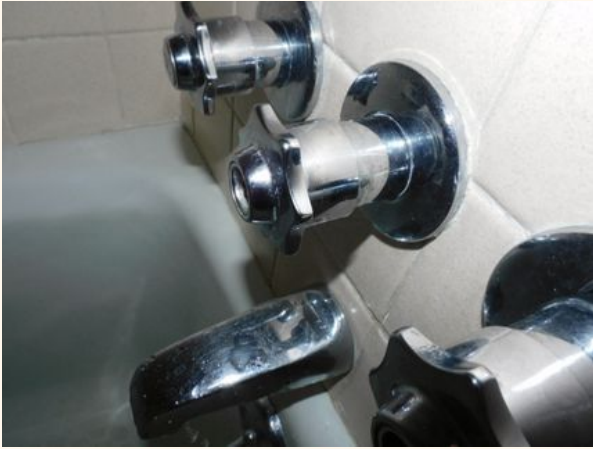
🔧 (B-8) Review: Shower valves leaking at the handles.

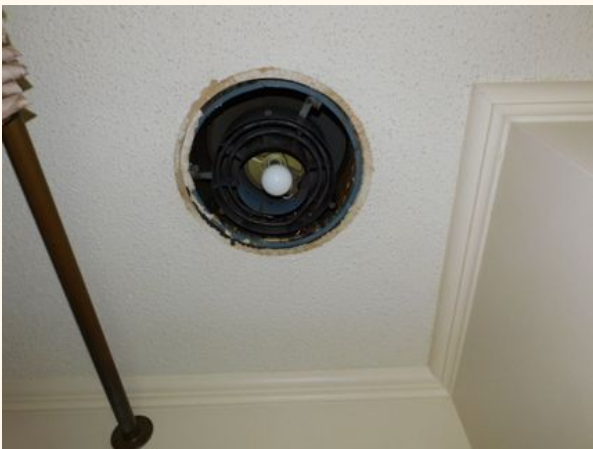
🔧 (B-9) Review: Install the missing cover to the master bathroom fan.

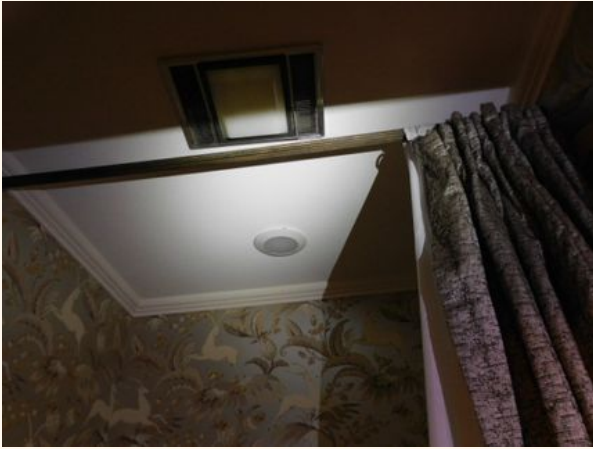
🔧 (B-10) Review: The master bath fan is dirty. Cleaning is recommended to ensure reliable performance.

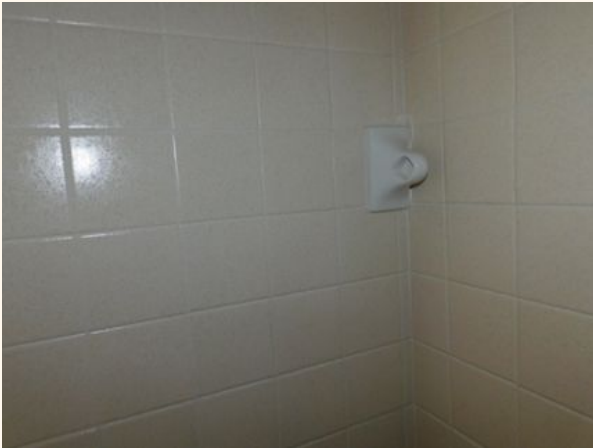
🔧 (B-13) Review: Install missing towel racks bars in the family bathroom.

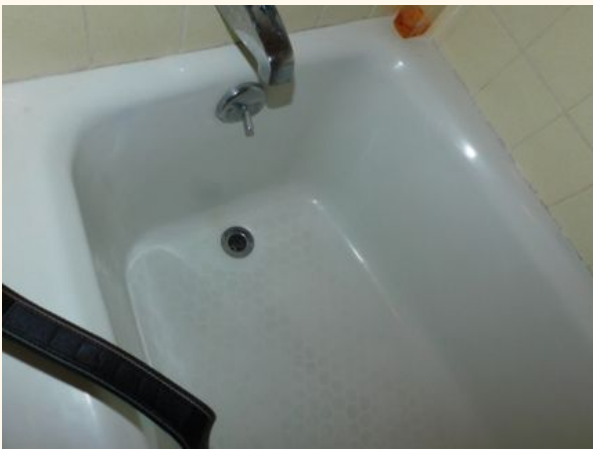
🔧 (B-14) Review: Drain screen damaged

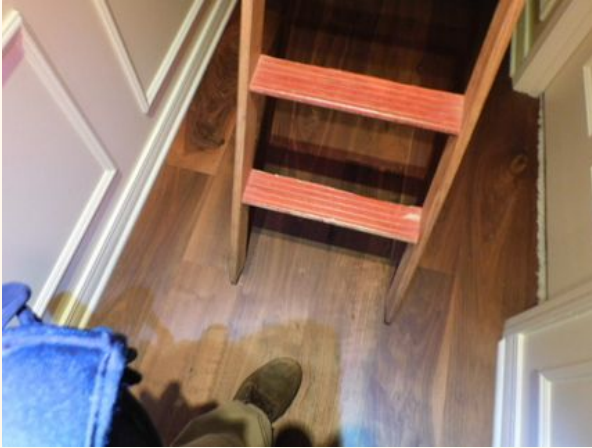
🔗 (A-1) Review: Attic access ladder damaged.

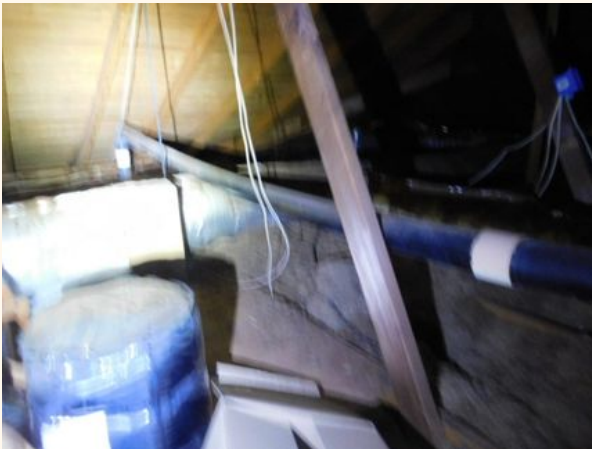
🔗 (A-2) Review: Attic access limited due to stored items

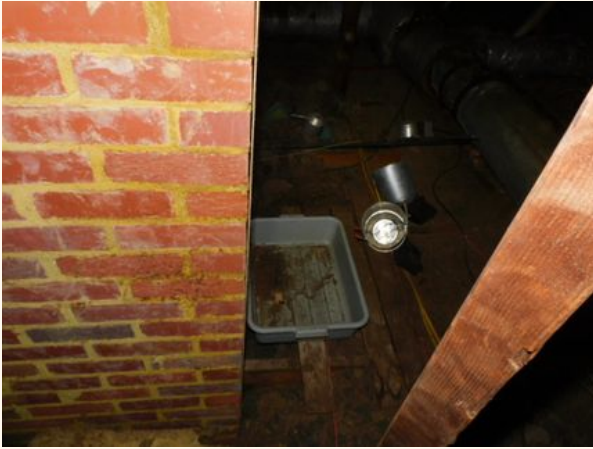
🔍 (A-3) Review: Signs of roof leaks noted in attic.

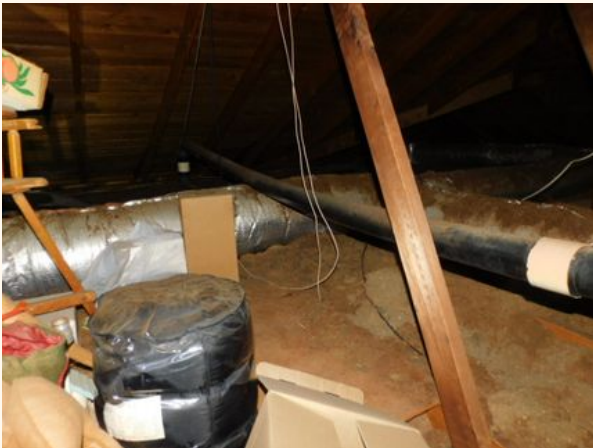
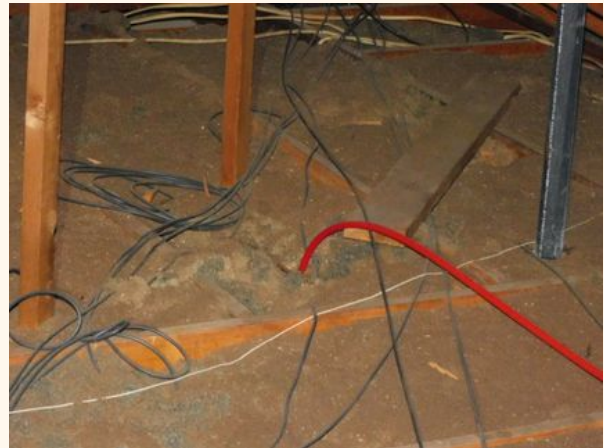
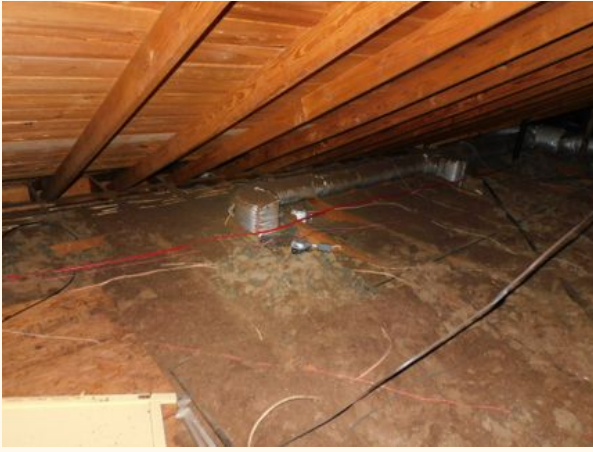
🔍 (A-4) Review: Insulation compressed and no signs of thermal barriers.

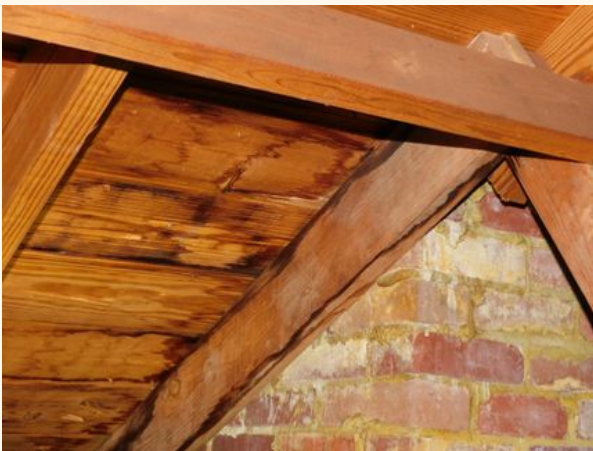
🔧 (A-5) Review: Signs of roof leakage and damage decking.

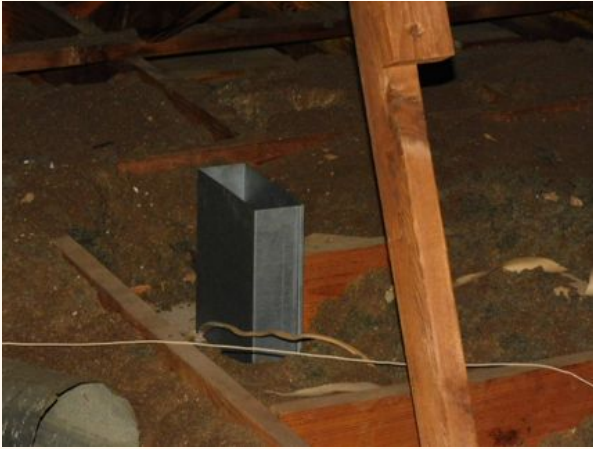
🔍 (A-6) Review: Appliance vent terminates in attic

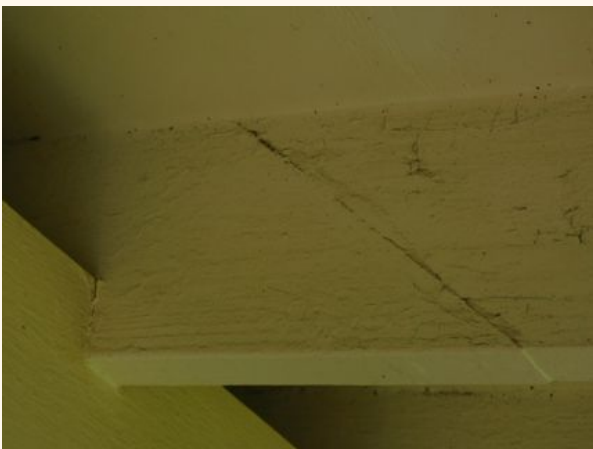
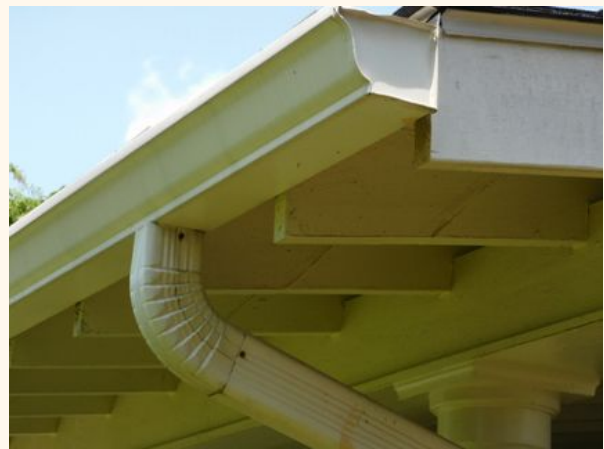
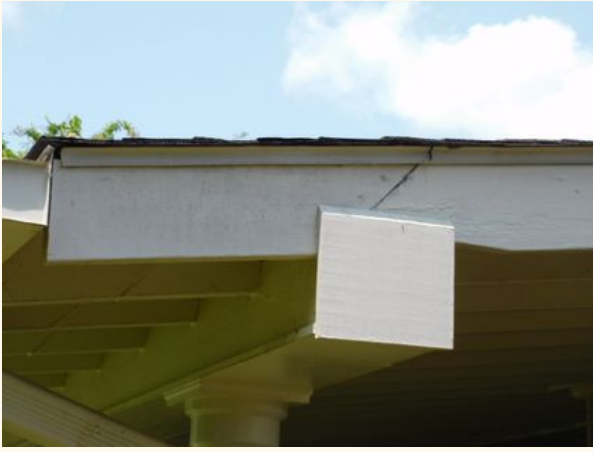
🔍 (SB-1) Review: Porch roof framing splice questionable.
