Inspection report for the property at
505 East Union, Minden, LA

This report is prepared exclusively for **Southern Meat Market**
Inspected On: **06-25-2024**

The Professional Real Estate Inspection Report

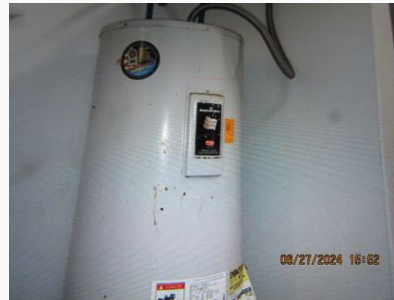
**Description:** This shows the data plate for this water heater.

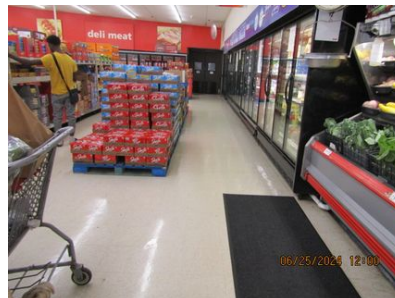
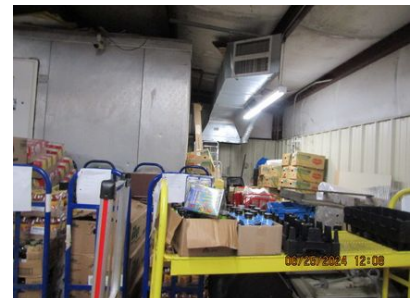
Warehouse ceiling (insulation) shows signs of possible dirt or suspected visible mold.

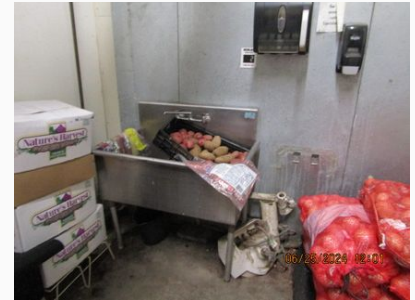
(K-1) Description:
Sink present and tested.

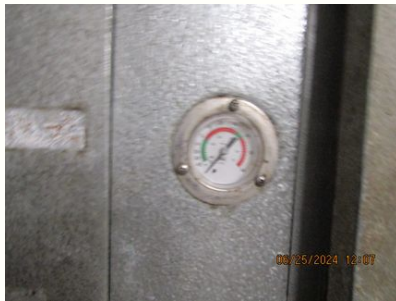
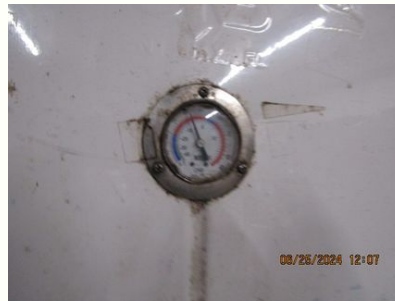
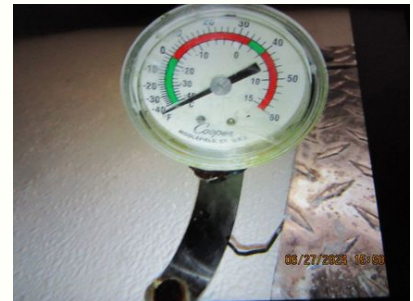
📌 (K-5) Note: Coolers operating at time of the inspection.
