Inspection report for the property at
616 Lakeshore Drive, Chatham, LA 71226

This report is prepared exclusively for **Tim Atkins**
On: **2022-07-26**

QED Service

Inspector: Michael Burroughs : LA State License #LHI 10044,
ASHI 202398

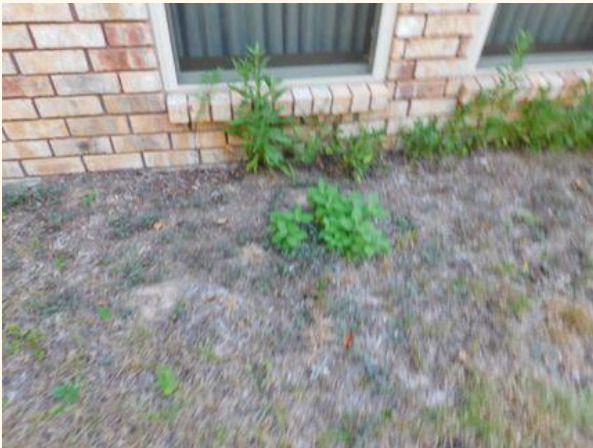
🔧 (ED1-3) Review: Earth in contact with siding materials in various areas around the home.

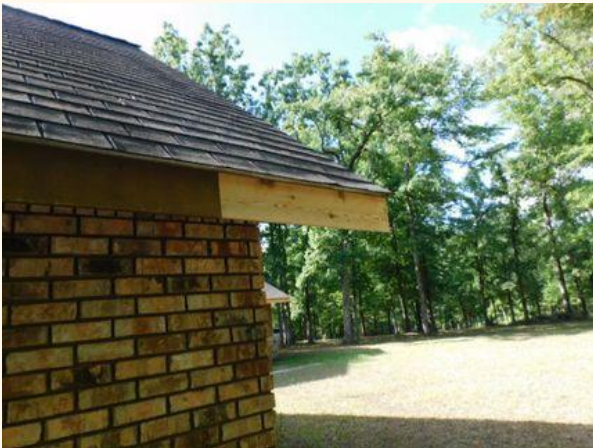
🔧 **ED1-4 Exteriors and Decks:** Exterior trims have been repaired or replaced. Repairs do not appear to be complete or have finishes applied.

🔧 (ED1-4) **Review:** Exterior trims have been repaired or replaced. Repairs do not appear to be complete or have finishes applied.

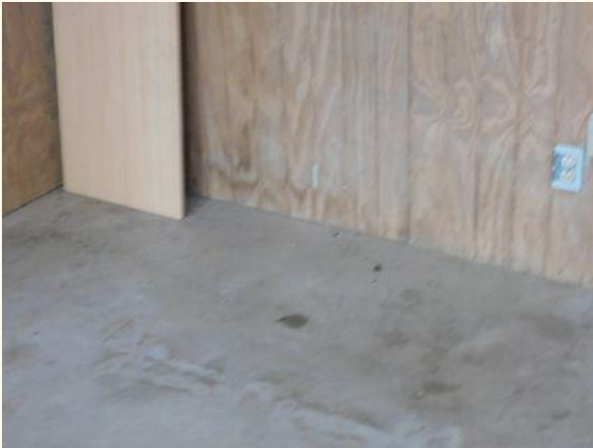
🔧 **ED1-6 Exteriors and Decks:** Water stains noted in the siding of the carport.

🔗 (ED1-6) Review: Water stains noted in the siding of the carport.

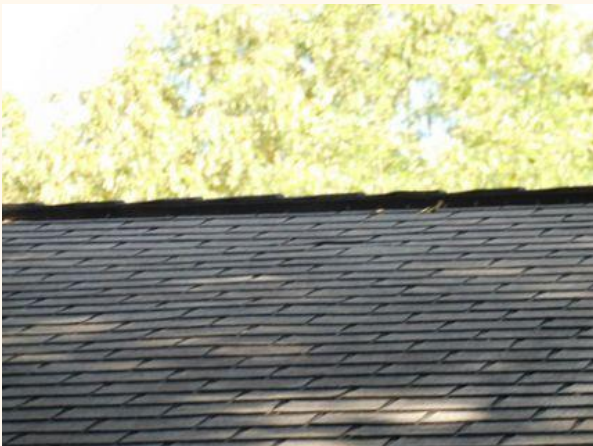
🔧 **RCG2-2 Roof, Chimney and Gutters:** Fungus growth or staining noted on shingles.

🔍 (RCG2-2) Review: Fungus growth or staining noted on shingles.

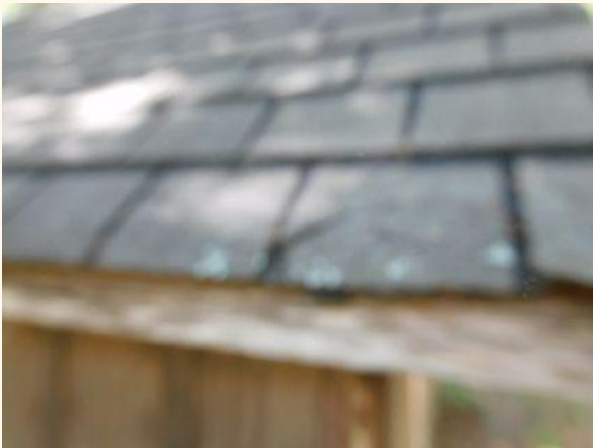
🔧 (RCG2-4) **Review:** fungus growth noted on roof

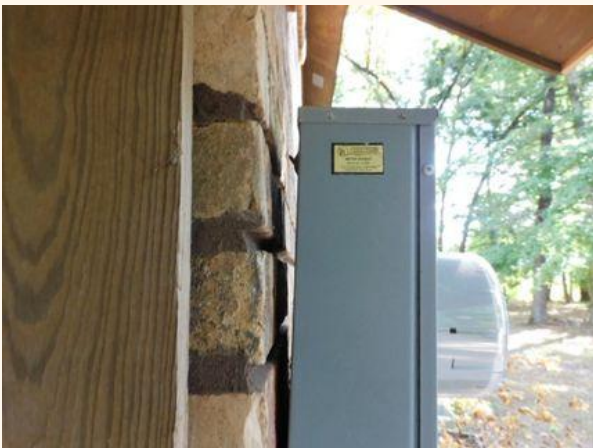
? (ES1-2) **Review:** meter can pulling away from wall.

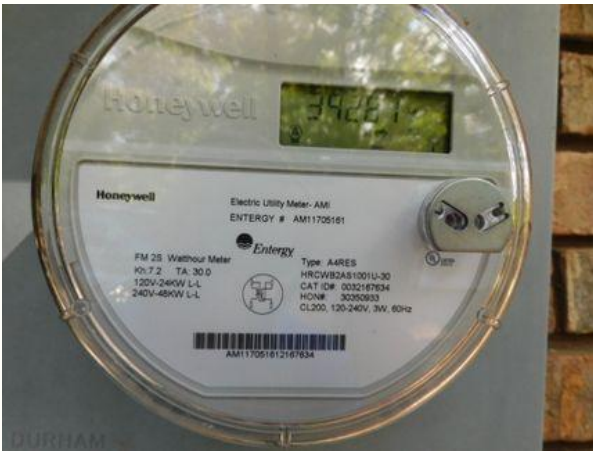
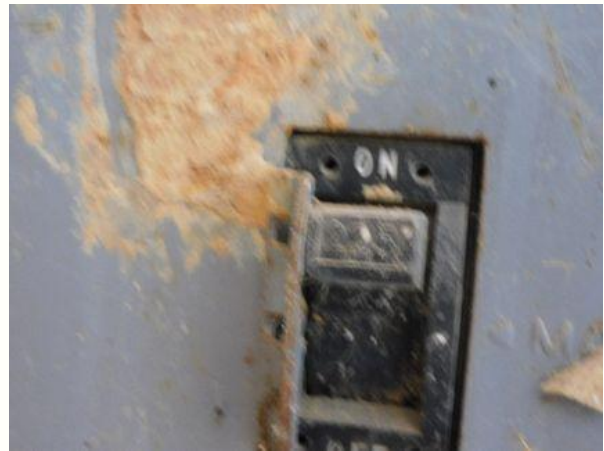
🔍 (ES1-1) Note: service meter and power ratings.

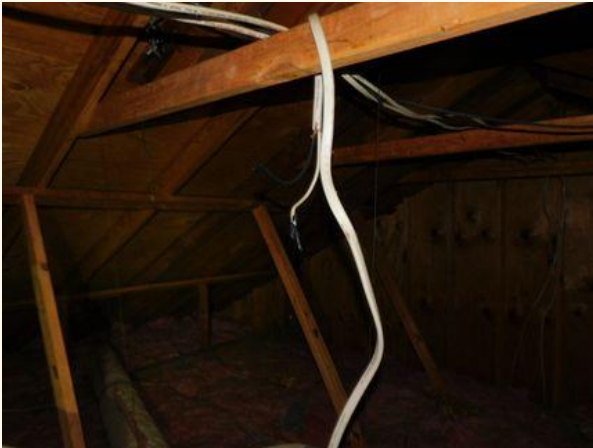
🔧 (EDFW-2) **Review:** Exposed wiring splice noted.

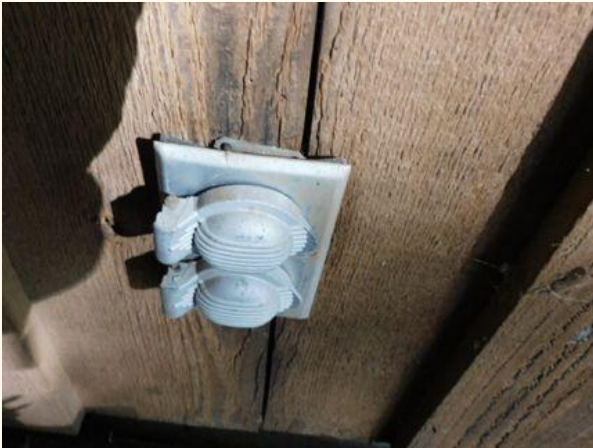
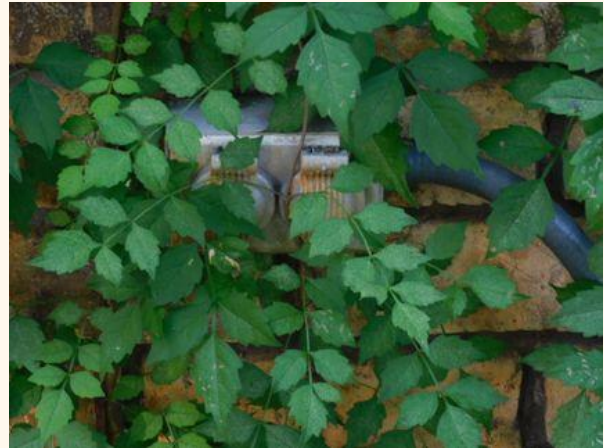
🔧 (EDFW-6) Review: Siding gaped around exterior outlets.

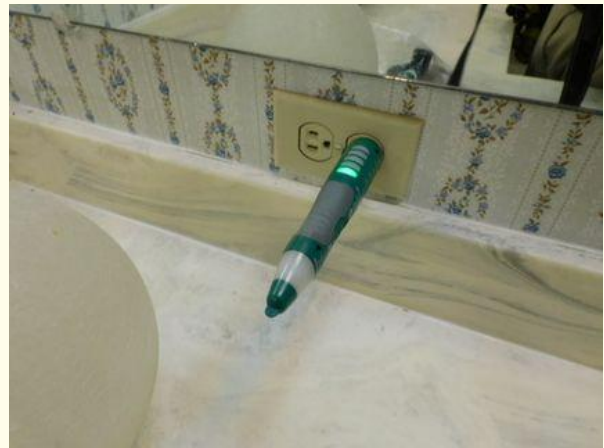
🏠 (EDFW-7) Improve: GFCI outlets not installed near sinks or exterior. The current outlet are typical of the age of the home.

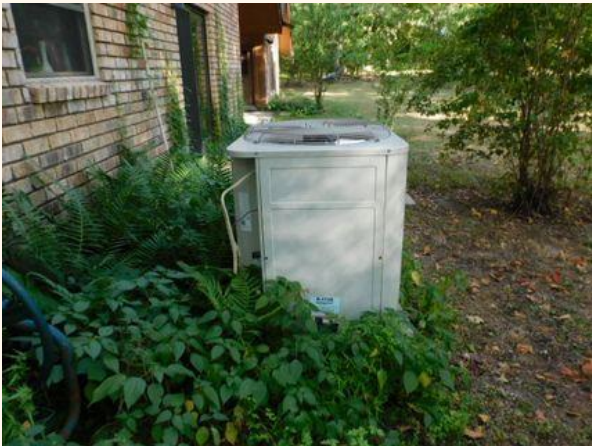
🔧 (HCFV-2) Review: Condenser coils damaged.

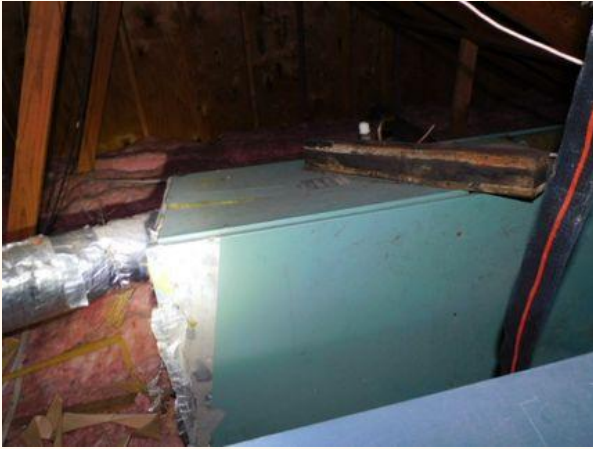
🔍 (HCFV-4) Review: Old, disconnected equipment left in attic.

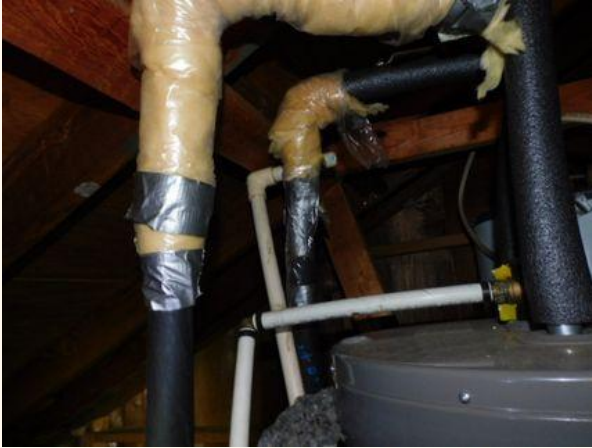
🔧 **(P2-7) Review:** Water pvc piping installed in attic without protective insulation cover.

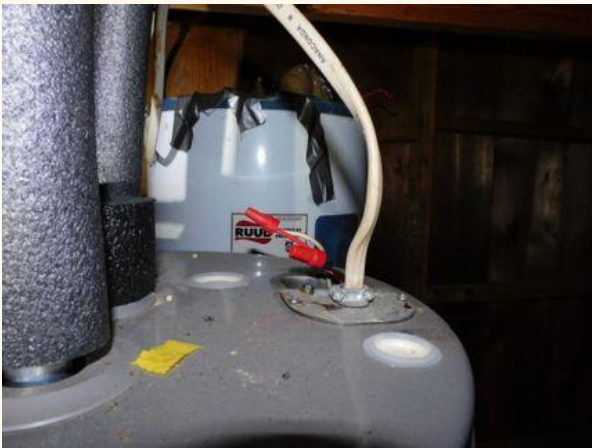
🔧 (P2-10) Review: Water heater electrical improper and exposed. NO means of electrical disconnect noted at appliance.

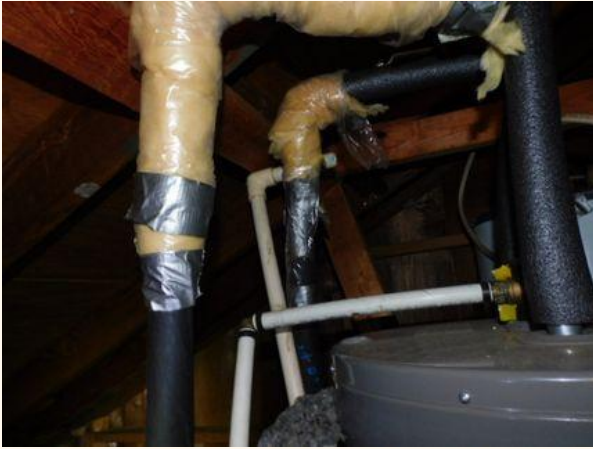
🔧 (P2-11) Review: Water pipes not supported at water heater

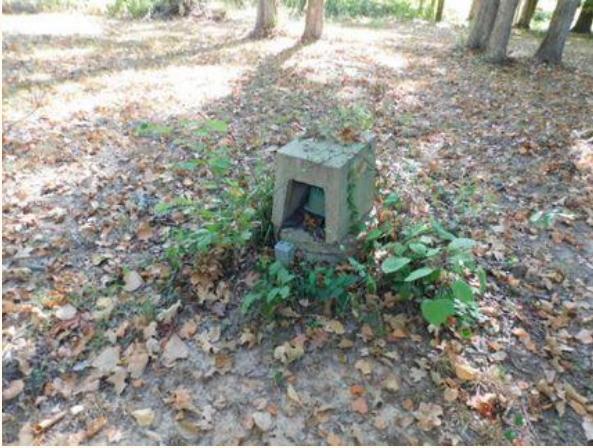
🔗 **(AP-1) Review:** Private waste system noted but not part of the home inspection. These types of systems need to be checked and certified by local health department.

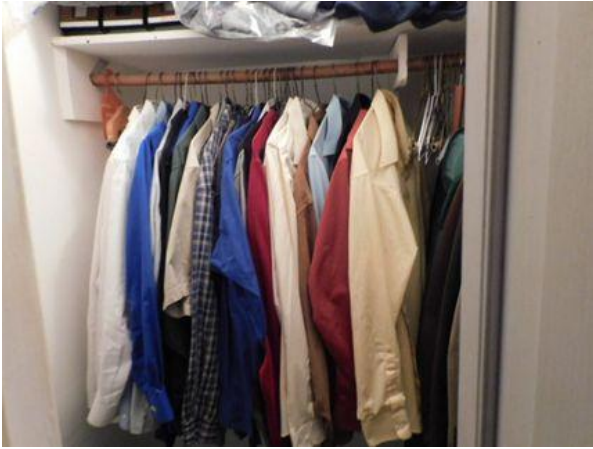
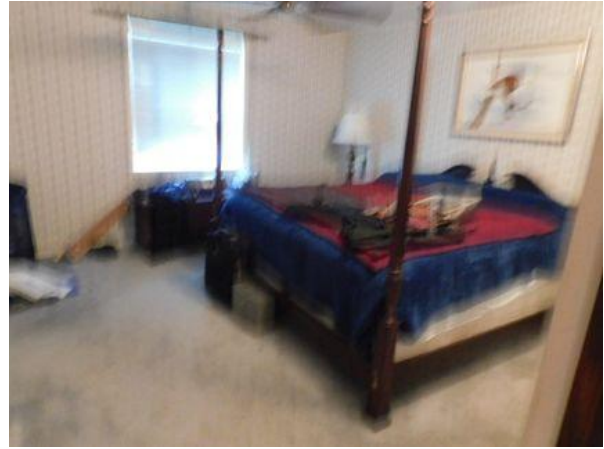
Access impaired closets full limiting access.

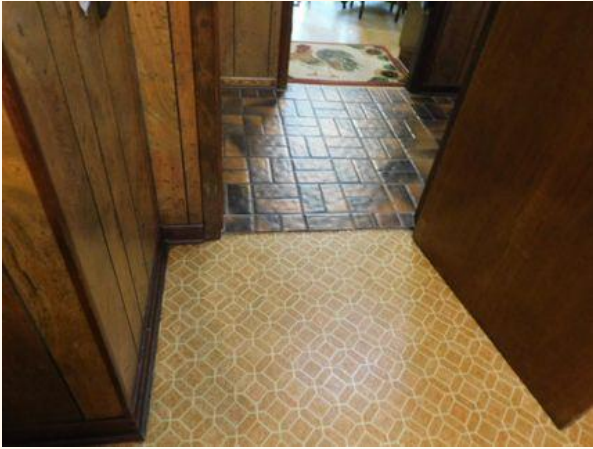
(I-4) Review: Flooring uneven.

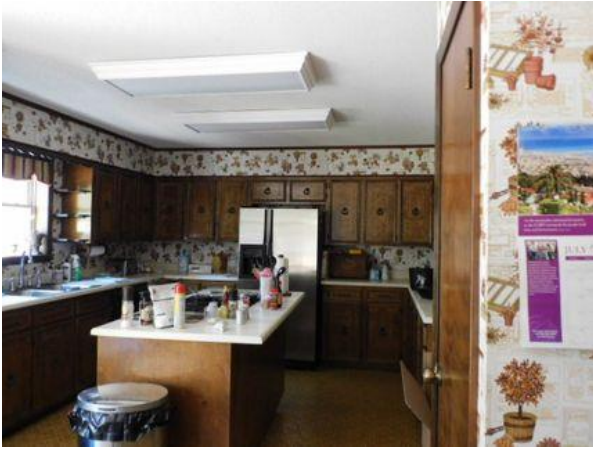
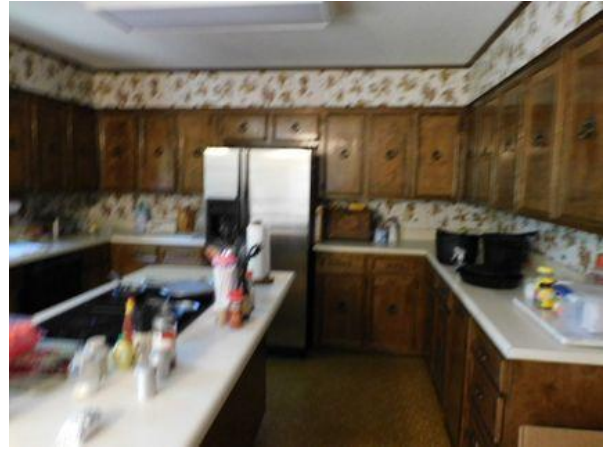
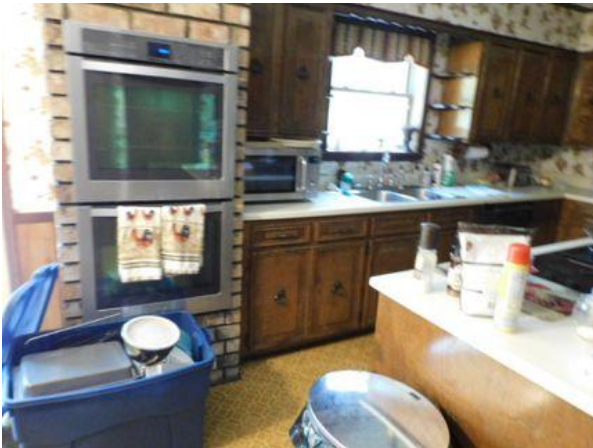
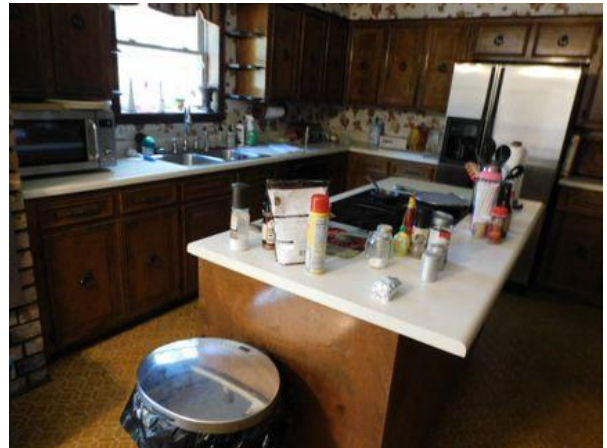
access impaired by homeowners items.

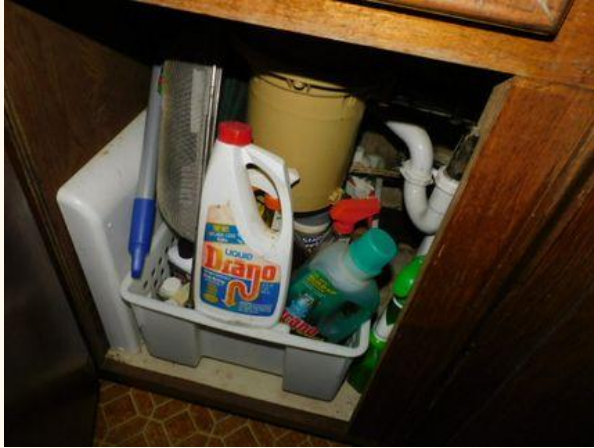
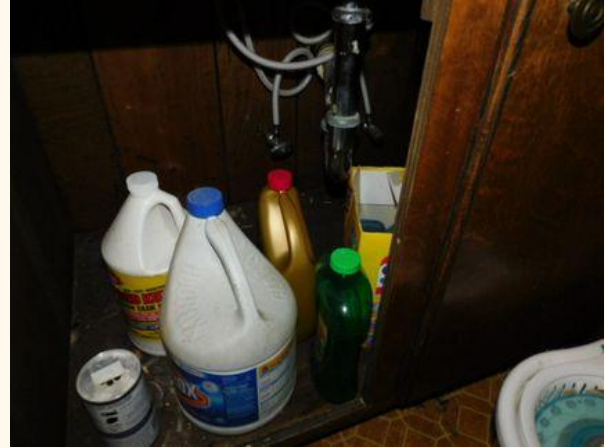
🔧 (K-3) Review: cabinets full limiting view

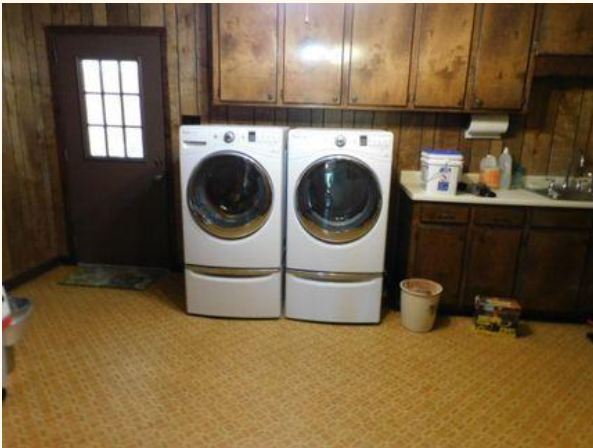
🔍 (LF-1) Review: washer dryer present but not part of the home inspection.

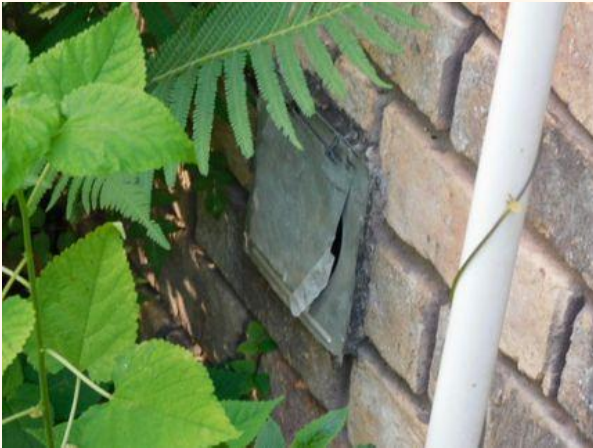
🔧 (LF-2) Review: Dryer vent hood damaged.

🔧 (LF-3) Recommended Preventive Maintenance: The dryer exhaust ductwork is dirty and needs to be cleaned for improved safety. This is important regular maintenance to eliminate a potential fire hazard.

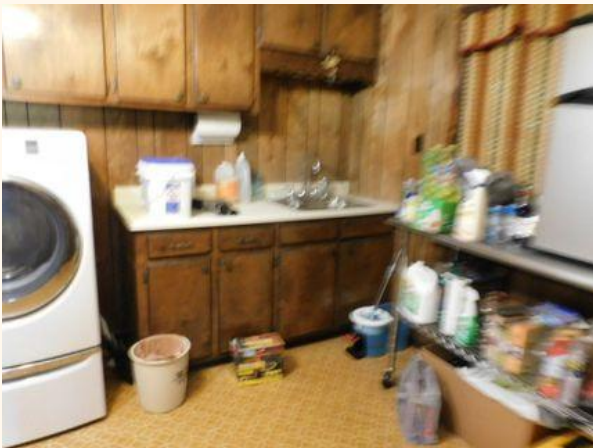
🔧 (LF-4) Review: access impaired to laundry sink

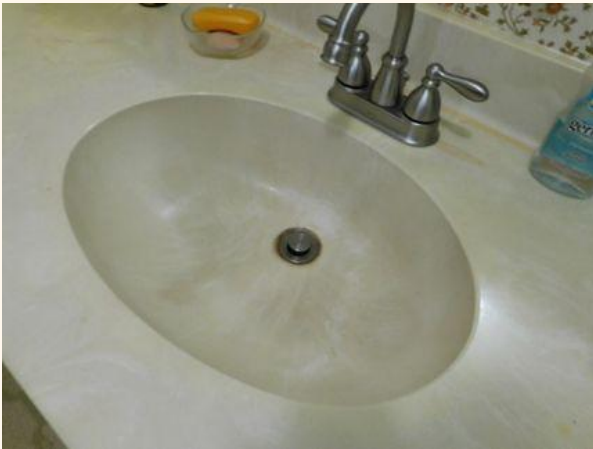
**(B-2) Review:** Sink stoppers need adjustments.

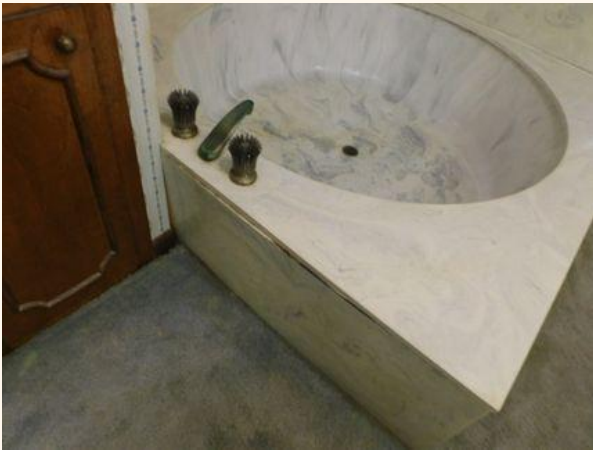
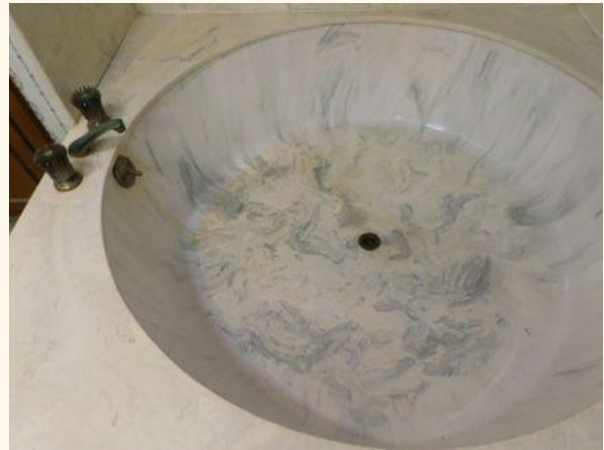
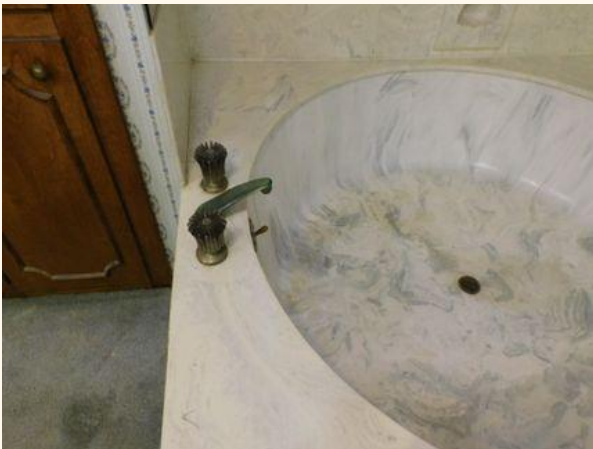
🔧 (B-5) Review: Tub surround faulty.

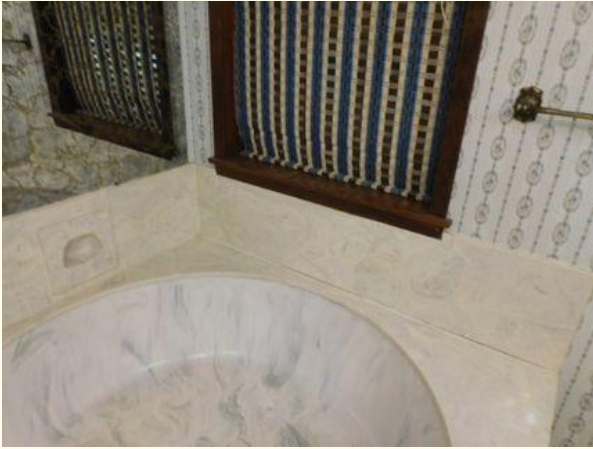
**(B-4) Improve:** Window near tub does not appear to be safety glazed.

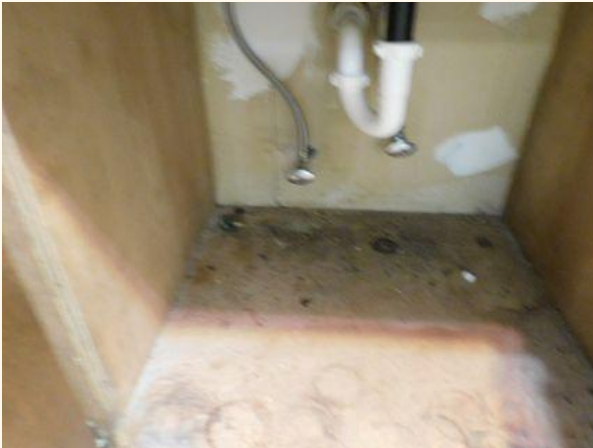
🔧 (B-8) Review: Bathroom cabinets water stained.

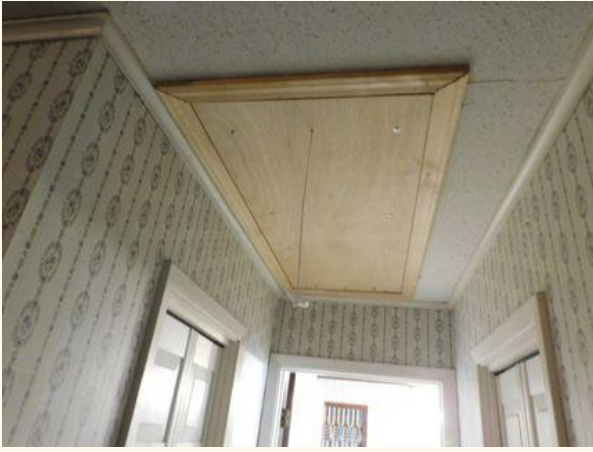
🔧 (A-1) Review: attic access not insulated.
