Inspection report for the property at
785 California , Camden, Ark.

This report is prepared exclusively for **southern Meat Market**
Inspected On: **07-11-2024**

The Professional Real Estate Inspection Report

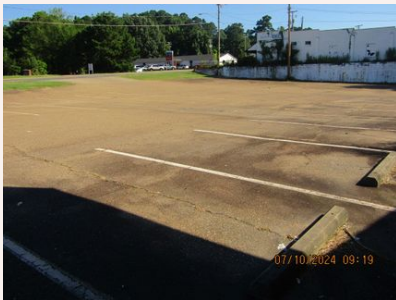
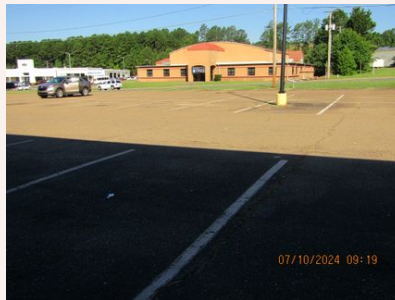
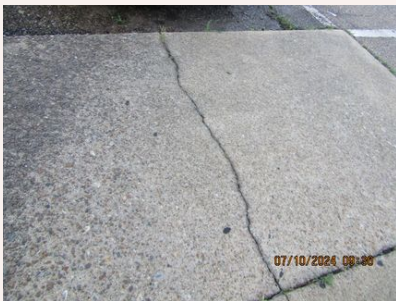
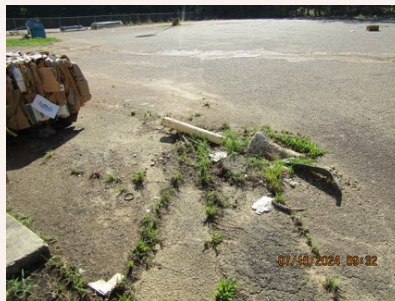
(G-1) Recommended Preventive Maintenance:

Typical concrete cracks noted in parking lot. Repaving parking lot cost could range from \$15,000 and up. Patching the Parking lot may cost around \$10,000 or less.

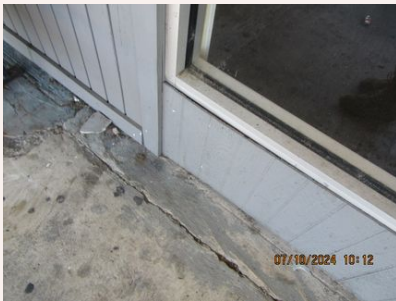
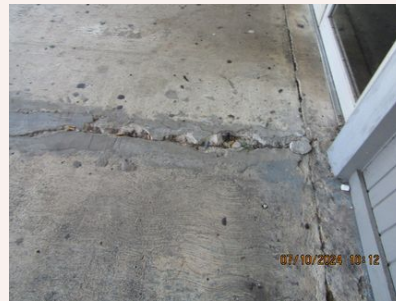
**(ED-1) Recommended Preventive Maintenance:**

Front sidewalk cracked and uneven in numerous locations. Estimated cost of repairs could be between \$1500.00 to \$3000.00.

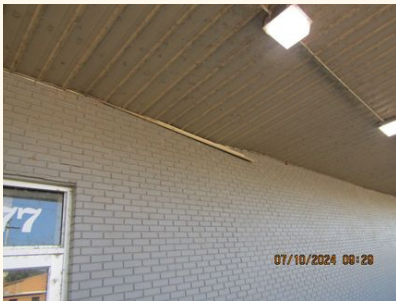
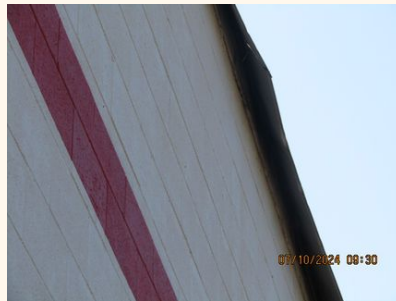
(ED-4) Review: Metal siding trim loose correction of trims cost \$2500 to 5000.00

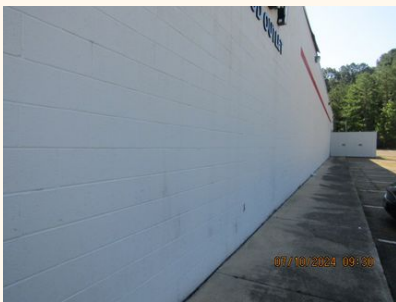
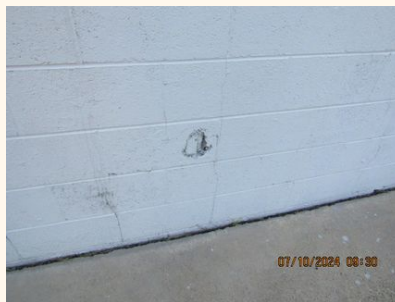
(ED-5) Review: CMU walls cracked. Repairs to CMU walls \$1000.00 to 2000.00

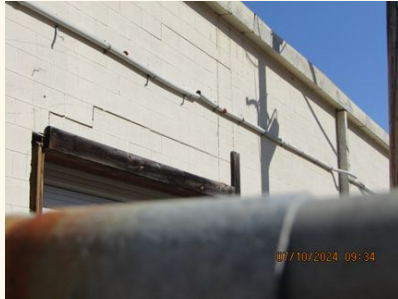
🔧 (ED-6) Review: Siding appears to be water damaged. Repairs for water damage \$5000 to \$1000.00

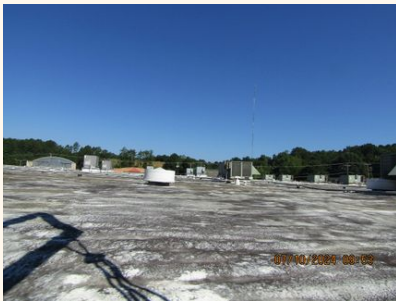
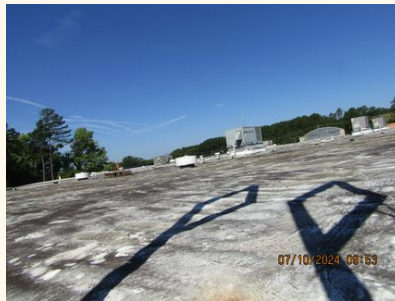
🔧 (RCG-2) Review:

Roof appears to sag in numerous locations. Repairs to roof cost \$15000 to 20000.

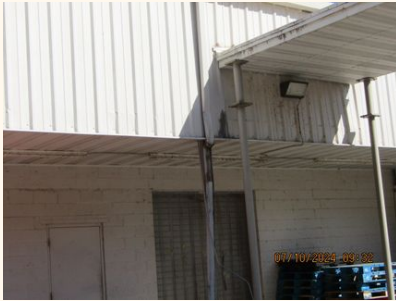
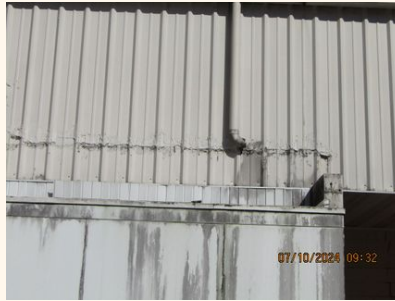
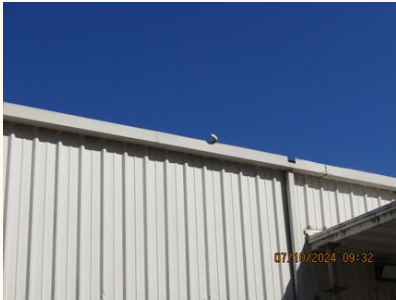
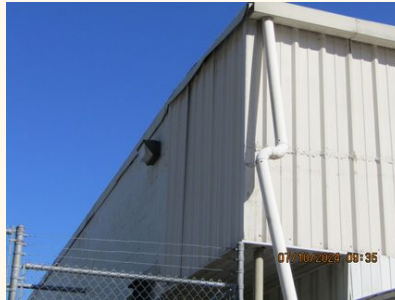
🔧 (RCG-6) Review: Gutter downspouts damaged. see above

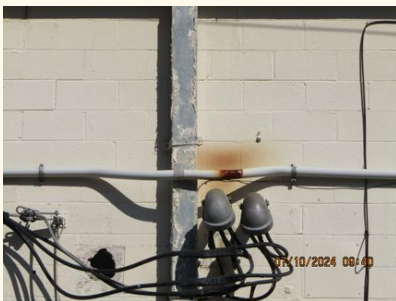
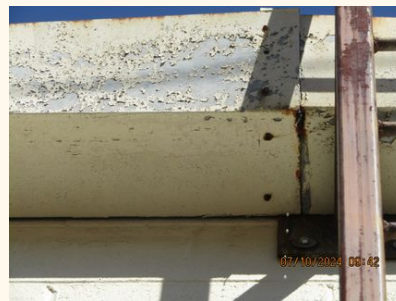
🔧 (RCG-7) Review: Gutters appear to leak. Repairs to gutter \$ 8 to 10,000

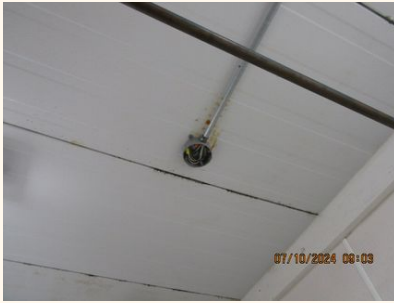
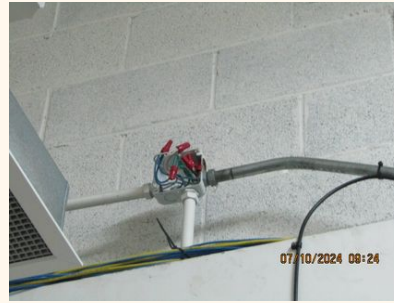
🔧 (EDFW-1) Review: Junction boxes missing covers in various locations.

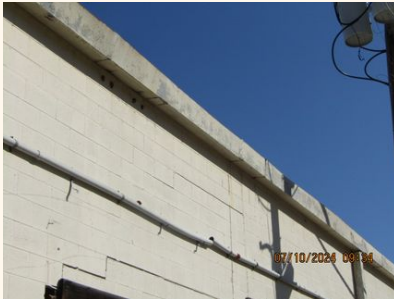
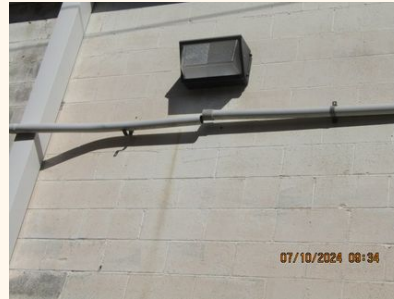
🔧 (EDFW-2) Review: Conduit separated.

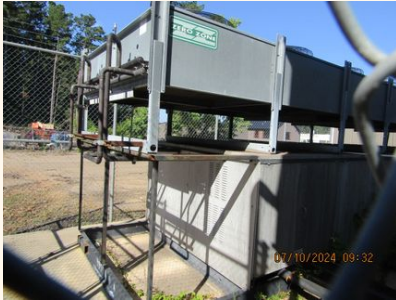
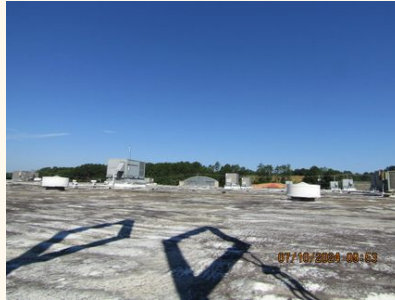
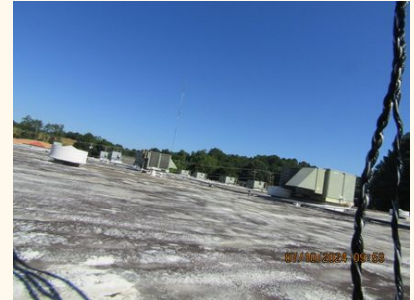
🔧 (HCFV-1) Review: A/C system appears to need service. Servicing of the a/c system \$5000.00 to 8000.00

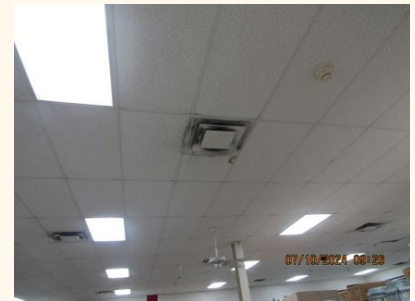
🔧 (HCFV-2) Review:
A/C register dirty and appear to need cleaning. Cleaning duct work \$5000

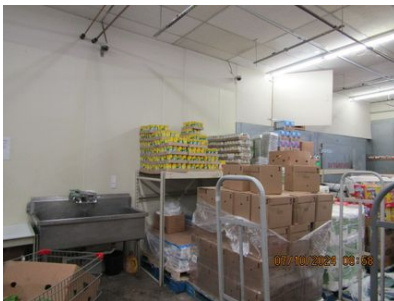
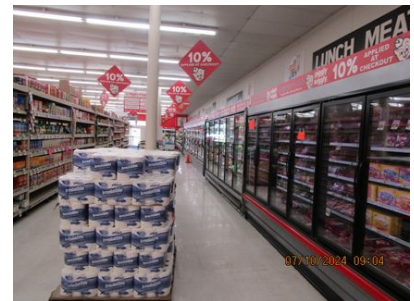
General Interior Photos

Warehouse access limited.

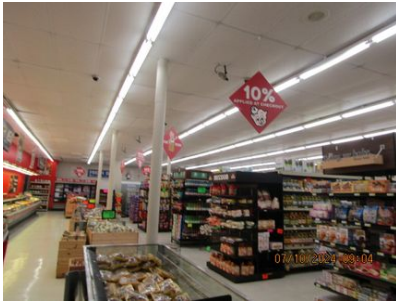
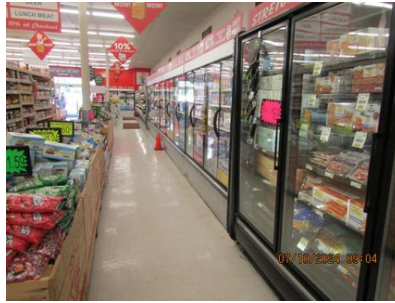
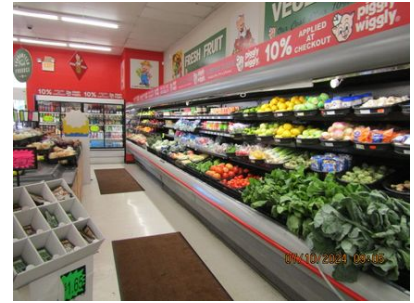
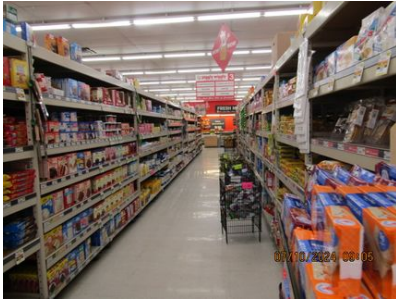
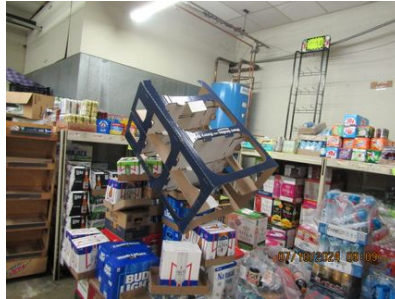
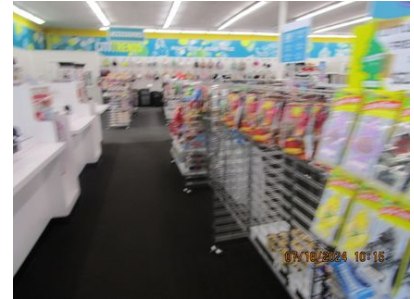
(I-2) Review: Patches and cracks noted in concrete floors.

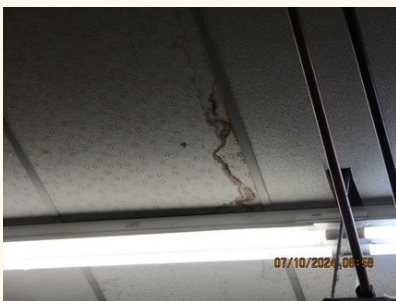
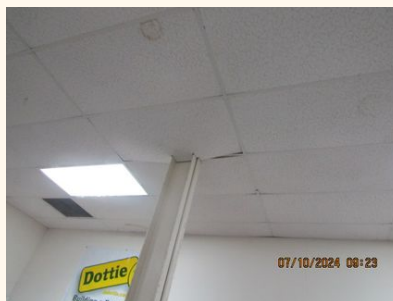
🔑 (I-6) Review: Water stains noted in ceiling tiles. Replacement of damaged and stained tiles estimate \$1000 to \$2500

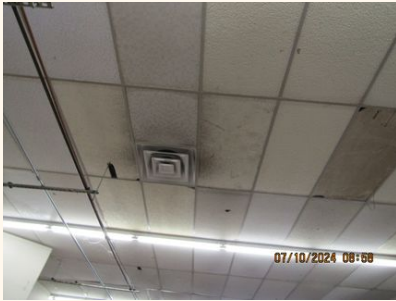
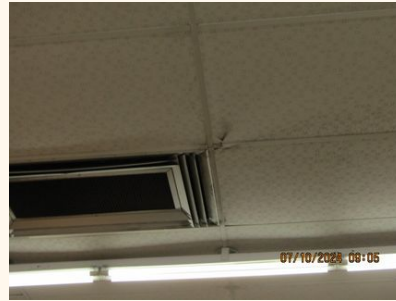
(I-7) Review: Ceiling tiles dirty at a/c registers.

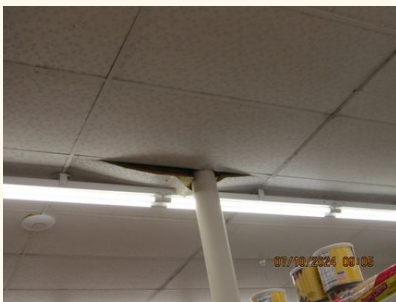
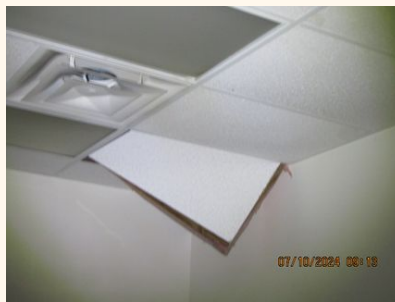
(I-9) Review: Ceiling tiles sagging and damaged. Repair of damage tiles \$500 to \$1000

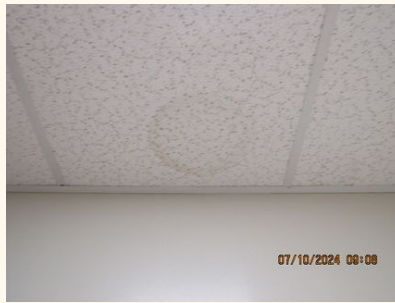
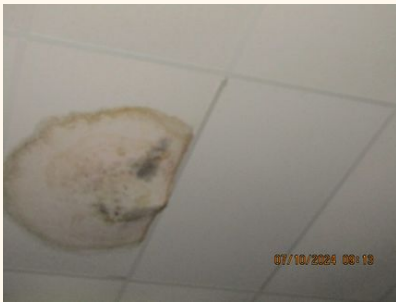
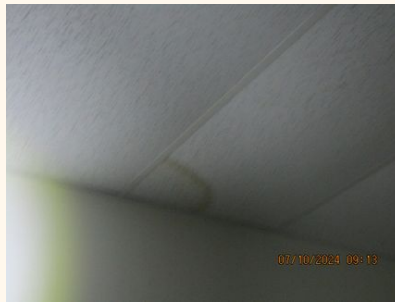
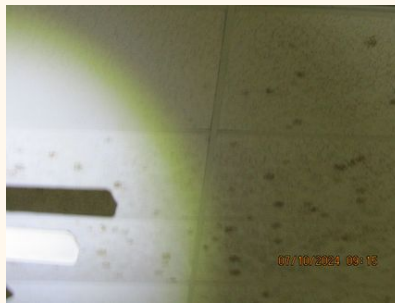
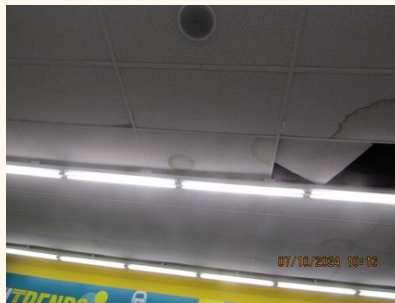
(I-10) Review: Signs of water stains and possible mold noted in several units and locations.

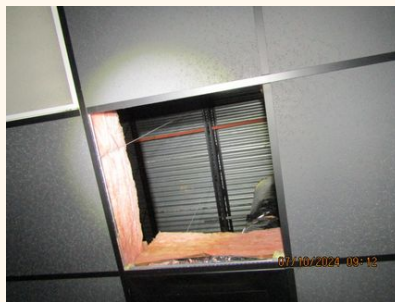
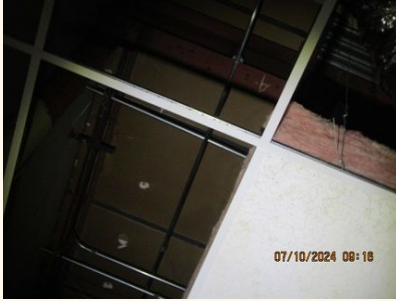
(I-13) Review: Ceiling tiles stained and missing in various locations.

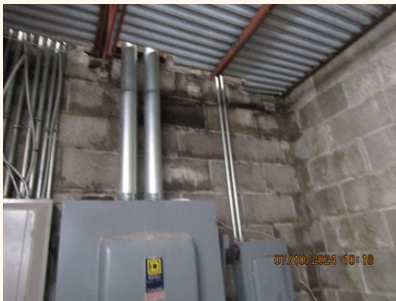
(I-15) Review: Signs of excessive water noted in warehouse. Cost estimate \$5000 to 8000.

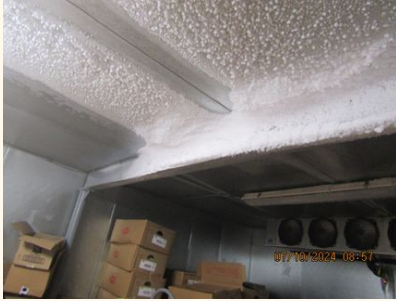
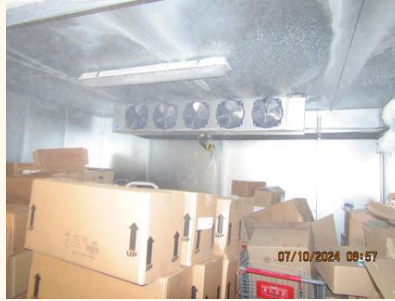
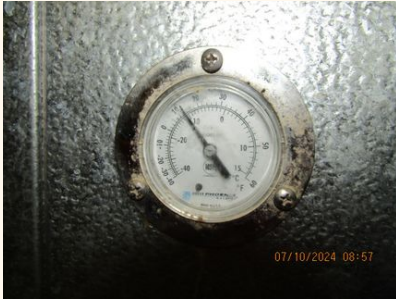
🔧 (K-4) Review: Freezer unit icing up.

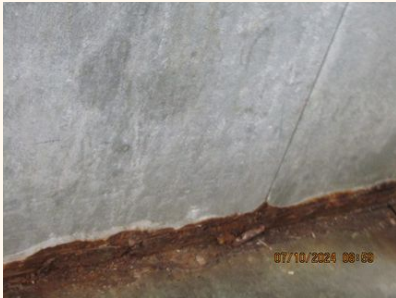
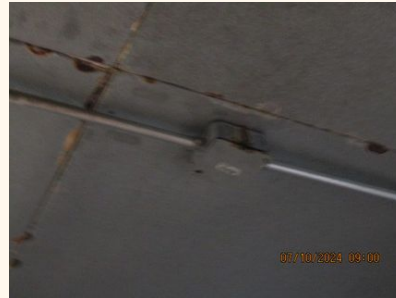
(K-5) Review: Metal walk ins rusting. cost of repairs 2500 to 5000

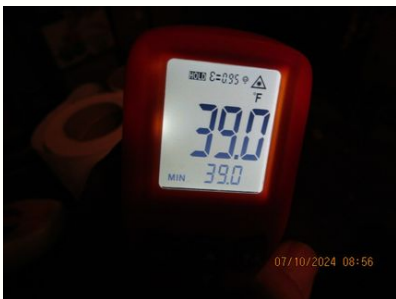
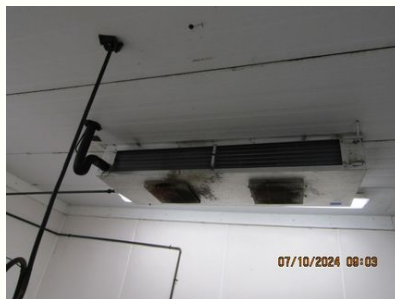
(K-2) Note: Coolers and freezers test and found operational but in need of maintenance. Cleaning and servicing of cooler equipment \$4000.00 to 7000

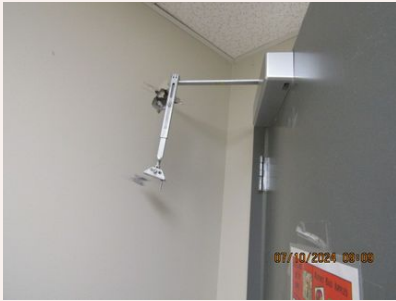
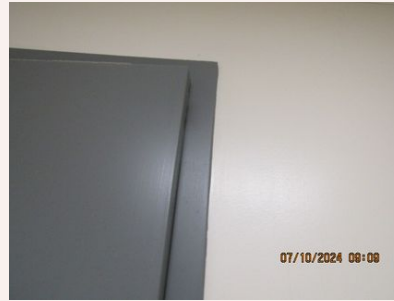
**(B-3) Recommended Preventive Maintenance:**
Door closure damage and door drags on jamb.

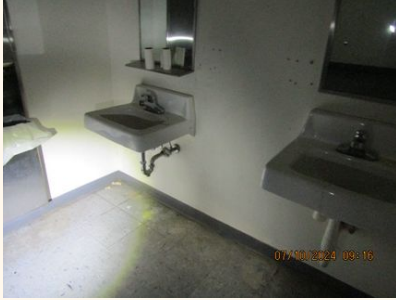
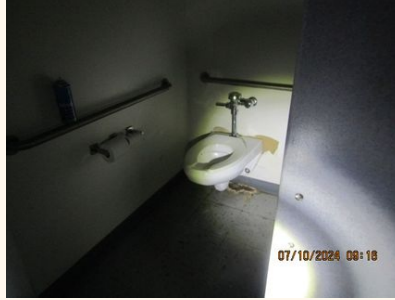
🔑 (B-5) Review: NO water on to unit could not test restroom. Signs of past excessive leaking noted at commode. Cost of cure unknown due testing not possible.

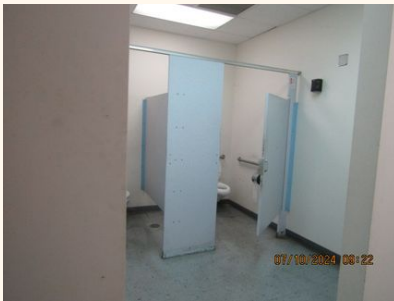
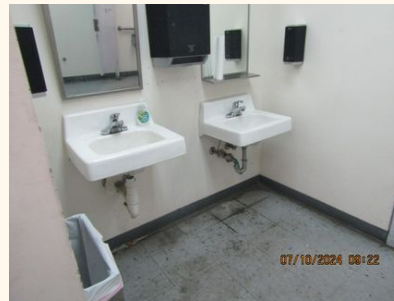
🔑 (B-10) Review: Floors stained.

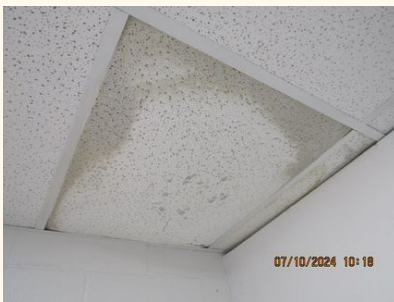
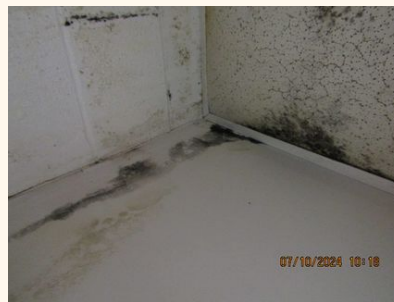
🔑 (B-11) Review: Ceiling tiles water damaged, stained and possible mold noted. Repair of water damage \$5000 to 10000
