## Home Inspection Report

Happy Valley Rd, Roseburg, OR 97471

Wednesday January 24, 2018

180124A

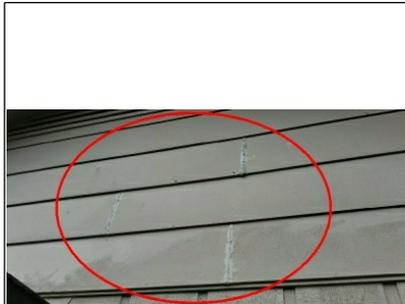
Siding at west side of home with silicone caulking joints

Repair areas of weathered siding and trim caulking.

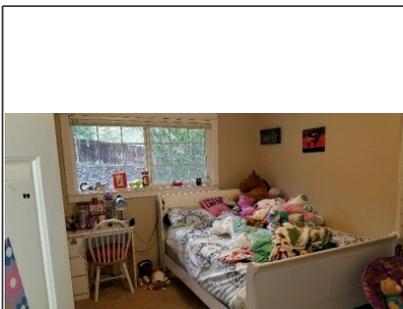
**Comments** Staining on bedroom carpet.

Staining on bedroom carpet

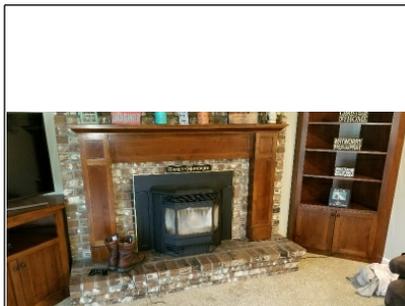
Pellet stove insert

**Comments** Electrical power cord for pellet stove is plugged into a cabinet outlet, recommend dedicated wiring for unit.

Power cord for pellet stove plugged into cabinet electrical outlet

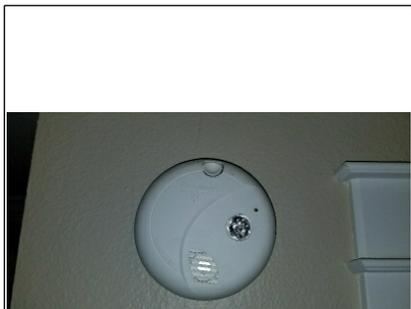
Smoke detector in NE bedroom

Recommend additional smoke detectors on interior of home.

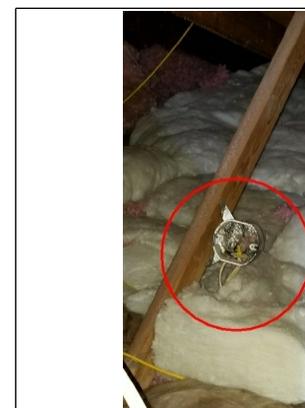
Open electrical junction box in attic

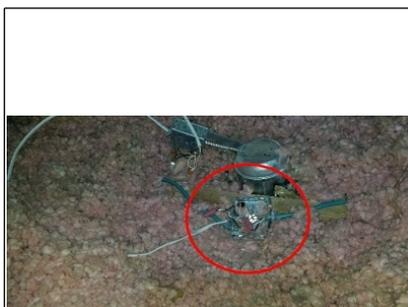
Open electrical junction box in attic

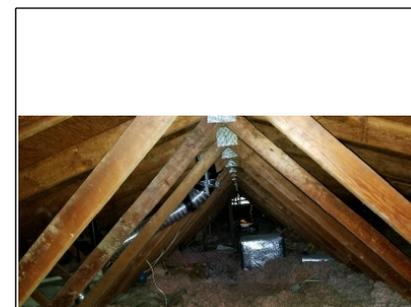
Vents from master bathroom do not vent to exterior
