Executive Summary

Engineer's Foundation Evaluation

123 Sample Address, Your City, TX, 12345

ENGINEER'S FOUNDATION EVALUATION

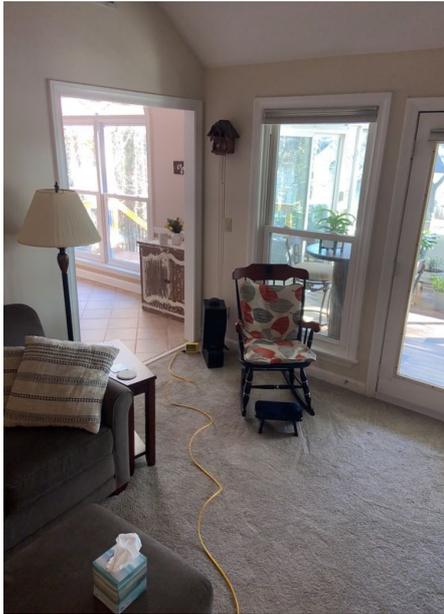
Living Room: Back-left elevation & photo

Living Room
0.2 inches

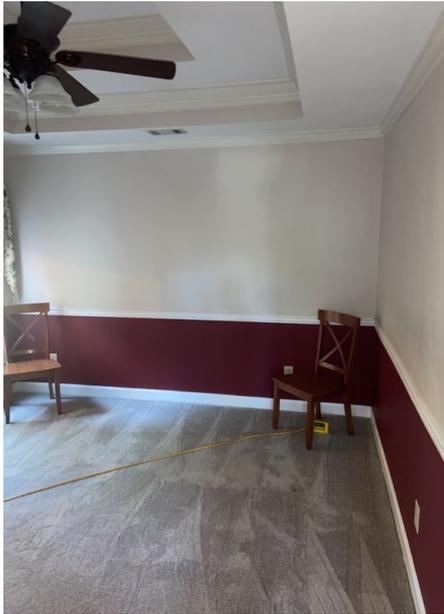
Dining Room: Front-left elevation & photo

Dining Room
0.4 inches

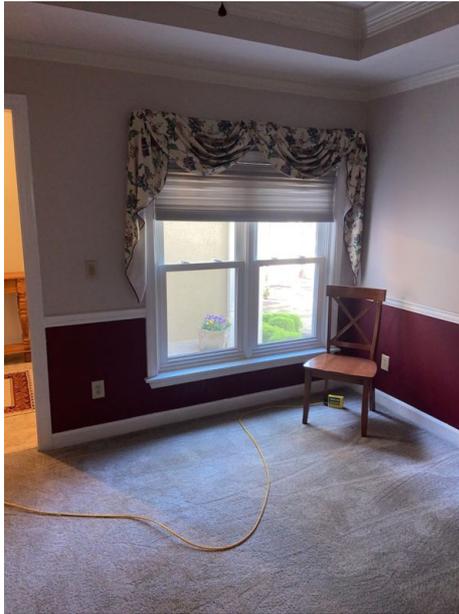
Dining Room: Front-right elevation & photo

Dining Room
0.5 inches

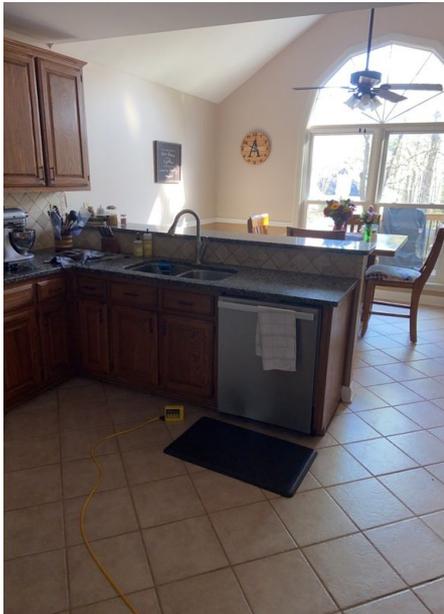
Kitchen & Nook: Front of sink elevation & photo

Kitchen
-0.1 inches

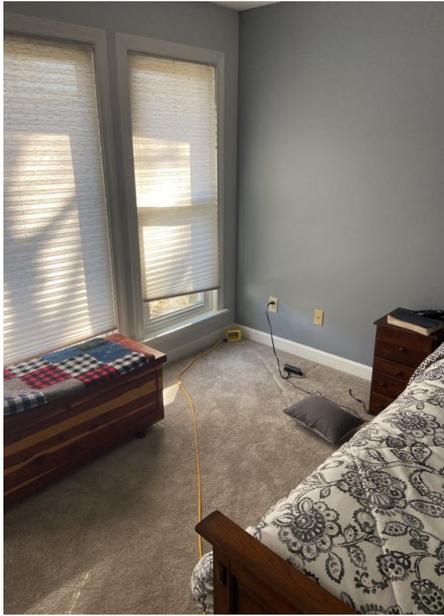
Primary Bedroom: Back-right elevation & photo

Primary Bedroom
0.4 inches

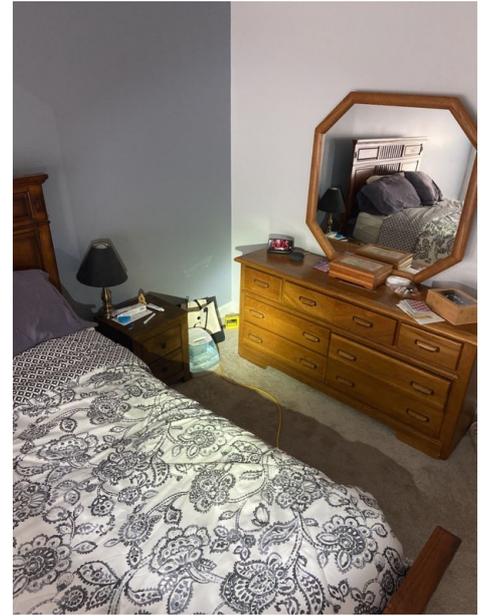
Primary Bedroom: Front-right elevation & photo

Primary Bedroom
0.2 inches

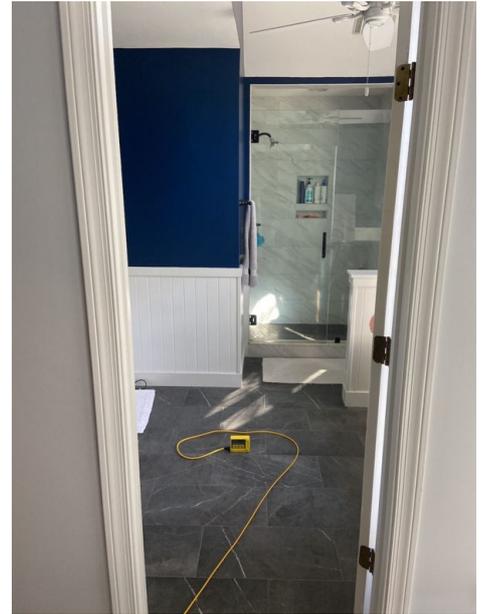
Primary Bathroom: Middle room elevation & photo

Primary Bathroom
-0.7 inches

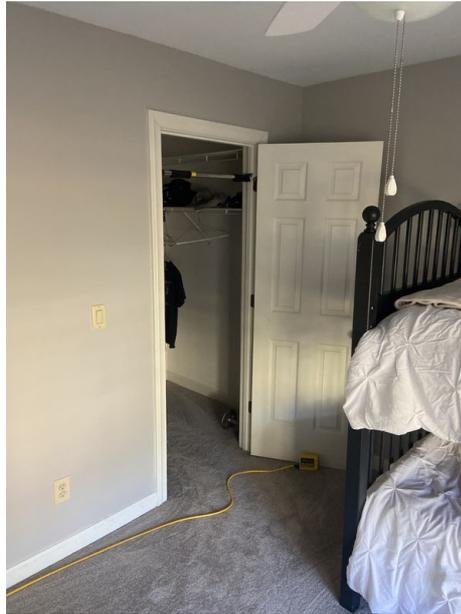
Bedroom: Back-right elevation & photo

Bedroom
0.3 inches

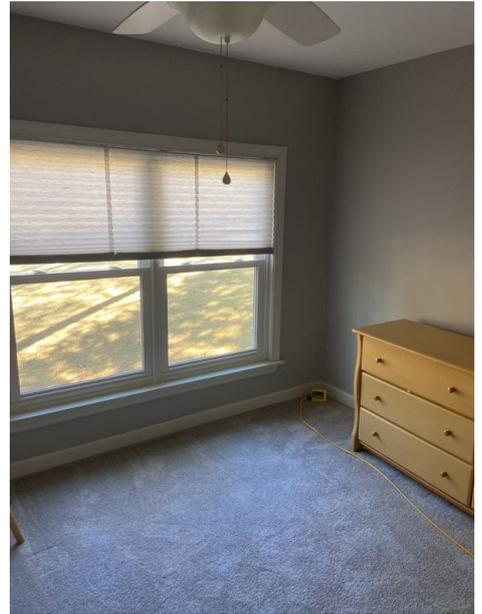
Bedroom: Front-left elevation & photo

Bedroom
0.4 inches

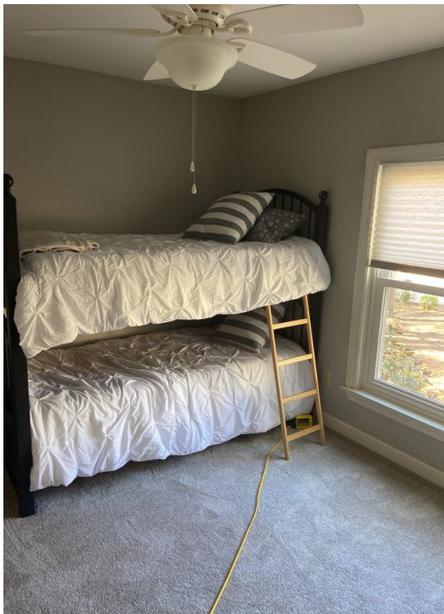
Bedroom: Front-right elevation & photo

Bedroom
0.4 inches

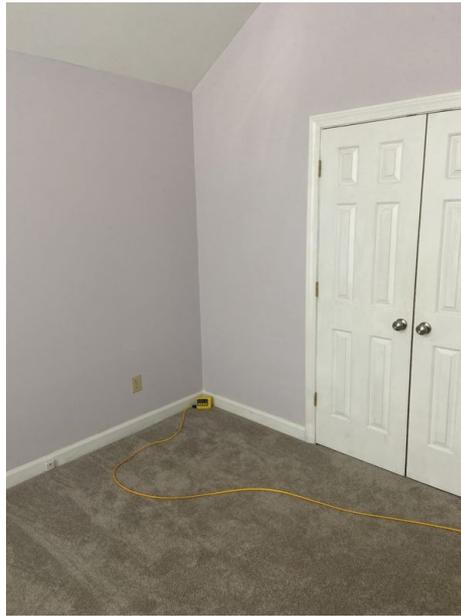
Bedroom: Back-left elevation & photo

0.2

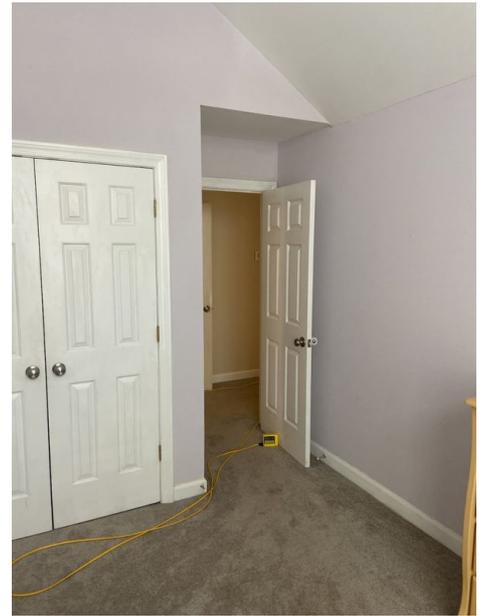
Bedroom: Back-right elevation & photo

0.2

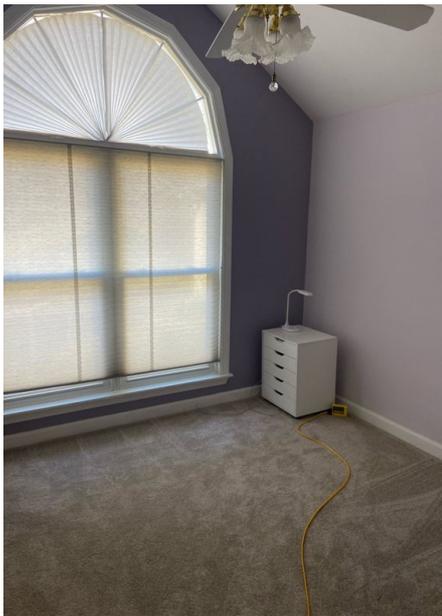
Bedroom: Front-left elevation & photo

0.4

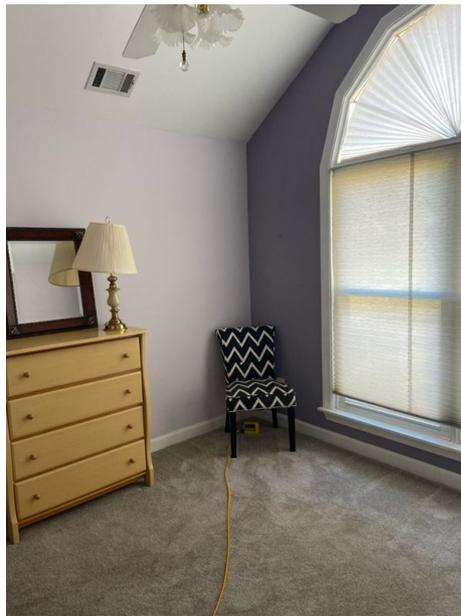
Bedroom: Front-right elevation & photo

0.2

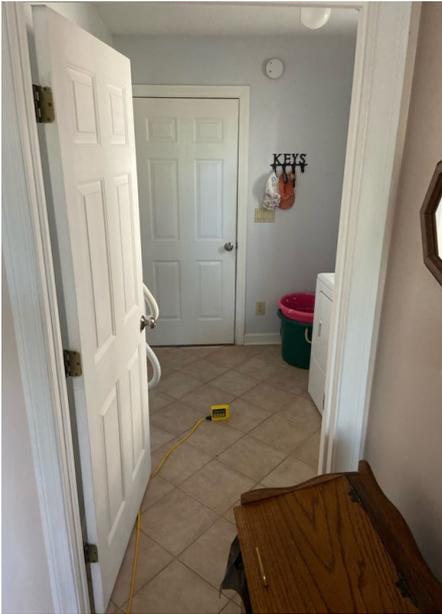
Laundry: Mid-room elevation & photo

Laundry
-0.1 inches

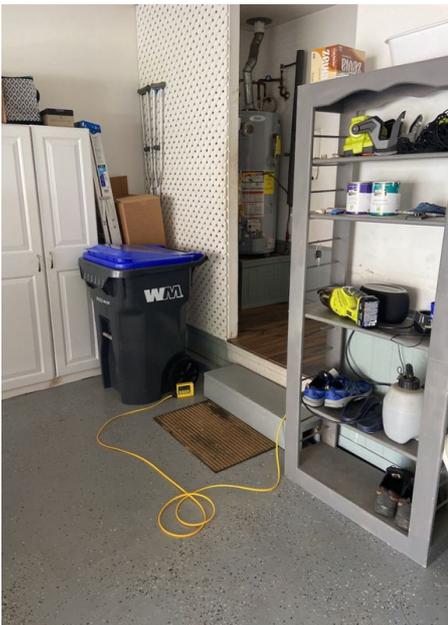
Garage: Back-left elevation & photo

Garage
Sunken and Sloped, Step Down
into Garage

Garage
-13.2 inches

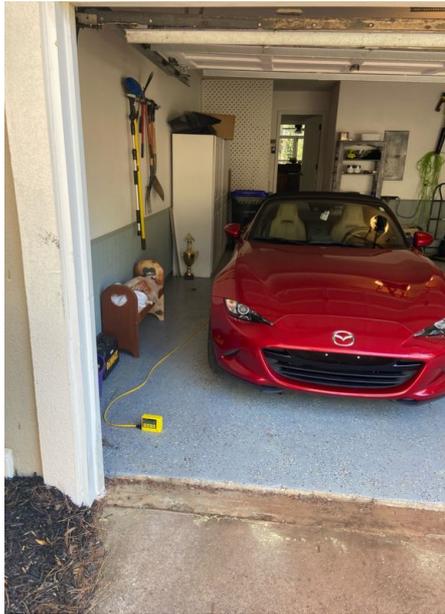
Garage: Front-left elevation & photo

Garage
-14.8 inches

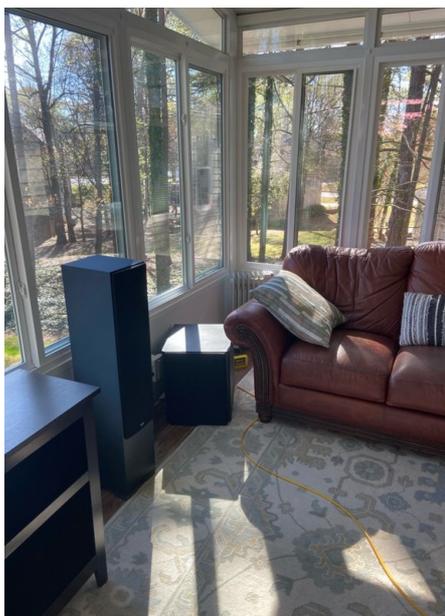
Sunroom: Room elevation 2 & photo

-0.3

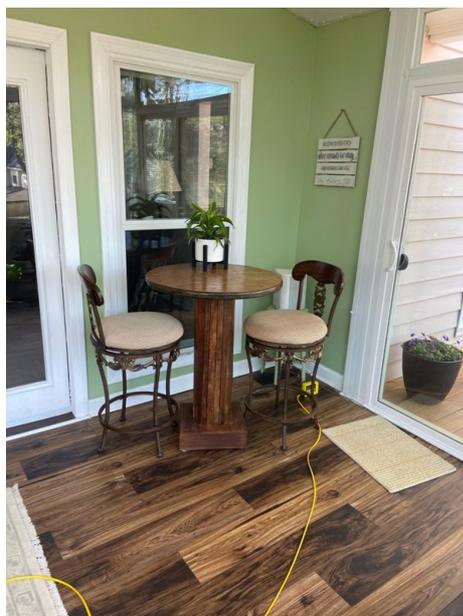
Sunroom: Room elevation 3 & photo

-0.3

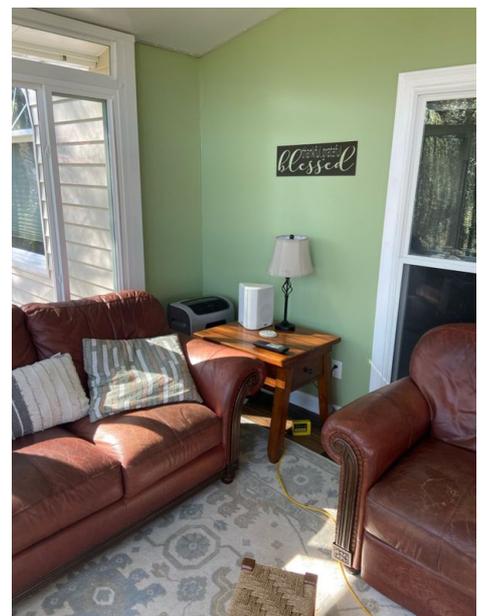
Sunroom: Room elevation 4 & photo

-0.5
