# Blue Line Home Inspections, LLC

## Home Inspection Report

Lexington, OK 73051

Inspected on Sun, Jul 12 2020 at 9:00 AM

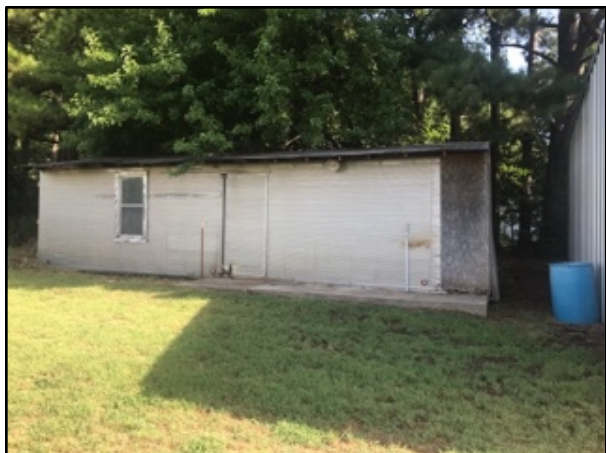
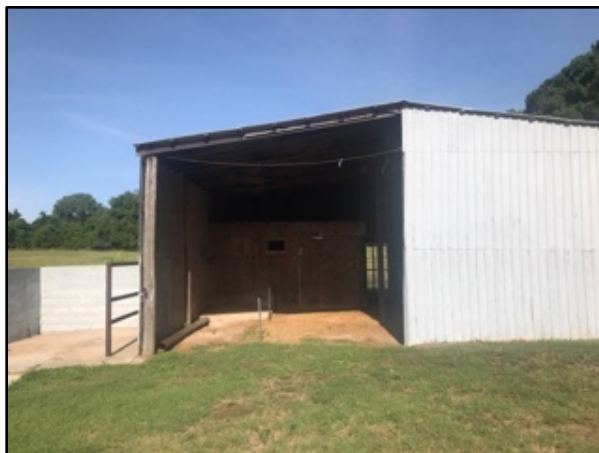
Sheds, barns, outbuildings, etc fall outside the scope of a home inspection. Several were present at this acreage and were not inspected.

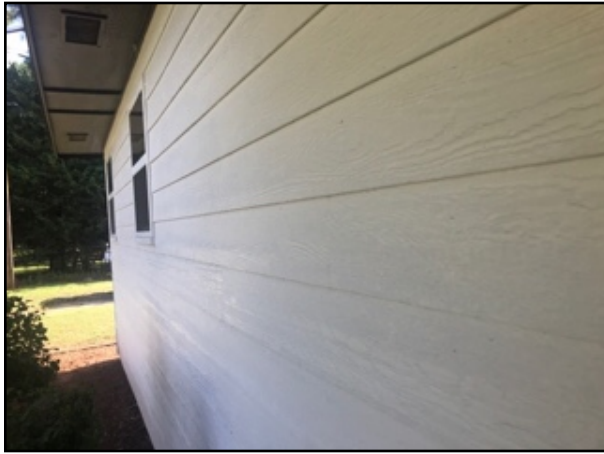
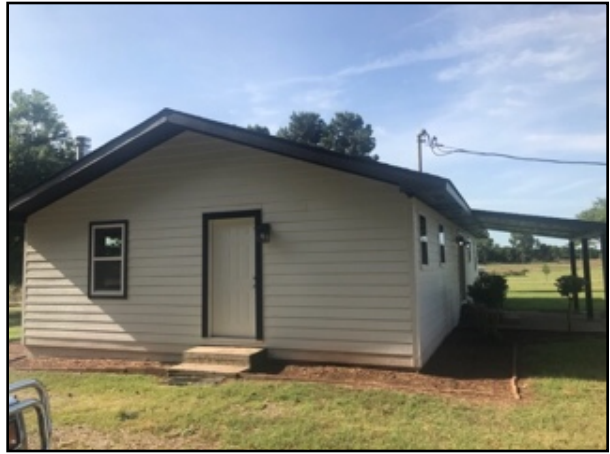
No damage was observed the exterior siding, doors, or windows.

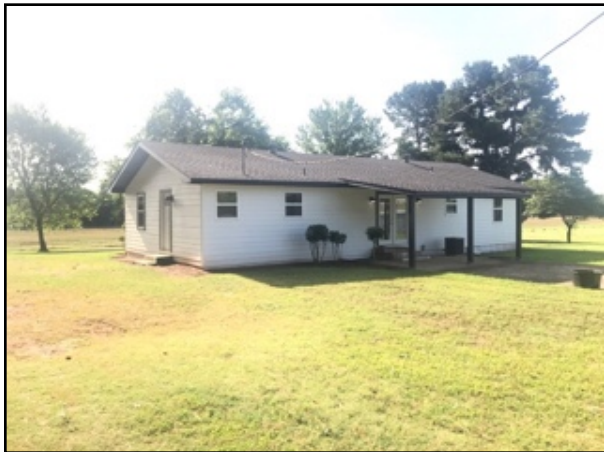
Figure 4-1

No standing water was observed around the home.

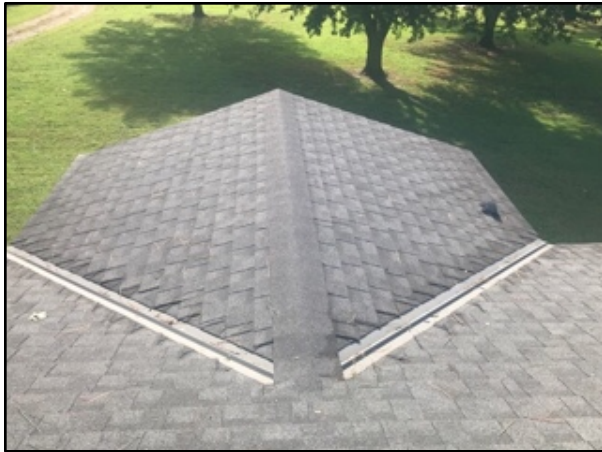
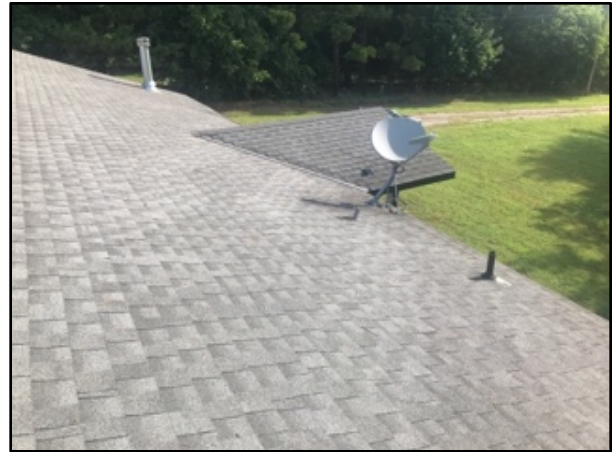
The shingles are in good condition. Note: it's unknown for sure if the roof leaks or not as there was no attic access.

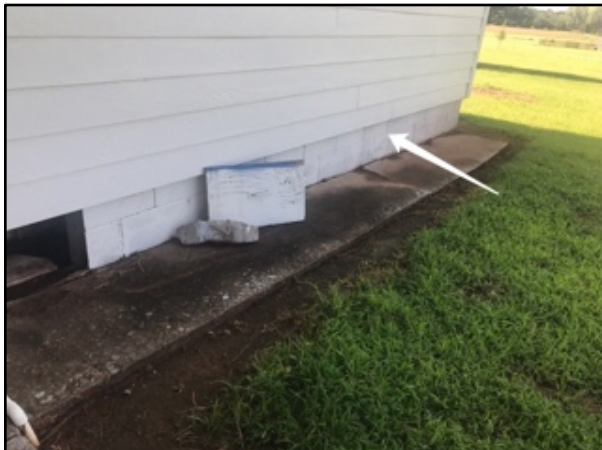
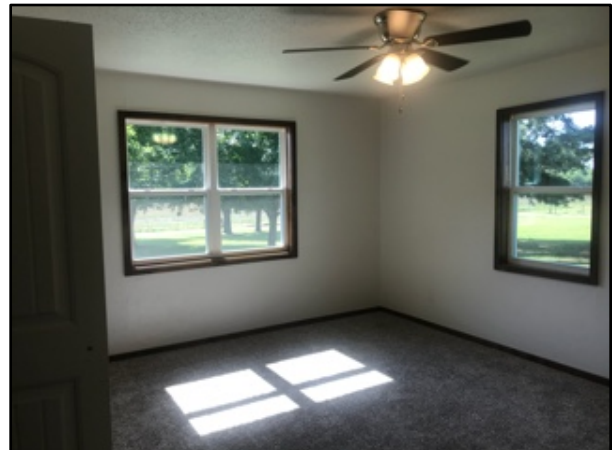
**Comment 10:**  
No defects observed in the block stem wall. The interior floor felt normal, no bouncy or soft areas. No major cracks were observed in the walls or ceilings.

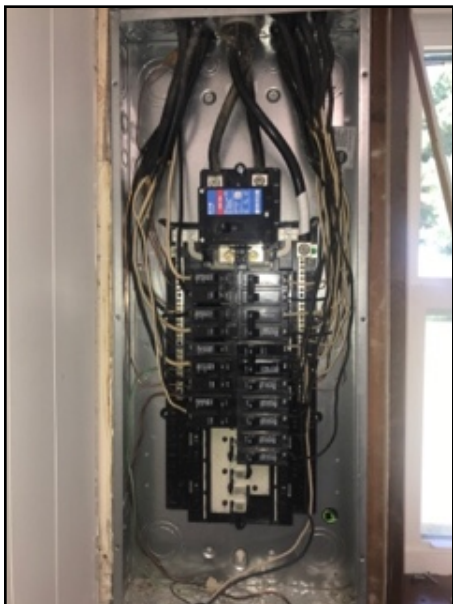
Figure 15-1

Main service panel with cover removed for inspection.

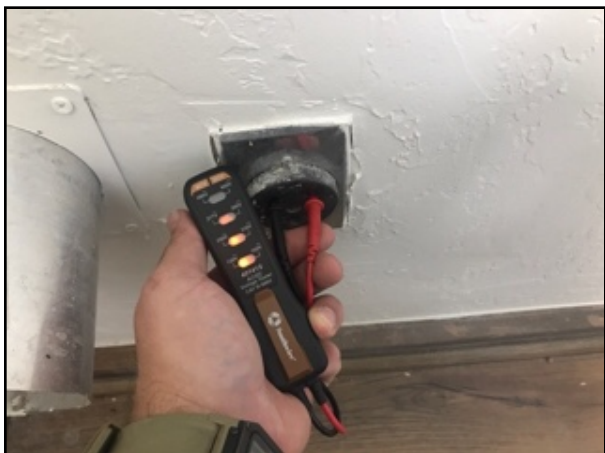
Figure 16-1

Voltage was confirmed at the dryer receptacle.

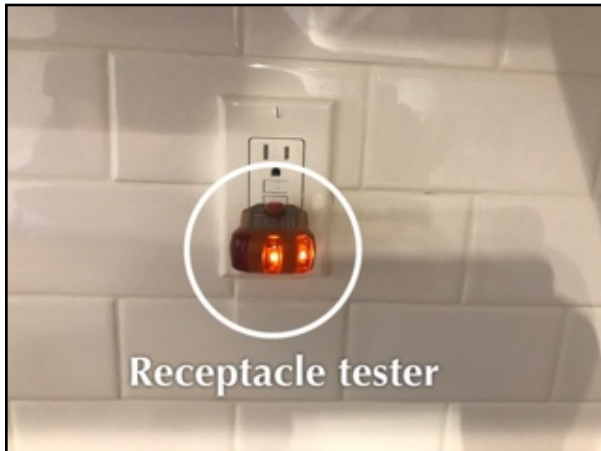
Figure 17-1

**Comment 17:**  
A representative sample of GFCI receptacles were tested with a GFCI tester.

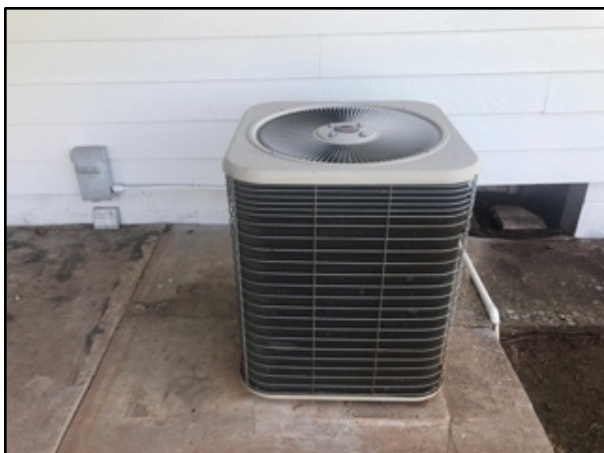
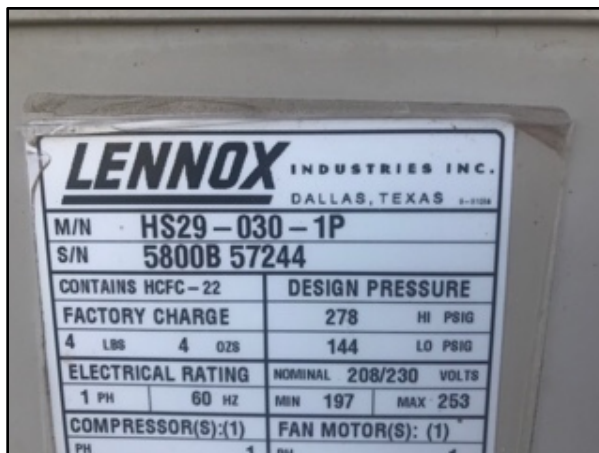
Comment 19:  
 Air conditioner and data label.

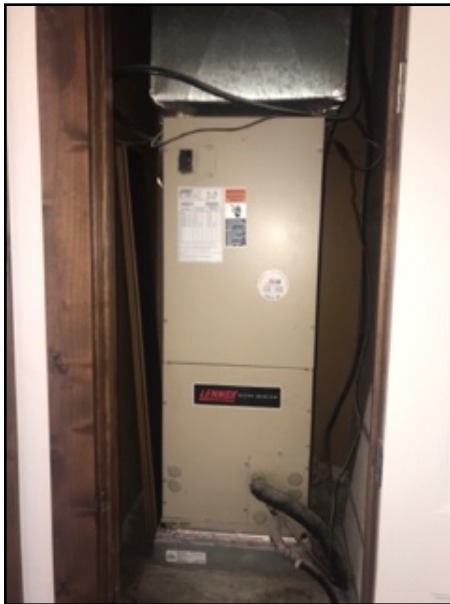
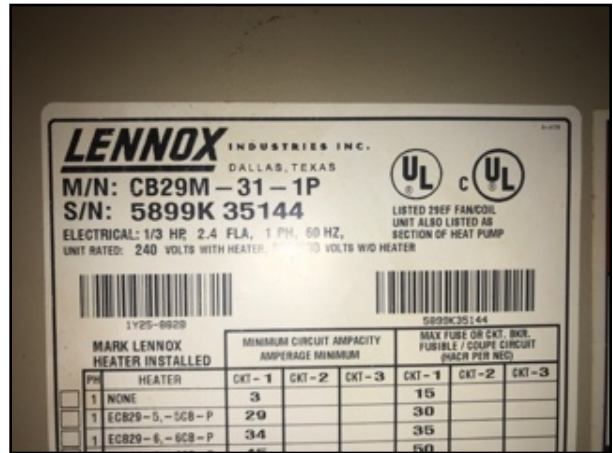
Comment 20:  
Electric heater/air handler and it's data label.

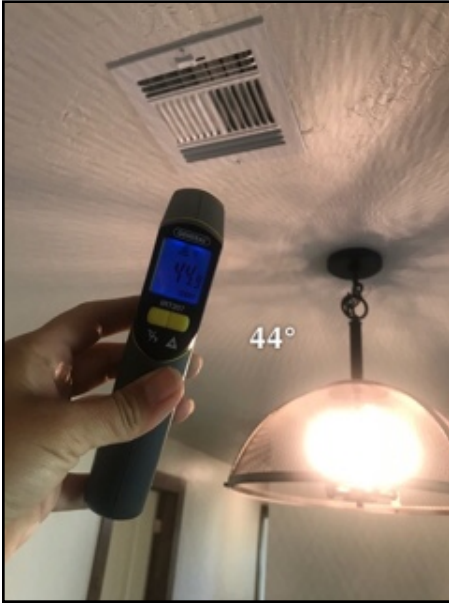
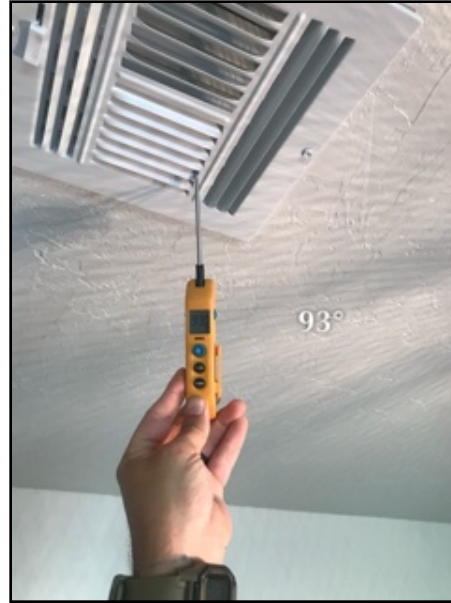
**Comment 26:**  
The HVAC equipment was operated in both heat and cooling modes.

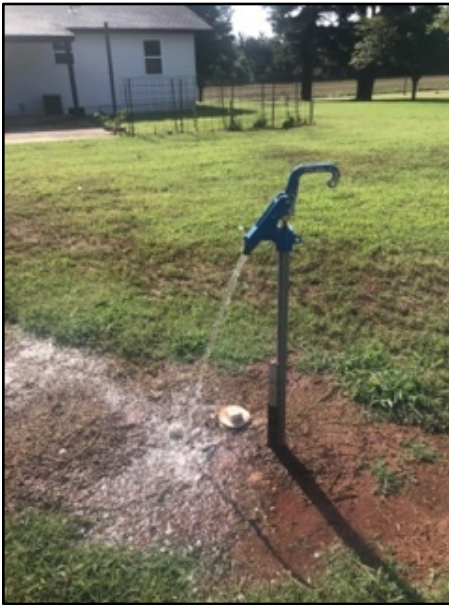
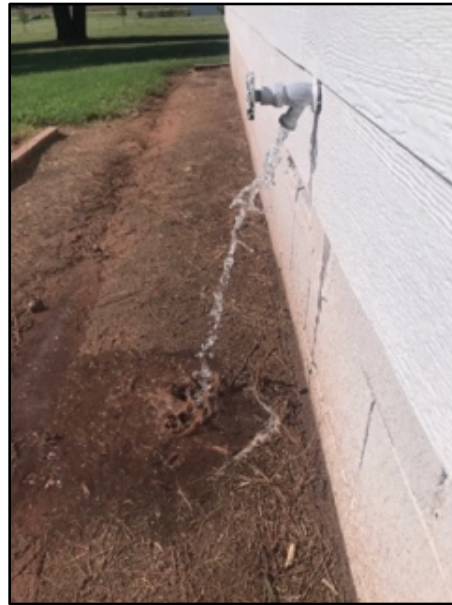
Water pressure at an outdoor faucets appeared satisfactory.

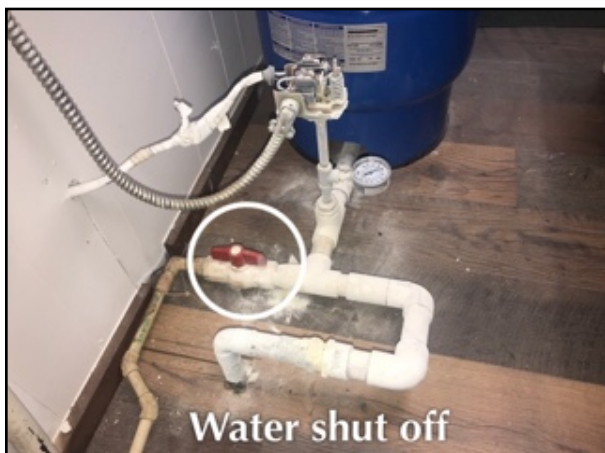
Figure 29-1

Comment 29:  
Location of water shut off valve.

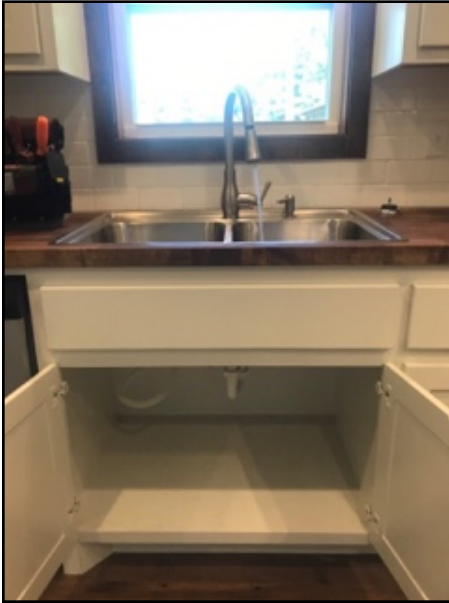
Figure 32-1

The kitchen sink's hot/cold water supply lines are reversed.

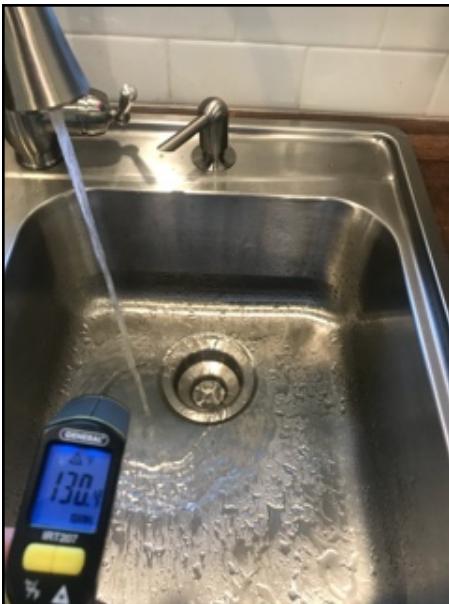
Figure 33-1

The water heater produced hot water at the time of the inspection.

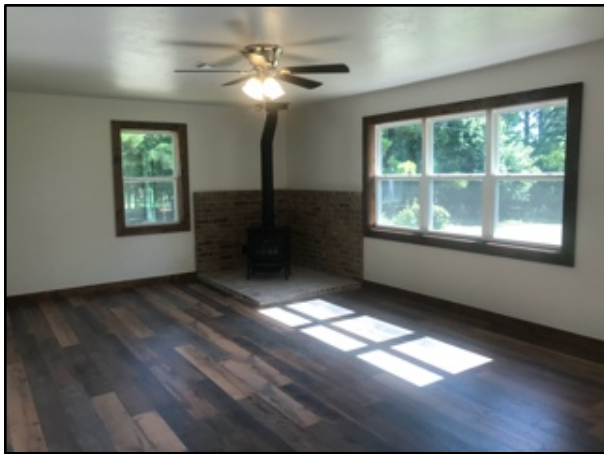
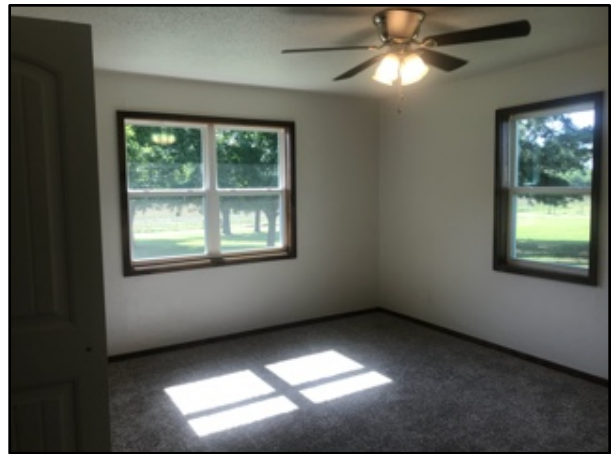
No interior defects observed. It is not uncommon for the seller of a property to prepare the the house for sale, which may include patching and painting finished surfaces. Such preparation has the potential to conceal latent conditions in the property that the home inspector will not be able to identify. Ask seller if they observed any defects prior to painting or patching finished surfaces.

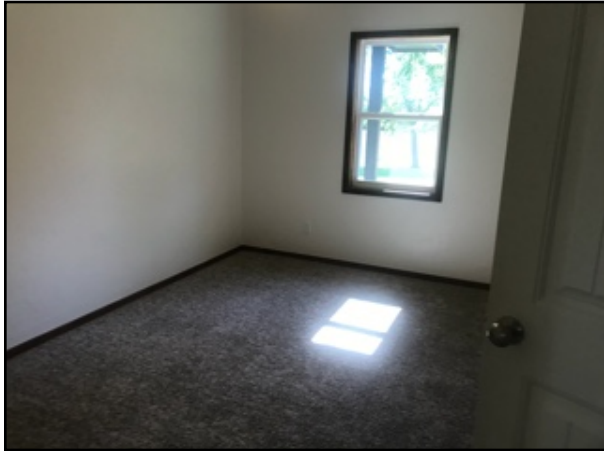
Figure 36-1

The carpets were checked for moisture with a Hydroshark moisture sensor. No moisture was found.

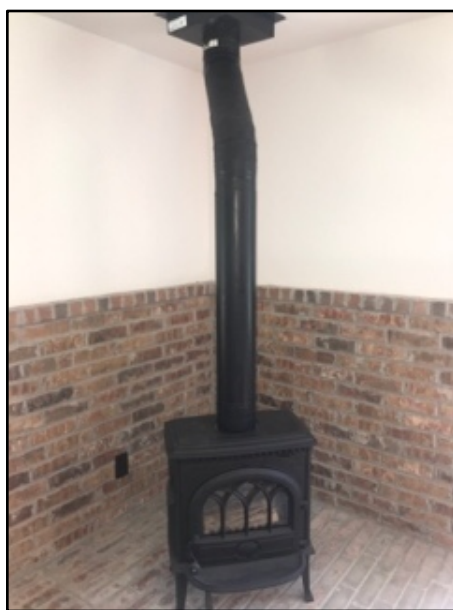
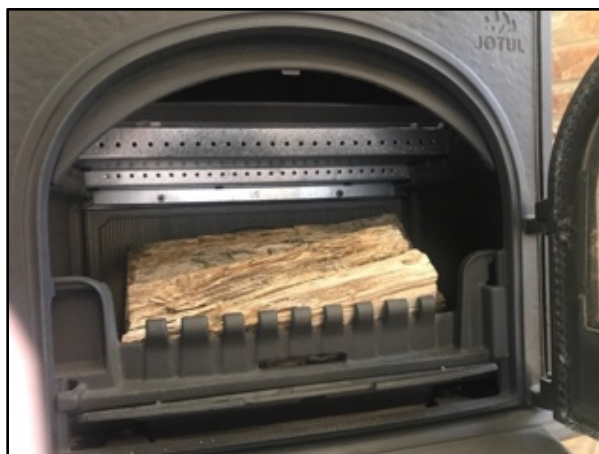
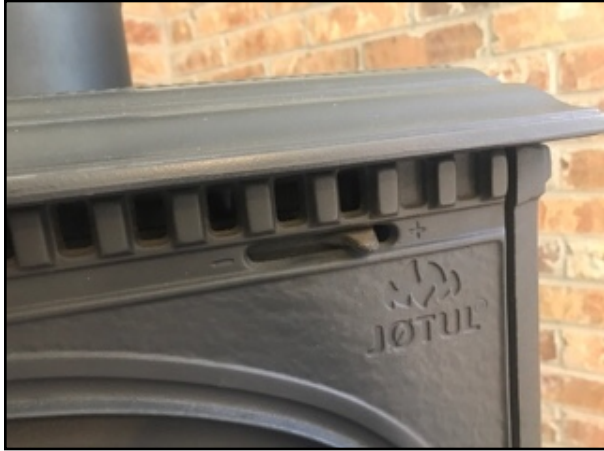
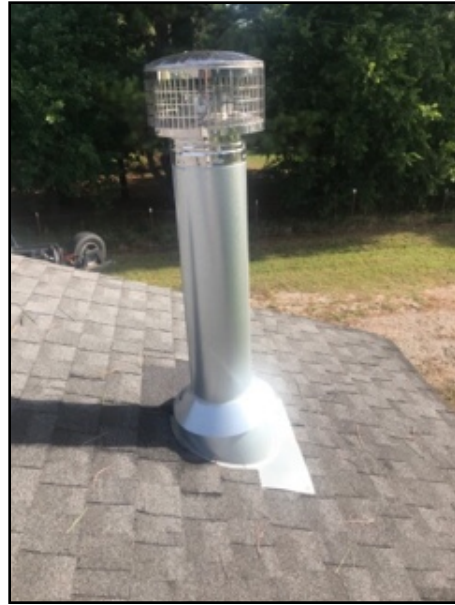
The home has a "Jotul F3" wood burning stove. I recommend the client locate the owners manual for the stove (possibly online ) to learn how to safely operate it.

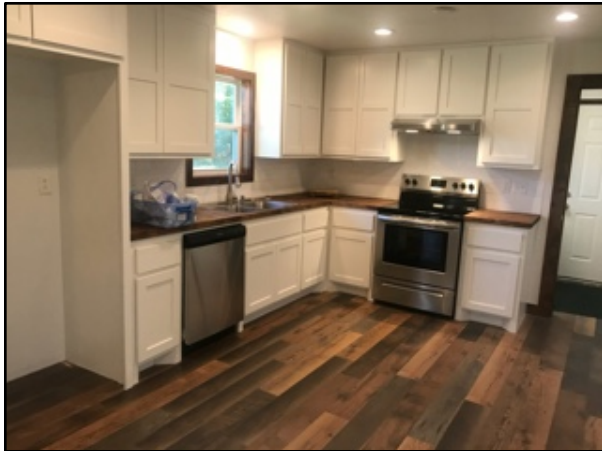
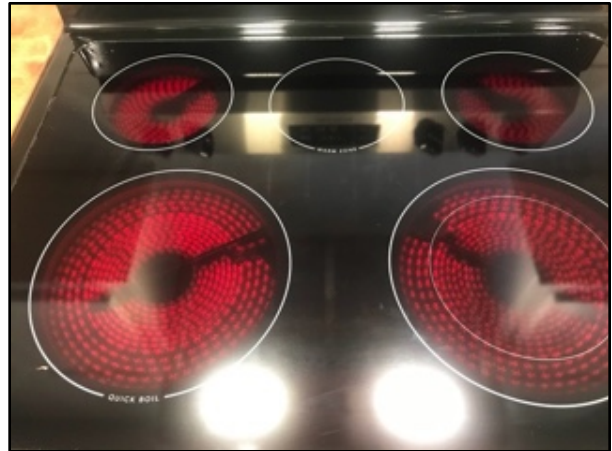
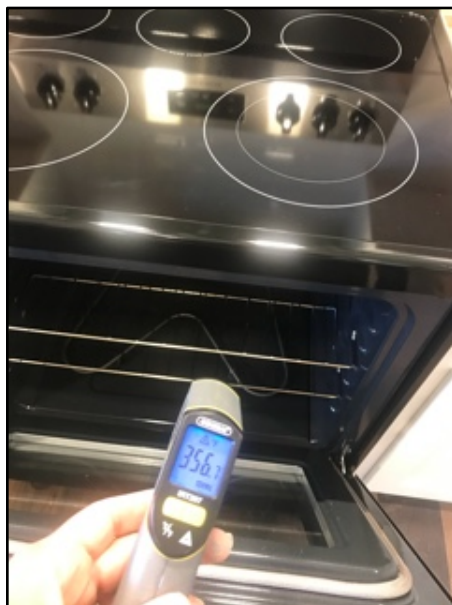
Comment 42:  
Kitchen appliances functioned when tested.

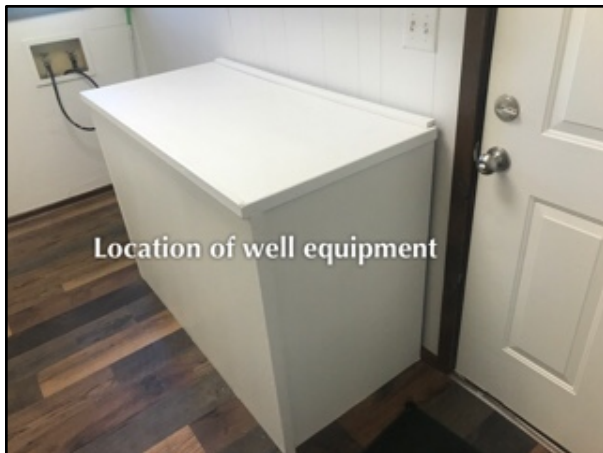
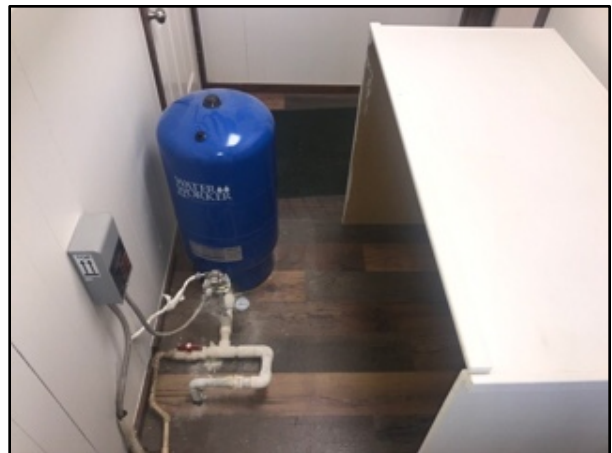
The water well equipment was inspected. It is located under a wood box in the laundry room.

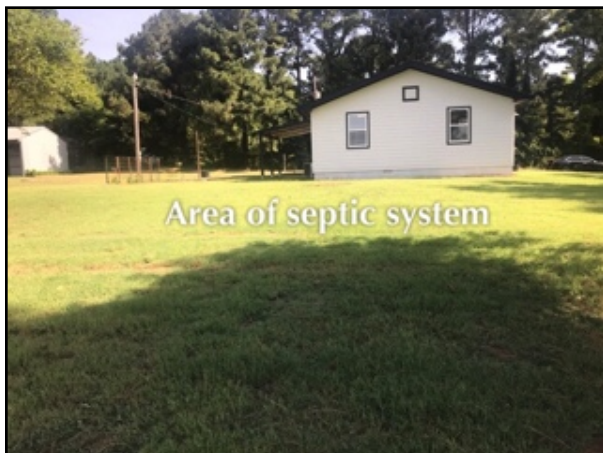
Figure 50-1

Trading dye was introduced into the system at a toilet while water was ran at various fixtures for 30-45 minutes. The area of the septic system was walked at the beginning of the inspection and at the conclusion. No standing water, effluent, odors were observed. While no obvious signs of problems were observed, a more invasive inspection (pumping the tank, probing the drain field etc.) is recommended.

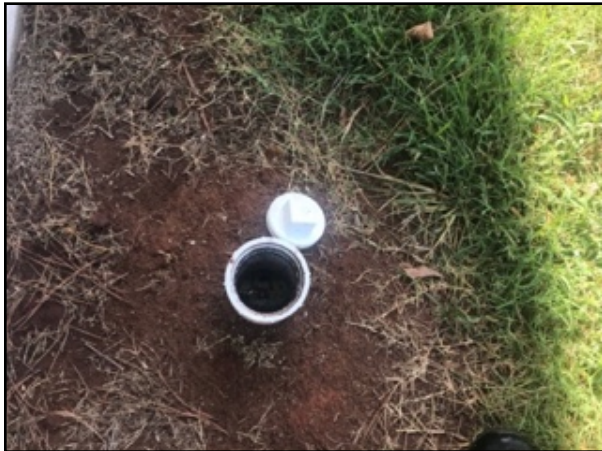
Figure 51-1

I removed the clean out cap. Water was confirmed to be flowing from the house to the septic system.

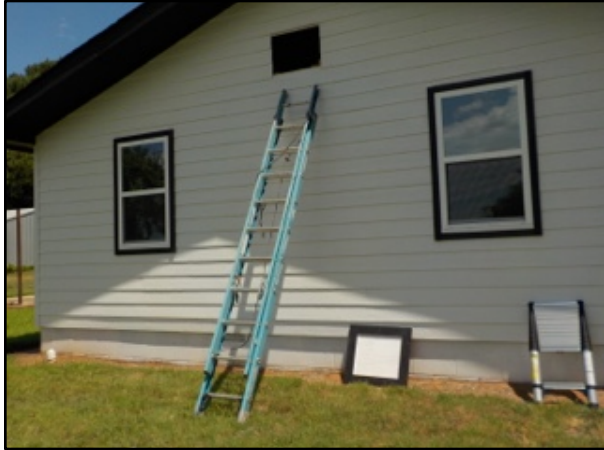
Figure 52-1

On 7-14-20 at 12:15 PM, I returned to the property to inspect the attic. The attic is accessed from the south gable end, behind a wood panel that is screwed into the wall. The attic is un-floored, therefore I did not enter as doing so risks damage to the drywall ceiling.

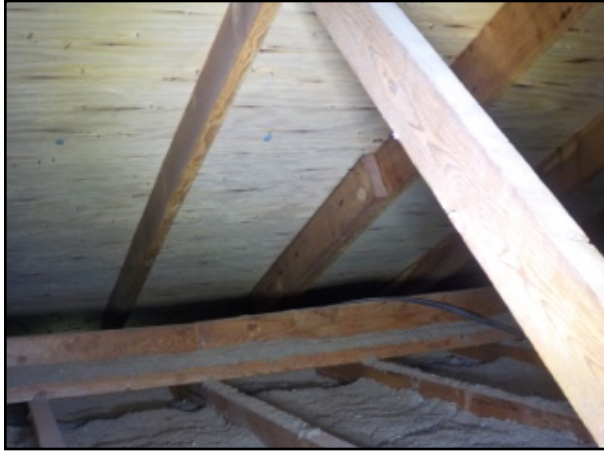
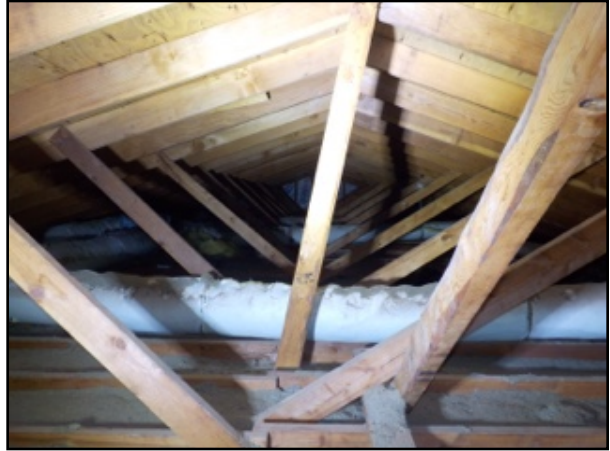
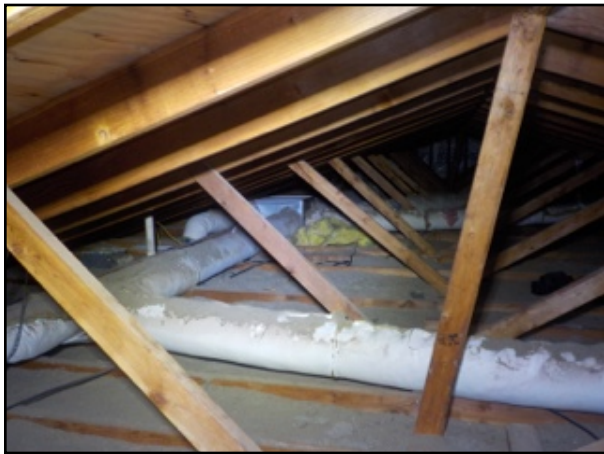
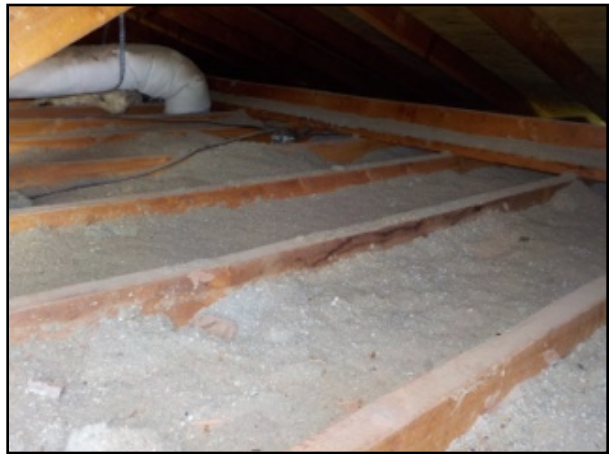
The areas of the attic I could observe from the hatch looked satisfactory. No evidence of moisture intrusion or damaged structural members.
