**AIRCRAFT  
ACCIDENT  
REPORT**  
**Trans World Airlines Flight 800**  
**Part I**  
**Consideration of Reasonable Probable Causes**

**Report on the accident to  
Trans World Airlines Flight 800  
Boeing 747-131, N93119  
Near East Moriches, New York  
July 17, 1996  
by John Barry Smith,  
Independent Aircraft Accident Investigator**

## **Part I: Consideration of Reasonable Probable Causes**

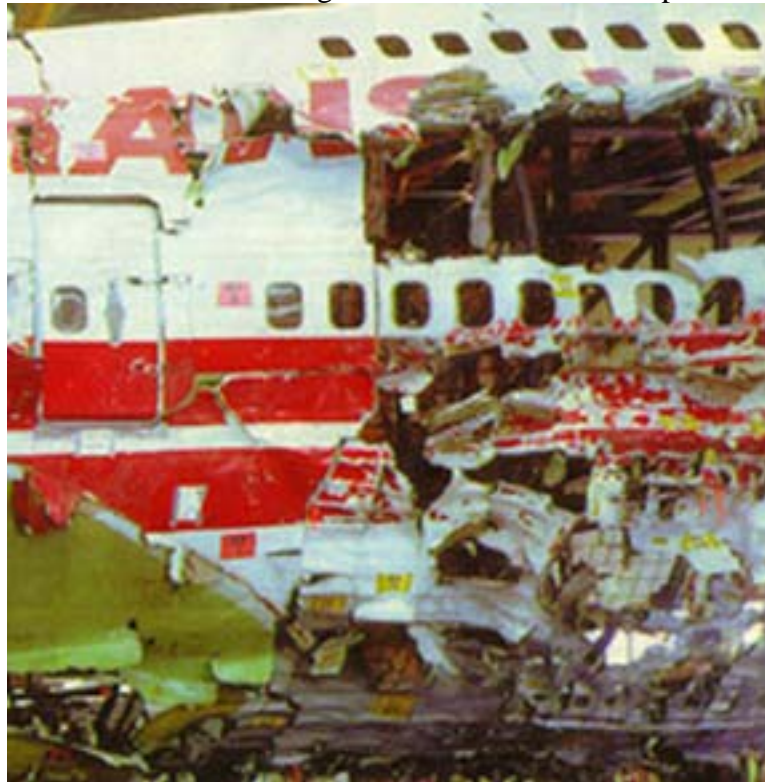
Trans World Airlines Flight 800 below from NTSB public docket and AAR 00/03:

Trans World Airlines Flight 800 photographs show the ruptured, split and shattered forward cargo door.

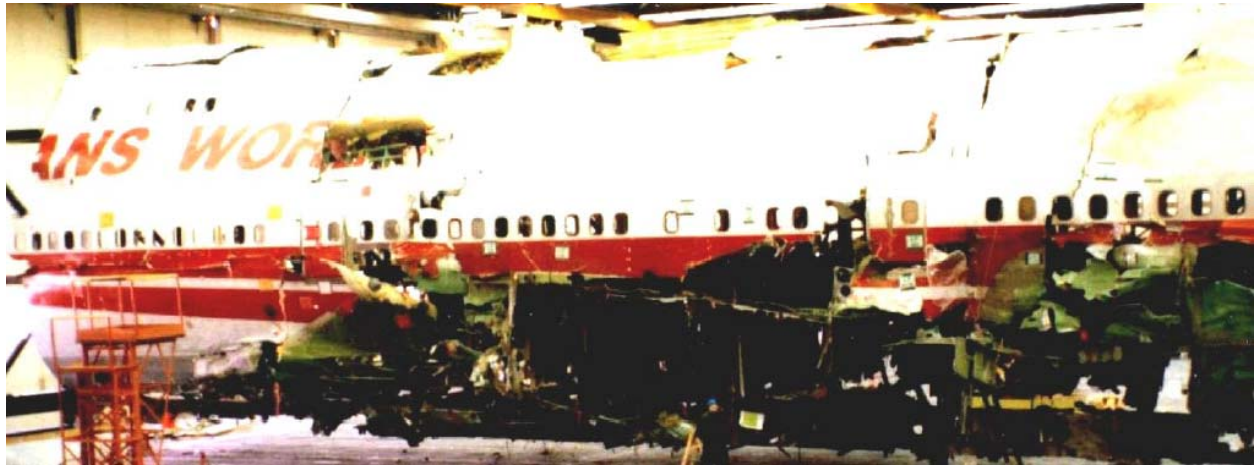
The left side of the plane

Nose to left.

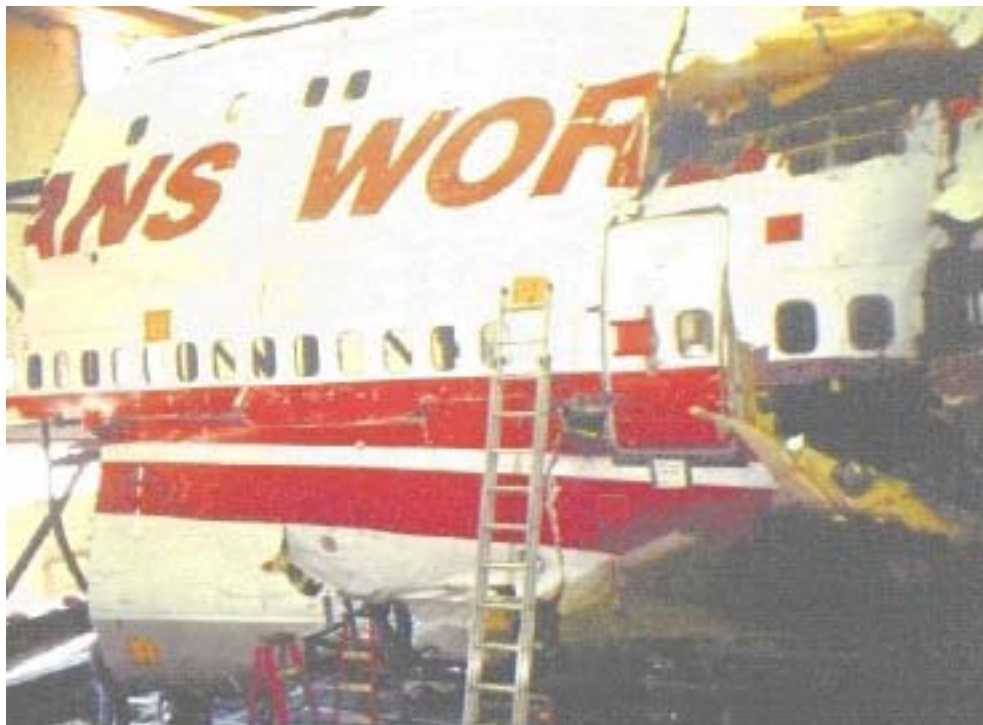
The left front of the reconstruction at LF4

Nose to left.

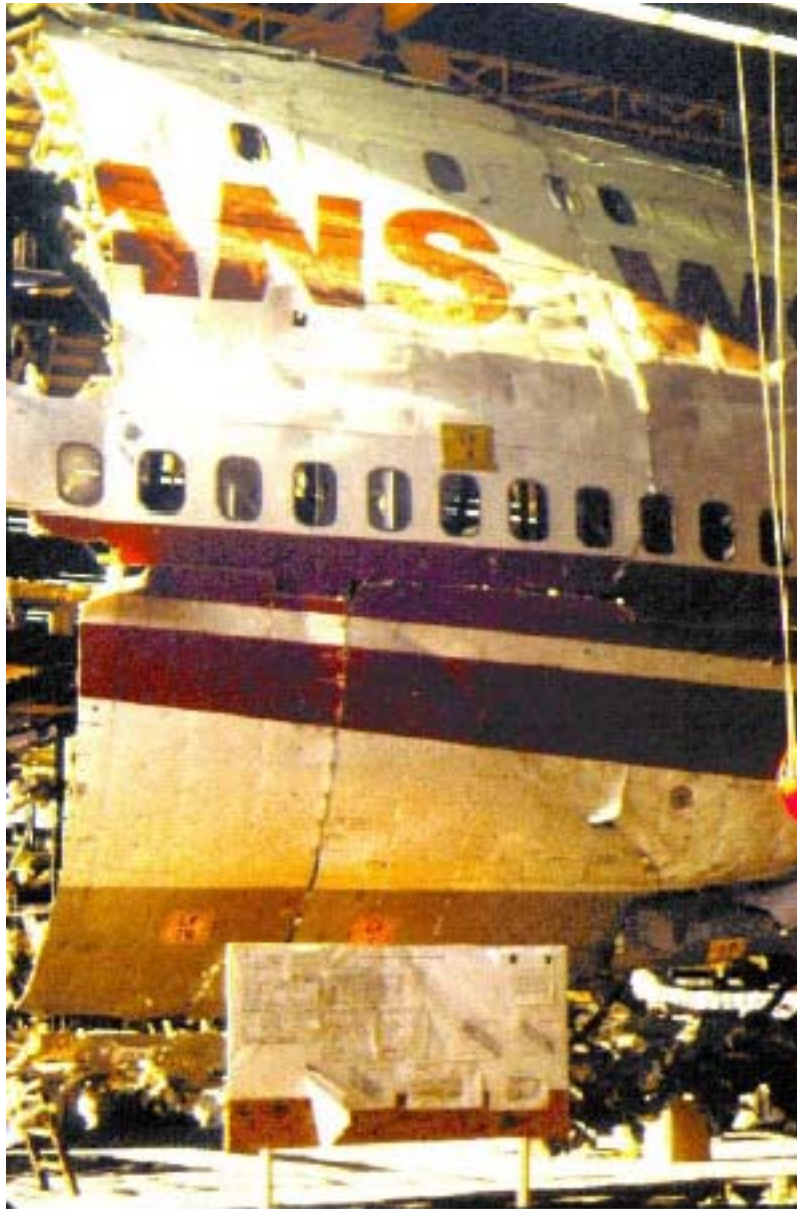
Left front of the plane

Nose to left.

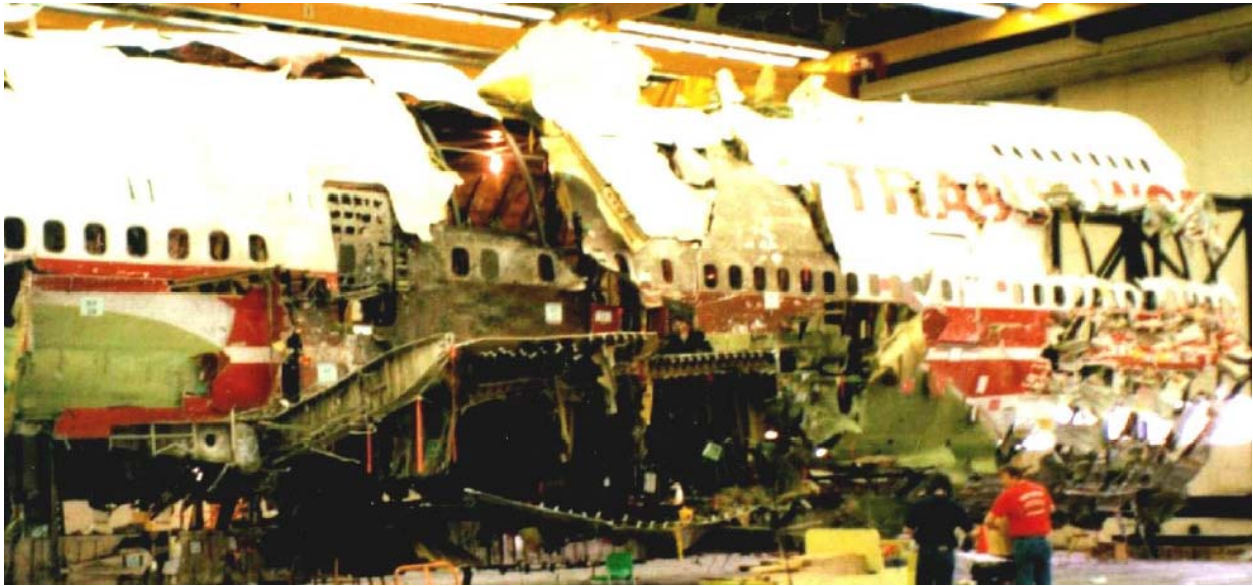
The right side of the plane

Nose to right

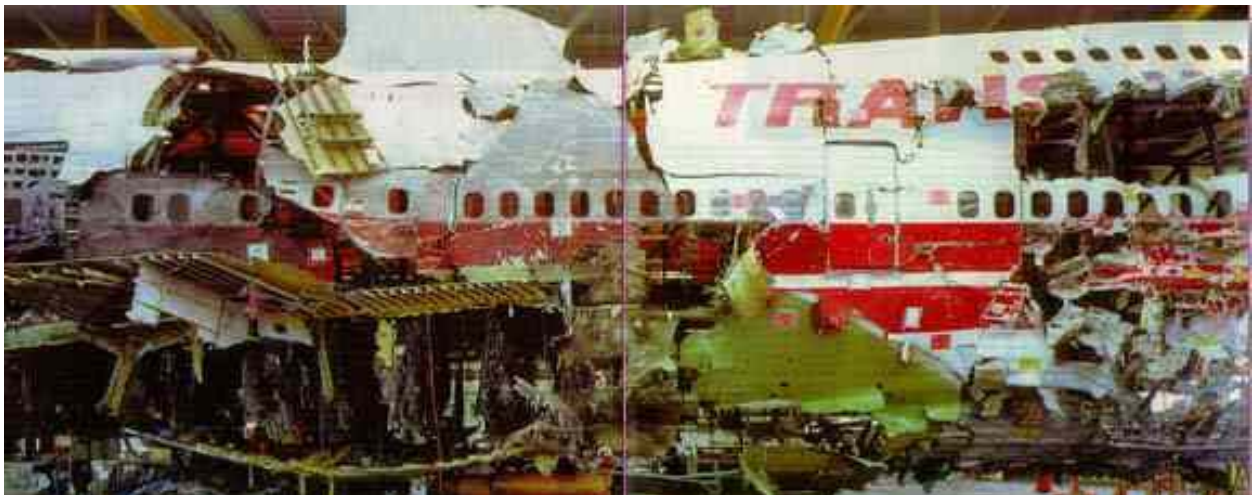
The right side of plane, nose to right.

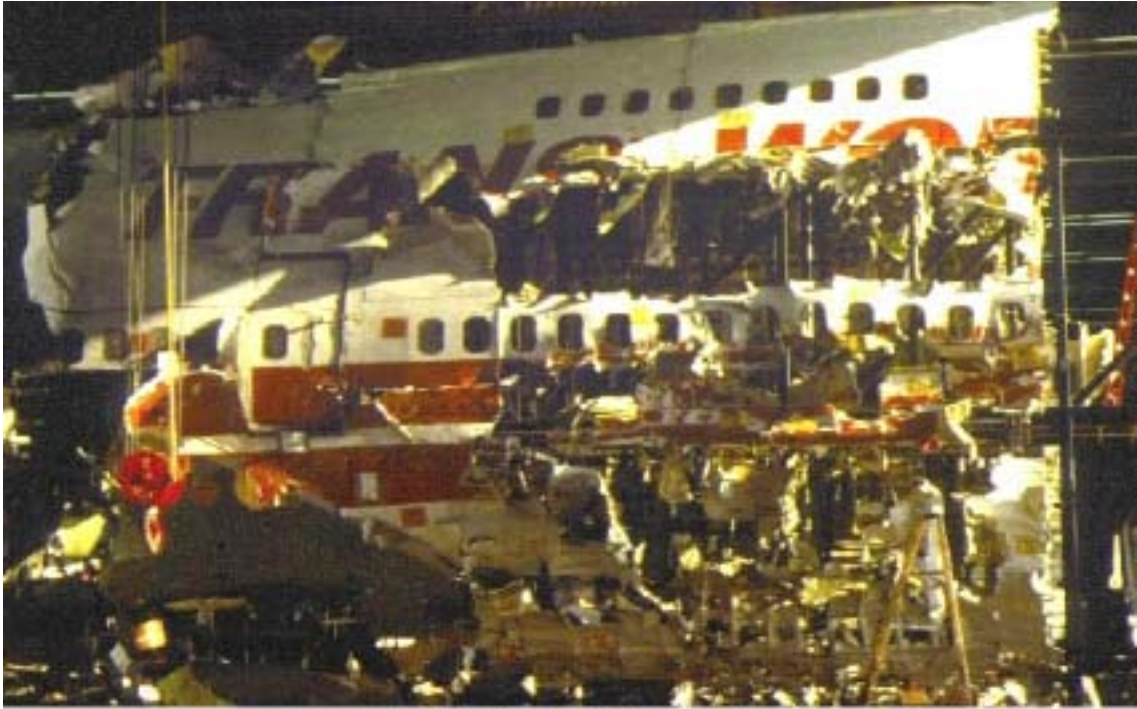
Right front of the plane

Nose to right.

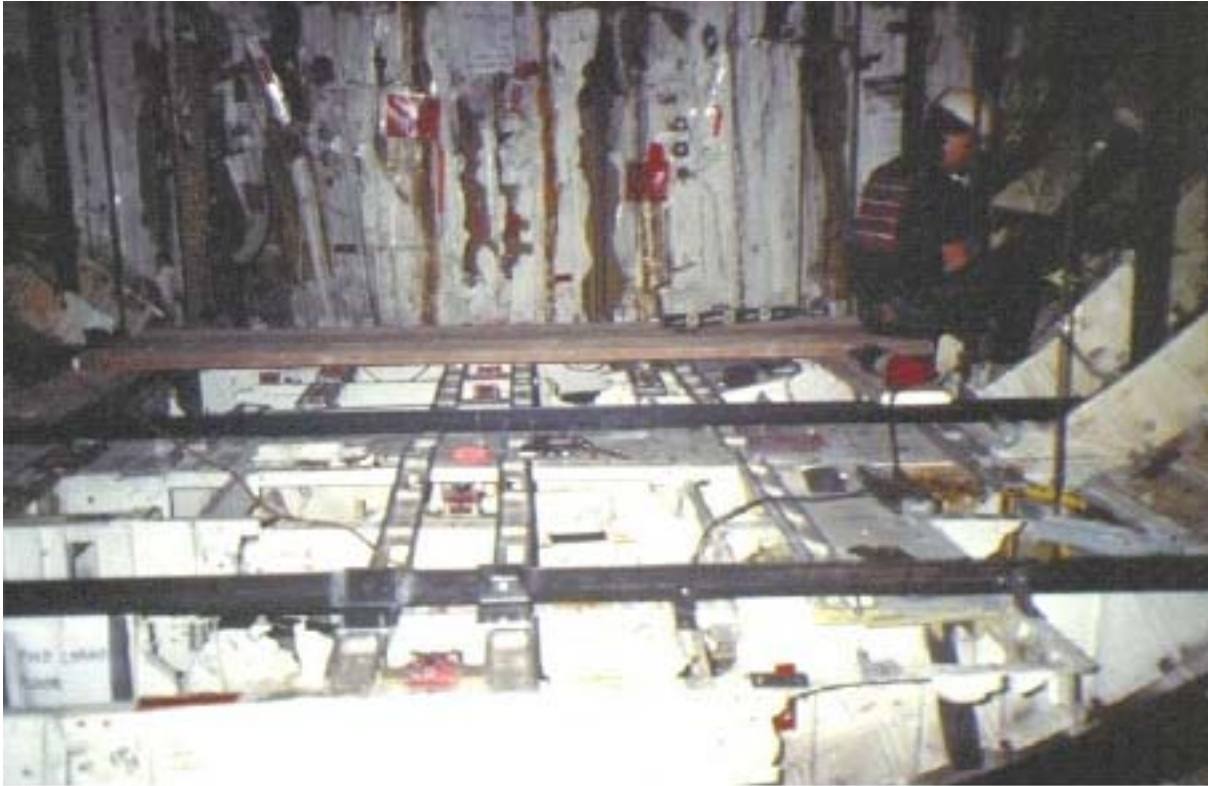
**The front cargo bay area in the red zone**

Red zone is area where pieces departed Trans World Airlines Flight 800 first.

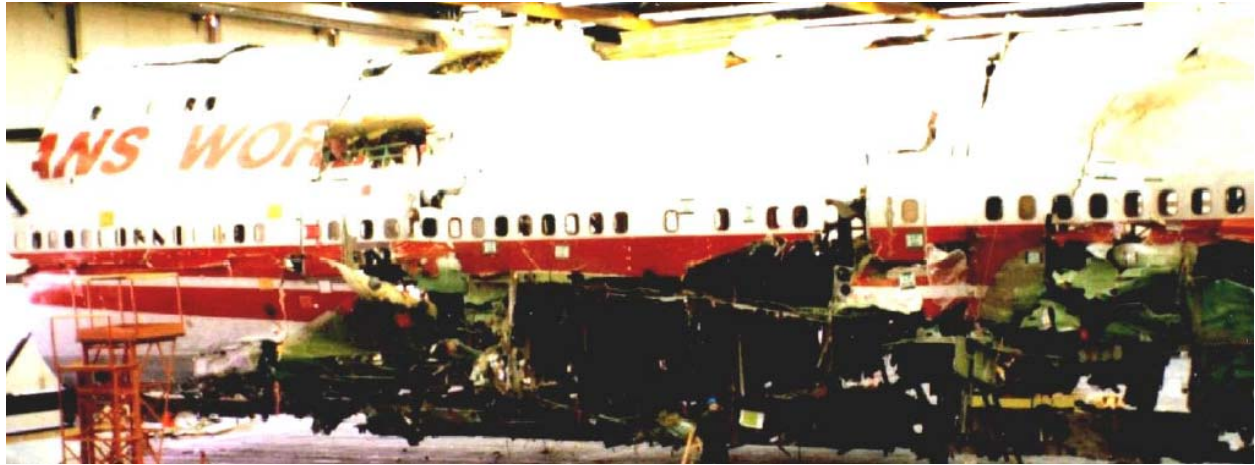
The left side of the plane

Nose to left.

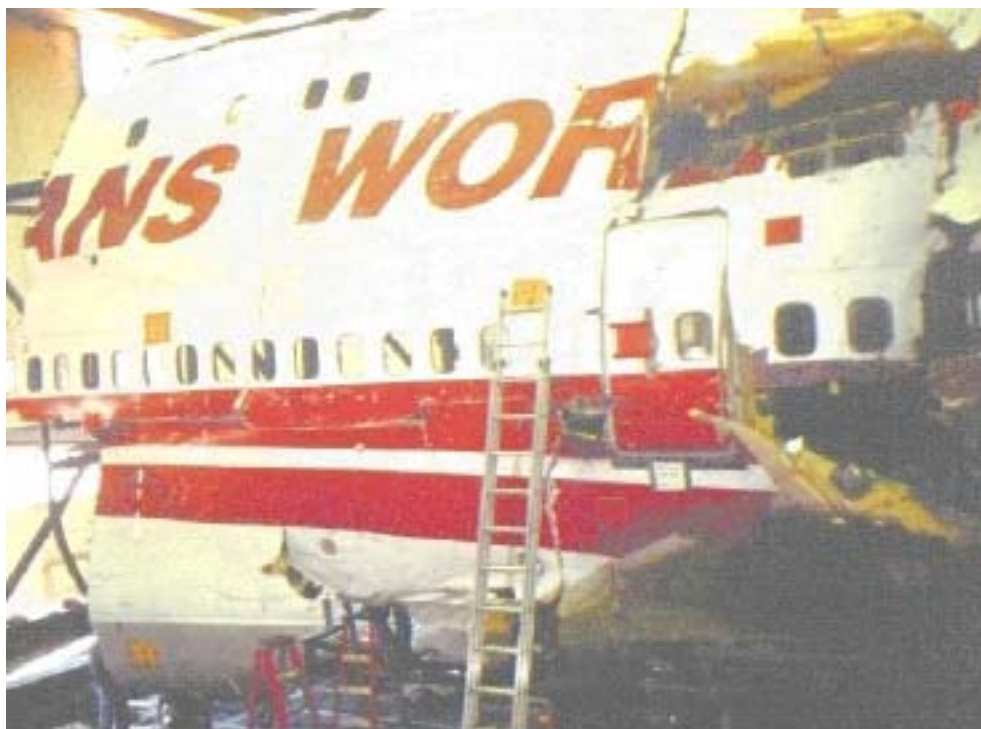
The left front of the reconstruction at LF4

Nose to left.

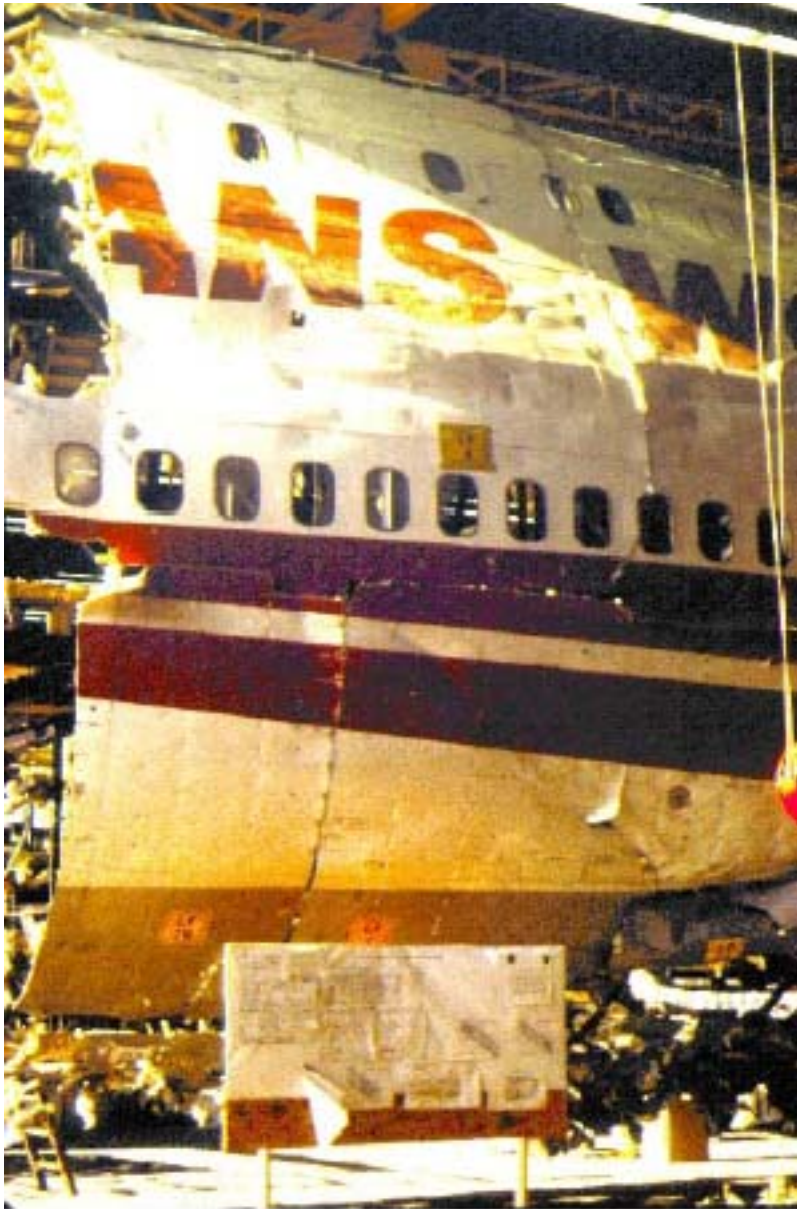
Left front of the plane

Nose to left.

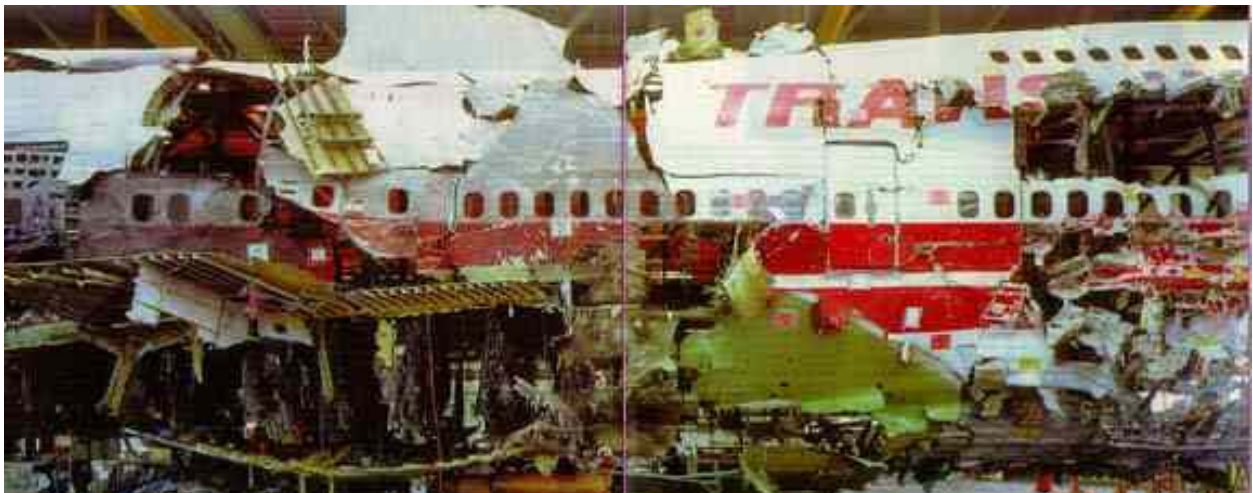
The right side of plane, nose to right.

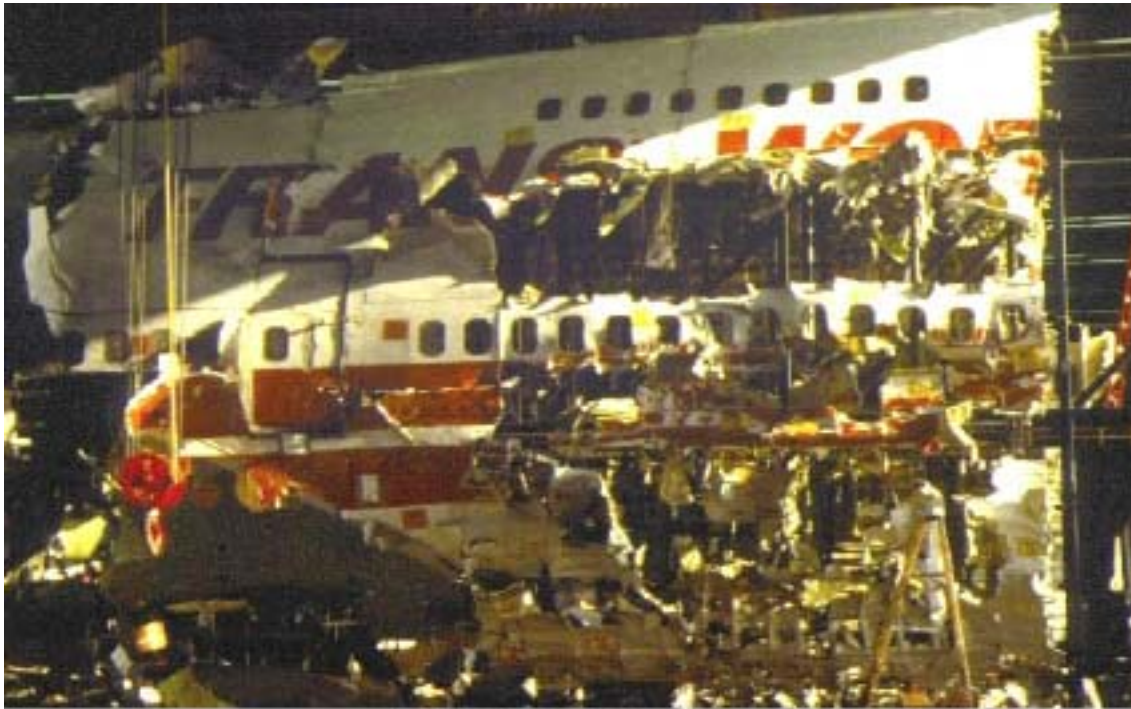
Right front of the plane
