ANDERSON  
PROPERTY  
GROUP,  
INC.

## RESIDENTIAL REPORT

Inspector  
**Arden Anderson**  
InterNACHI# NACHI23050109  
+19862265355  
[arden@theandersonpropertygroup.com](mailto:arden@theandersonpropertygroup.com)

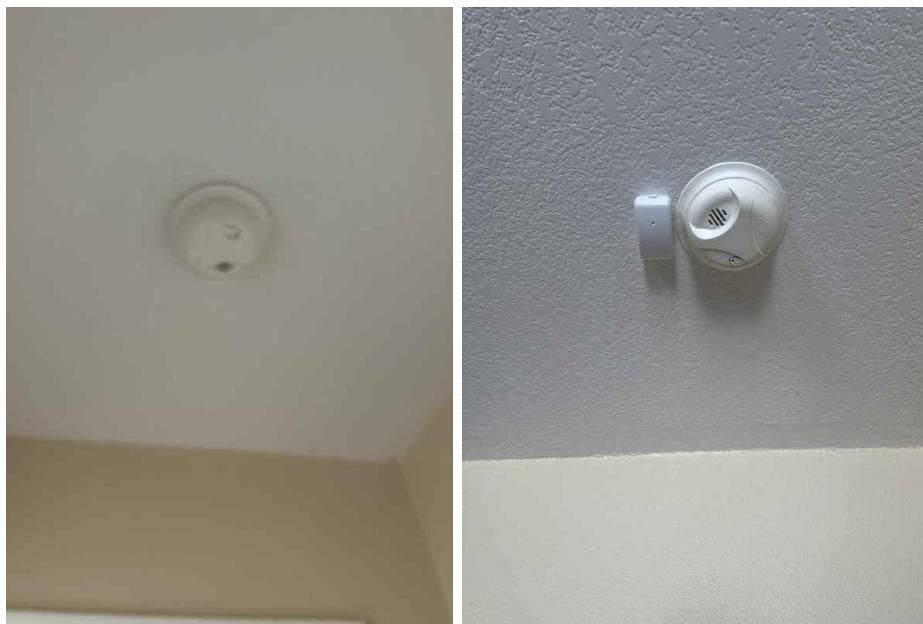
First Alert

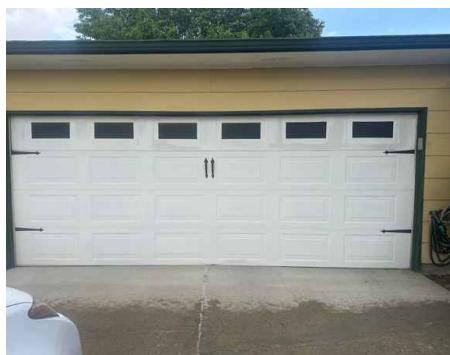
No battery in exterior keypad

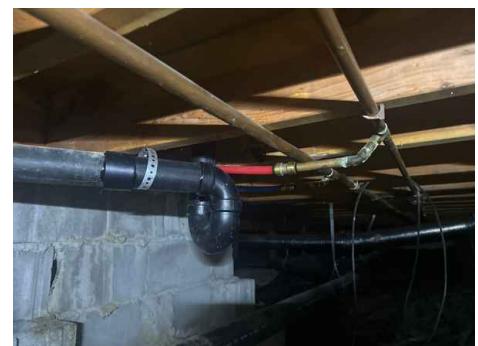
PEX has been added where the master bathroom was remodeled.

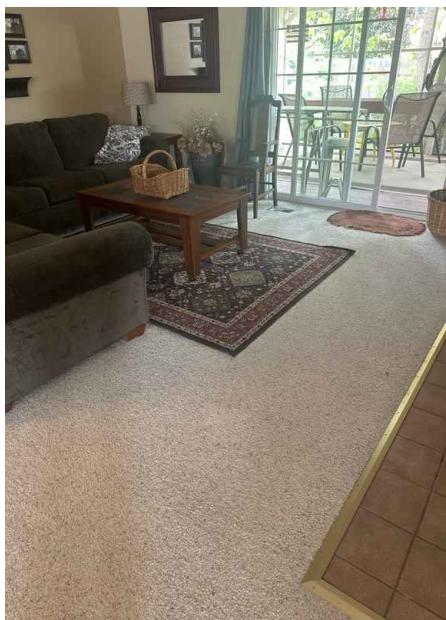
**Living Room: Flooring**  
Carpet

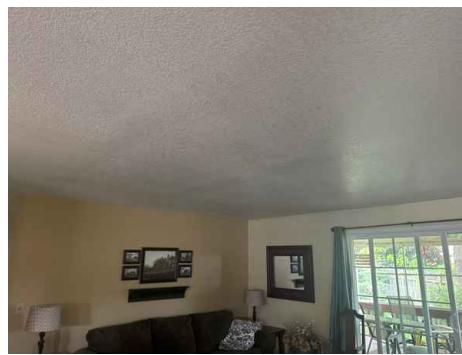
**Living Room: Walls**  
Drywall, Paint

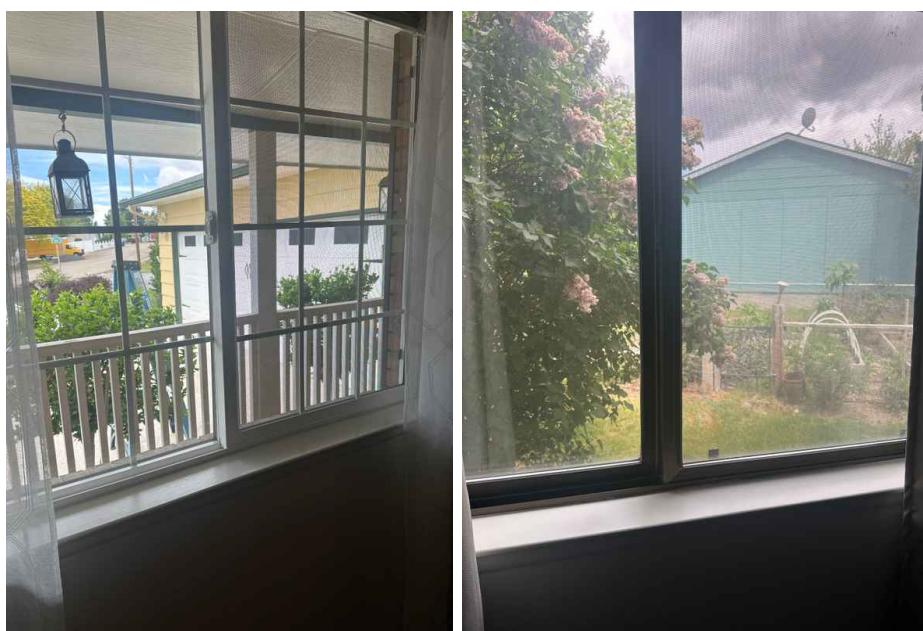
JELD-WEN, Unknown

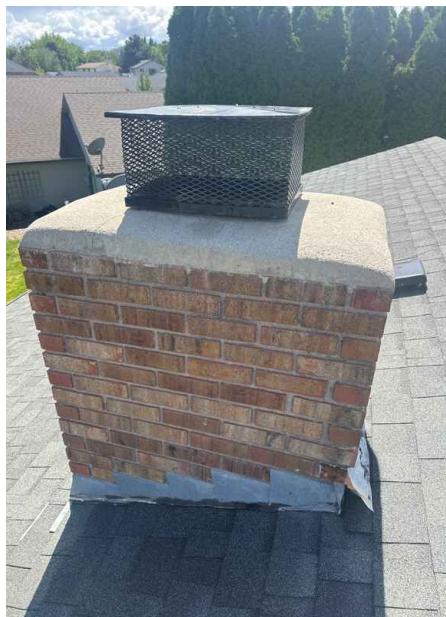
The chimney exterior was inspected during my home inspection.

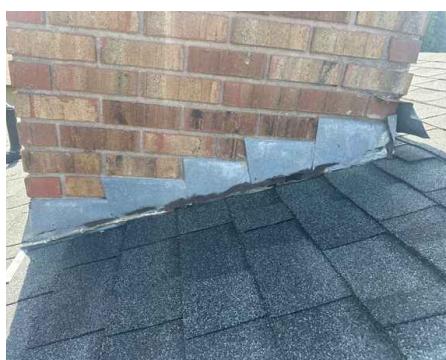
I inspected for flashing installed at the chimney.

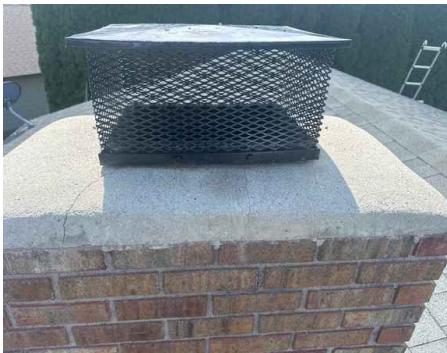
A hood or cap was installed at the masonry chimney. Good.

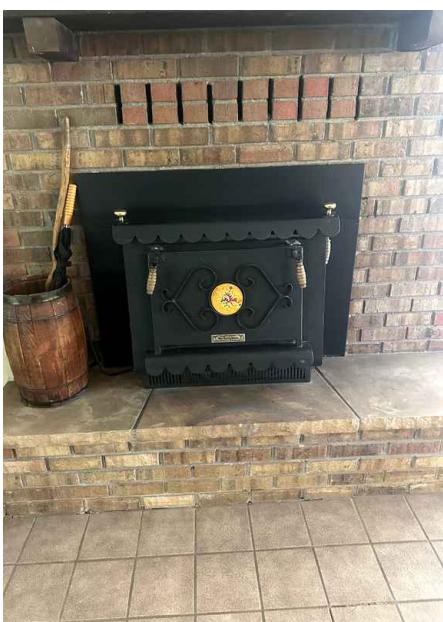
The wood stove was clean and the seal was in good condition.
