**Revised**  
**FULL RESERVE STUDY**  
**Sunset Lakes**  
**Homeowners' Association, Inc.**

**Merritt Island, Florida**  
**Inspected - February 23, 2021**  
**Revised - October 15, 2021**

Sunset Lakes Homeowners' Association, Inc.  
Merritt Island, Florida

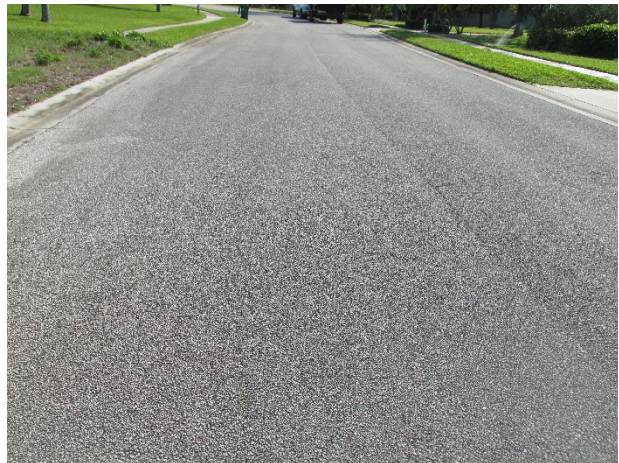
**Asphalt pavement on Tradewinds Trail**

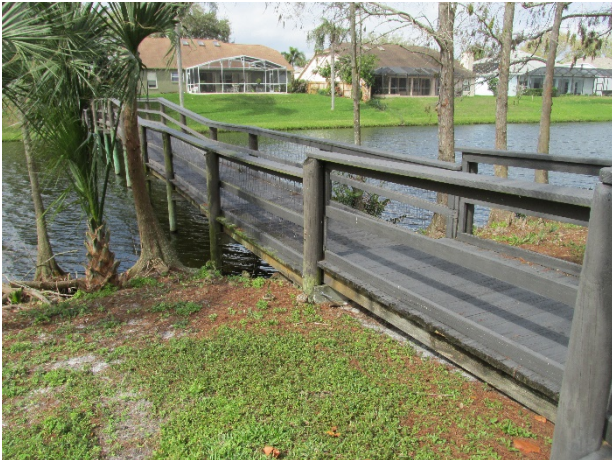
**Condition:** Fair to poor overall condition with deterioration of railing components and wood deterioration evident.

**Bridge overview**

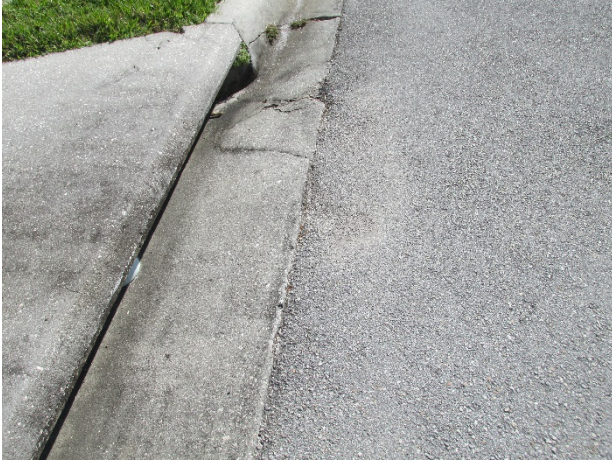
**Catch basin with settlement evident on Sunflower Court**

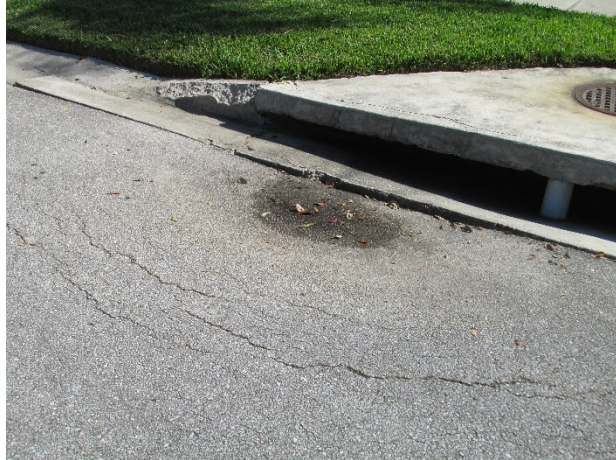
**Catch basin with settlement evident on Killarney Court**

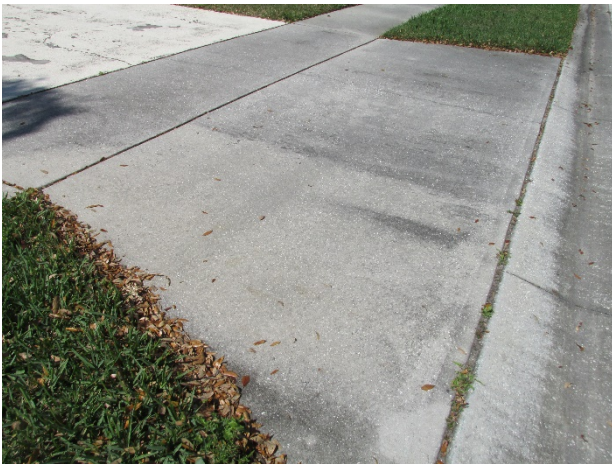
**Condition:** Good overall with minor cracks evident

**Concrete apron**

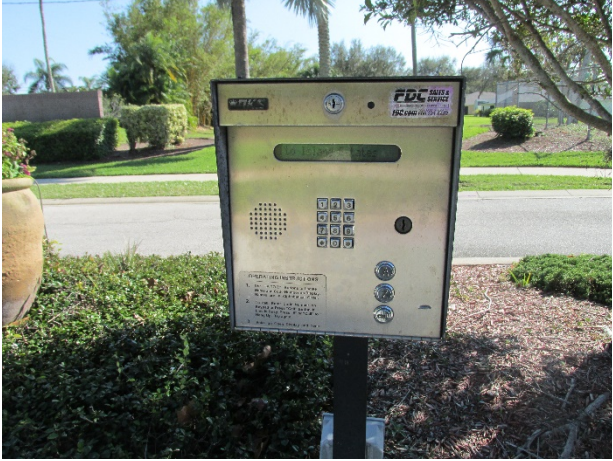
**Condition:** Reported unsatisfactory overall

**Intercom panel at Island Estates gate**

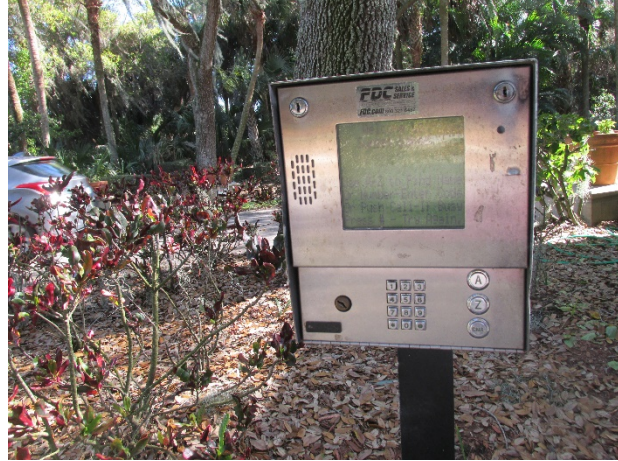
**Intercom panel at main gate**

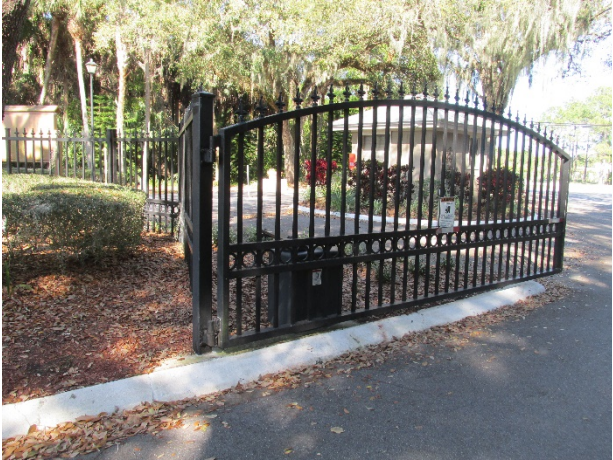
**Condition:** The gates are in satisfactory condition overall with some finish deterioration and damage evident. The gate operators are reported in unsatisfactory condition with a history of ongoing repairs.

**Gate and operator at main gate**

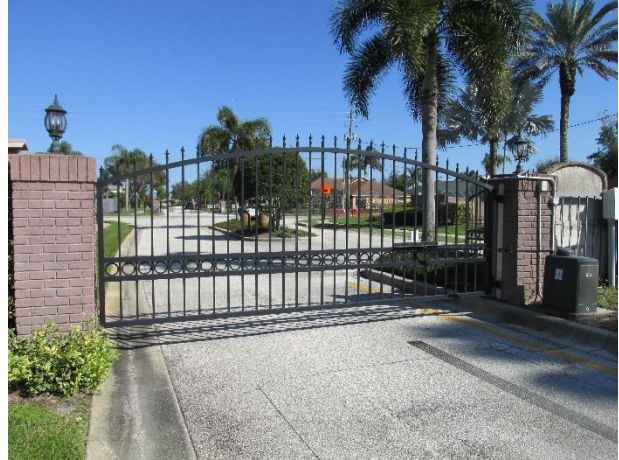
**Gate and operator at Island Estates**

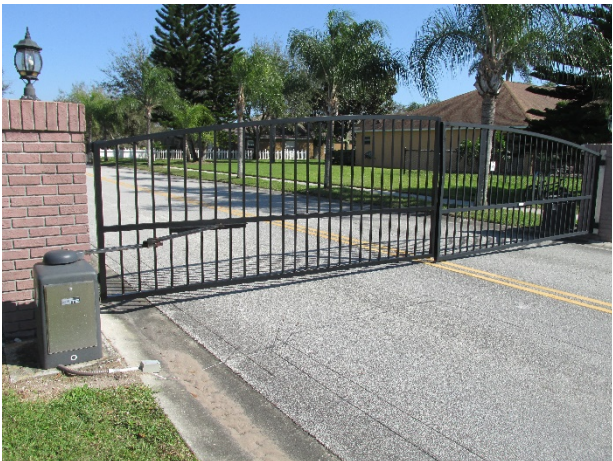
**Gates and operators at rear gate**

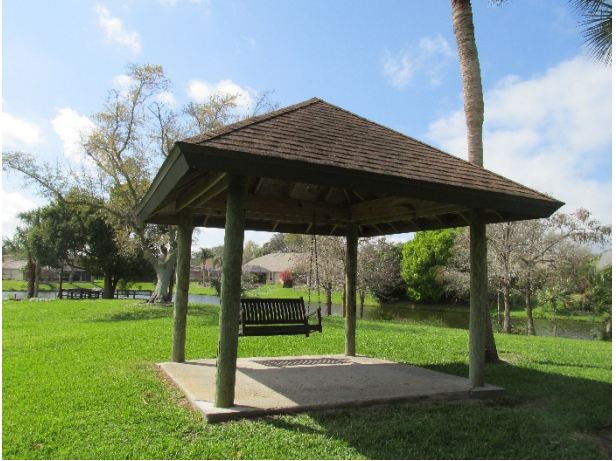
**Condition:** Fair overall with cracks evident at bases of posts

**Pavilion overview**

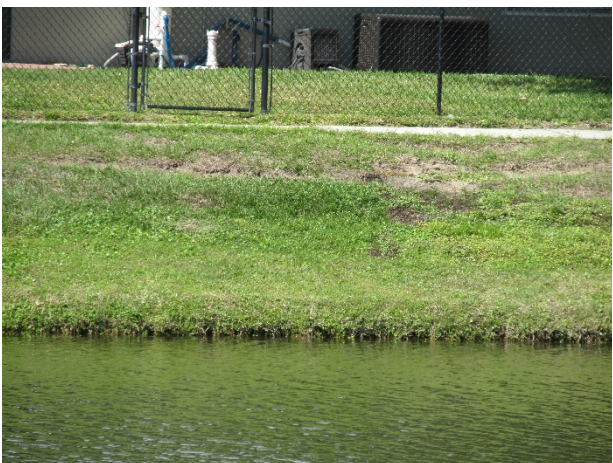
**Condition:** Good overall condition with isolated soil erosion evident

**Pond shorelines with isolated erosion**

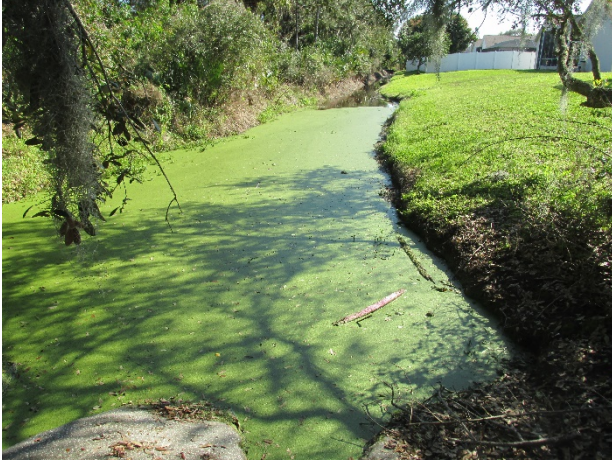
**Canal at east perimeter of property**

**Expenditure Detail Notes:** Expenditure timing and costs are depicted in the **Reserve Expenditures** table in Section 3. We recommend the Association plan to install or augment a combination of plantings and geotubes around the ponds along 2,045 linear feet, or approximately eight percent (8%), of the shorelines per event.

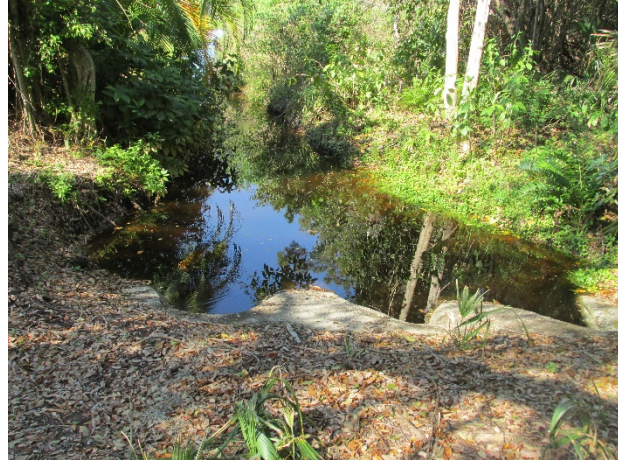
**Canal at east perimeter of property**

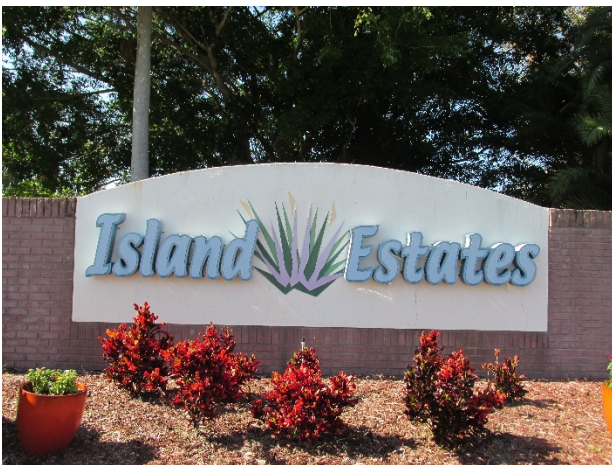
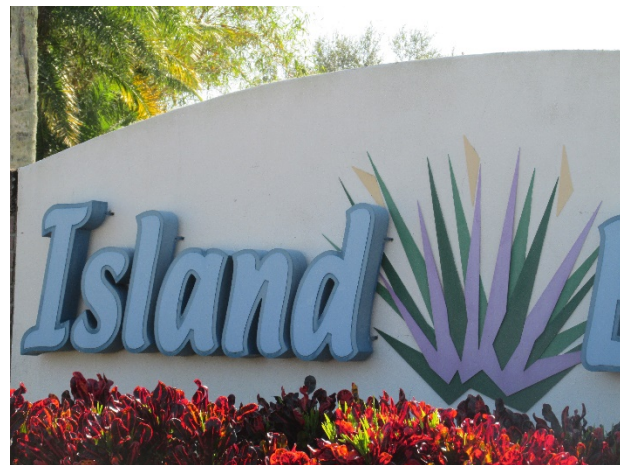
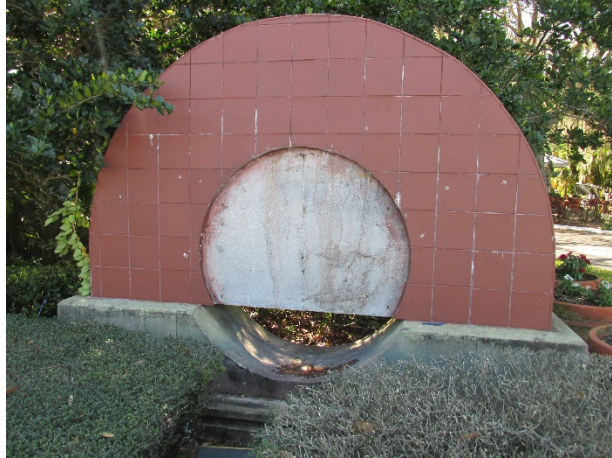
**Condition:** Good overall

Signage

**Signage**

**Expenditure Detail Notes:** Expenditure timing and costs are depicted in the **Reserve Expenditures** table in Section 3. Our cost for renovation includes repointing and repairs to the masonry and replacement of the remaining components listed above. We include a 2021 partial expenditure to replace the missing components on the main entrance sign. Future updates can incorporate the exact materials used.

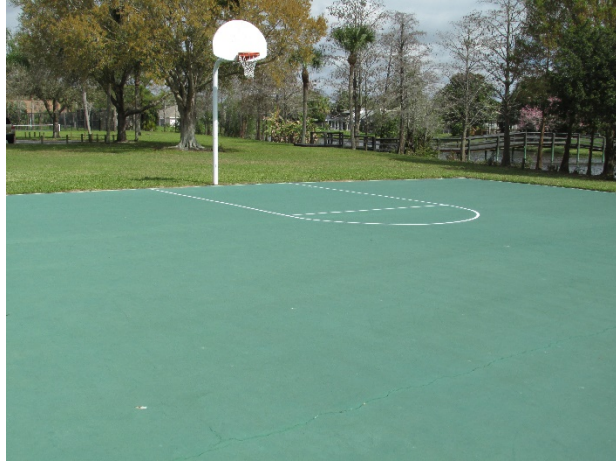
**Condition:** The tennis court is in poor overall condition and the basketball court is in good to fair overall condition.

Basketball court overview

**Component Detail Notes:** Prior to the application of the color coat, the Association should require the contractor to rout and fill all cracks with hot emulsion. This deters water infiltration and further deterioration of the asphalt playing surface.

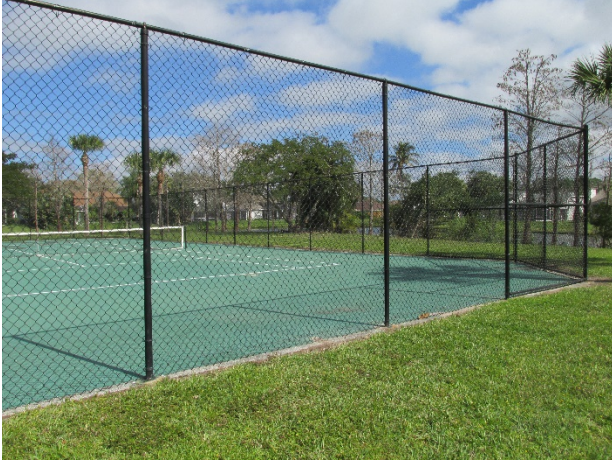
**Condition:** Good overall

**Tennis court fence**
