SUMMARY

This Summary outlines potentially significant issues from a cost or safety standpoint. This section is provided as a courtesy and cannot be considered a substitute for reading the entire report. Please read the complete document.

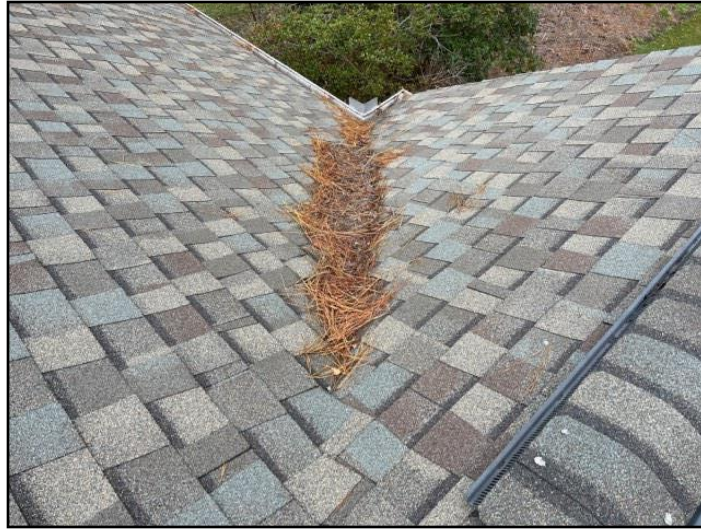
Observed leaves and debris at several valleys on roof. Recommend cleaning.

16. *Debris/moss*

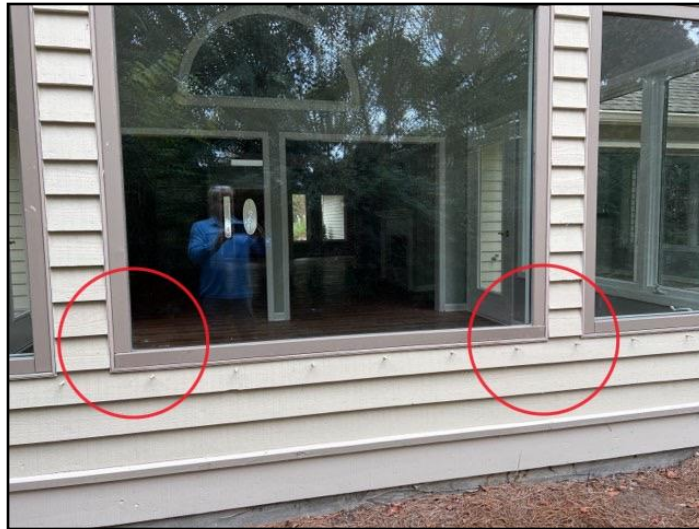
39. Rear window at sunroom

Observed loose metal trim on rear glass window. Observed wood deteriorated behind metal trim on both sides of window. Observed no moisture on the interior side of window. Recommend further evaluation repair.

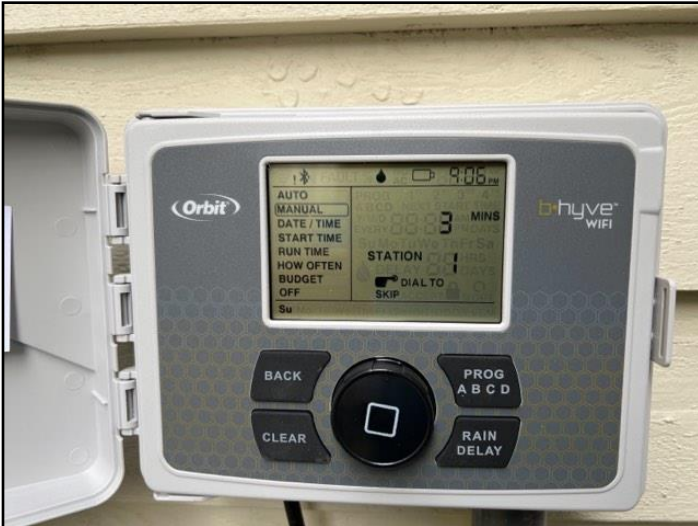
48. Panel not operating.

Task: Request disclosure Further evaluation

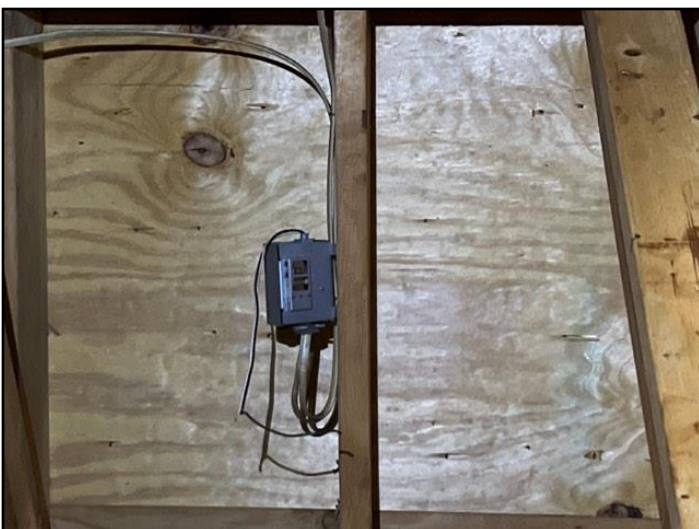
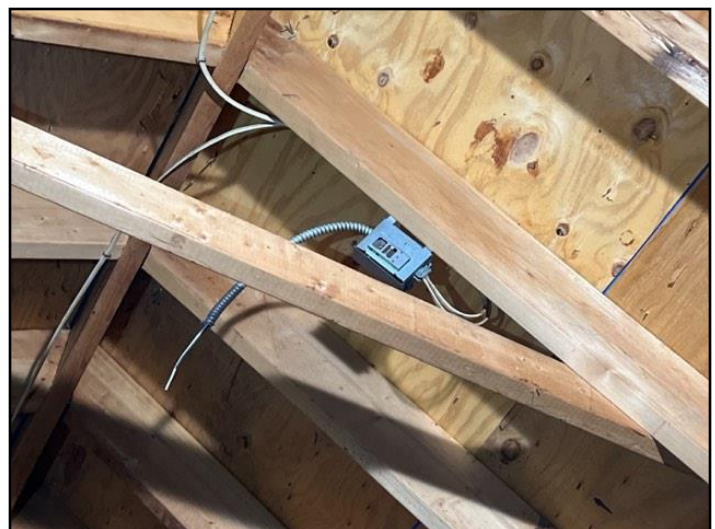
23. Condition: • Exposed on walls or ceilings

Observed two electrical junction boxes attached to the roof rafters with exposed wires at top ridge on left and right side of attic. Possibly went to an old mechanical attic fan that is no longer present. Observed new plywood sheathing at those locations. Unable to reach junction boxes to test if wires are live. Recommend further evaluation and request disclosure of repair.

80. Exposed wires in attic

81. Exposed wires at junction box, attic

Task: Further evaluation Improve

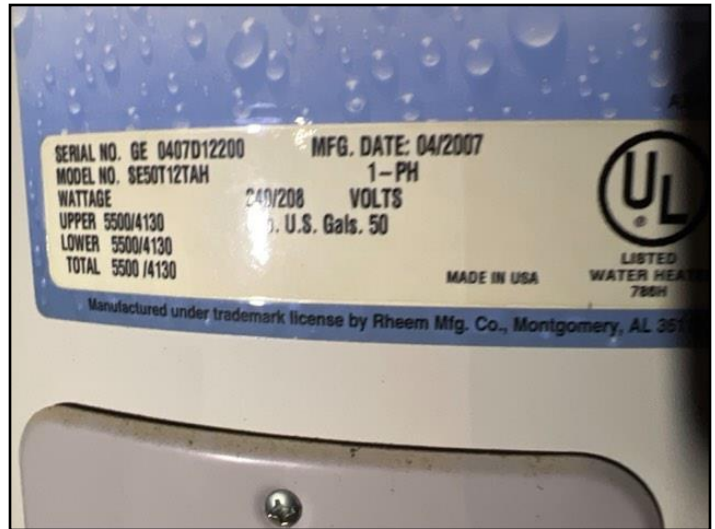
127. 50 Gal / 2007'

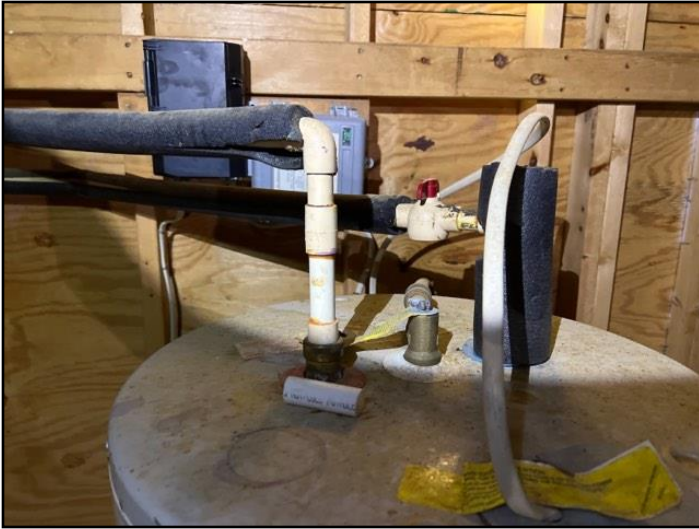
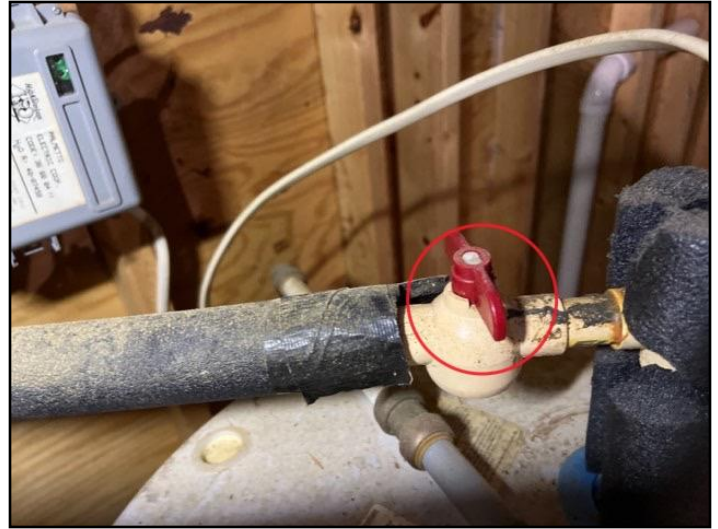
128. Plumbing on top of water heater

129. Water valve turned off

Observed water valve shut off at GE water heater in attic over laundry area. No hot water present.

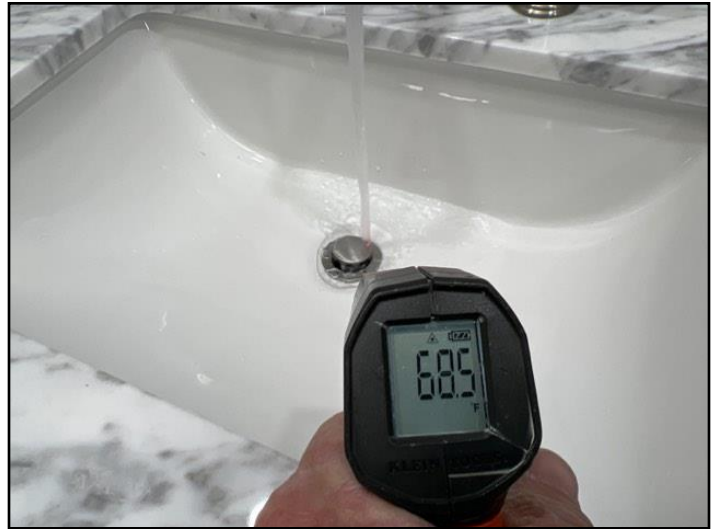
Observed no hot water at all three faucets in bathrooms and at kitchen sink. Water valve turned off at GE water heater.

135. Less than 100° F

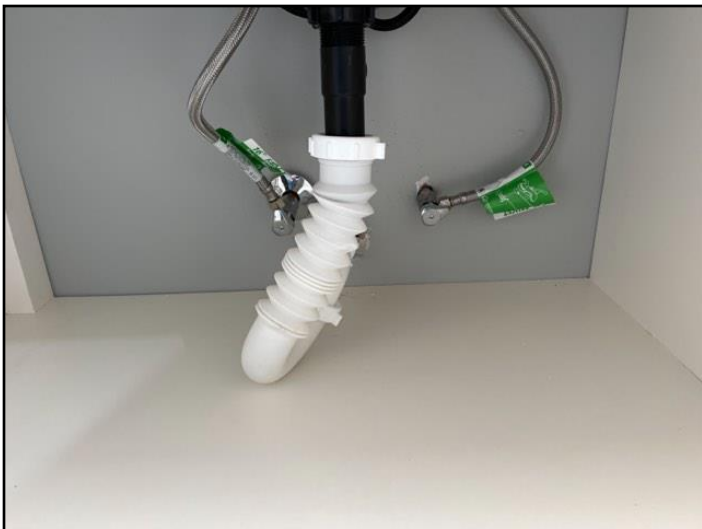
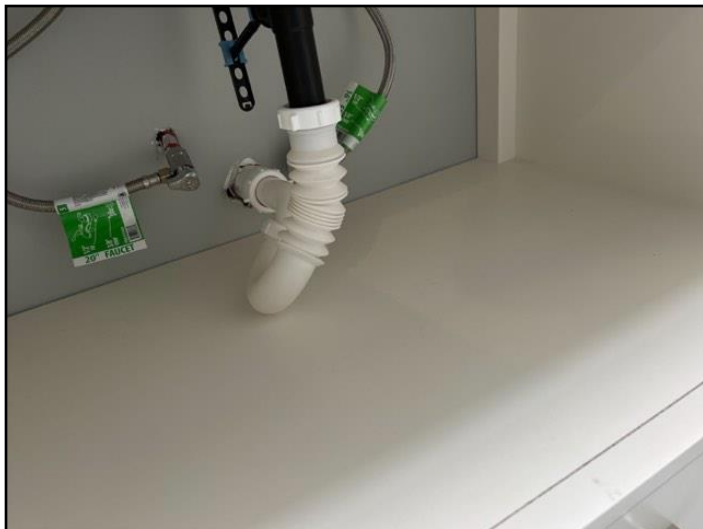
42. Condition: • Accordion type drain... This accordion type drain lines do not have a smooth interior surface and are subject to poor drainage conditions called 'fouling' due to possible blockage and/or sagging along the flexible ribbing. Recommend that a qualified plumbing contractor replace the flexible accordion type drain line with standard plumbing components with a smooth interior surface.

.....Observed flexible accordion type waste plumbing at P-traps below both sinks in primary bathroom and under sink in middle bathroom. No leaks present. Recommend replacing.

146. Flexible accordion waste piping

147. Flexible accordion waste piping

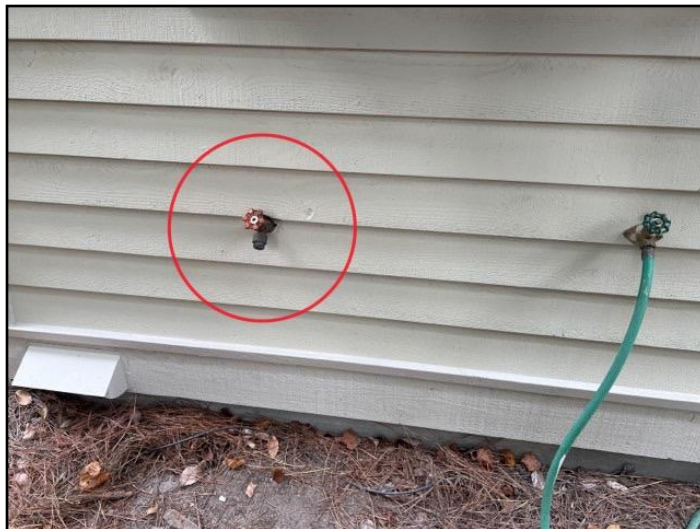
43. Condition: • Inoperative

149. Inoperative hose bibb.

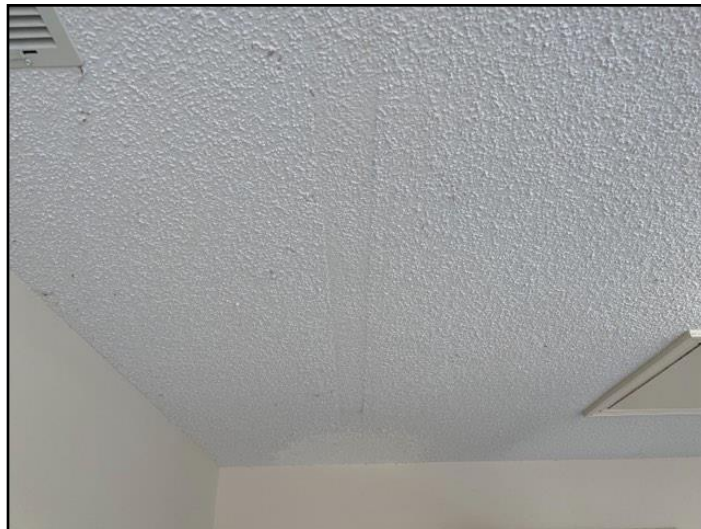
Observed several patched areas on drywall ceiling in the garage. No moisture present when tested. Recommend disclosure of repair

169. Patched ceiling
