40 Sailmaster Com, Hilton Head Island, SC June 26, 2021

Report No. 1011, v.3

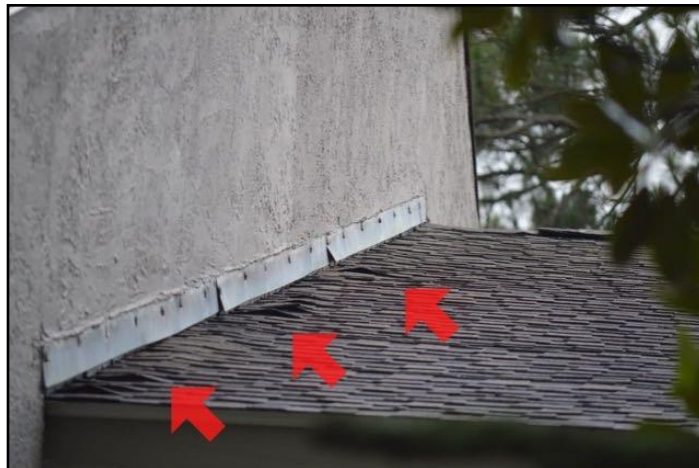
Condition: • [Cupping, curling, clawing](#)

Implication(s): Chance of water damage to structure, finishes and contents

1. Bowing uplift of shingles

Task: Further evaluation

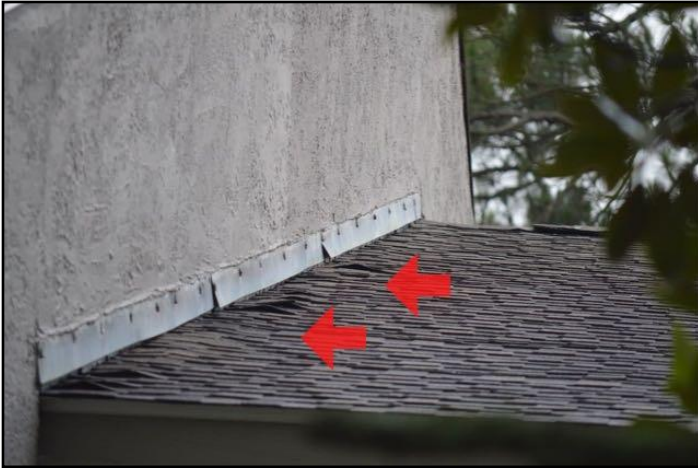
2. Damage, loose, open seams, patched

Recommend Licensed Roofer further evaluation Potential Water Intrusion.

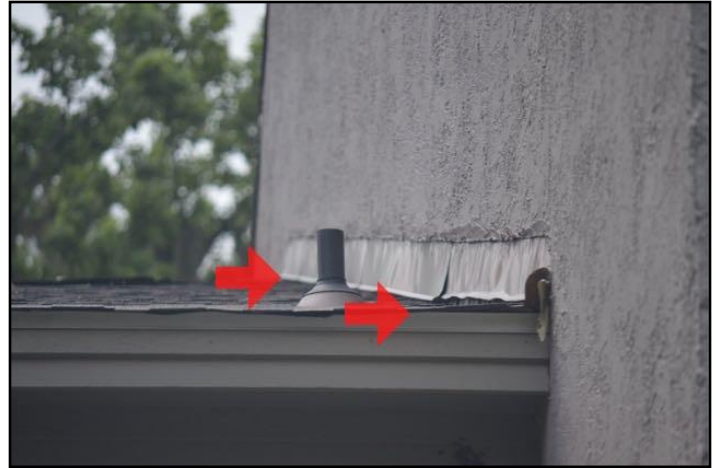
3. Open Loose Flashing

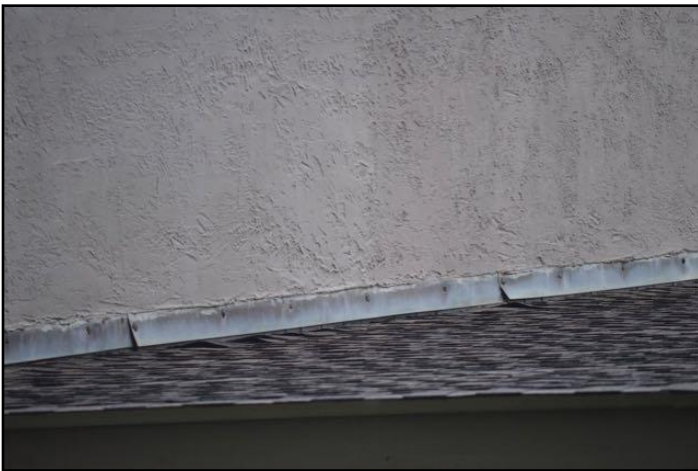
4. Open, loose seams

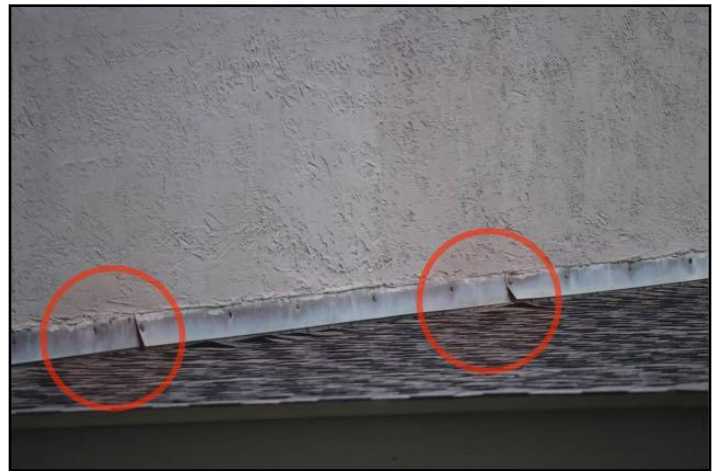
5. Open, loose seams Flashing

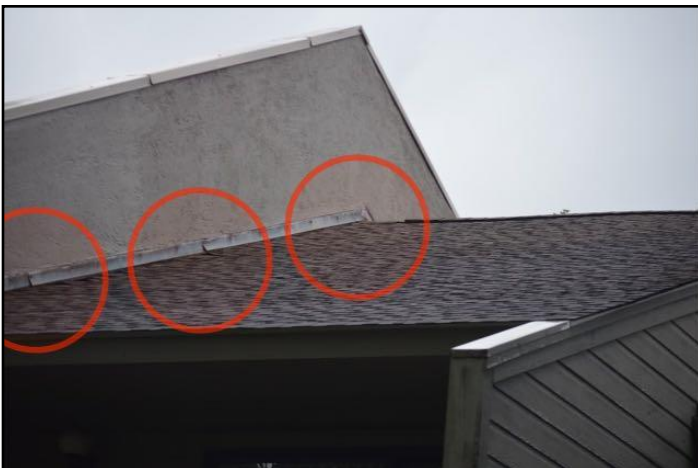
6. Open, loose seams Flashing

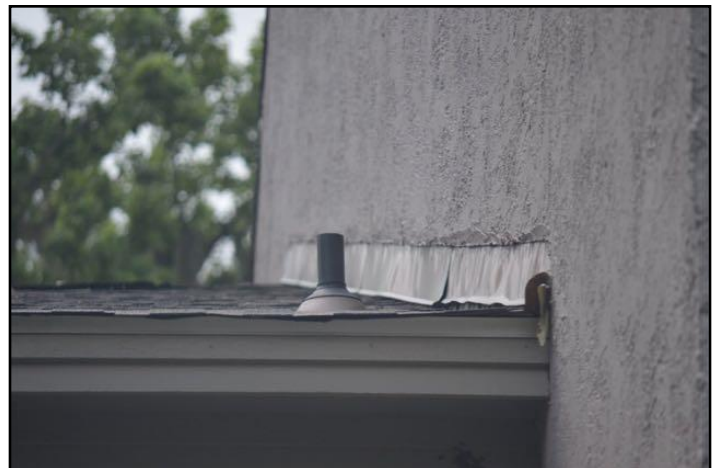
7. Loose open Seams Flashing

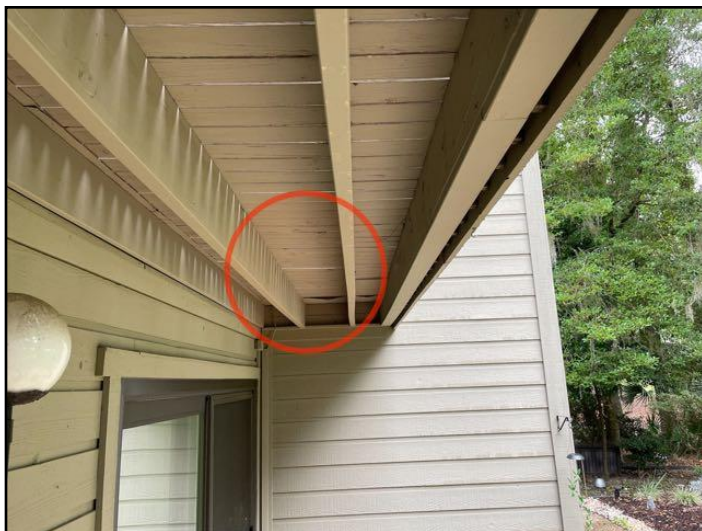
13. Sag Under Balcony

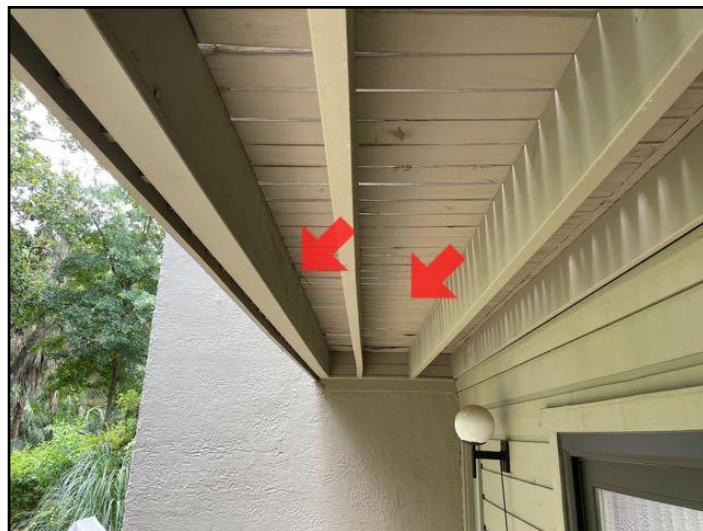
14. Sag Under Balcony

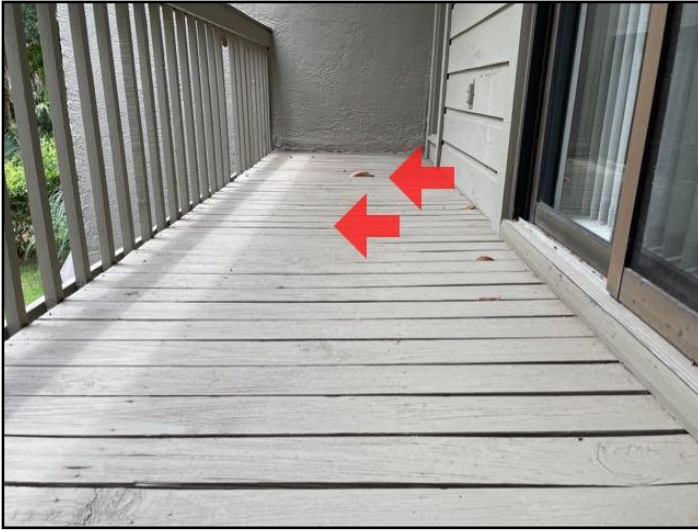
15. Sag, Top of Balcony

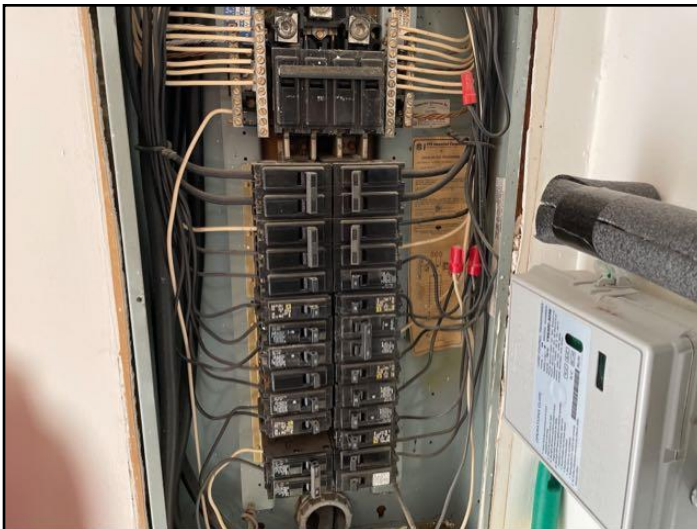
25. Wire nuts used in Panel

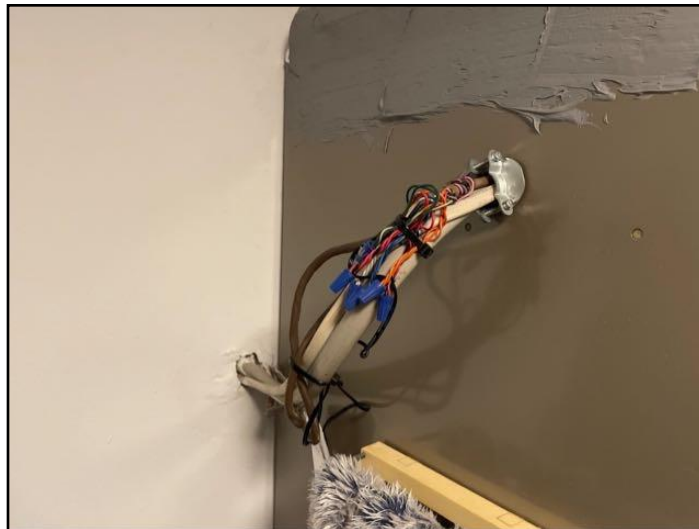
Condition: • [Open splices](#)

Wiring for Air Handler needs an enclosed junction box. Recommend qualified Electrician for further evaluation.

Implication(s): Fire hazard | Electric shock

28. Open Splices Air Handler

Task: Further evaluation

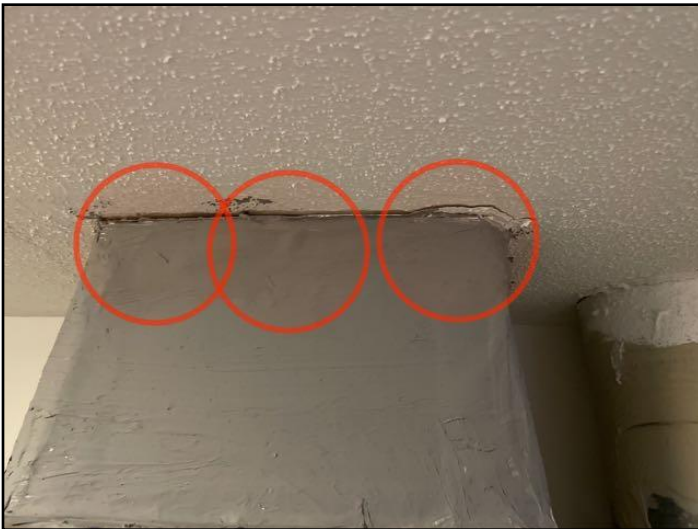
Condition: • Loose/Missing Tape

29. Loose/Missing Tape

Task: Repair and Improve

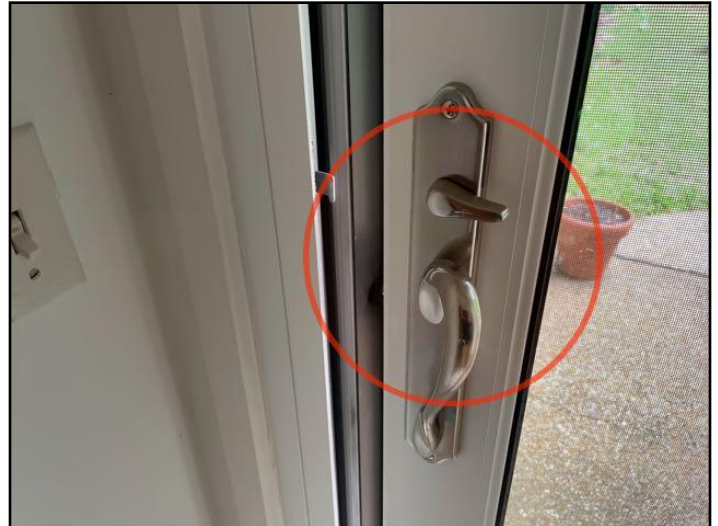
Lock on rear slider difficult to operate and lock. Recommend improvement. Safety and Security Issue

35. Lock not effective on exterior door

Task: Improve / repair

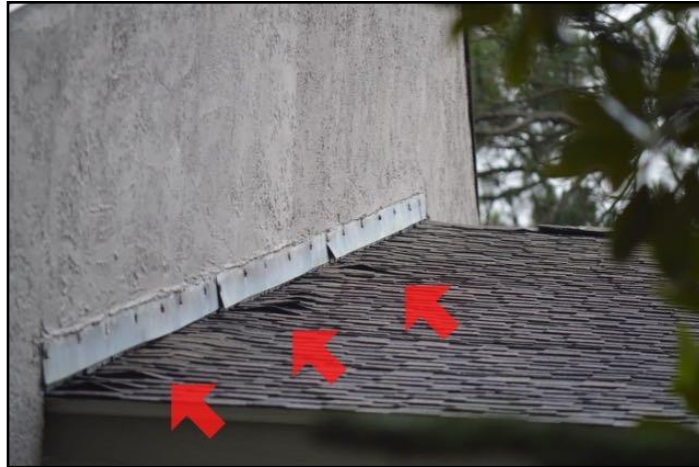
1. **Condition:** • [Cupping, curling, clawing](#)

Implication(s): Chance of water damage to structure, finishes and contents

43. Bowing uplift of shingles

Task: Further evaluation

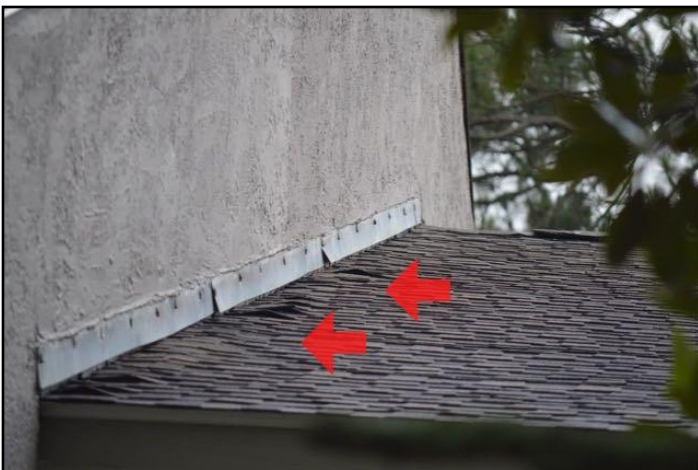
2. **Condition:** • [Damage, loose, open seams, patched](#)

Recommend Licensed Roofer further evaluation Potential Water Intrusion.

44. Damage, loose, open seams, patched

Task: Further evaluation

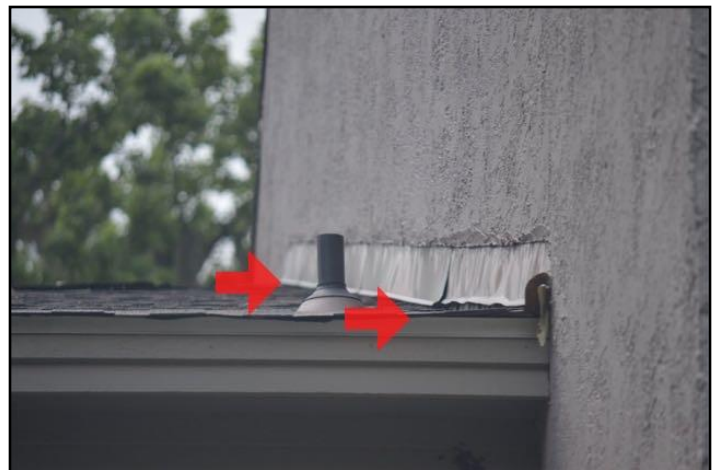
45. Open Loose Flashing

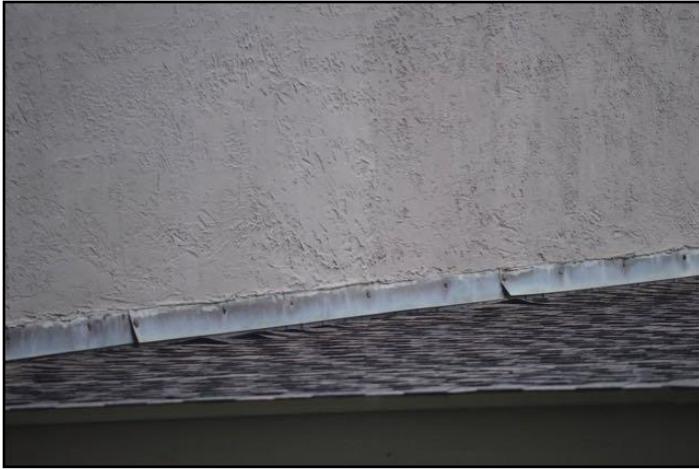
46. Open, loose seams

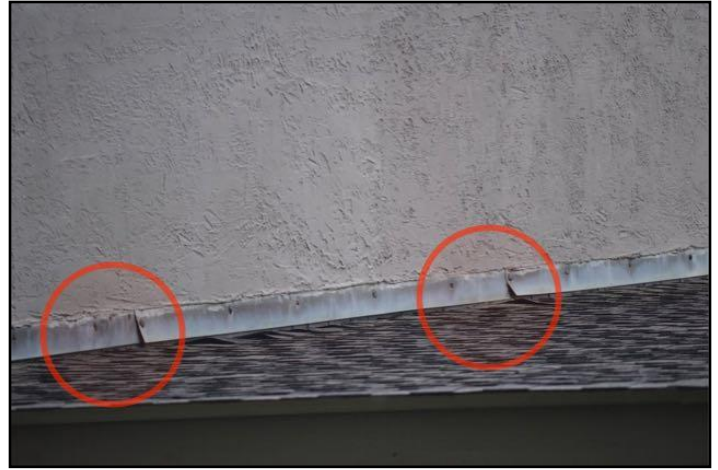
47. Open, loose seams Flashing

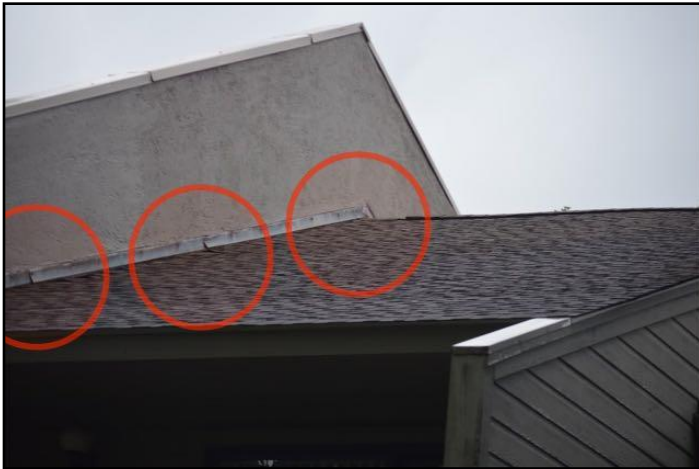
48. Open, loose seams Flashing

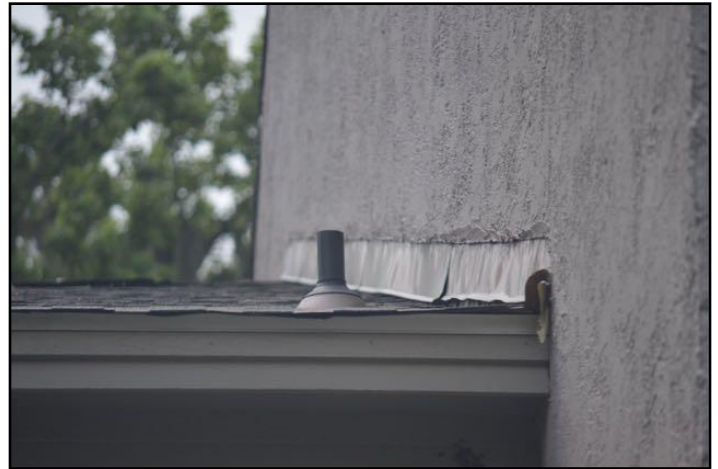
49. Loose open Seams Flashing

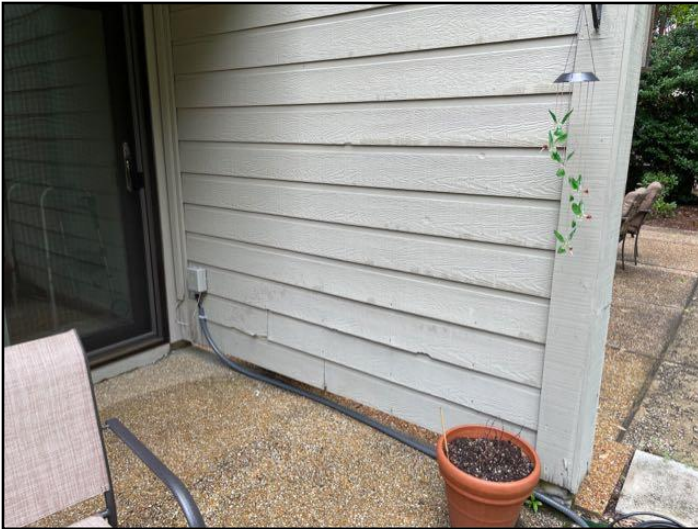
4. Condition: • [Loose or missing pieces](#)

Implication(s): Chance of water damage to structure, finishes and contents

51. Loose or missing pieces

Task: Further evaluation

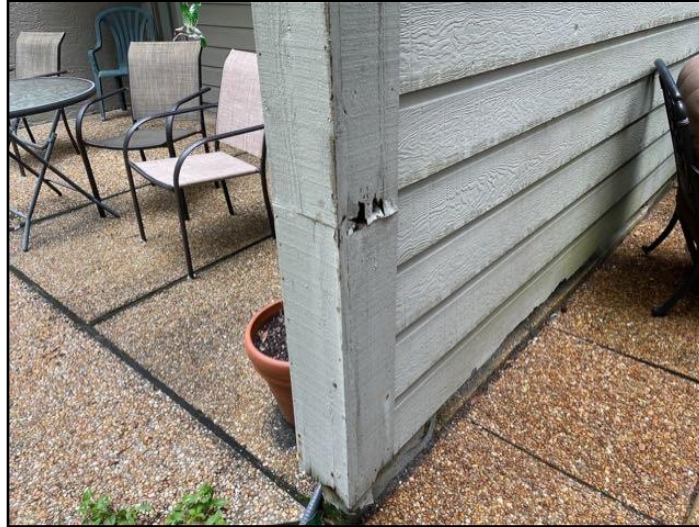
6. Condition: • Rot

Implication(s): Chance of water damage to structure, finishes and contents | Weakened structure | Material deterioration

54. Rot

Task: Further evaluation

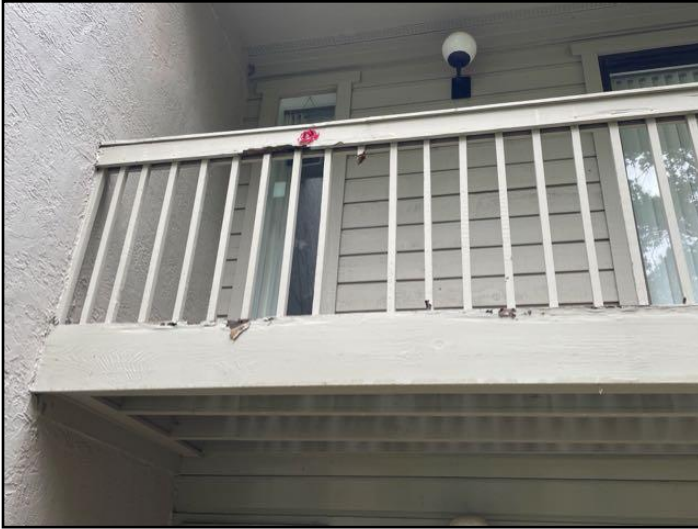
8. Condition: • [Damage](#)

Deterioration of wood possible Safety issue

57. Damage

Task: Further evaluation

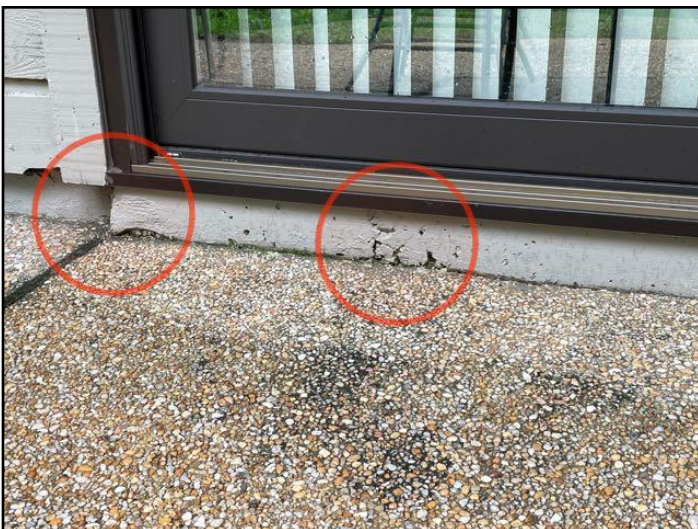
65. Step and landing rear slider

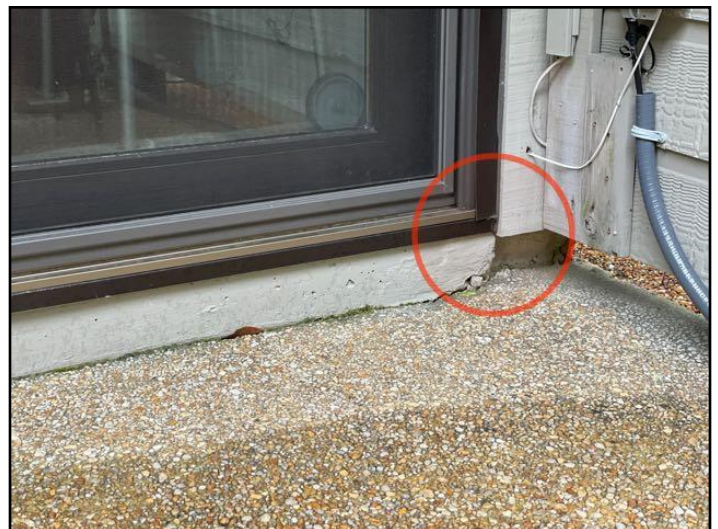
66. Step and landing rear slider

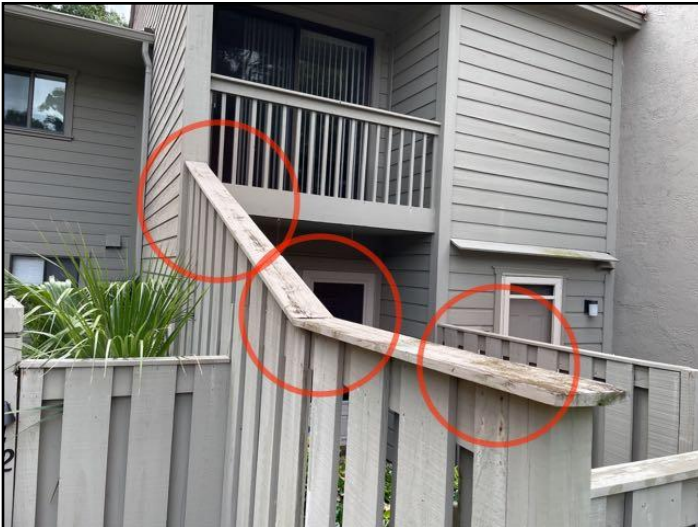
68. Deteriorated

Task: Further evaluation

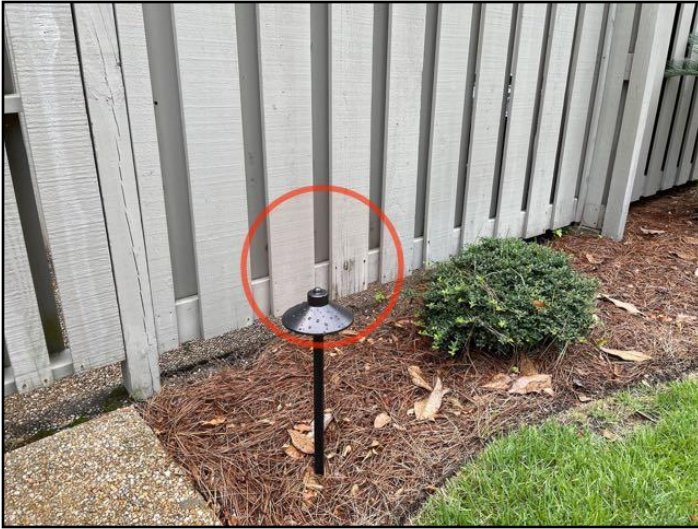
73. Rotfencing

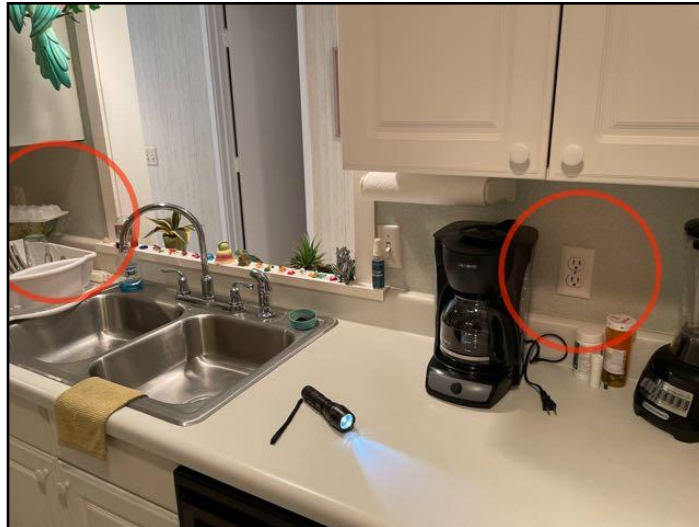
No GFCI present

83. NO GFCI's Present in home

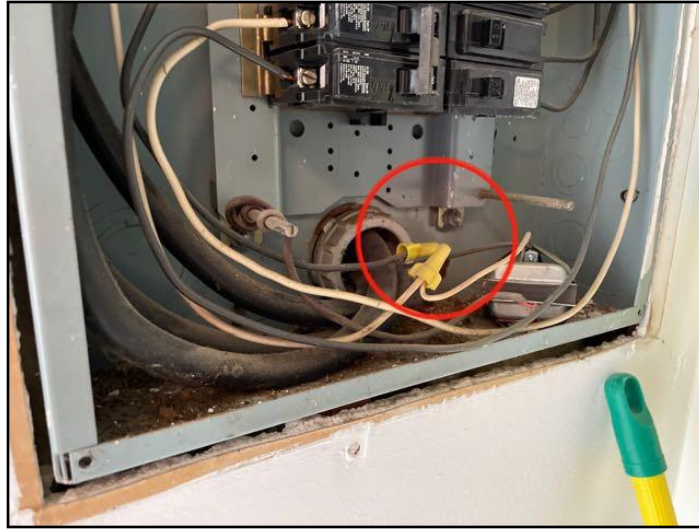
21. Condition: • [Illegal taps](#)

Implication(s): Electric shock | Fire hazard**Location:** At, but not limited to those in the photograph(s) Utility Room**Task:** Further evaluation**Time:** As soon as possible

87. Neutral wire connect outside of bus bar

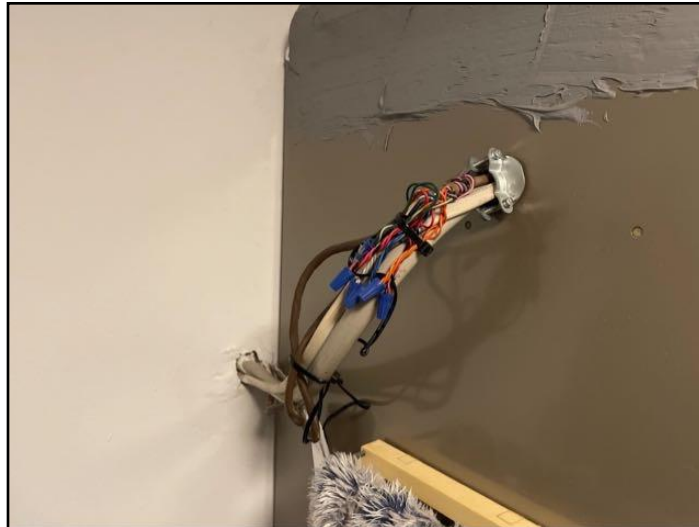
22. Condition: • [Open splices](#)

Wiring for Air Handler needs an enclosed junction box. Recommend qualified Electrician for further evaluation.

Implication(s): Fire hazard | Electric shock

88. Open Splices Air Handler

Task: Further evaluation

Time: As soon as possible

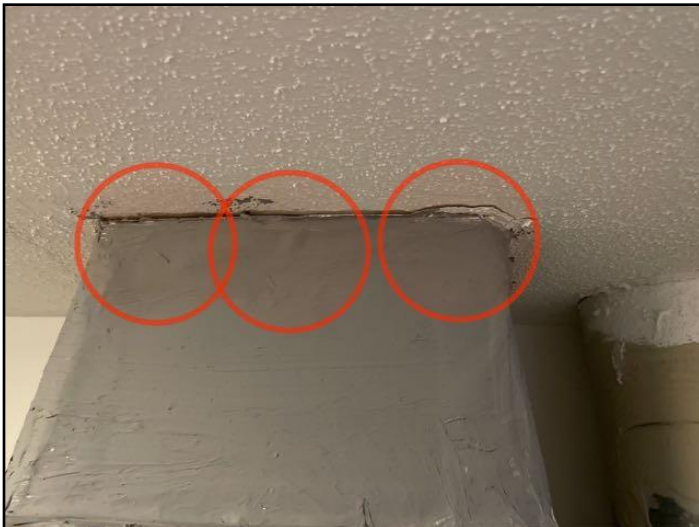
24. Condition: • Loose/Missing Tape

96. Loose/Missing Tape

Task: Repair and Improve

Time: As soon as Practicable

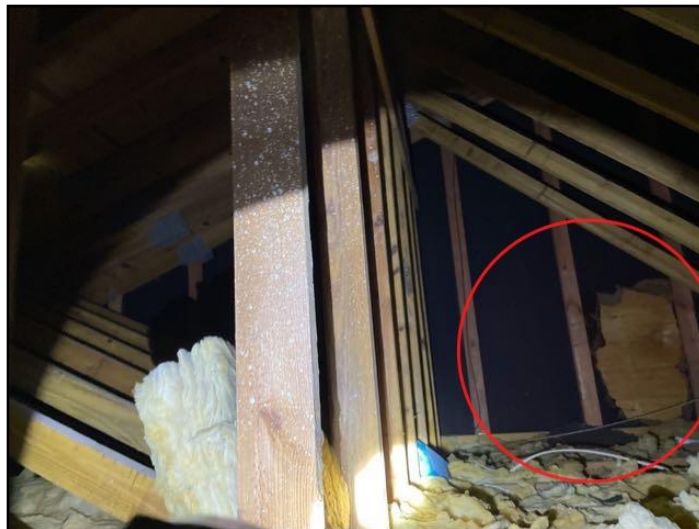
Vapor Barrier missing in attic space left side of Structure. Recommend further evaluation.

Task: Further evaluation

Time: As soon as possible

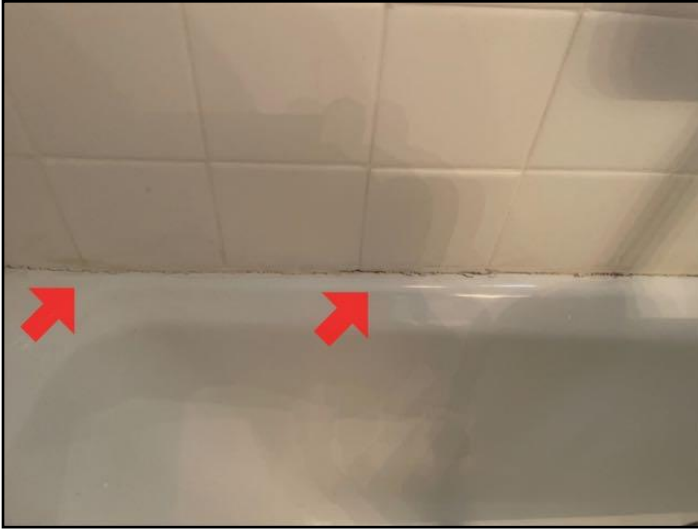
29. Condition: • [Caulking loose, missing or deteriorated](#)

Implication(s): Chance of water damage to structure, finishes and contents

107. Caulking loose, missing or deteriorated

Time: when practical

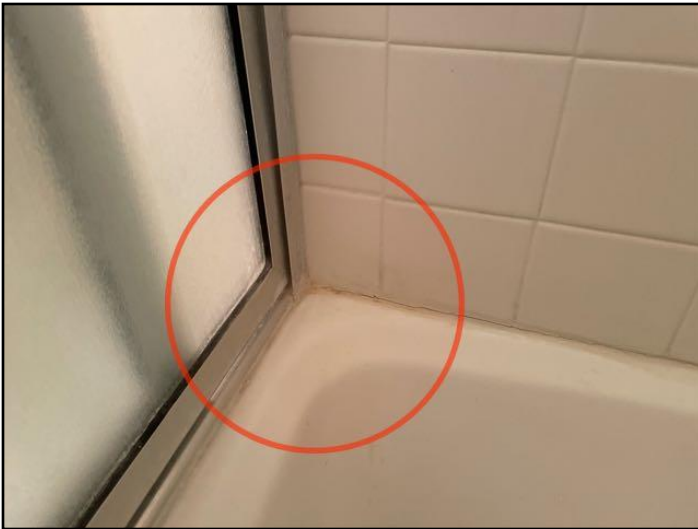
30. Condition: • [Grout loose, missing or deteriorated](#)

Master Bath Grout loose / Missing

Implication(s): Chance of water damage to structure, finishes and contents

109. Grout loose, missing or deteriorated

Task: Improve

Time: Discretionary

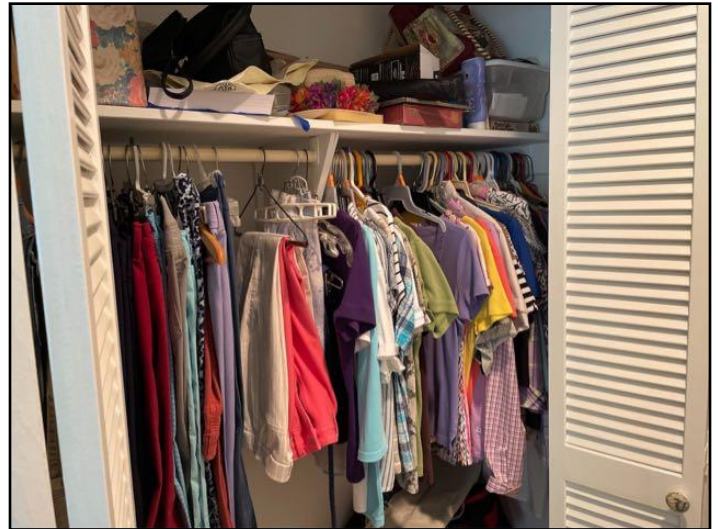
133. Storage in closets and cabinets / cupboards

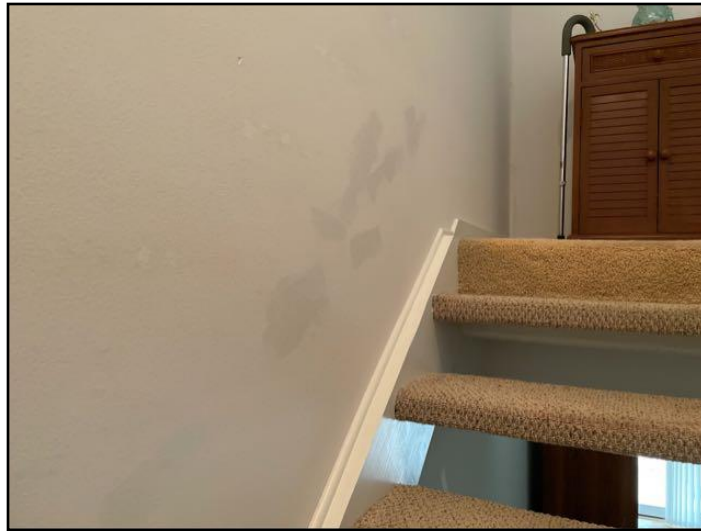
135. Cosmetic issues Decorative items Aesthetics...

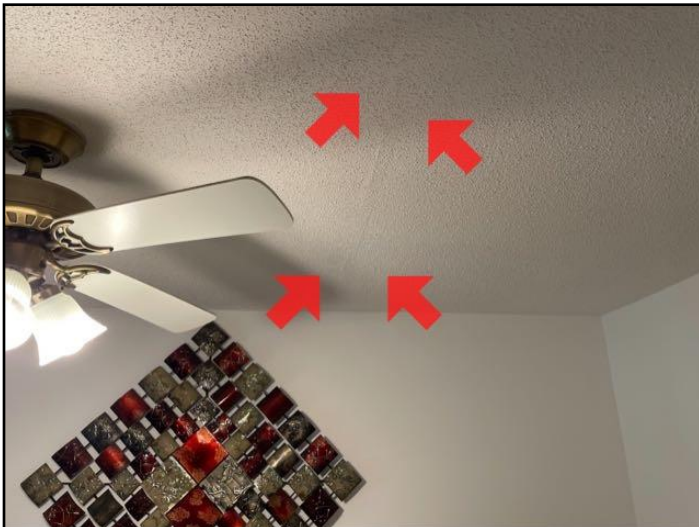
35. Condition: • Typical flaws

136. Tape on drywall Sagging

Task: Monitor

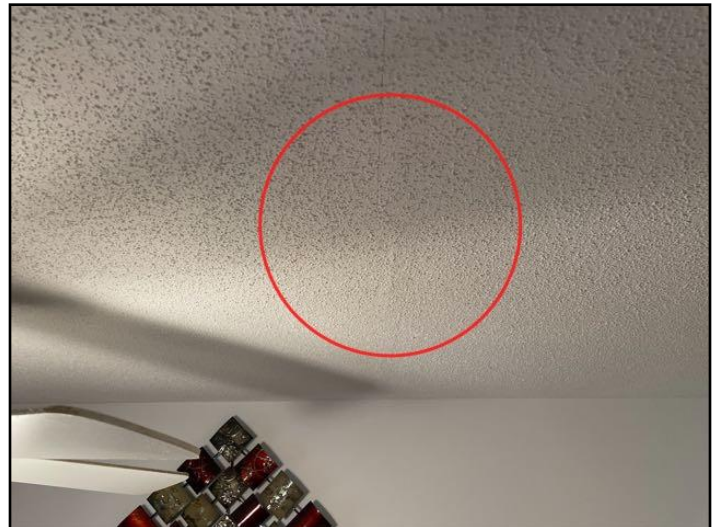
137. Tape on Drywal sagging

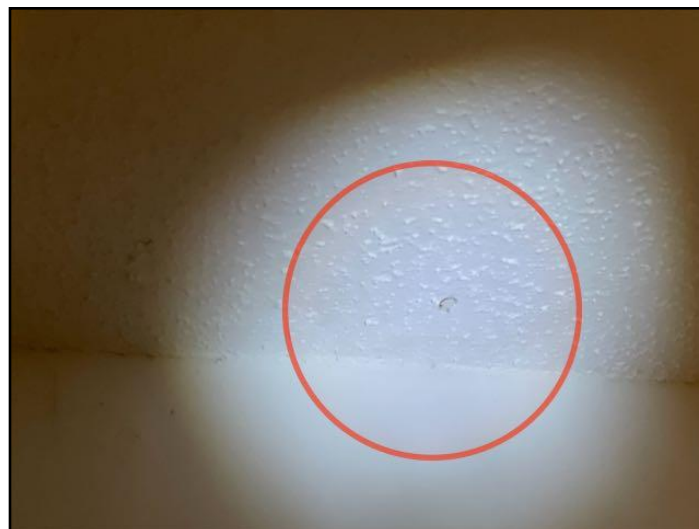
36. Condition: • [Nail pops](#)

138. Nail pops

Task: Monitor

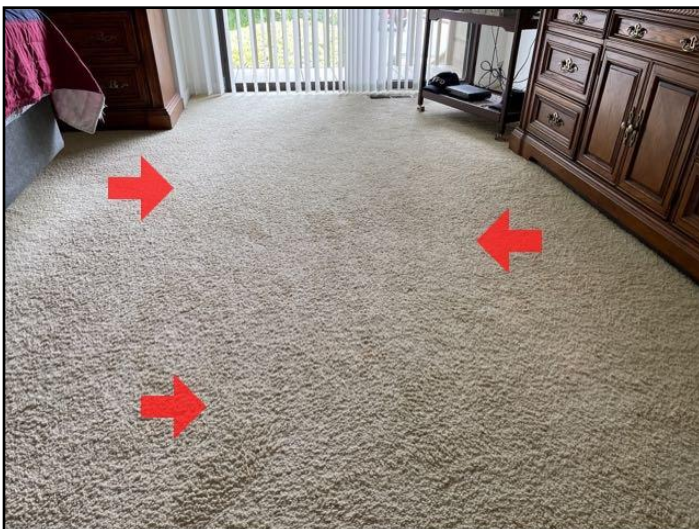
38. Condition: • [Squeaks](#)

140. Squeaks flooring

Task: Monitor

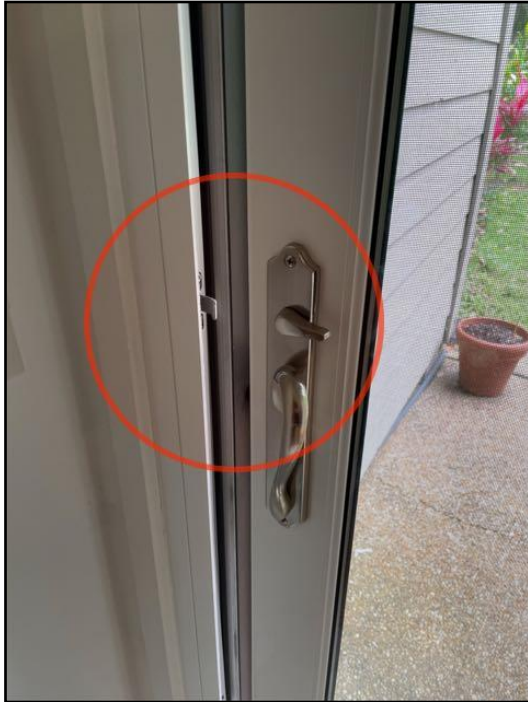
40. Condition: • Lock not effective on exterior door

Lock on rear slider difficult to operate and lock. Recommend improvement. Safety and Security Issue

144. Lock not effective on exterior door

Task: Improve / repair

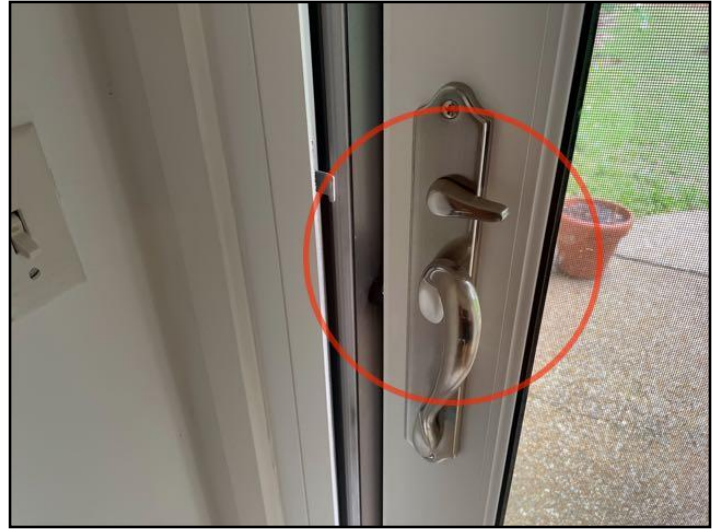
145. Lock not effective on exterior door

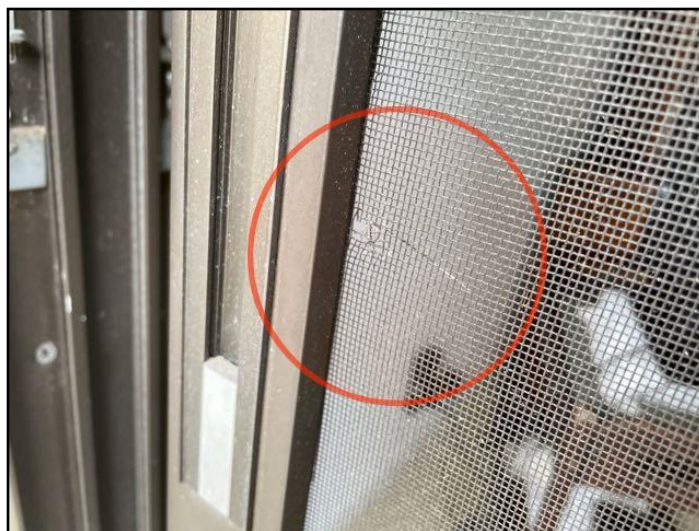
41. Condition: • [Torn](#)

146. Torn Screen

Task: Monitor

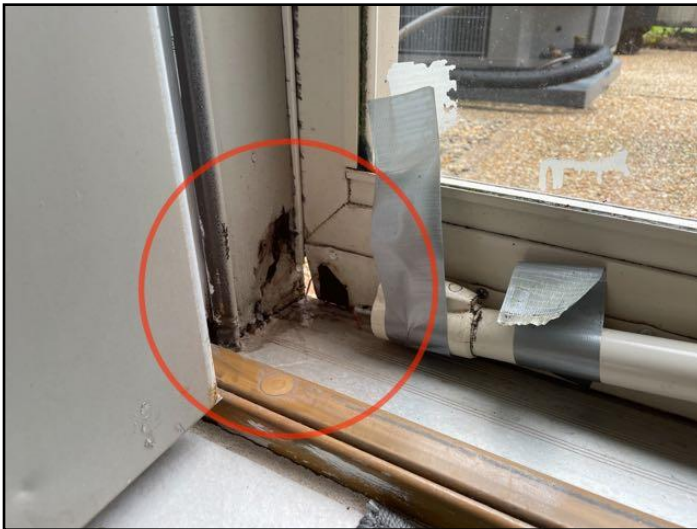
43. Condition: • [Rot](#)

Implication(s): Material deterioration

wood is vulnerable to rot attack when the moisture content is above 20%

150. Rot Door sill

Task: Repair or replace
