# INSPECTION REPORT

For the Property at:  
**202 SAMARITAN AVENUE**  
ASHLAND, OH 44805

Inspection Date: Wednesday, November 27, 2024

RE: Report No. 3858  
202 Samaritan Avenue  
Ashland, OH  
44805

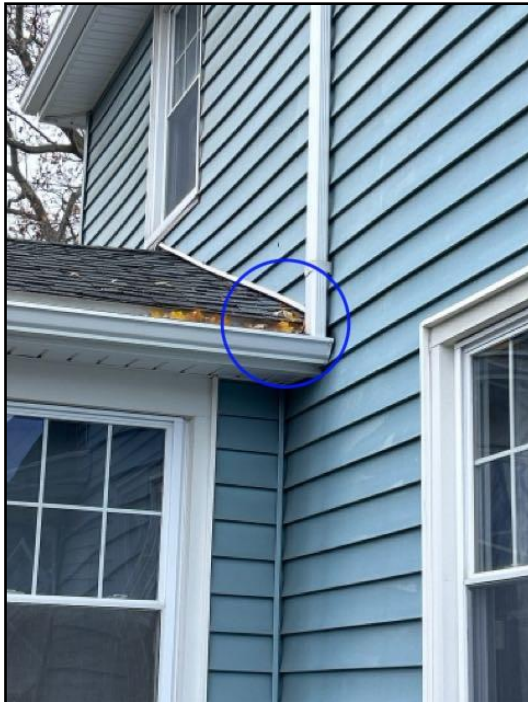
**6. Condition:** • Monitor for overflowing water and install splash guards as needed

4. Monitor for overflowing water and install...

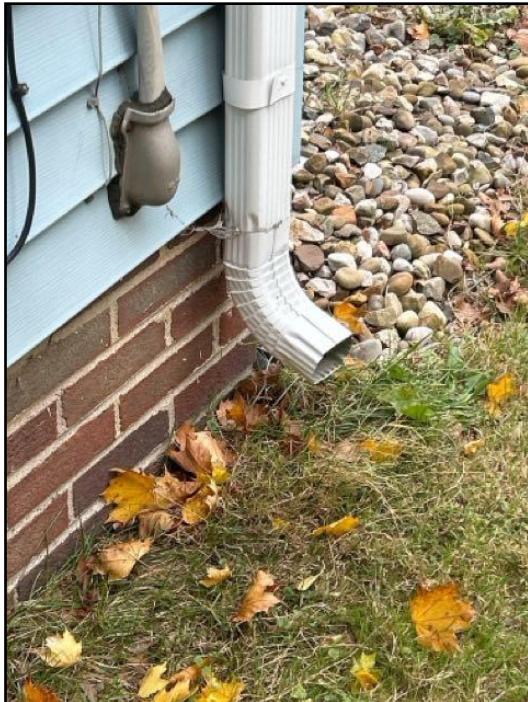
9. Downspout is not directed into its proper...

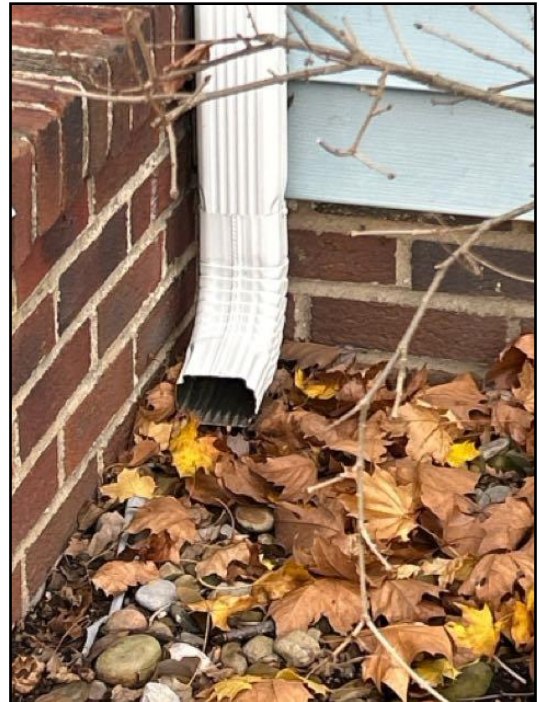
10. Downspout is not directed into its proper...

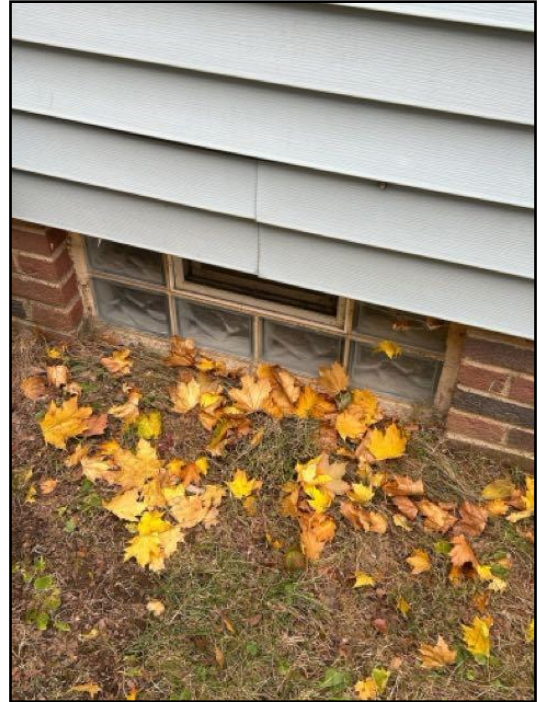
**16.** Too close to grade. This is a vulnerable...

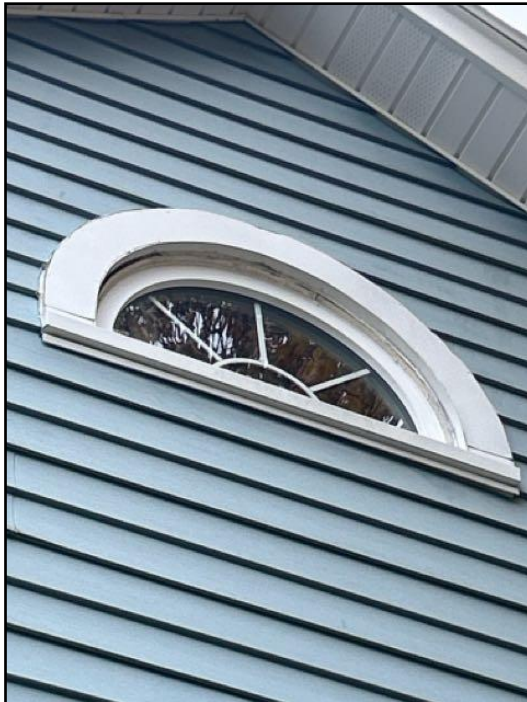
17. Paint and caulking needed on window(s).

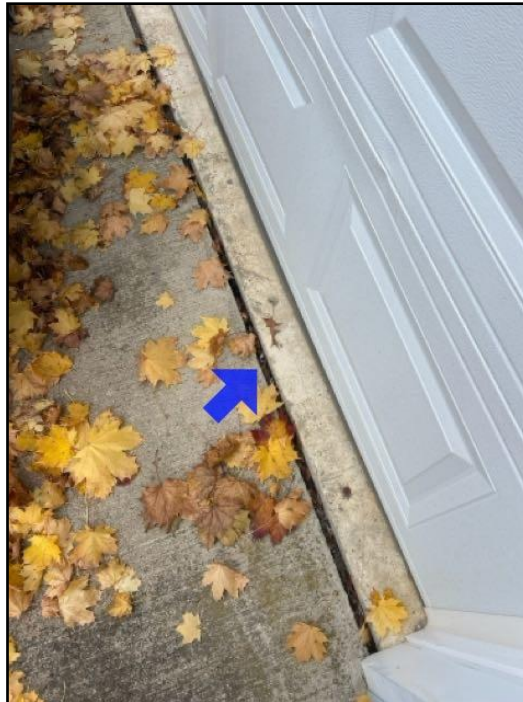
27. Recommend sealing the expansion joint at th...

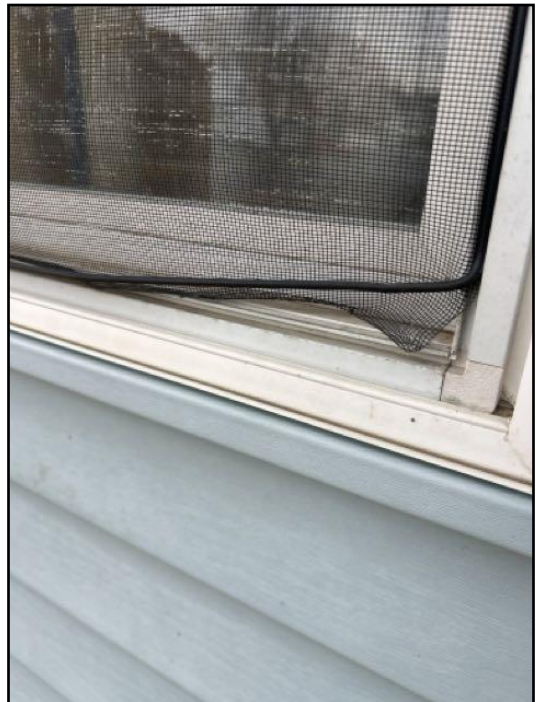
35. The following are defects that were found o...

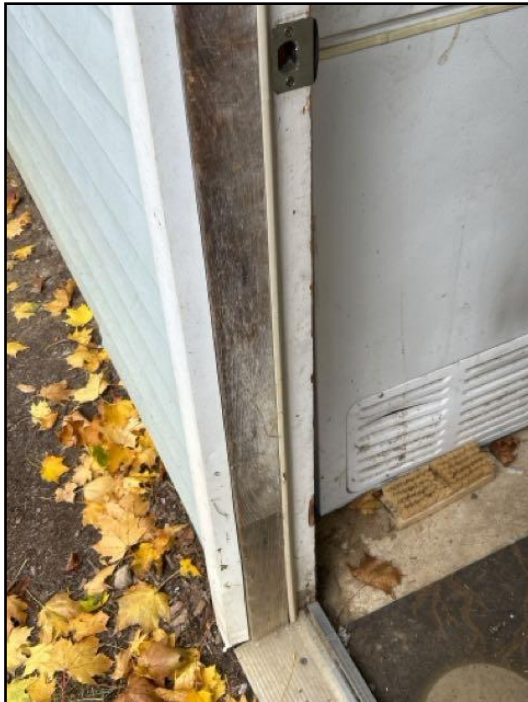
36. The following are defects that were found o...

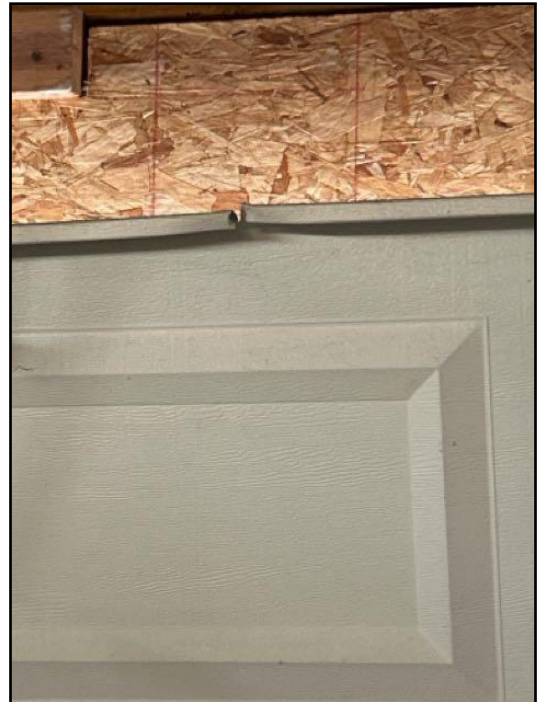
37. The following are defects that were found o...

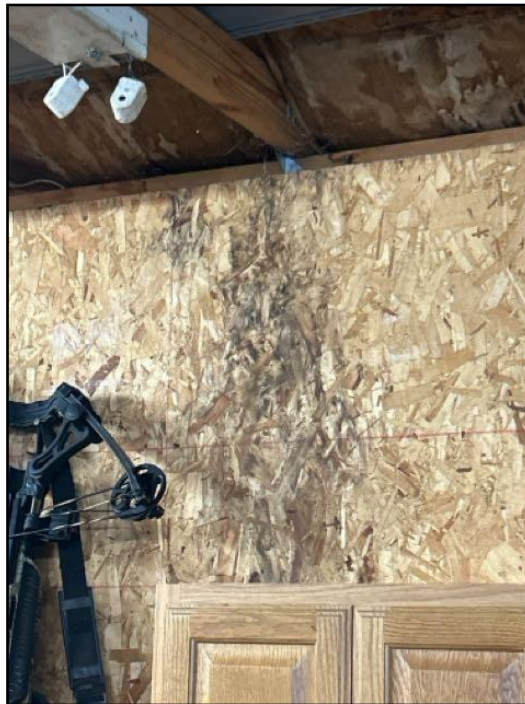
38. The following are defects that were found o...

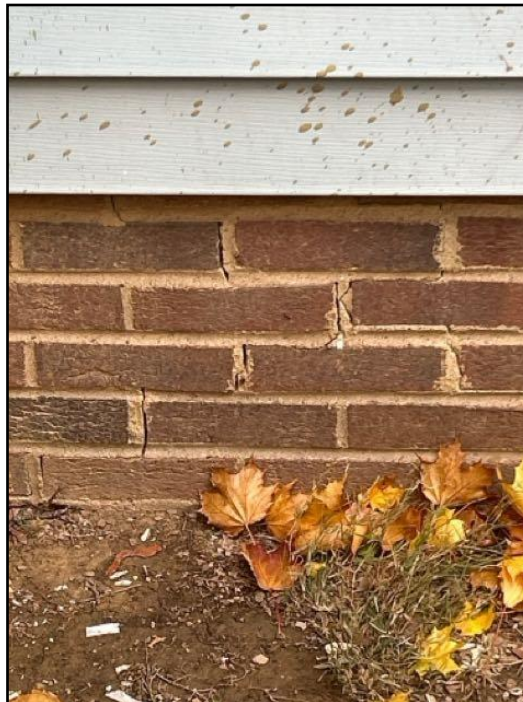
45. Crack(s) noted on the basement foundation....

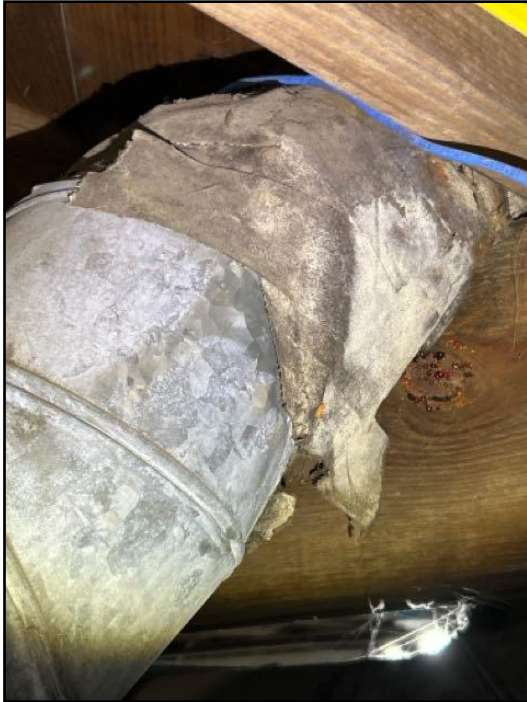
56. The white tape covering some of the joints...

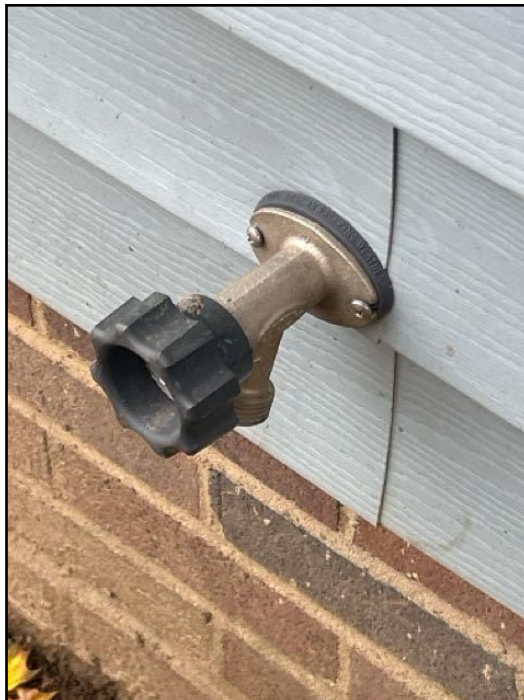
**49. Condition:** • Recommend installing frost free hose bibs to prevent freezing in cold temperatures.

65. Recommend installing frost free hose bibs t...

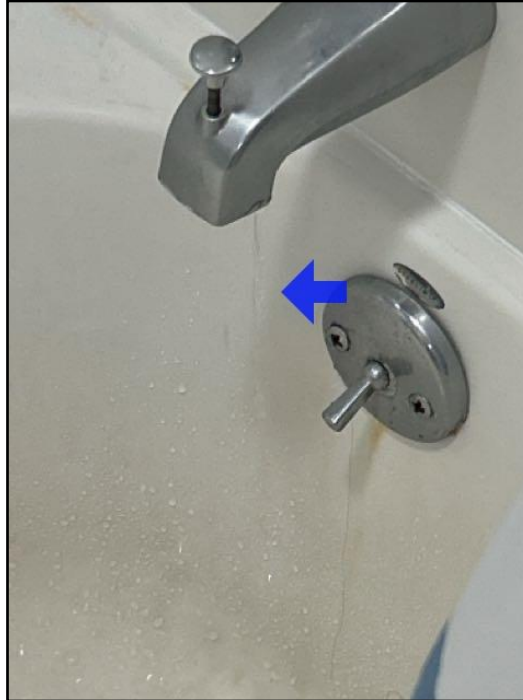
**50. Condition:** • The shower diverter leaks while the shower head is on. Although common, this wastes usable water. Recommend cleaning or replacing the diverter as needed.

**66.** *The shower diverter leaks while the shower...*

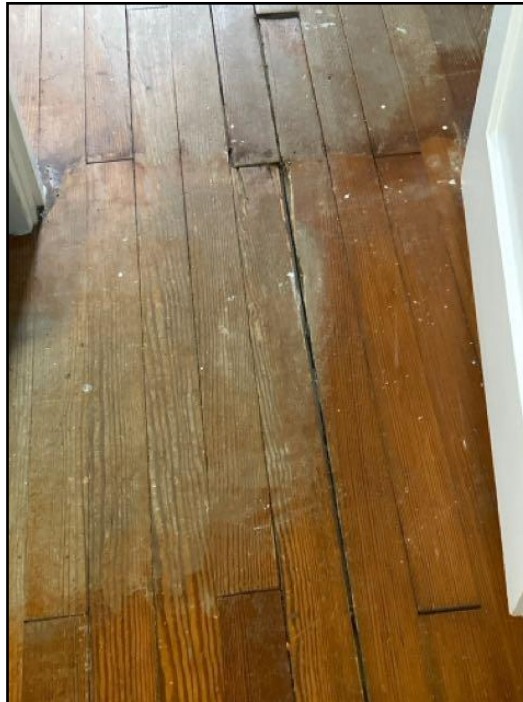
**59. Condition:** • Typical stains/flaws for a home this age. Repair as needed.

*77. Typical stains/flaws for a home this age....*
