**103 WOOD LANE
PILSALL
WS3 5DZ**

29TH OF OCTOBER 2025

Instructions were received on the 13th of October 2025 to undertake a snagging report of the property at 103 Wood Lane, Pilsall WS3 5DZ

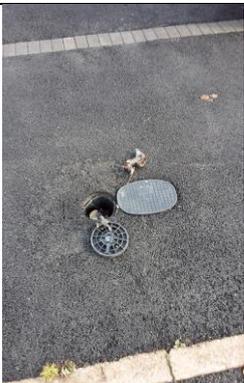
<p>The water meter is positioned on the pavement at the front of the driveway.</p> <p>This water meter casing is smashed, and the lid isn't attached.</p>

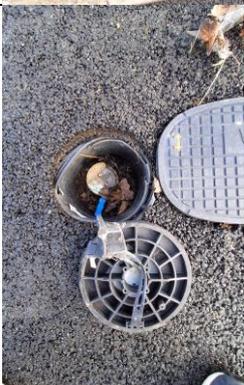
<p>The water meter is full of debris that needs to be cleared out.</p>

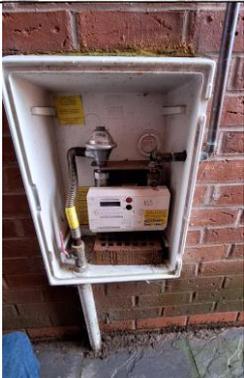
<p>The gas meter is positioned on the left-hand elevation.</p> <p>The gas metre box door is missing.</p> <p>The mastic seal around the box is missing.</p>

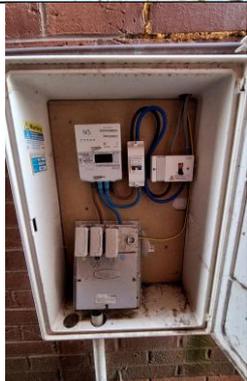
<p>The gas meter is positioned on the left-hand elevation date of sign off 19/04/23</p> <p>I advise getting the house re-commissioned before completion</p>

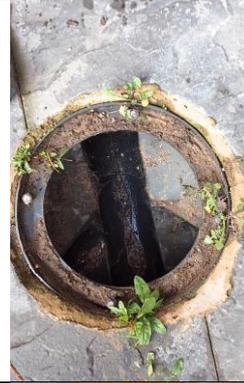
This drain was clear, but the lid is all smashed and the screws for the lid are still in the chamber casing.

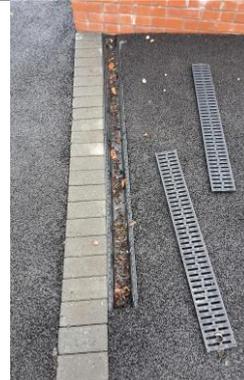
There is an Acho drain on the left-hand side of the driveway on the front elevation.

This is full of tarmac, and no drainage is connected to this Acho drain, so the water has nowhere to go.

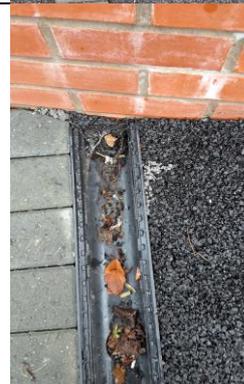
As above

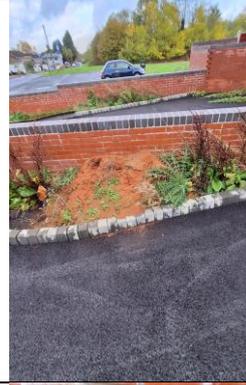
There is a pile of sand on the left-hand side of the driveway.

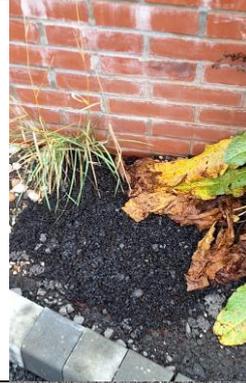
There is a pile of tarmac on the left-hand side of the driveway.

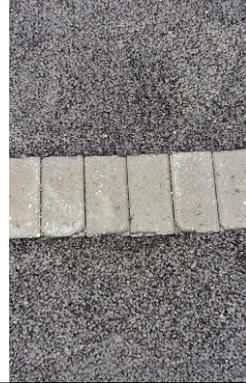
The blockpaving edges are all smashed up at the start of the driveway.

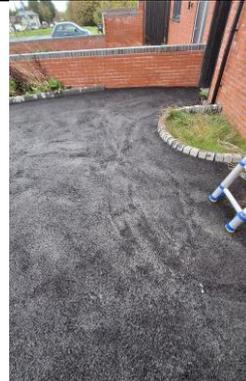
The tarmac has a very poor finish.

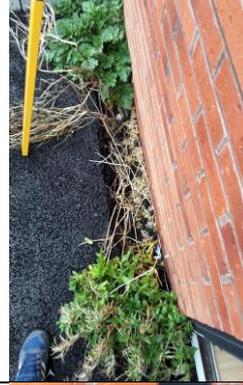
There are no edgings on the left-hand side of the door to hold the tarmac in place.

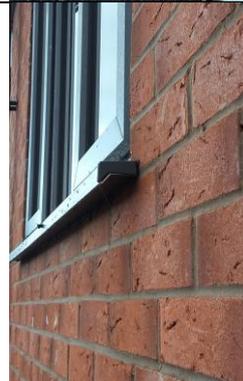
The windowsill end caps need adjustment on the left-hand window on the first floor.

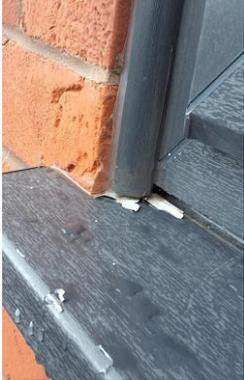
<p>Protection needs to be removed from the left-hand first-floor window.</p>

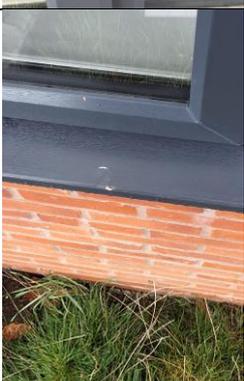
<p>There is damage to the left-hand windowsill.</p>

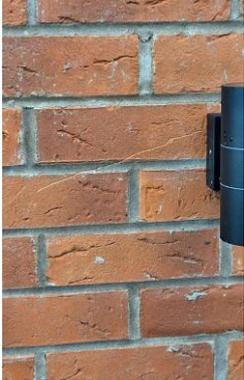
<p>There's a large scratch in the brickwork. By the outside light</p>

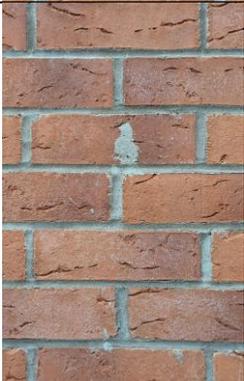
<p>A full brick clean is required.</p>

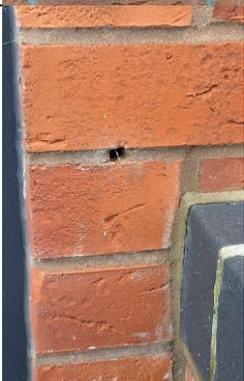
<p>Pointing is required on the right-hand side of the door.</p>

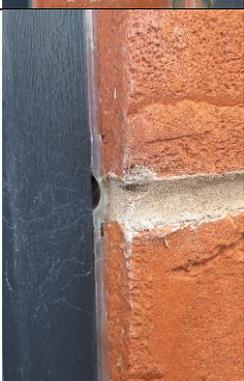
<p>The mastic seal on the front door is poor and needs attention.</p>

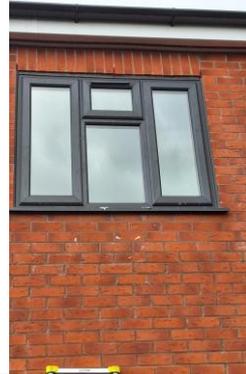
Protection needs to be cleaned off the first floor left left-hand window.

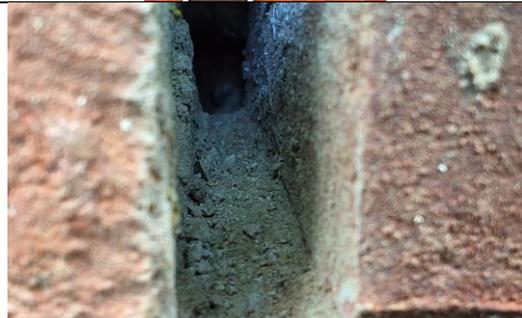
I looked through where the weep vent was meant to be under the living room window, and I cannot see a DPC or a cavity tray.

I would ask the builder to provide photographic evidence that this DPC has been installed above the splash course and below the weep vents.

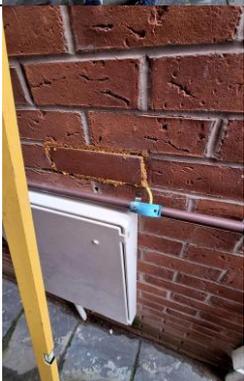
<p>A brick has been taken out to add an earth cable to the gas pipe, and it has been foamed back in. This needs to be taken out and properly pointed in with cement.</p>

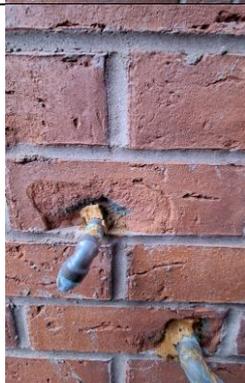
<p>Using foam around gas pipes is not acceptable. You have sleeved the gas pipe through the wall and then filled it with foam. You have also destroyed the brick.</p>

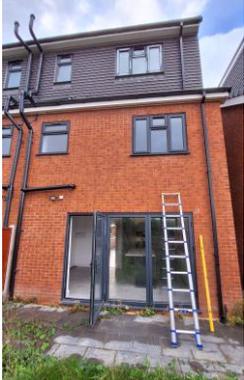
<p>This broken brick behind the tab needs to be replaced, and using foam to fill the gaps is not acceptable.</p>			
<p>Brick cleaning is required around the boiler flue.</p>			
<p>The extractor fan vent needs to be mechanically fixed to the wall. Not stuck on with silicon. Also, the pipe needs to be clipped to the vent, which it isn't</p>			
<p>A brick clean is required.</p>

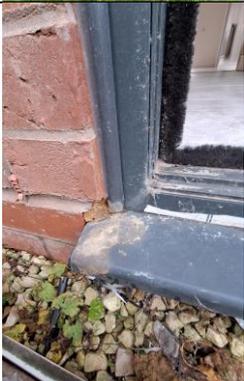
<p>This needs to be properly pointed ,using foam is not acceptable.</p>

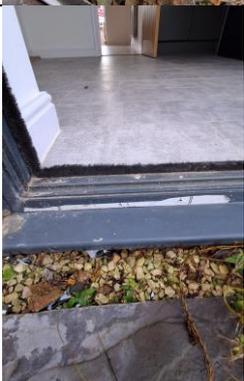
<p>Door protection needs to be removed from the doors.</p>

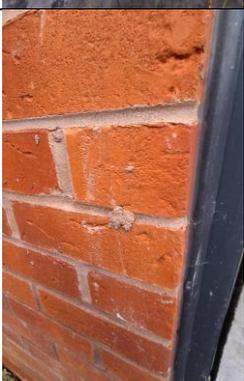
<p>A brick clean is required.</p>

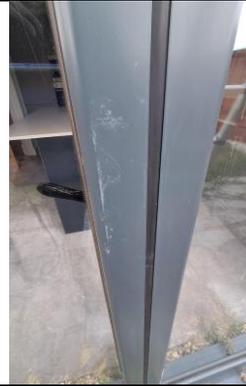
There's damage to the bi-fold doors in various locations.

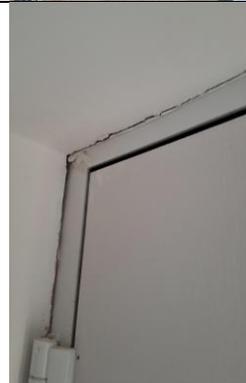
Decoration and a mastic seal is required all around the front door reveals

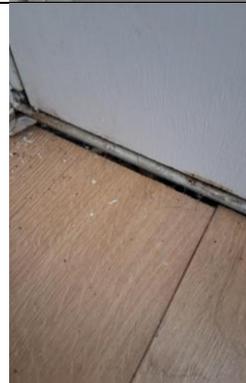
The flooring has been cut too short on the left-hand side of the front door.

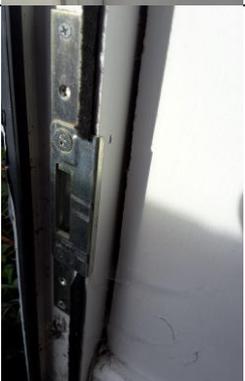
<p>The gap by the front door in the plasterboard is excessive, and there is no mastic seal.</p>

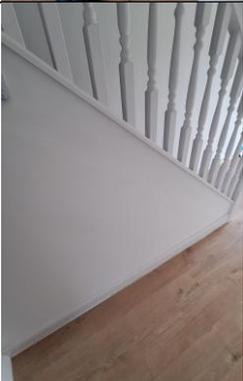
<p>Decoration is required to the whole wall underneath the bannisters.</p>

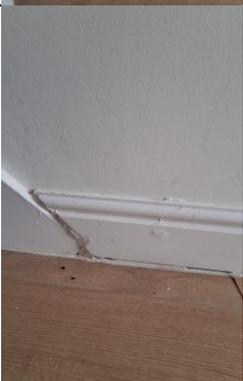
<p>The skirting to the stair string needs to be re-cut; filling with filler is not acceptable.</p>

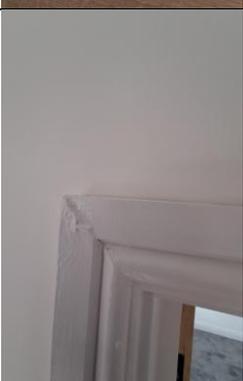
<p>The architraves on the living room door are not flush.</p>

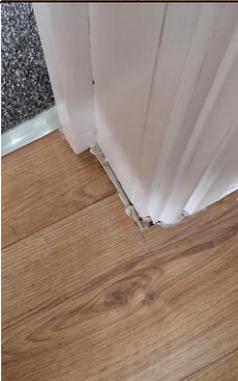
<p>The wood flooring has been cut too short, and the gap has been filled with silicon.</p>

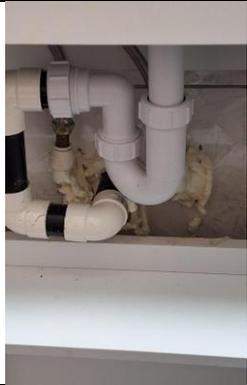
<p>Using foam to fill holes underneath the sink in the vanity cupboard is not acceptable.</p>

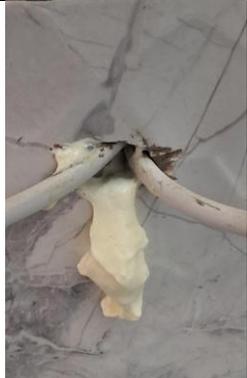
<p>Using foam to fill holes underneath the tower rail is not acceptable.</p>

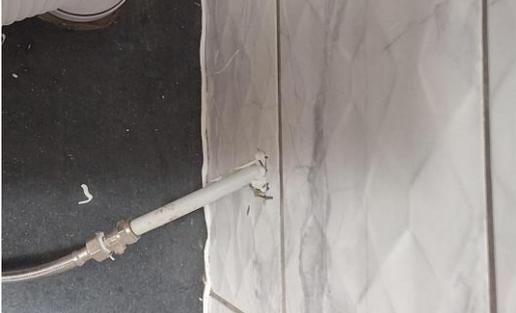
<p>This is the water feed to the toilet?</p>

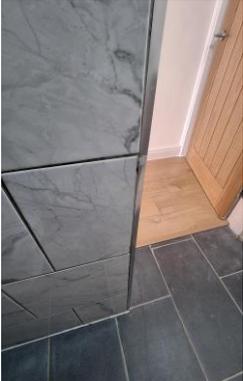
<p>The tiling on the left-hand side of the toilet is not consistent and is very bumpy.</p>

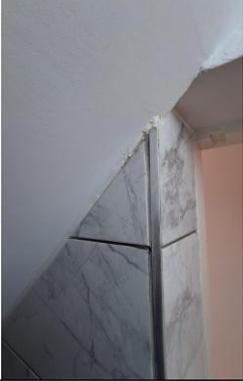
<p>Decoration and tiling are very poor.</p>

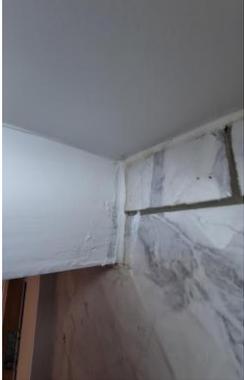
<p>The decoration on the left-hand side of the door is very poor.</p>

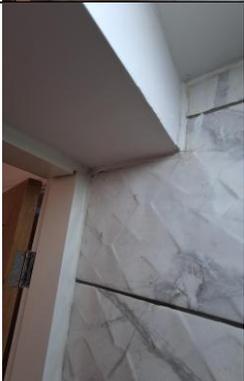
<p>The decoration on the right-hand side of the door is very poor.</p>

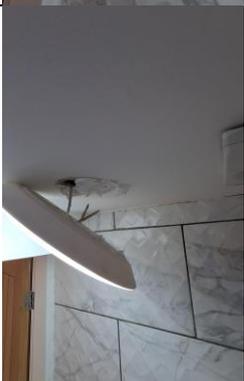
<p>The light is hanging from the ceiling.</p>

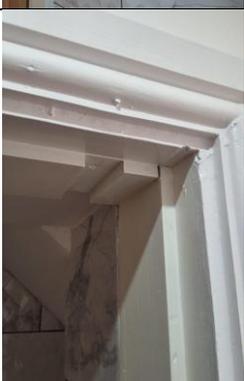
<p>If you're going to use the wrong-size door frame, at least fill the holes</p>

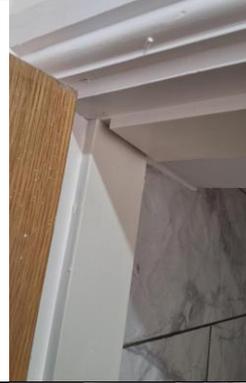
Holes need filling on the left-hand side of the door frame.

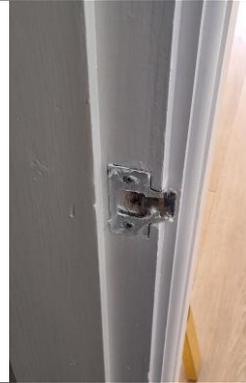
The door keep needs cleaning.

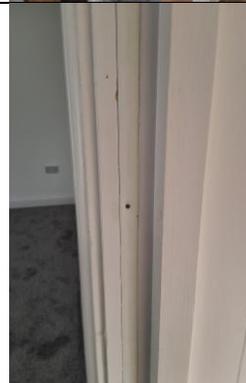
The fire seal has been nailed into position. This will not work in the case of a fire.

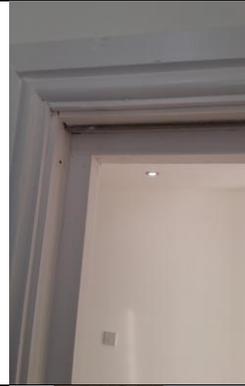
Carpentry isn't the best.

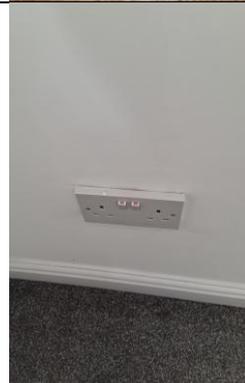
<p>Decoration is required to the skirting joint.</p>

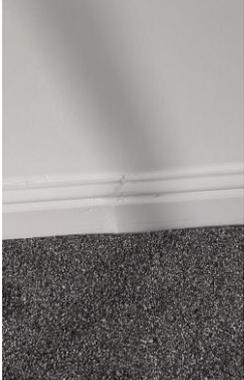
<p>Decoration is required to the left-hand corner.</p>

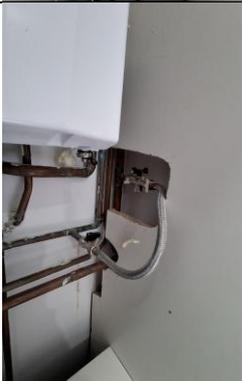
<p>There is a sticky residue on the boiler cupboard door</p>

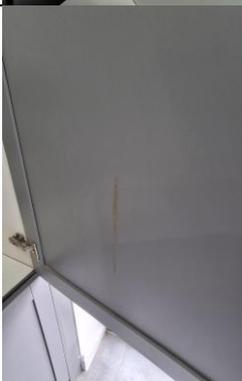
<p>There are various marks on the tiles</p>

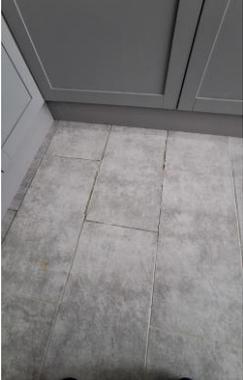
<p>Cleaning is required underneath all the base units.</p>

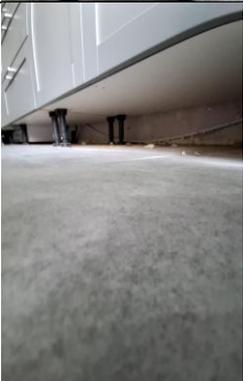
<p>The plinth underneath the boiler cupboard is too short.</p>

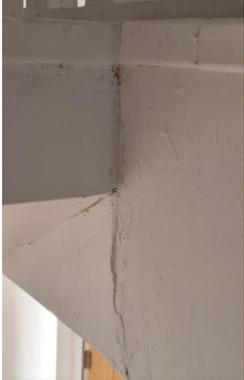
<p>Decoration is required to the bulkhead on the left-hand side.</p>

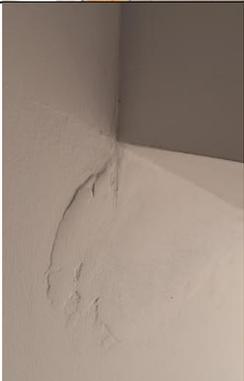
<p>Decoration is required on the right-hand side of the top of the stairs.</p>

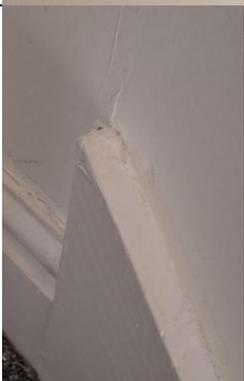
<p>Decoration is required for the base rail and spindles.</p>

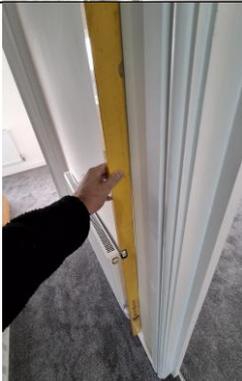
<p>The wall at the top of the stairs on the right-hand side of the first floor is 6mm out of plumb.</p>

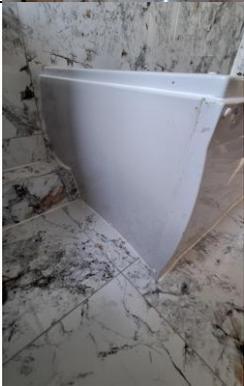
<p>The bath panel need attention. It shouldn't be out like this.</p>

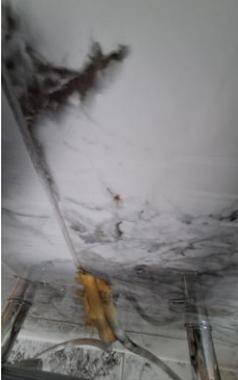
<p>Foaming behind the tower rail is not acceptable.</p>

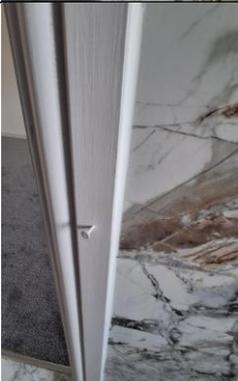
<p>There is a random screw in the right-hand architrave.</p>

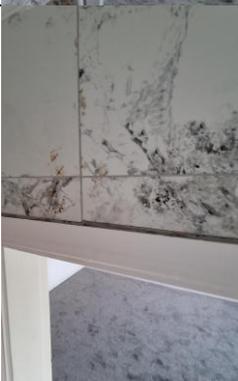
<p>The tiling above the doors doesn't meet up and is extremely poor.</p>

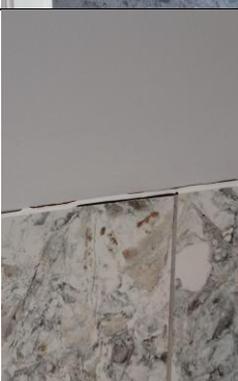
<p>The mastic seal between the tiles and the ceiling requires attention throughout this bathroom.</p>

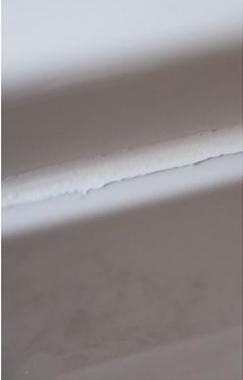
<p>The bath panel has been siliconed on</p>

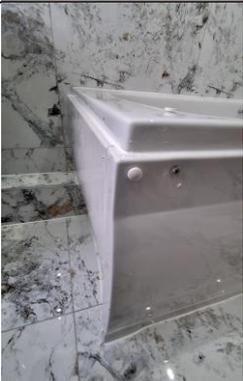
<p>The bath panel needs serious attention. Additional screws in the top need covers</p>

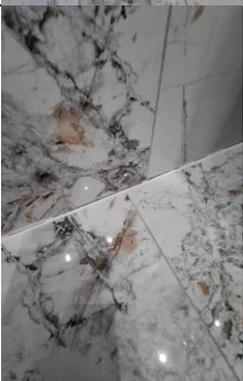
<p>The mastic seal on the left-hand side of the sink requires attention, and throughout the whole bathroom.</p>

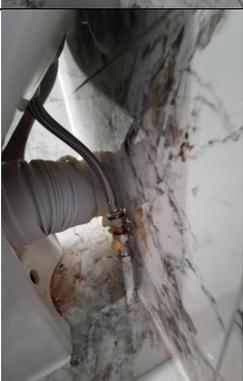
<p>Foaming, the SVP behind the toilet, is not acceptable.</p>

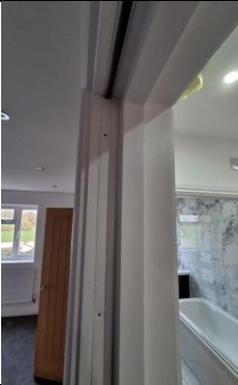
<p>The wrong intumescent seals have been installed in this door frame, and they have been nailed in.</p>

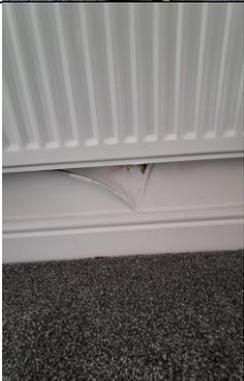
<p>Radiator pipes are coming up through behind the skirting.</p>

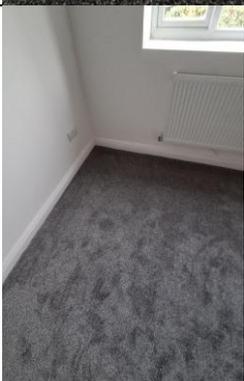
<p>The floor is extremely creaky in the left-hand corner.</p>

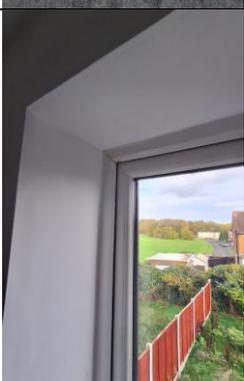
<p>The mastic seal requires attention on the left-hand side of the window.</p>

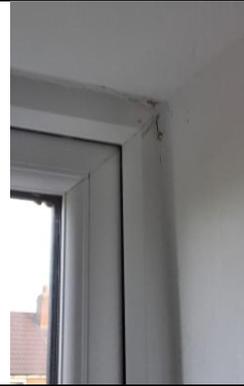
The mastic seal requires attention on the right-hand side of the window.

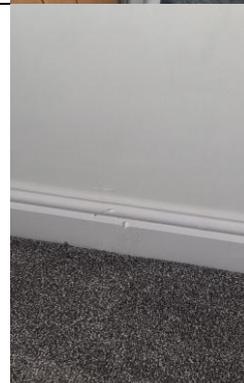
Decoration is required to the skirting on the right-hand side and underneath the radiator.

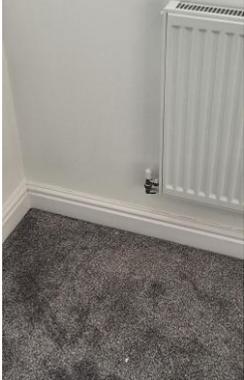
<p>Decoration is required for the skirting all the way along the wall</p>

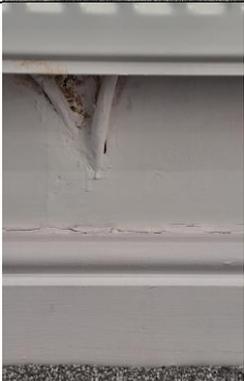
<p>Radiator pipes are visible underneath the radiator.</p>

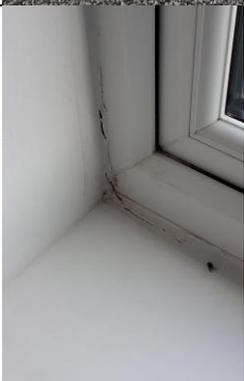
<p>The mastic seal requires attention all the way around this window</p>

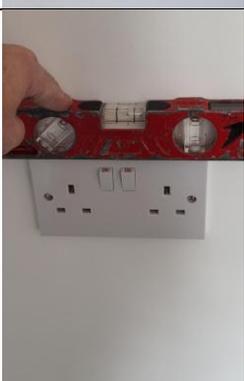
<p>All the sockets are out of level.</p>

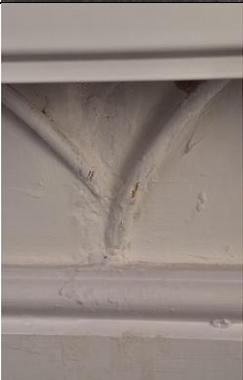
<p>The radiator pipes are visible underneath the radiator.</p>

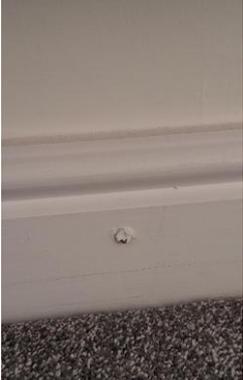
<p>Decoration is required to the skirting.</p>

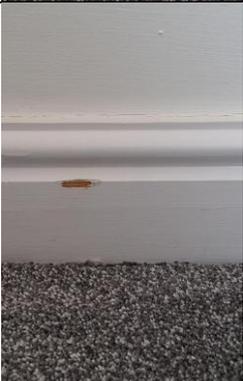
<p>Decoration is required to the skirting.</p>

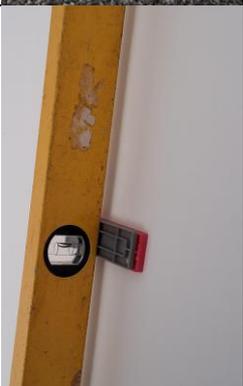
<p>The wall on the left-hand side of the window is 9mm out of plumb.</p>

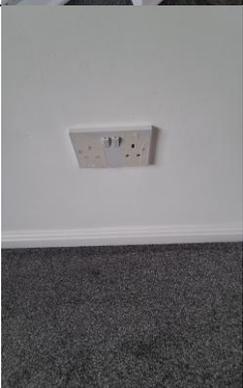
<p>All the sockets are covered with tape " Do not use" Get a qualified electrician to sign off on this property. I advise an independent electrician</p>

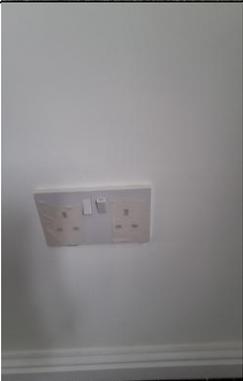
<p>All the sockets are taped over as if to say, do not use I strongly advise getting an electrician to check all the electrics within this property and get another sign-off.</p>

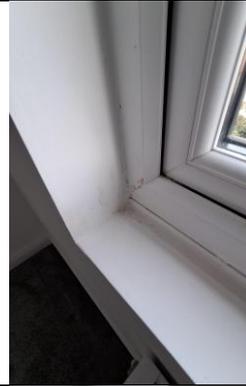
Decoration is required to the lower left-hand corner of the window.

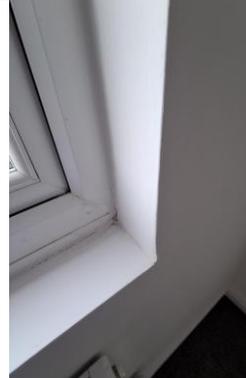
Decoration is required to the lower right-hand corner of the window.

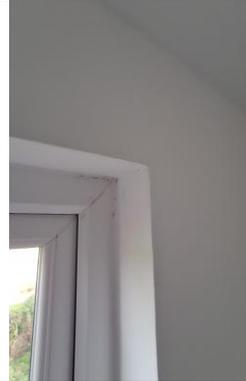
Decoration is required to the right-hand corner of the window.

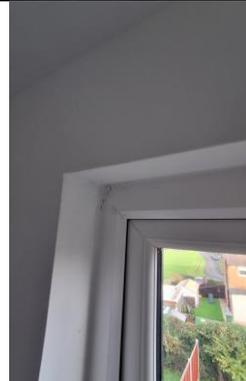
Decoration is required to the left-hand corner of the window.

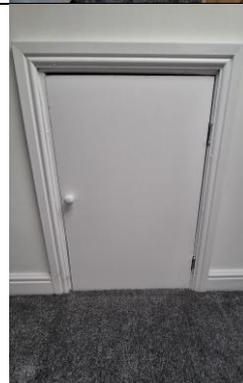
The eve's door gaps are uneven.

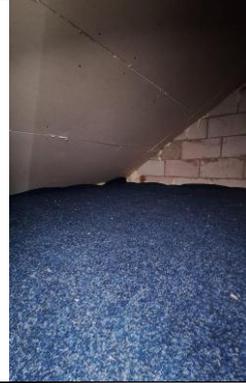
There is a lot of foam around the gable wall and along the plasterboard.

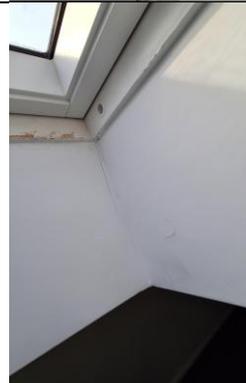
Decoration is required

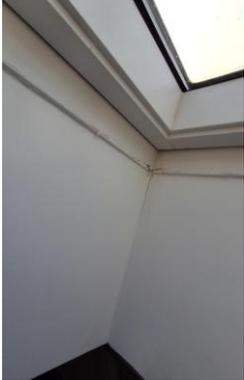
Decoration is required

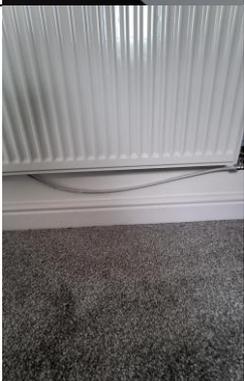
Radiator pipes are visible.

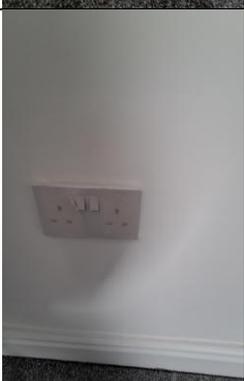
All the sockets have been taped over.

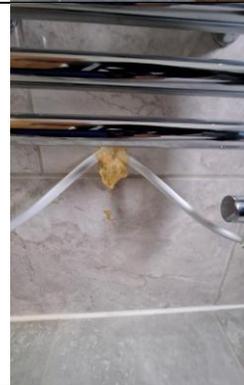
There's foam underneath the towel rail.

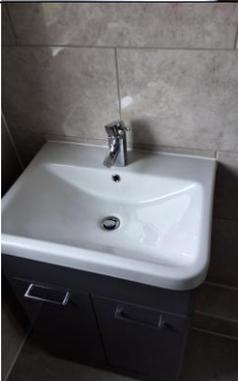
<p>There was no water at all in the hand basin.</p>

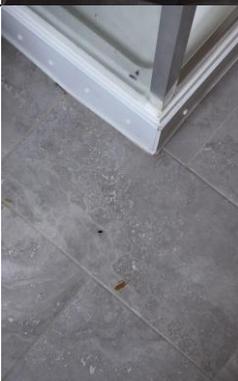
<p>There are marks all over the tiled floor.</p>

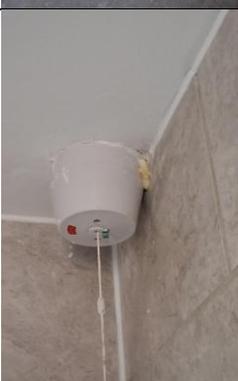
<p>Foam behind the shower switch</p>

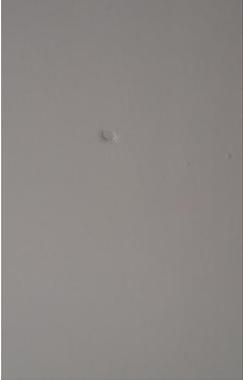
<p>Screw pops are visible in the ceiling</p>

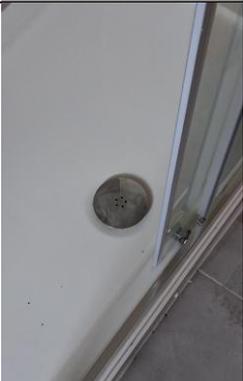
<p>The shower cover is glued on, and I couldn't take this off to check the waste</p> <p>I couldn't get the shower to work</p>

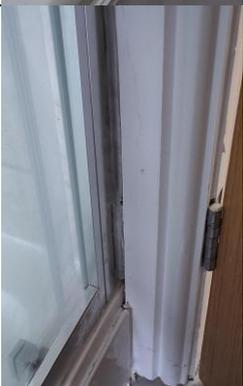
<p>The mastic seal for the shower is very poor</p>

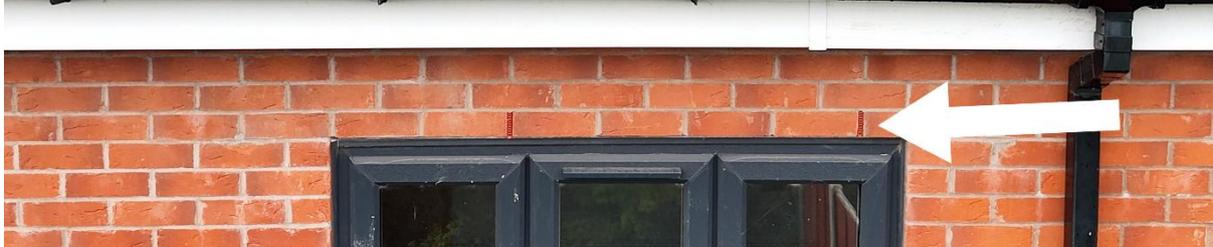
The weep vents are unevenly spaced
450mm maximum spacing is allowed.
There needs to be weep vents at both
ends of the window opening
