PROFESSIONAL
SNAGGING
SURVEYS

LAUREN HOUSE

25TH JANUARY 2025

Instruction was received on 20th January 2025 to undertake a snagging report of the property at Lauren House, Example Rd, GL20 7GG. The survey was carried out on 25th January 2025.

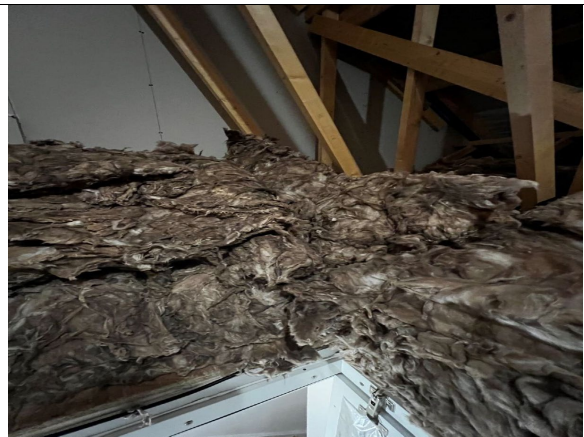
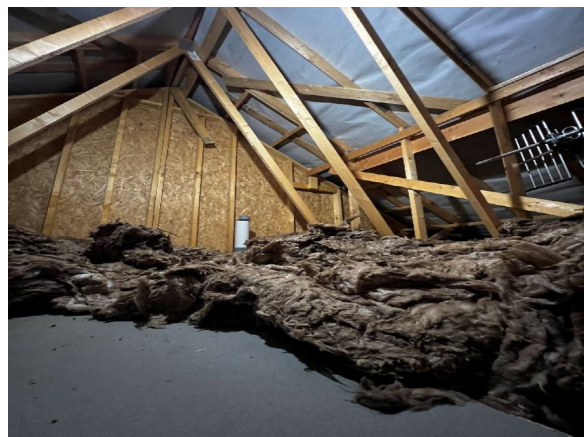
The loft insulation needs to be properly installed (layered). Currently laid incorrectly.

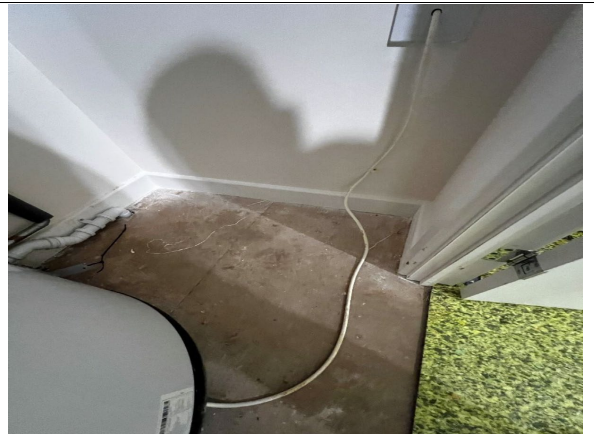
This cable that runs from the immersion heater to the control panel will need to be installed correctly. Needs to be off the floor and clipped to the wall as a bare minimum.

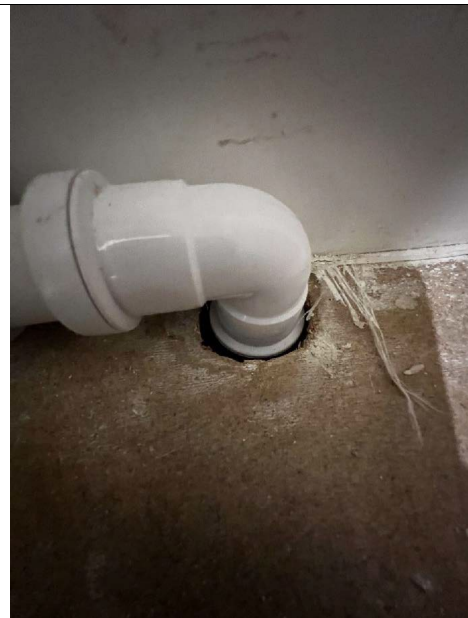
This waste pipe that penetrates the floor will need to be properly fire stopped as well as the other penetrations in the photo bottom photo.

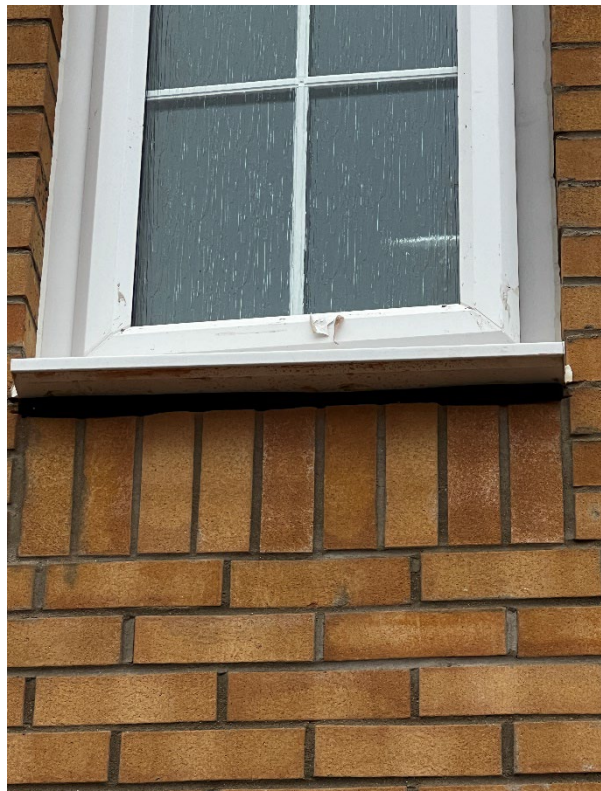
The contraband seal under the window sills needs attention. They are all fitted badly and needs to be installed properly

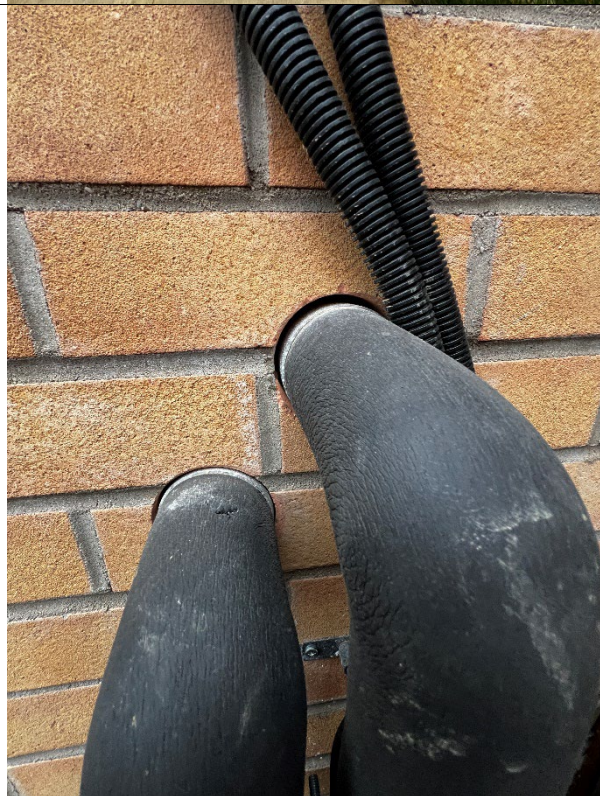
The wall penetrations need to be properly sealed.

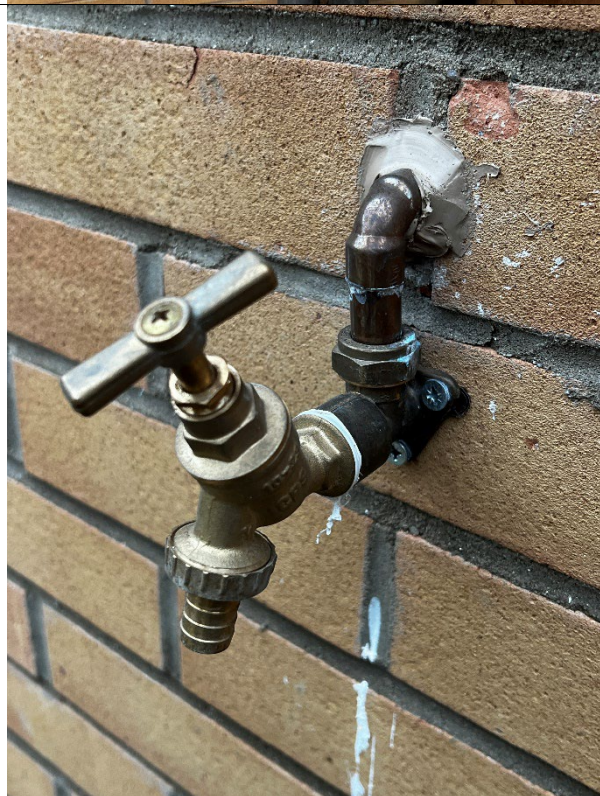
The outside tap will need insulating to stop it freezing in the winter

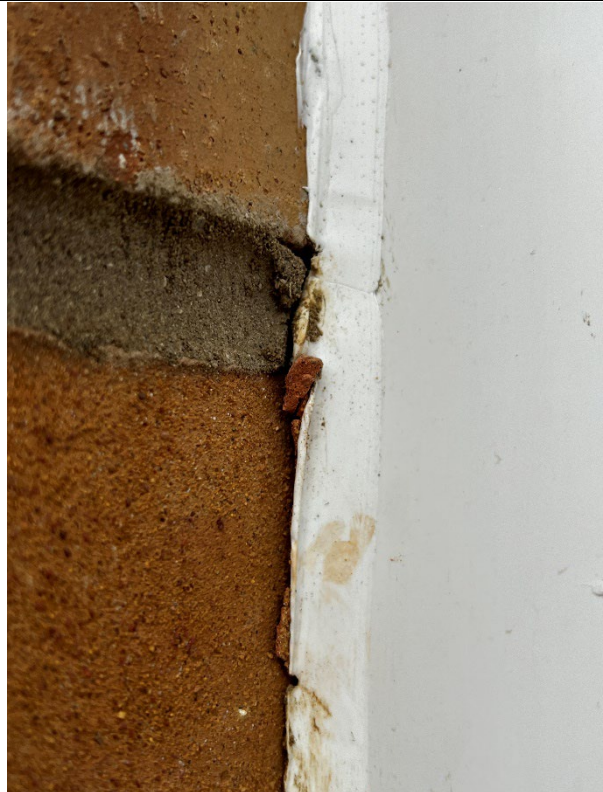
Window seals need attention

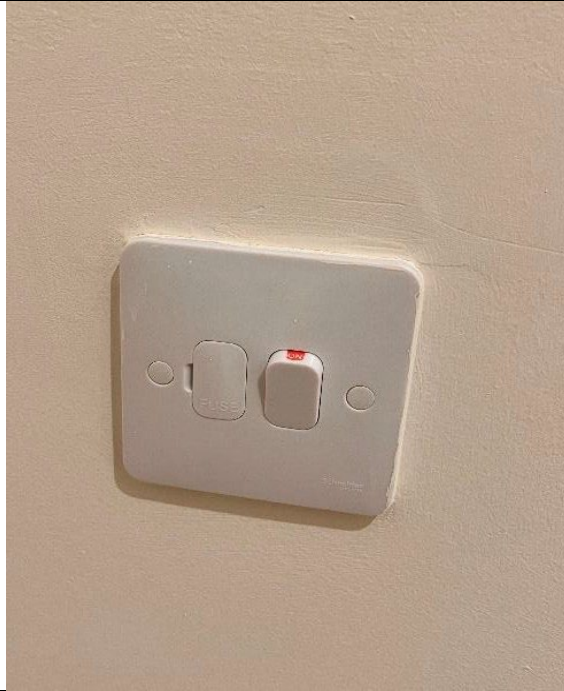
Decoration around this spur socket needs attention

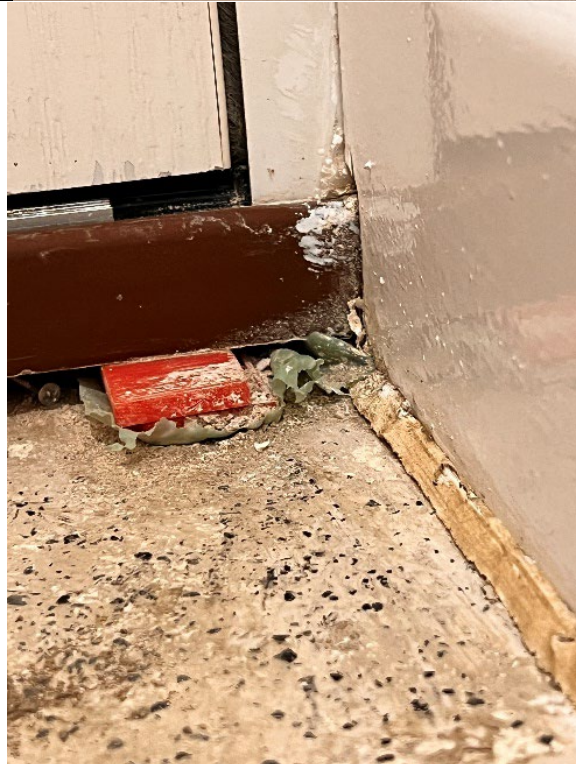
Space between the cupboard and stairs will need decoration

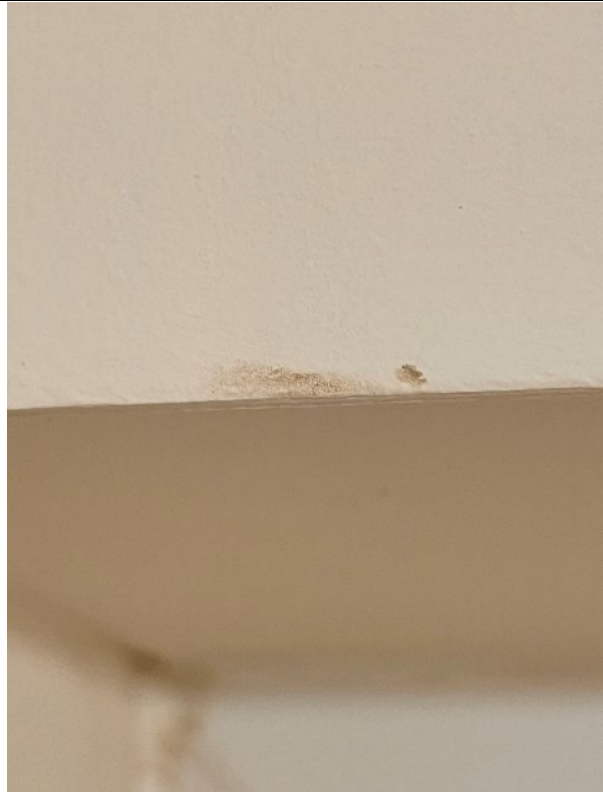
Wall marked above the door on
the corner of the reveal

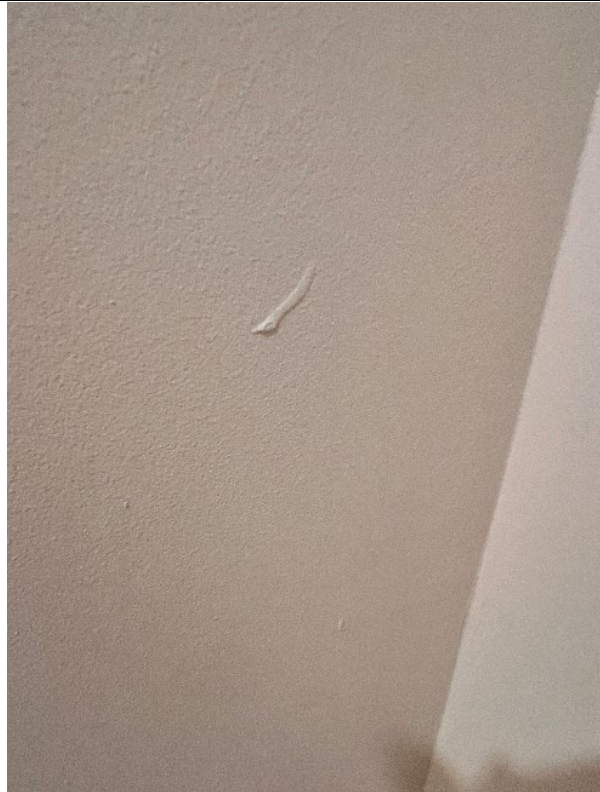
As above, decoration required.

I advise my client to request a full re decoration within his area as localised could make the walls look patchy

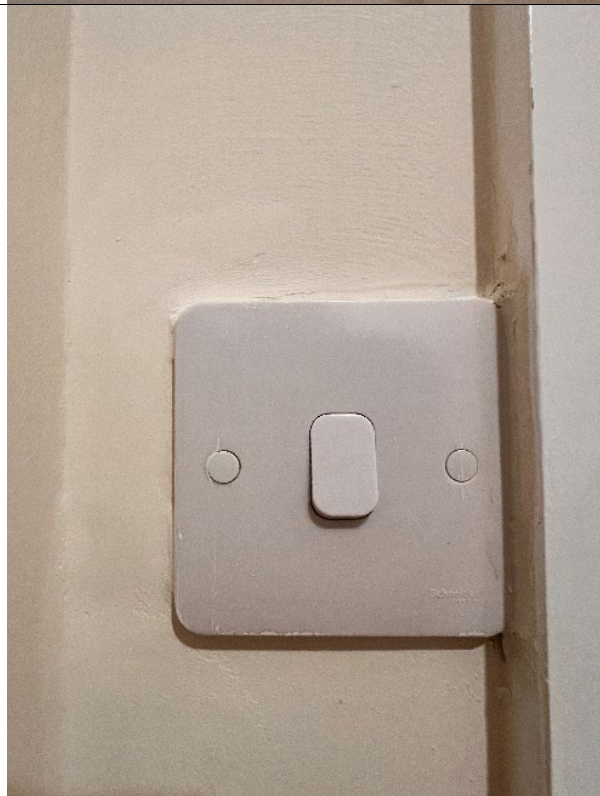
Decoration around the light switch needs attention

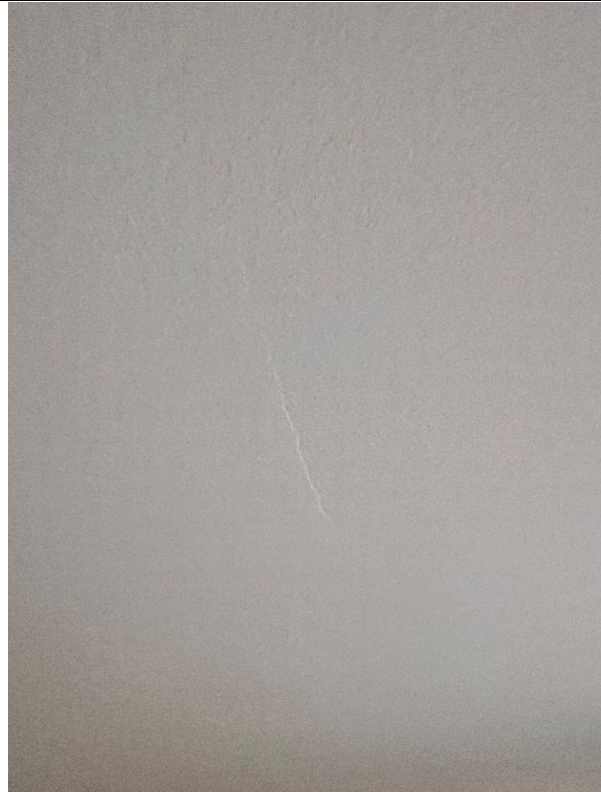
More decoration needed

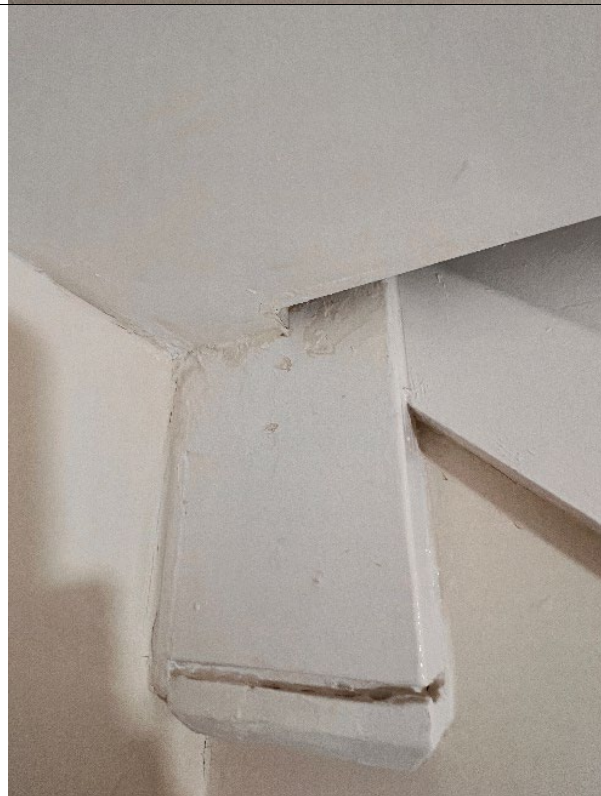
The decoration around the base of the newel post needs attention

Property needs a spark clean before handover to my client

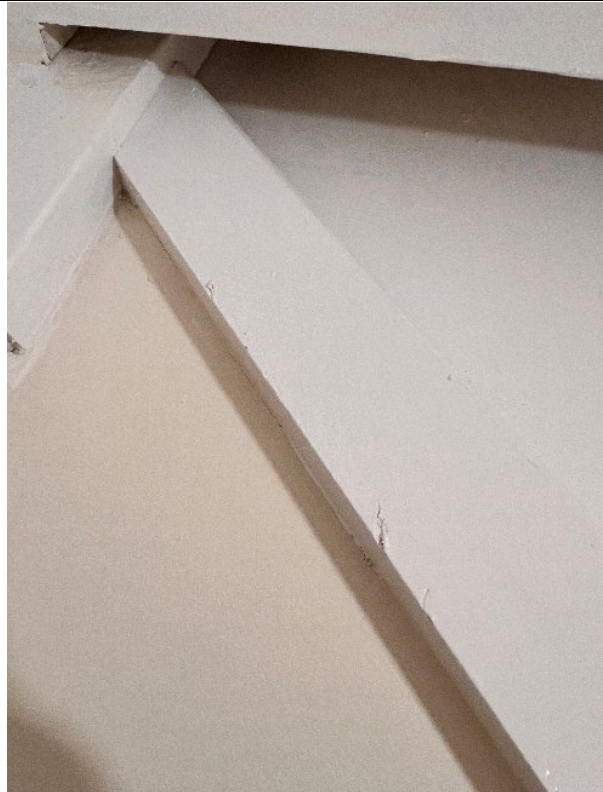
This area on the staircase needs further decoration.

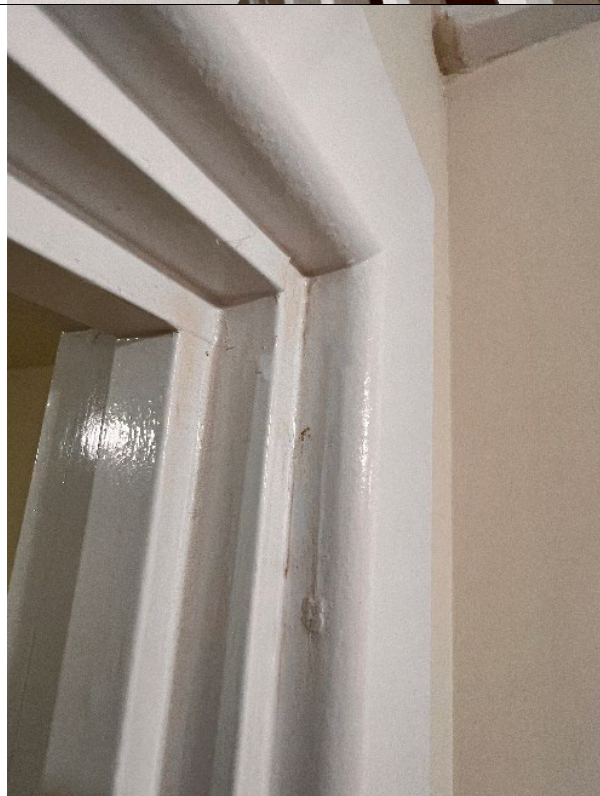
The architrave on all the doors throughout the property needs to be cleaned, sanded and painted

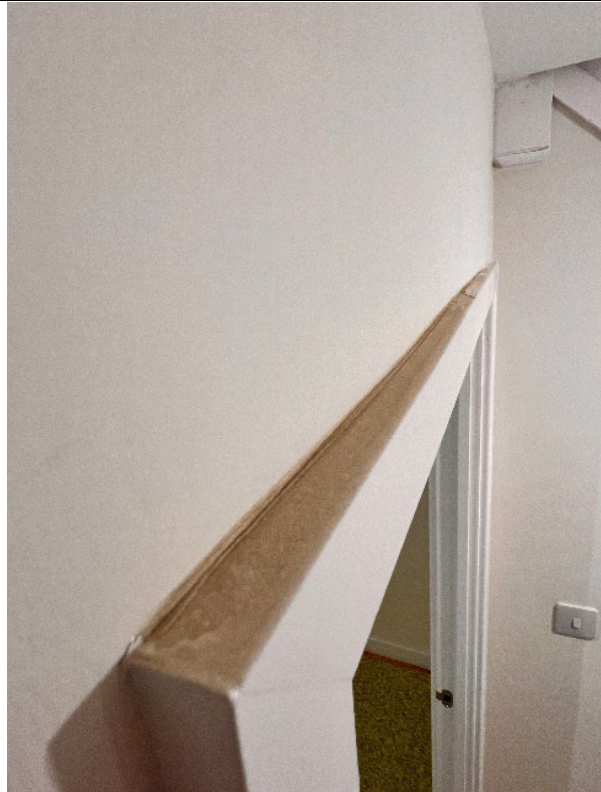
Again, more decoration is required to the stair handrail and spindles

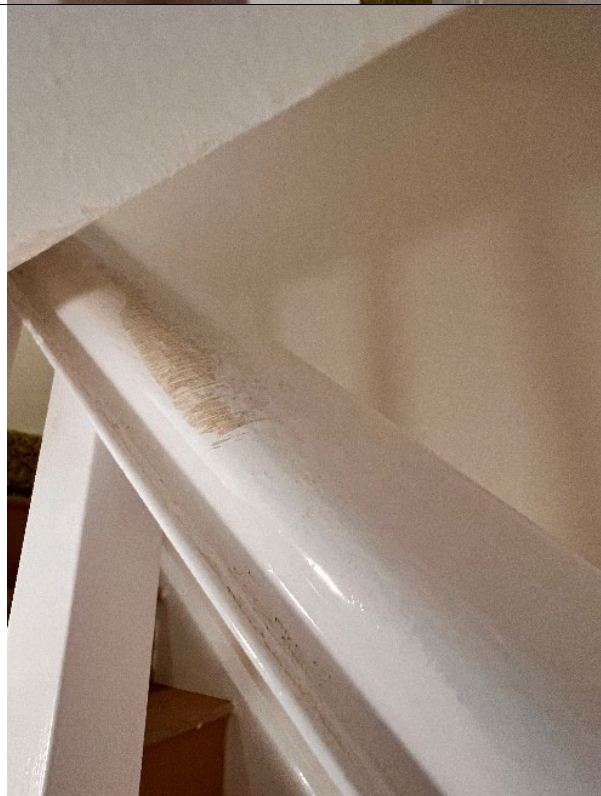
As above, decoration required

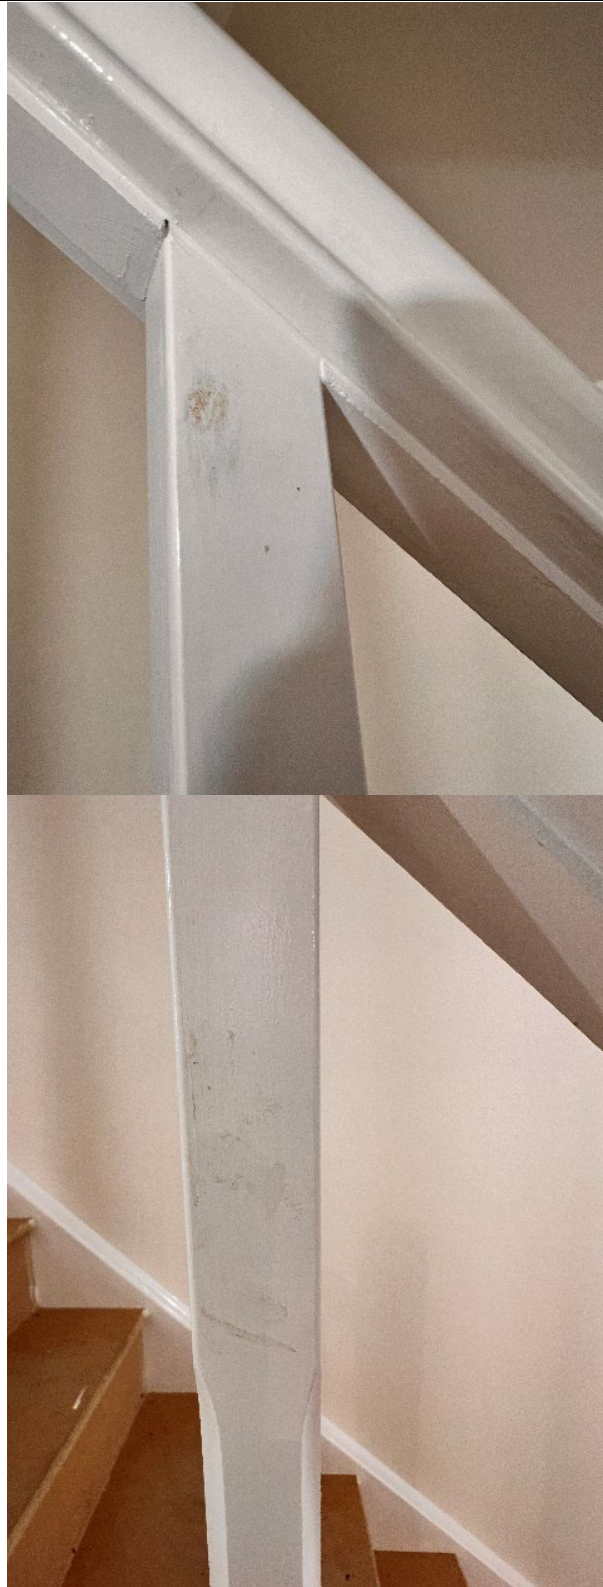
As above

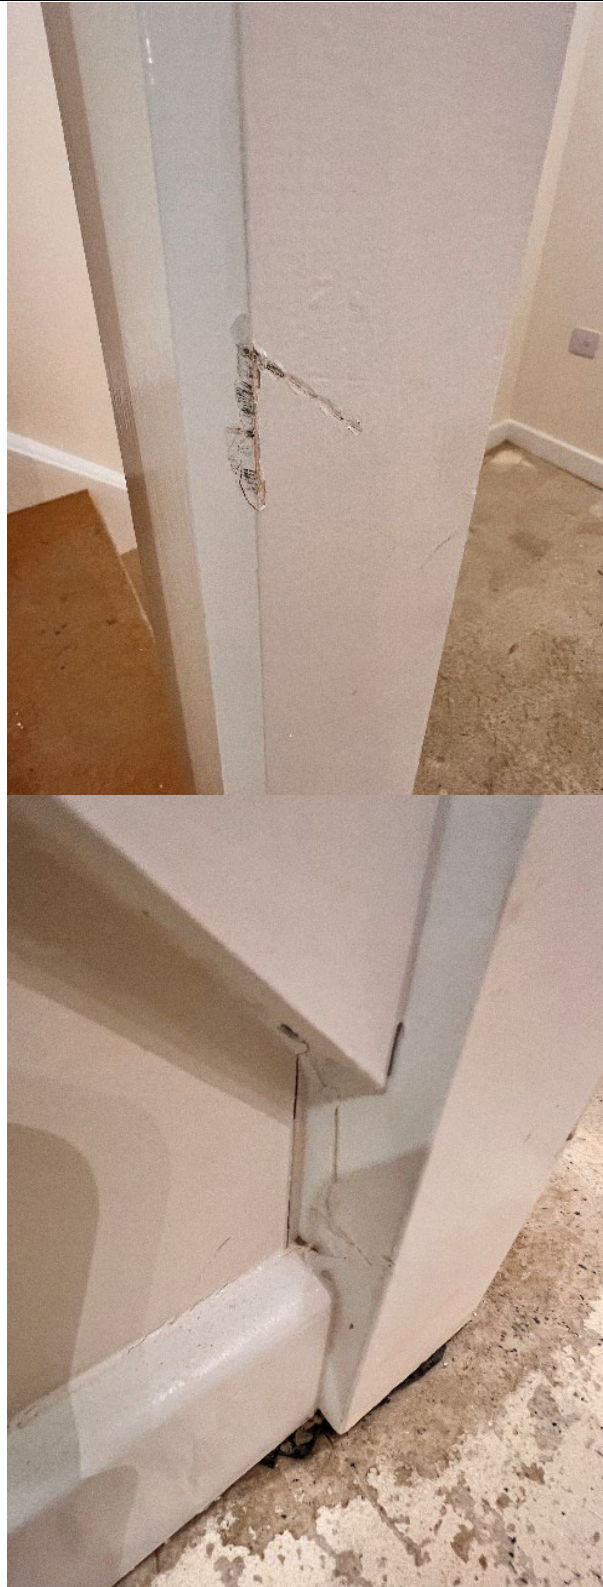
Clearly this property hasn't had a builders clean or sparkle clean prior to handover to my client

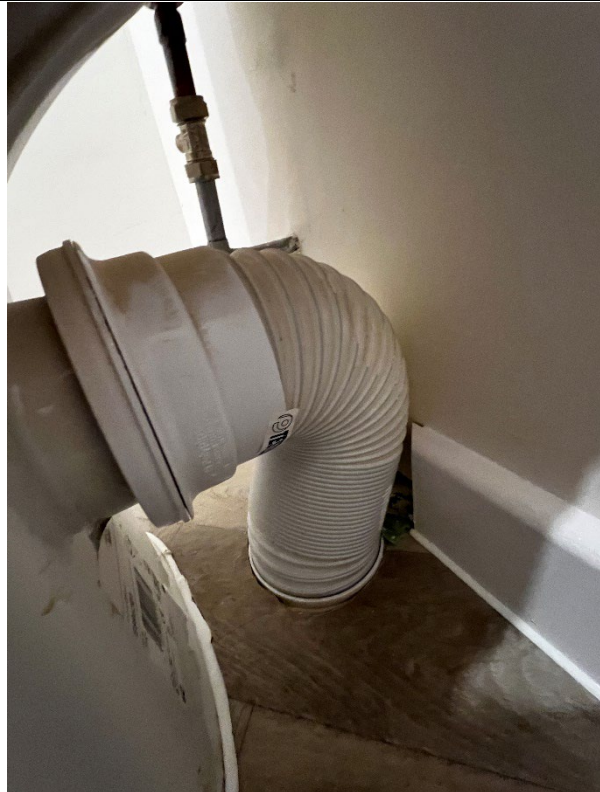
Plastic needs to be removed from behind the waste pipe and properly filled and decorated

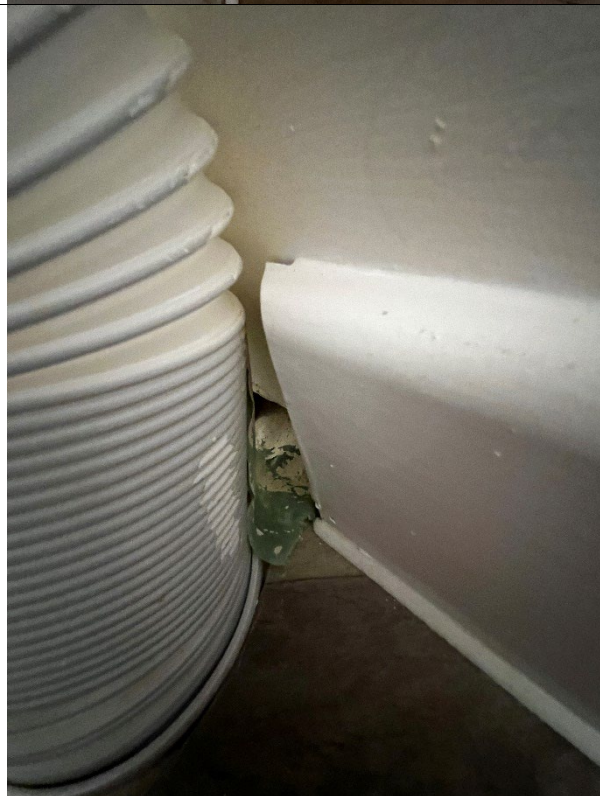
This corner needs a lot of decoration , filler, sanding and painting to make good

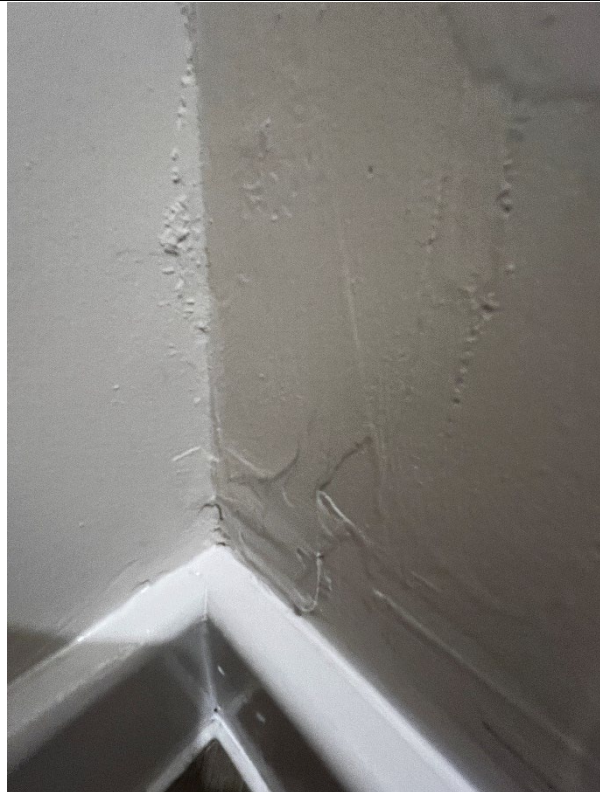
Vinyl around the soil pipe is cut too short and need attention

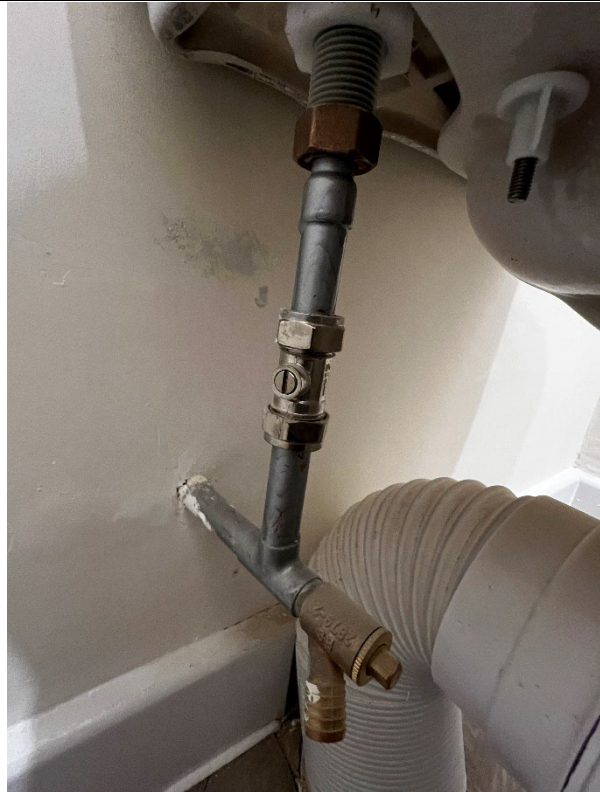
More decoration issues

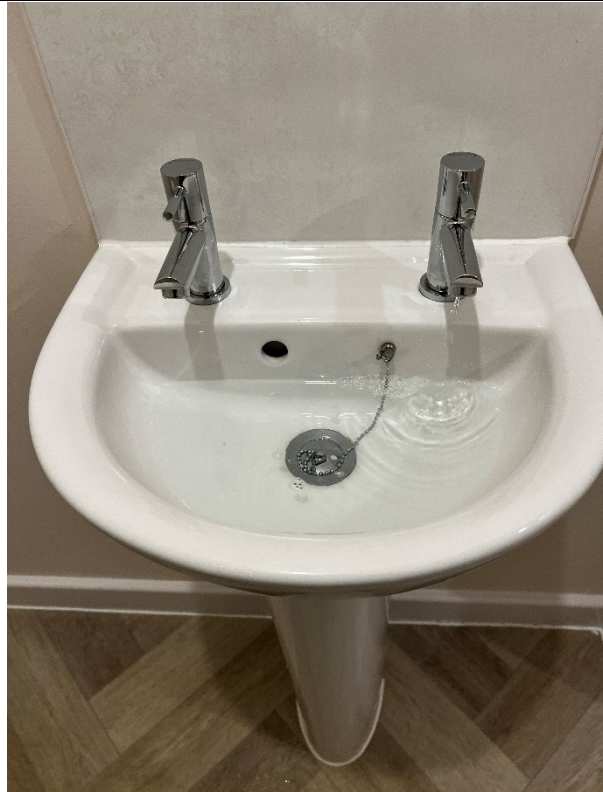
Decoration required

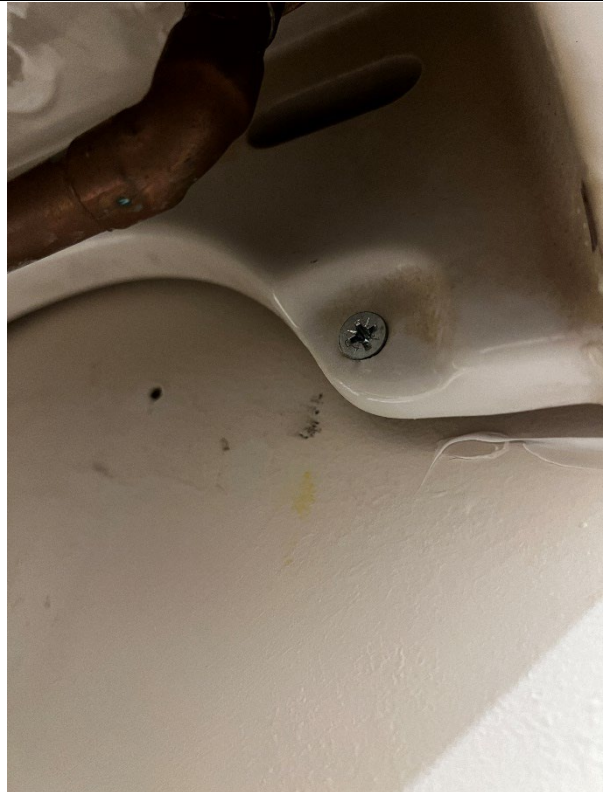
More decoration is required

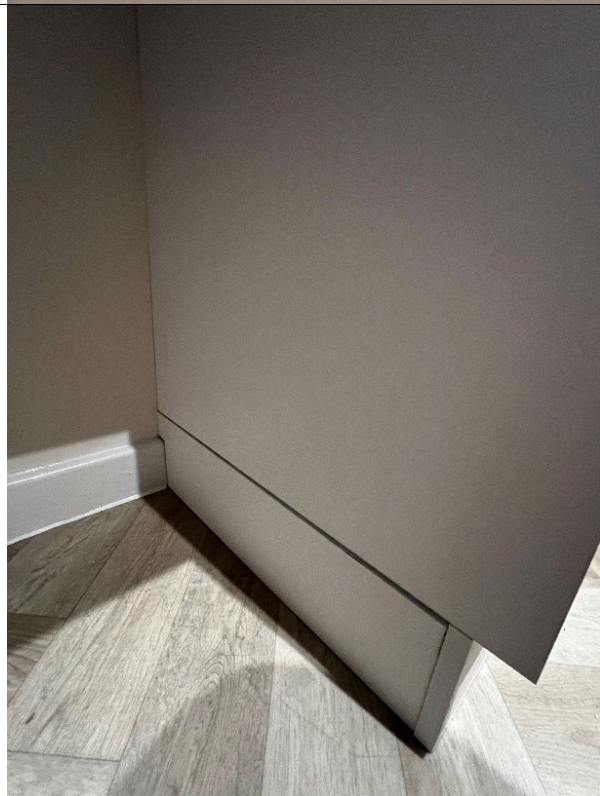
Holes needed in the side panel so my client can plumb in his washing machine

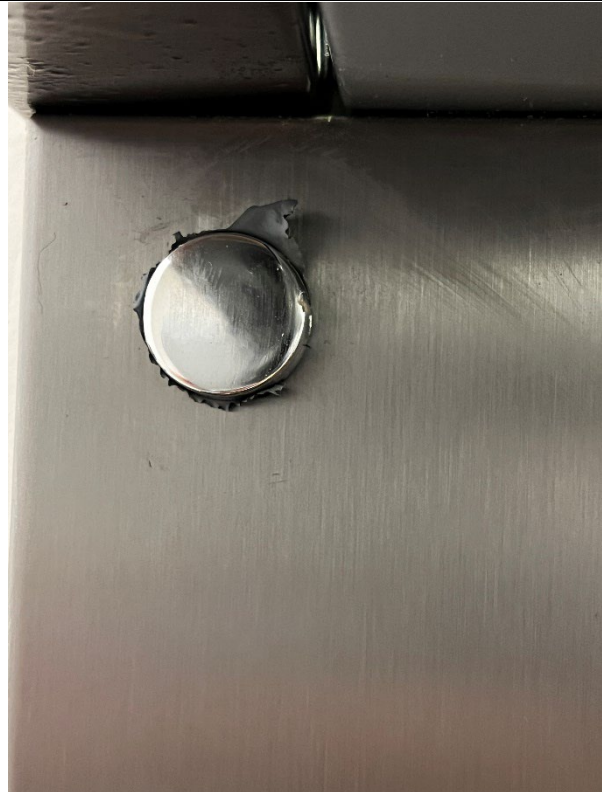
Plastic protection has been left
on the screws on the cooker
splashback. Attention to detail

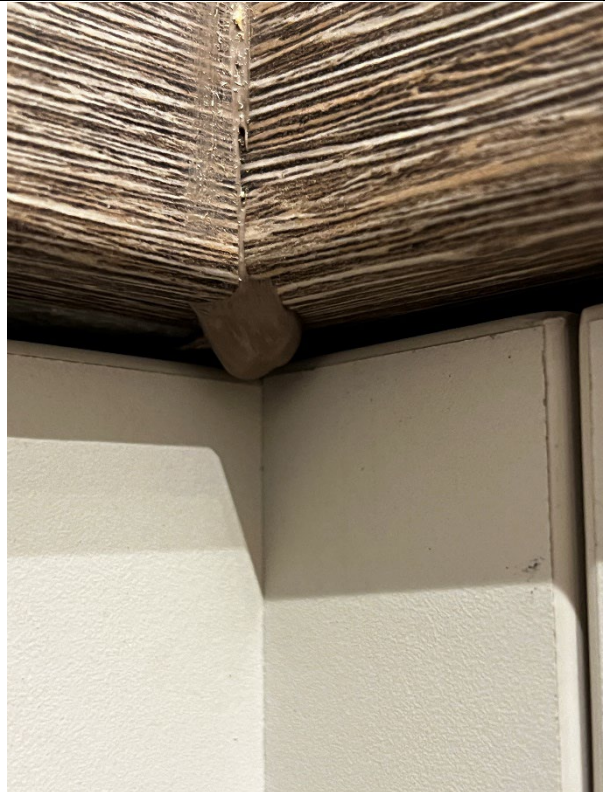
Colour fill left under the worktop joint

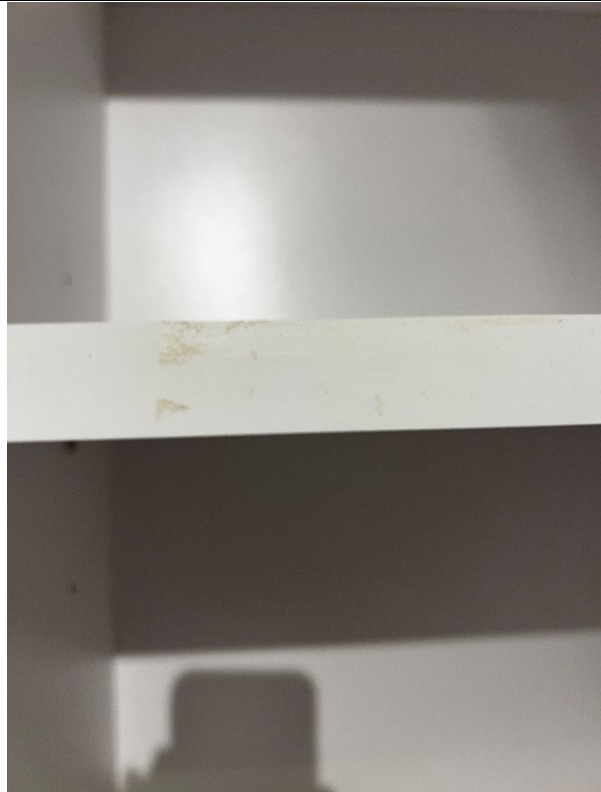
Marks on shelf inside base units
and wall units

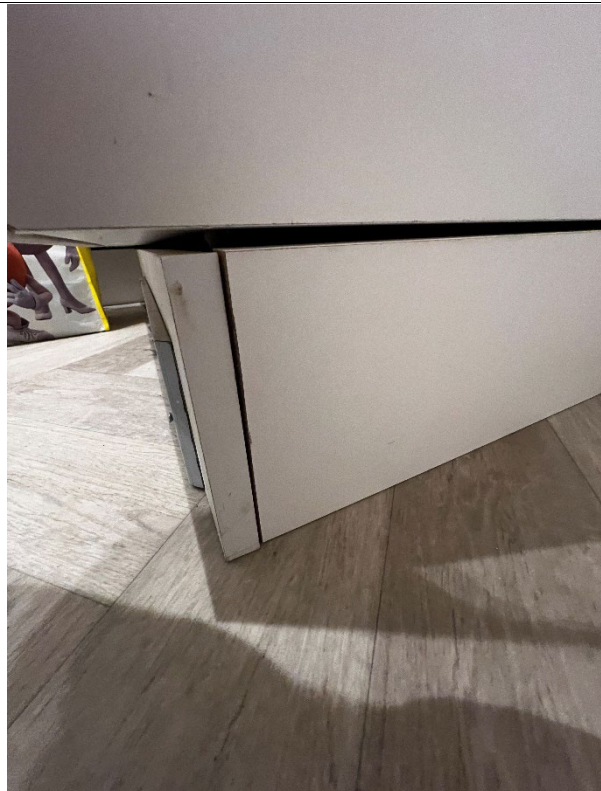
The plinth needs properly
clipping and where are the plinth
end covers?

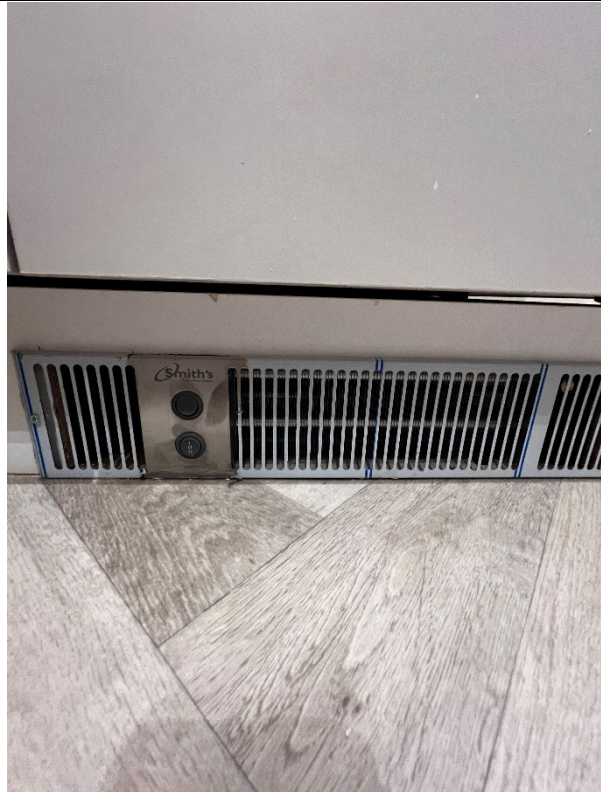
Floor heater/ ventilation requires protective film removing

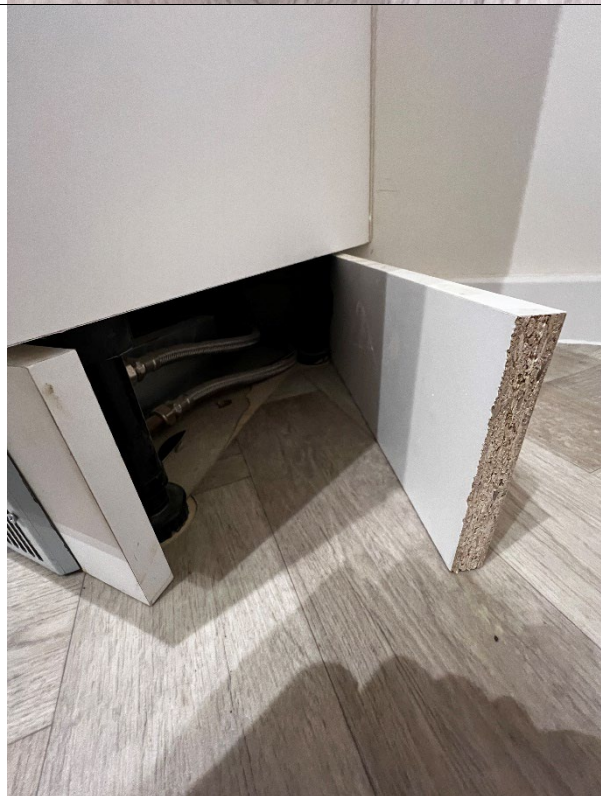
Plinth needs securing properly with clips and there is rubbish behind that needs cleaning out

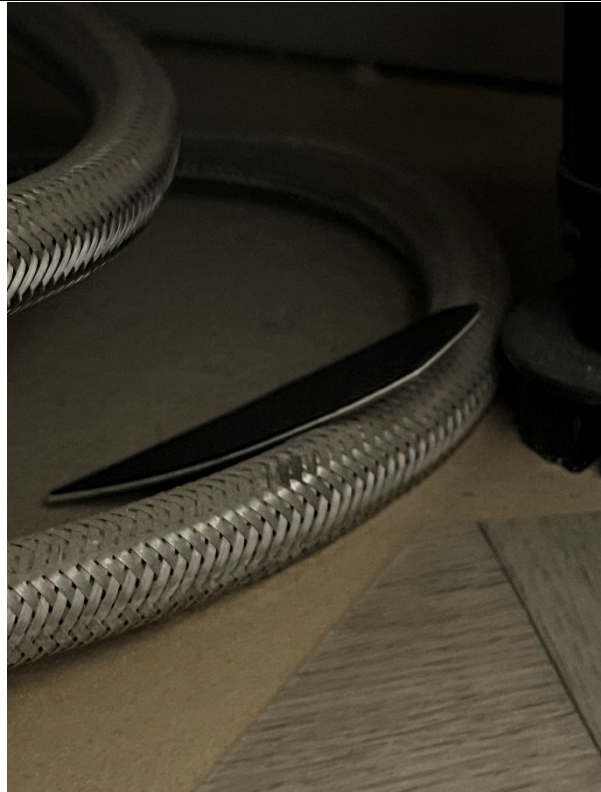
As above, rubbish needs cleaning out from under the base units

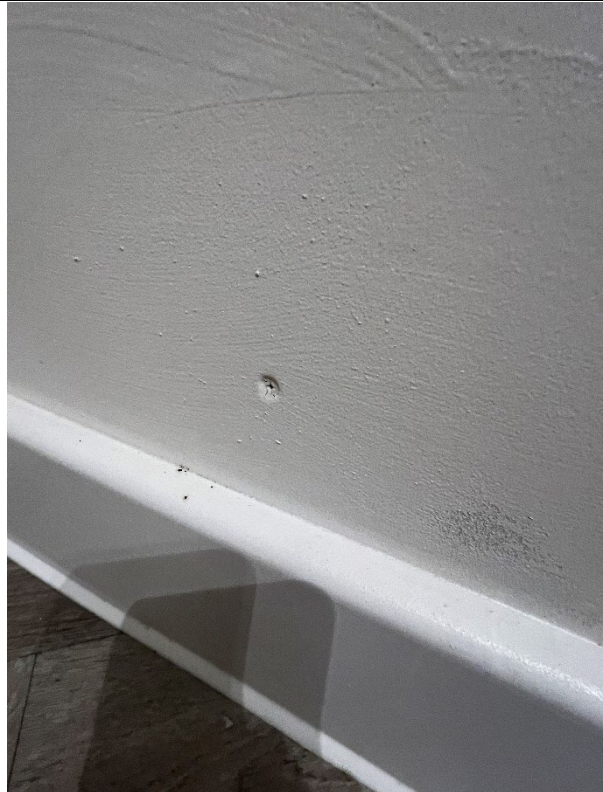
Screw head popping through ,
needs filling and decoration

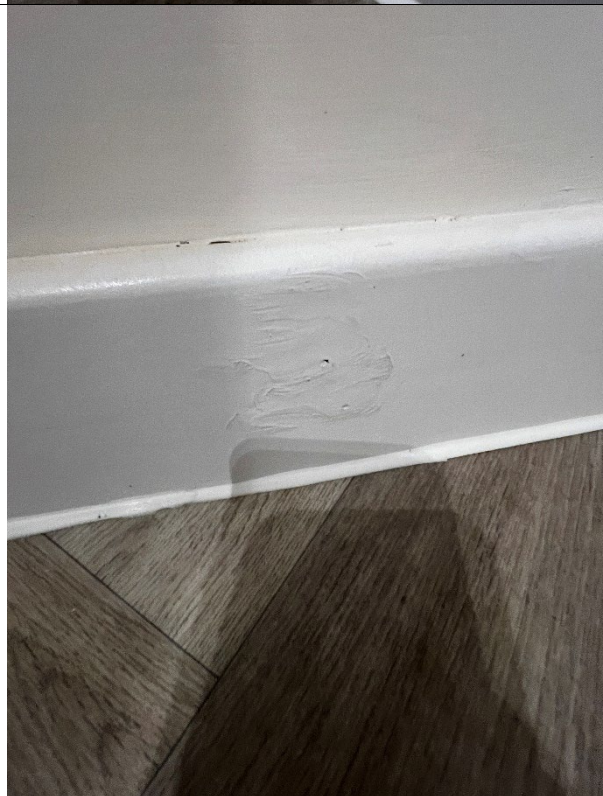
Decoration is poor to the skirting
and needs addressing

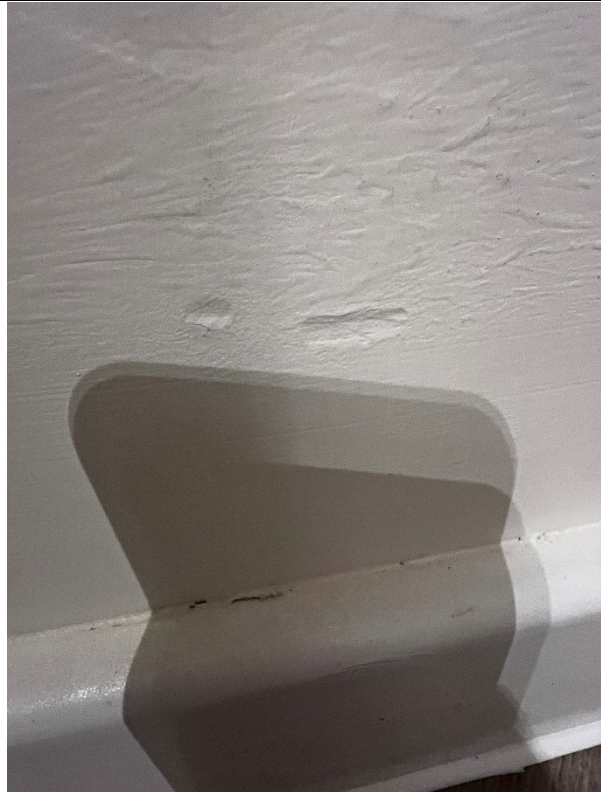
Poor decoration

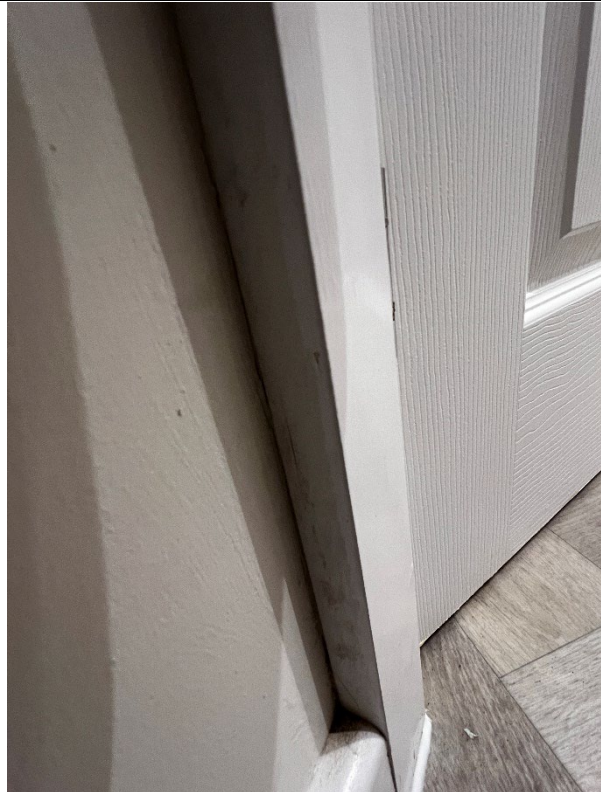
The rear of the door architrave
needs decoration

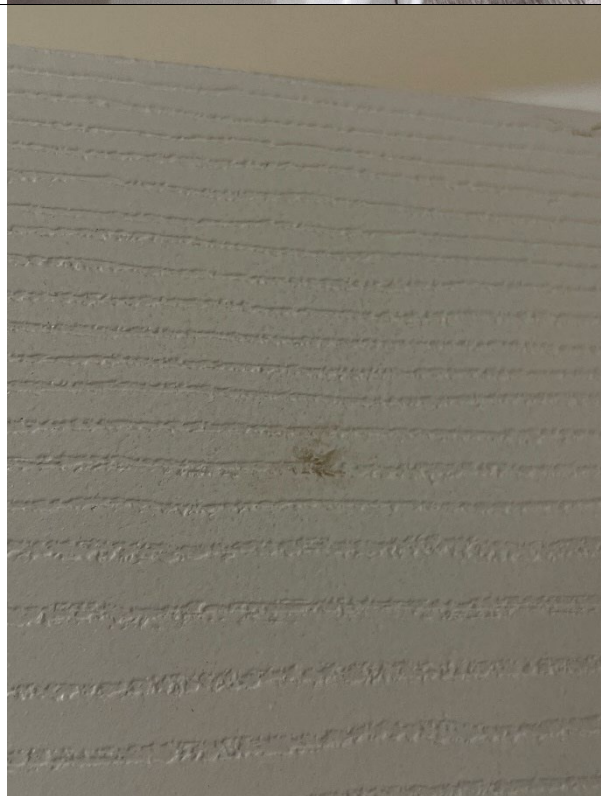
Door needs decoration

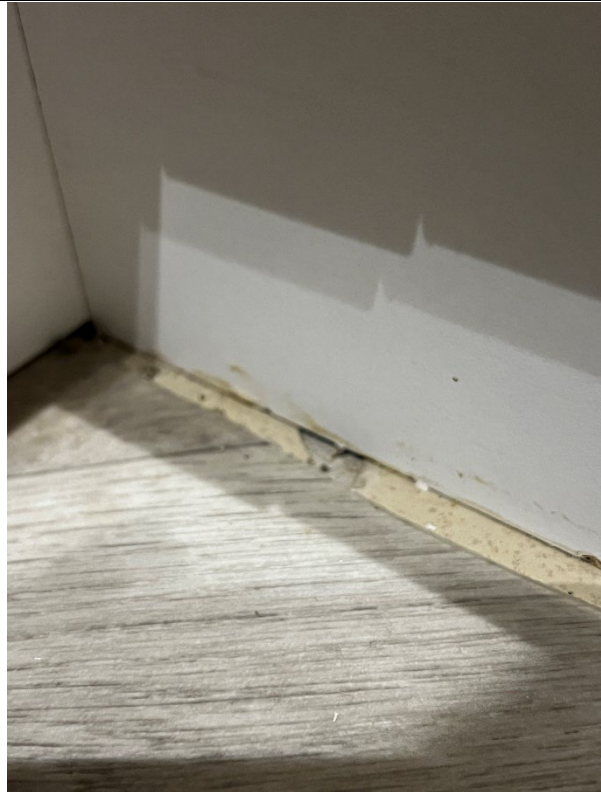
This needs to be tidied up!

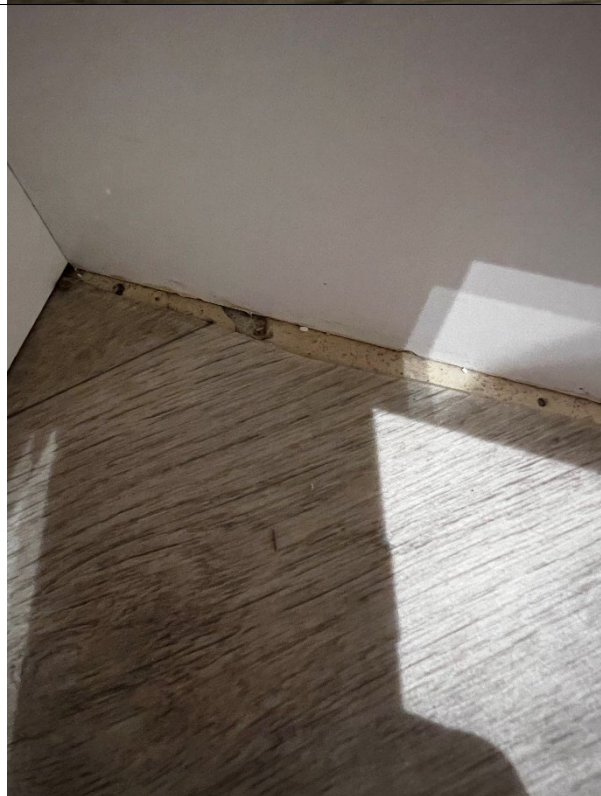
The flooring in the kitchen has been cut too short and is visible and will need to be replaced

The vinyl flooring has been cut too short and we can see the concrete screed below, this will need to be taken up and relayed fully

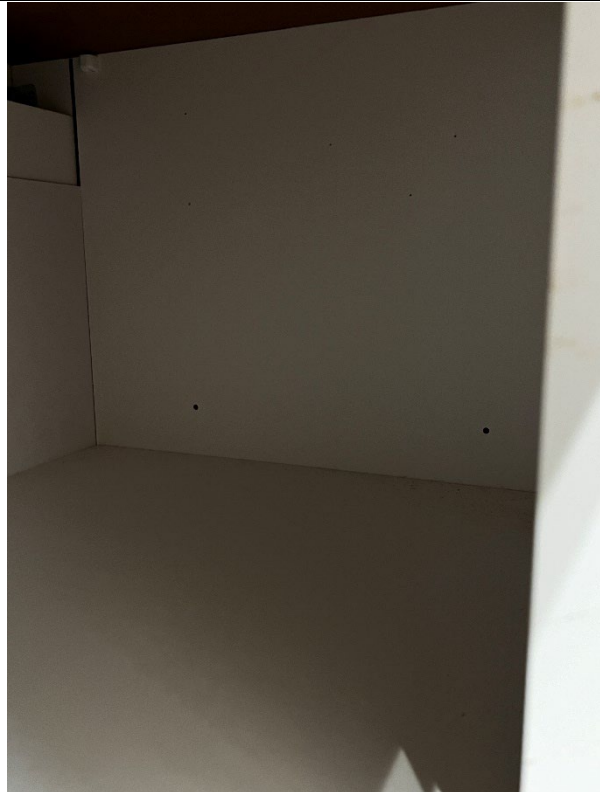
Holes at the back of the base unit in the cupboards needs covers or filling

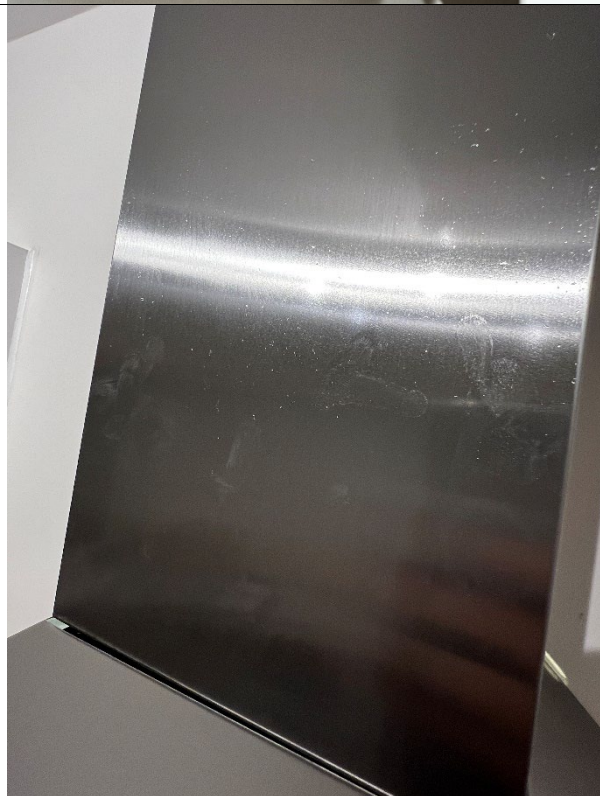
The cooker hood is greasy and needs cleaning. It also needs to be fitted correctly

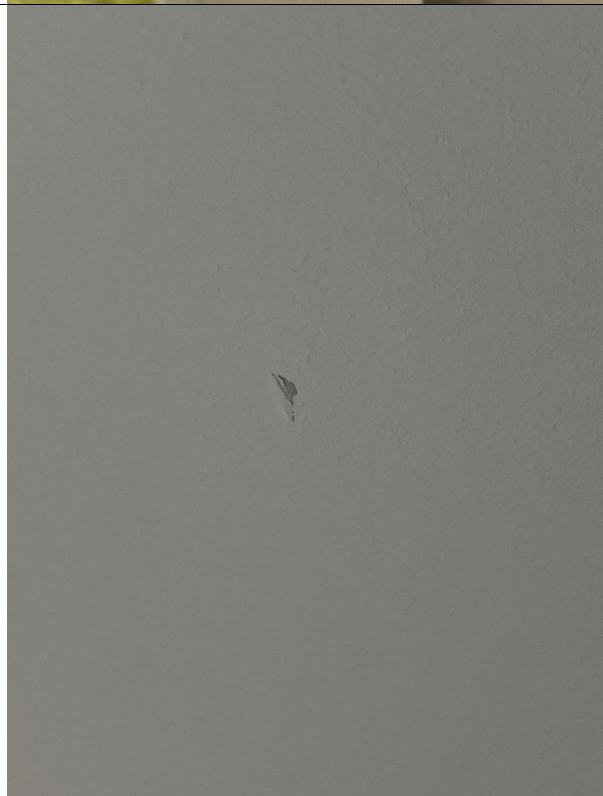
More decoration required
