PROFESSIONAL
SNAGGING
SURVEYS

LAUREN HOUSE

25TH JANUARY 2025

Instruction was received on 20th January 2025 to undertake a snagging report of the property at Lauren House, Example Rd, GL20 7GG. The survey was carried out on 25th January 2025.

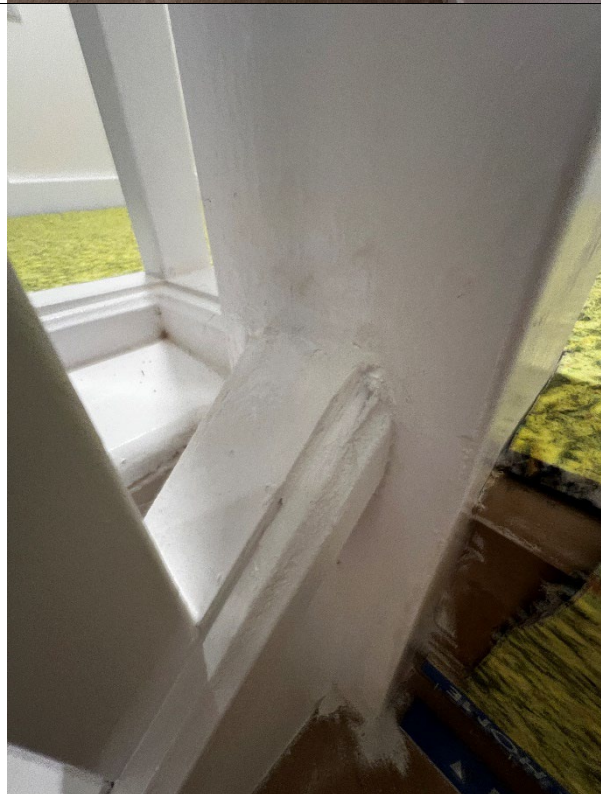
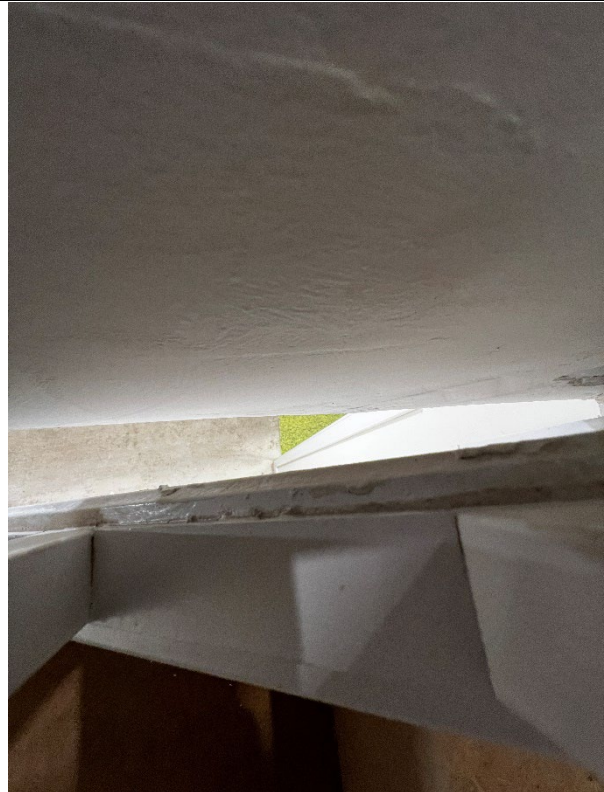
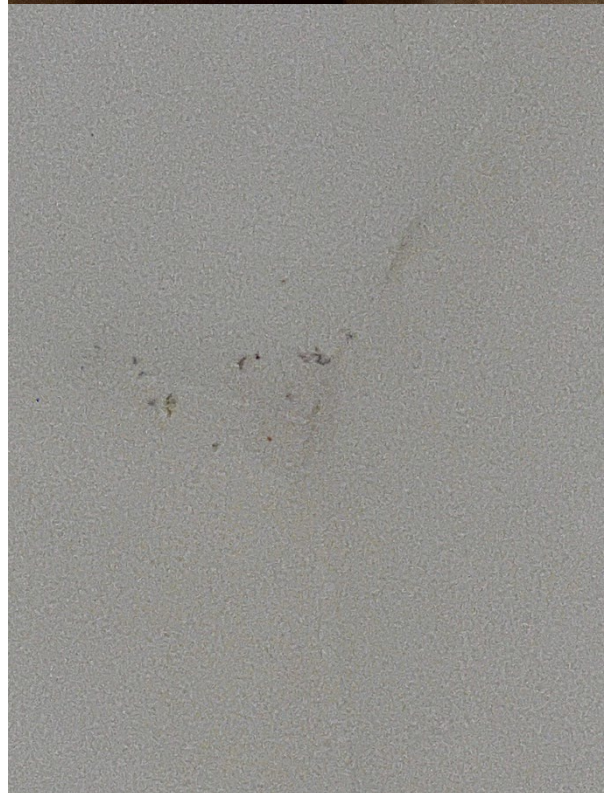
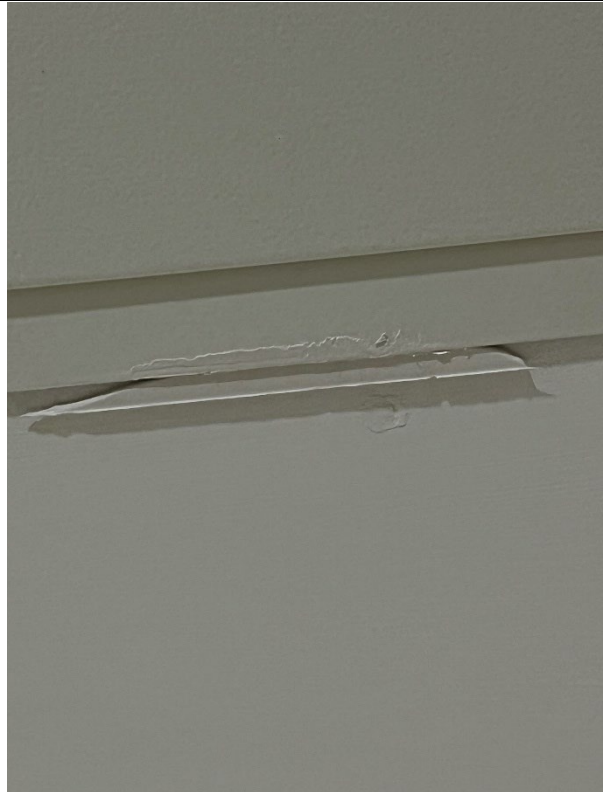
The staircase needs a lot of decoration, there are areas than need filling and decoration as you can see from the following picture

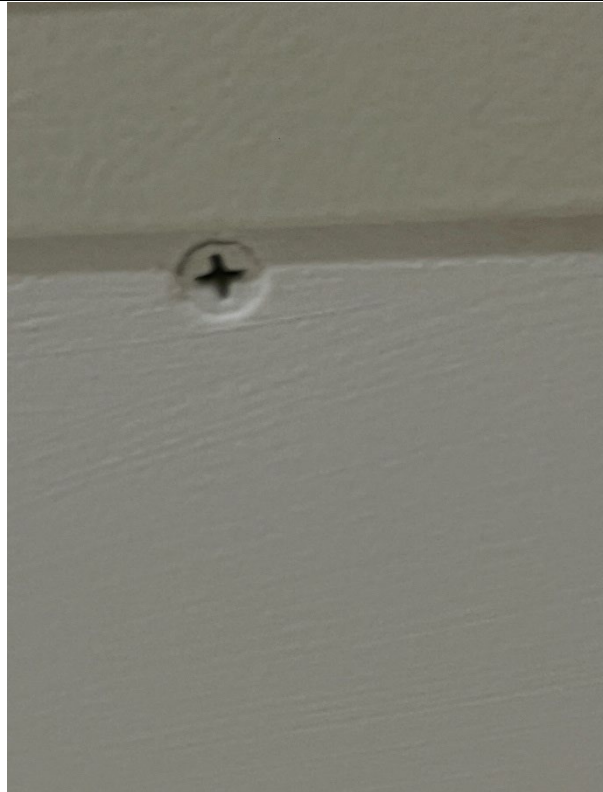
Screws are visible around the loft hatch , they need filling over , sanding and decoration

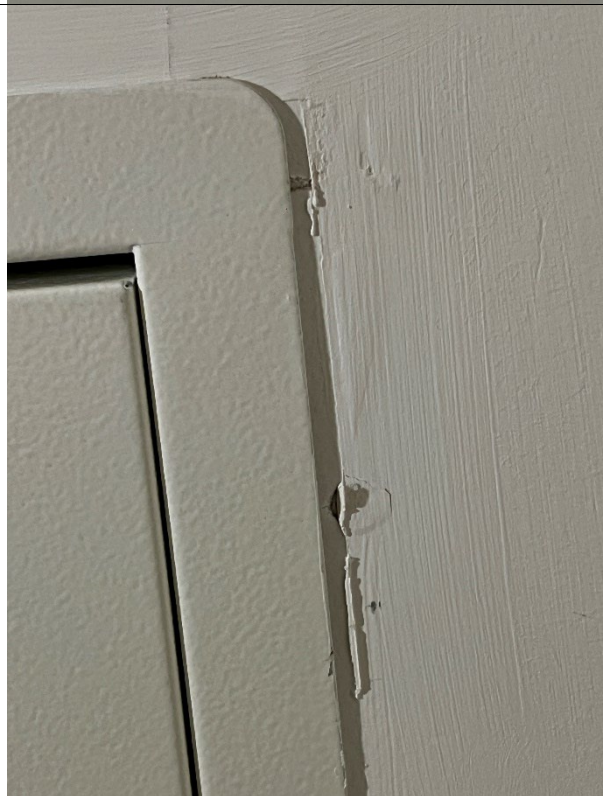
Around the loft hatch needs decoration and making good.

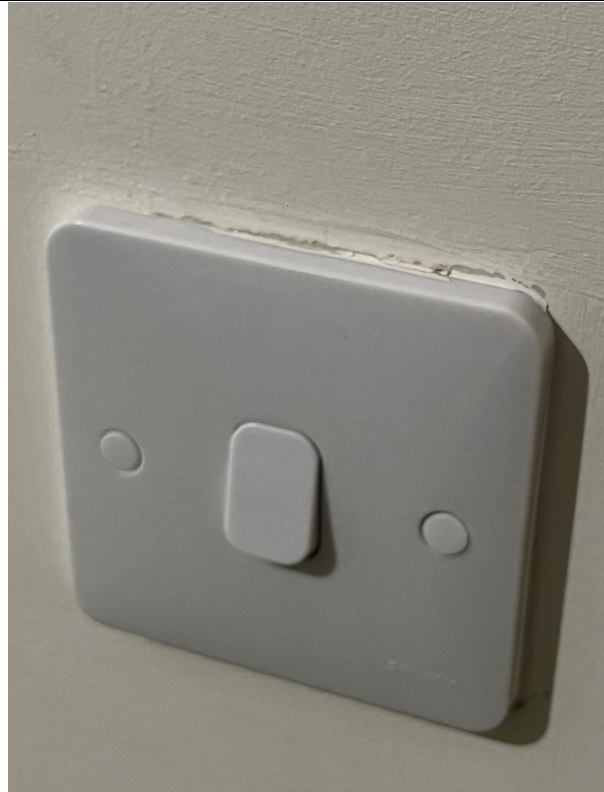
Decoration required around the light switch

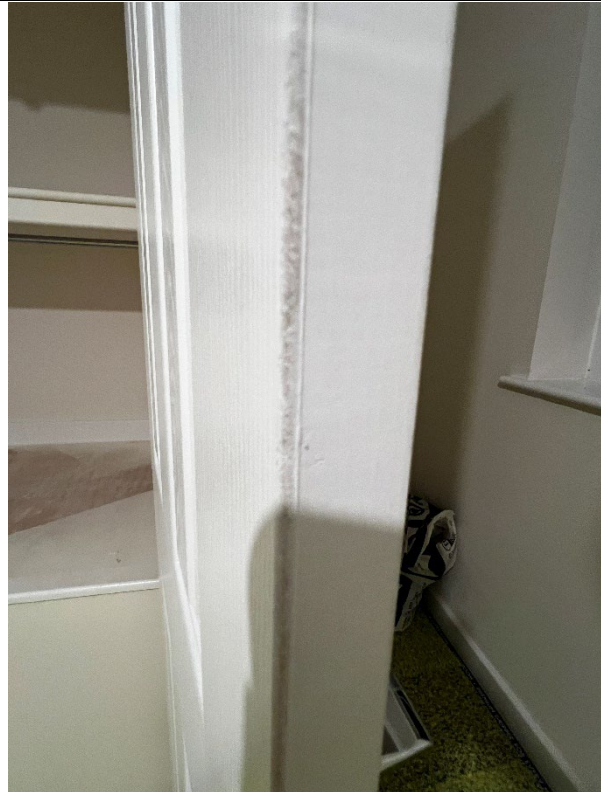
Decoration is poor and needs addressing

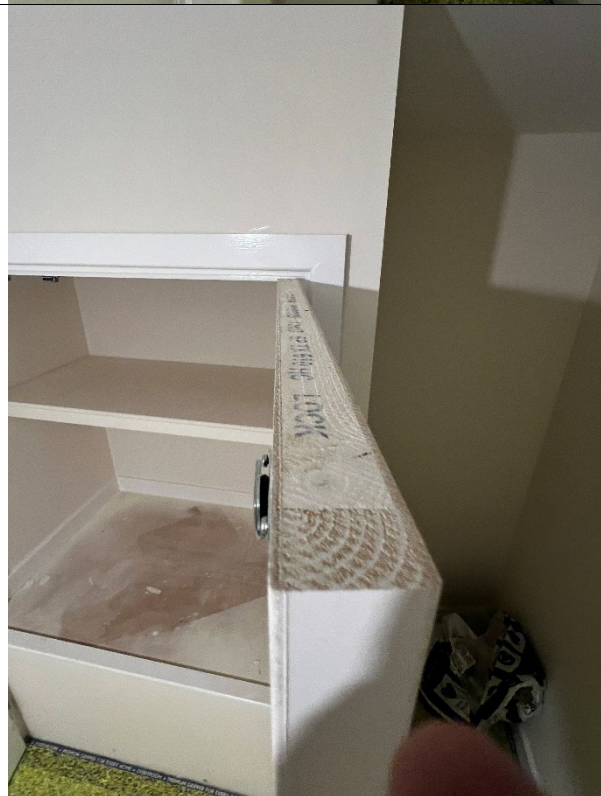
Top of the door needs decoration, again this is throughout the whole property and needs to be addressed

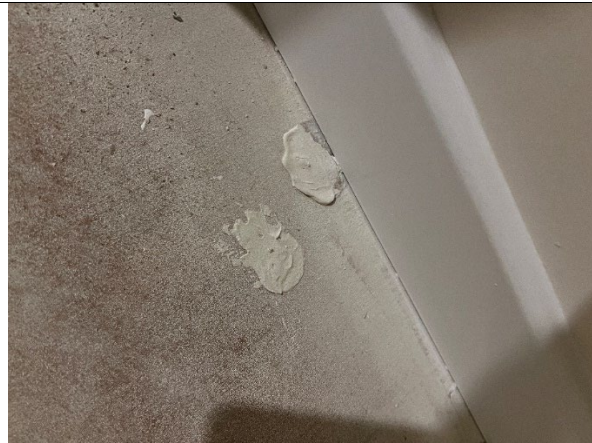
Filler left on the floor.

Builders clean hasn't been done,
nor has a sparkle clean

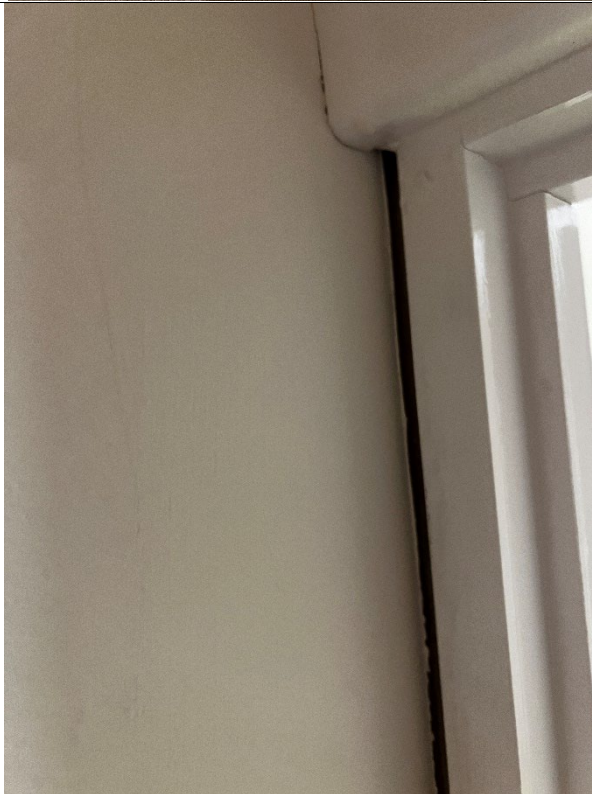
This gap in the cupboard will
need decoration or architrave
installed to cover.

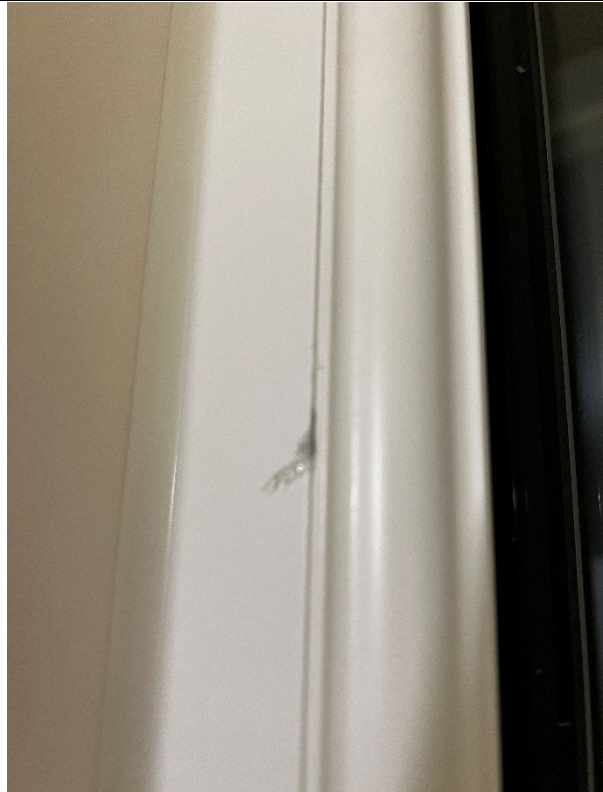
Decoration required and window frame is marked

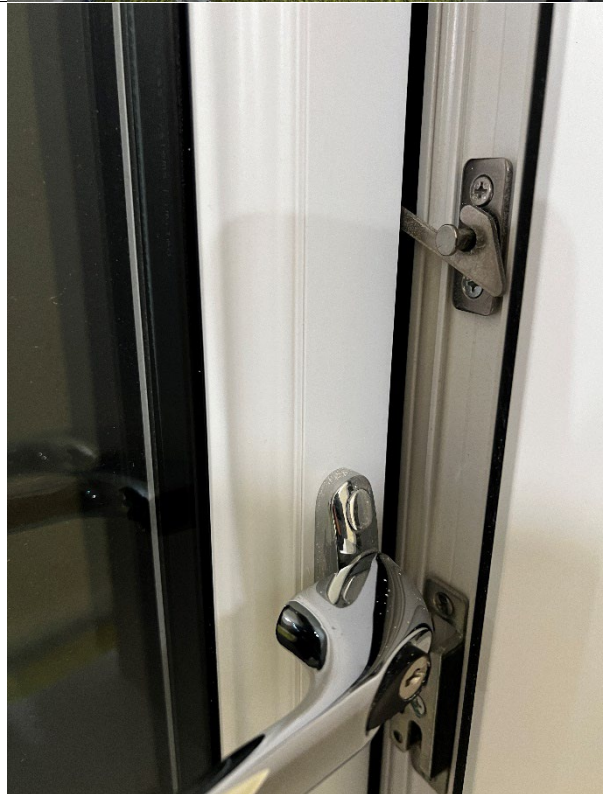
Cleaning required

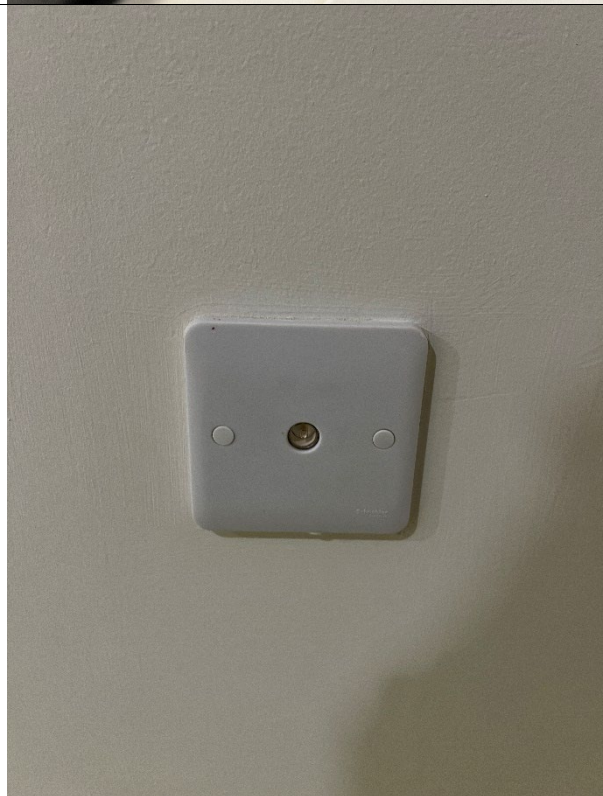
Decoration required to the top of the door and throughout the property

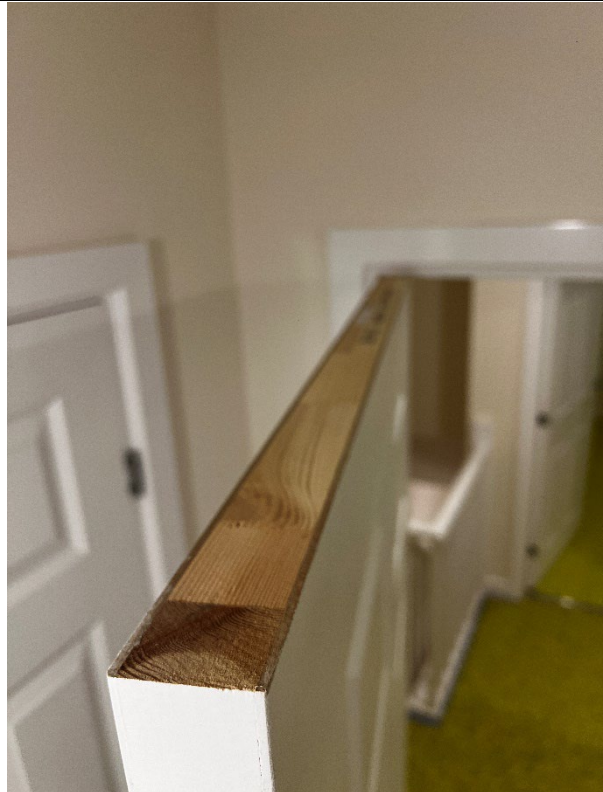
Decoration required

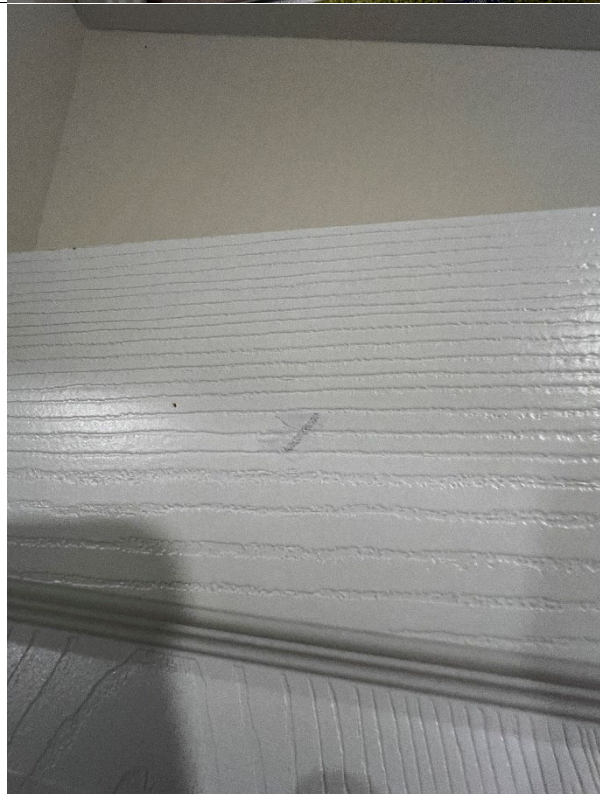
Decoration required to top of the door

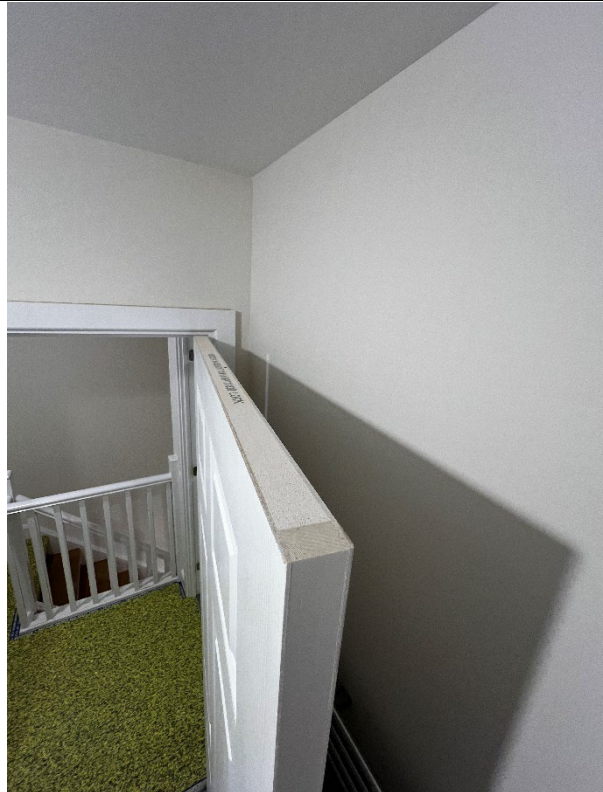
Decoration required to top of the architrave

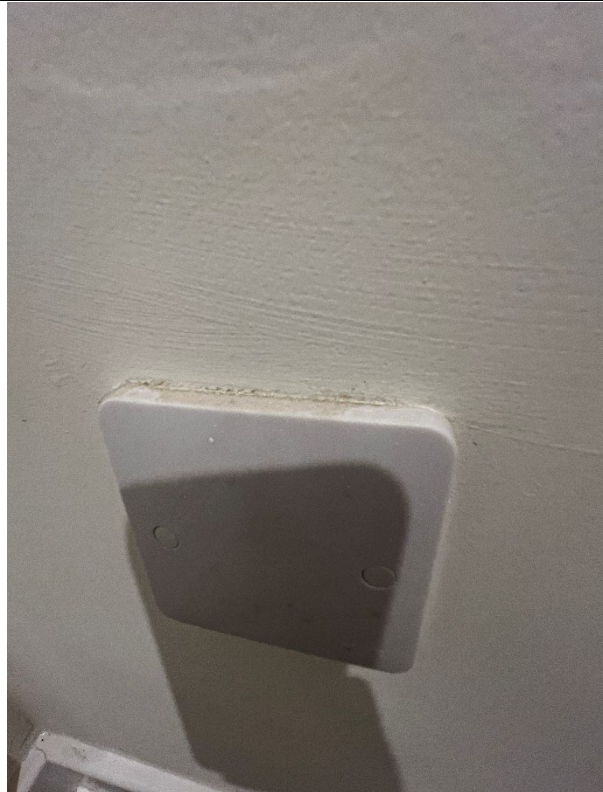
Decoration required and roses
added to finish

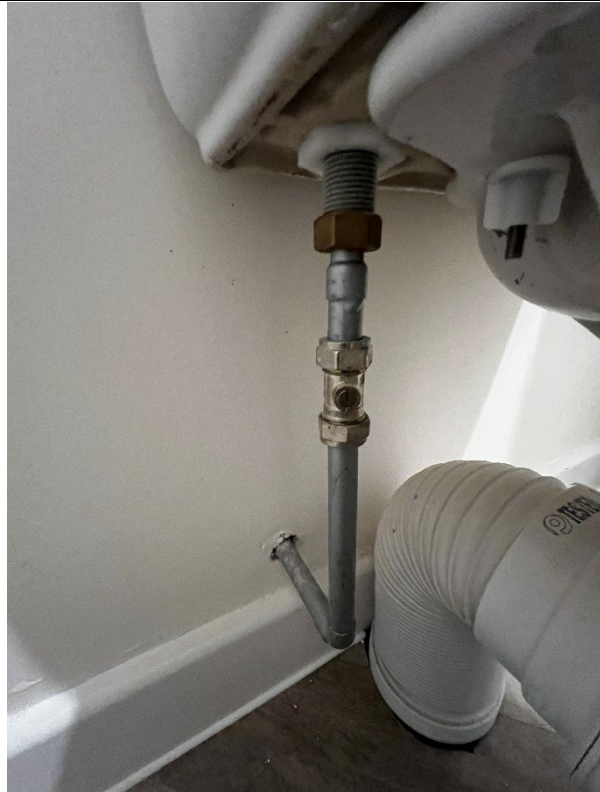
Decoration required and roses to finish

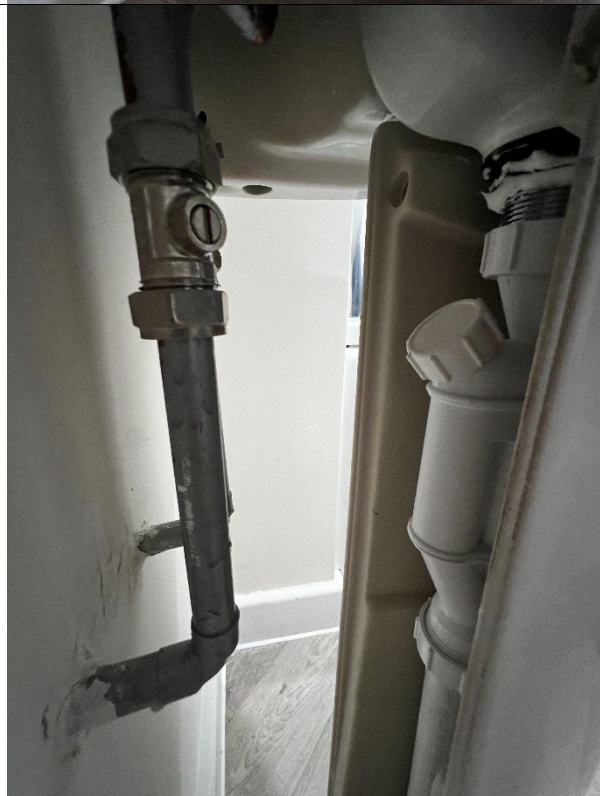
Has this house been cleaned?
This is appalling!

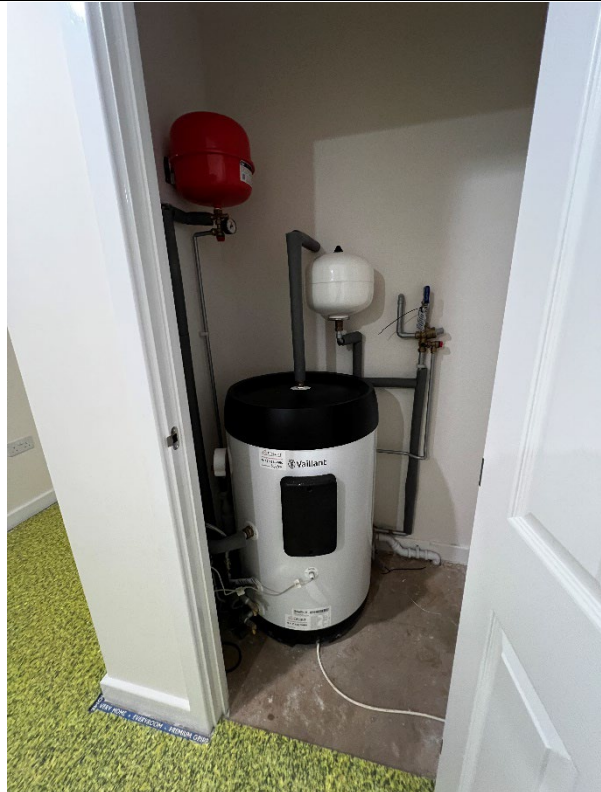
This cable will need to be installed properly

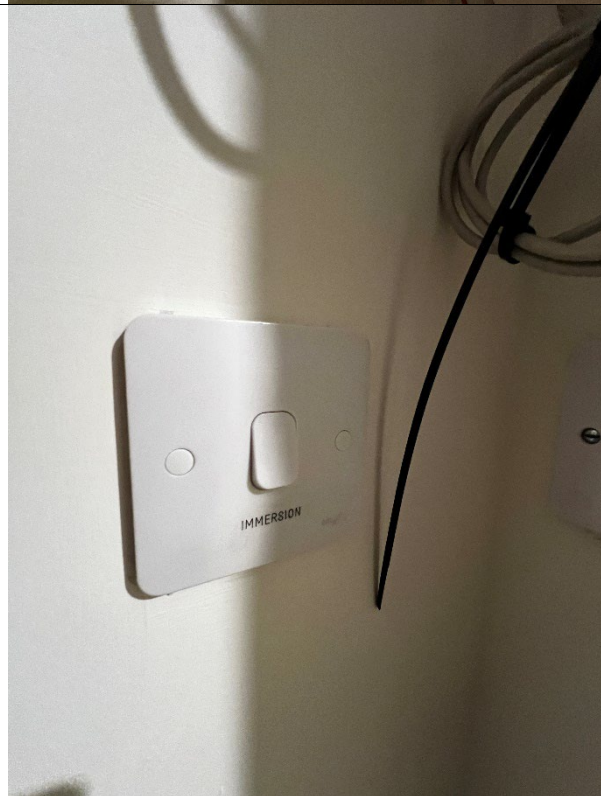
Decoration required

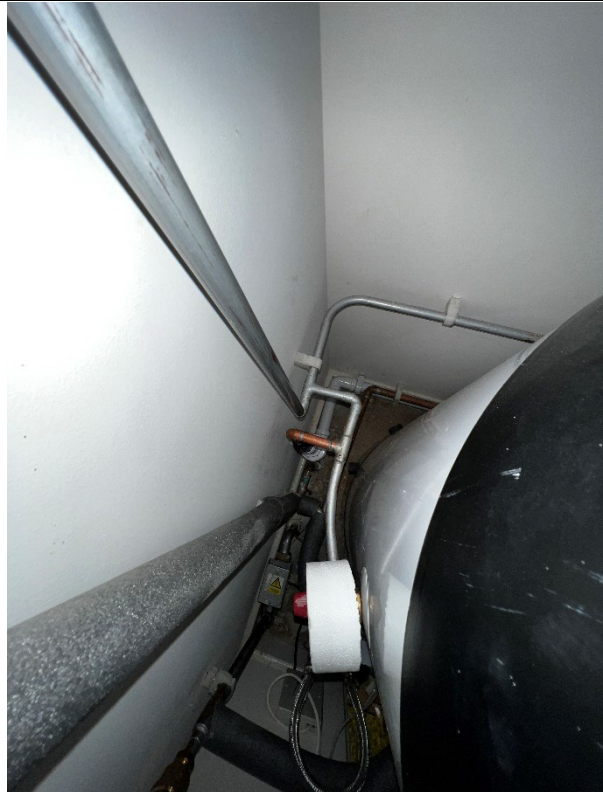
Decoration required and
cleaning.

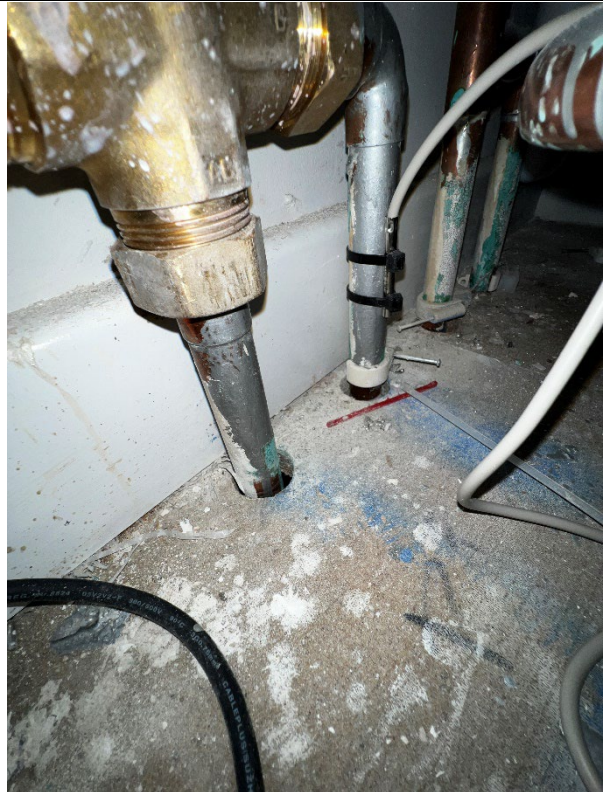
Fire stopping to floor
penetrations required here

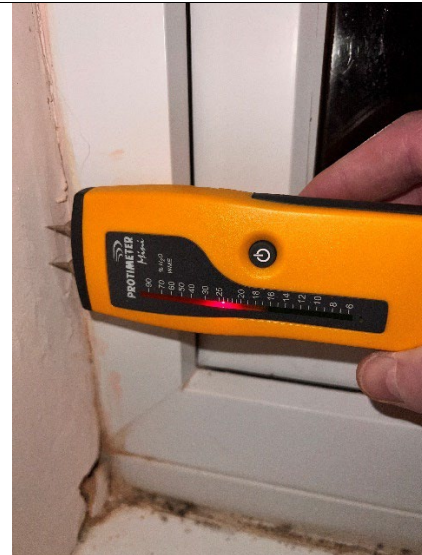
9.7°C

First image shows overview of internal window surround. Second image shows thermal image of cold spot. Third image shows the moisture meter picking up moisture. External seals need replacing.
