VILLAGE AT HAILE CONDOS

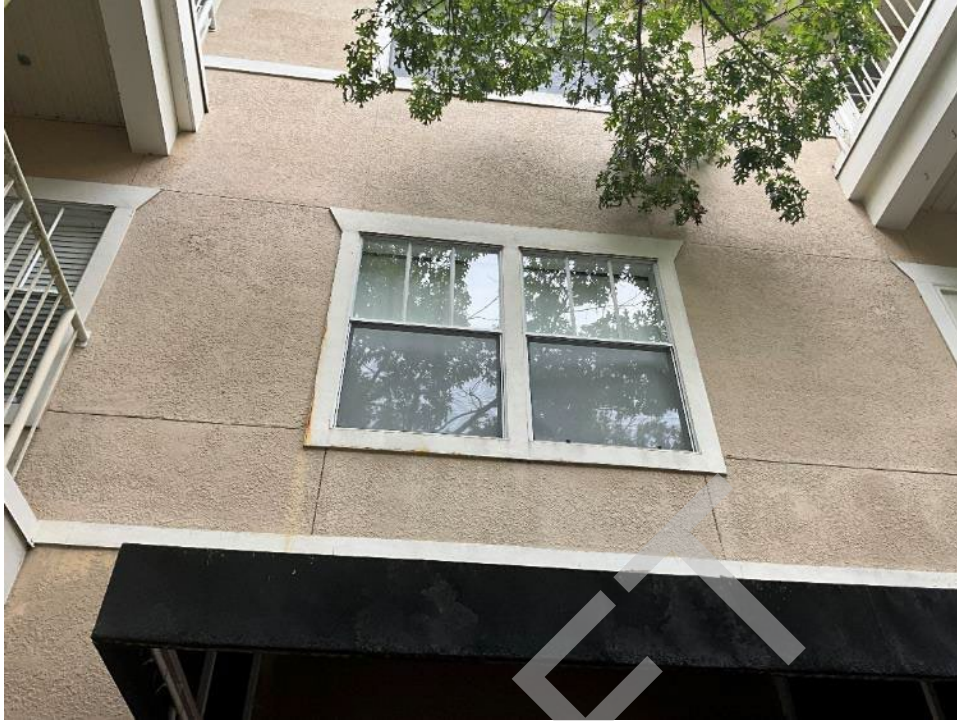
7. View of staining along the finish around the windows.

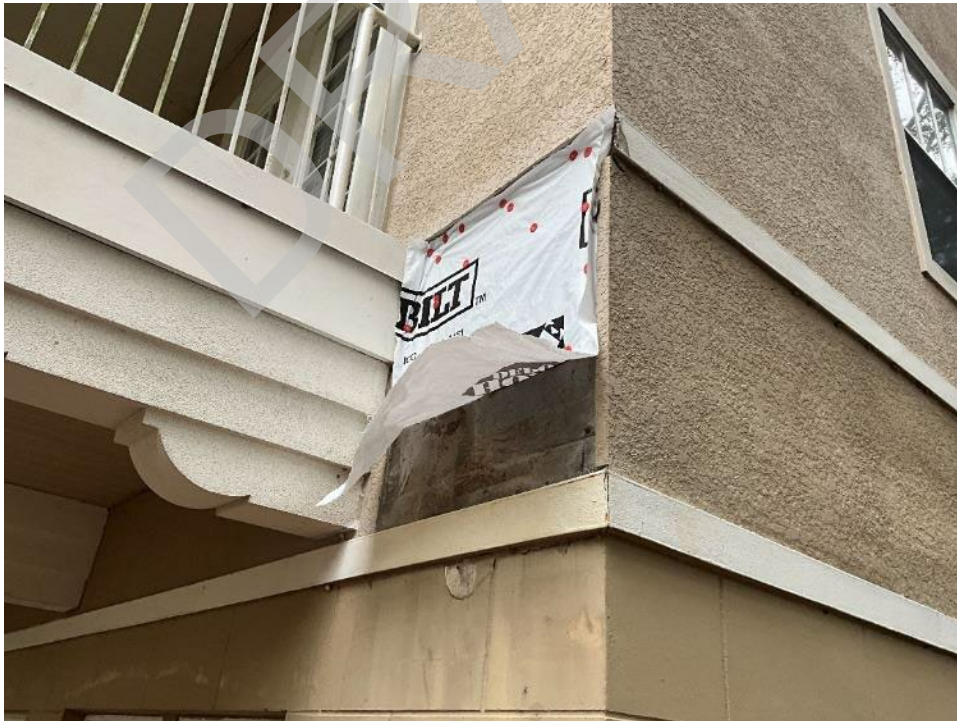
14. View of an area of Building A where stucco is unrepaired and paint delamination below.

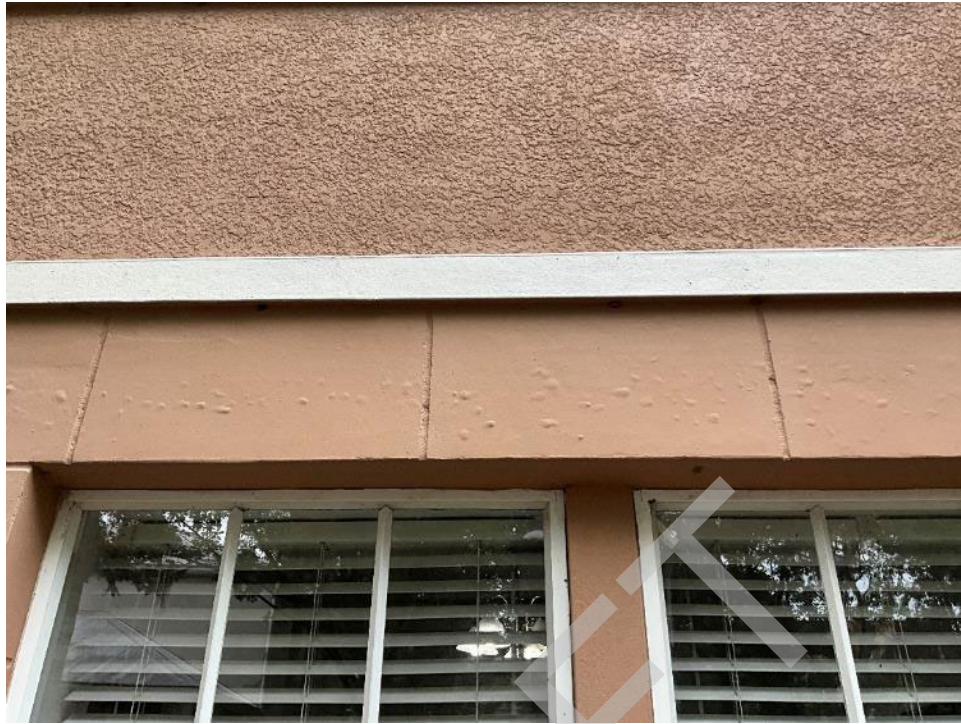
43. View of paint bubbling along all the walls.

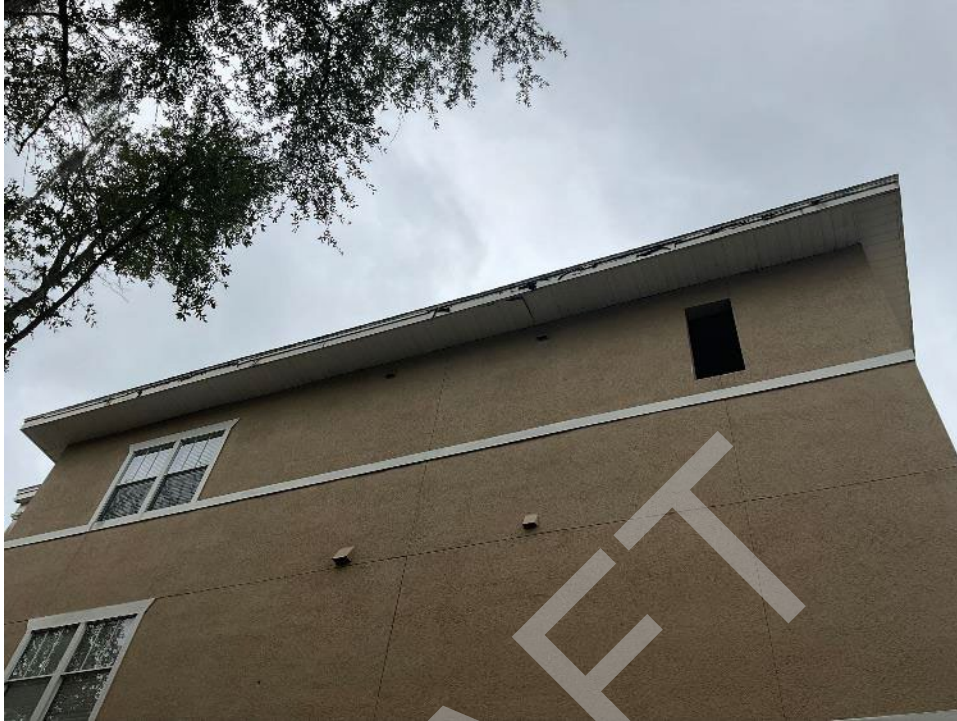
53. View of cracked section along the west elevation fascia. The fascia will need to be removed to expose the trusses for Phase II.

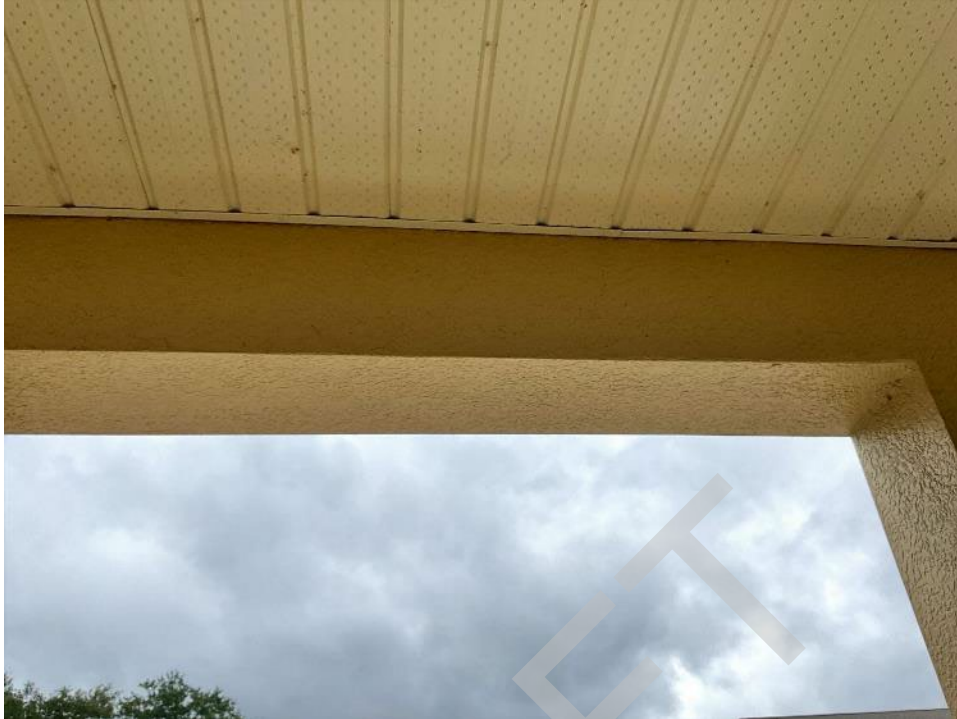
77. View of cracked section along the beam near unit G201. The stucco will need to be removed to expose the beam for Phase II.

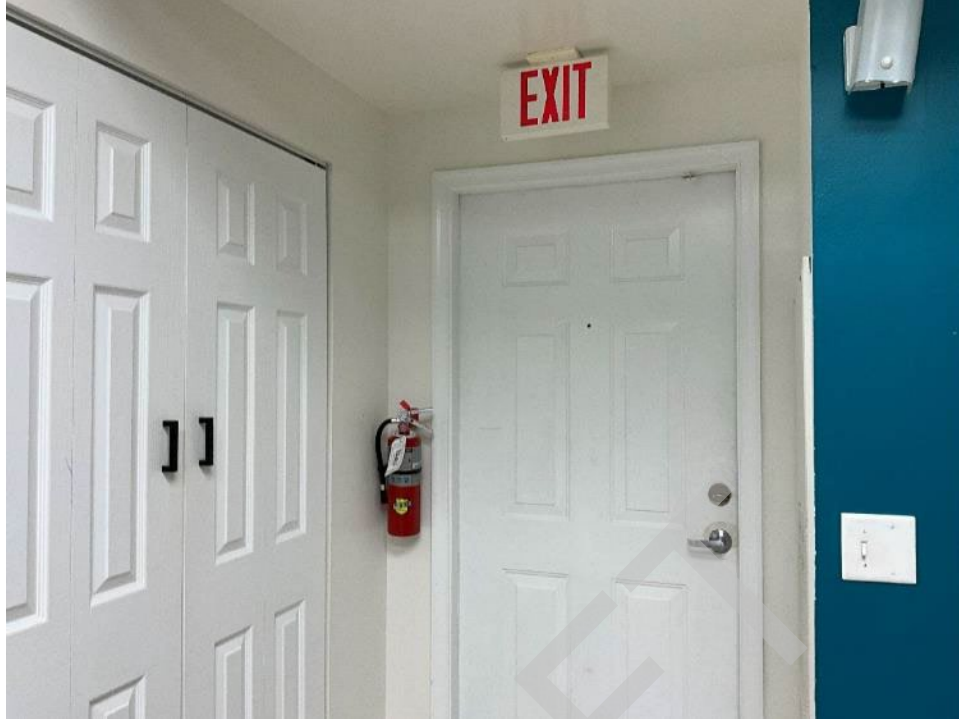
131. View of typical fire equipment around the community.
