# RESERVE STUDY

**The Colony at Edina Condomonium Association**  
**6330 Barrie Road**  
**Edina, MN**

**Date of Inspection: November 28, 2020**

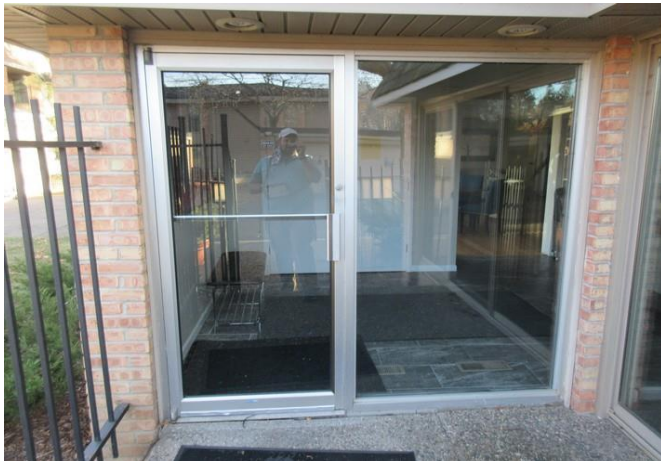
Clubhouse entry

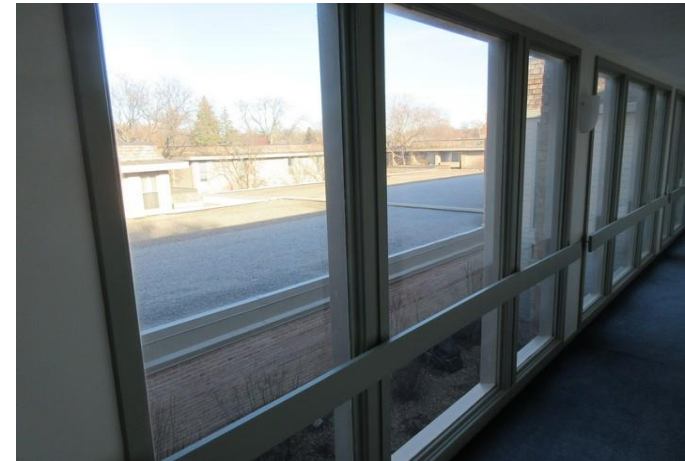
Interior of windows at common hallway

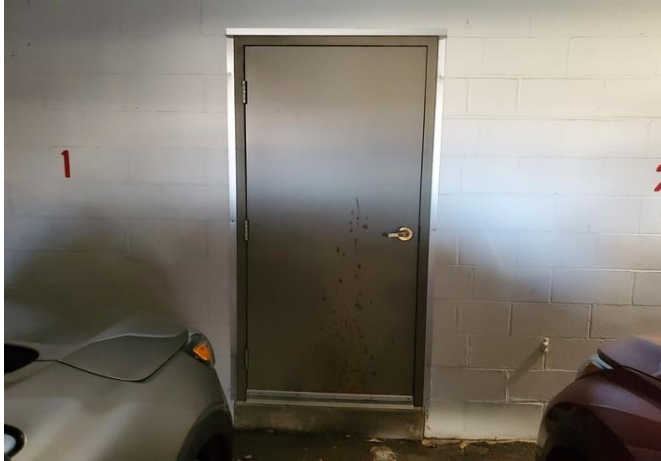
Typical utility door

Metal entry doors are located at the Clubhouse, Poolhouse, and garages adjacent to the Galleries buildings. We have included replacement of these doors in 2024, with subsequent replacement in 2049.

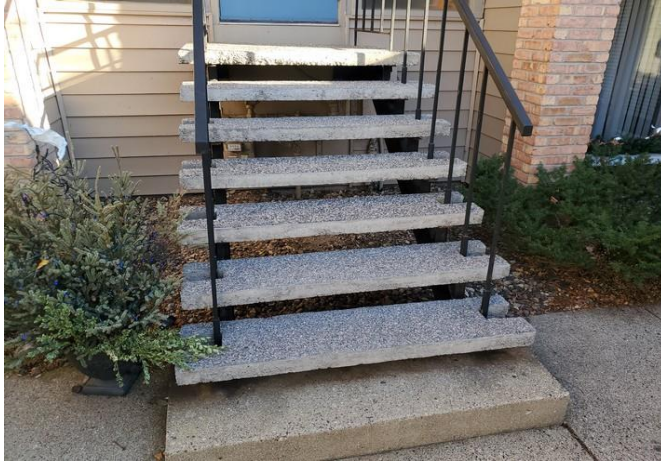
Front entry steps

The 17 cluster buildings each have two entries with concrete steps. These steps are constructed on steel support beams and include steel railings. Many of these entries are deteriorating and in poor condition. We have included phased replacement of these steps starting in 2022. Replacement cost includes steel supports, steel railings, and new concrete steps.

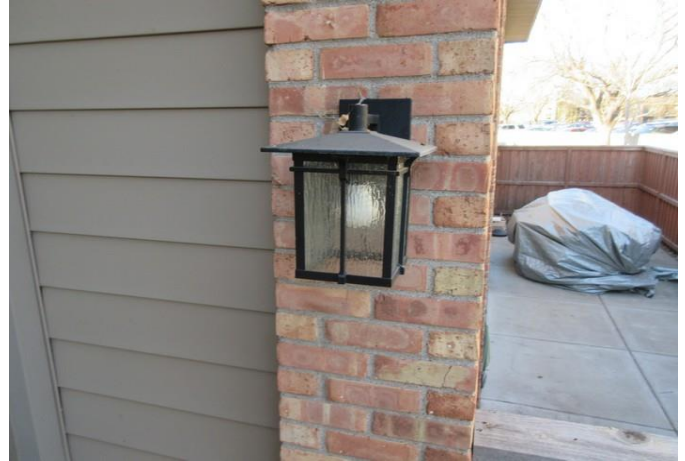
Sconce near garage

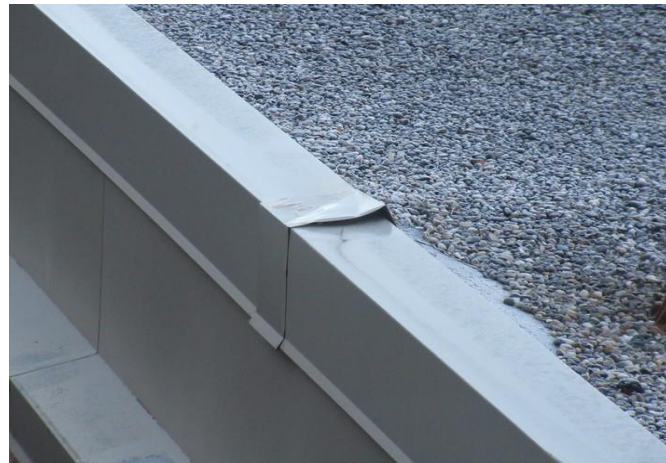
Bent coping

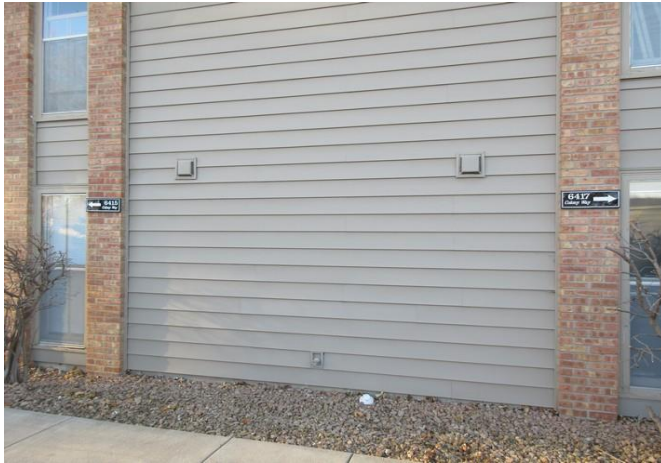
Typical siding

Vinyl siding at all units and garages is less than 7 years of age according to the Property Manager. With a typical useful life of up to 40 years the siding will have reached an age of approximately 80% of the typical useful life by the end of this study. We have included long term funding for 80% of the cost of the siding replacement by 2051.

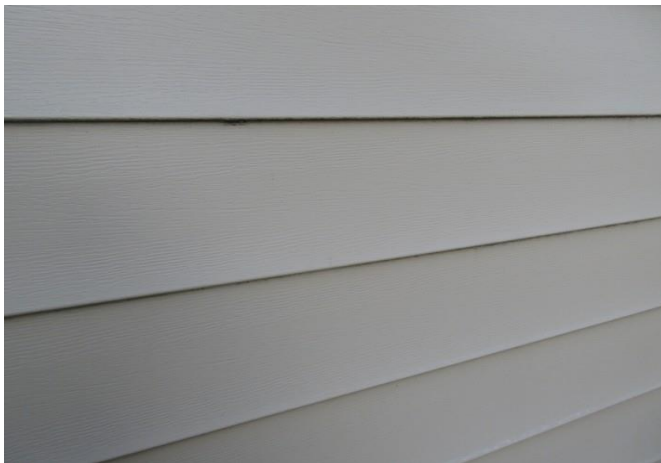
Vinyl surface

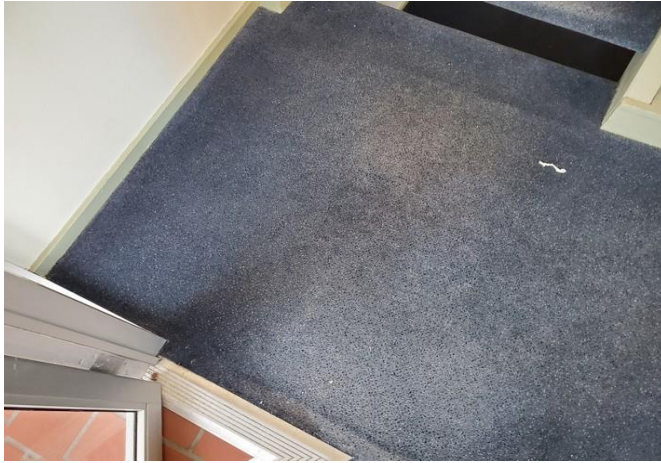
Faded stair carpet

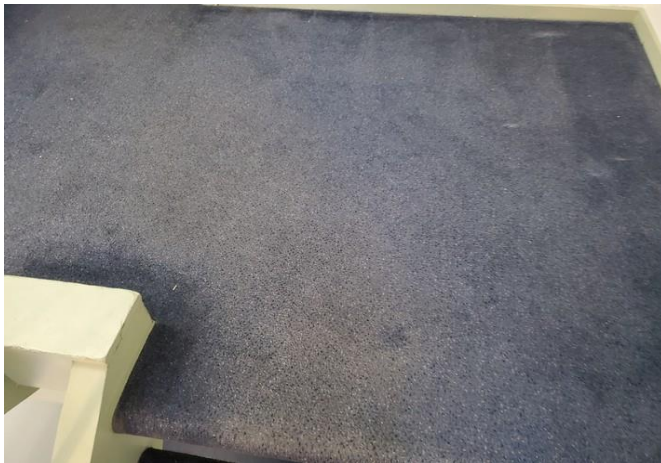
Carpets are faded in high traffic areas

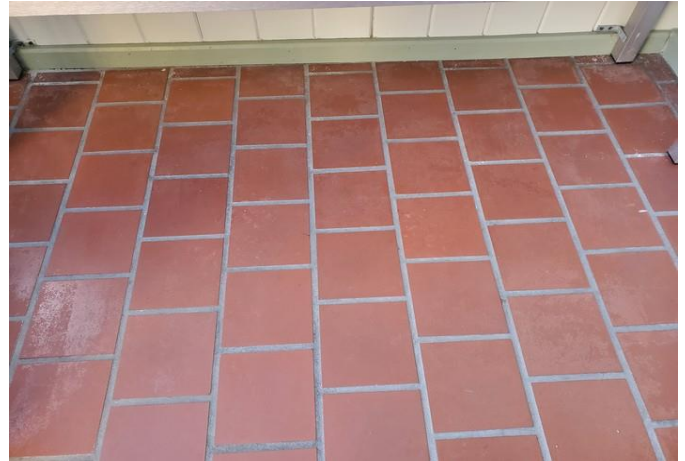
Tile floor in good condition

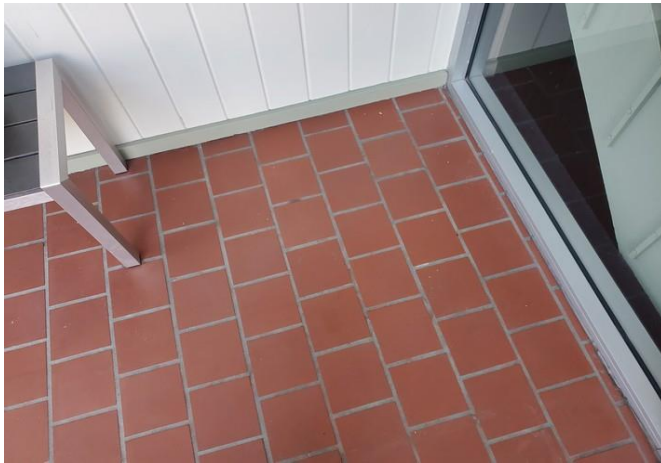
Tile at entry

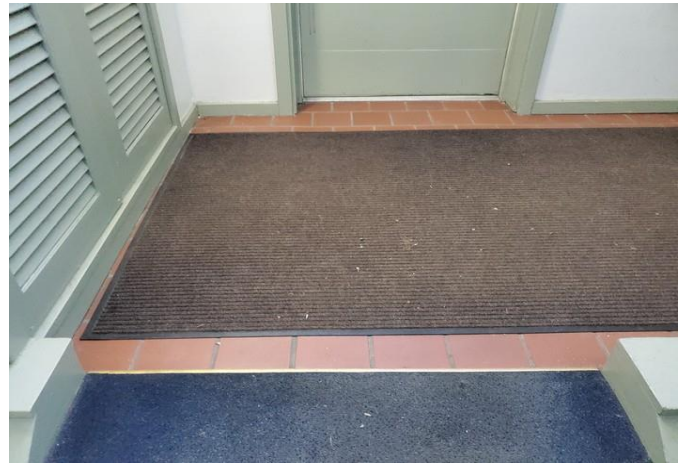
Side entry floor tile is protected by floor mat

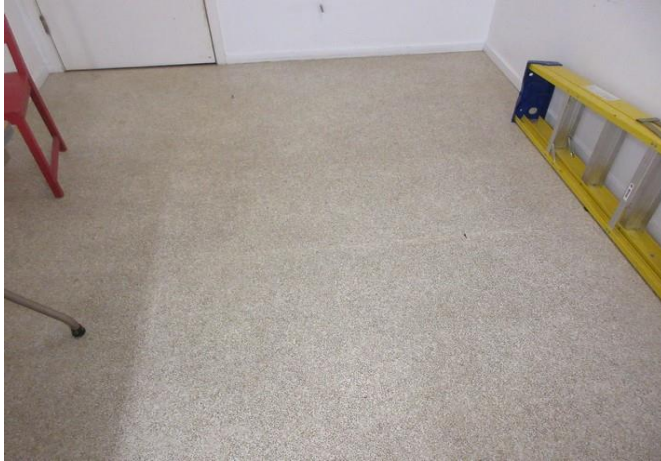
Laundry room vinyl flooring

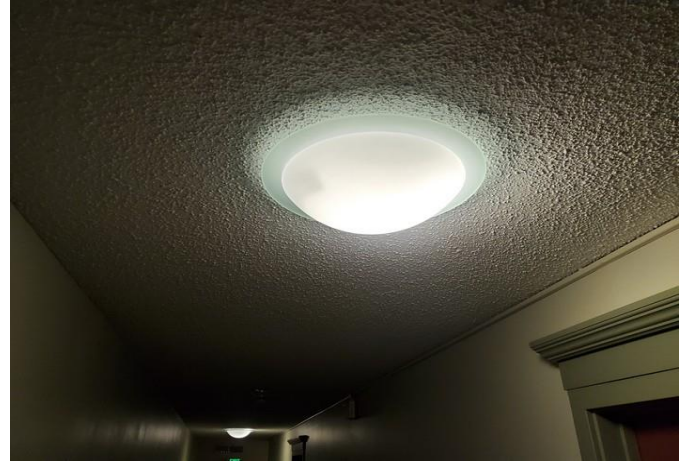
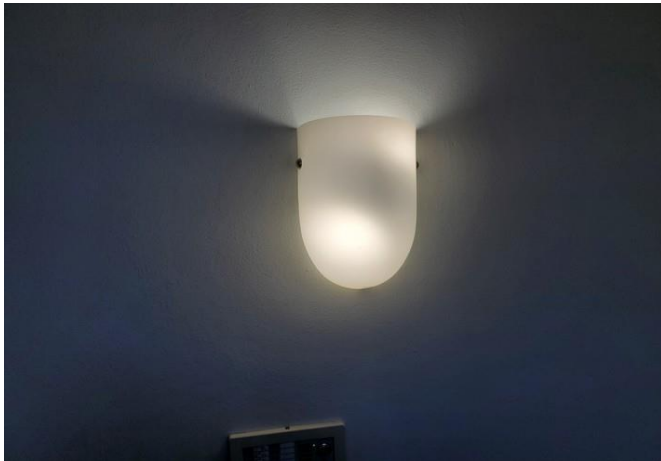
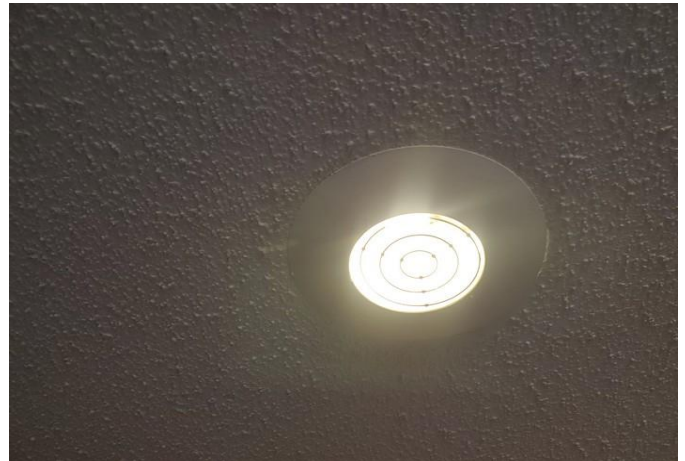
Typical hallway fixture

Ceiling fixture

Wall sconce in Galleries building

Interior can fixture

Interior light fixtures vary in style and age. Included in this component are fixtures in the Galleries buildings and Cluster buildings. We recommend that the Board fund replacement of all of the common fixtures in a single instance in 2035. Replacement at one time will allow for consistent style and appearance across the entire community common areas.

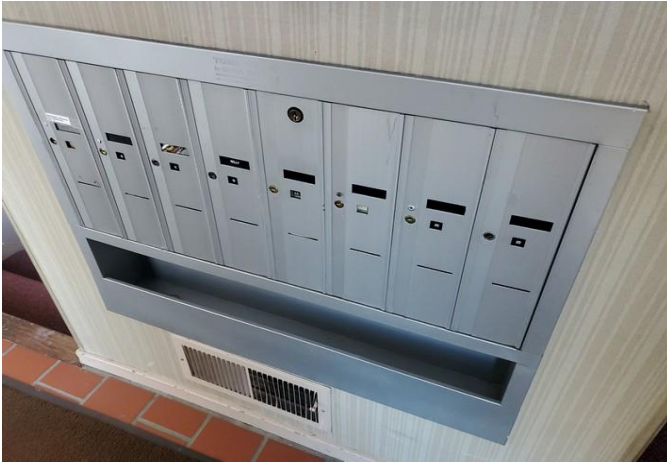
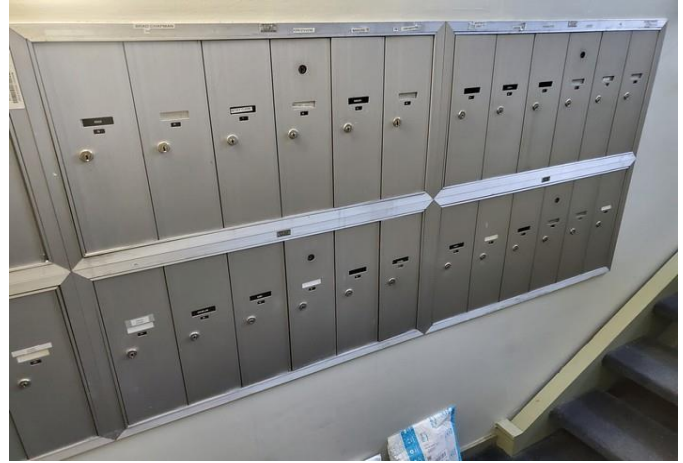
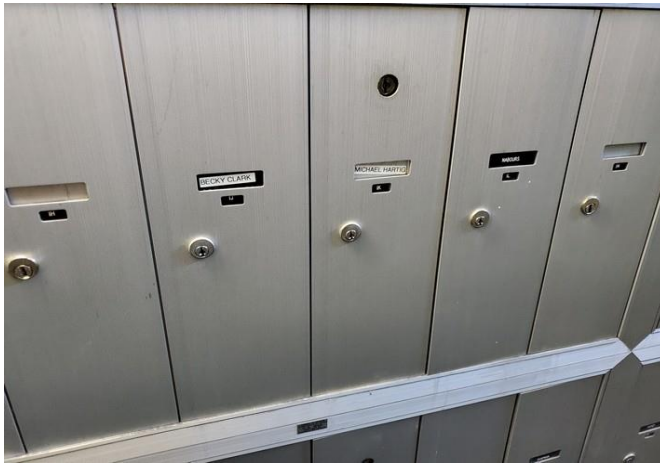
Typical mailboxes

Mailboxes in galleries stairwell

Mailbox surfaces

Mailboxes are in fair to good condition

Interior mailboxes have a typical useful life of up to 35 years. We recommend that the Board reserve funds for the eventual replacement of the mailboxes. For budgetary reasons we have included this replacement by 2041. Mailboxes includes are located at the Galleries and XXX buildings.

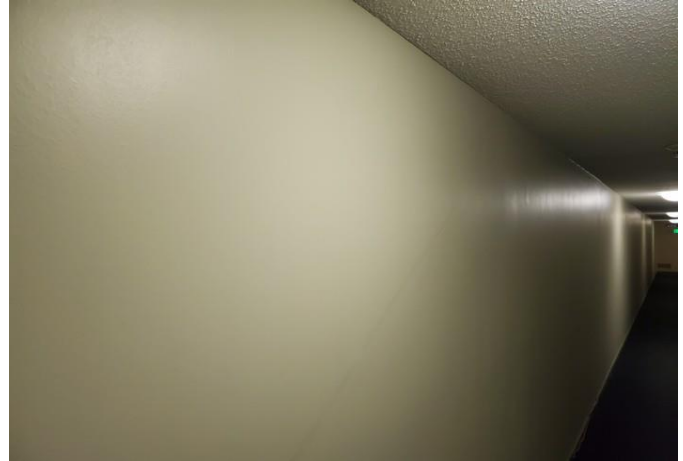
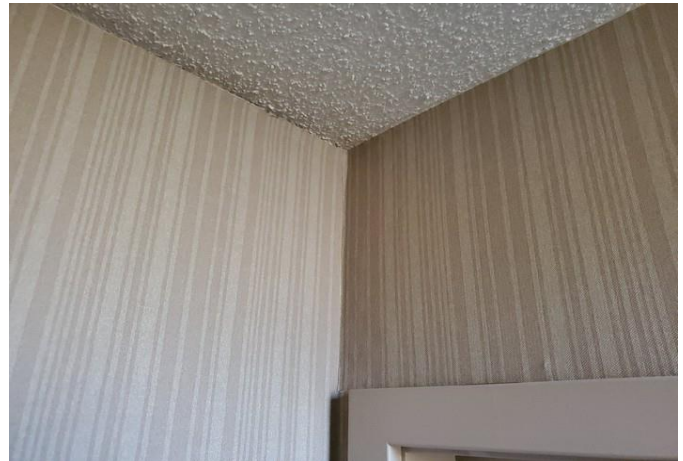
Painted walls and ceiling in common laundry

Hallway paint

Painted wood in stairwell

Wallpaper (anticipated to be removed) in Clusters

Common area paint finishes include hallway walls and ceilings, and stairwell surfaces in the Galleries and Cluster buildings. Painting appears to be over 5 years of age, although actual age is not known. We recommend that the Board fund scheduled painting of common areas every 12 years starting in 2023. This schedule coincides with carpeting replacement.

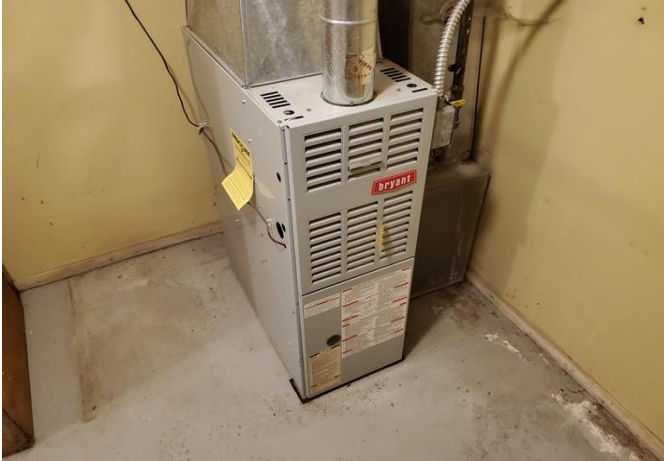
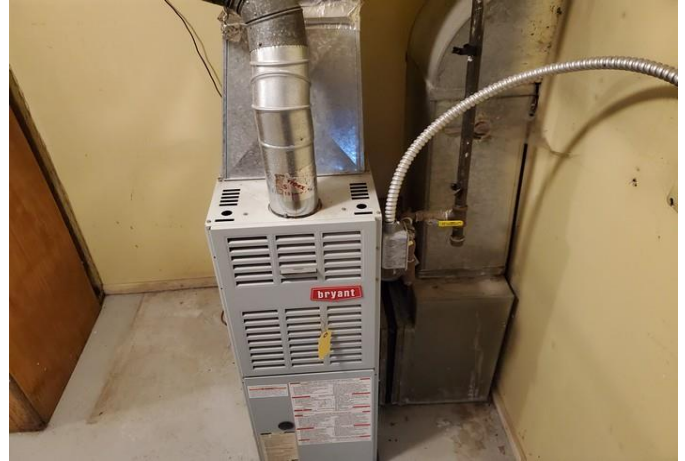
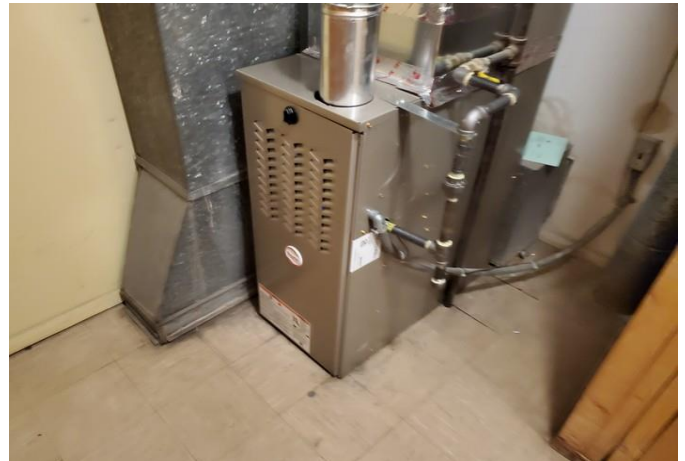
Typical furnace

Furnaces are in common storage

Furnace in common storage room

Newer furnace

Common furnaces are located at the Galleries buildings. These units provide heat for the common hallways at all three floors. These units vary in age. We recommend that the Board reserve funds for the phased replacement of the furnaces, with 33% replaced each instance starting in 2027.

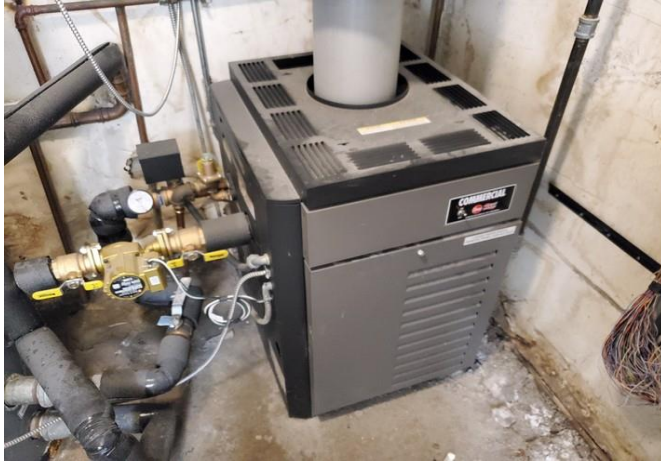
Typical boiler

Boiler located in behind laundry room

Boiler vent hood

View of boiler in mechanical room

There are 2 hot water boilers located in the Galleries buildings. These units have a manufacture date of 2015. Storage tanks located at the boilers are anticipated to be long-lived. We recommend that the Association reserve funds for replacement of these units in 2035.

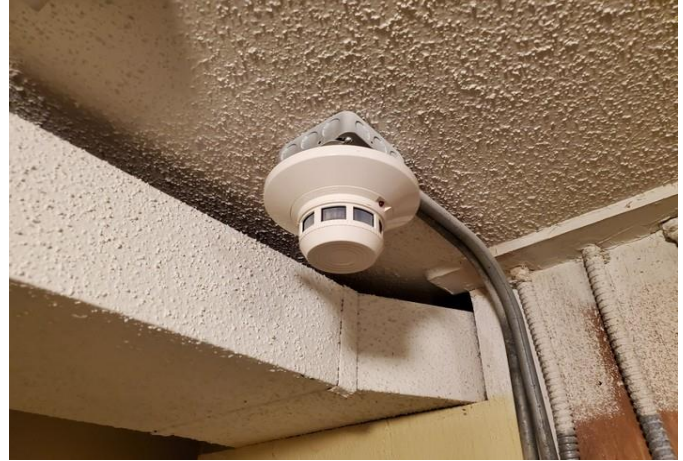
Typical fire panel in storage room

Smoke detector

Annunciator in hallway

Pull station in common hallway

Fire detection devices include smoke detectors, heat detectors, annunciators, panels, and horn/strobes at the Galleries and Clusters common hallways and rooms. Devices in individual residences are the responsibility of the individual homeowner. We recommend replacement in 2031 to update the system to future code requirements.

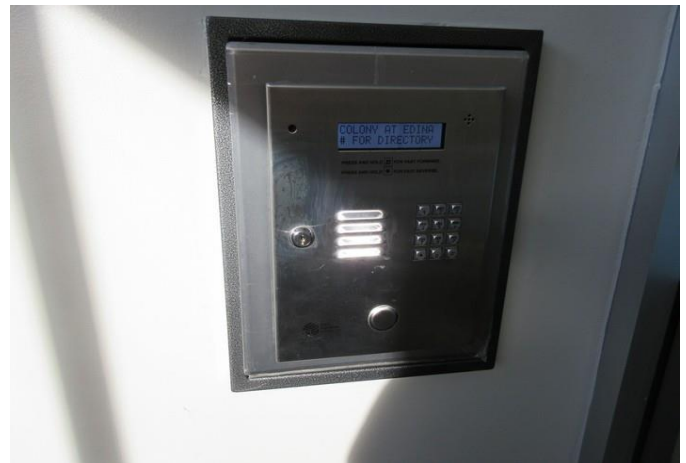
Typical intercom panel

Intercom at galleries entry

View of intercom panel surface

Typical panel

Intercom entry panels at the Galleries exterior entries are in fair to poor condition. The units are older per Management. We have included replacement of the intercoms in 2022, with subsequent replacement in 2047.

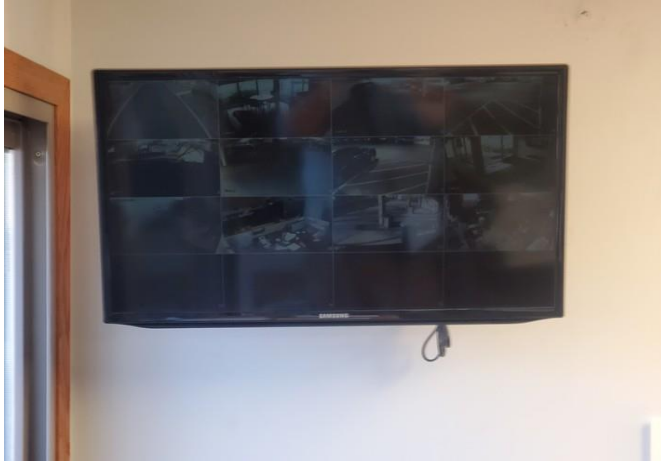
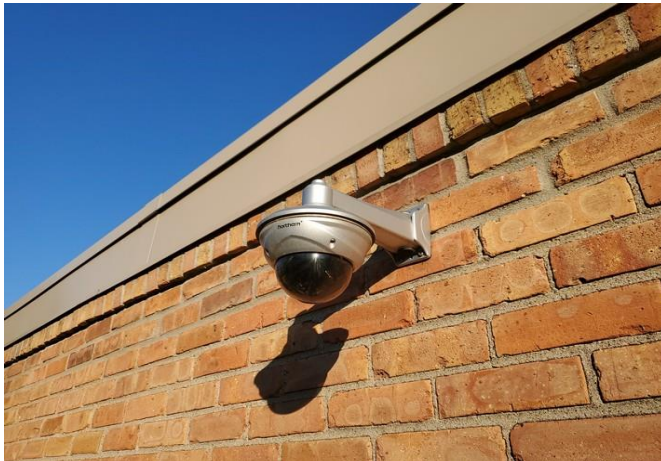
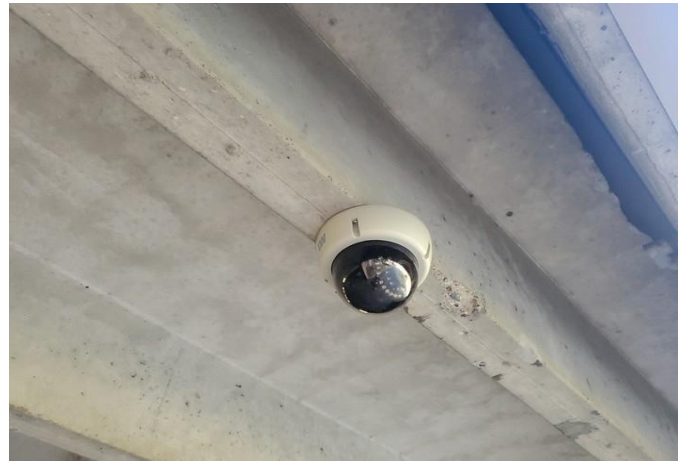
Monitor in clubhouse

DVR and monitoring system

Exterior camera

Typical camera at garage

Engineering Narrative
Unit cost is an average cost among the following surveillance system items: (15) security cameras, (1) surveillance monitor, and (1) digital video recorder. Future replacements are recommended at 15-year intervals. The system appears to be in good current condition. Age is not known. We recommend replacement in 2028.

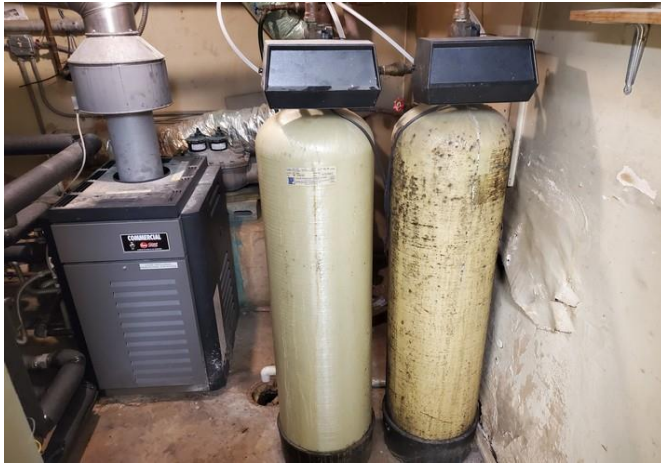
Galleries softeners

Water softener in laundry

Hardware on softener

Water softener panel

Engineering Narrative
Water softening systems are located at the Galleries and Clusters buildings. Systems vary in age. The Association has been replacing rental units with purchased units. We recommend continuing this pattern, with the replacements being scheduled in phases starting in 2026.

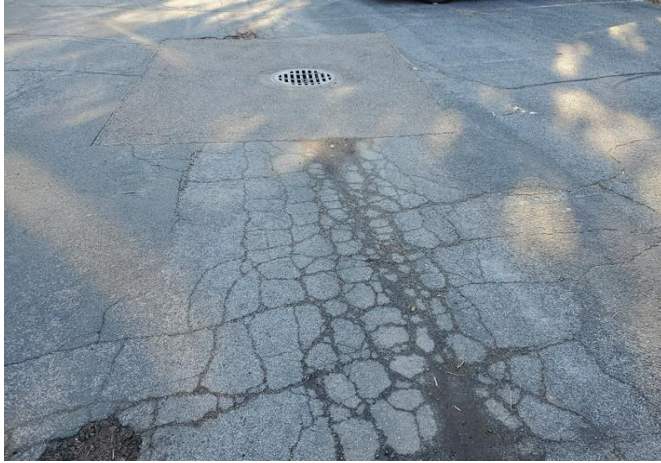
Deteriorating pavement

Engineering Narrative
Unit cost includes crack routing and filling, spot patching as required, and the application of a seal coat at the asphalt pavement. Pavement seal coat is in fair condition at unknown age. We recommend repairs to the pavement every 5 years. Exceptions to this schedule include those years when pavement is being replaced.

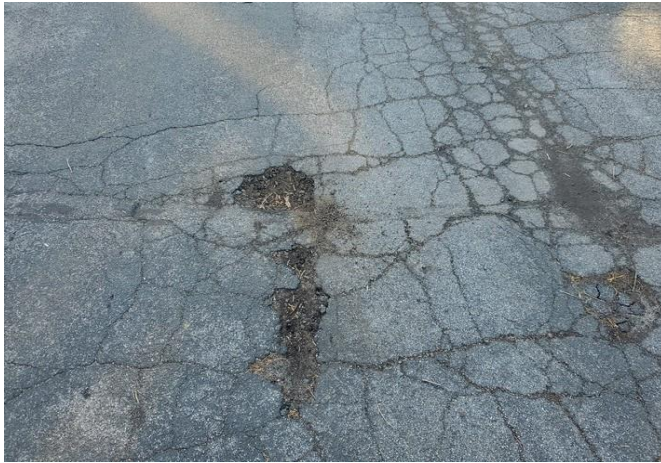
Potholes forming

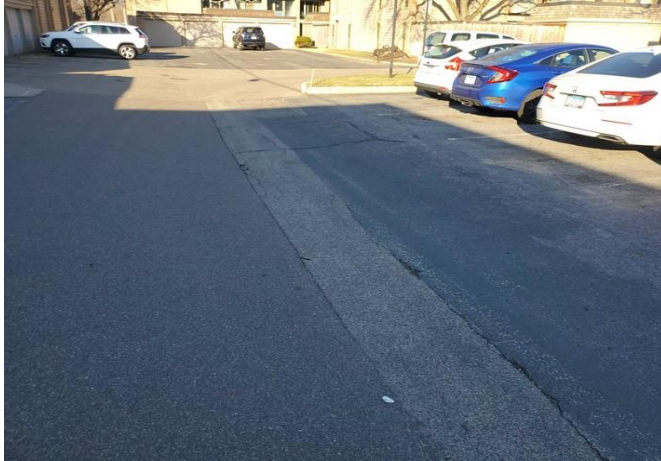
Typical pavement

Engineering Narrative
<p>Component includes a mill and overlay of the asphalt pavement. Unit cost includes milling (removal) of the top layer of asphalt pavement and overlay (new installation) of a new top wear course of asphalt pavement. Mill and overlay is recommended 20 years after full depth replacement.</p>

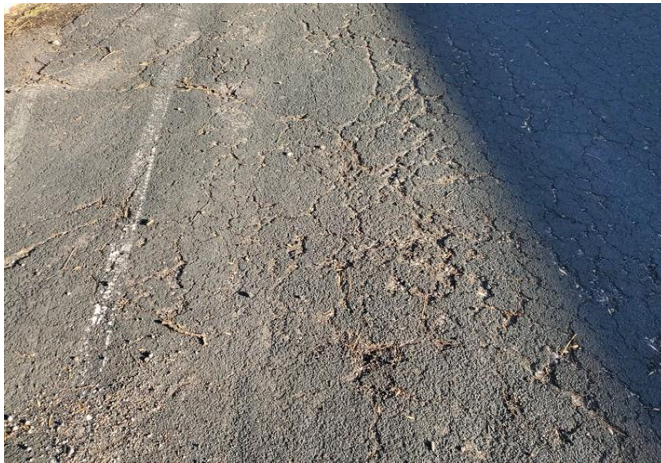
Cracking pavement

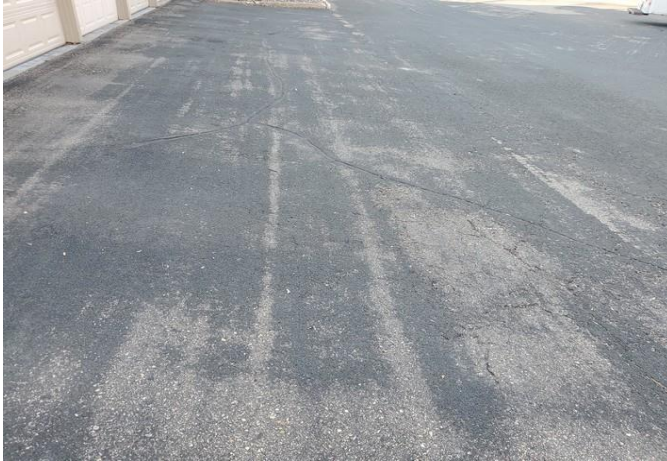
Typical pavement

Component includes a full-depth replacement of the asphalt pavement, including removal of both the wear course and asphalt base course, aggregate base course corrections, and reinstallation of new asphalt base course and wear course. Due to the age of the community and condition of the pavement we recommend completing full depth replacement of the asphalt alleys in 2025.

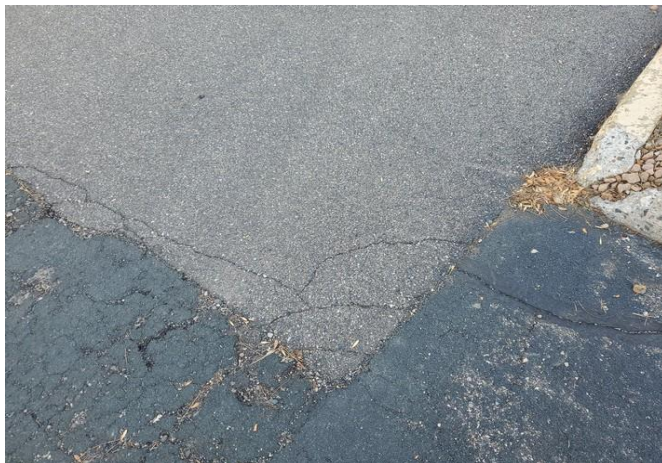
Patched pavement

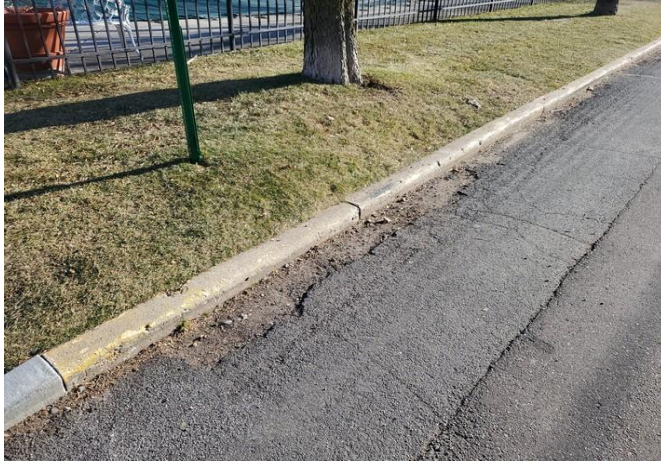
Typical curb

Concrete curbs typically has a useful life of up to 65 years with ongoing replacements. We have included replacement of 60% of the curbs starting in 2025 and coinciding with other paving projects.

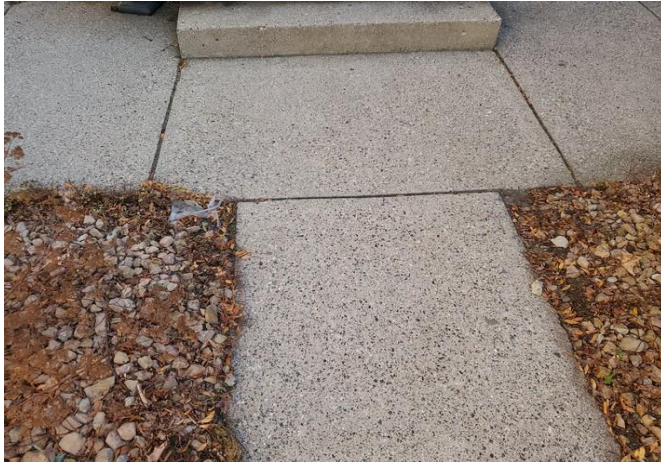
Front entry stoop and walk

Concrete flatwork includes sidewalks in common areas. Patios are a homeowner responsibility. We recommend that the Board reserve funds for the replacement of 50% of the concrete flatwork over the next 30 years. These replacements coincide with other concrete and asphalt projects.

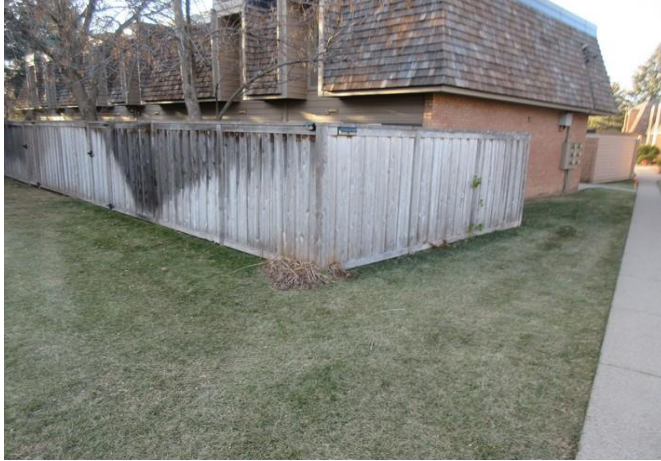
Unstained fence

This component includes the replacement of the wood privacy fences at rear yards. The fencing overall is in good condition. We recommend that the Board fund future replacement in 2041. Interim repairs should be funded operationally.

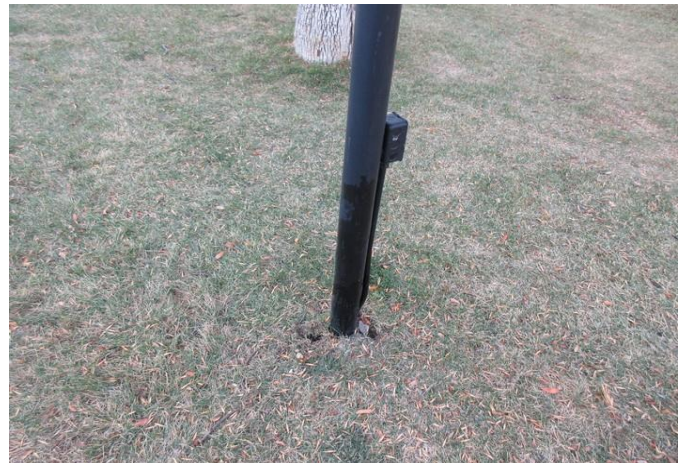
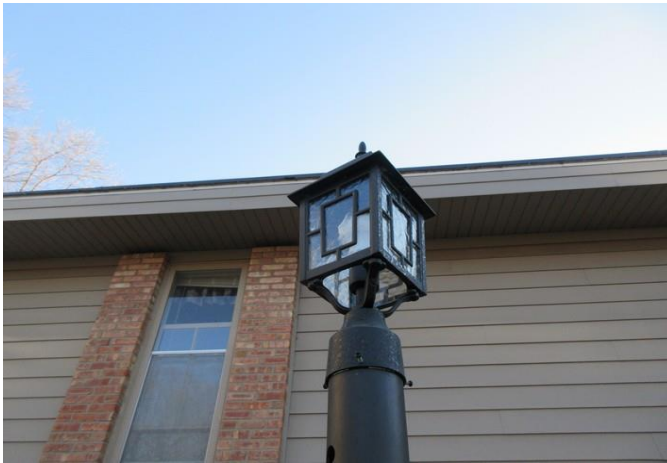
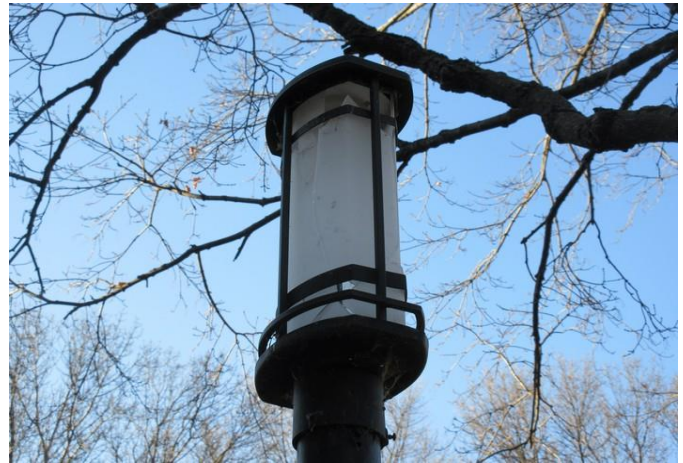
Typical pole location

Pole base

Single fixture

Fixtures vary in style

The light poles included in this study are the single-fixture poles located at the private alleys/streets. We recommend that the light poles be replaced in a single phase to maintain appearance and style. Replacement is recommended in 2036.

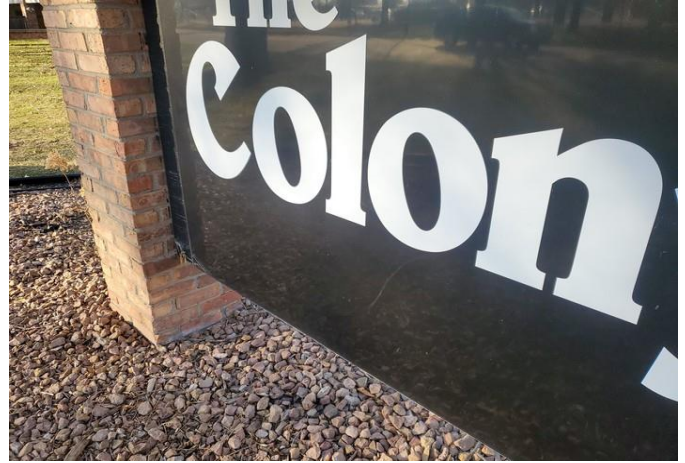
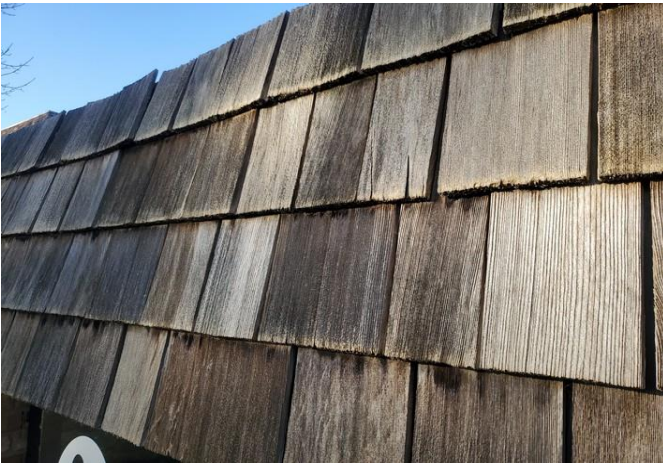
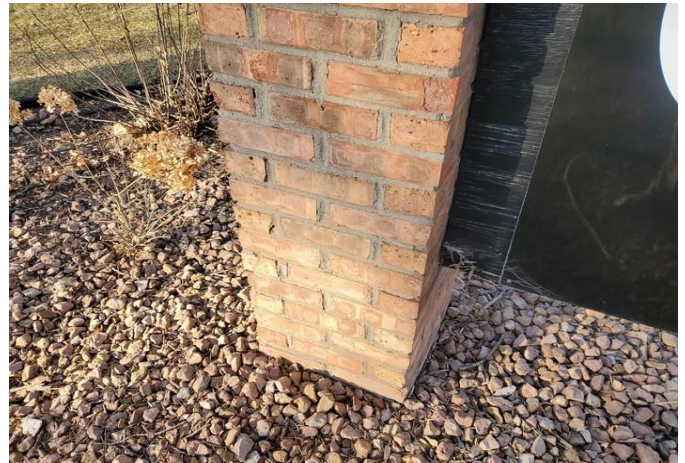
View of typical sign

Plastic placard

Cedar shake accent

Masonry pillar

There are 2 monument signs in the community. Signs are built with a wood frame, include mansard cedar shakes, and have plastic placards with the community name. We recommend that the Board reserve funds for the eventual replacement of the monument signs by 2036.

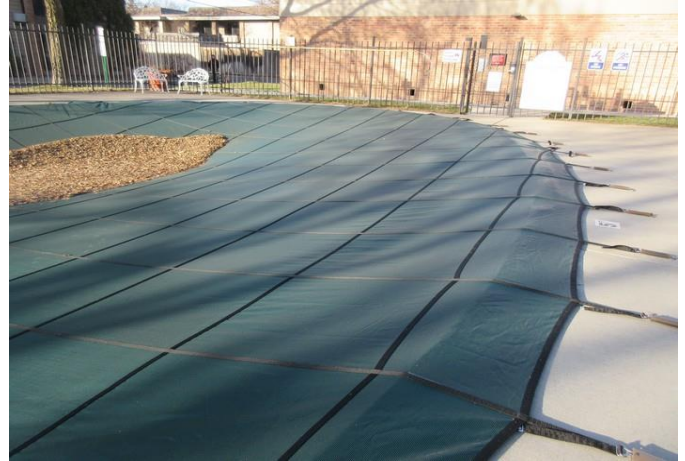
Pool cover is newer and in good condition

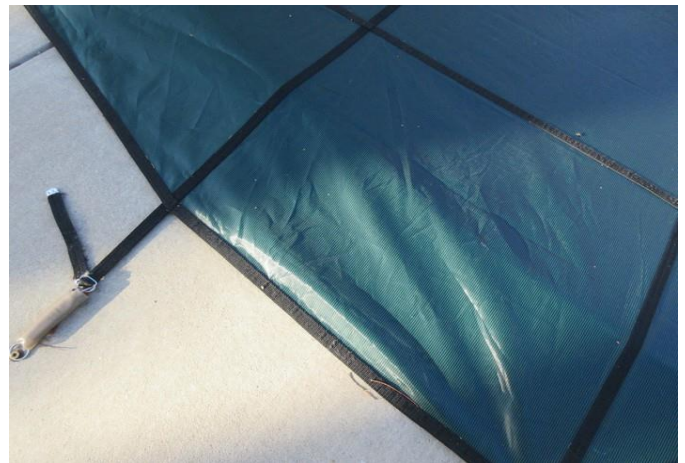
Typical condition of cover material

Per Management the cover was replaced in 2020. Pool covers typical require replacement every 6 to 10 years. We recommend that covers be replaced in 2030, 2040, and 2050. The replacement in 2030 coincides with pool replacement.

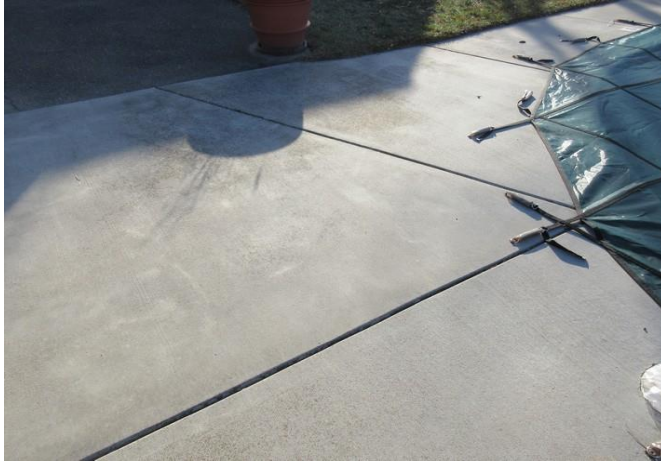
Concrete deck

The concrete pool deck is recommended for replacement in 2030. This is the same time as the pool is scheduled for replacement. Future replacement of individual panels should be completed as-needed out of the operating budget (after replacement in 2030).

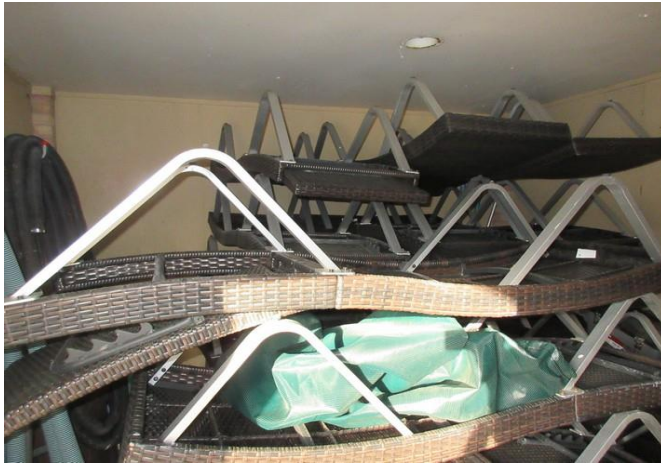
Furniture stored in poolhouse

Pool furniture was reported to be less than 5 years of age. Furniture replacement is considered a reserve expense. We have included new furniture in 2030 along with pool replacement. Future replacement is recommended in 2042.

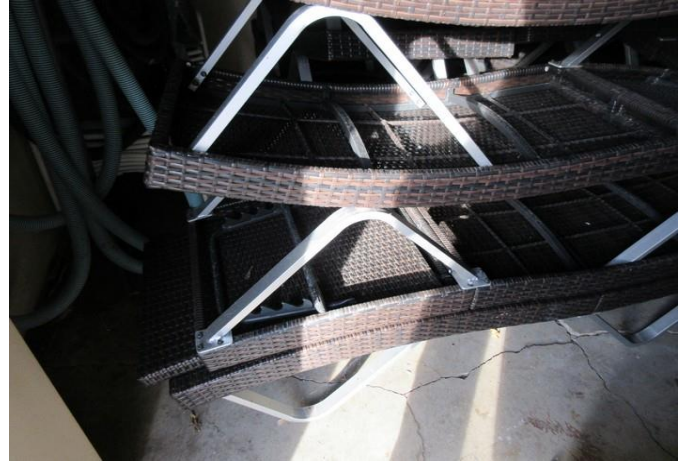
View of plastic wicker loungers

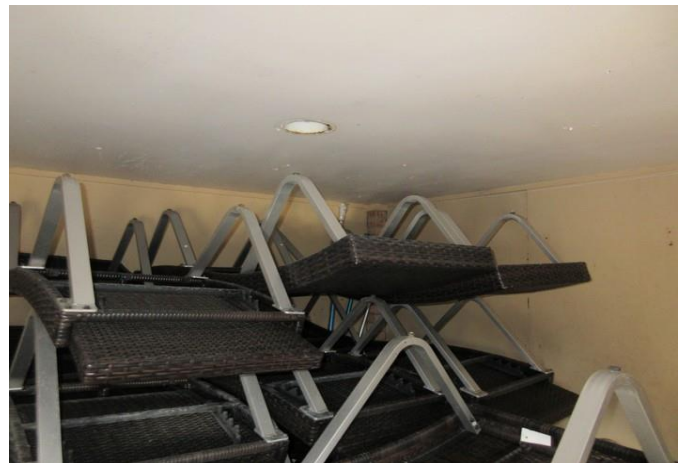
Most of the furniture is in storage

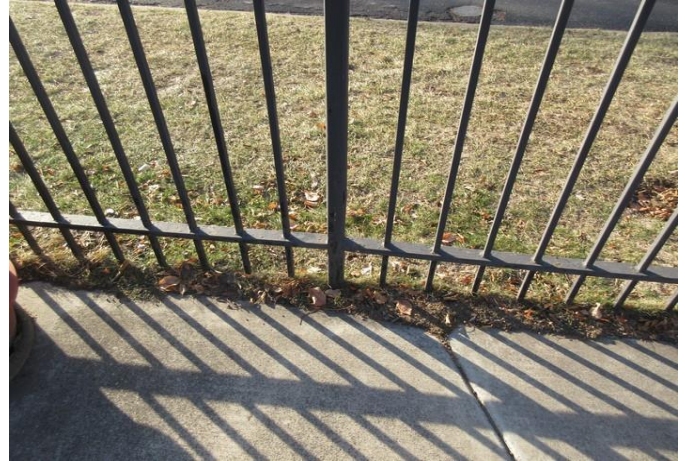
Metal pickets and post

A metal picket fence is located at the pool. It is anticipated that this fence will be replaced when the pool is replaced in 2030. Future repairs to the fence are anticipated to be operating expense.

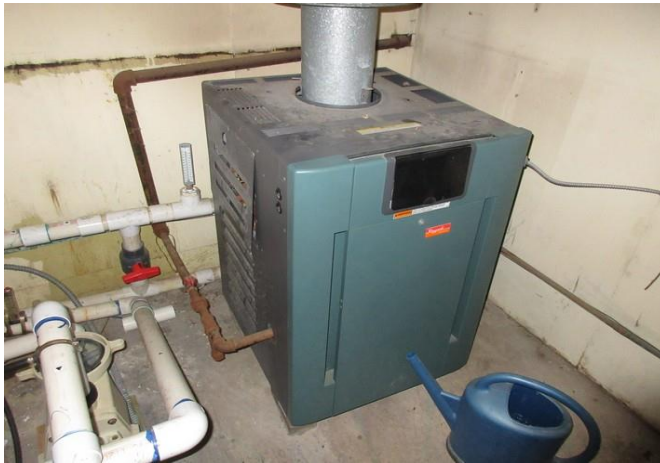
Pool heater

Engineering Narrative
<p>Pool mechanical systems include the pump, two filters, heater, and chlorinating system. We recommend that the mechanical systems be replaced as part of the pool replacement in 2030. Future replacement is recommended 15 years after replacement in 2045.</p>

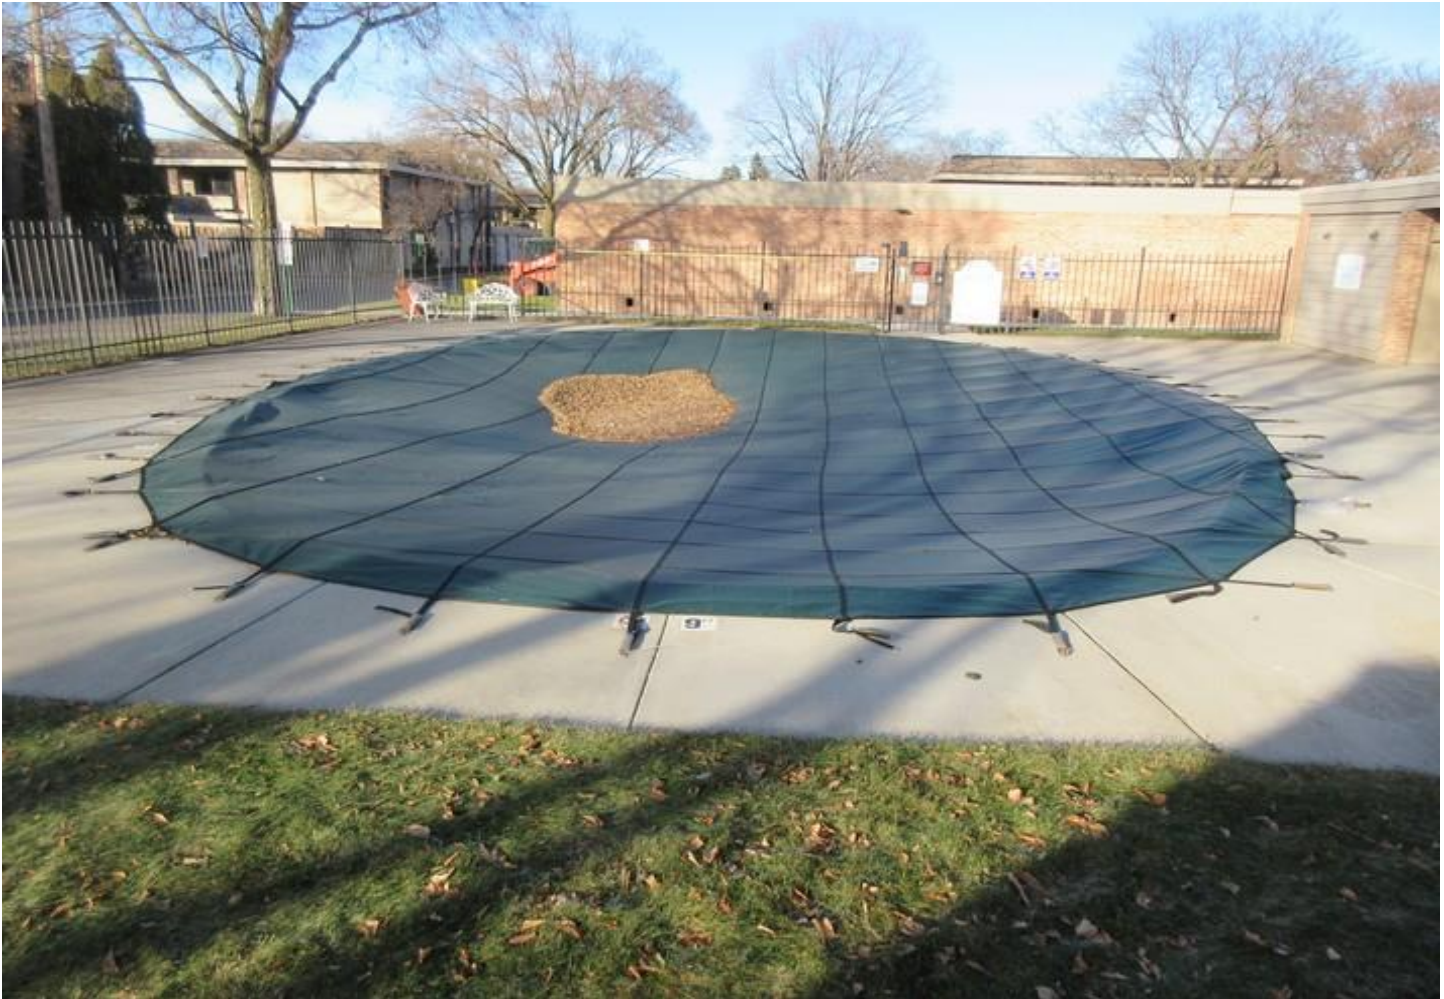
Overview of pool

Engineering Narrative
Unit cost includes new recessed concrete swimming pool shell, replacement of all sub-grade plumbing, new strainers/drains, mechanical equipment, new pool finish, tile work, formed concrete coping and permits. Pool replacement coincides with concrete deck replacement and metal fence replacement.

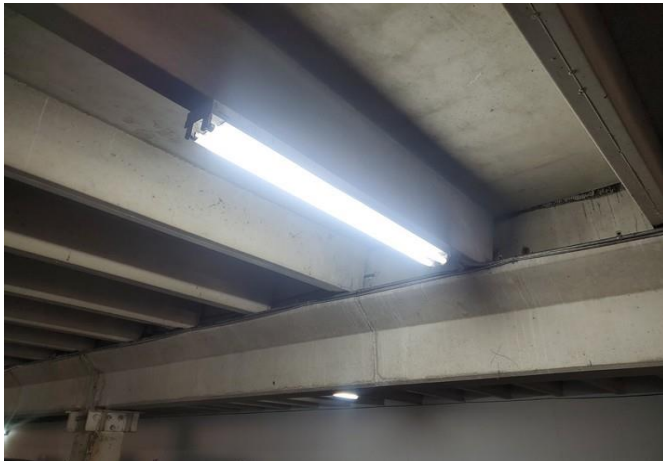
Light at parking stall

Light fixtures at the garages include various halogen and fluorescent fixtures. These fixture appear to vary in age. We recommend that the lights be replaced at the same time as the asphalt replacement in 2026.

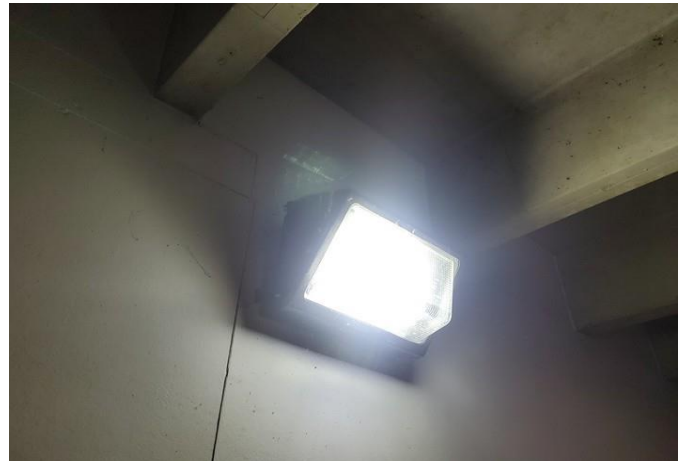
Typical light at wall

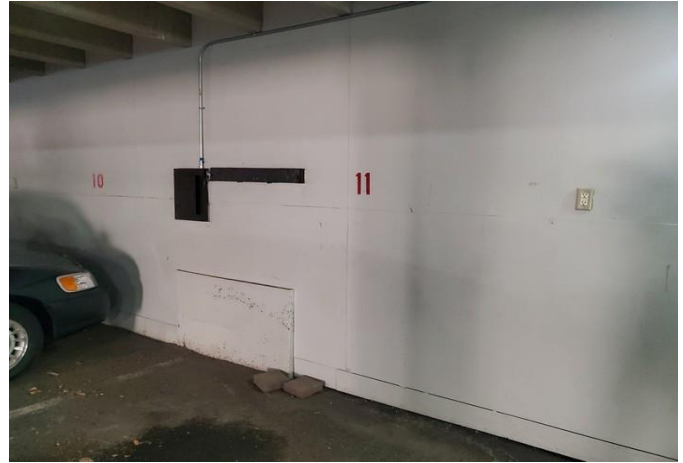
Painted walls with stall numbers

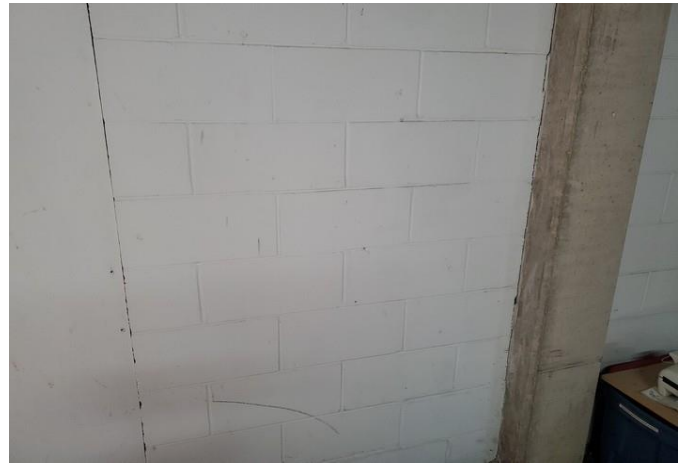
Painted block wall
