# Private Home Inspection Report

## Wright-Pro Home Inspection LLC

**22560 Country Ave.  
Anytown, MI 48000**

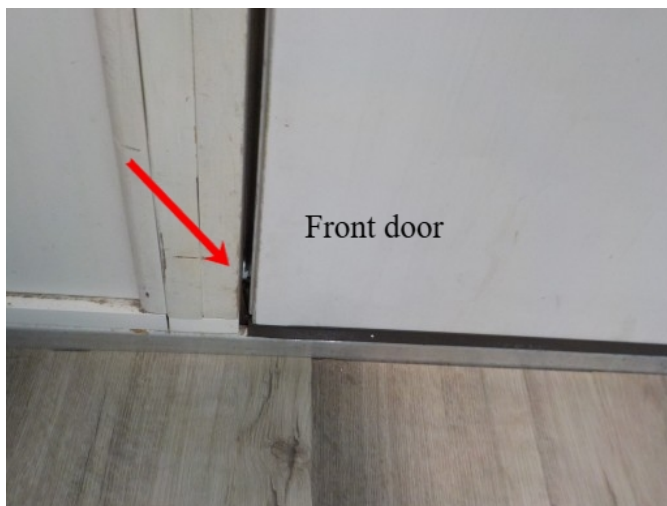
All doors functioned properly when tested. Only minor issue is you may have a small draft gap at the front door which may require additional weatherstrip at the lower corner. Otherwise no issues.

Minor daylight gap when door is fully closed could be an area of draft.

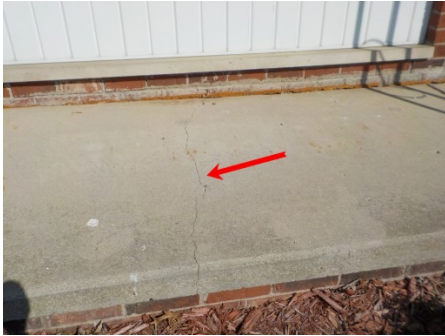
Cracked cap.

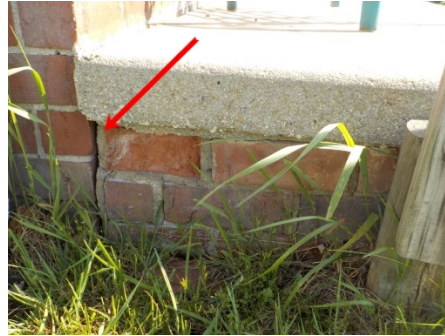
- Appears porch has pulled away from the structure somewhat. Where insulated foam was added against the home, the separation is noticeable.

Separation noted.

Have repaired then monitor. If cracks reappear this will suggest ongoing movement. Making sure all downspout run-off is directed away from the porch structure -- this should help to stop further movement.

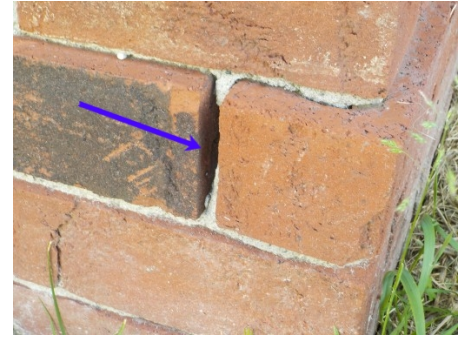
Wall at garage trim has pulled away

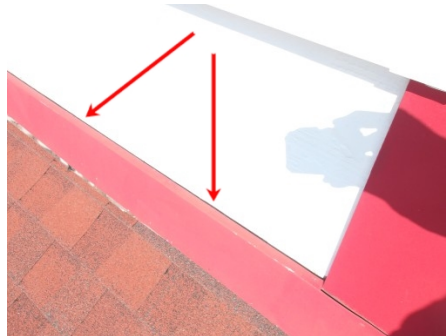
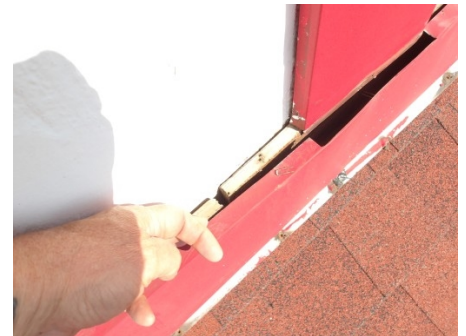
Loss aluminum trim

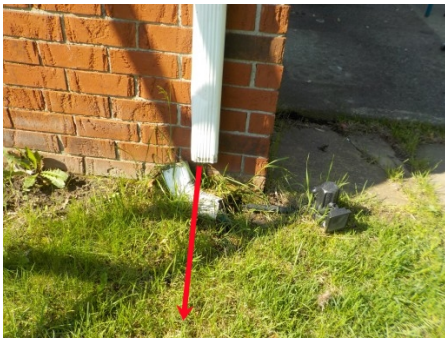
Extend well away from the structure.

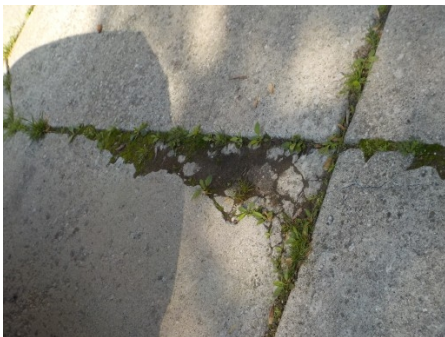
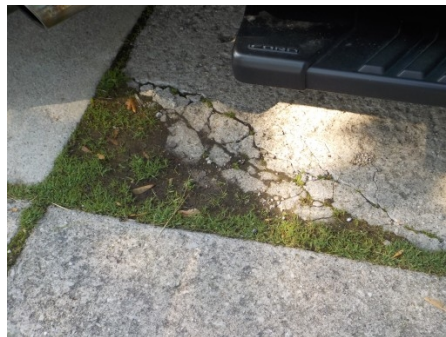
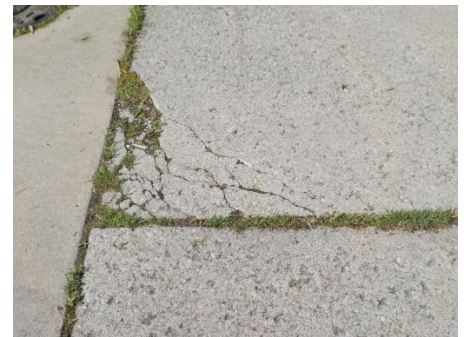
Driveway has some deterioration of the slabs. Consider the condition can worsen with each seasonal freeze/thaw cycle as concrete expands and cracks further.

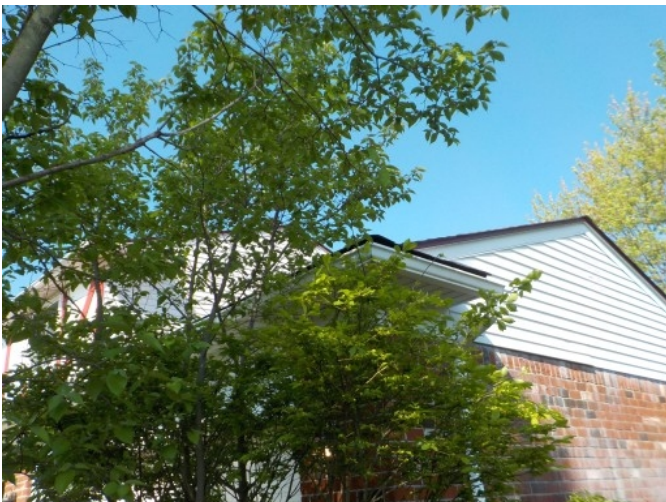
Recommend cutting vegetation back from the roof and structure. Root balls too close to the foundation can cause issues over time. Leaf movement on shingles can cause them to prematurely deteriorate.

Cut back vegetation from the structure

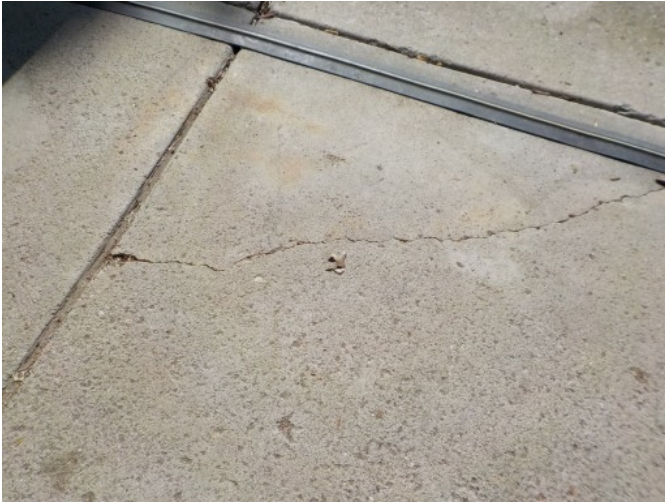
Concrete, cracked but no heaving or displacement. There is one area that is crumbling. Consider this area may deteriorate further with the seasonal freeze/thaw cycles.

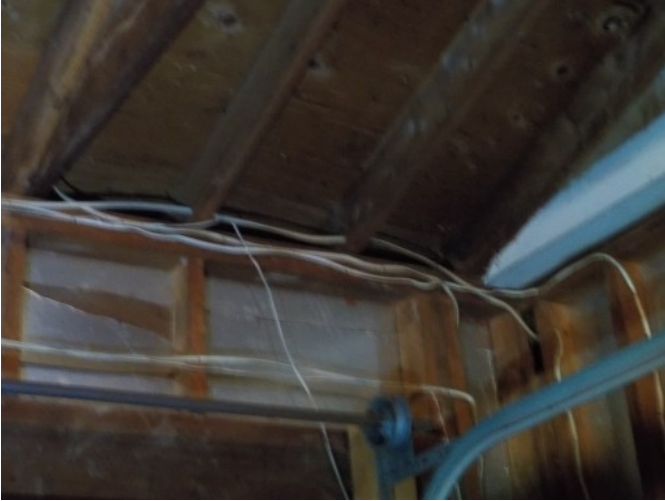
1. The wire along the floor is bent and shows an area of worn sheathing. Potential shock hazard. This wire running along the floor should be in conduit.
2. Sloppy wire runs present, doesn't appear to be a professional installation.

Sloppy wire runs.

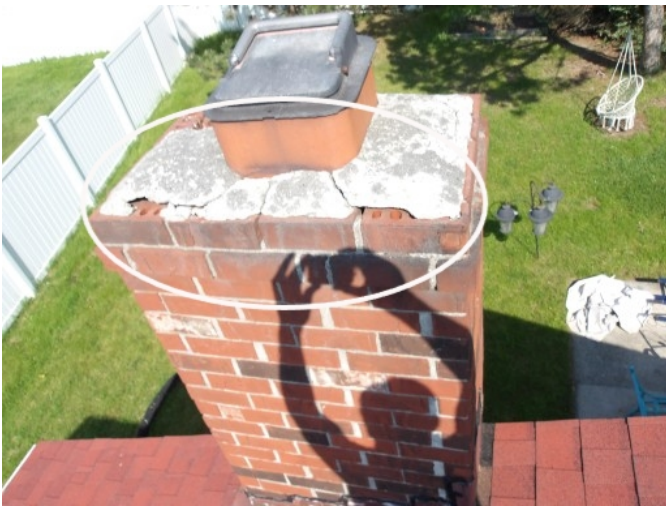
Both chimneys feature brick chase construction, which is currently in good overall condition. However, the mortar crowns on both chimneys show significant signs of age-related deterioration and will require repair. It is recommended to have a qualified brick mason, or a skilled handyman, perform further evaluation and complete the necessary repairs.

Fireplace chimney crown is age deteriorated.

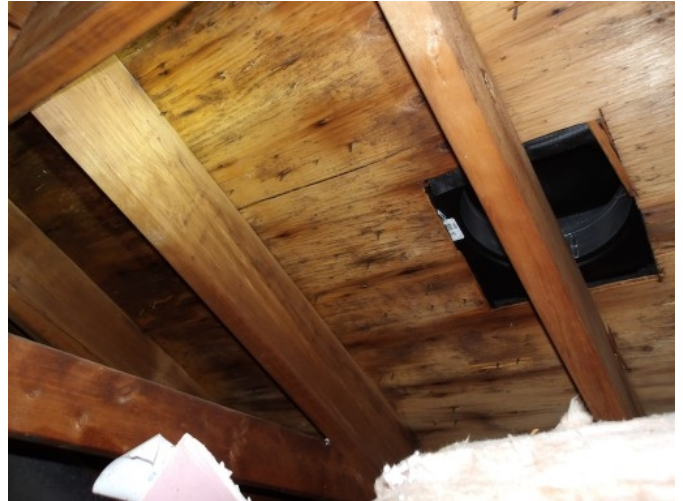
3.) Evidence of organic growth (likely mold or mildew) was observed on the roof sheathing in the area around the attic hatch entrance. While this growth appeared dry at the time of inspection, it can become active again if exposed to future moisture, particularly from condensation. This indicates a prior or ongoing moisture issue likely related to inadequate attic ventilation.

Dark areas are organic growth

It is recommended to have a qualified insulation or ventilation contractor further evaluate the attic space. Corrections may include installing proper baffles at the soffits to maintain airflow, sealing any bypasses, and insulating or covering the attic fan opening during winter months. Addressing these issues will help maintain the integrity of the insulation system and prevent potential moisture-related problems. Mold / mildew growth as a result of moisture issues can be a health concern for some people.

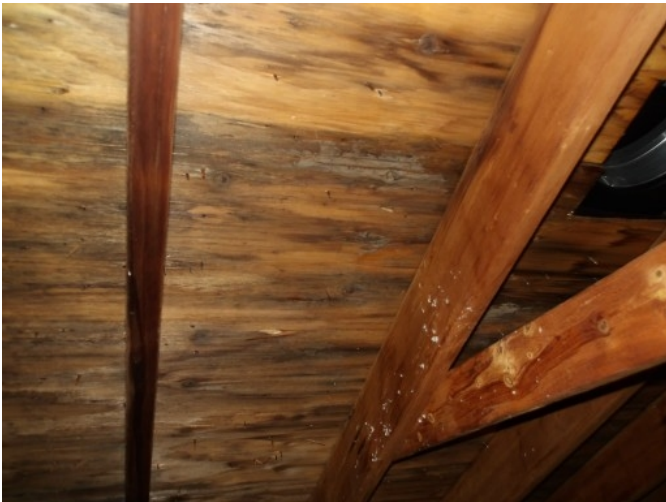
Dark areas are organic growth.

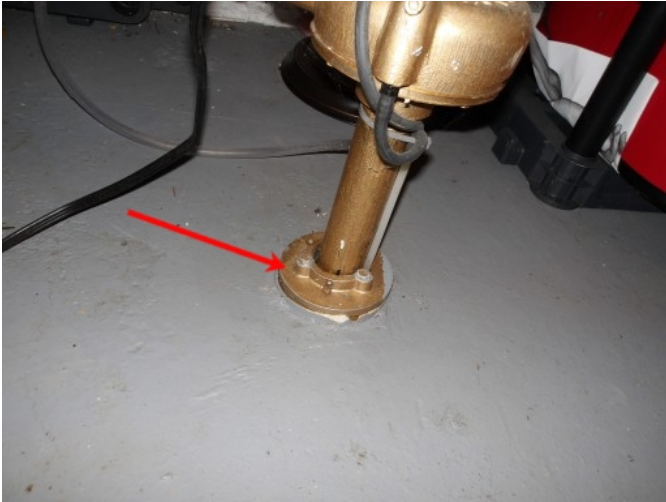
A pedestal sump pump with a float switch was present and operated as expected during testing. However, a strong sewer gas odor was noted upon initial activation. Inspection revealed that the pump seal at the floor was loose, and it appeared this may have been the source of the odor. Additionally, the sump pump drain discharges into the backyard, but the location could be improved to ensure proper drainage.

Pump base is loose.

Recommend further evaluation and correction by a licensed plumber to ensure proper drainage configuration and compliance with local plumbing regulation.

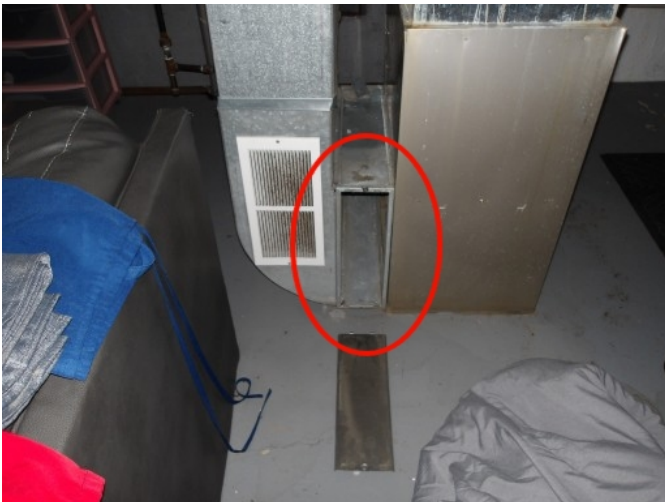
Missing, needs filter.

Filter missing

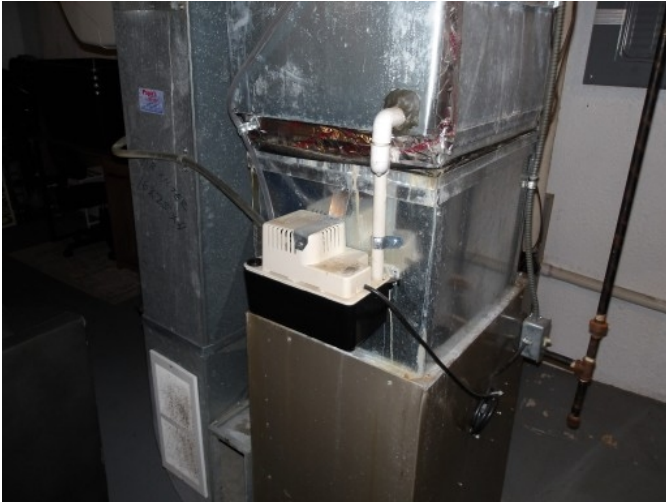
An electric condensate pump with a plastic drain tube is present, with the drain line terminating at the sump pump. While the general configuration is functional, the condensate drain tube should be better routed and properly secured to prevent potential leaks, disconnections, or damage. Recommend adjustment by a qualified technician to ensure proper drainage and long-term reliability.

Condensate pump.

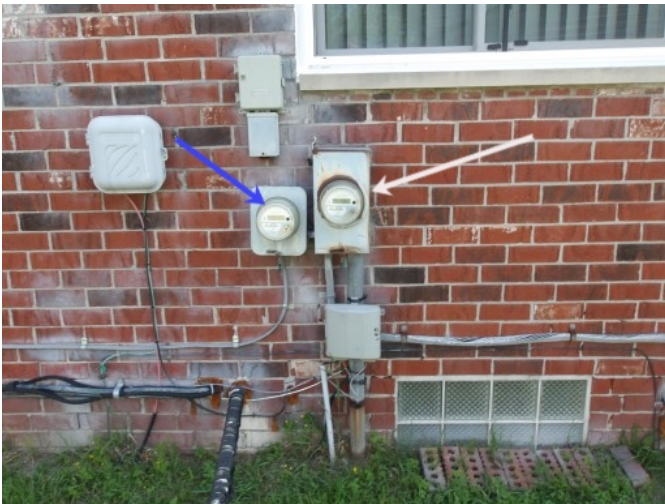
Electrical meter boxes, main meter and air conditioning meter, are in good condition. Underground service (service lateral) wires cannot be visually inspected.

Main meter is white arrow. Blue is AC.

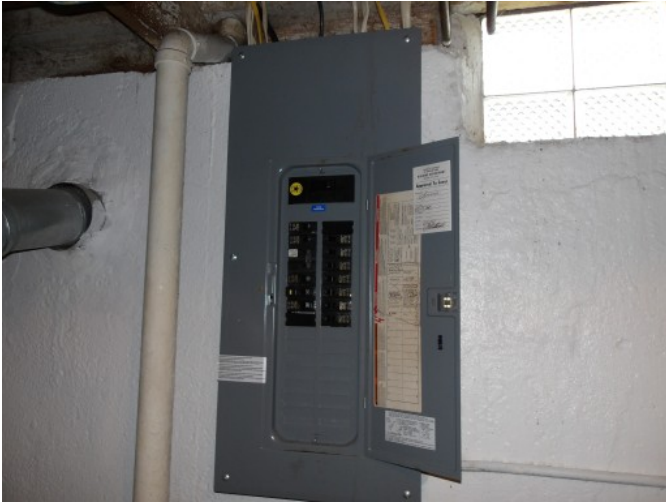
Plenty of room to add additional branch circuits.

Branch circuits are clearly identified.

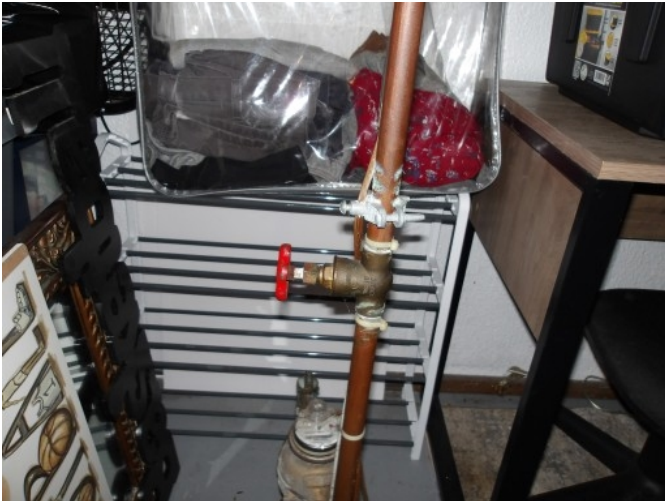
Main water shutoff valve located at the water meter.

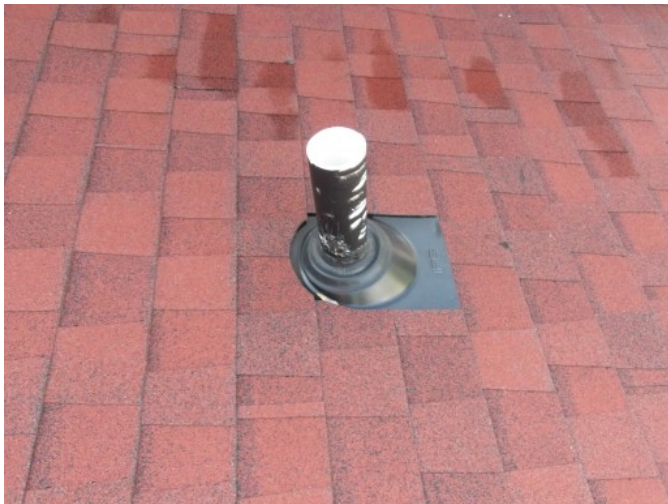
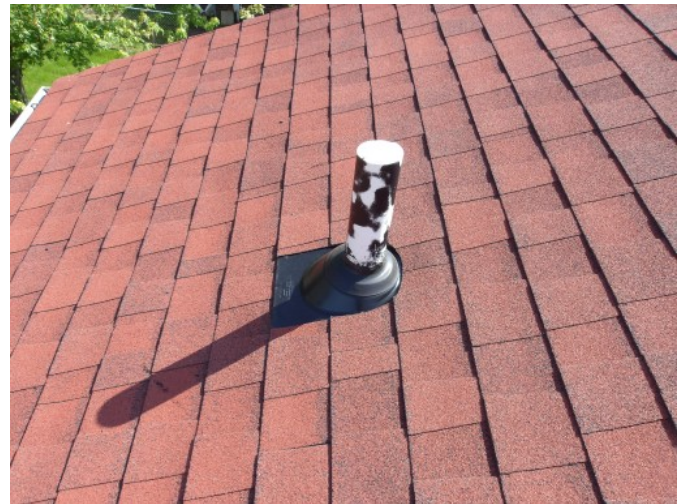
(2 vents ) PVC with rubber flashings. No issues noted.

Through roof plumbing vents

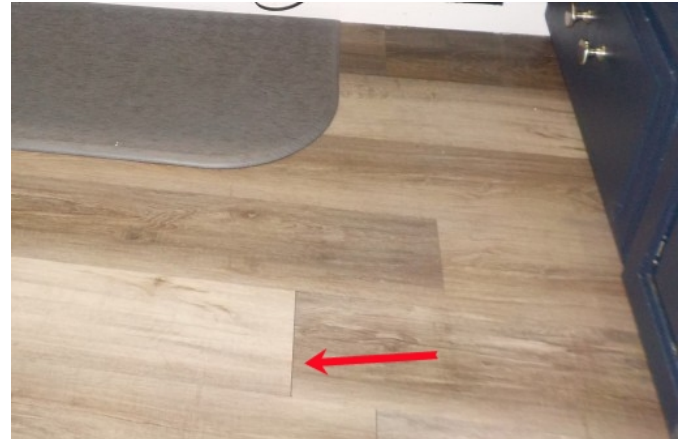
Vinyl Plank - a couple of shrinkage gaps noted. Mostly cosmetic (although some cities require wall-to-wall waterproof floors in kitchens and bathrooms). These small gaps can widen over time and may allow moisture to get to the underlayment during regular cleaning.

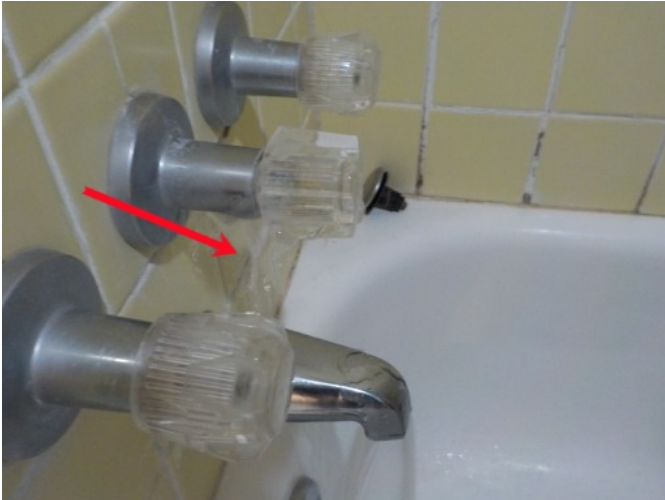
1. Shower/tub faucet diverter (center) handle leaks and will need repair in the near future as this condition will likely worsen over time.
2. The shower diverter works at about 80%, not all water gets to the showerhead. Some remains at the spout.

Leaks
