# Inspection Report

100 Neptune Dr, Hypoluxo, Florida 33462

**Inspection Date** July 15, 2018  
**Client** Andrew Orndorff  
**Inspector** Brad Bergoine  
561.425.6300  
[brad@mixconsultants.com](mailto:brad@mixconsultants.com)

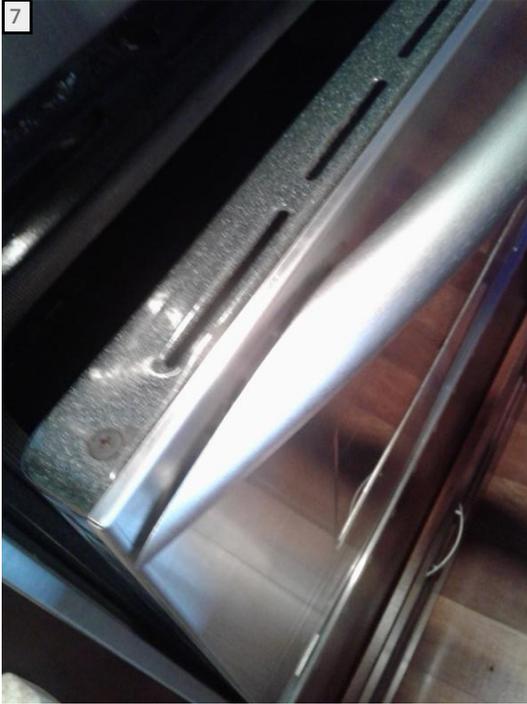
### Not Working. Door hardware is damaged.

Location	Kitchen
Impact	The Oven and Microwave Oven are not working. The clock is lighted., assuming there is power to both units. The damage to the hardware may worsen causing the door to become inoperable
Suggested Action	Repair or replace the Oven

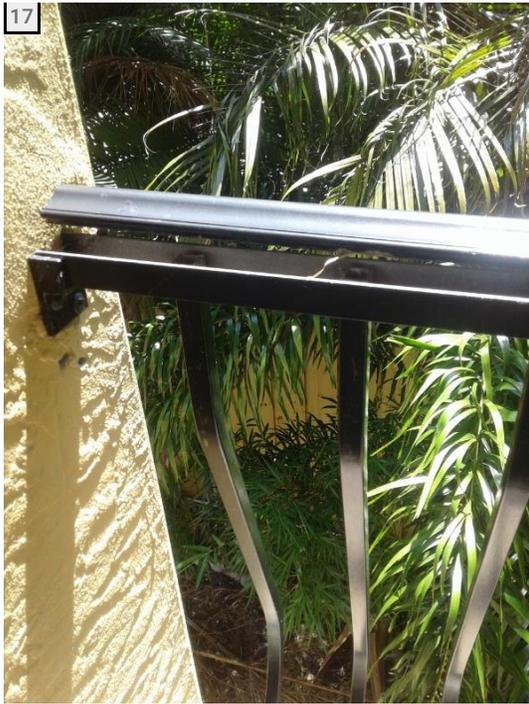
**Handrail is damaged**

Location	Loft
Impact	Deficient handrails reduce the stability of the railing
Suggested Action	Replace the missing component

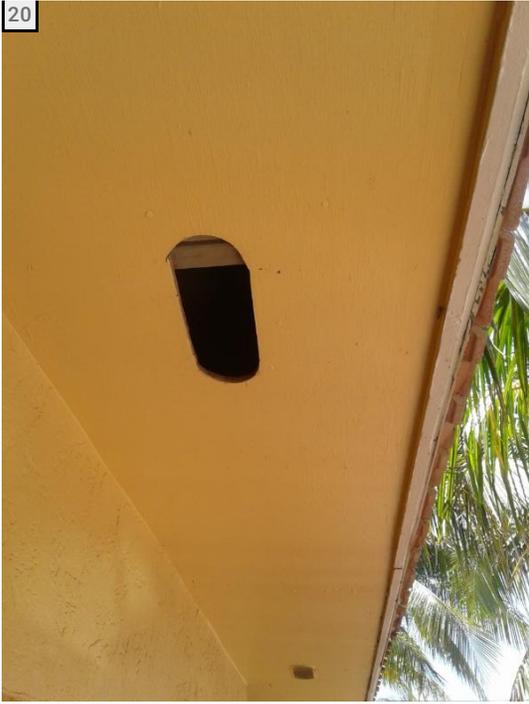
#### Soffit vents appear to be missing

Location	Exterior: Ground View
Impact	Without insufficient ventilation is timely moisture evaporation will not occur
Suggested Action	Add soffit vents to improve ventilation

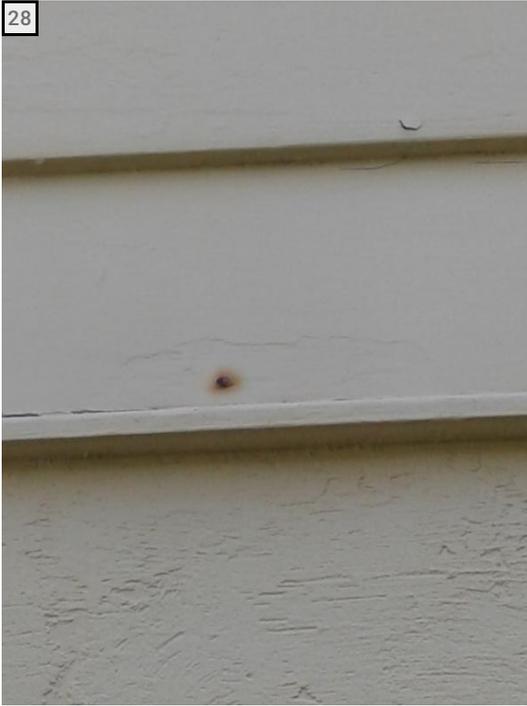
**Rusted nail pop**

**Location** Exterior: Ground View

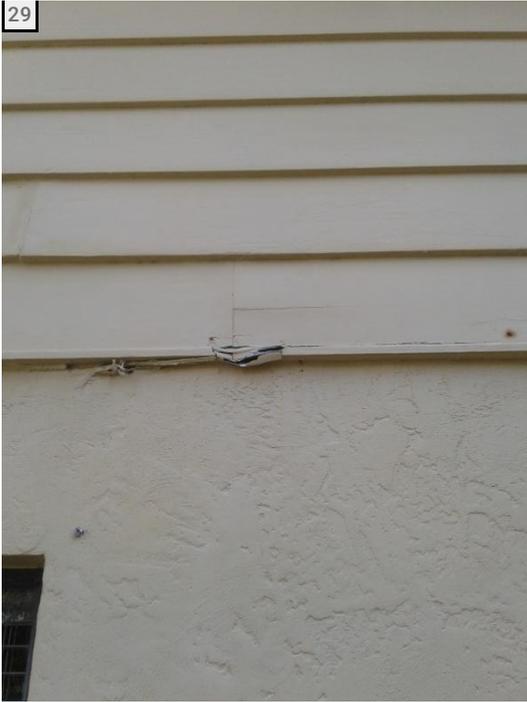
**Wood rot**

**Location** Exterior: Ground View  
**Suggested Action** Replace trim

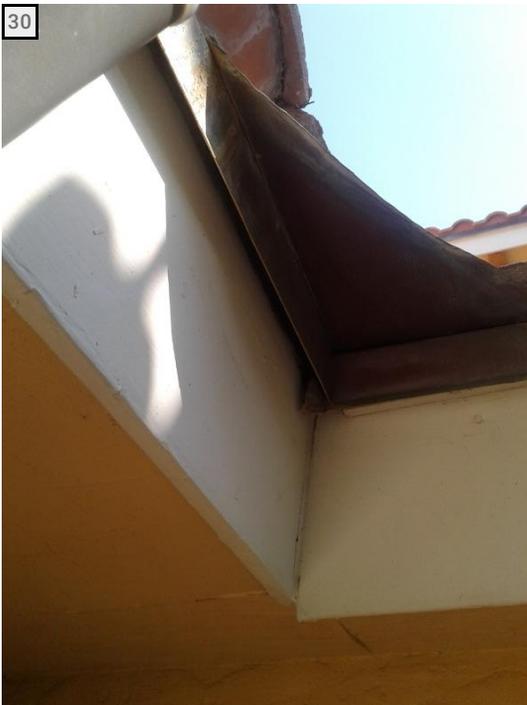
**Wood under flashing missing**

Location	Exterior: Ground View
Suggested Action	Replace trim

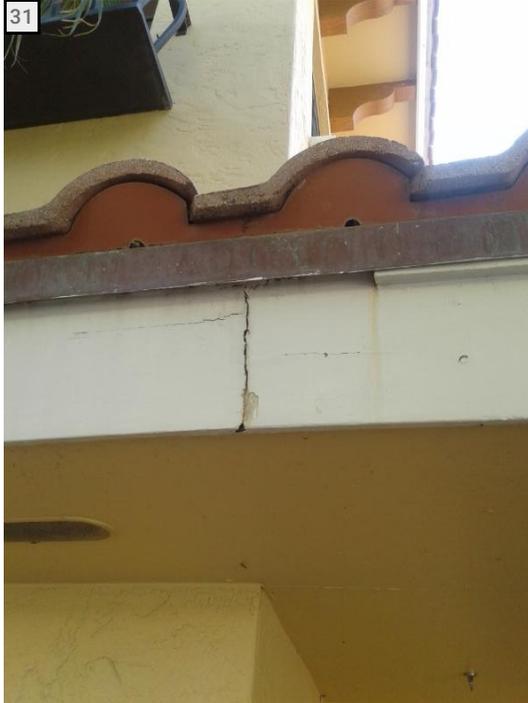
### Caulk has aged leaving holes or gaps

Location	Exterior: Ground View
Impact	The gaps could allow for moisture and insect intrusion which may cause cause damage to the wood over time
Suggested Action	Repair the caulking

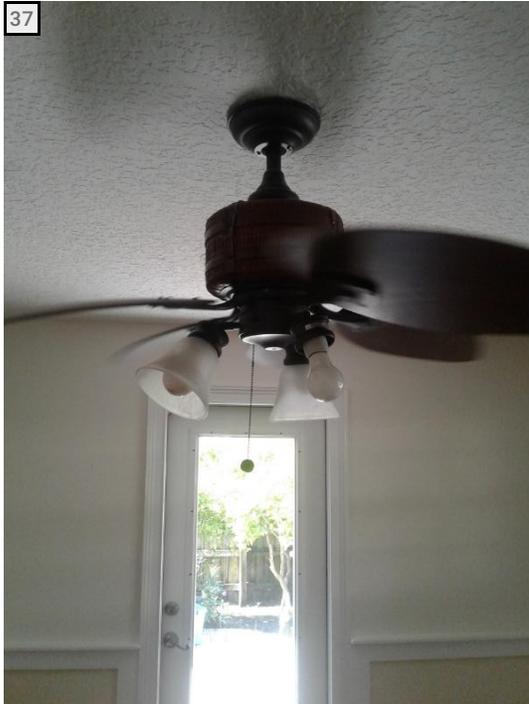
Lights not working

Location 5th Bedroom

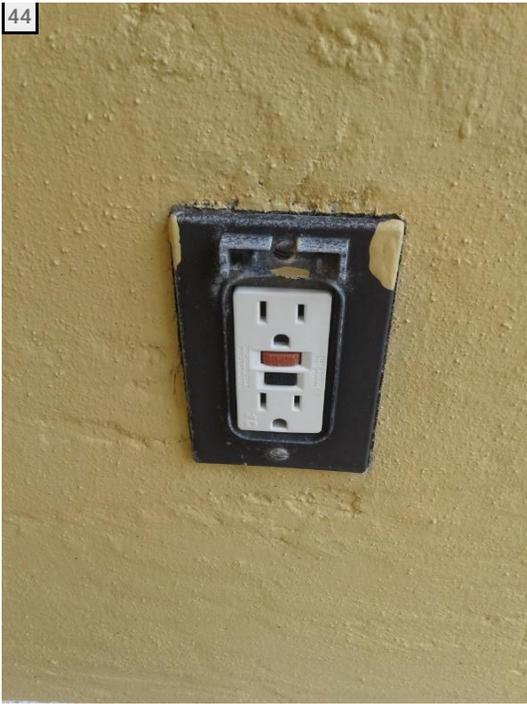
Cover is missing

Location	Loft
Impact	Without a cover plate, can cause electrical shock if touched
Suggested Action	Install a cover

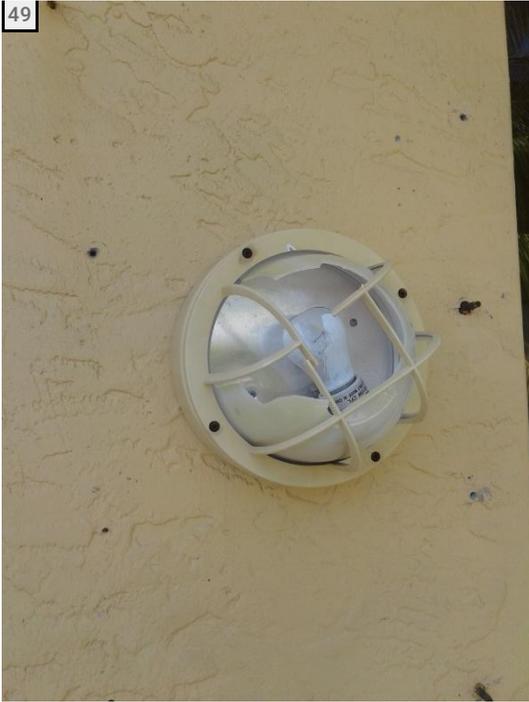
**Damaged**

**Location** Loft

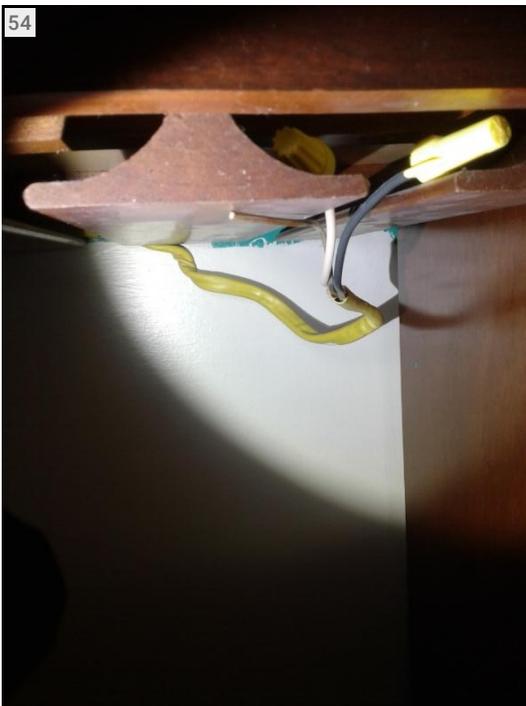
**Not installed in a junction box**

<b>Location</b>	Kitchen
<b>Impact</b>	Without a junction box the wiring is exposed thus lacking protection from shock or arcing
<b>Suggested Action</b>	Have repaired by a licensed electrician

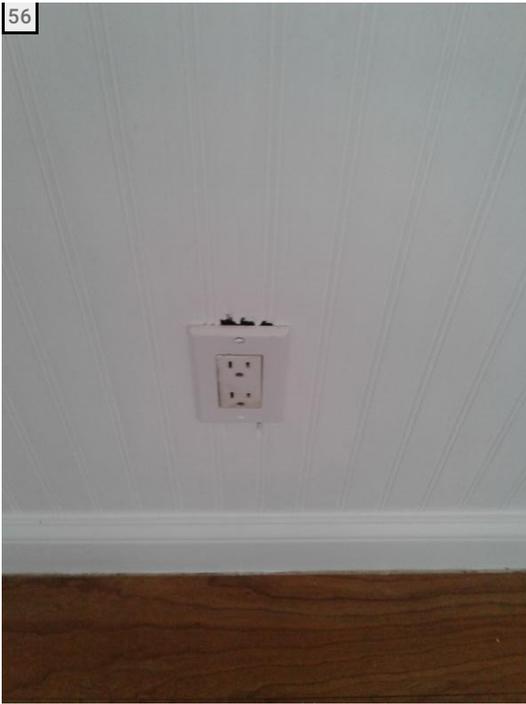
**Outlet loose**

**Location** Family Room

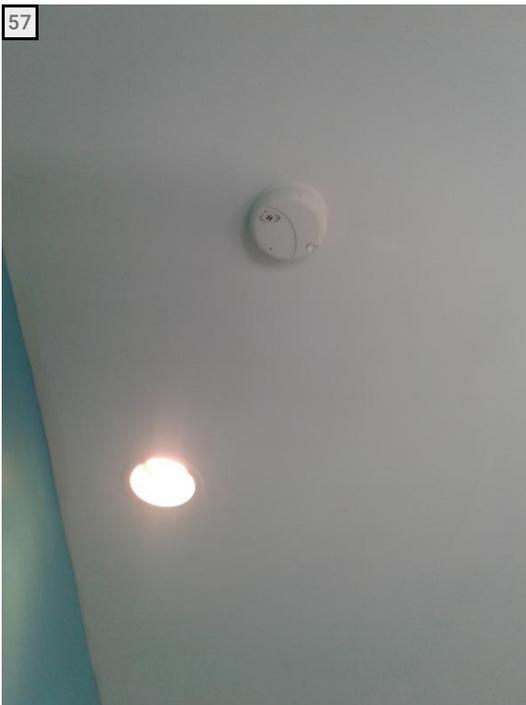
**Not Tested. Recommend replacing all smoke detectors.**

Location	Master Bedroom
Suggested Action	Have a trained professional replace all smoke detectors with new smoke detectors.

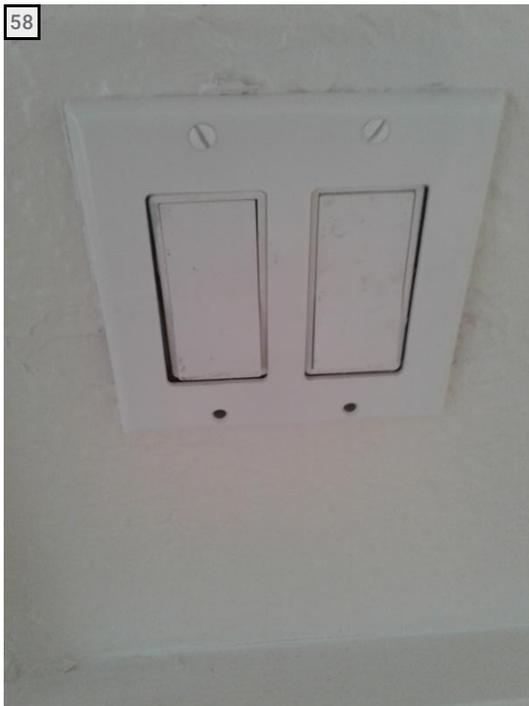
Location Living Room

### Missing screw

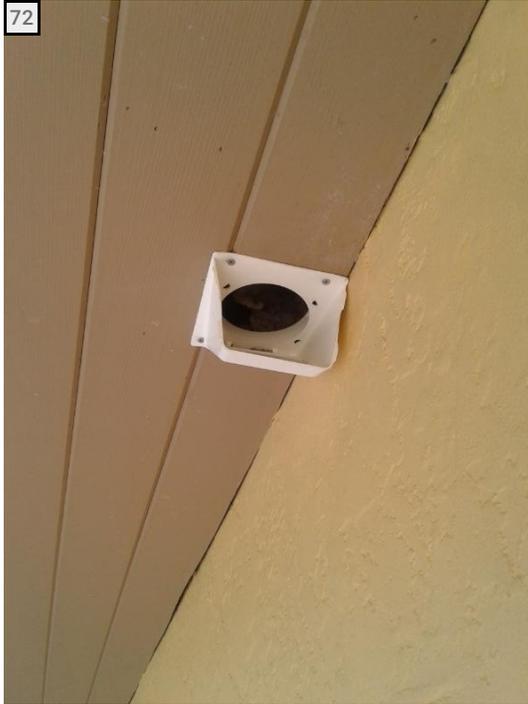
#### Cover is missing

Location	Exterior: Ground View
Impact	Without a cover / grill, debris will build up in flue exhaust areas
Suggested Action	Install a cover

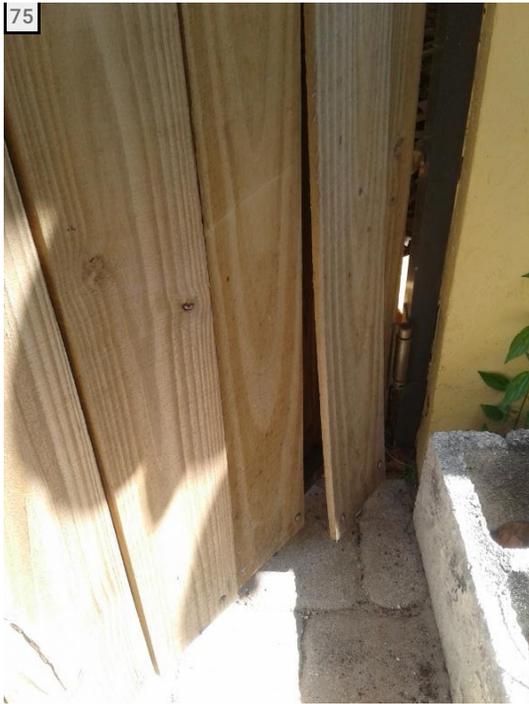
**Damaged**

Location	Exterior: Ground View
Suggested Action	Repair the gate

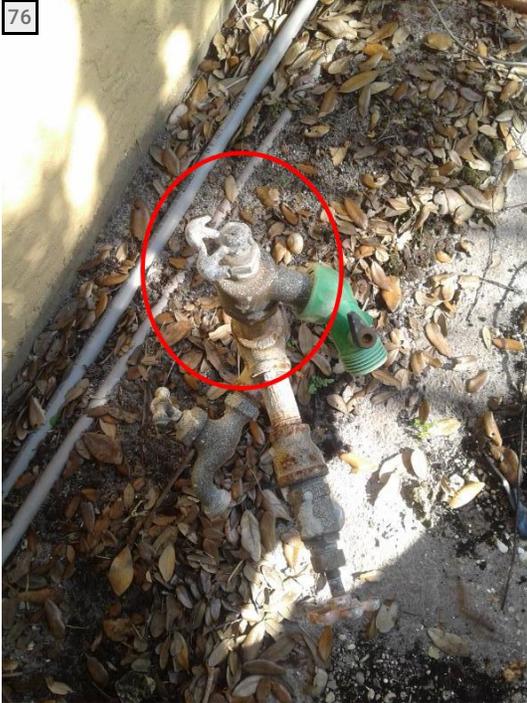
### Broken / Damaged Handle

Location Exterior: Ground View  
Suggested Action Repair or replace the hose bibbs

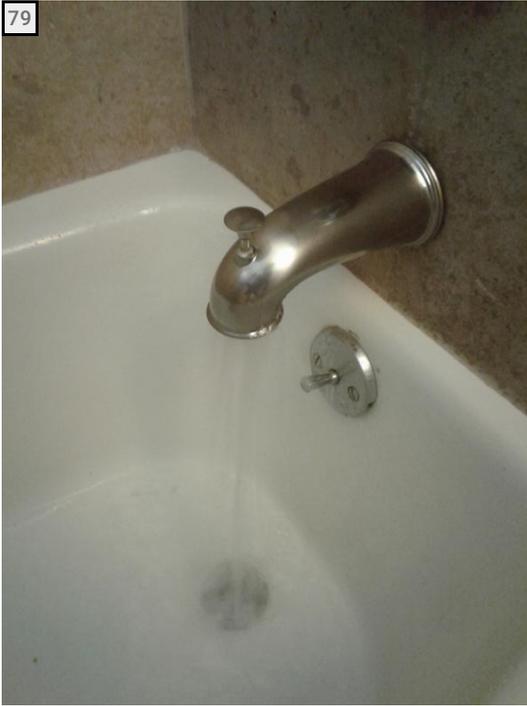
Location 2nd Bathroom

**Diverter is not operating properly**

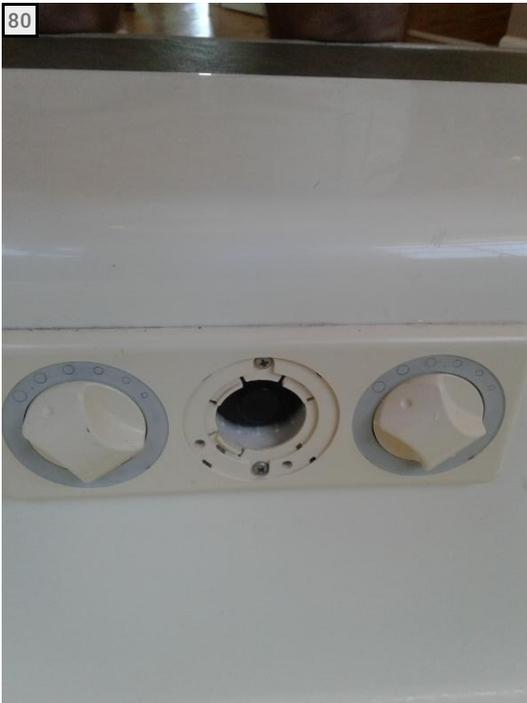
Location 4th Bathroom

**Missing hardware for air switch**

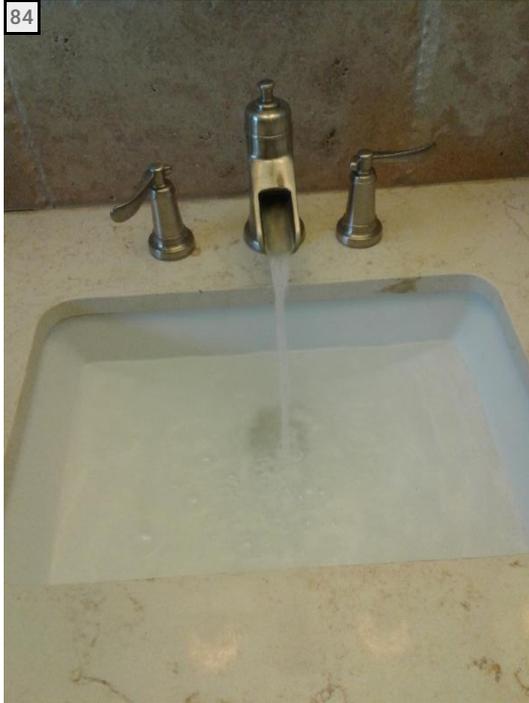
**Drains slow**

**Location** 2nd Bathroom, 4th Bathroom  
**Suggested Action** Clear the drain of debris with a rodder (vs. chemical)

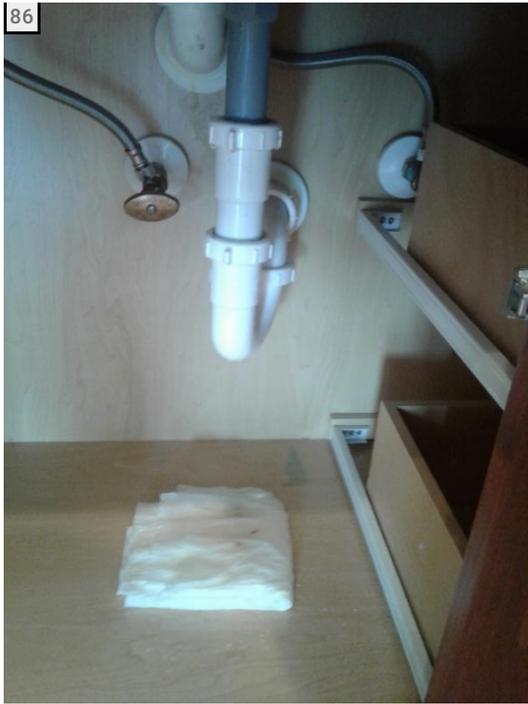
**Pipes are leaking at the connecting joint**

**Location** 4th Bathroom  
**Impact** The water may damage the surrounding areas  
**Suggested Action** Remove the connecting joint and reinstalling with plumbers putty or nylon tape

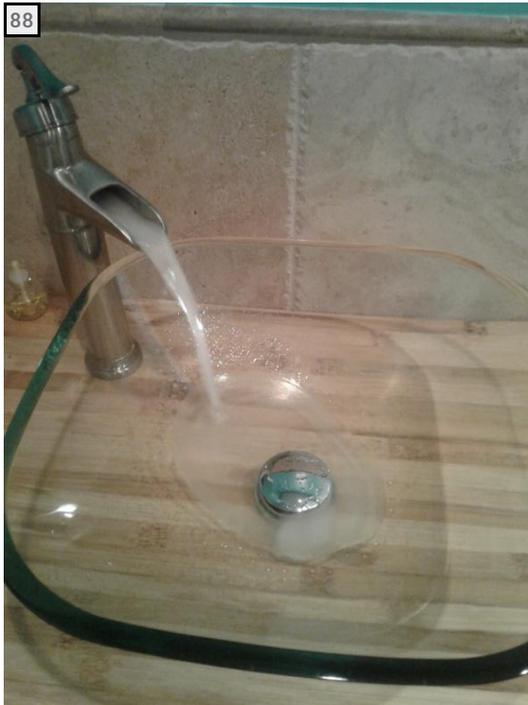
#### Water is milky.

Location	1st Bathroom
Impact	I have not seen this before, however I suspect that the water heater and pipes has built up sediment from not being run.
Suggested Action	Strongly recommend having a qualified plumber review and repair.

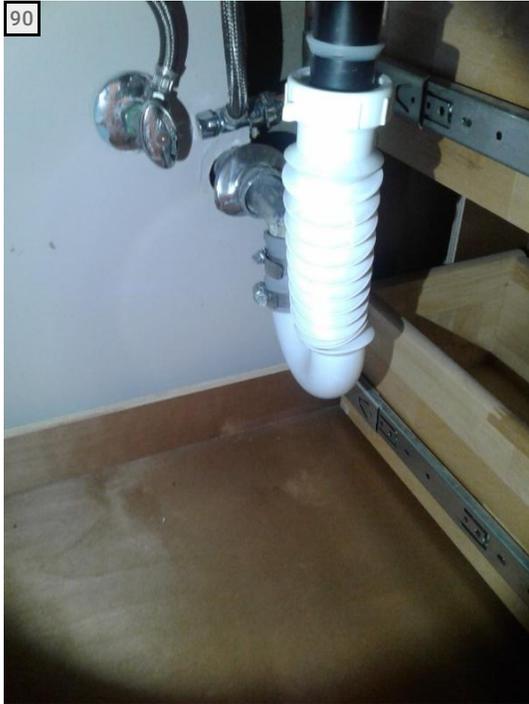
### Flex pipe

<b>Location</b>	2nd Bathroom
<b>Impact</b>	Been known to leak. In addition all fittings should conform to the the type of pipe used, Drainage fittings should have no ledges, shoulders or reductions which can retard or obstruct drainage flow in the piping.
<b>Suggested Action</b>	Recommend correction by a qualified plumber.

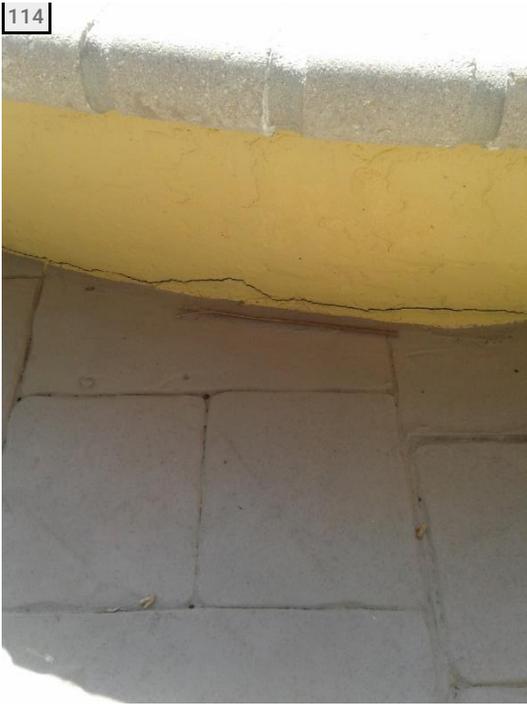
Location Pool Area

**Crack in stucco - Scattered**

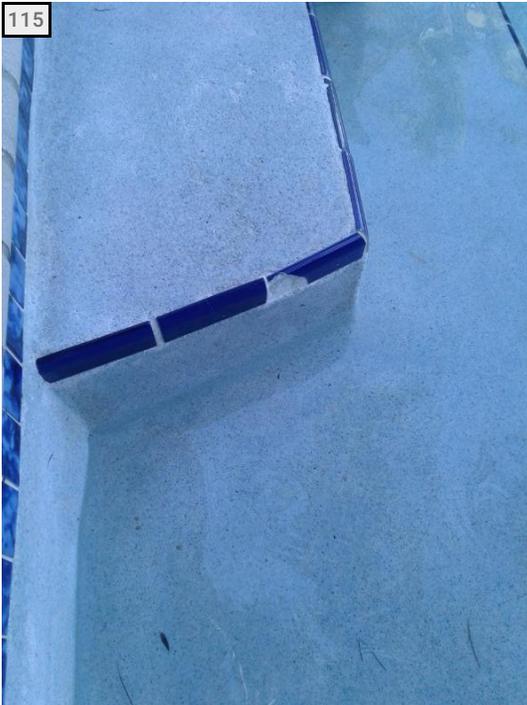
**Cracked / Broken tile**

**Location** Pool Area  
**Impact** Possible location of leak. Potential safety hazard

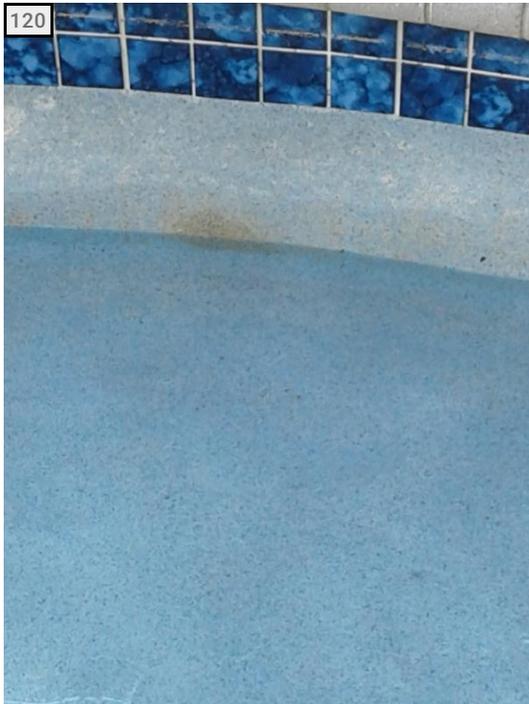
Location Pool Area

**Stained / discolored**

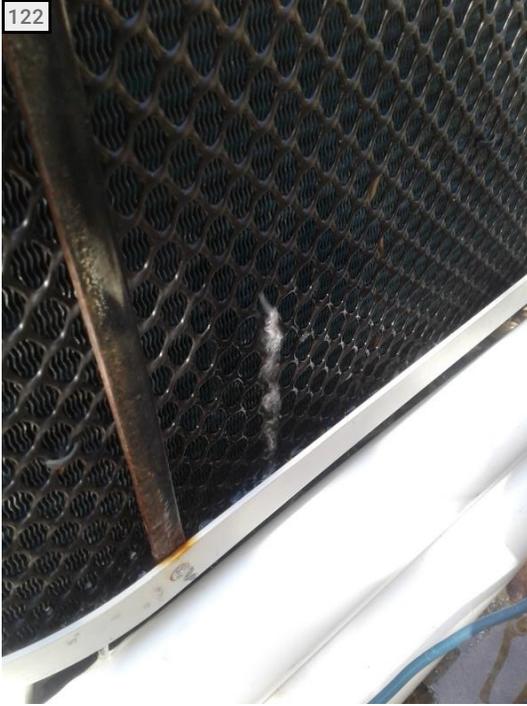
**Major Leak**

Location	Pool Area
Impact	Leaking from heater.
Suggested Action	Repair or replace heater.

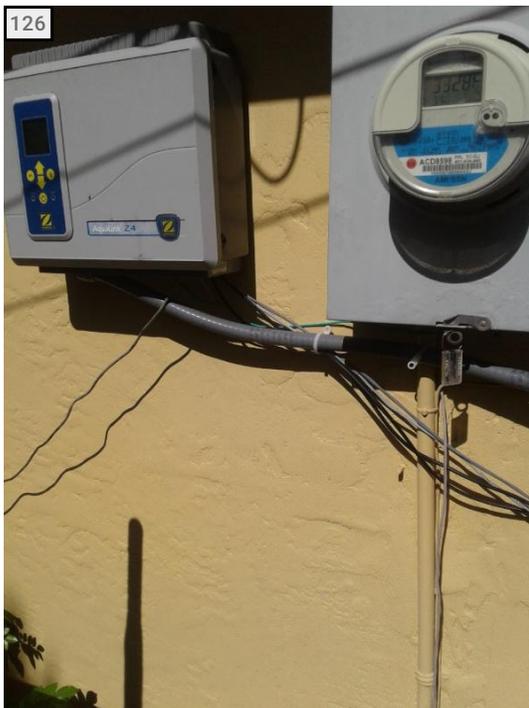
**Exposed wires**

Location	Pool Area
Suggested Action	Wires should be in conduit

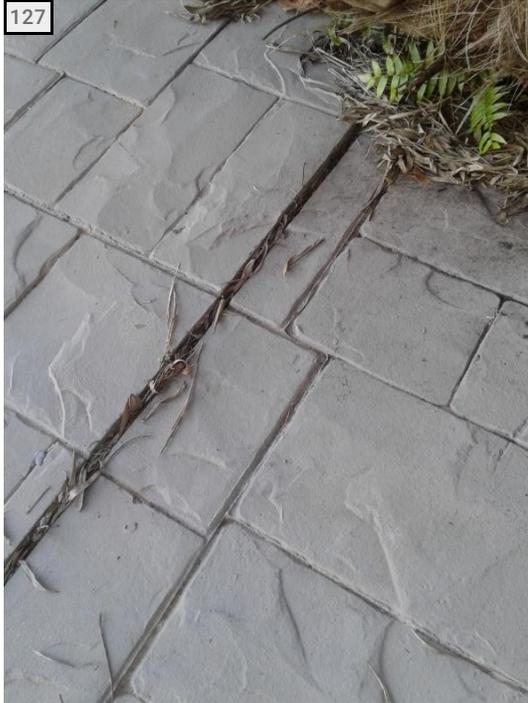
### Deck separation

Location	Pool Area
Impact	Tripping hazard

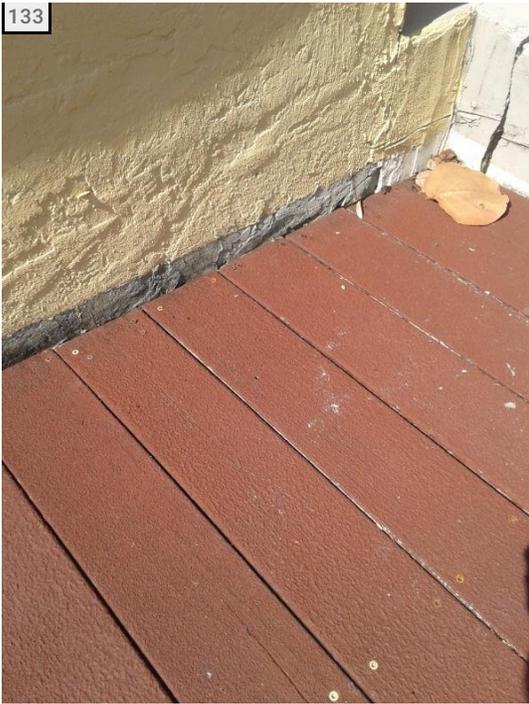
**Dock dropped several inches**

Location	Pool Area
Suggested Action	Have a qualified dock / Seawall professional repair or Replace.

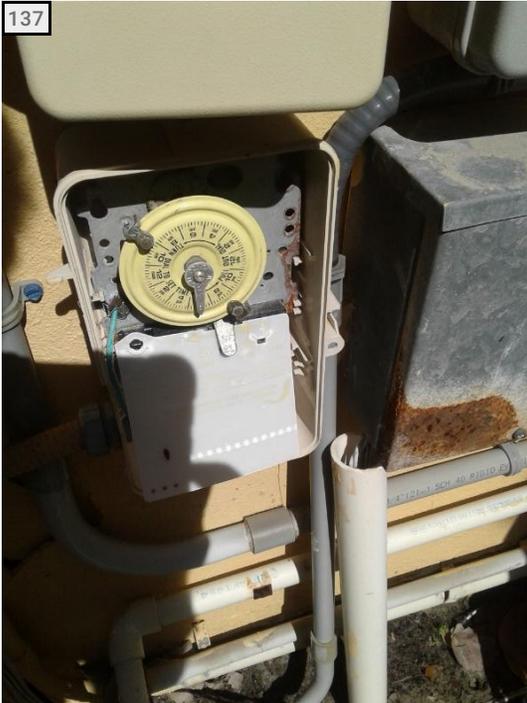
Location Pool Area

Timer missing cover

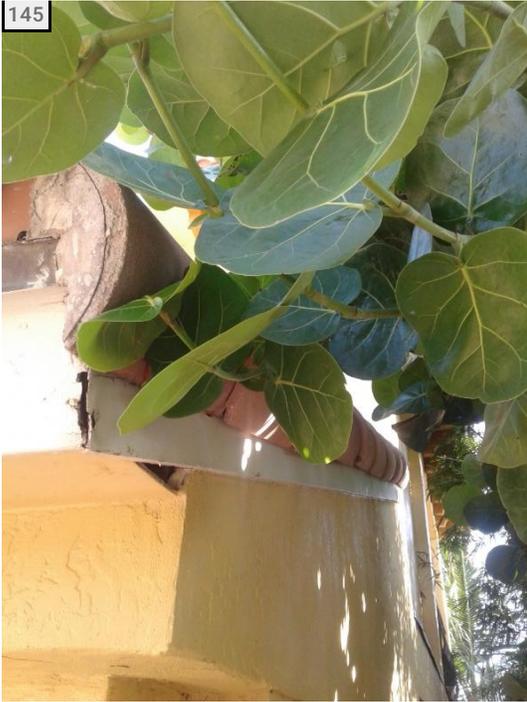
Location Exterior: Roof View

**Tree / Branches overhanging roof**

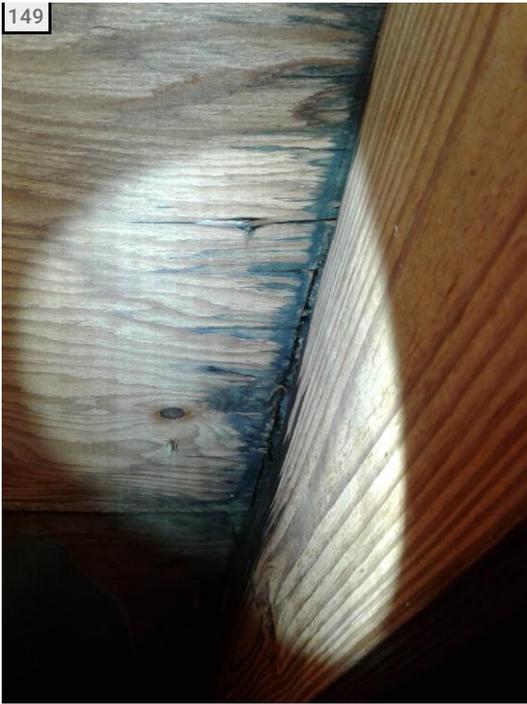
Location Attic

**Evidence of prior water leak- tested dry**

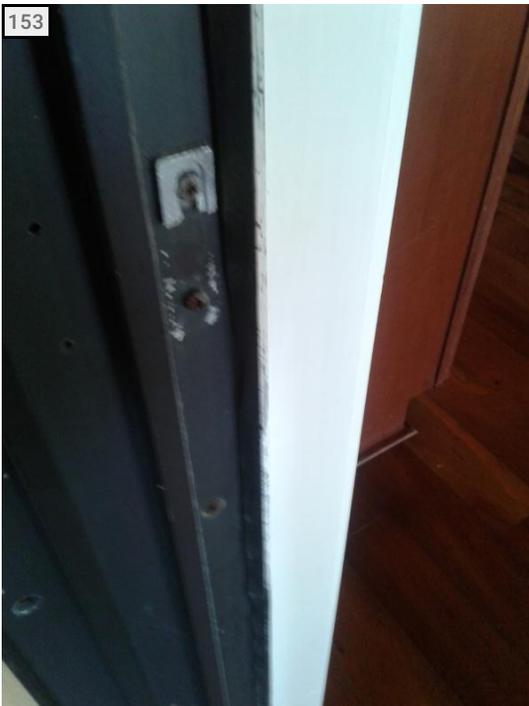
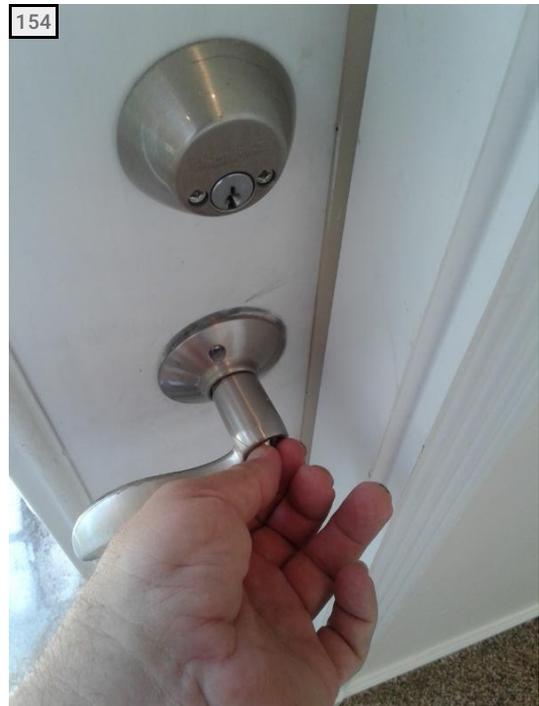
Location Living Room, Loft

**Locking mechanism not working properly**

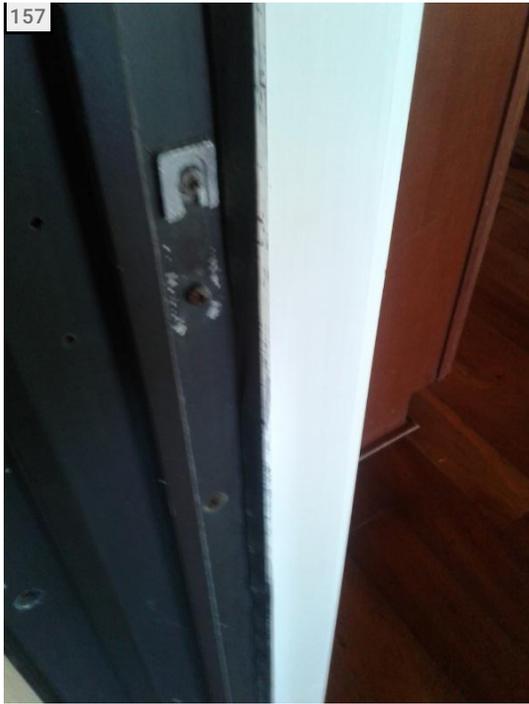
### Damaged

Location	Master Bedroom, Living Room
Suggested Action	Repair the damage or replace the door depending on your preference

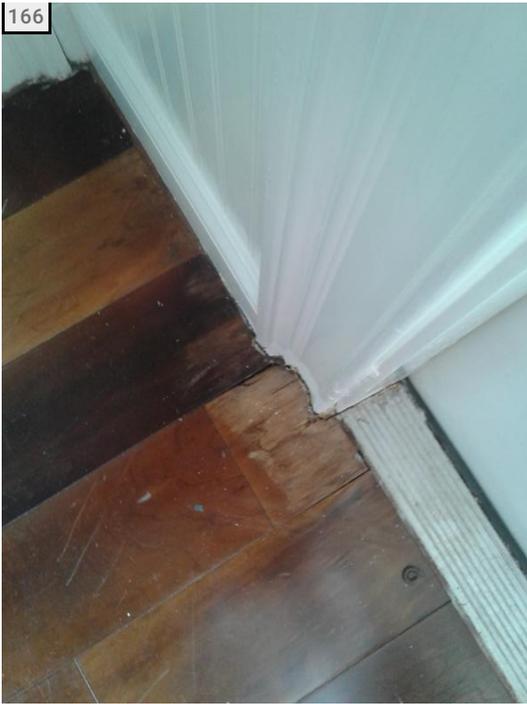
Location Living Room

**Damaged**

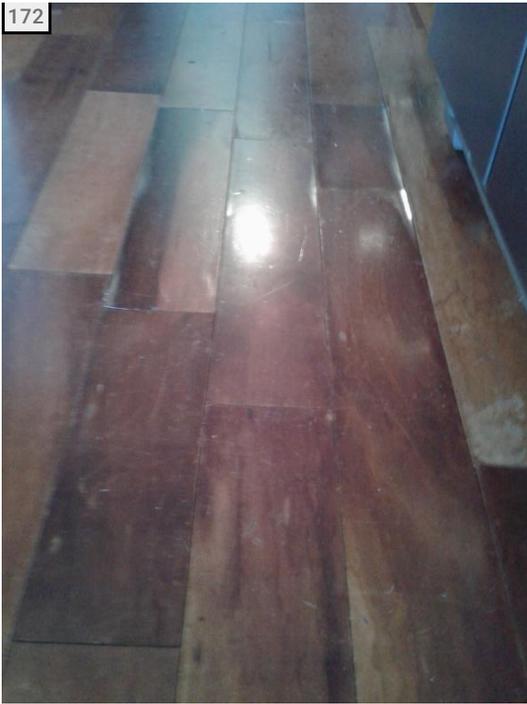
**Moderately to excessively warped**

**Location** Kitchen  
**Impact** Warped floors lack astethic appeal and may be a trip hazard  
**Suggested Action** Manage the humidity levels such that moisture levels are in the range of 35% to 50% and no more than 20% higher than the wood floors. Have the floor repaired by a qualified wood floor professional

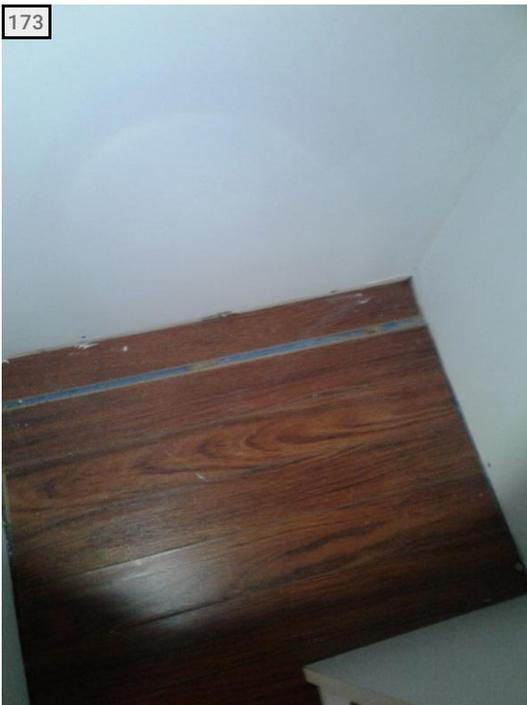
#### Floor boards are loose

Location	4th Bedroom
Impact	Loose floor boards may squeak and in an extreme case may create a trip hazard
Suggested Action	Have repaired by a qualified wood floor professional

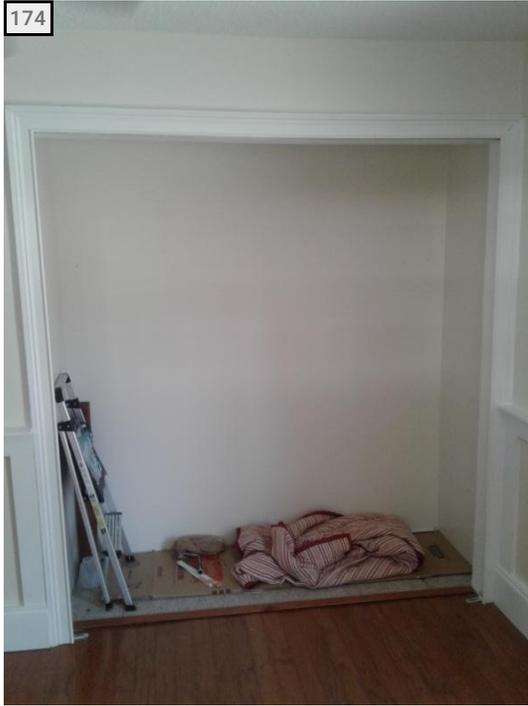
Location 4th Bathroom, 5th Bedroom

### Missing

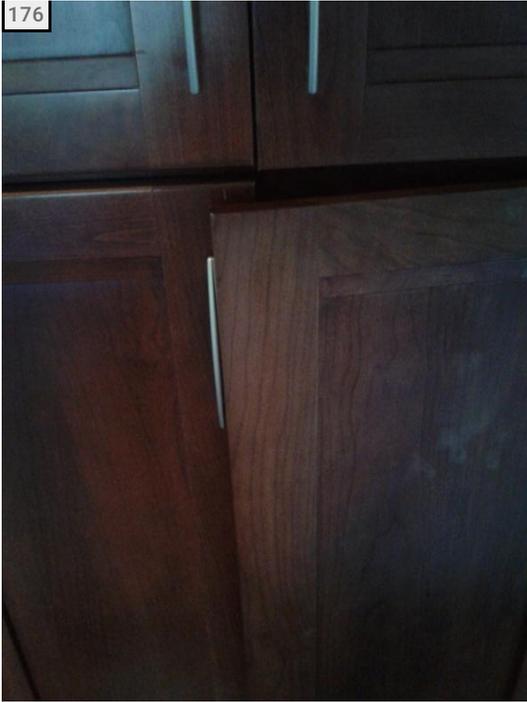
Location Hallway and Stairs

### Door on linen closet wrong size

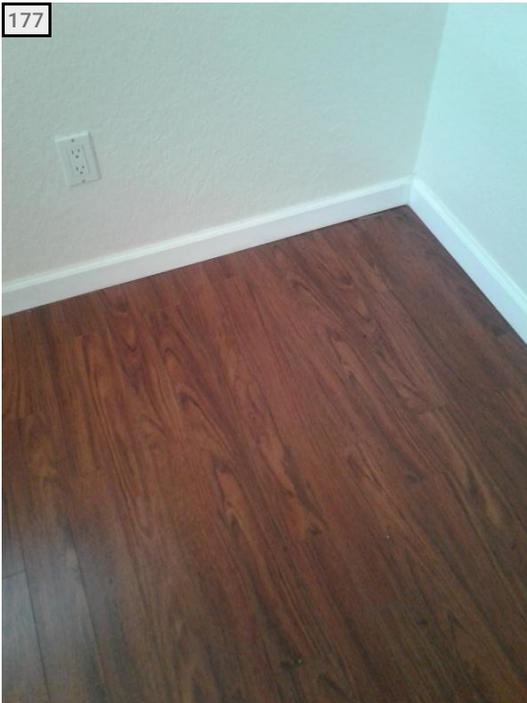
#### Caulking or sealant missing

Location	4th Bedroom
Impact	Without weather-tight sealant, moisture intrusion may occur causing long-term damage to surrounding trim and structure
Suggested Action	Seal with a weather-resistant color-matched flexible sealant

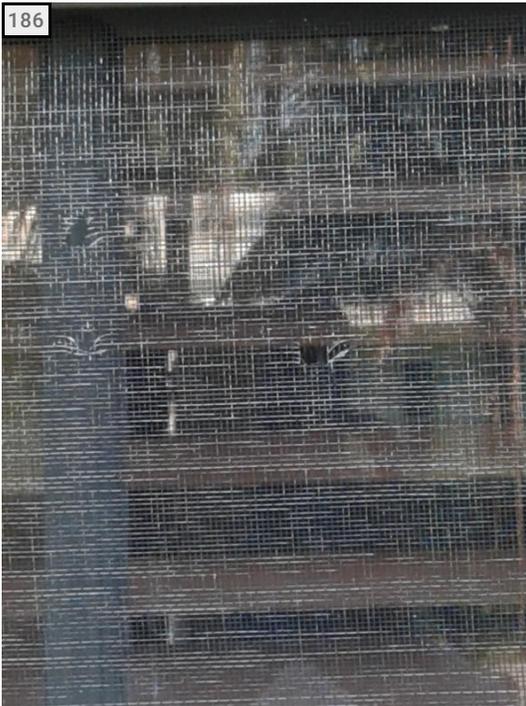
#### Torn or damaged

Location	Exterior: Ground View
Impact	Should the window be open, lacks protection from insects
Suggested Action	Replace the screen

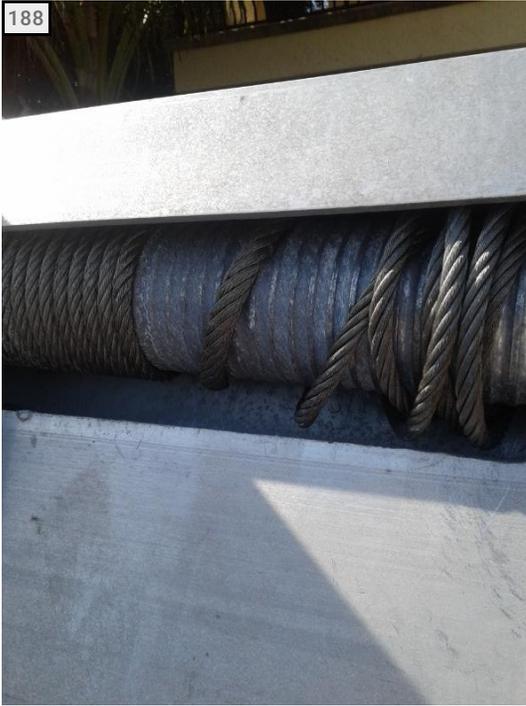
Location Boat Lift

**Cable not rolling properly**

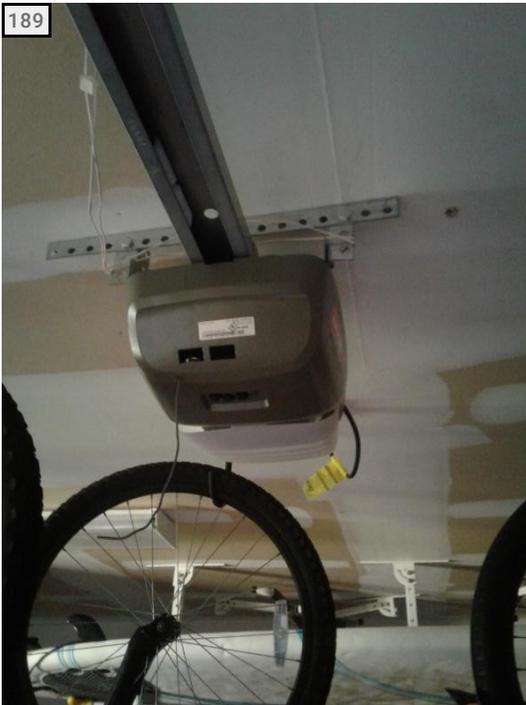
Location Attached Garage

**Garage door opener does not work**

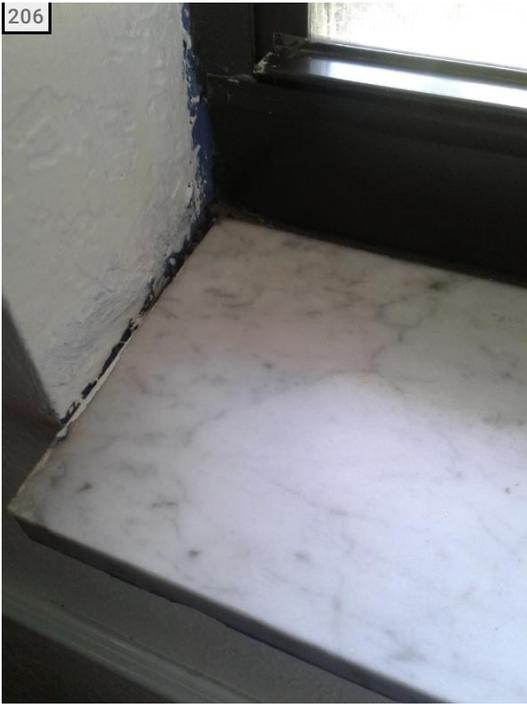
**Caulking or sealant is missing**

Location	4th Bedroom
Impact	Without proper caulking, air, moisture and/or insect intrusion may occur
Suggested Action	Caulk all windows and doors where caulking has deteriorated

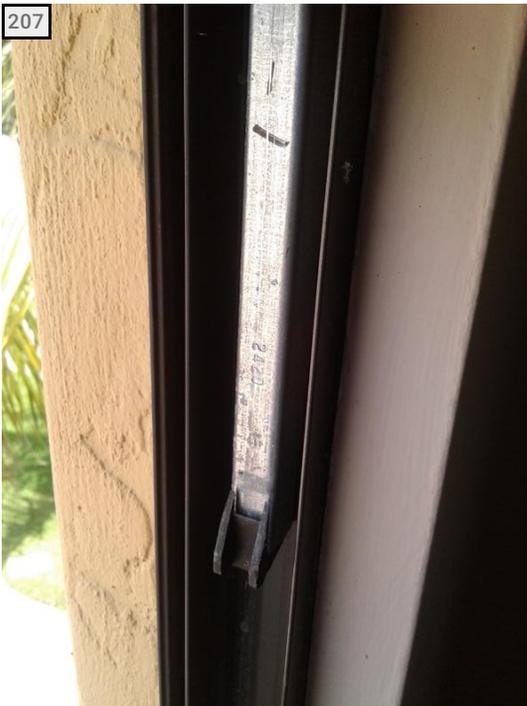
#### Lift mechanism is broken

Location	4th Bathroom
Impact	Without a lift mechanism, the window can not be opened
Suggested Action	Repair or replace the lift mechanism
