Rosebud Power Plant Annual Engineer's Inspection Report

Prepared for Rosebud Operating Services, Inc.
by Allied Engineering Services, Inc.

January 19, 2017

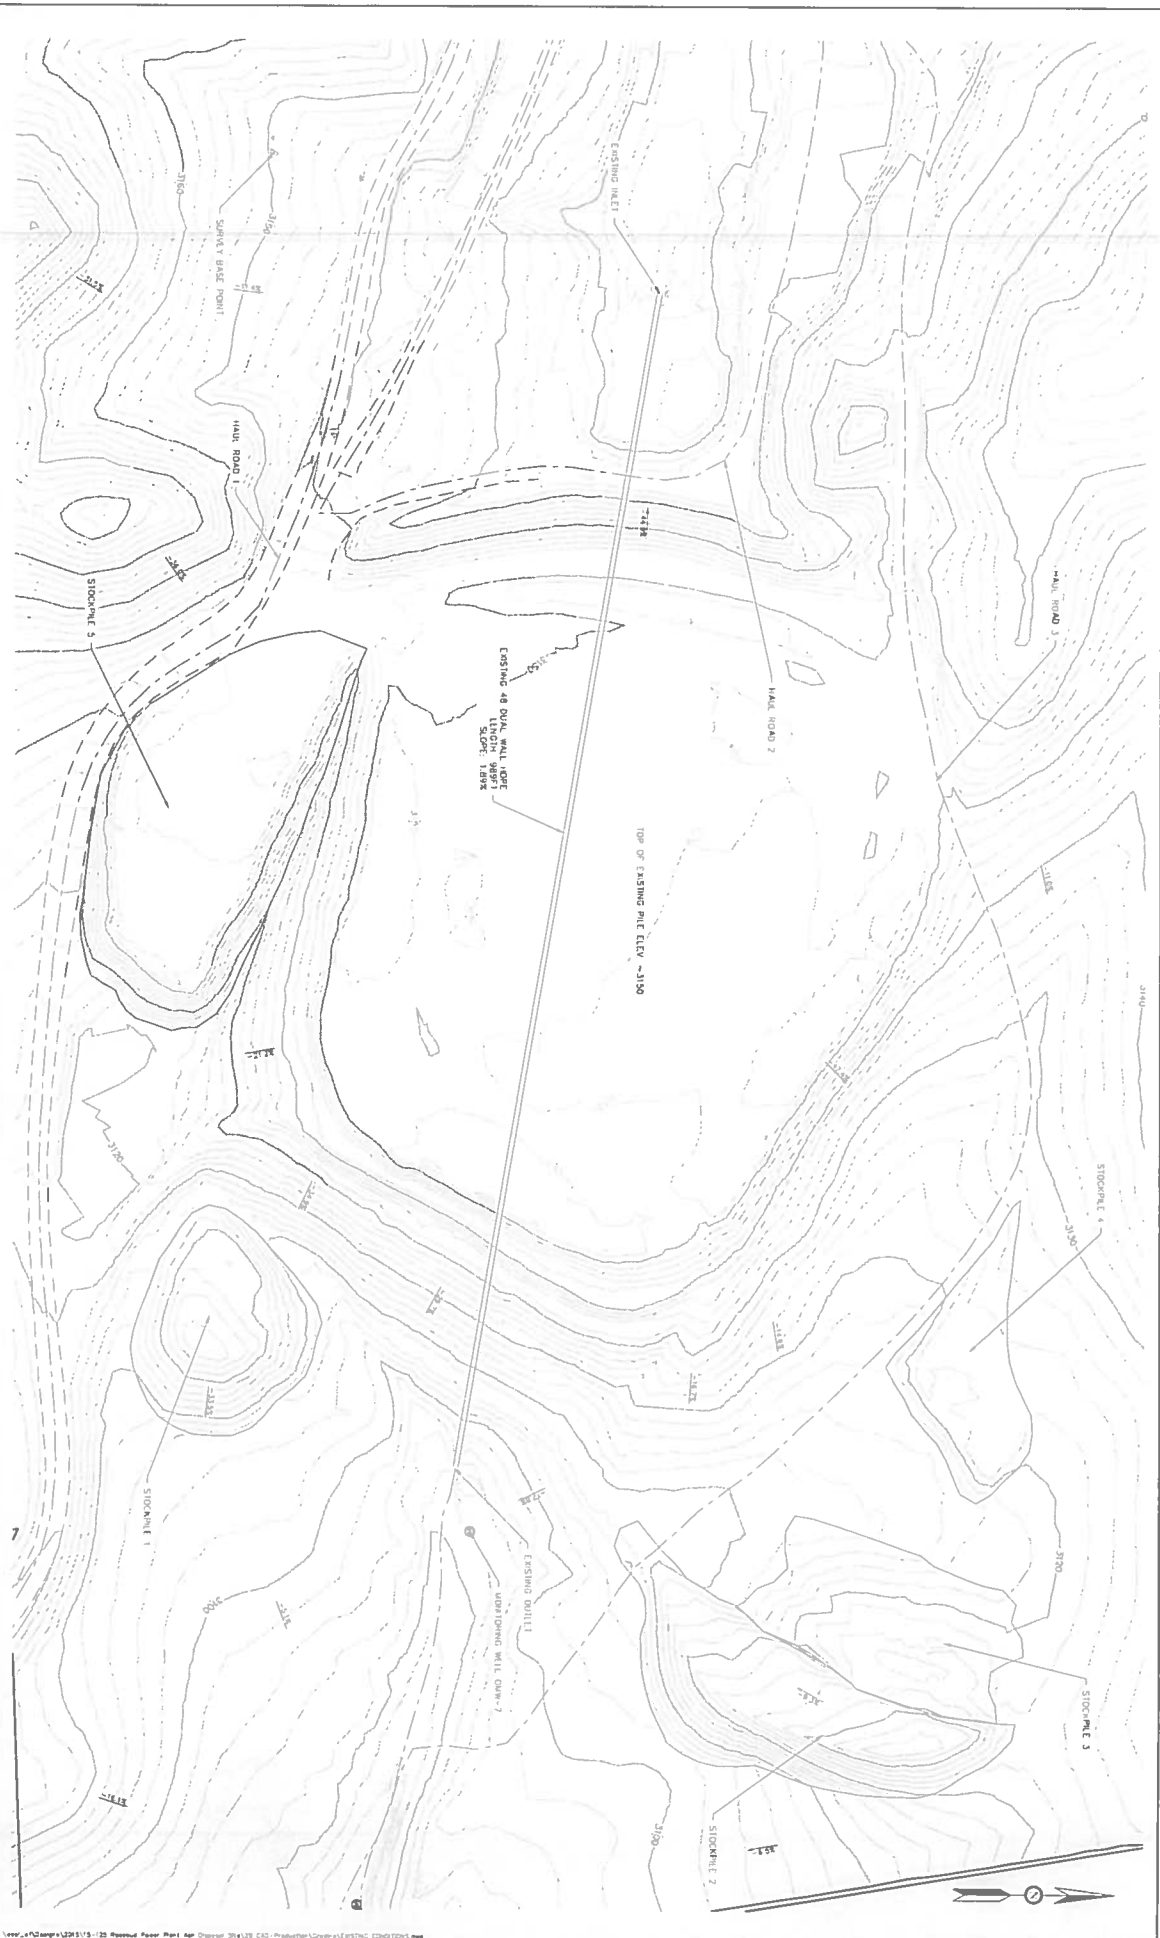
ITEM	YES	NO	REMARKS/LOCATION
(1) Any visual settlement, sloughing, slumps, depressions or bulges?		✓	
(2) Any misalignments?		✓	
(3) Any cracking?		✓	
(4) Any traffic or animal damage?		✓	
(5) Top Width (10-ft design) except at prescribed exterior bench locations (see map)	✓	✗	
(6) Interior Side Slopes (1.5H:1V design)	✓	✗	
(7) Height of Berm above Ash Surface (ft)	✓		<u>4-5ft Phase 1</u>

ITEM	YES	NO	REMARKS/LOCATION
(8) Any Debris, Erosion, or Cracking?		✓	
(9) Side Slopes meet minimums (3:1 exterior, 1.5:1 interior)?	✓	✓	
(10) Any exposed ash on exterior slope?		✓	
(11) Any visible water pooling or ponding?		✓	
(12) Any visible water/runoff spill points?		✓	
(13) Pipe Condition?			good
(14) Water flowing from pipe?		✓	
(15) Any pooling or ponding at pipe inlet or outlet?		✓	
(16) Any erosion/undermining of pipe at inlet or outlet?		✓	
(17) Other? Ash pit phase I			pit is heaving Need Bladed

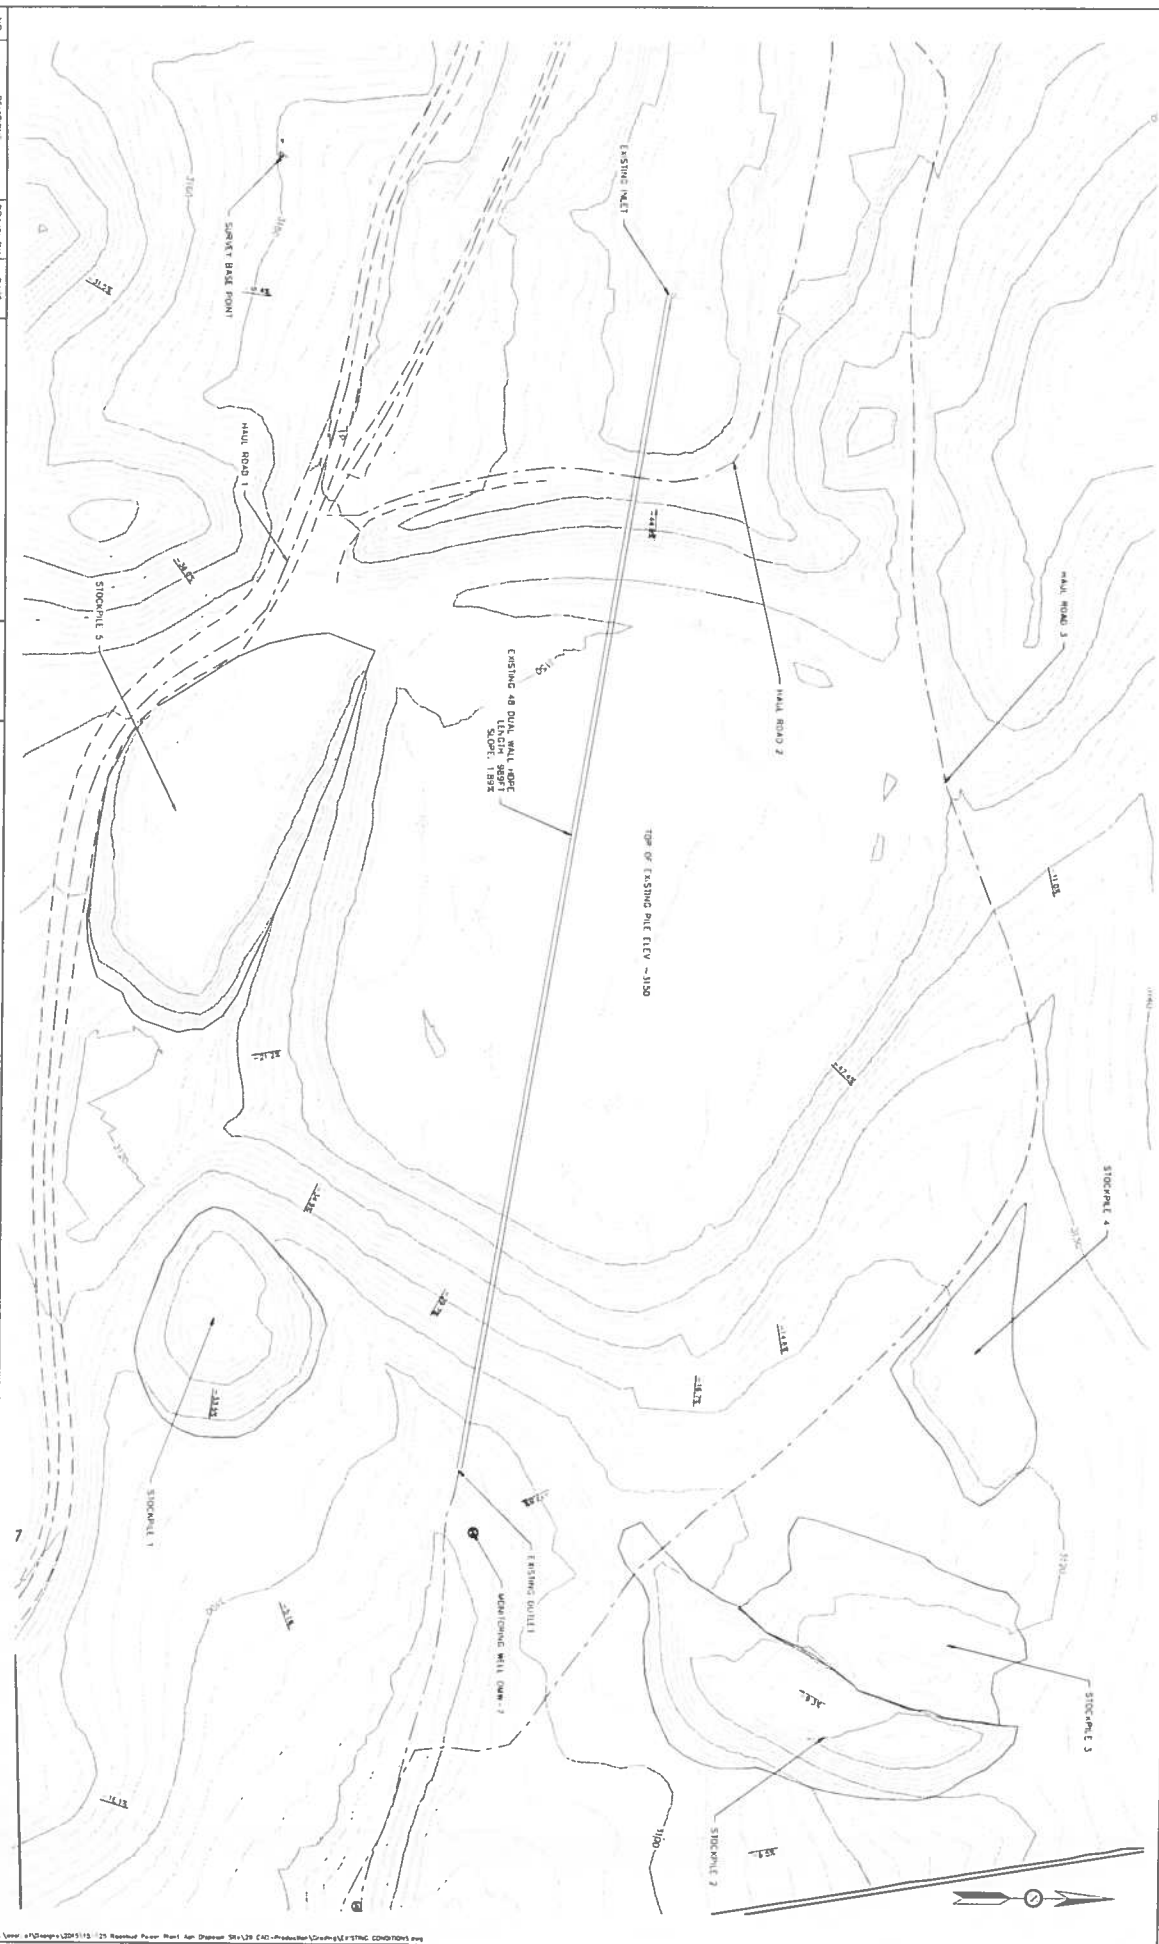
good Removing Ash from upper pit-
