Buyer Buying

1234 Elm St
San Diego, California 91915

Tuesday
April 23, 2024

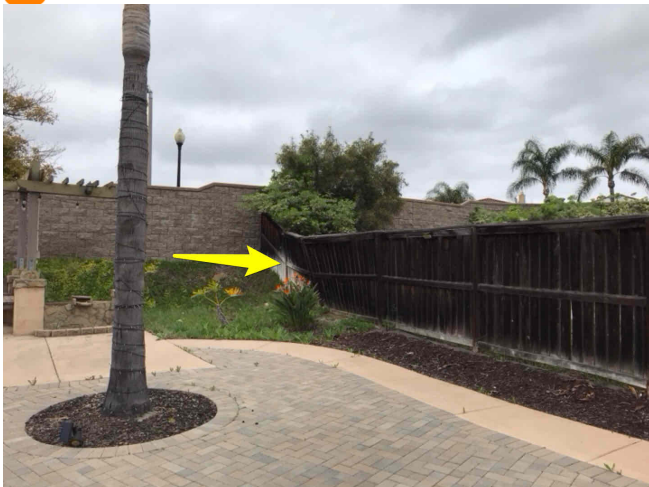
R 35: There is major damage to the fencing. We recommend the fencing be repaired and/or replaced.

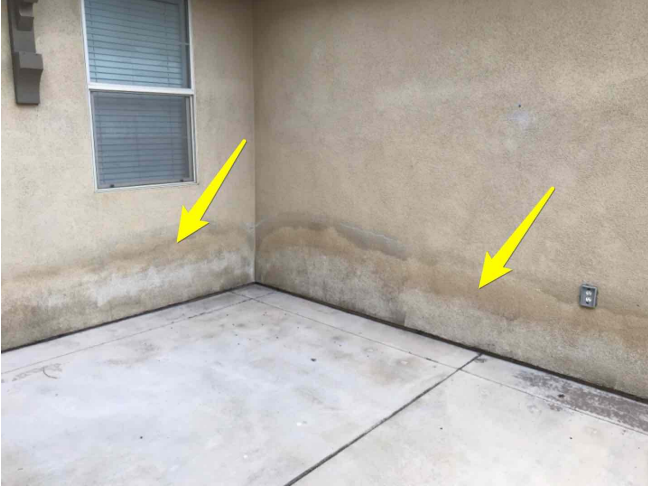
W 38: There is water staining to the exterior stucco. The gutters, flashing, exterior drainage and sprinkler system should be serviced to prevent future staining.

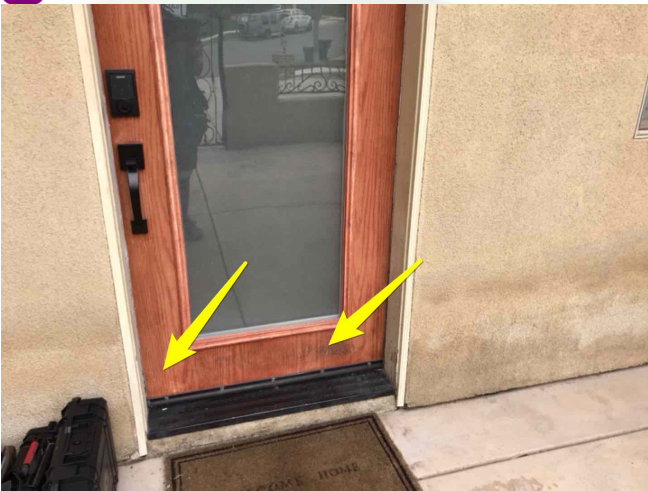
M 42: The exterior door is in need of maintenance service. Painting, sealing, caulking etc..

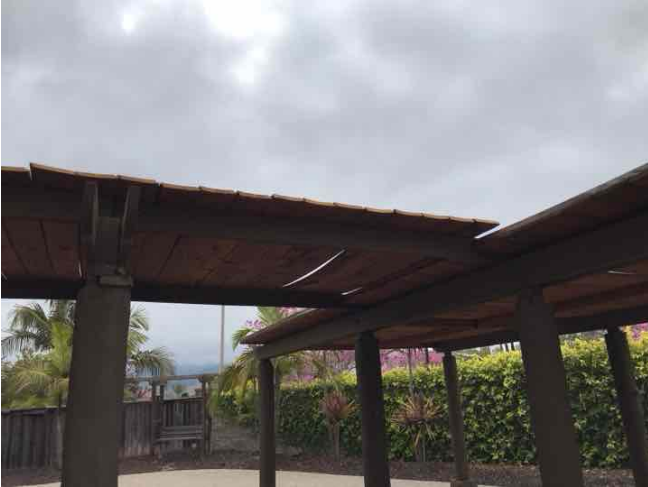
R 60: The rear patio cover is damaged and needs to be repaired or replaced

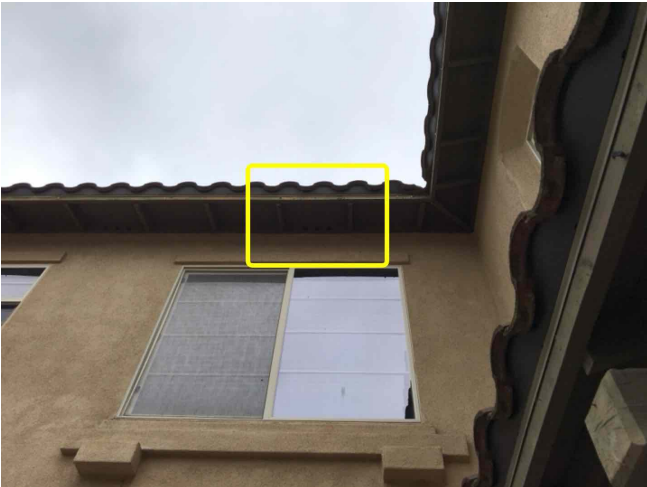
S 73: There is an active bee hive at the eaves. We recommend this hive be removed by a professional beekeeper. Inspection was limited because of this condition.

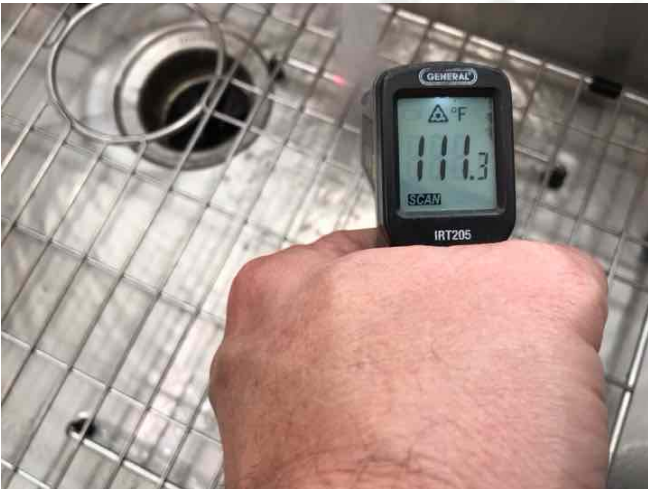
167: The water temperature measured 111 degrees which is an acceptable safe temperature. Any Temperature over 126 degrees is a potential scalding hazard.

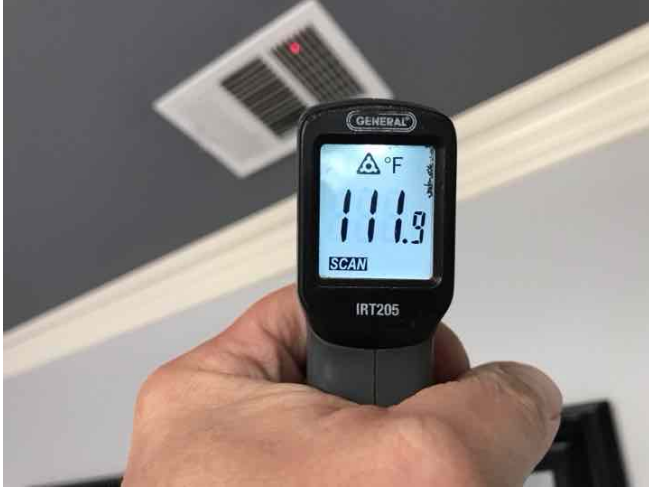
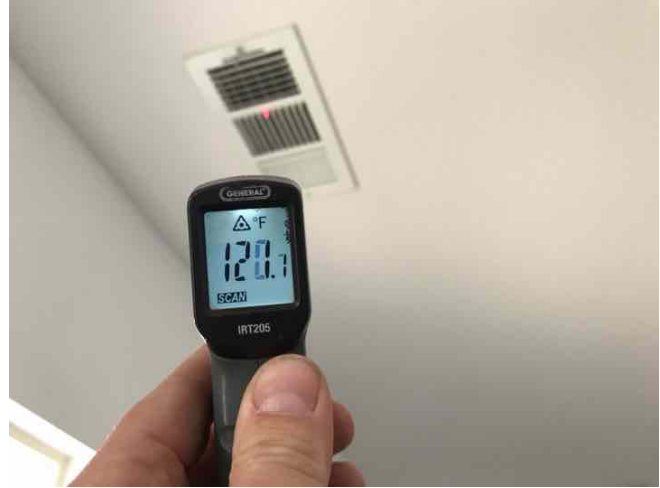
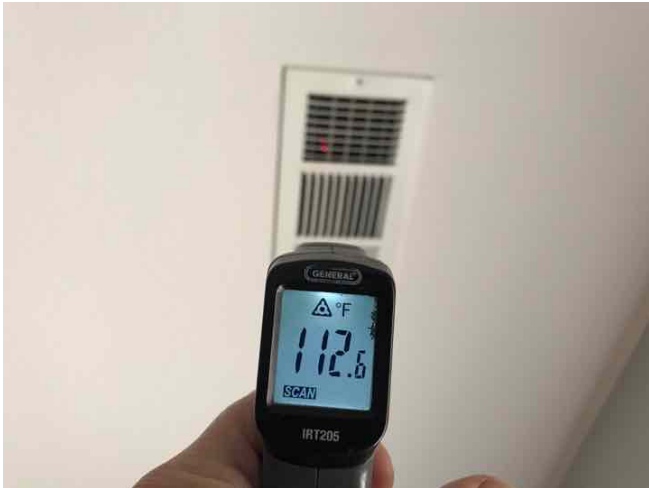
226: The heating system responded to normal user controls at the time of inspection. With an average temperature of 116 degrees coming out of the register vents.

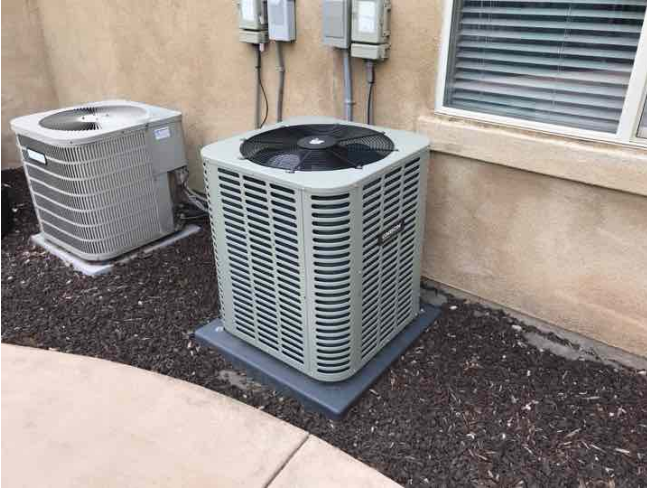
256: The condensing unit appears to be properly installed and in serviceable condition.

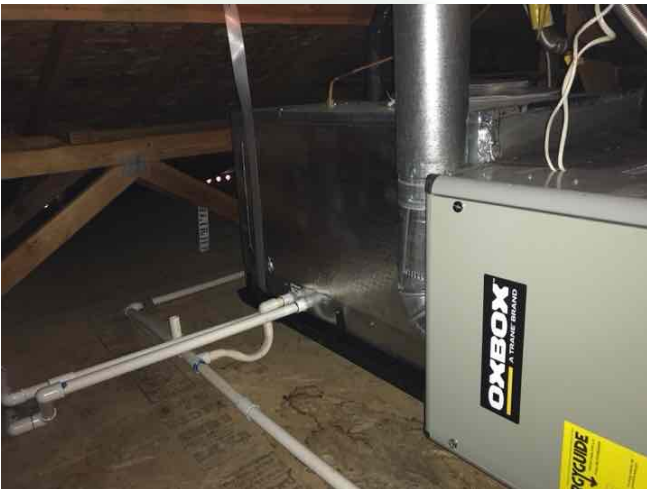
258: The horizontal drip pan appears to be in satisfactory condition.

259: The primary and secondary condensation drip lines appear in satisfactory condition.

W 260: The secondary condensation drip line at the rear exterior show signs of previous leakage. This could be an indication of a clogged primary condensation line. Further evaluation is suggested.

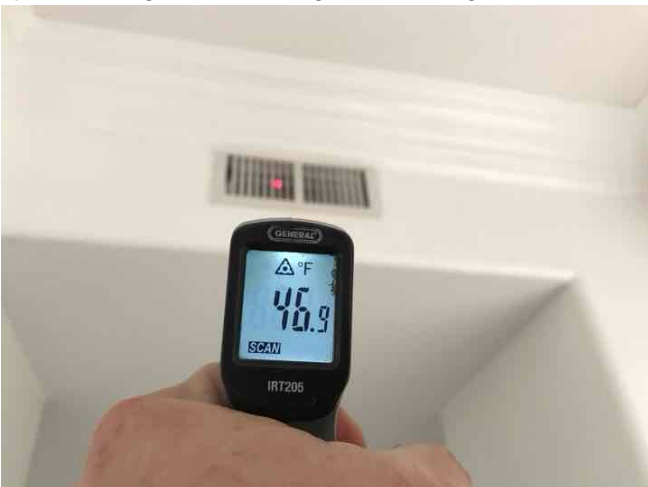
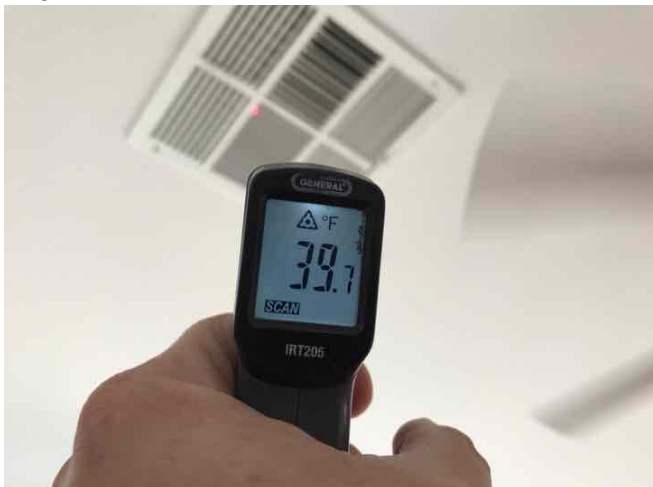
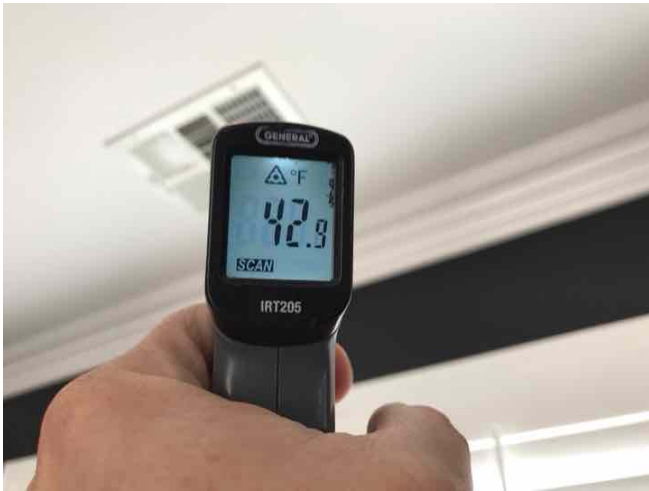
267: The air conditioning system responded to normal user controls at the time of inspection. With an average temperature split of 19 degrees air coming out of the register vents and air going into the return.

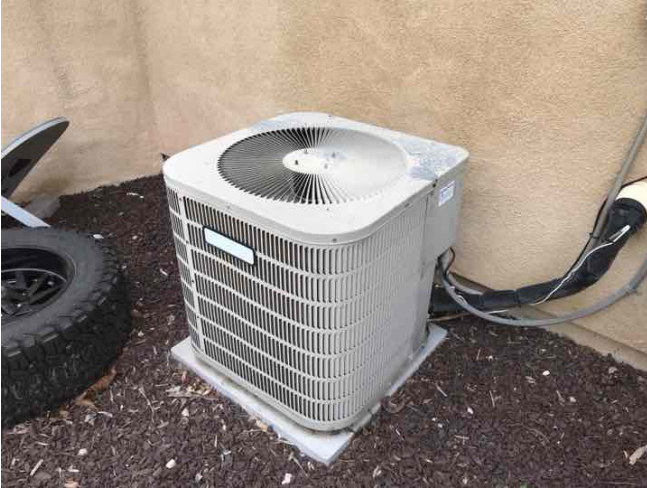
280: The condensing unit appears to be properly installed and in serviceable condition.

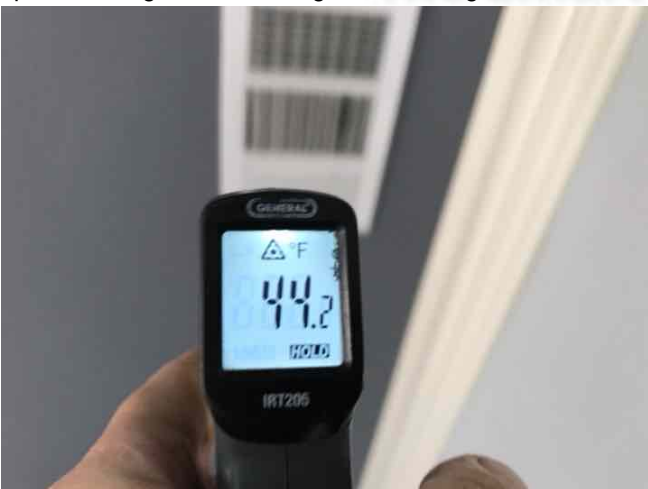
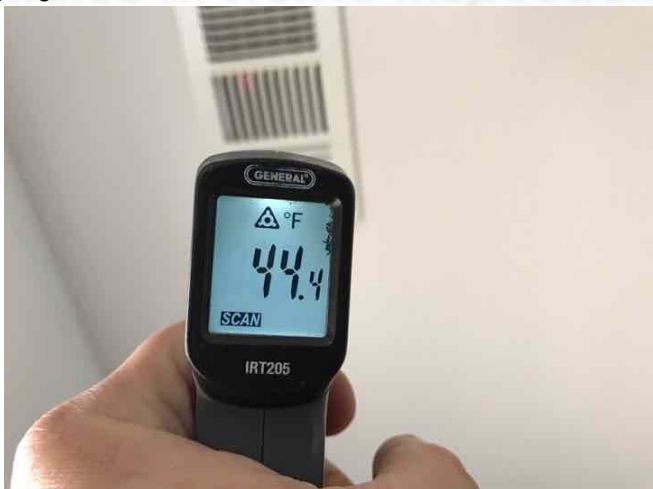
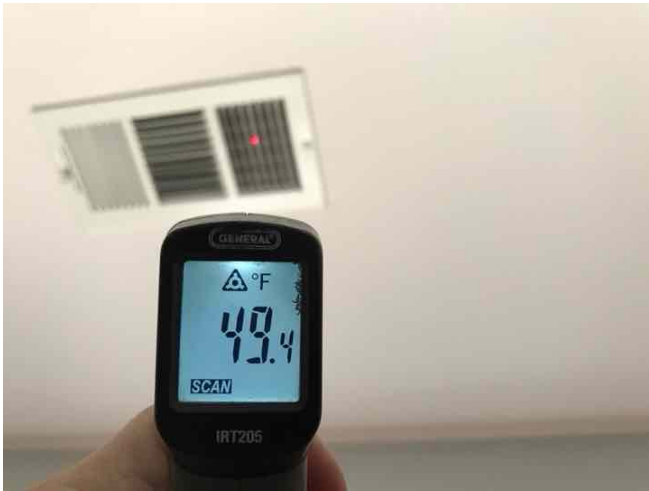
291: The air conditioning system responded to normal user controls at the time of inspection. With an average temperature split of 18 degrees air coming out of the register vents and air going into the return.

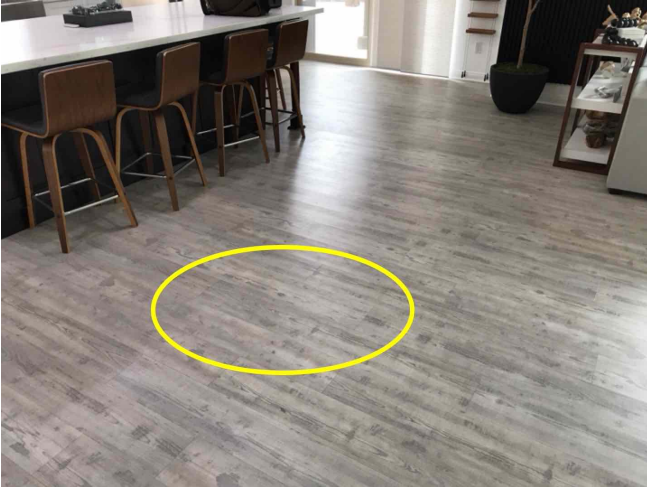
W 325: The kitchen floating floor has areas that are not secured or level with the sub flooring. This has resulted in bounce or soft spots on the flooring. We noted no resulting weakness, failure or nonperformance as a result of the bounce. No immediate corrective actions are required.

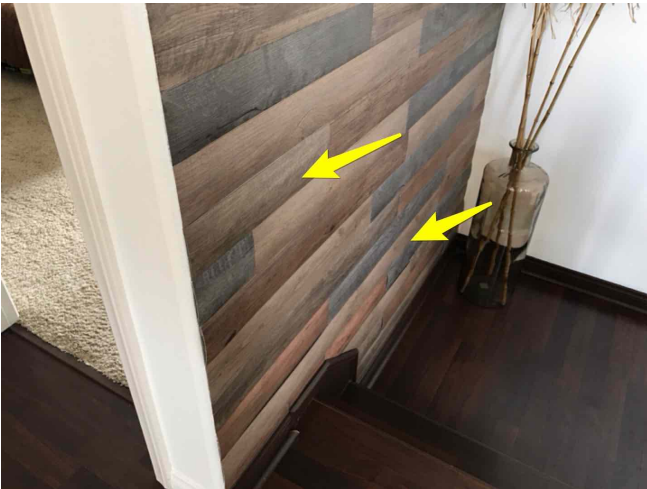
358: The wall surfaces are blemished, and can be repaired in the course of routine maintenance.

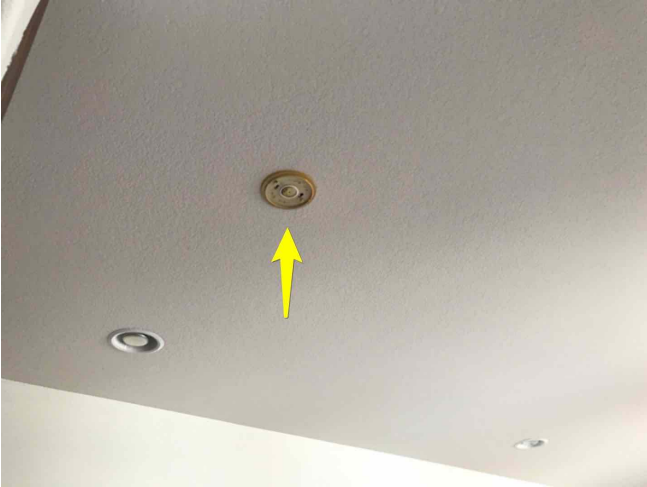
S 366: The smoke detector has been removed and needs to be replaced.

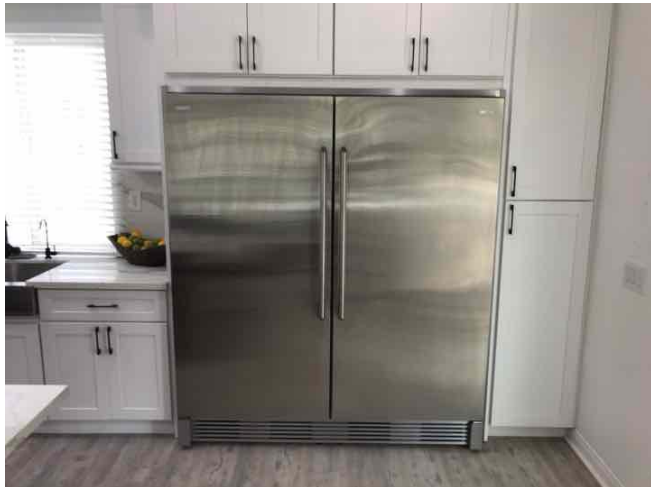
390: Manufacturer: Electrolux.

391: The refrigerator/freezer responded to normal user controls and was found in good condition. The interior temperature was 34 degrees and 1 degrees at the time of inspection.

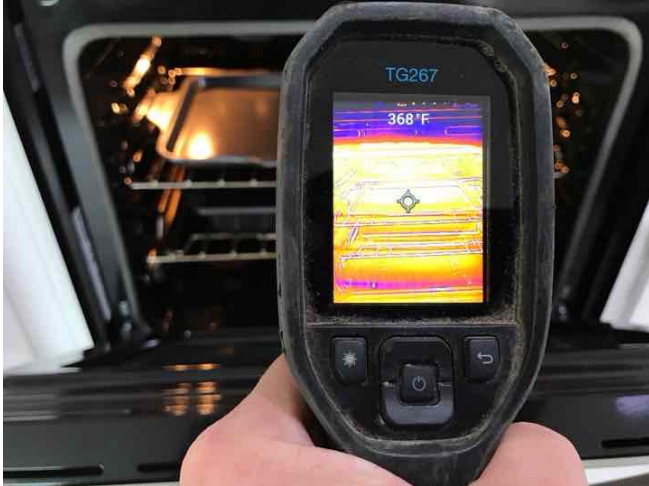
394: The oven was turned on with the normal operating controls and found to be in satisfactory working condition.

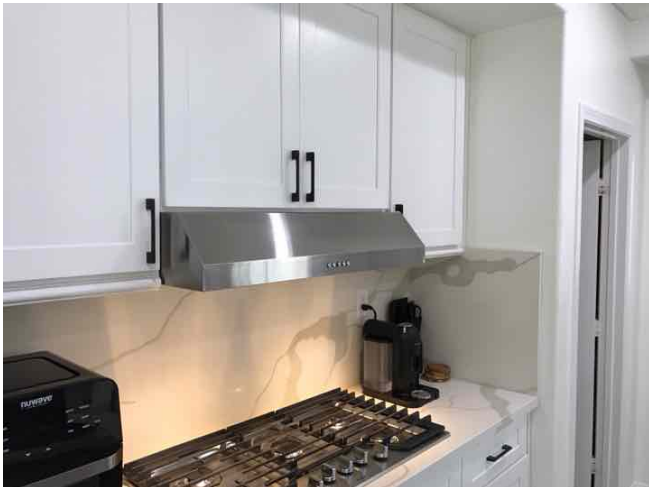
395: Manufacturer: Vissant.

396: Kitchen ventilation is provided by a range hood over the burners. The fan appears to be properly installed and in serviceable condition.

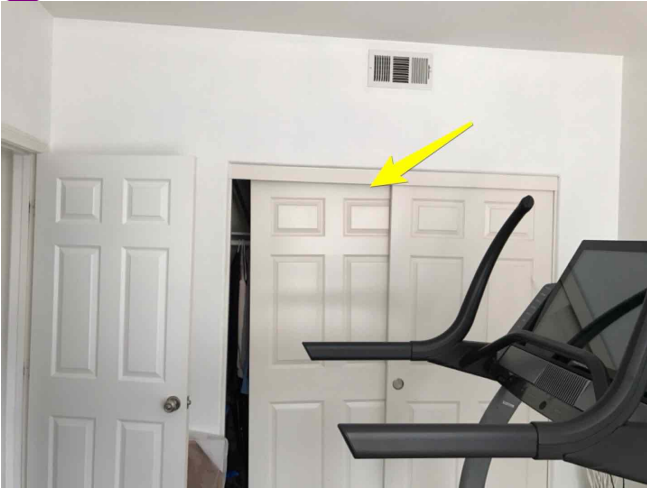
M 410: The closet doors are off track and need service.

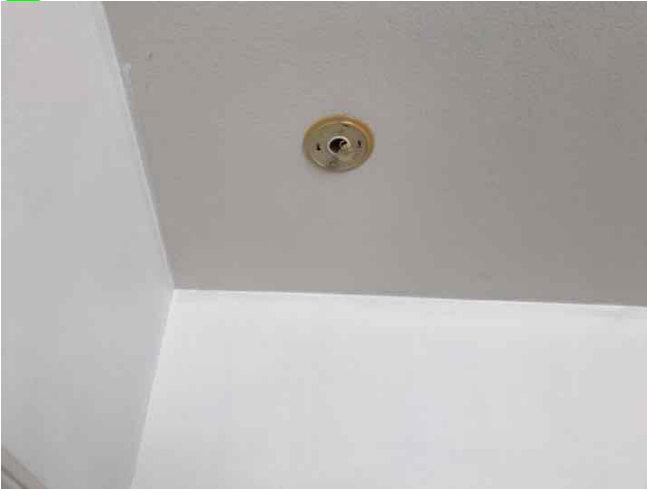
S 414: The smoke detector has been removed or is missing and needs to be installed.

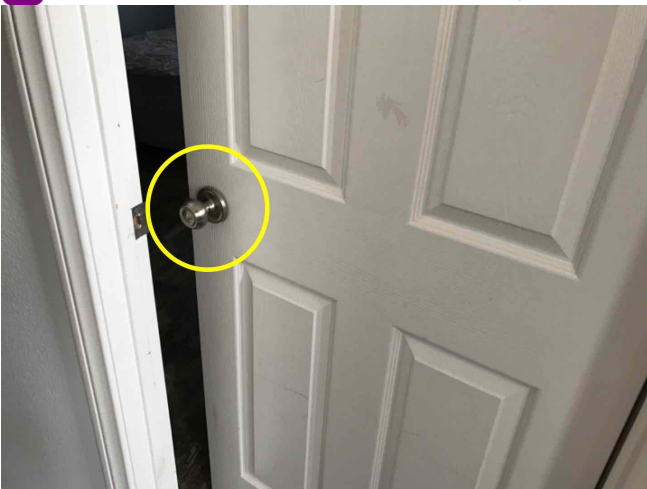
M 421: The door knob is loose and needs repair.

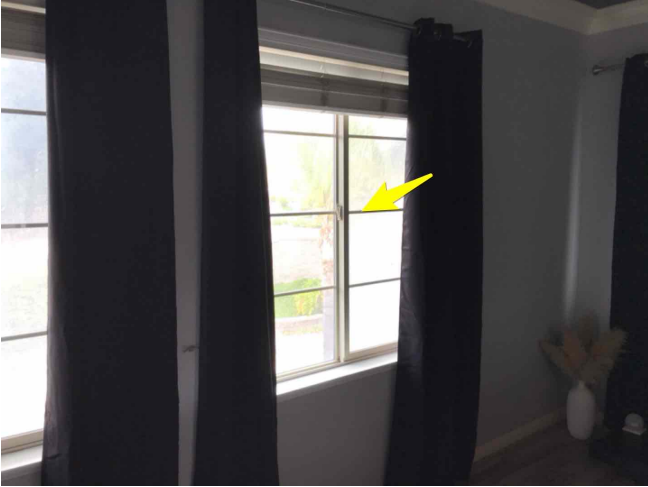
M 444: The window hardware does not latch needs service to function properly.

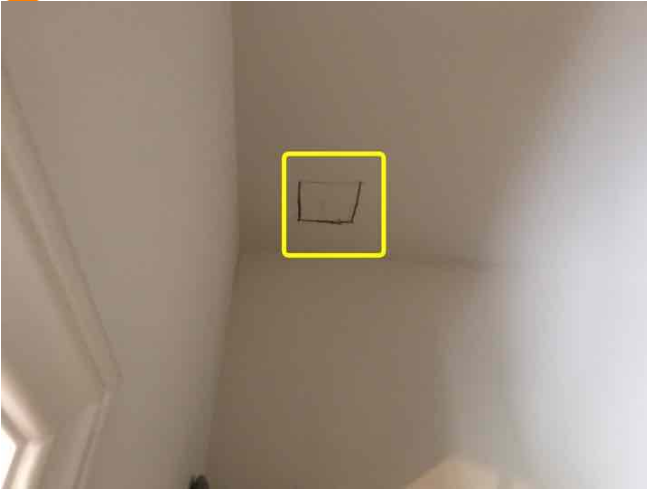
R 451: The ceiling is damaged at the closet. We recommend repair or refinishing.

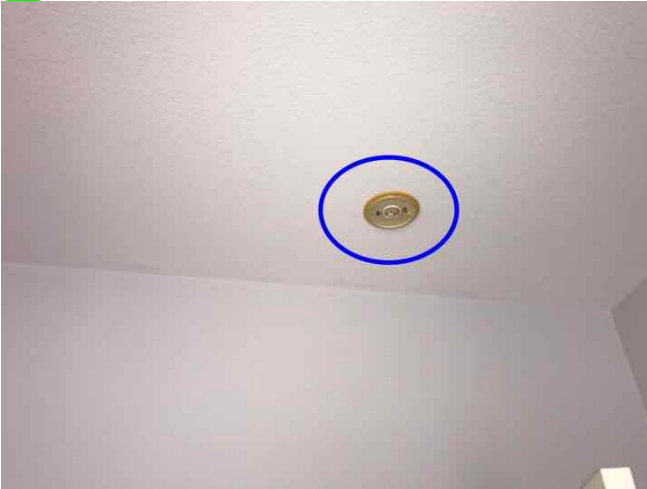
S 458: There is no smoke detector in this area, as required. We recommend one be installed.

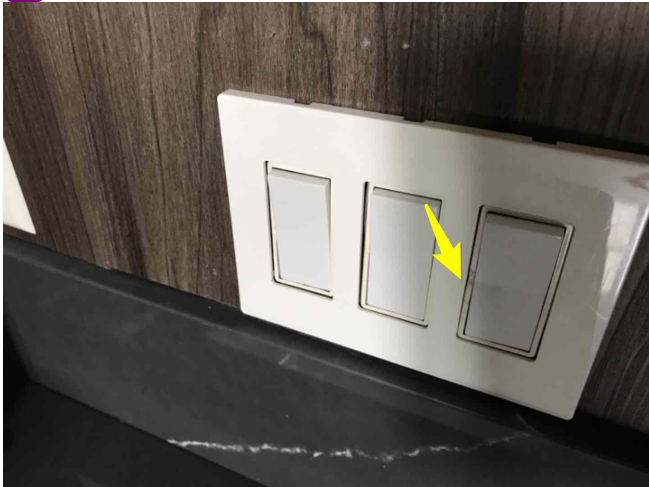
M 475: The switch for the bathroom is damaged. We recommend it be replaced.

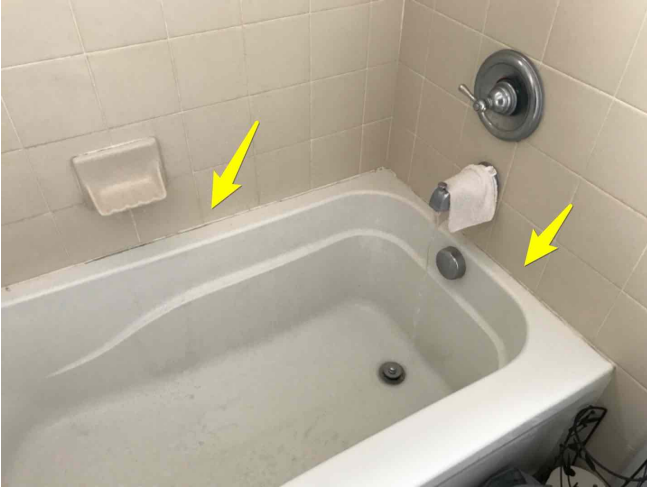
M 499: Caulking needed at shower to prevent moisture intrusion or damage.

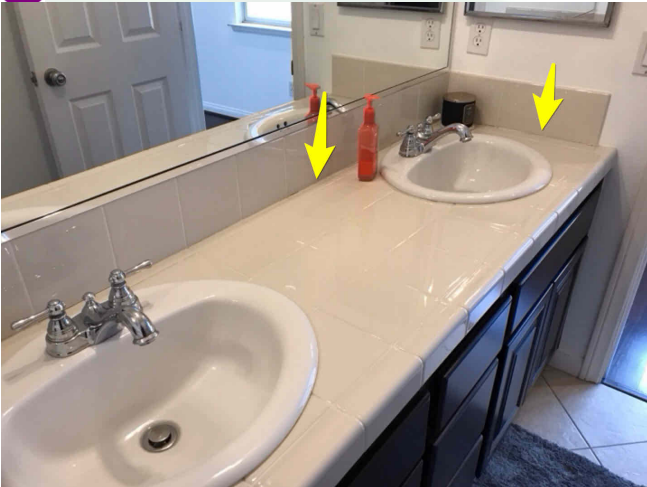
M 500: Caulking needed at backsplash to prevent moisture intrusion or damage.

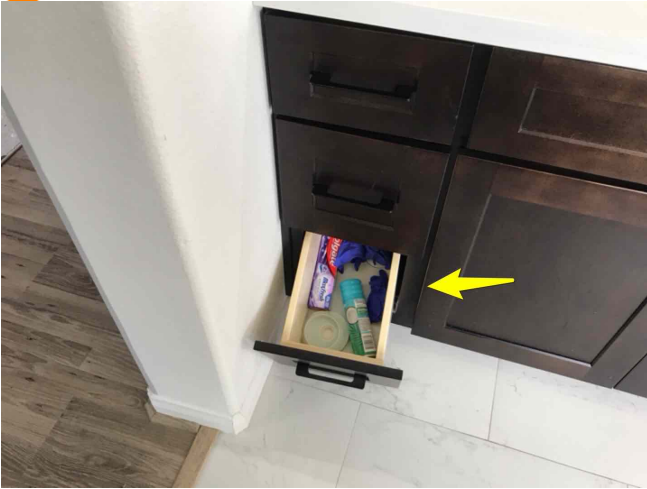
R 528: One or more of the bathroom cabinet drawers is damaged and needs to be repaired or replaced.

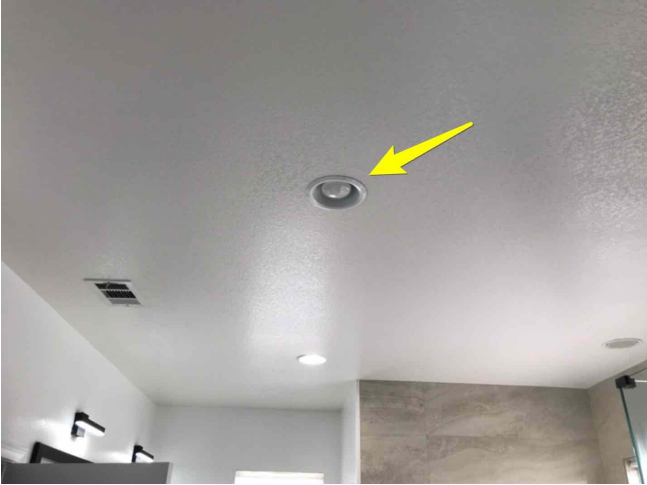
M 542: The light is not working. The bulb may have burned out. We recommend that the bulb be tested and replaced, if necessary, and the proper operation of the fixture be verified.

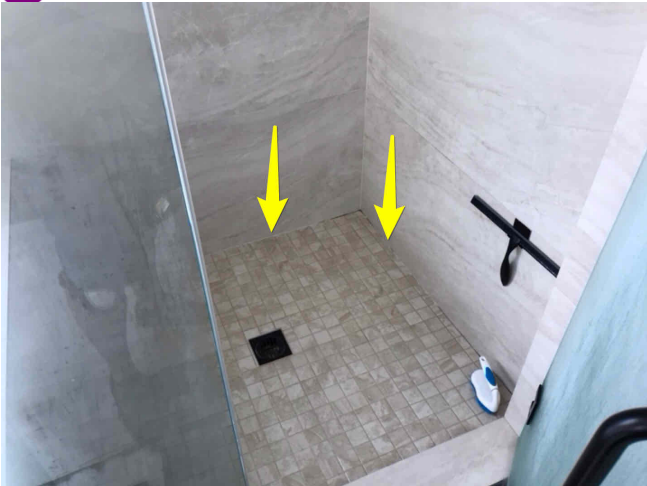
M 543: Caulking needed at shower to prevent moisture intrusion or damage.

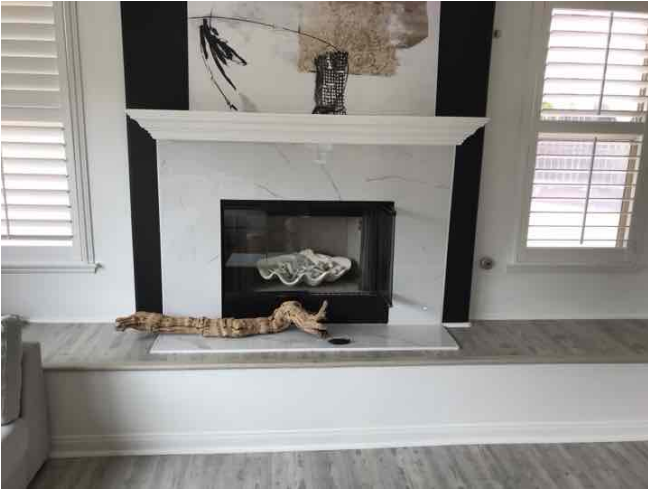
544: The fireplace is located in the family room.

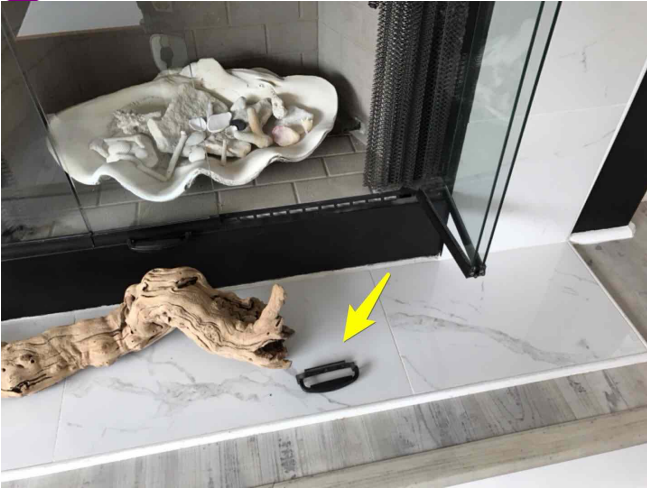
M 554: The fireplace glass doors off track and have a damaged handle and need service or repair.

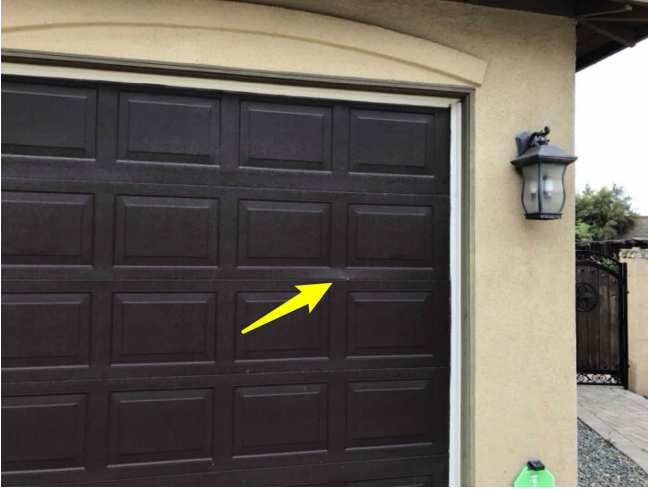
M 562: The garage door has minor dents or scratches that appear to be cosmetic flaws only. These are not affecting the function of the garage door or the garage door equipment.

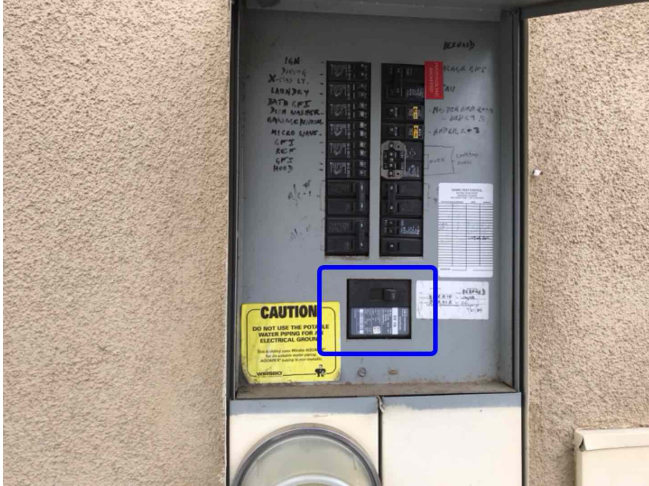
ELECTRICAL SYSTEM

2: The main disconnect is incorporated into the electrical service panel.

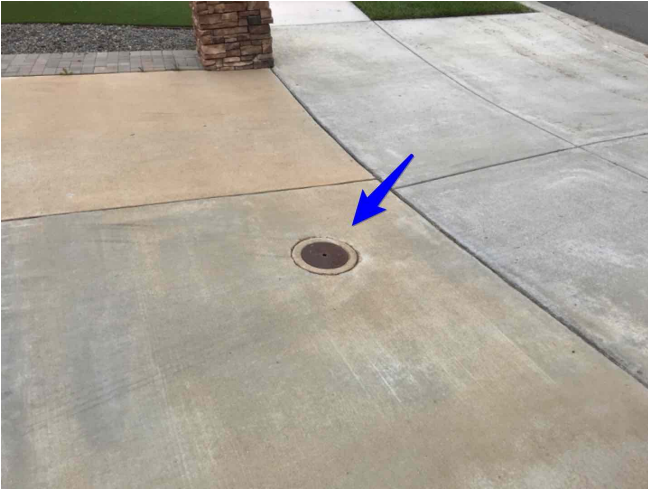
SEWER CLEANOUT

4: The sewer cleanout is located at the front of the structure.

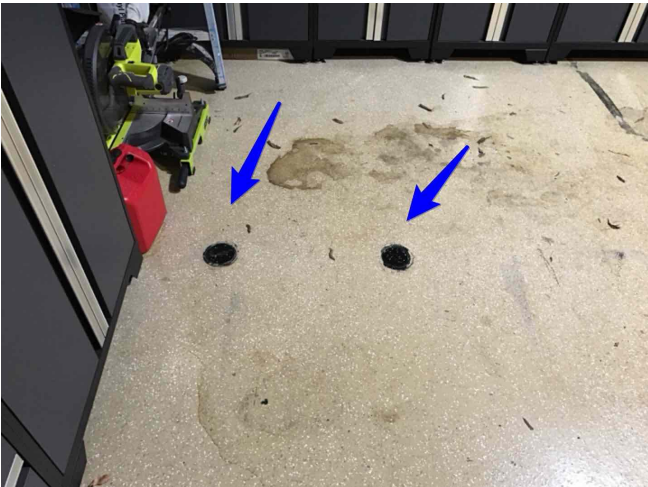
5: The sewer cleanout is located in the garage.

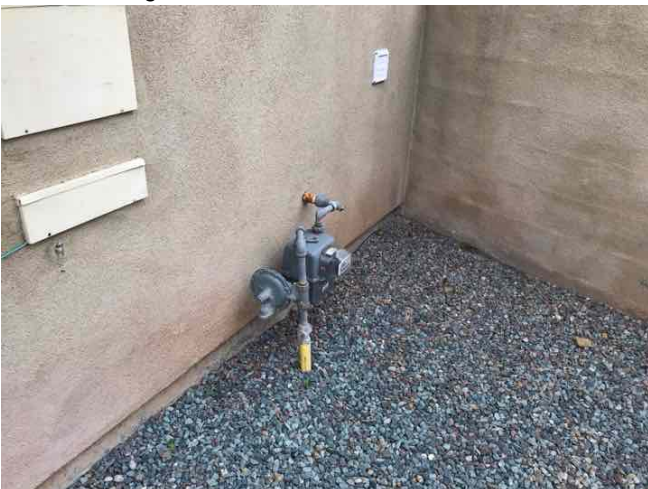
GAS METER LOCATION

6: The gas meter is outside on the right side of the building. The main gas supply shutoff valve is located on the riser pipe between the ground and the meter. This valve should be turned 90 degrees (either way) in order to shut off the gas.
