# Lead Cable Investigation

June 30, 2023

**Prepared for:**

Marine Taxonomic Services, Ltd.  
Below the Blue 501(c)3

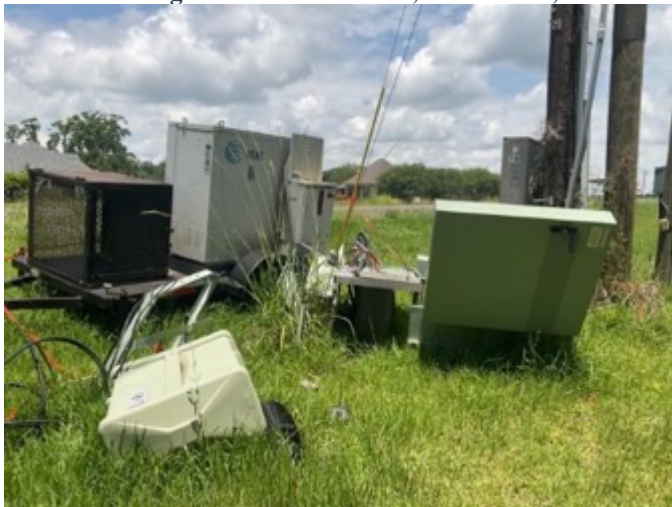
(D) Equipment debris field left by workers near the N Lewis Street Bridge. BT 16.1 June 2022, New Iberia, Louisiana.

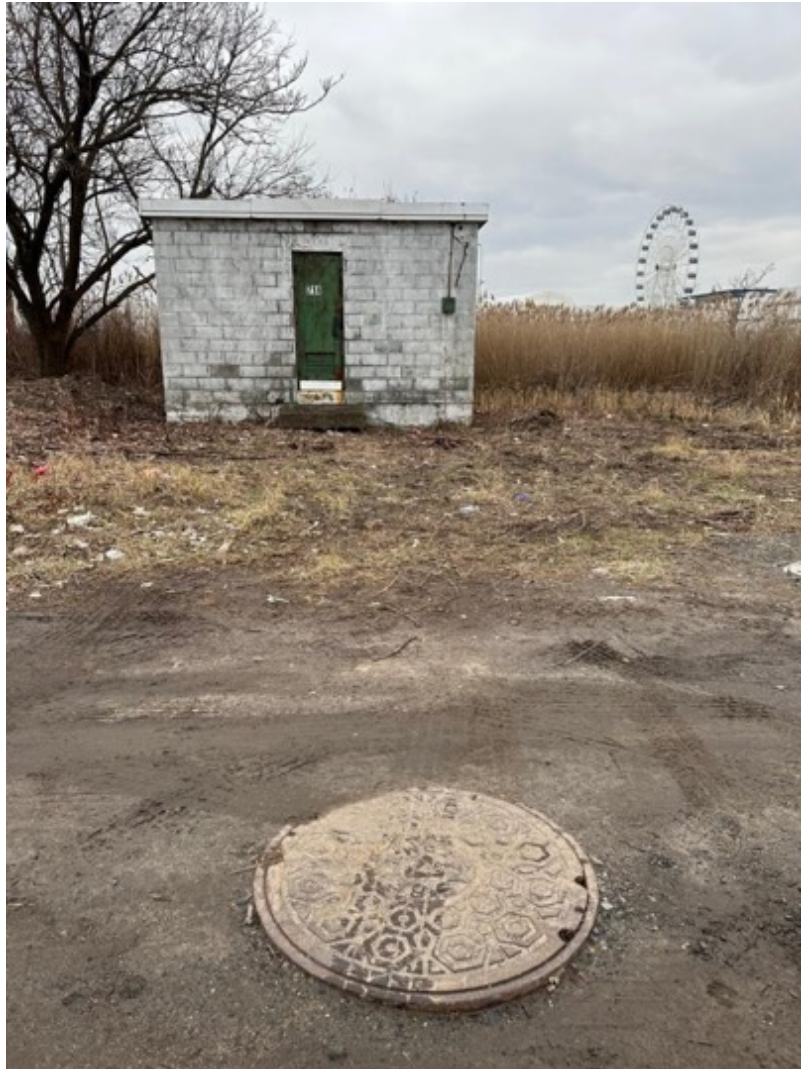
Figure 21. Photos. New Jersey continued. (E) Largely abandoned area around the Meadowlands. Old Bell Systems manhole and utility building. (F) Concrete casing that would have laid on top of the old lead sheathed cable. This is like those found on the Detroit River, Location 1. (G) Newer AT&T flagging found a few feet away from the building. Hackensack 3.2. January 2023, Meadowlands, New Jersey.

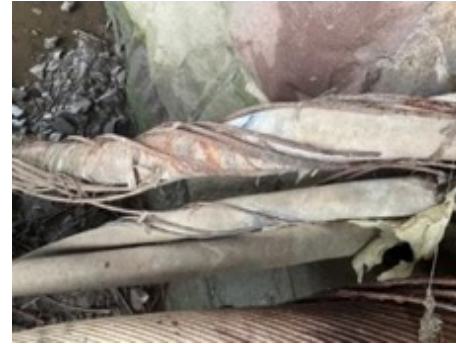
**(K)** Close up of cables at Passaic 8. January 2023. New Jersey.

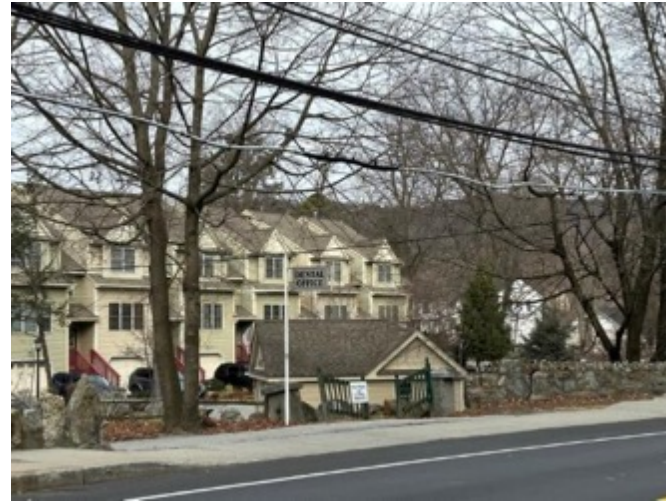
Four generalized data points were recorded for Highland Falls Township. Lead sheathed cable appears to run throughout the town and is occasionally covered with a protective sheathing that encompasses parts of the cable. Visible bare leaded splice boxes were observed at nearly every telephone pole. (Figure 25(A-C)). This site required more time than was available for detailed observations and further investigation is recommended.

(B) Overhead lead sheathed cables in front of an apartment complex. January 2023. Highland Falls, New York.
