## **RV Inspection Report**

**Inspection Date:** 4/29/2021

**RV Model: 2018 George Town Forest River GT5 36B5**

**Blue Line Mobile RV Service**

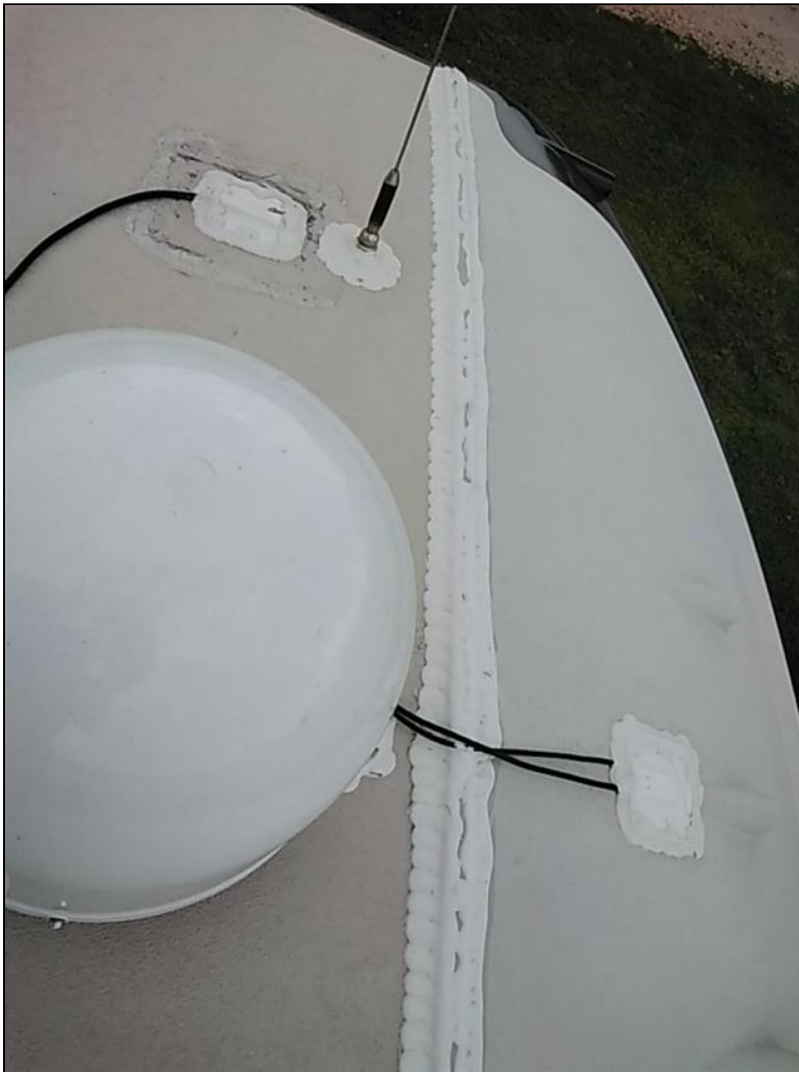
Front Cap seal

Front sealant looks new and is white in color over tan.

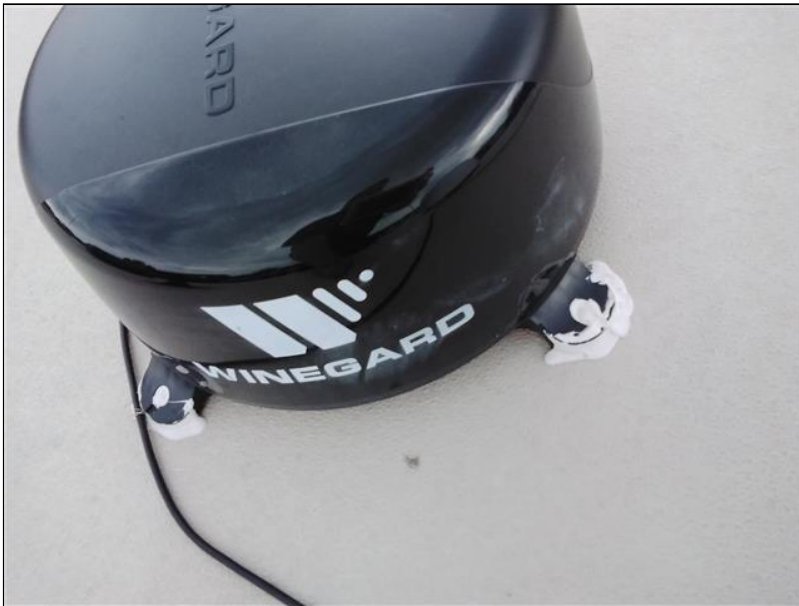
Wingard WiFi

(1) Owner installed WI-FI

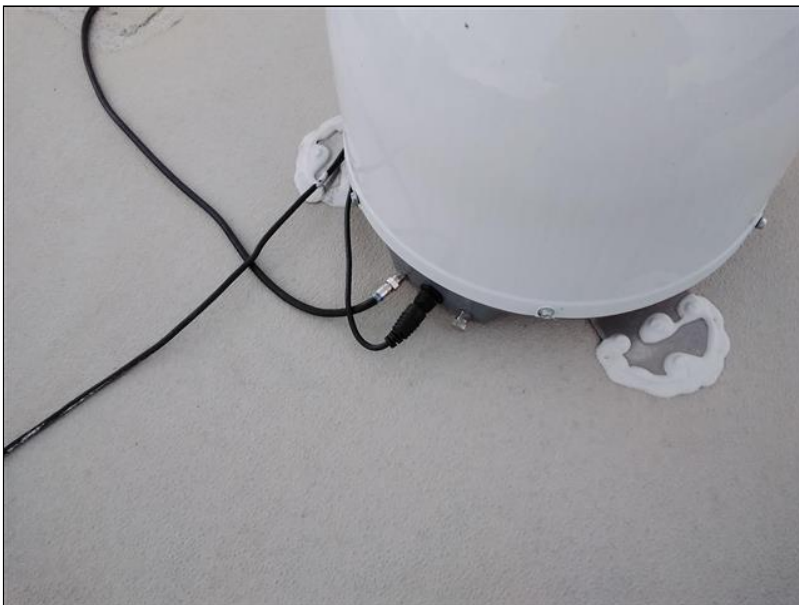
Satellite

(2) Owner installed satellite

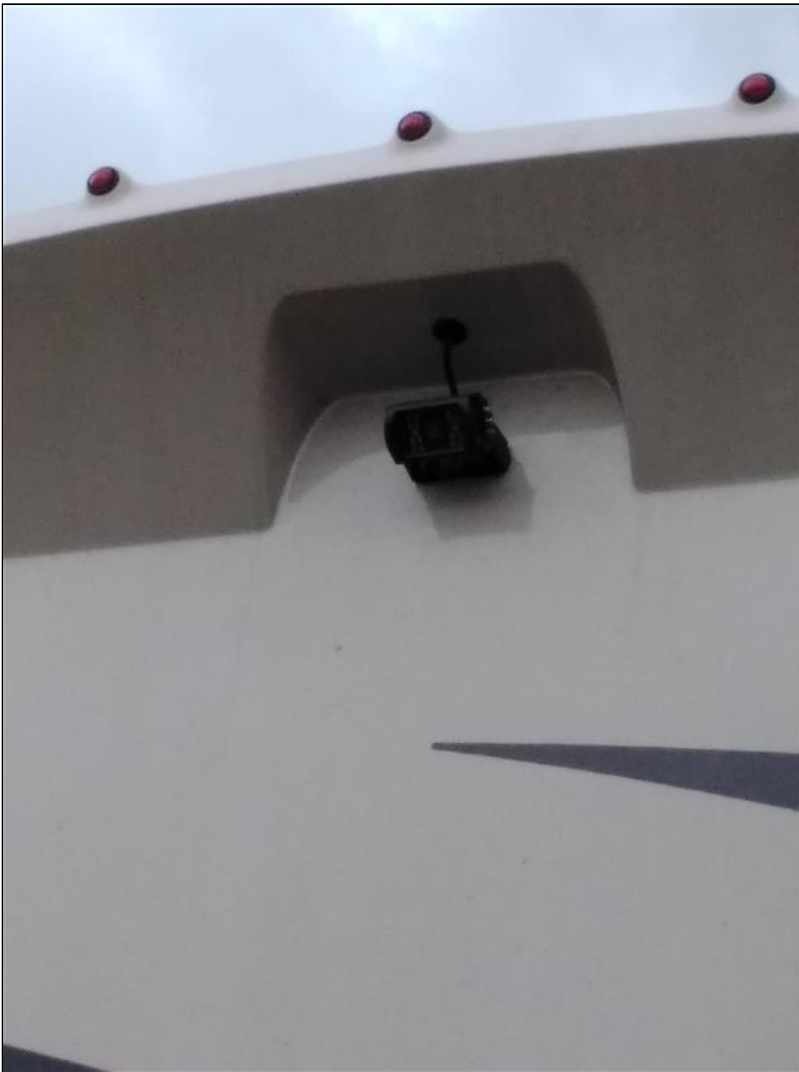
Rearview Camera

Vehicle also has a rearview camera installed.

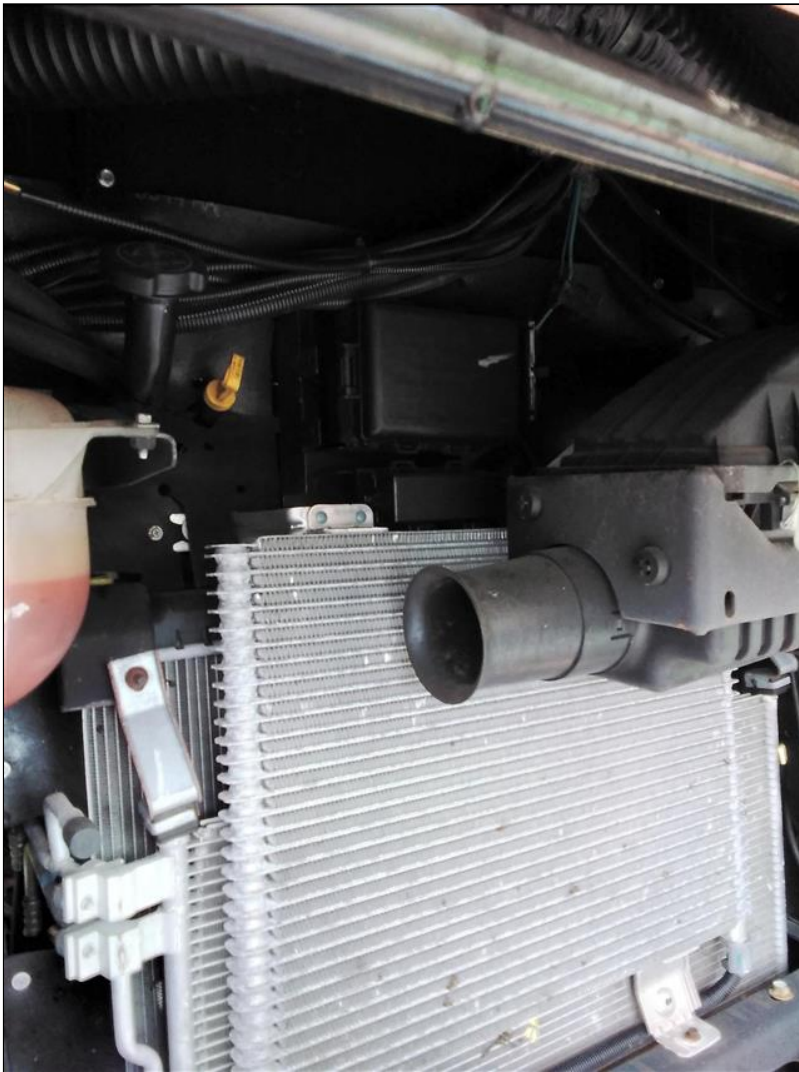
engine radiator

Photo inside front engine compartment showing radiator.

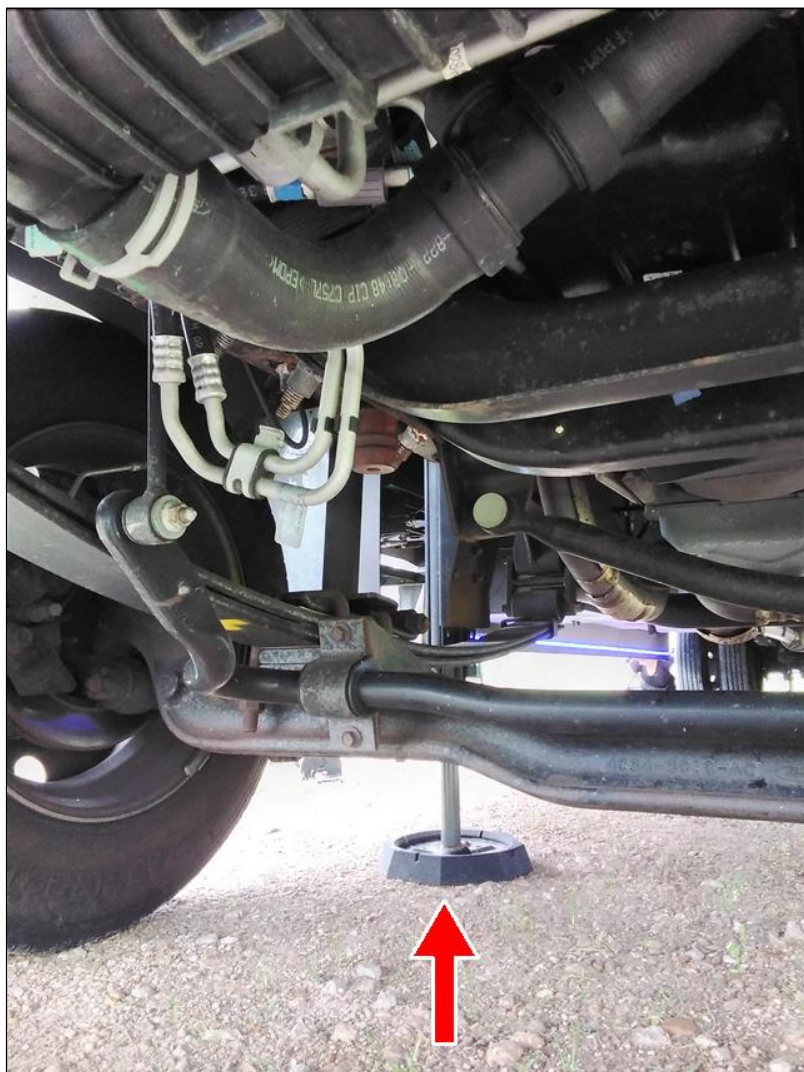
Jack Feet

Owner has installed snap pad on all four hydraulic jack feet.

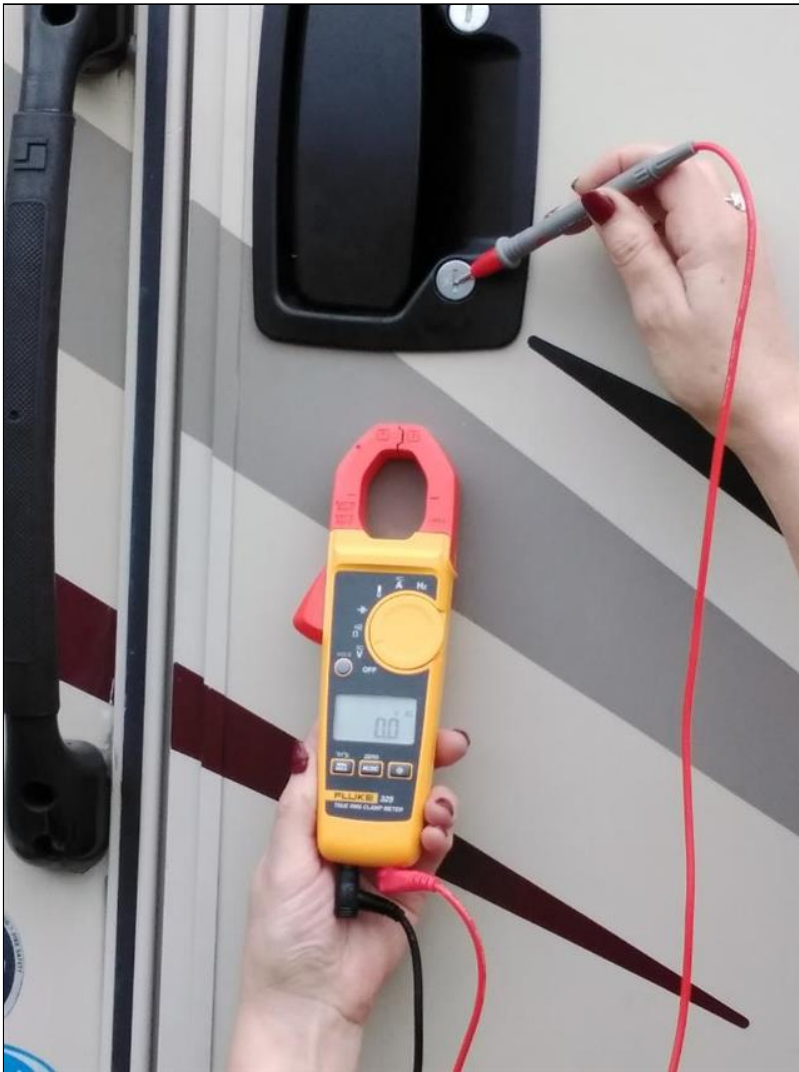
door handle

Door handle hot skin test

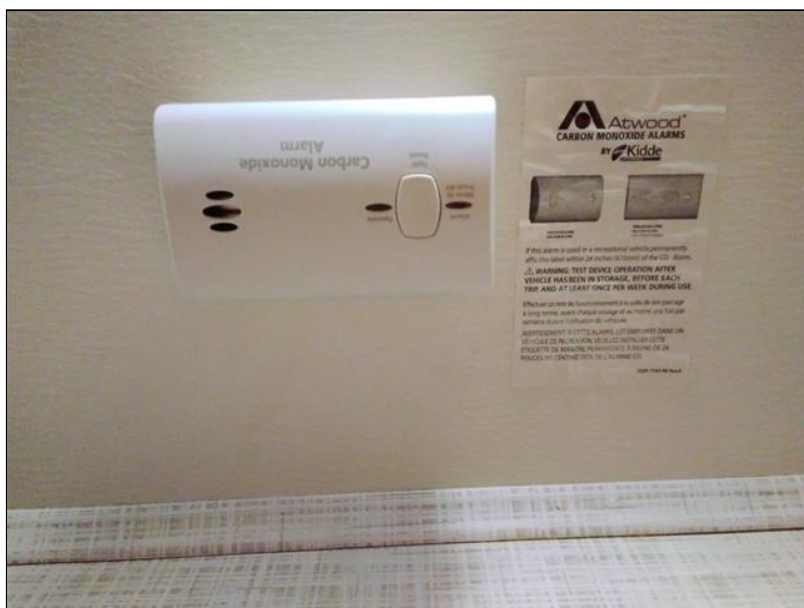
Comments: Acceptable

Photos of carbon monoxide detector, front and rear.

carbon monoxide detector

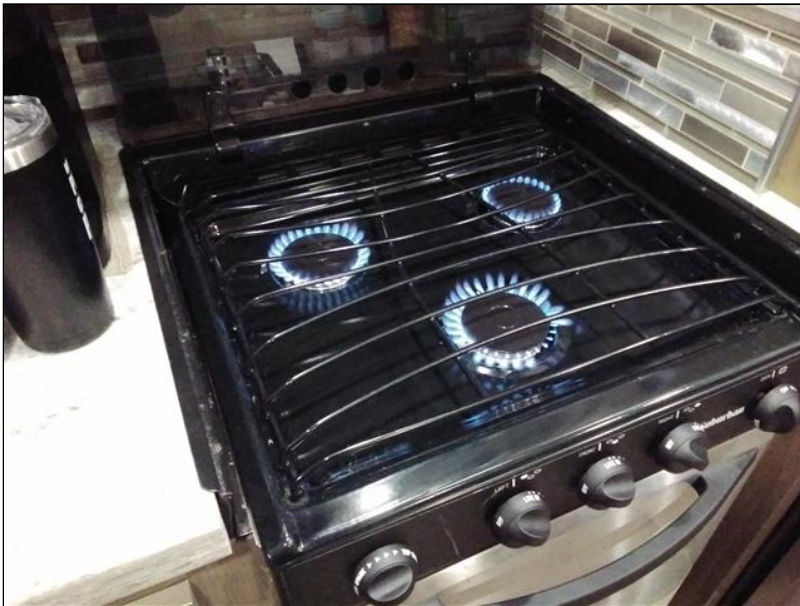
Comments: Acceptable

Cooktop flame and color

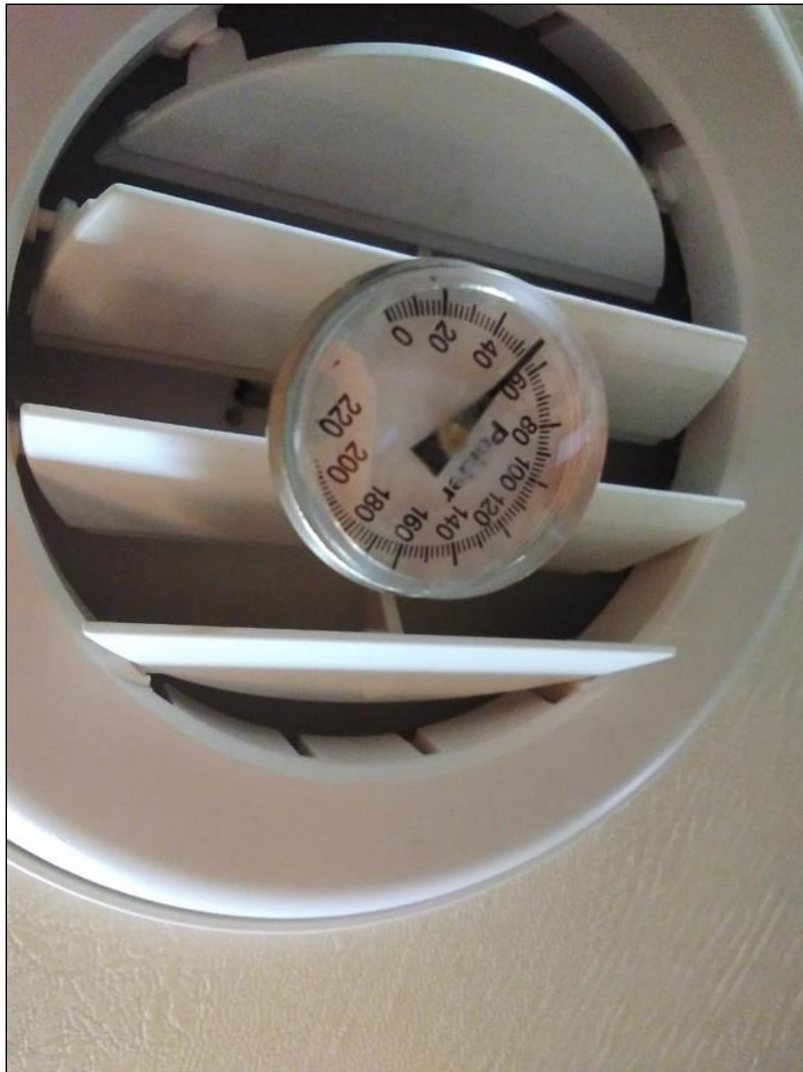
Comments: Acceptable

Delta-t photos at register and vent

vent temperature

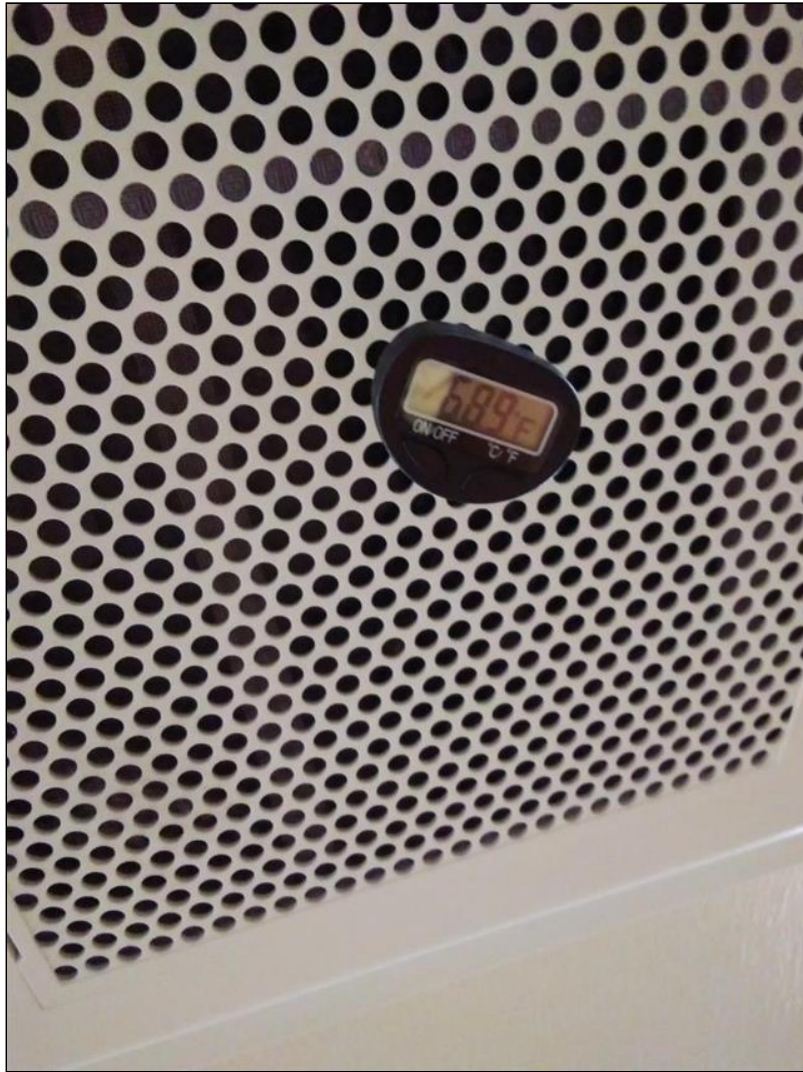
return air temperature
