RV Inspection Report

2018 Cruiser RV, Stryker, ST-2916, Athens, Texas 75751

Inspection Date: 4/22/2021

Blue Line Mobile RV Service

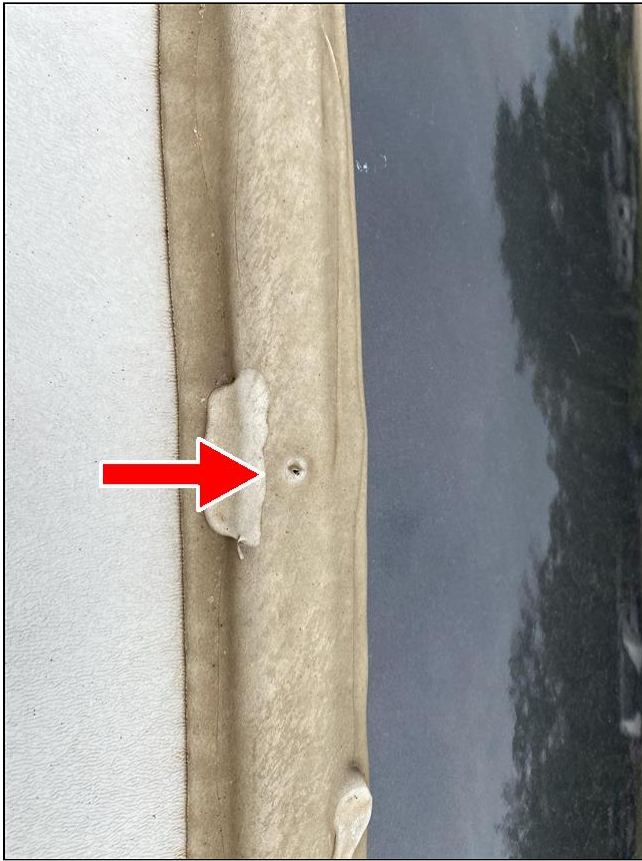
Center of front cap seal

Inspector found several areas of possible water intrusion in the front cap seal. Recommend seal be evaluated by qualified RV technician for repair.

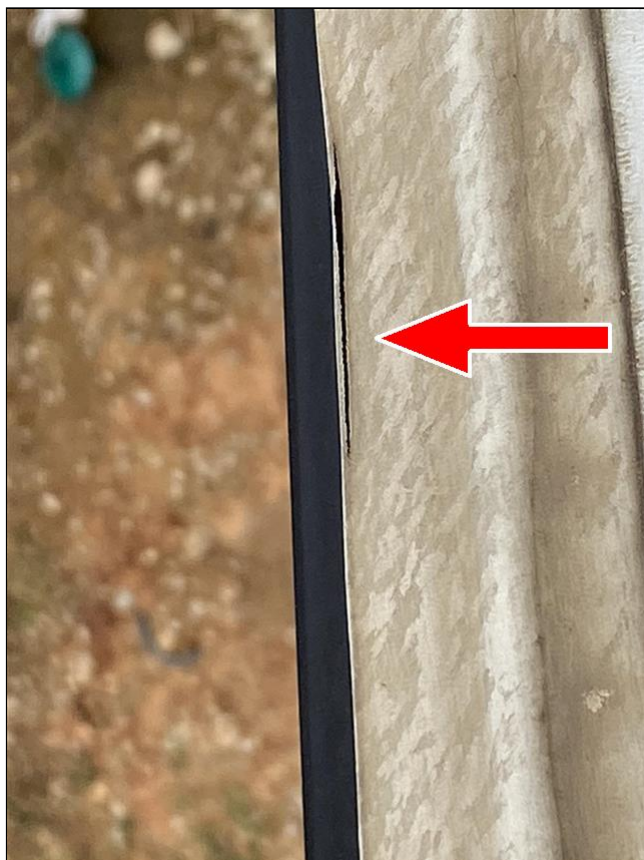
Front streetside gutter rail

Inspector found sealant crack long the curbside gutter/trim rail in two locations at the rear side of the vehicle, where water can possibly enter the vehicle. Recommend that this trim rail be resealed by qualified RV technician.

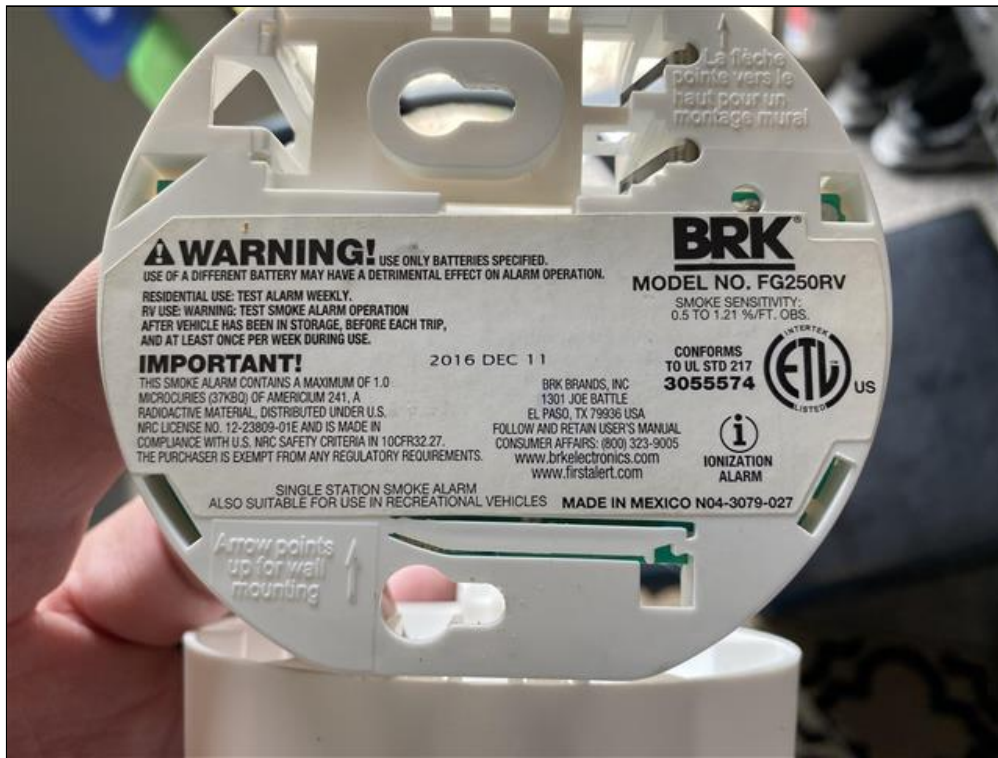
Comments: Acceptable

Smoke Detector Photo

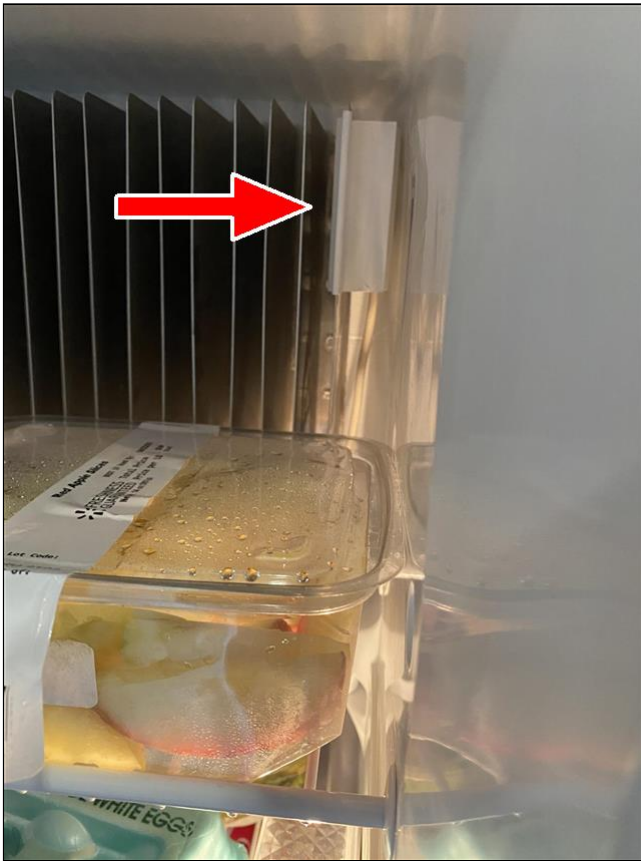
(2) Thermister Location

thermister

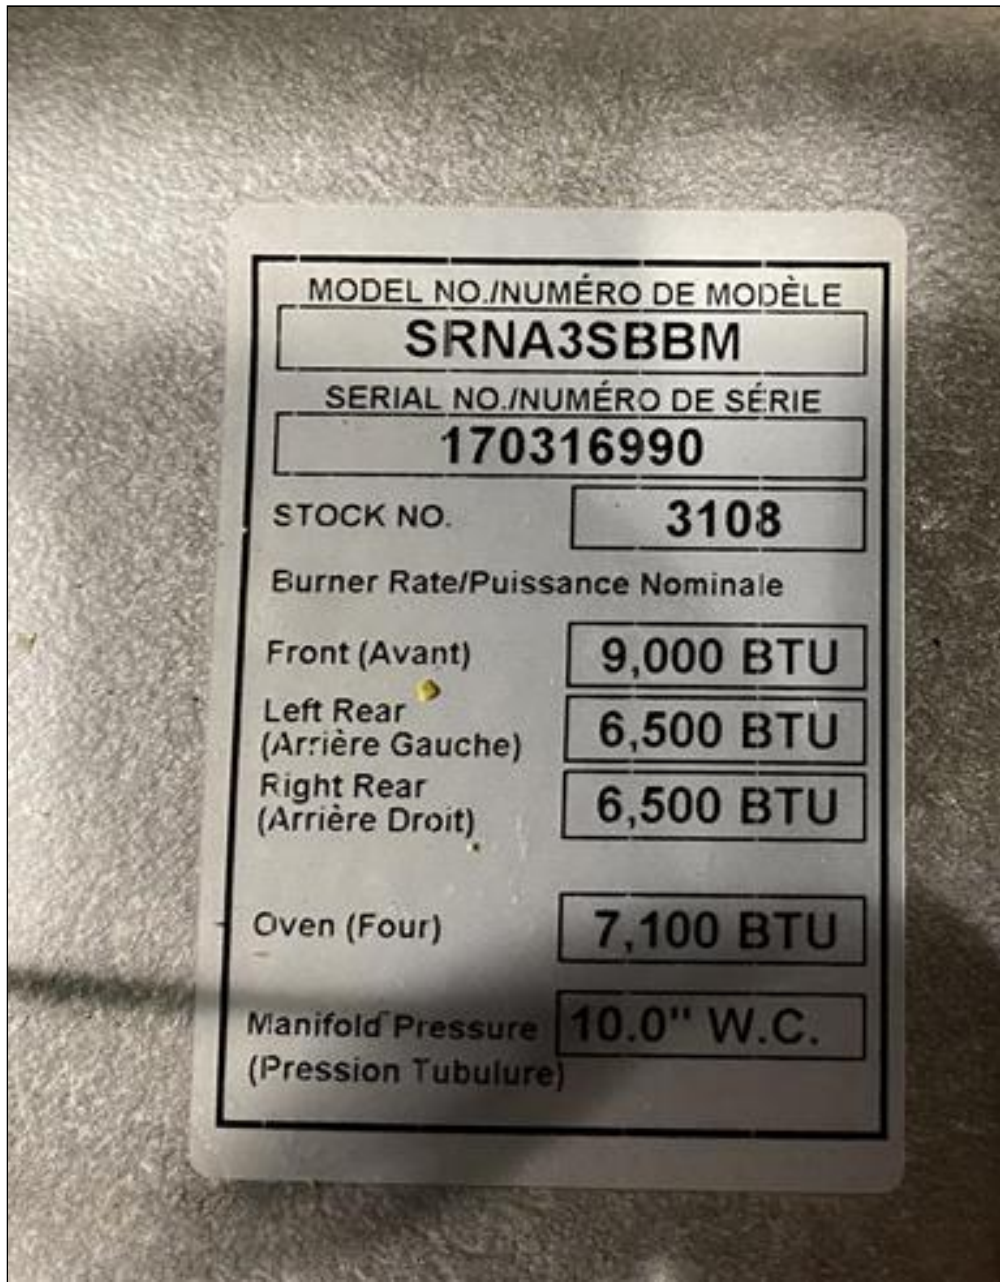
(1) Cook Top Plate

Comments: Acceptable

cook top plate

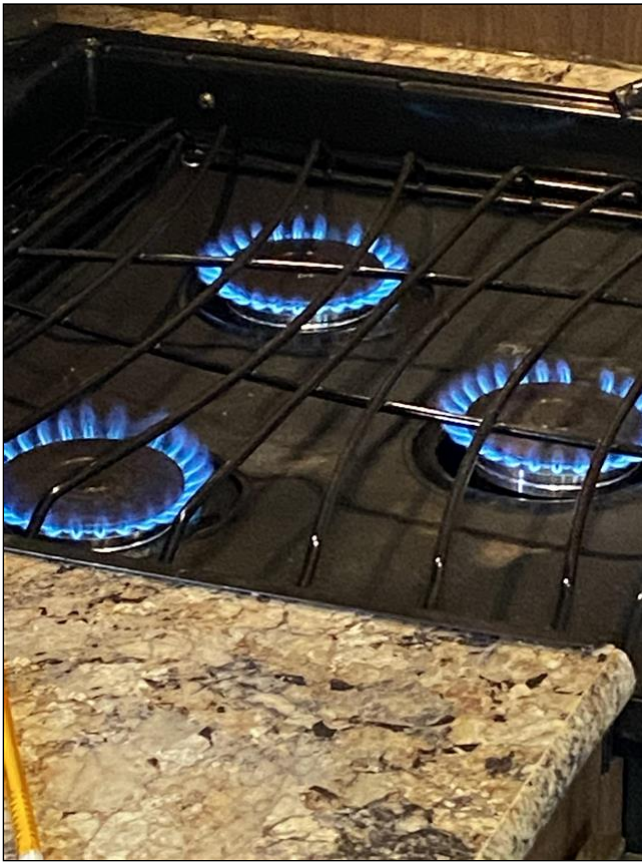
(2) cooktop running

cook top running

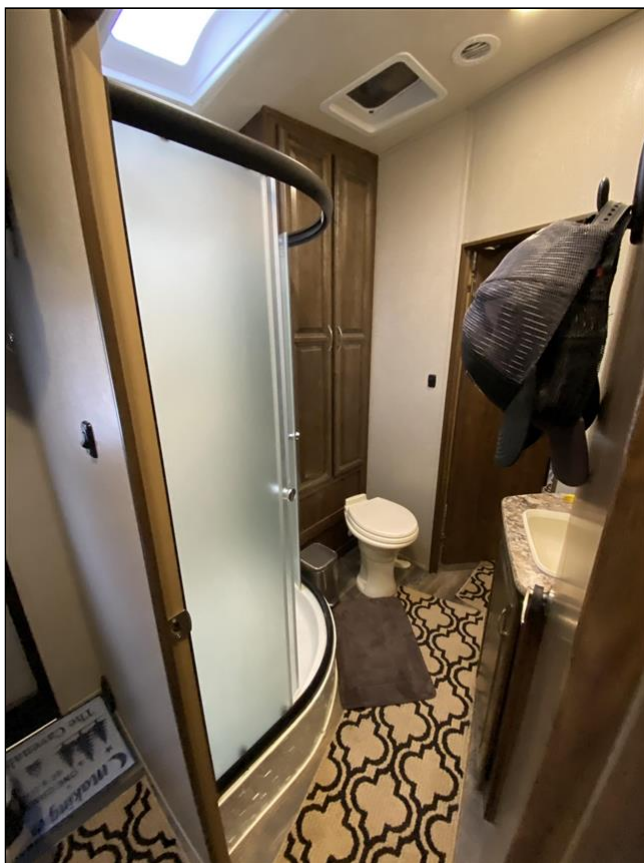
bath overall photo

bathroom overall

17.55 Shower / Tub - Stains, Chemical Buildup in Stall / Tub
Comments: Yes

17.56 Shower / Tub - Water Damage or Leaks
Comments: Yes

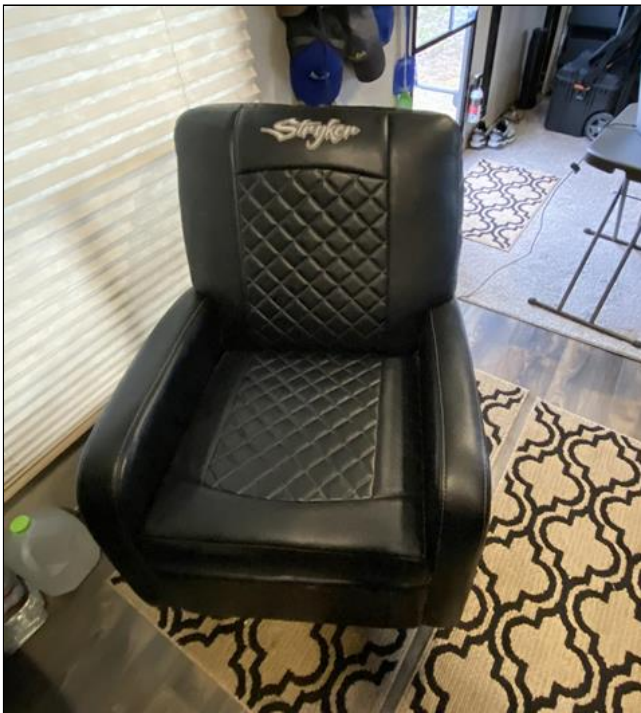
rear chair photo

Extra Info : damage to rear upper right corner of rocking swivel chair

rear chair

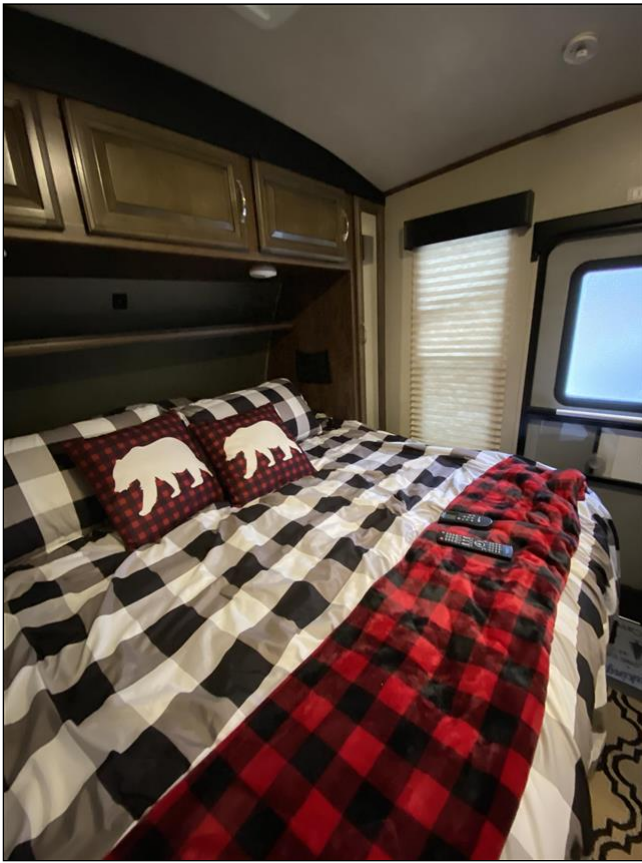
Owner advises that mattress was purchased in July 2020.

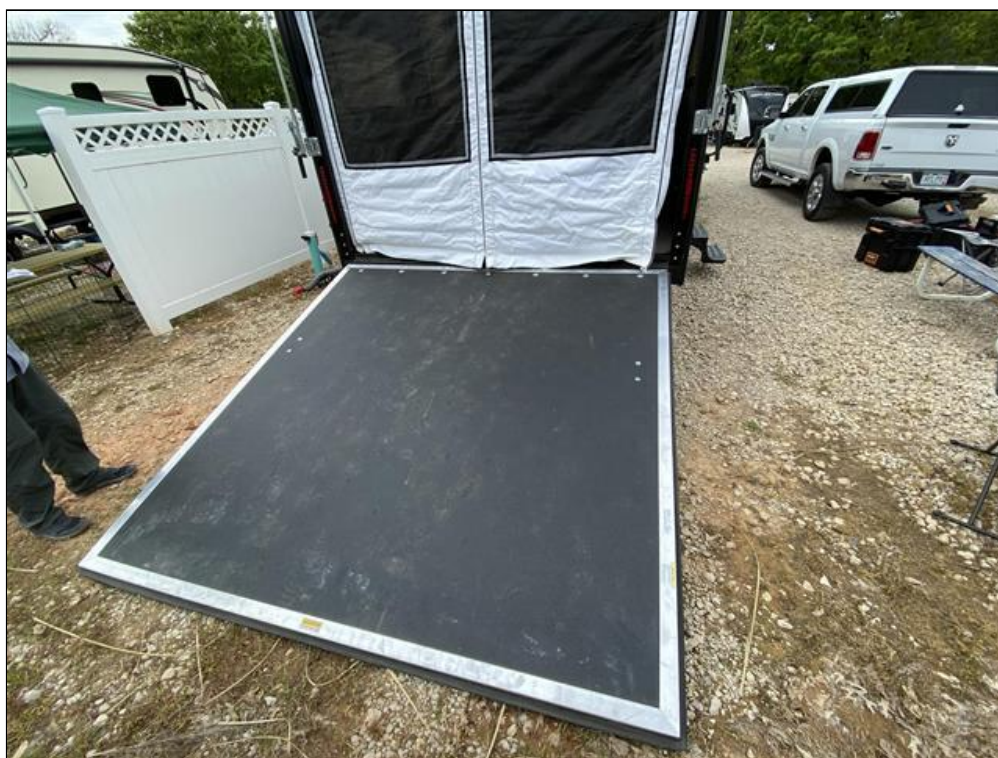
(1) Rear Ramp Door

Comments: Acceptable

Rear Ramp

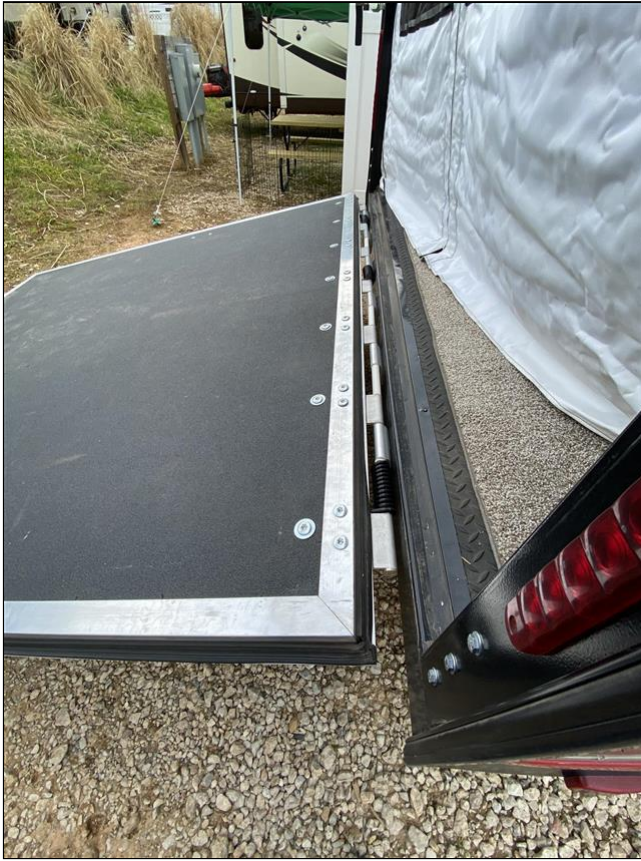
Ramp Hinges

Comments: Acceptable

Ramp Hinge
