# RESERVE STUDY

**Plum Creek Condominium Association  
13913 Camelot Dr.  
Sterling Heights, MI**

**Date of Inspection: 8/15/2018**

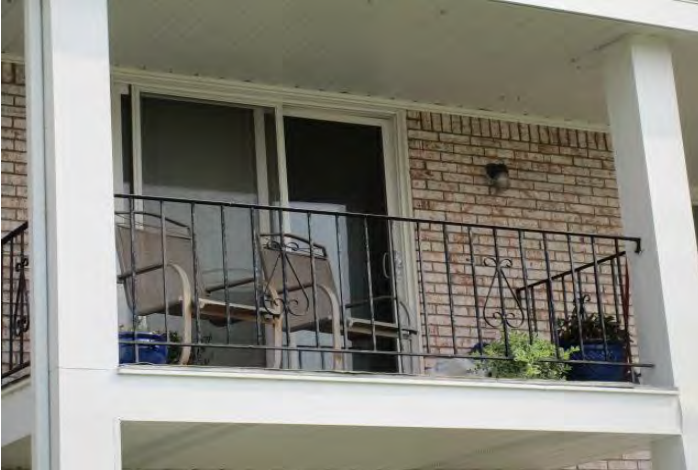
Overview of a typical railing at the balcony of an apartment style building

Engineering Narrative
The paint finishes of the metal railings, located at the balconies of the apartment style buildings, are of an unknown age, and they are in an overall fair condition. Per the current condition, we recommend for paint finishes in 2020, in 2 years. With an average useful life of 6 to 8 years, and per request of the property manager, subsequent paint applications are planned every 6 years after. Paint applications are not included in 2032, when railing replacements are recommended.

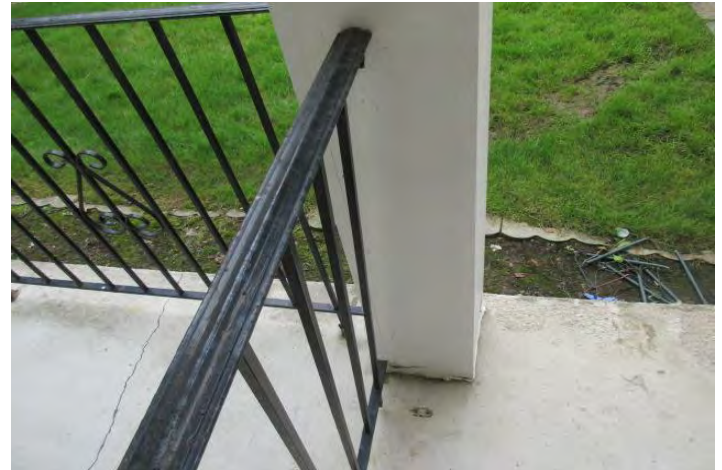
Typical condition

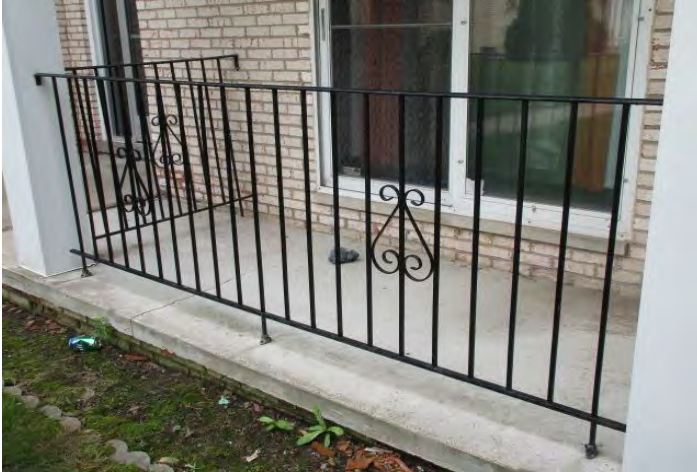
Overview of a typical railing at the balcony of an apartment style building

The metal railings, located at the balconies of the apartment style buildings, are 46 years of age, and they are in good condition. Per the current condition, and an average useful life of 50 to 60 years, we are recommending a replacement of the railings in 2032, at 60 years of age.

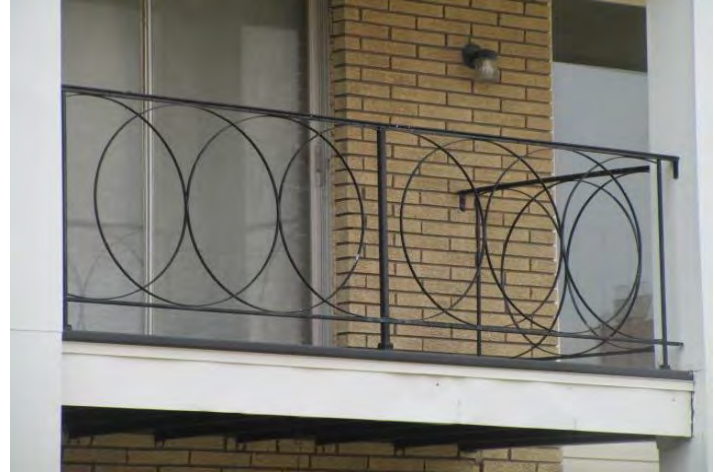
Isolated condition of a unique style of railing

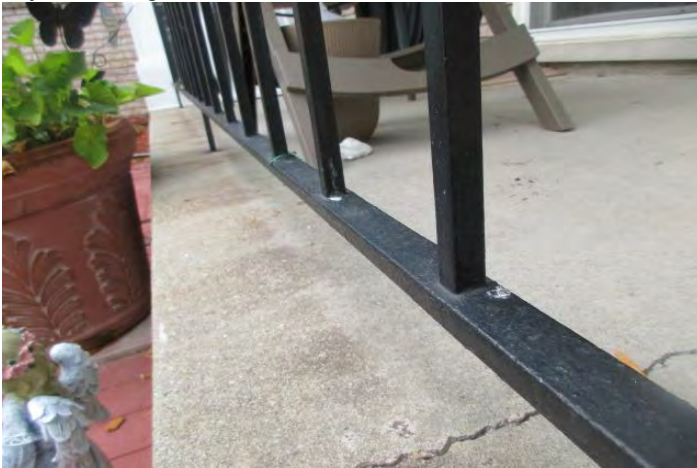
Typical surface condition at a bottom rail

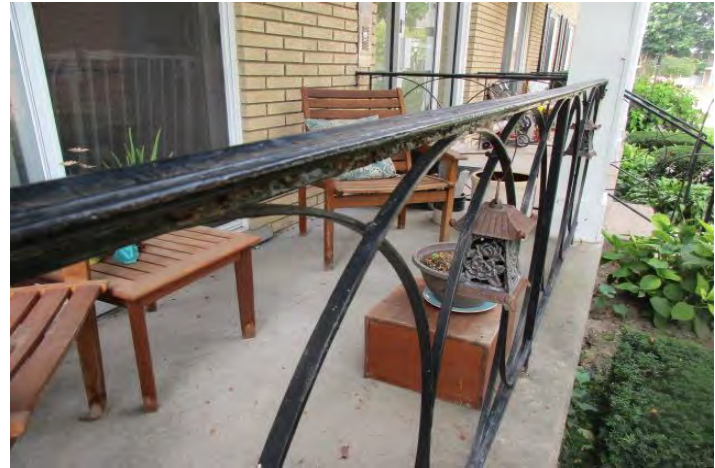
Typical surface condition at a top rail

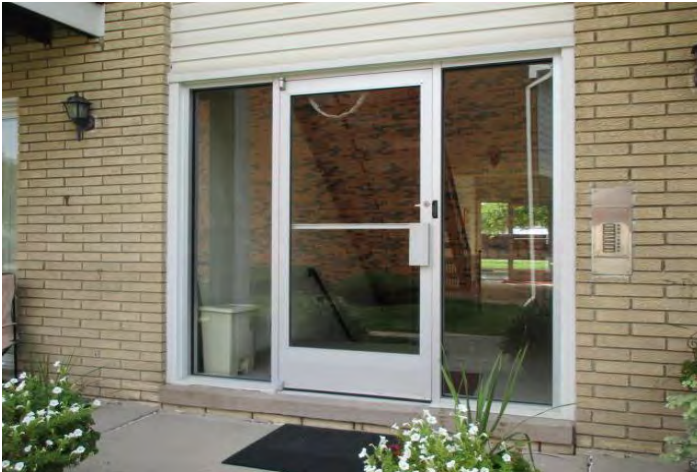
Overview of a typical glass entry door and surrounding glass at an apartment style building

The glass entry doors (and their surrounding glass) are 46 years of age, and they are in good condition. Per the current condition, and request of the property manager, we are recommending a phased replacement of these units between 2027 - 2032, ranging from 55 to 60 years of age.

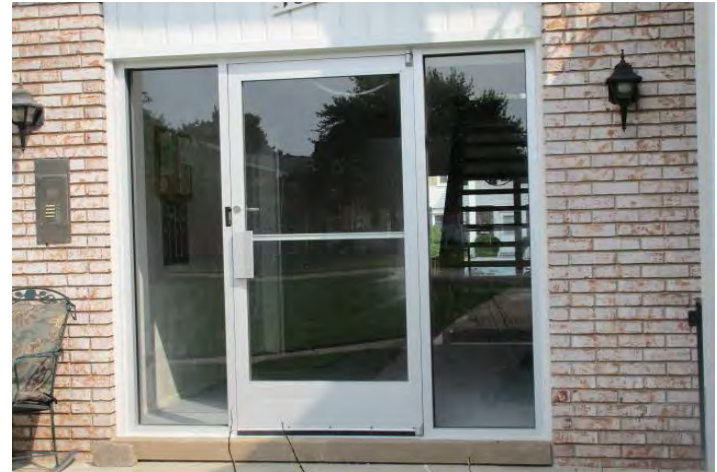
Typical condition

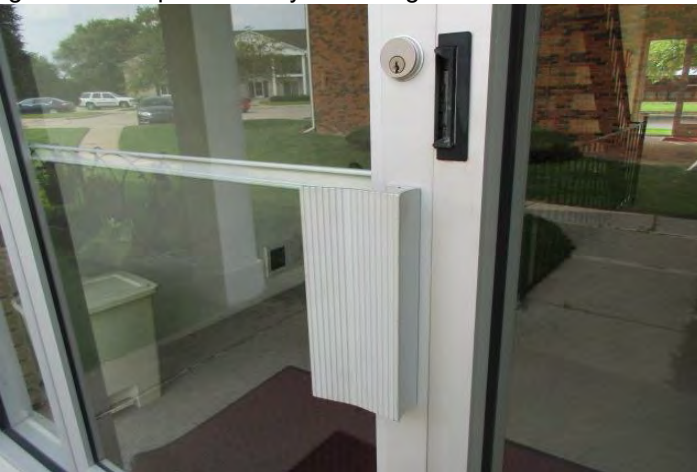
Typical surface condition at a door handle

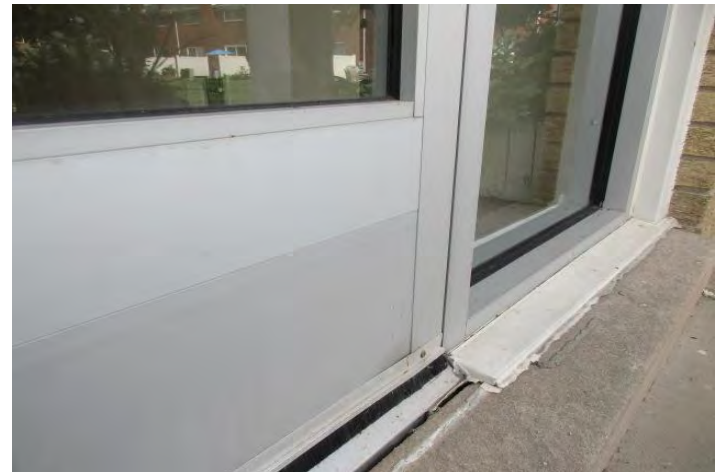
Typical surface condition at the bottom of a door

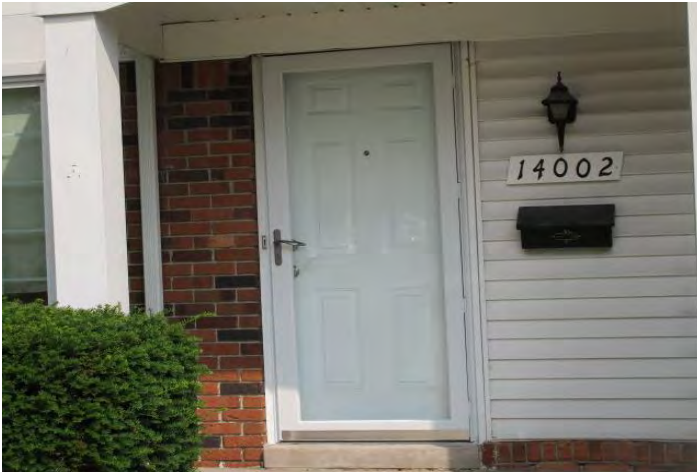
Overview of a typical entry door at a townhome unit

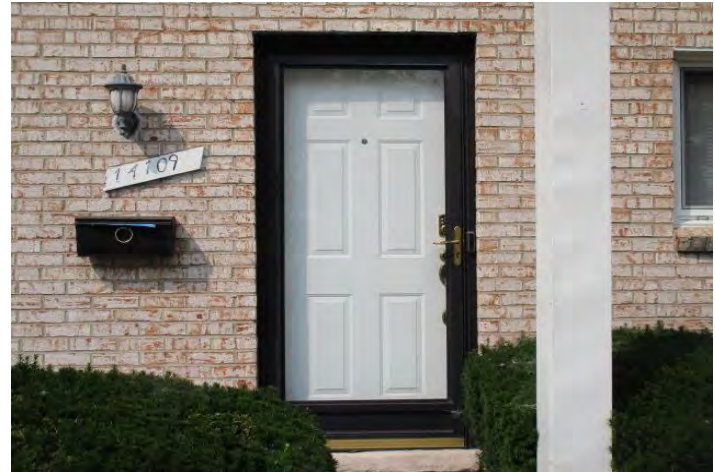
Typical condition

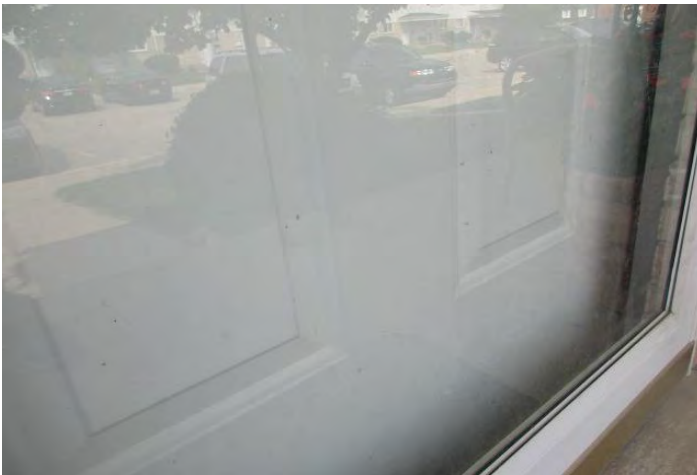
Typical surface condition

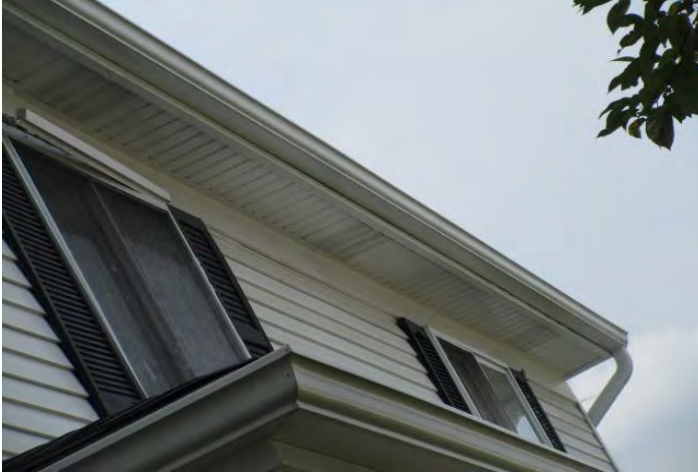
Overview of typical gutters

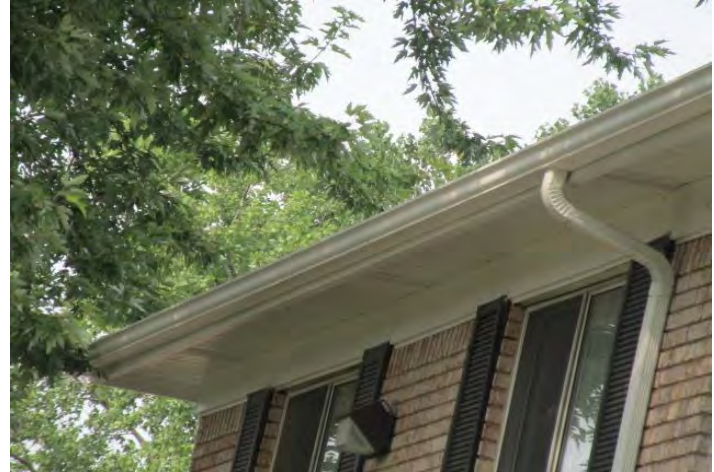
Typical condition

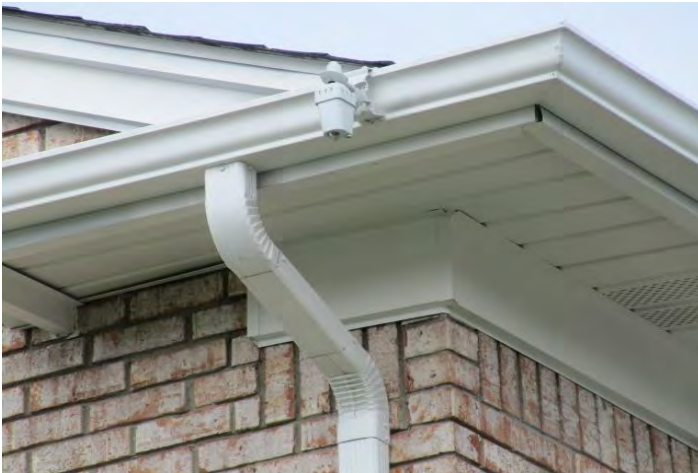
Typical gutter to downspout connection

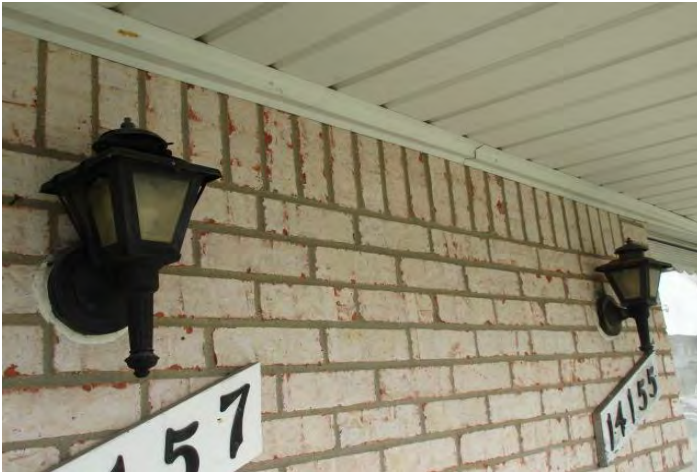
Overview of typical exterior sconces

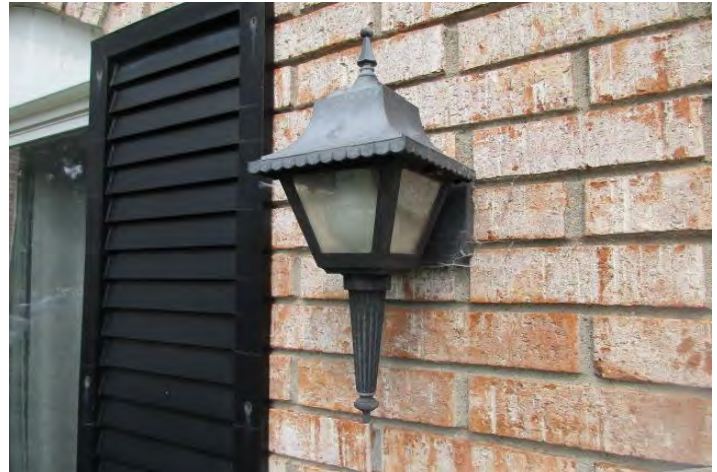
Typical condition

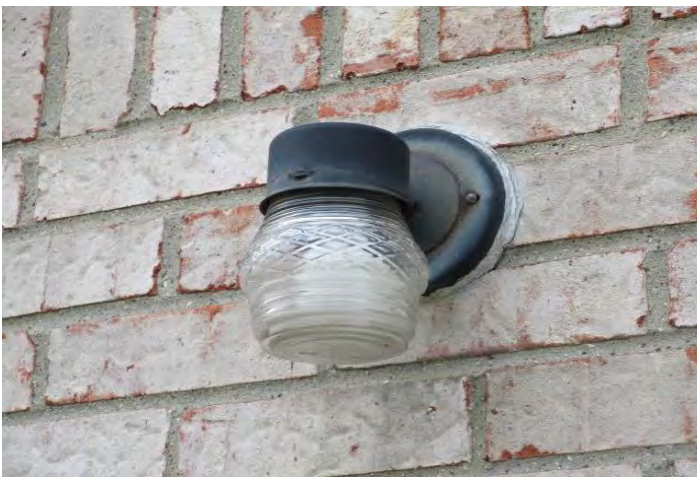
Example of a small sconce

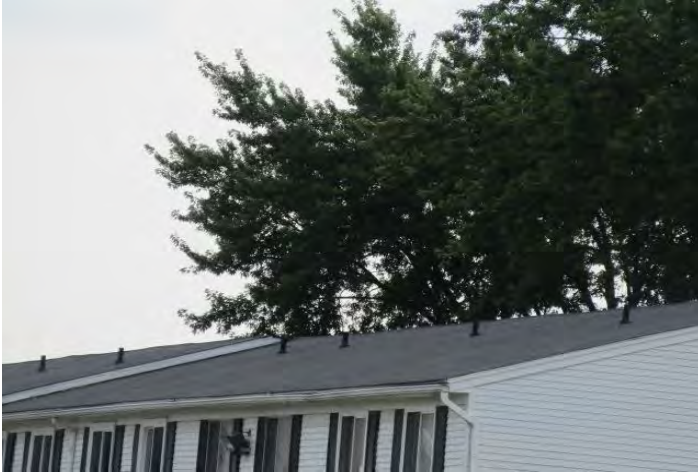
Overview of a typical asphalt shingle roof

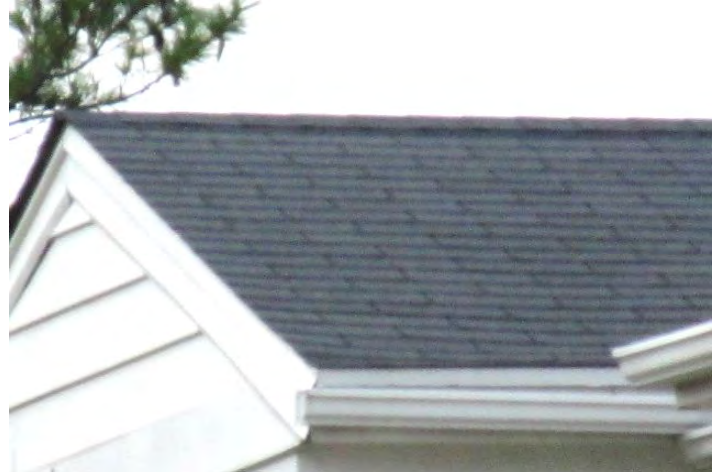
Typical condition at the ridge of a gable

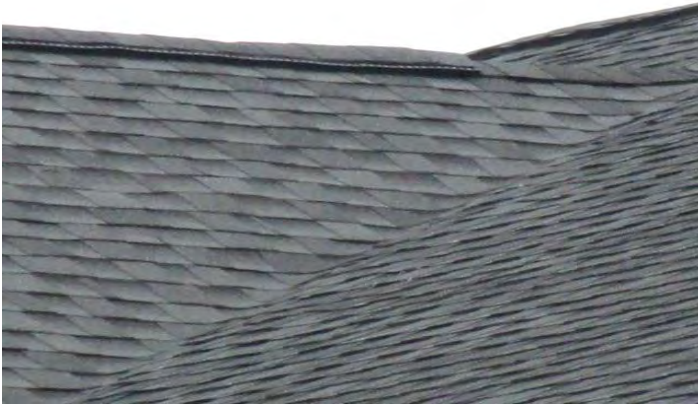
Typical surface condition at a valley

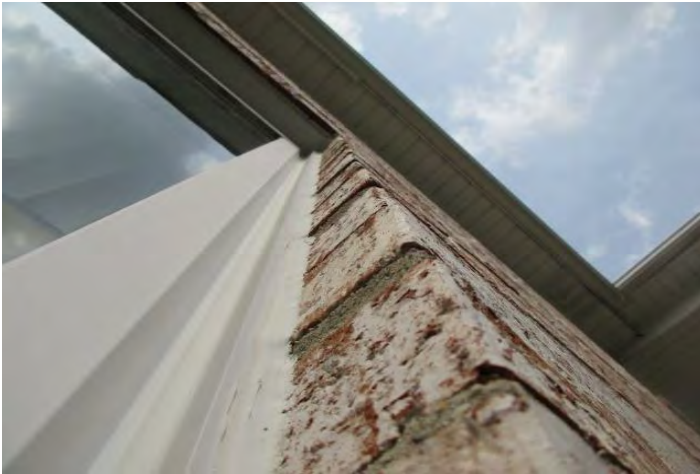
Overview of typical sealant at a window jamb

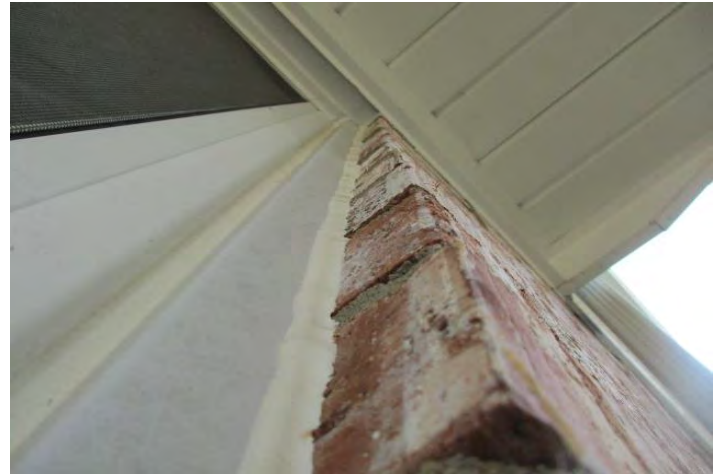
Typical condition

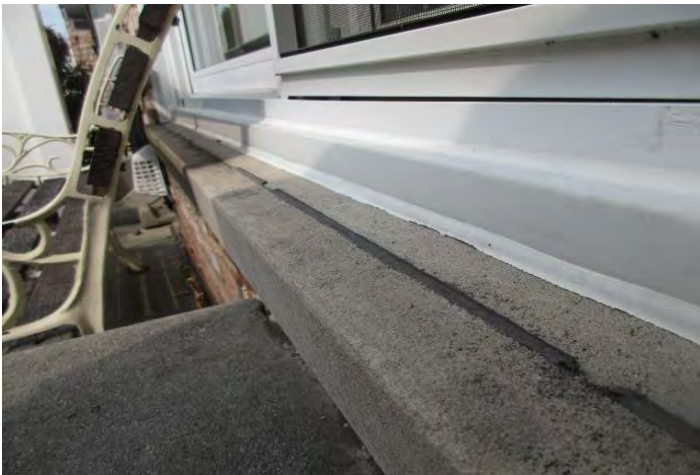
Overview of typical sealant at a window sill

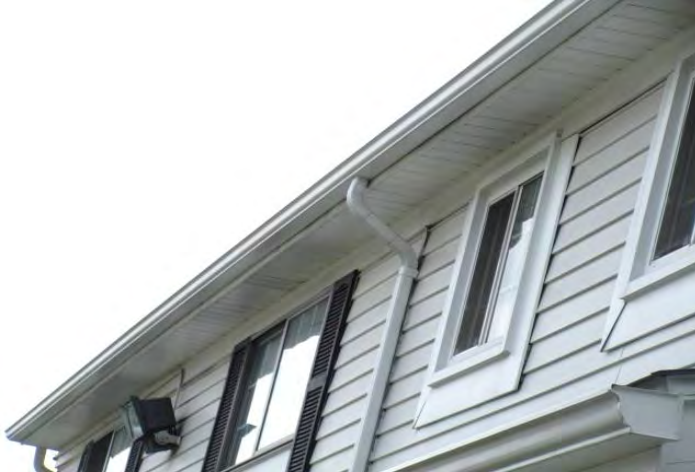
Overview of a typical soffit and fascia

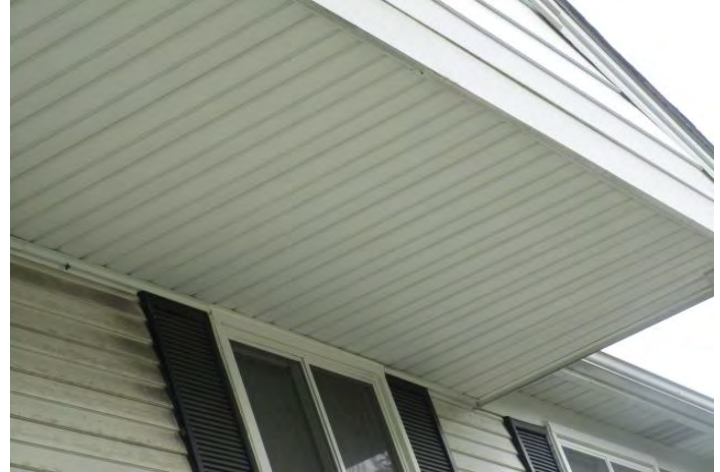
Overview of soffit at a front gable bump-out

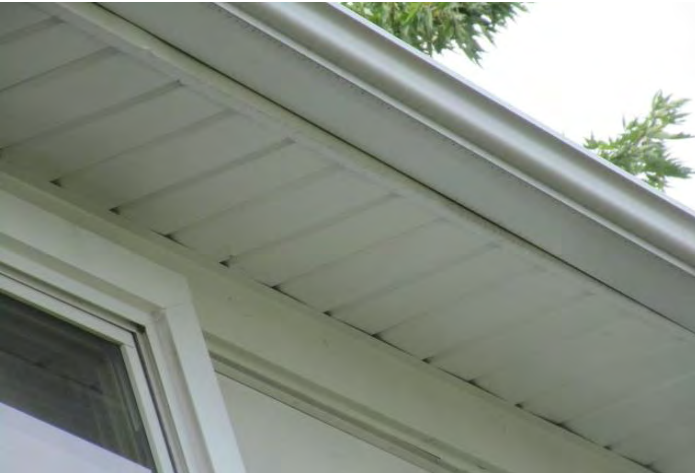
The soffits and fascia are in good condition

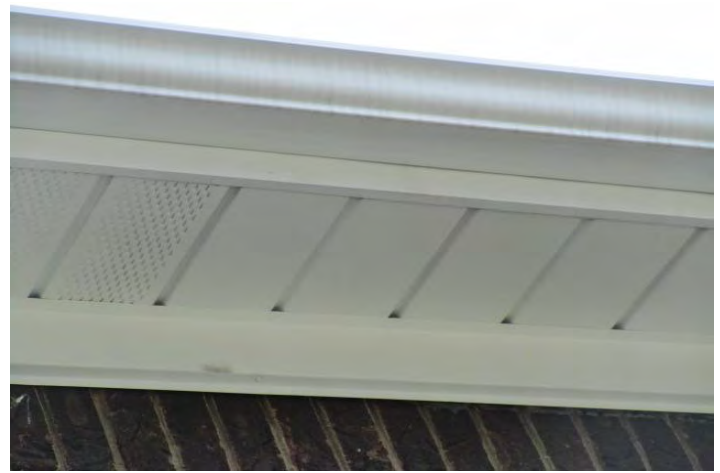
Typical surface condition

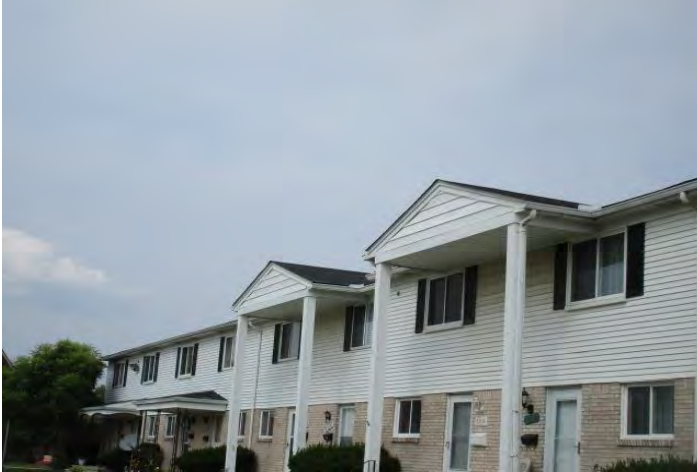
Overview of typical siding surfaces

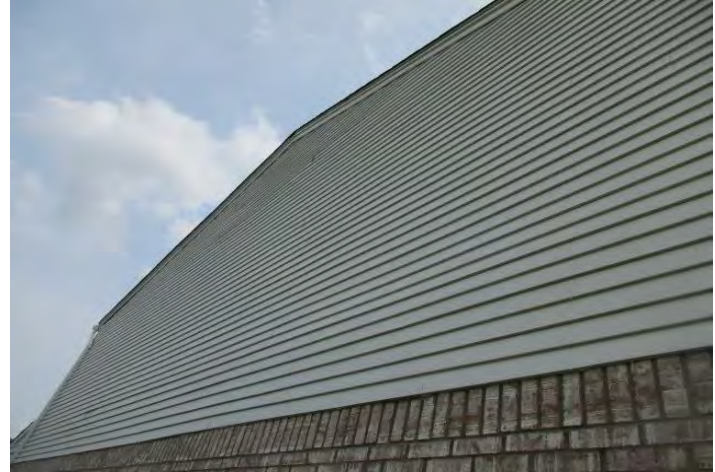
Typical condition at the end of a building

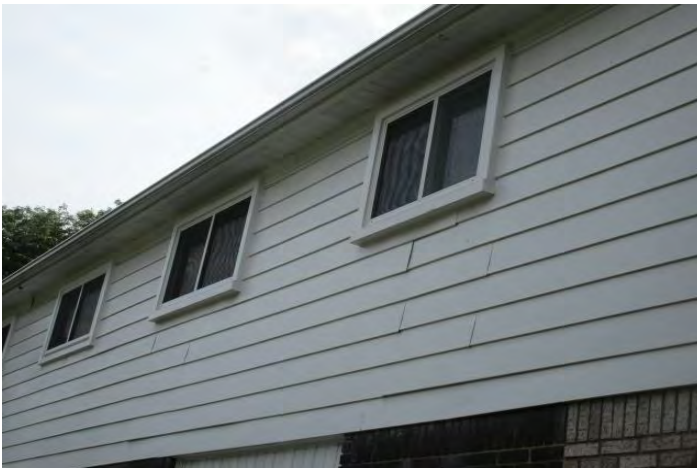
Some sided surfaces are aluminum siding, as seen in this photo

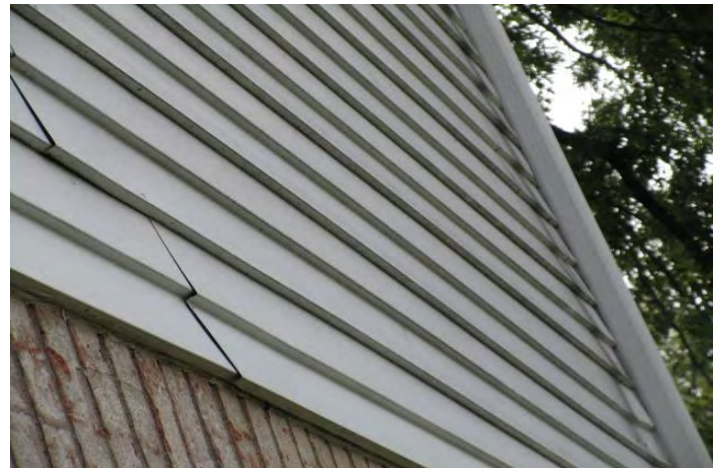
Typical surface condition

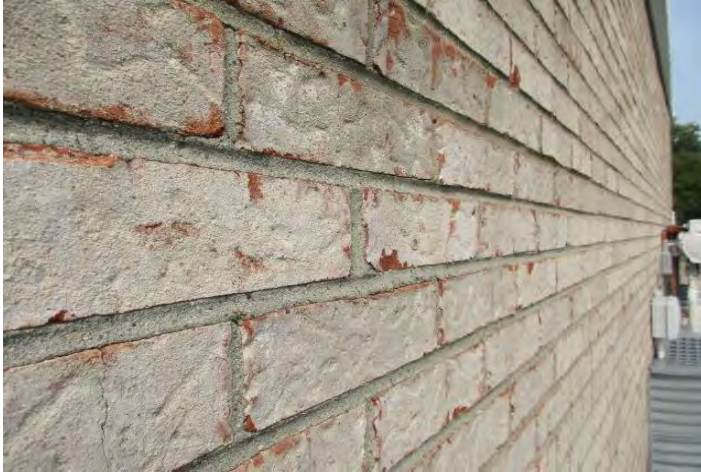
Overview of typical surface conditions at masonry brick

Engineering Narrative
<p>The masonry surfaces are original (repairs have been addressed in the past as-needed, but surfaces vary between poor and good condition). Areas that are in poor condition have surface spalling and occasional brick deterioration. Accordingly, masonry repairs are recommended between 2019 - 2023. An additional \$16,750 is included in 2018, for repairs the association is addressing in 2018 (project cost provided by the property manager). Subsequent phased repairs are recommended every 12 years after.</p>

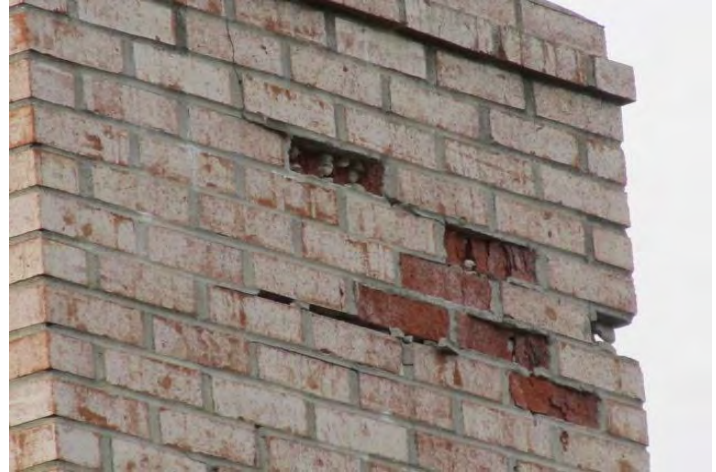
Overview of spalled faces and damage at masonry bricks

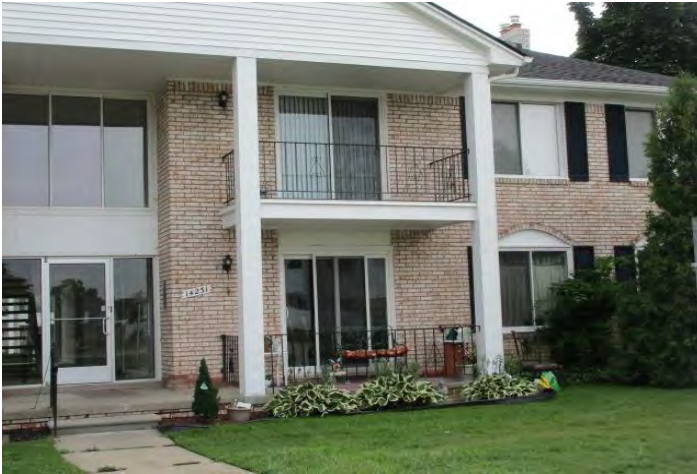
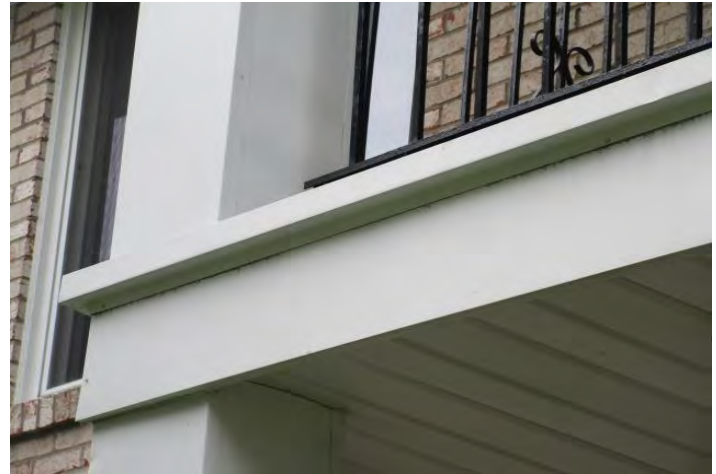
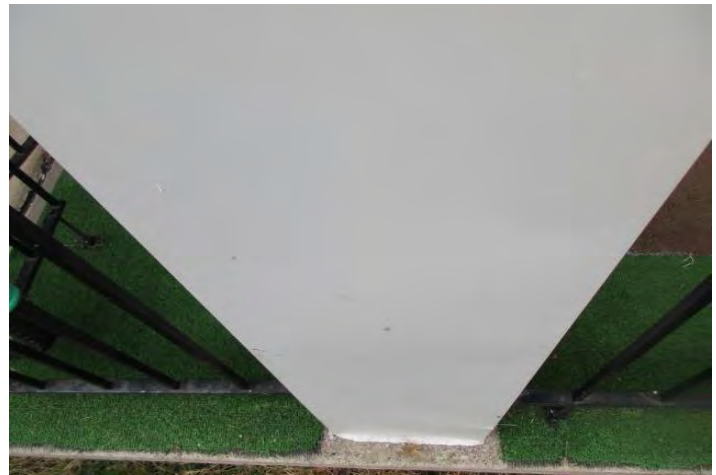
The paint finishes (which are not factory original) range from fair to good condition

The columns and perimeter boards, located at the apartment style building balconies, are clad in aluminum and the paint finishes are not factory original. Per request, paint finishes are planned to be addressed on a 5 year cycle. Per the current condition, we are recommending the next paint finishes between 2021 - 2025. Subsequent paint applications cycles are recommended every 8 years after.

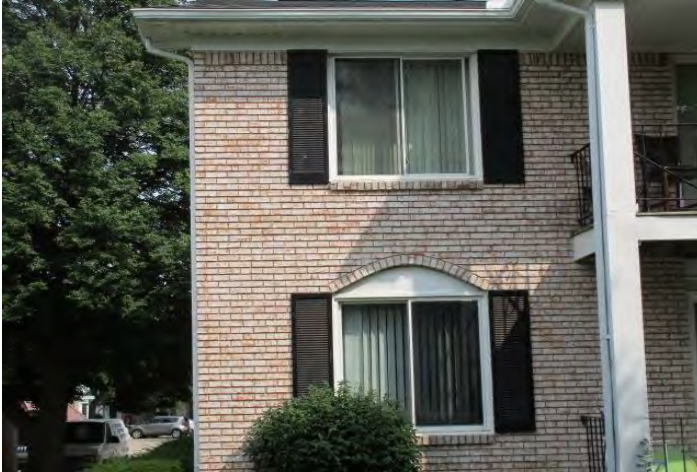
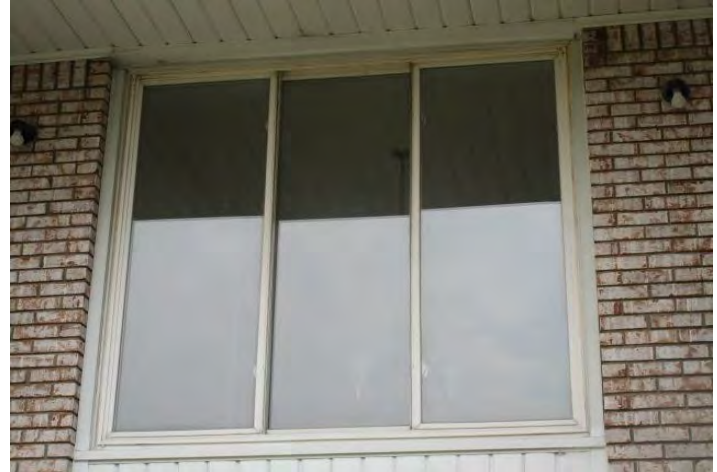
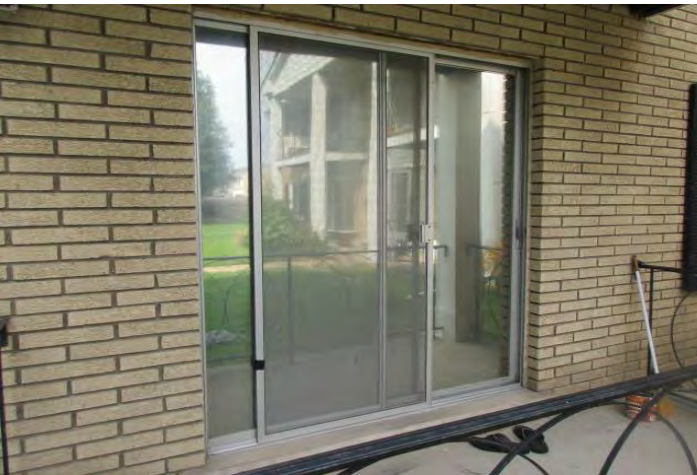
All common windows, private windows, and patio doors are the responsibility of the association. These elements vary in age, and they are in an overall fair to good condition. Per request, we are including a phased replacement between 2026 - 2035.

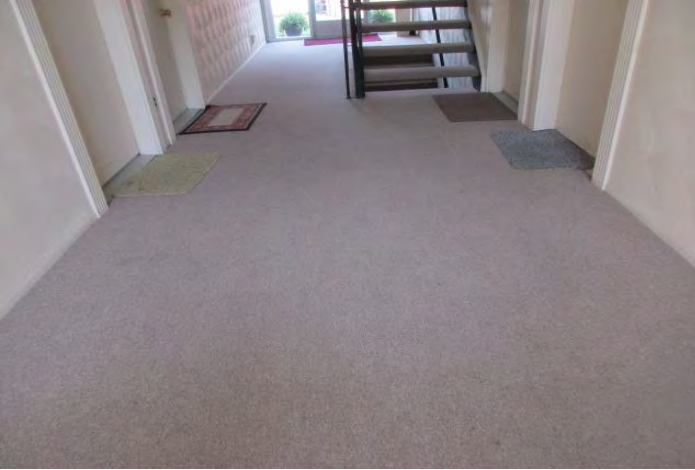
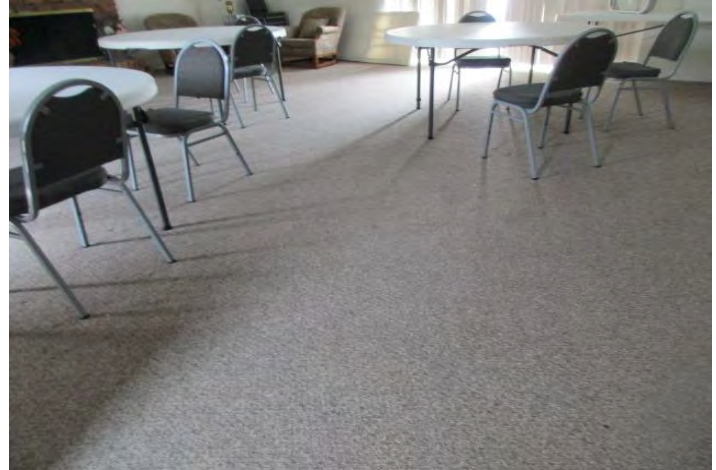
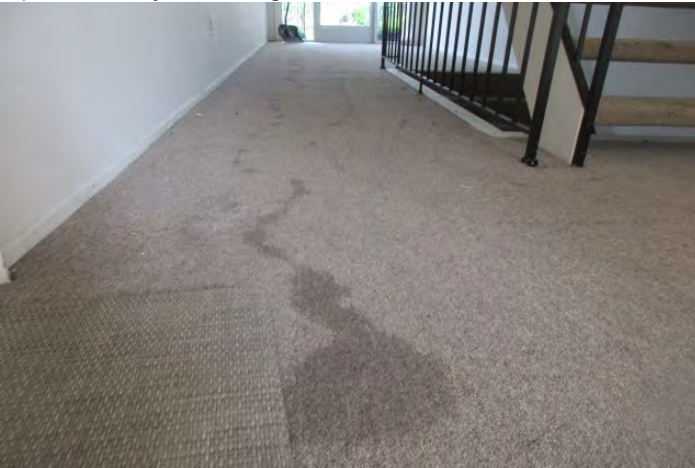
Example of a stain in the carpet of a hallway

Interior carpet floor coverings, located at the apartment style building common spaces and the clubhouse, vary in age, and they are in an overall fair condition. Per request, a phased replacement is planned between 2019 - 2023. With an average useful life of 8 to 12 years, subsequent phased replacement cycles are recommended every 12 years after.

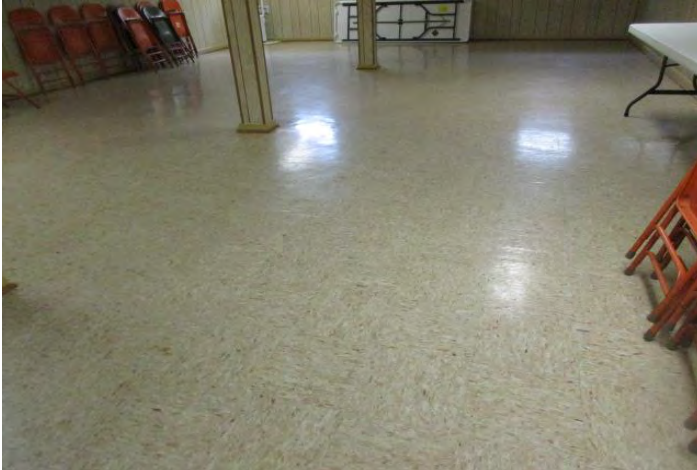
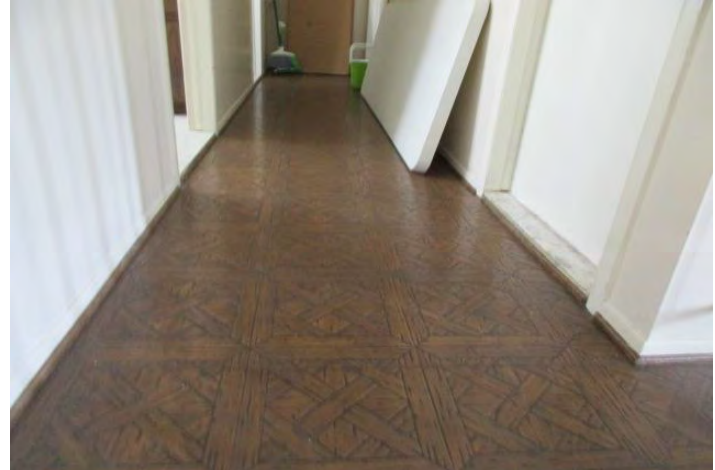
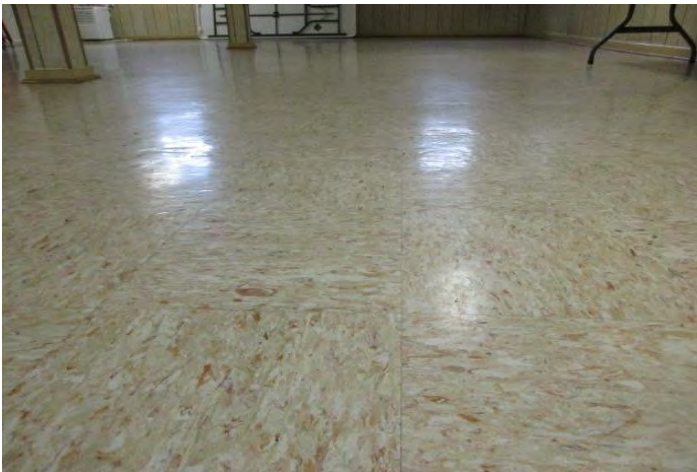
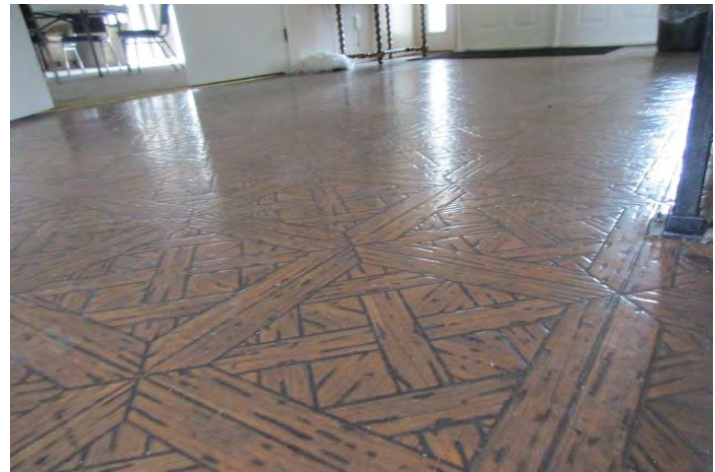
Engineering Narrative	
<p>The resilient floor covering surfaces, located at the clubhouse, are 46 years of age and they are in fair condition. Per the current condition, a replacement is recommended in 2021, in 3 years. With an average useful life of 20 to 25 years, a subsequent replacement is recommended 25 years after.</p>

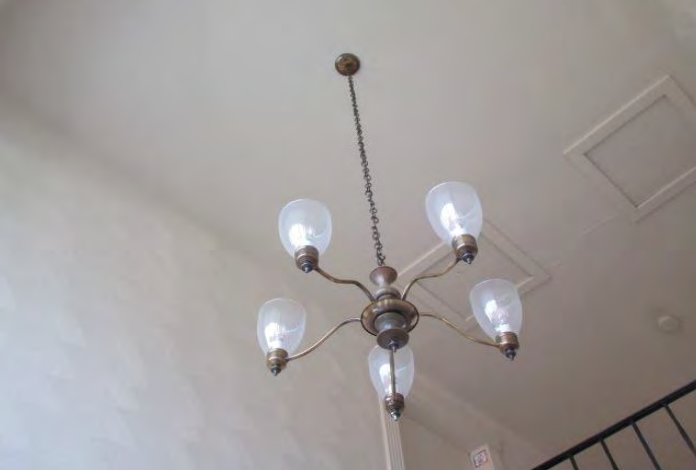
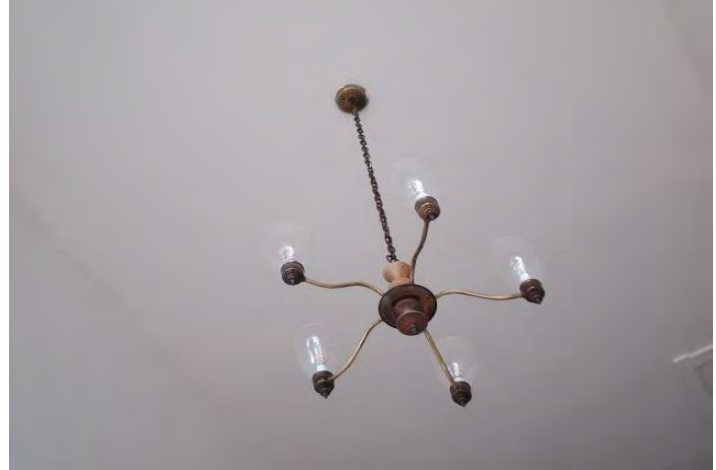
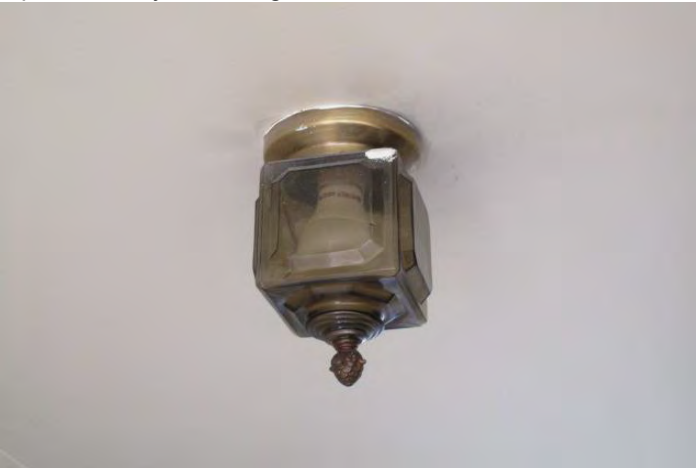
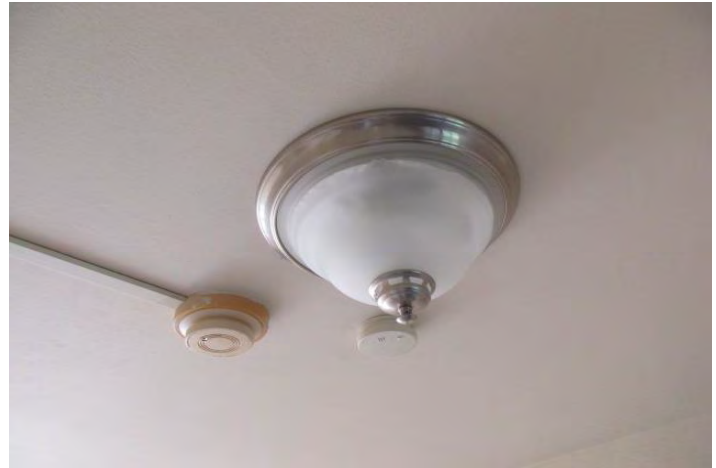
Isolated condition of a previously replaced ceiling mounted fixture

The interior light fixtures, located at the apartment style common interior spaces, vary in age and they are in fair condition. Per request, a phased replacement is included between 2019 - 2023. With an average useful life of 20 to 25 years, a subsequent phased replacement is recommended 25 years after. Unit cost is based upon a weighted average among the (46) chandeliers and (62) ceiling mounted fixtures. Light fixtures in the clubhouse are addressed as an operating expense.

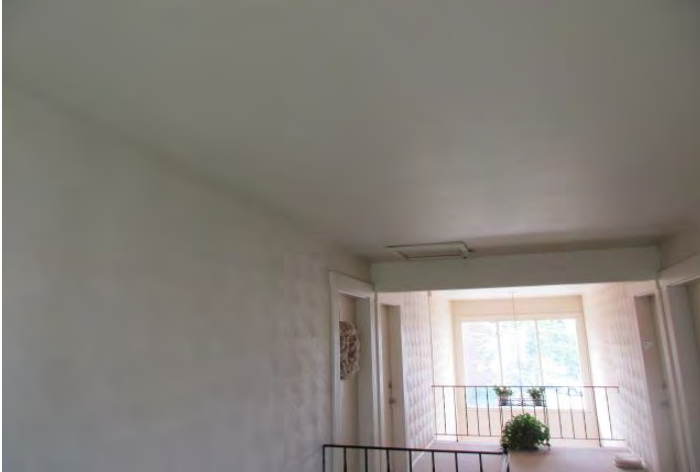
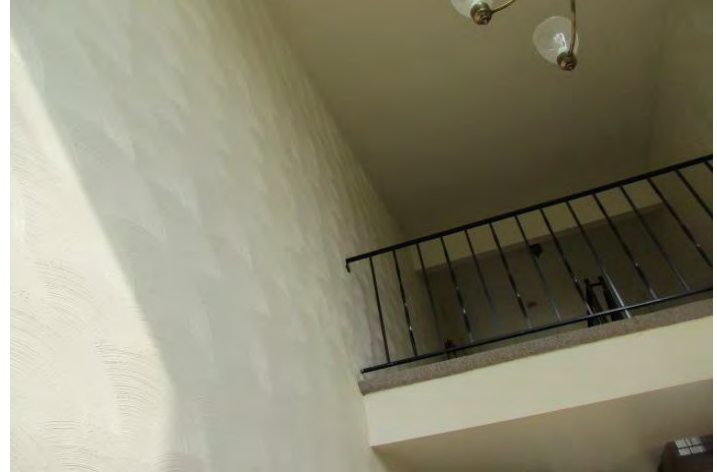
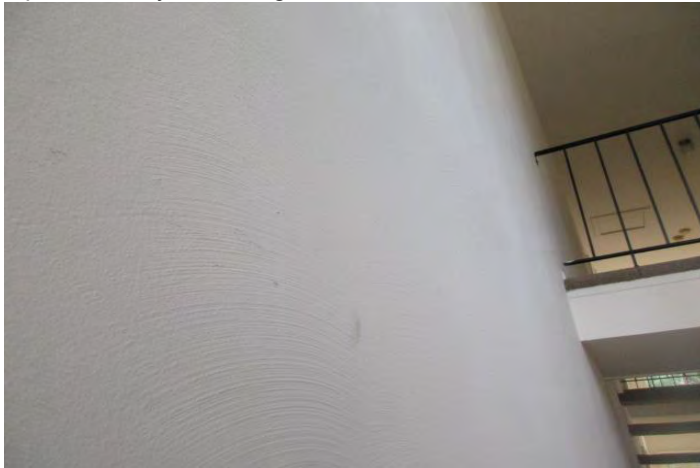
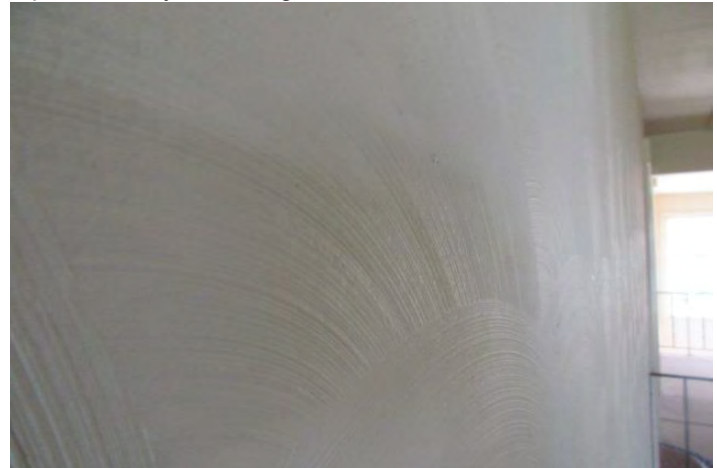
The interior paint finishes, located at the apartment style common interior spaces, vary in age and they range from good to fair condition. Per request, a phased paint application is included between 2019 - 2023. With an average useful life of 6 to 12 years, and per request, subsequent applications are planned every 12 years after. Paint application years coincide with carpet replacements. Paint finishes in the clubhouse are addressed as an operating expense.

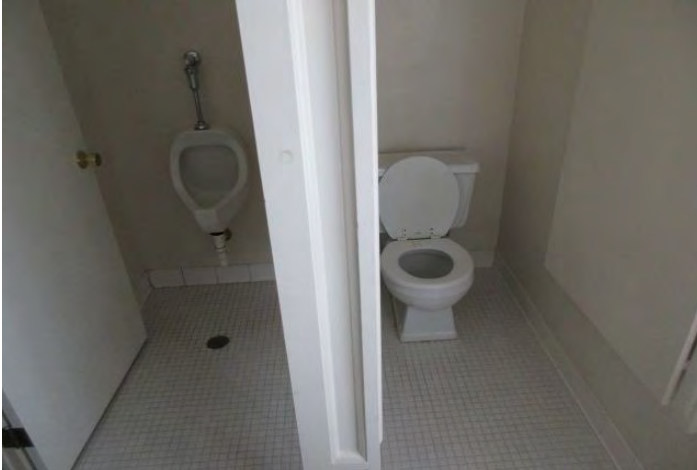
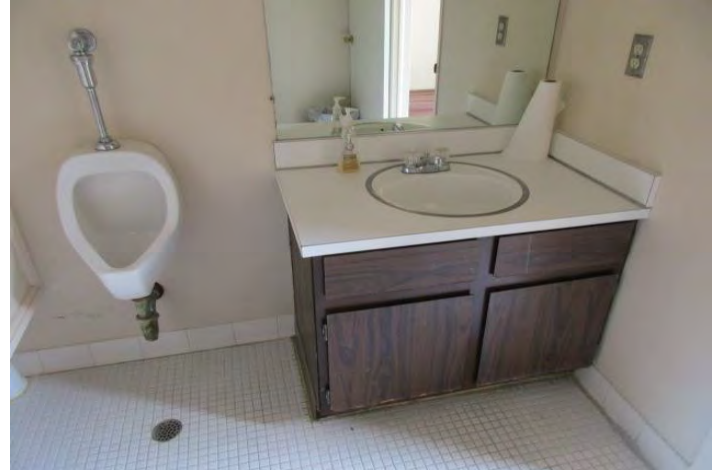
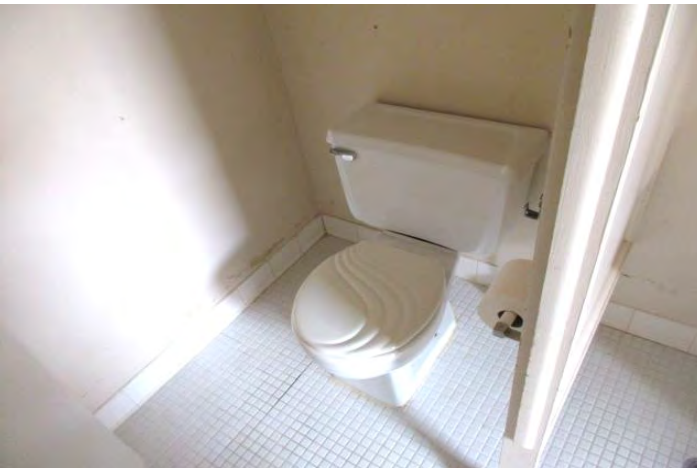
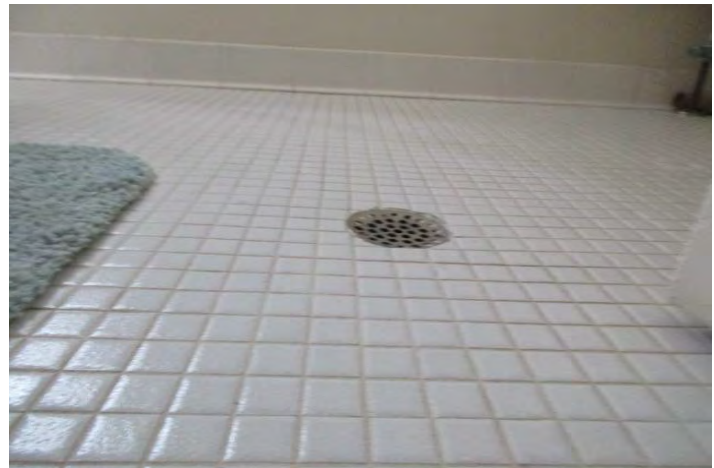
Engineering Narrative
There are (4) restrooms in the clubhouse: (2) serving the interior gathering space and (2) serving the pool area. At 46 years of age, the restrooms are in fair condition. Per the current condition, and request, we are recommending restroom renovations in 2026, in 8 years. Renovations include: tile replacements, paint finishes, partitions, plumbing fixtures, and related restroom accessories.

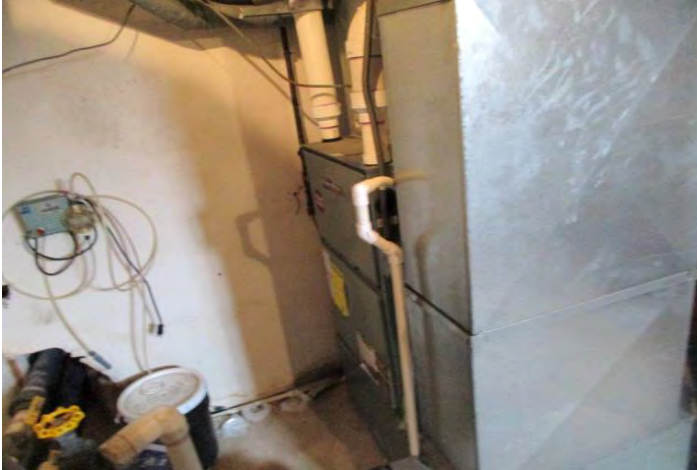
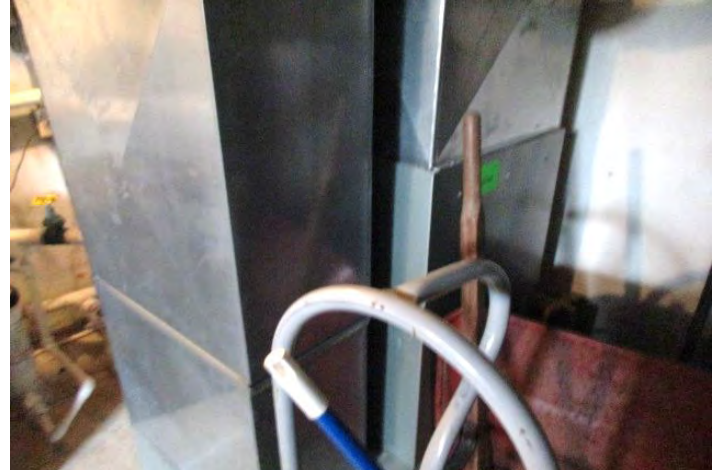
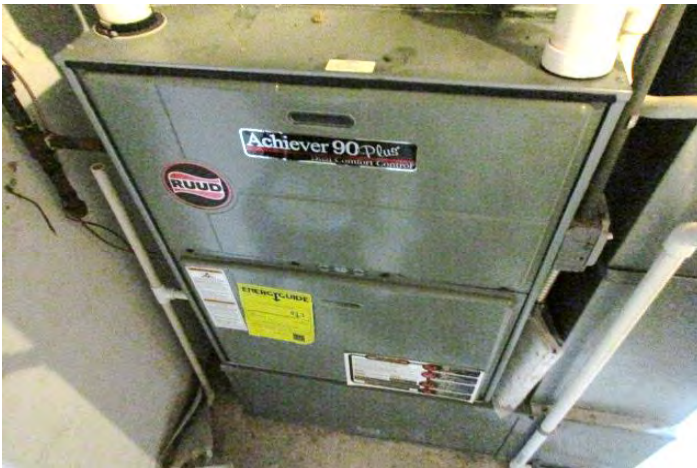
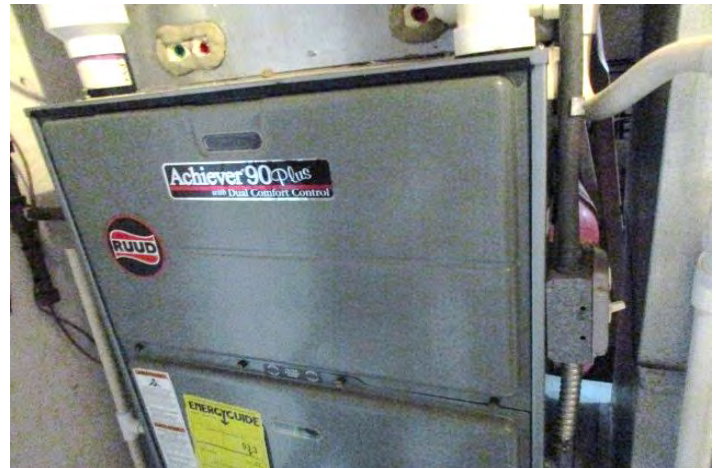
The furnace is reported to be in good working condition

The furnace, serving the clubhouse, has an unknown age, and it is reported to be in good working condition. Per the current condition, we recommend to plan for a replacement of this unit in 2024, in 6 years. With an average useful life of 15 to 20 years, a subsequent replacement is recommended 20 years after. Replacements coincide with the associated condensing unit. Actual furnace size is unknown and presumed to be +/- 100-MBH.
