# RESERVE STUDY

**Plum Creek Condominium Association  
13913 Camelot Dr.  
Sterling Heights, MI**

**Date of Inspection: 8/15/2018**

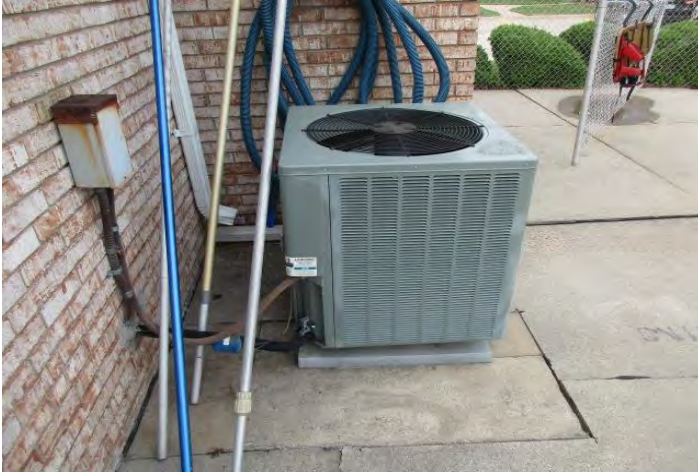
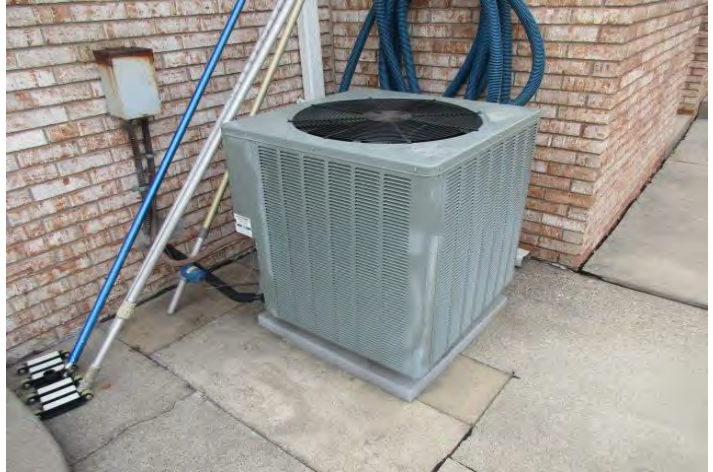
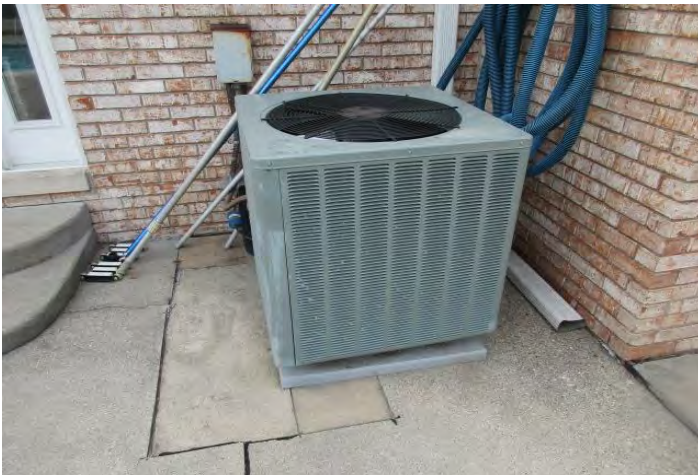
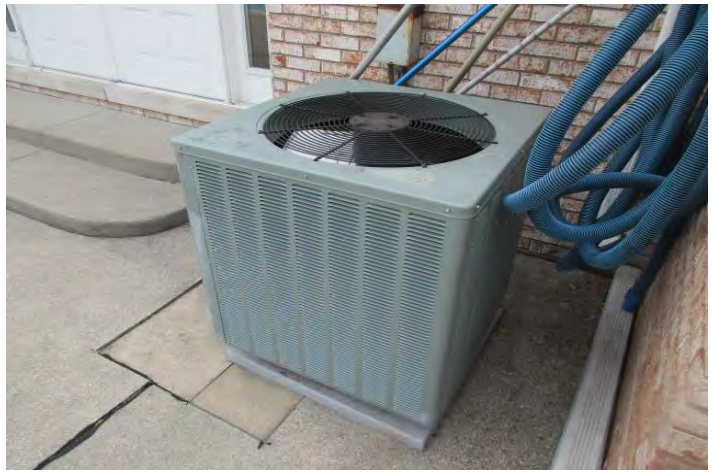
The condensing unit is reported to be in good working condition

The 5-ton condensing unit, serving the clubhouse, has an unknown age, and it is reported to be in good working condition. Per the current condition, we recommend to plan for a replacement of this unit in 2024, in 6 years. With an average useful life of 15 to 20 years, a subsequent replacement is recommended 20 years after. Replacements coincide with the associated furnace unit.

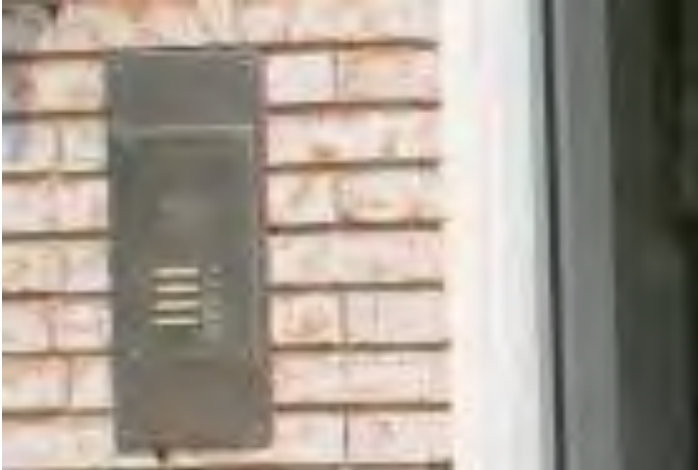
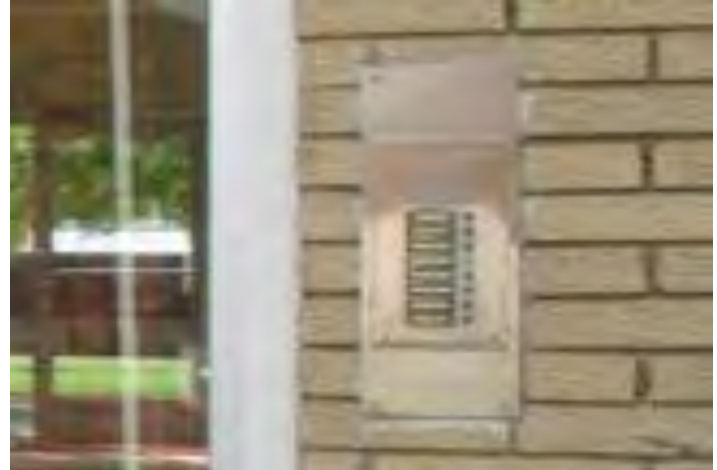
Engineering Narrative
The (46) entry intercom panels, located at the apartment style building entries, are 46 years of age and they are in fair, but functional, condition. Per the current working condition, and discussion with the property manager, we are recommending a replacement of these units in 2028, in 10 years.

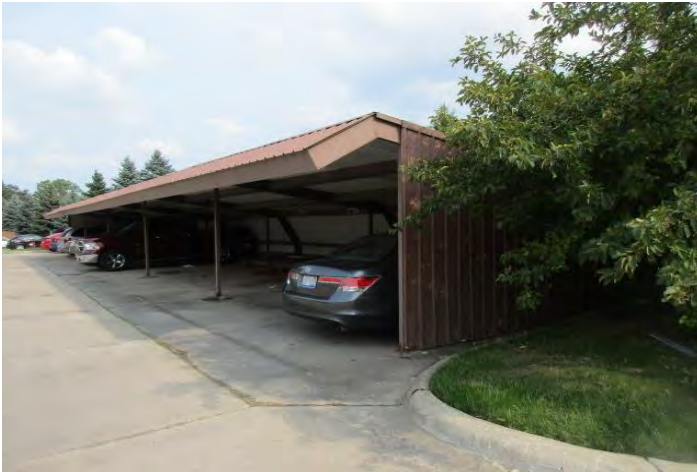
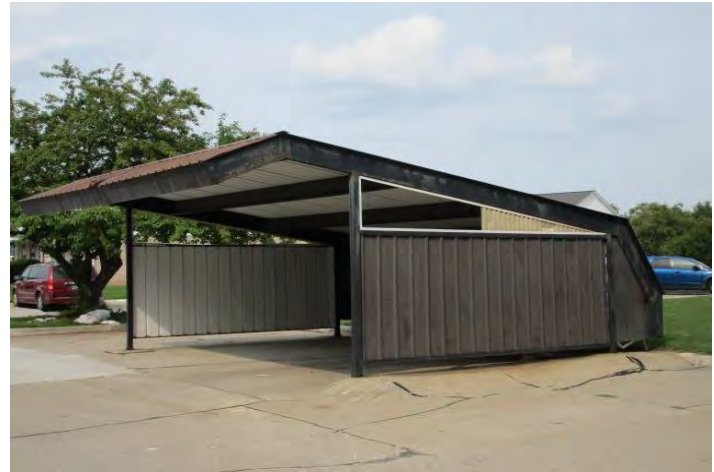
Engineering Narrative
The carports vary in age and the range from fair to good condition. Per request, replacements are planned to be phased over the next 15 years, addressed in coordination with phased concrete street replacements. Paint finishes are addressed as an operating expense. The estimated unit cost has been provided by the property manager.

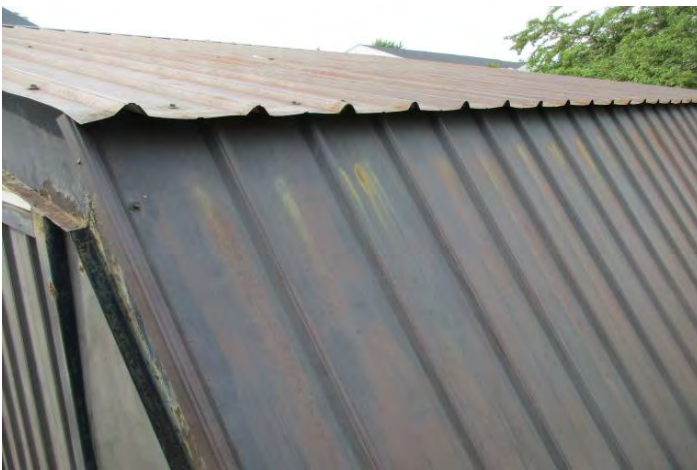
Typical surface condition at the metal roofs are the carports

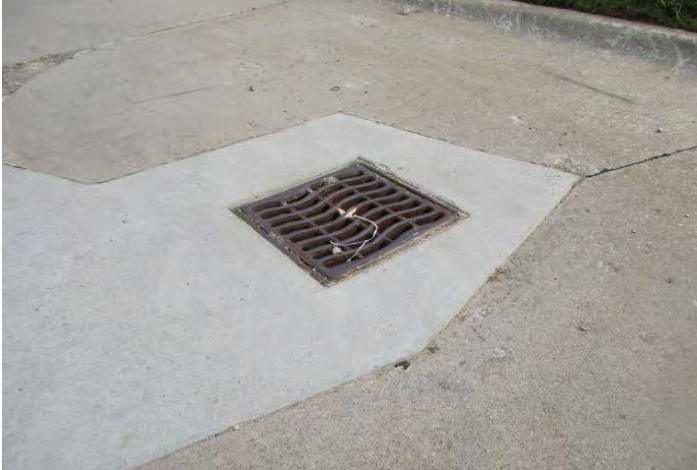
Overview of a previously repaired catch basin

The catch basins vary in age and they are in an overall good condition. Per the current condition, we recommend to plan for repairs in 2025, coinciding with a year of partial concrete street replacements. With an average useful life of 15 to 20 years, a subsequent cycle of repairs is recommended 20 years after.

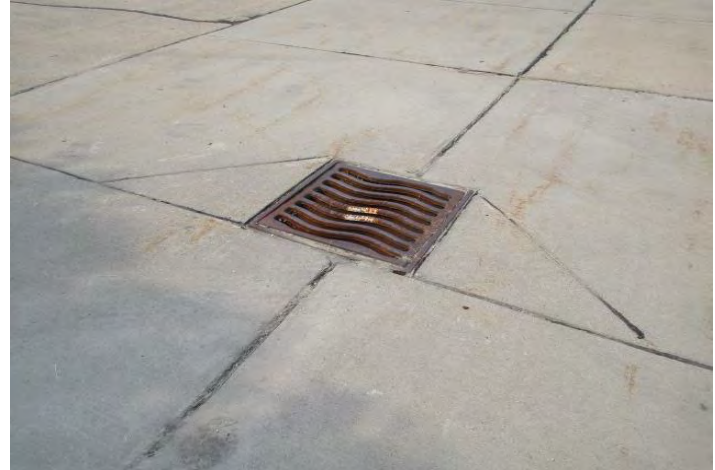
Typical condition

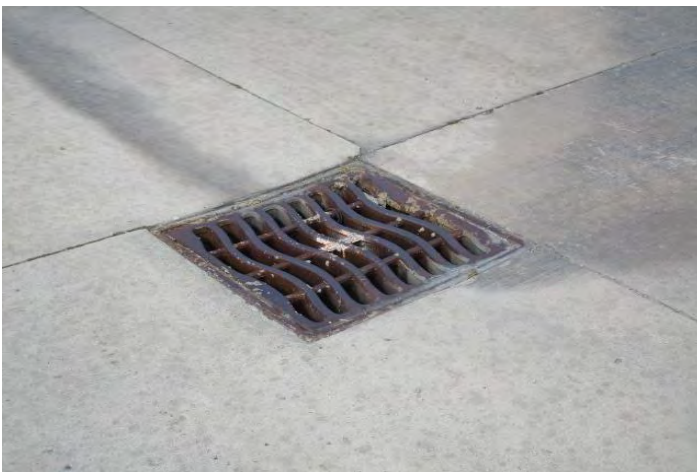
The catch basins are in good condition

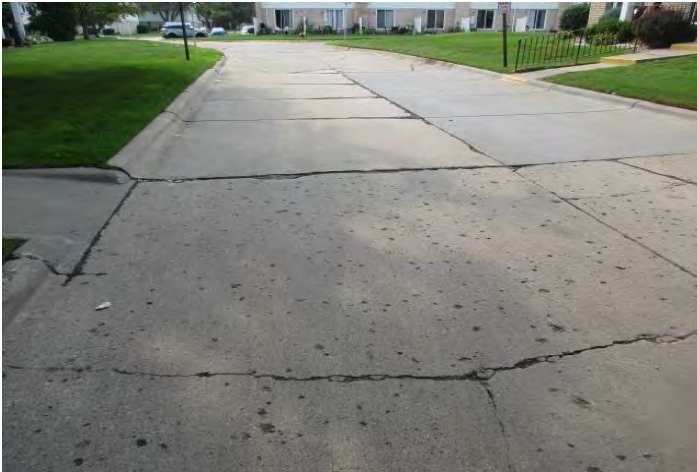
Overview of a typical concrete street

The concrete streets (and integrated curbs) vary in age and they are in an overall fair condition. Per the current condition, and request of the property manager, the association is planning a phased replacement of the concrete streets between 2019 - 2033. Subsequent repairs to the streets are included on page 2-25.

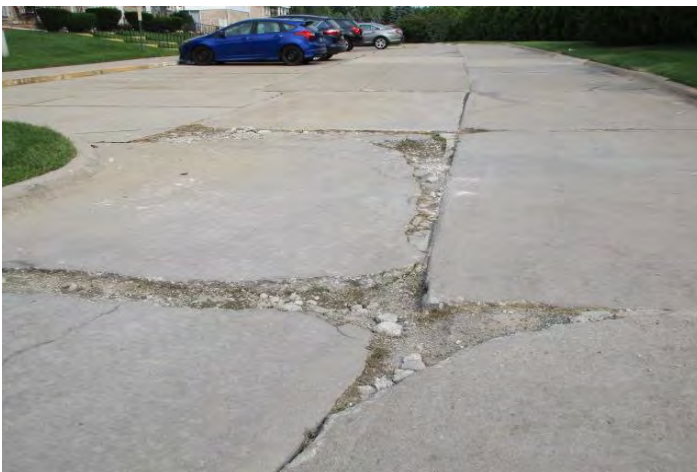
Isolated condition of significant damage to a concrete street

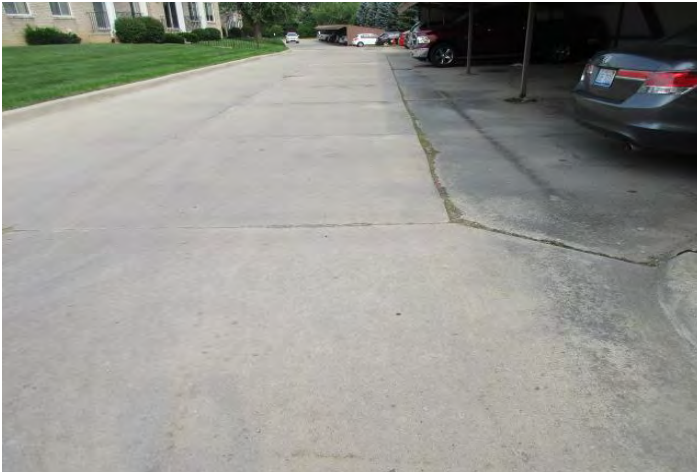
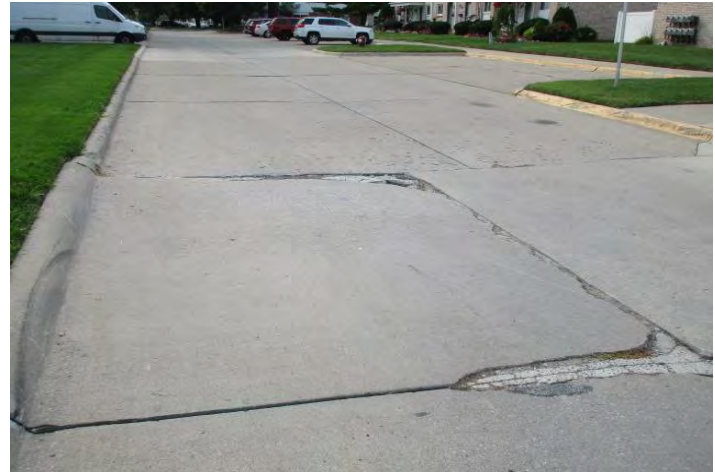
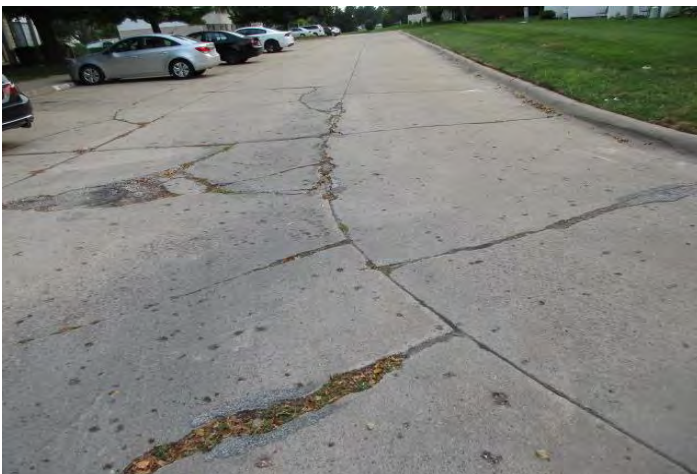
Typical condition

Engineering Narrative
Upon completion of the concrete street replacements, they will range from good to very good condition. A 10% replacement is recommended to be phased between 2036 and the end of the reserve study.

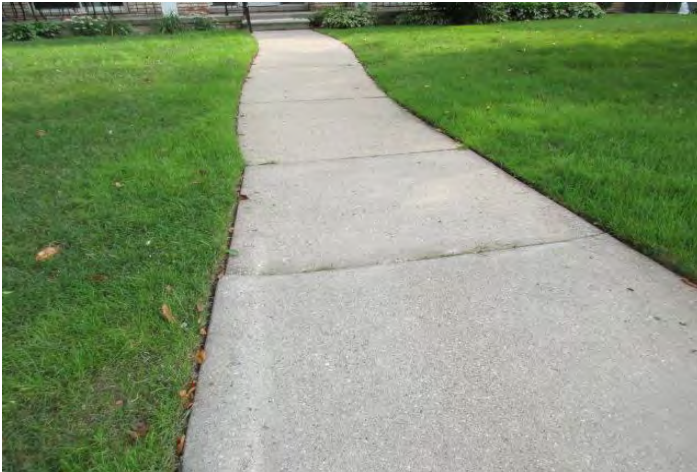
Overview of a typical concrete sidewalk

The concrete sidewalks, entry stoops, and patios vary in age. These surfaces range from fair to good condition. Over time, erosion, landscape growth, vehicular traffic, and the freeze-and-thaw cycles cause the need for periodic partial replacements. Per the current condition, and discussion with the property manager, we are recommending a 100% replacement to be phased over the next 30 years.

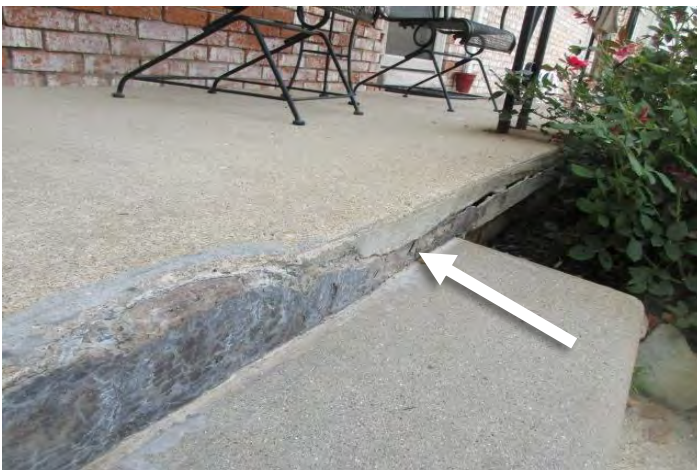
Isolated condition of a damaged entry stoop

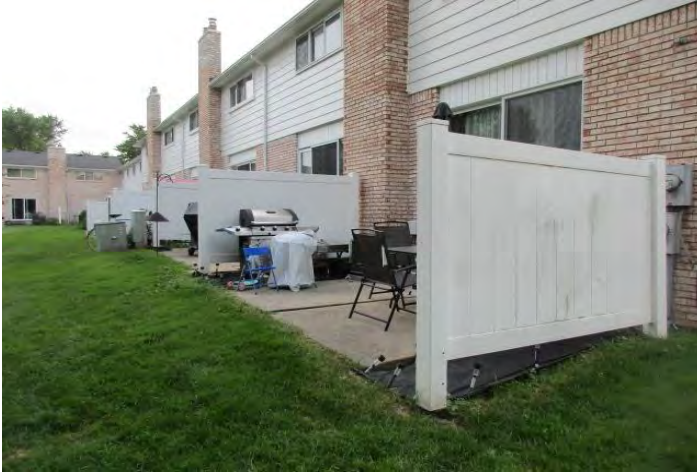
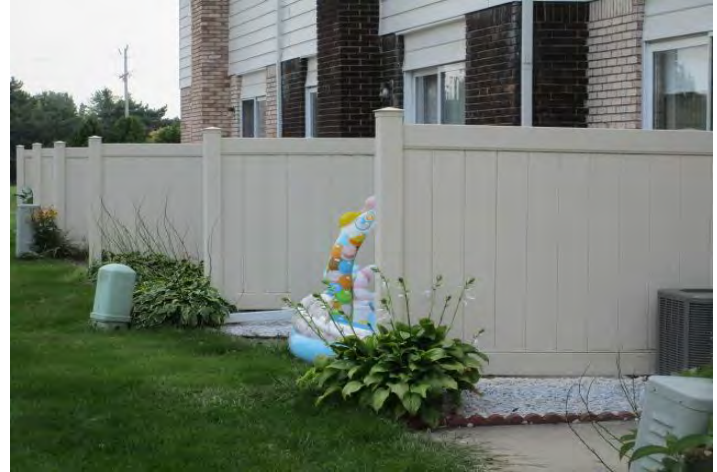
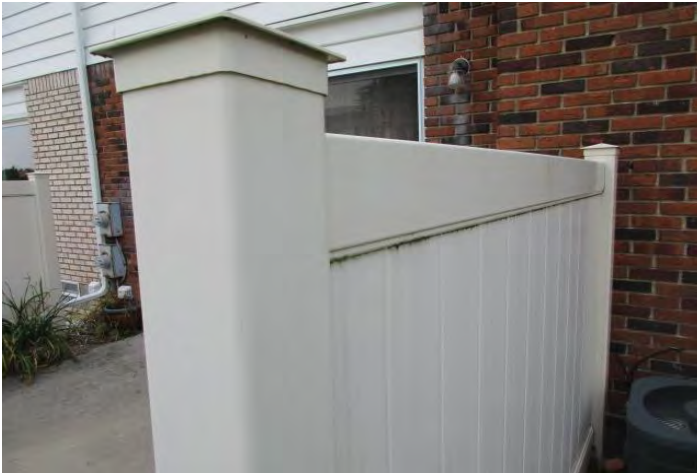
Typical condition

Engineering Narrative
The vinyl privacy fences are 5 years of age, and they are in good condition. With an average useful life of 20 to 25 years, we recommend to plan for a replacement in 2038, at 25 years of age. Interim repairs, and potential adjustments needed from the heaving of freeze/thaw cycles, are addressed as an operating expense.

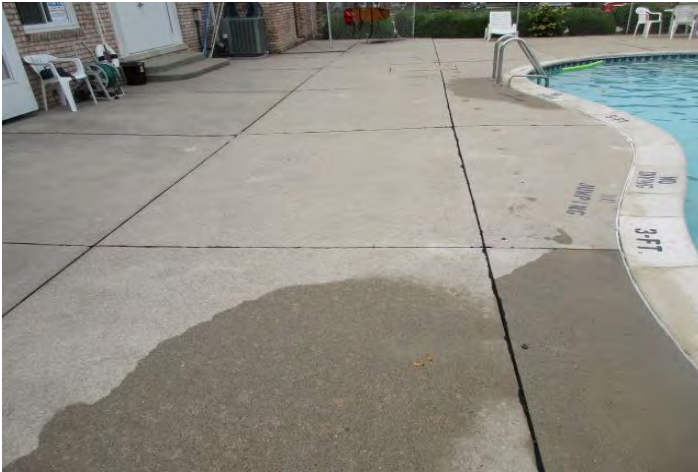
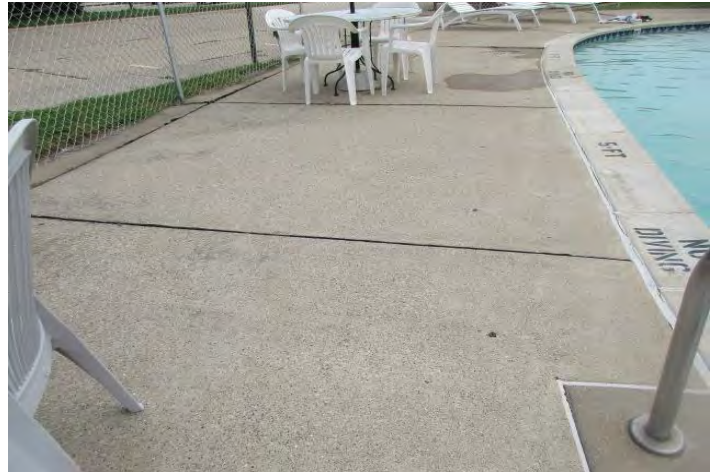
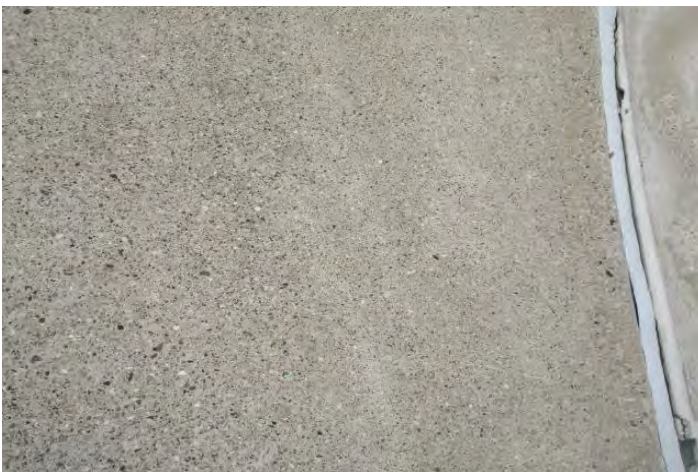
Typical condition

The concrete deck, located around the pool, is 46 years of age, and it is in good condition. We have included a 35% partial replacement (in 2 phases) prior to the planned pool replacement in 2037. An additional phase has been included at the end of the study, 11 years after the proposed pool and deck replacement in 2037.

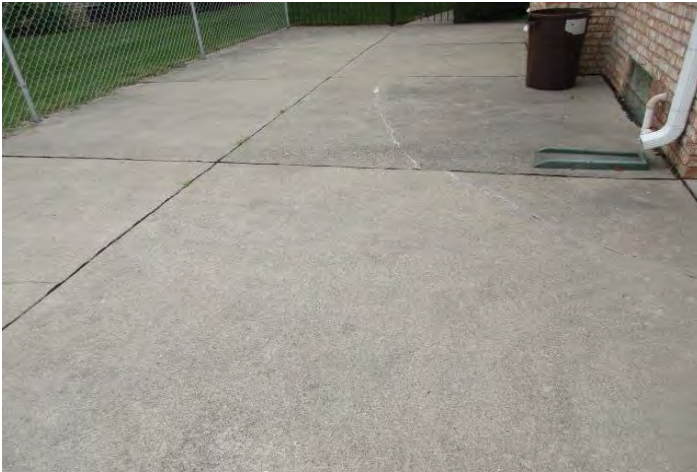
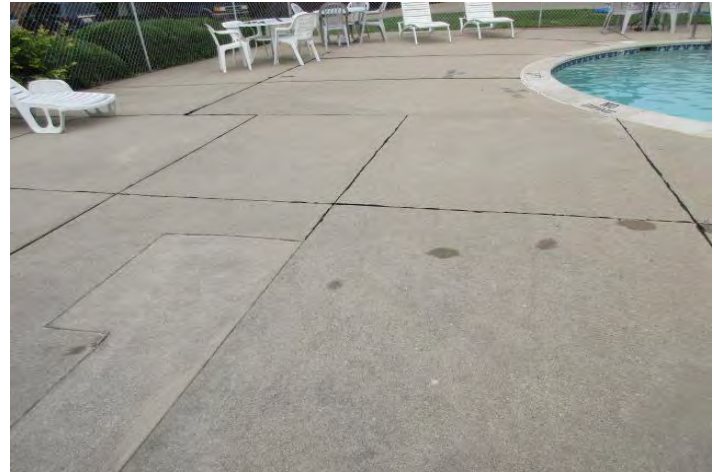
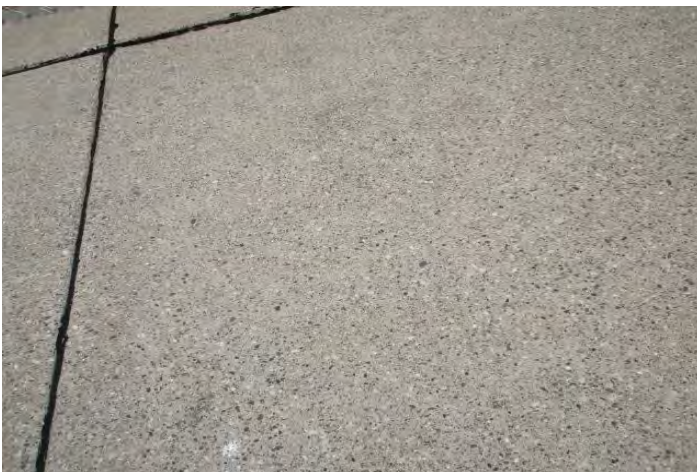
Typical condition

The pool deck is 46 years of age, and it is in good condition. We are recommending a 100% replacement of the pool deck in 2037, at 60 years of age and coinciding with a recommended pool replacement.

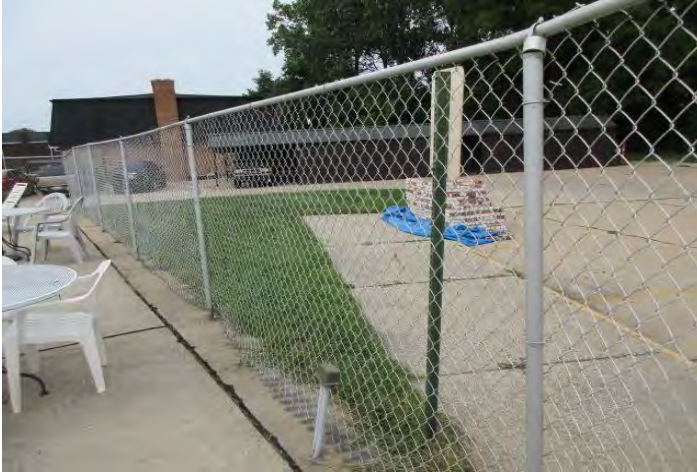
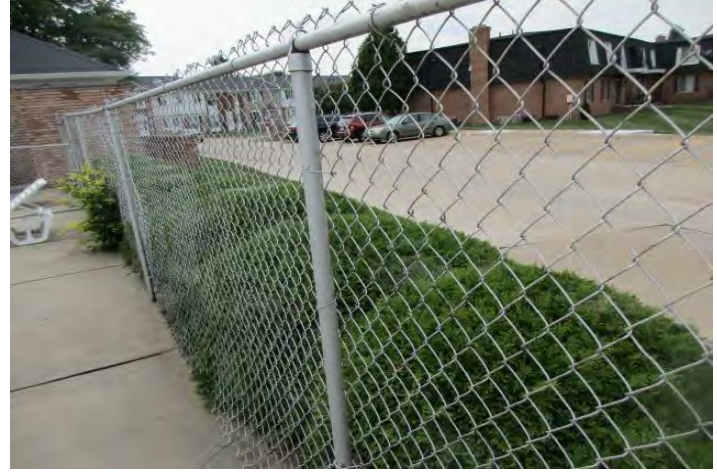
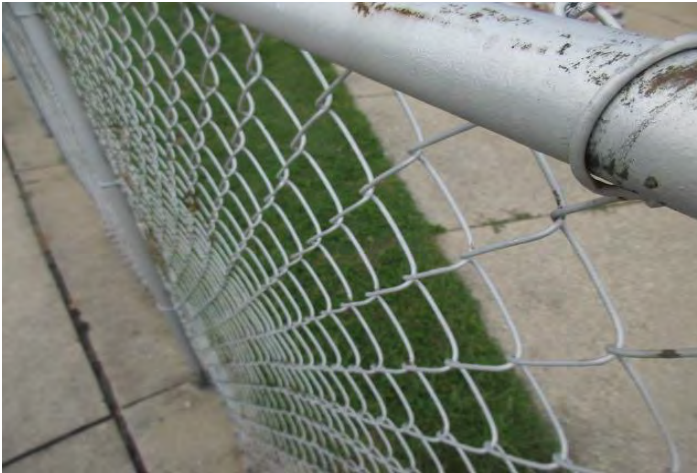
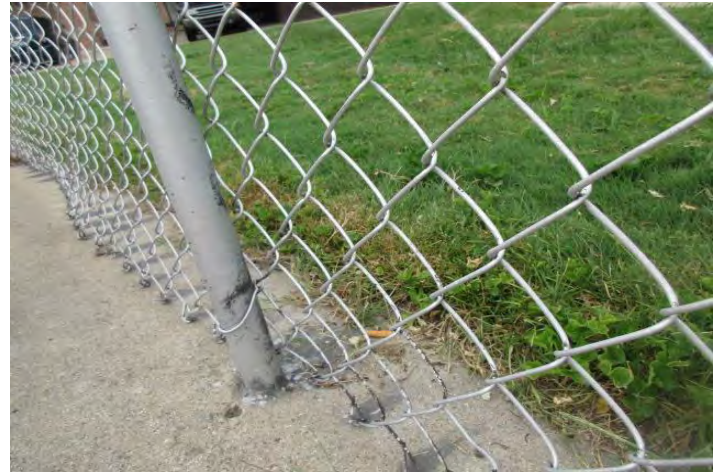
Typical condition

Typical surface condition at the top rail of the fence

Typical surface condition at the base of the fence

The chain-link fence, located around the pool perimeter, has an unknown age, and it is in good condition. Per the current condition, and discussion with the property manager, a fence replacement is recommended in 2037, coinciding with the pool and pool deck replacement. It is our recommendation to replace this fence with an aluminum, picket style fence.

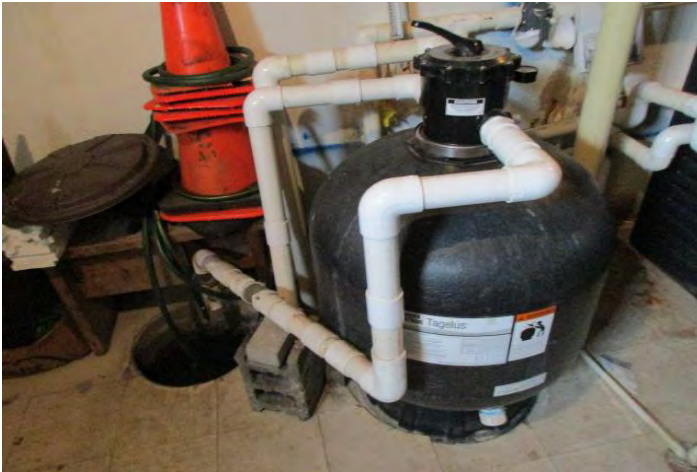
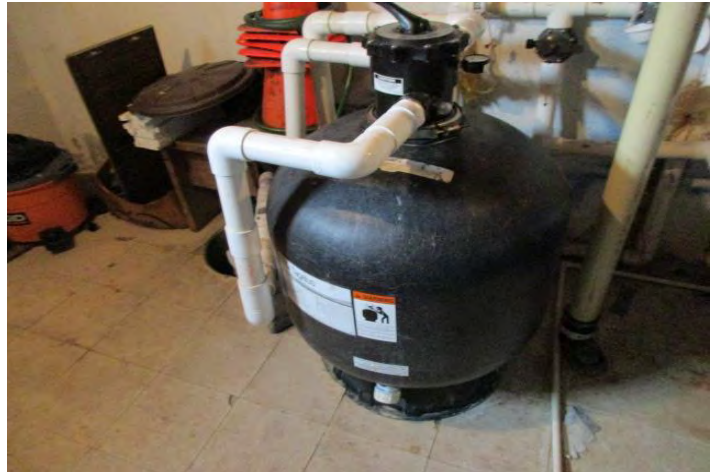
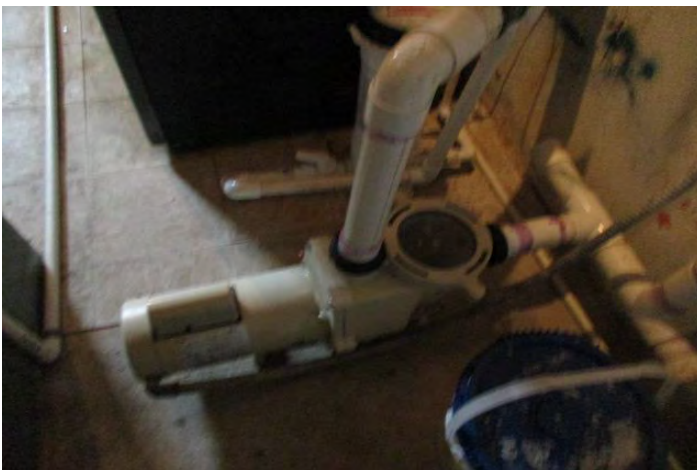
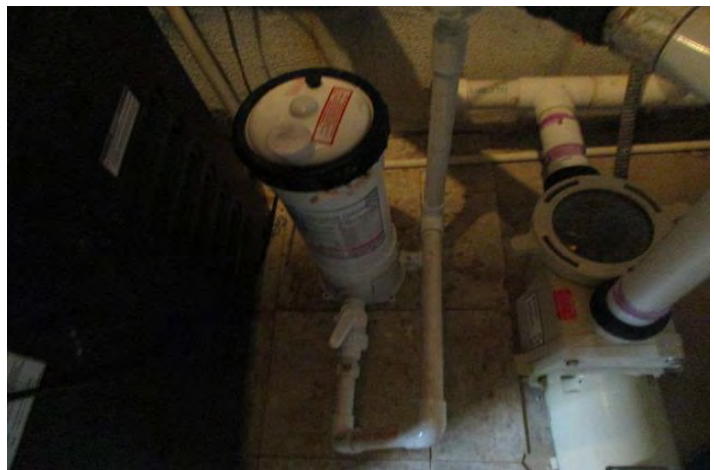
The pool's sand filter, 2-hp pump, and chlorinator vary in age, and they are reported to be in good working condition. Per the current condition, we are recommending a replacement of these devices in 2025, in 7 years. A subsequent replacement is not included on this page because a replacement is included in the 2037 pool replacement cost.

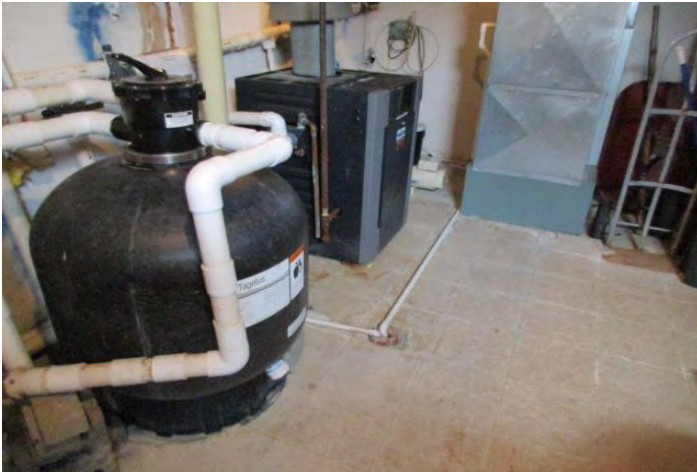
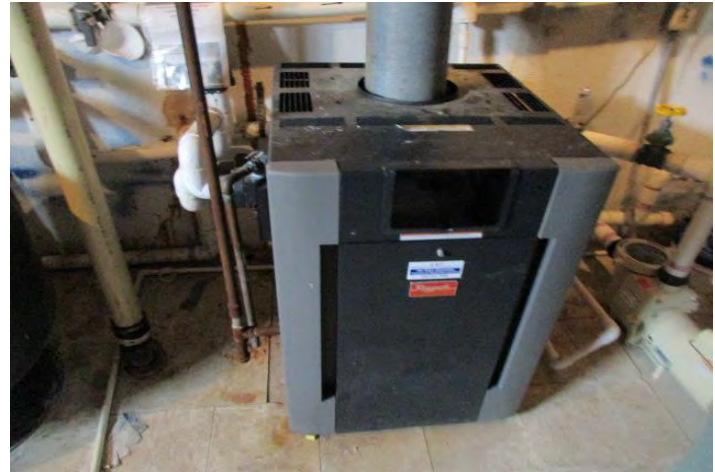
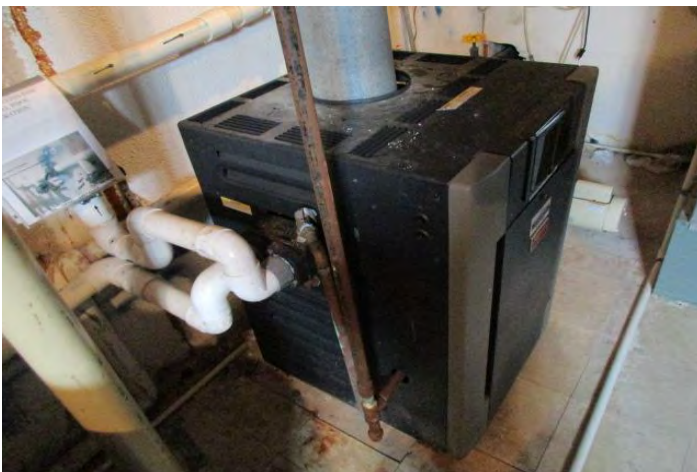
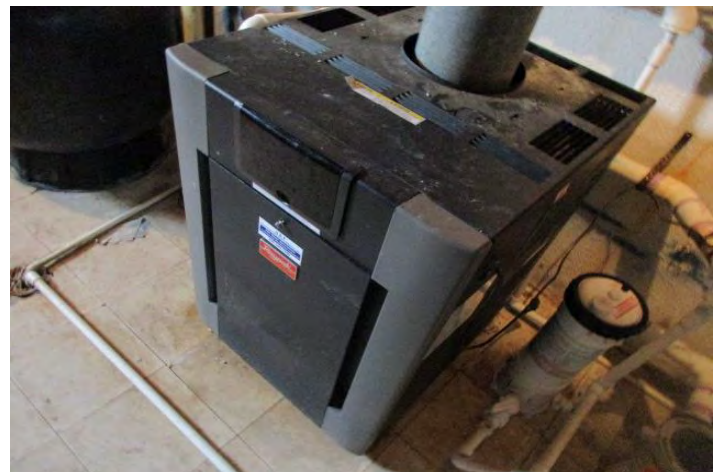
The pool heater is reported to be in good working condition

Engineering Narrative
The 382-MBH heater, serving the pool's water, has an unknown age, and it is reported to be in good working condition. Per the current condition, it is our recommendation to plan to replace this unit in 2025, coinciding with the other pool mechanical equipment. A subsequent replacement is not included on this page because a replacement is included in the 2037 pool replacement cost.

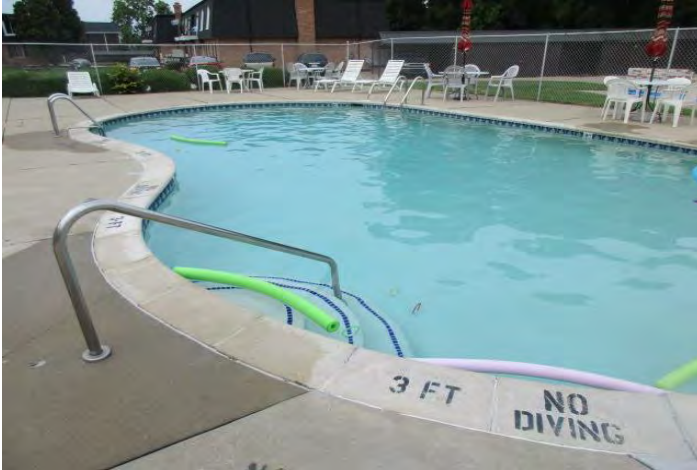
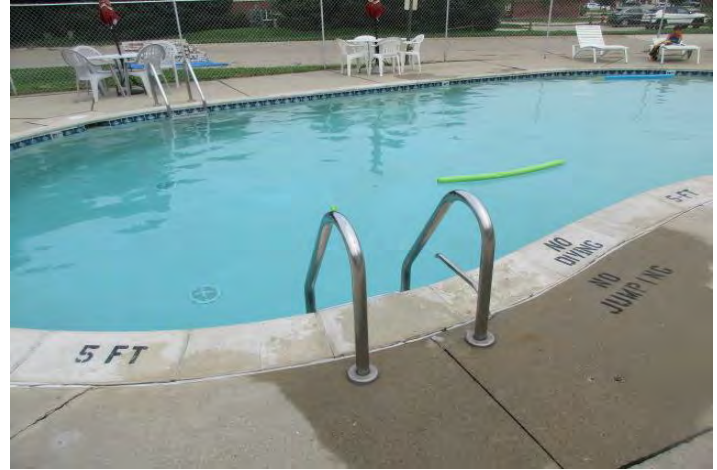
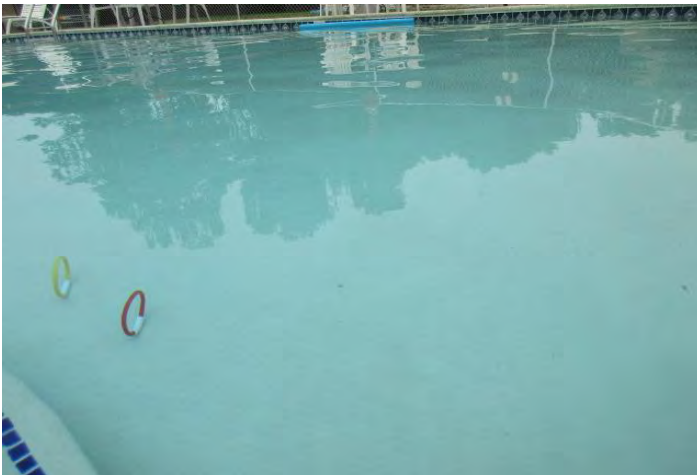
Paint finishes at the pool are in fair condition

The age of the pool's plaster finish is unknown. The surfaces have not been painted to date. Per request, we have planned for paint finishes in 2019. A subsequent paint cycle is included in 2031, 6 years after a recommended plaster resurfacing. No paint finishes have been included after the 2037 pool replacement, as it is anticipated that a different type of pool finish will be used.

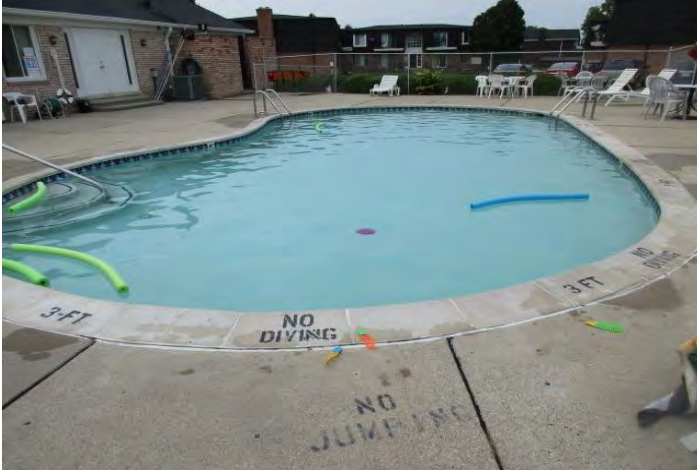
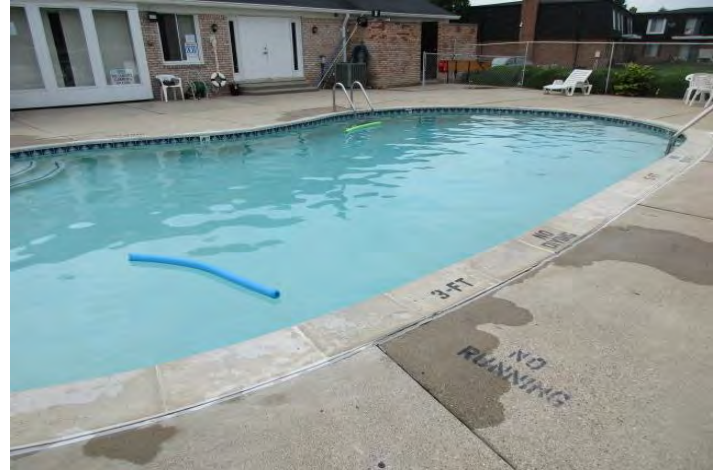
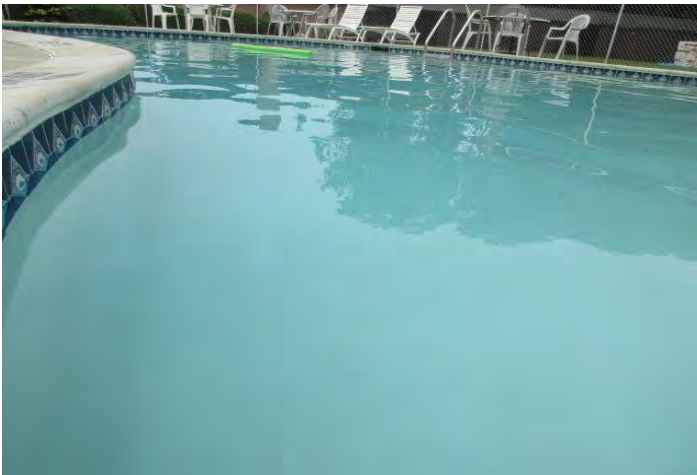
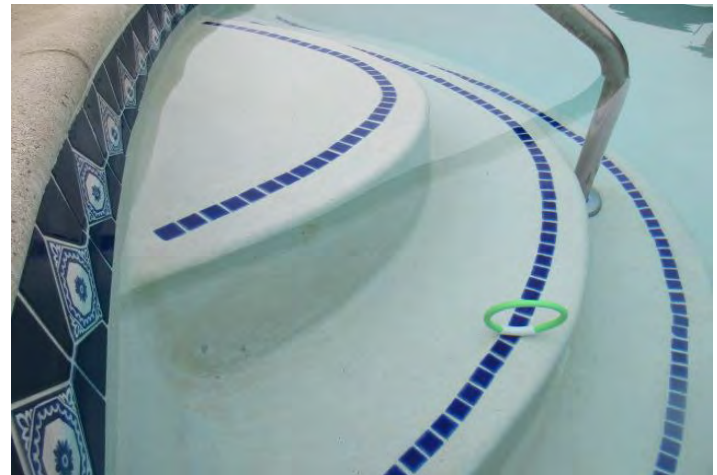
Plaster finishes at the pool are in good condition

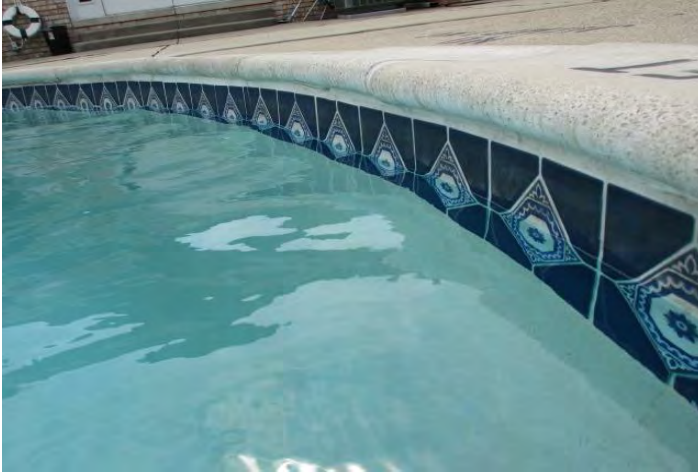
Overview of the pool's perimeter tile

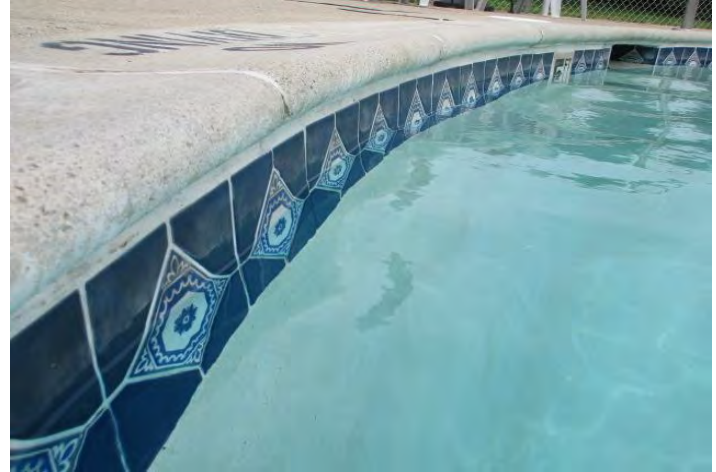
Typical surface condition

The pool's perimeter tile has an unknown age, and it is in good condition. Per the current condition, and request, we have included a replacement of the perimeter tile in 2025, in 7 years. This replacement is planned to coincide with the plaster resurfacing of the pool. With a pool replacement recommended in 2037, which will include new perimeter tile, there are no subsequent tile replacements included.

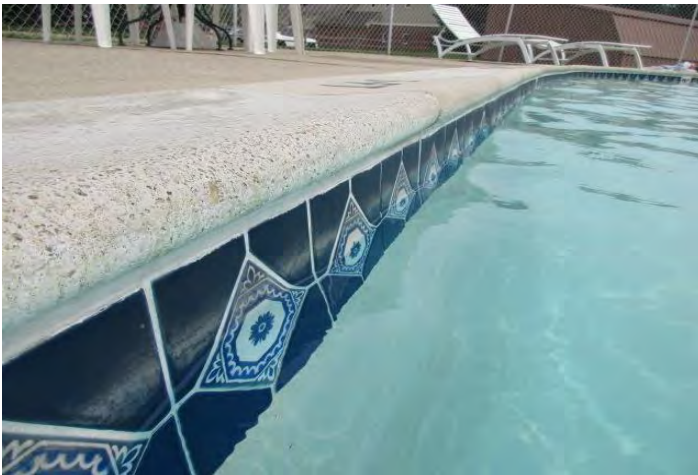
The perimeter tile is in good condition

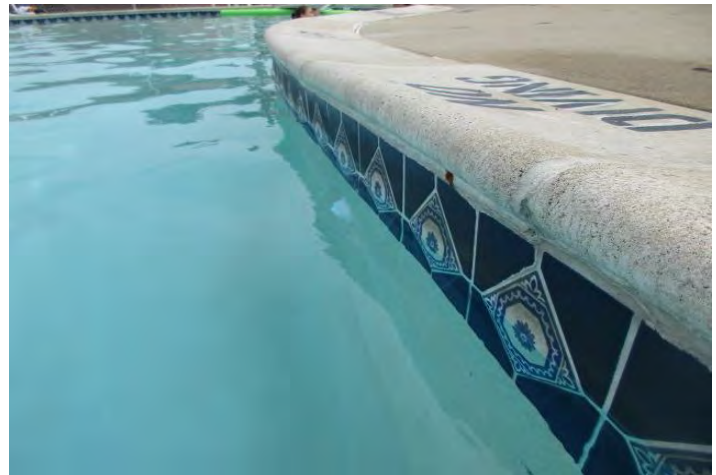
Typical surface condition

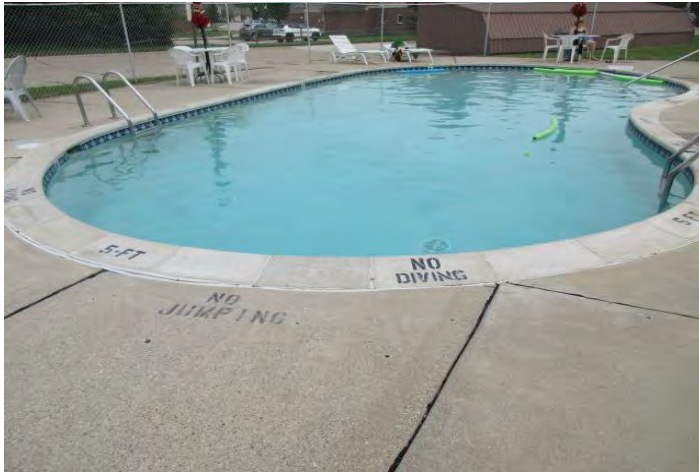
Overview of the community pool

The pool is 46 years of age, and it is in good condition. With an average useful life of 60 to 65 years, a replacement is recommended in 2037, at 60 years of age. Replacement coincides with the concrete pool deck and the pool's fence. Unit cost includes: concrete shell, quartz aggregate finishes, perimeter coping, perimeter waterline tile, mechanical equipment, subsurface piping, new plumbing, valves, drains, skimmers, and entry stairs.

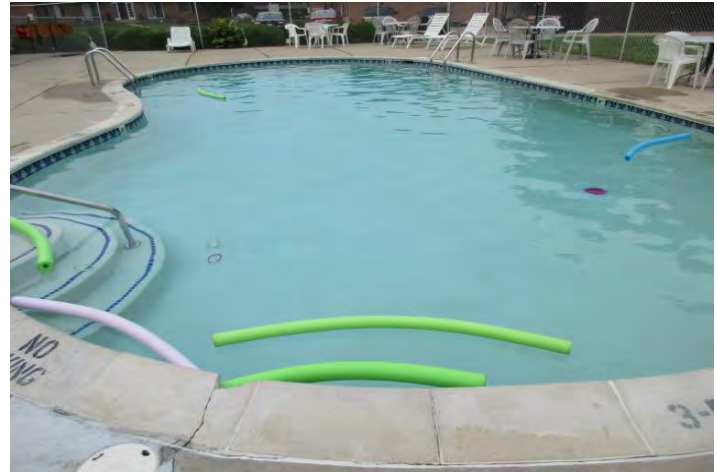
Typical condition

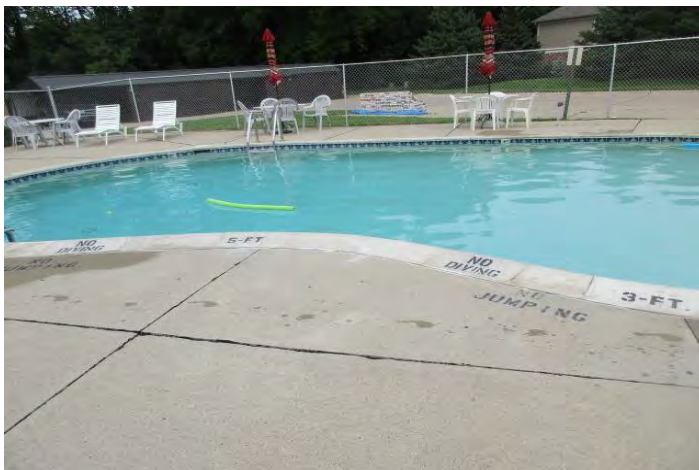
The pool has been maintained in good condition

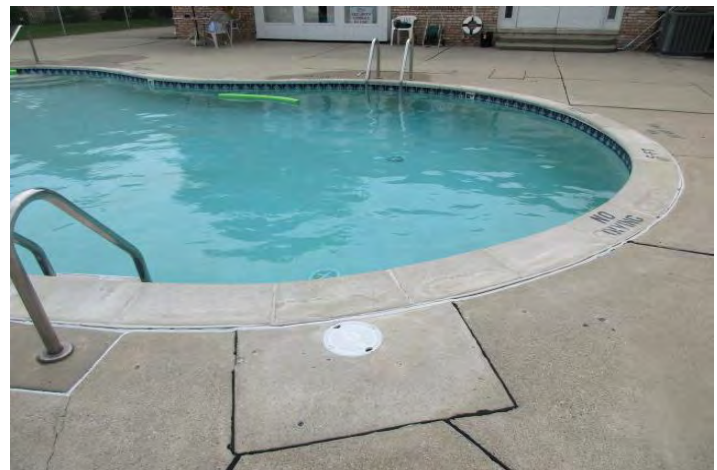
Typical condition
