## Batavia Home Inspection Services, LLC

## Property Inspection Report

Property address: **123 Main Street  
Anywhere, USA**

Inspection date: **Saturday, January 23, 2021**

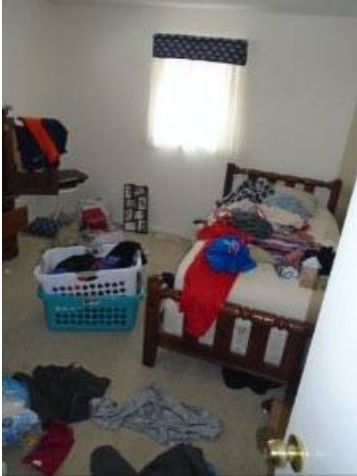
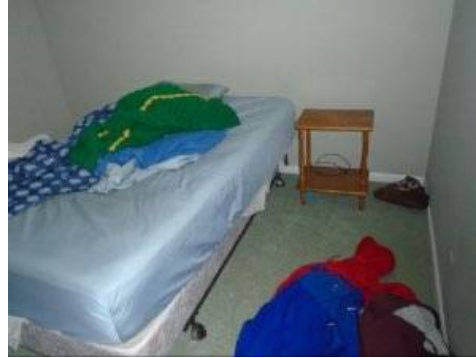
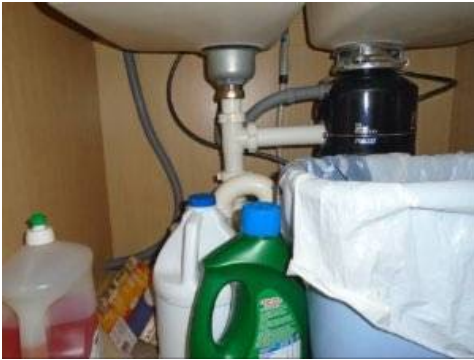
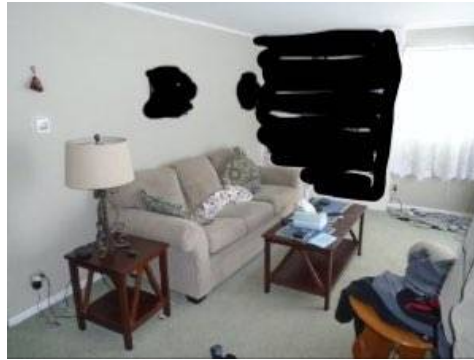
2) *Comment* - Many areas and items at this property were obscured by furniture and/or stored items. This often includes but is not limited to walls, floors, windows, inside and under cabinets, under sinks, on counter tops, in closets, behind window coverings, under rugs or carpets, and under or behind furniture. Areas around the exterior, under the structure, in the garage and in the attic may also be obscured by stored items. The inspector in general does not move personal belongings, furnishings, carpets or appliances. When furnishings, stored items or debris are present, all areas or items that are obscured, concealed or not readily accessible are excluded from the inspection. The client should be aware that when furnishings, stored items or debris are eventually moved, damage or problems that were not noted during the inspection may be found.

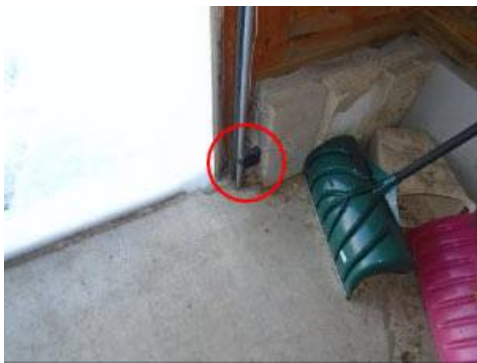
Photo 17-1 Garage door safety eye

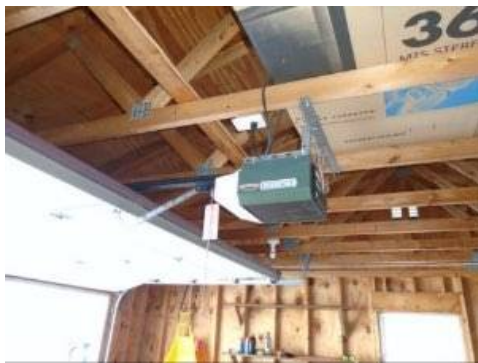
Photo 17-2 Garage door opener

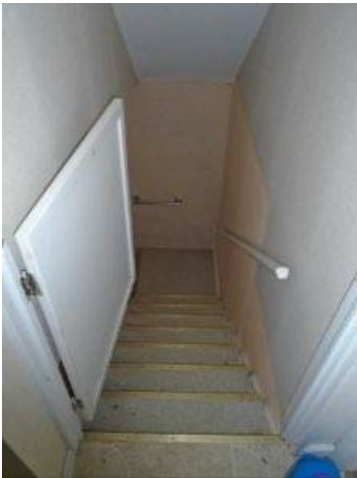
Photo 27-1

27) *Comment* - Basement Stairs

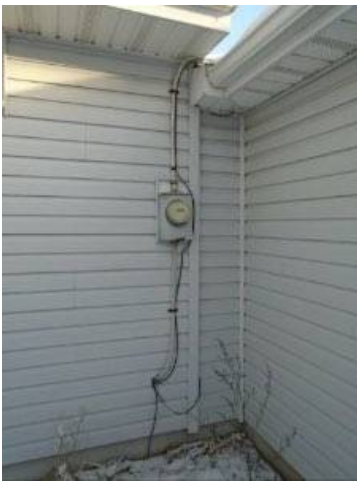
Photo 44-1

44) *Comment* - Electric Service

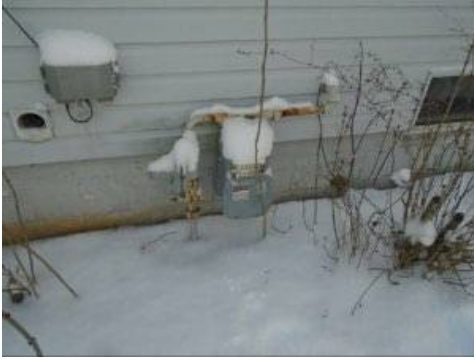
Photo 56-1

56) *Comment* - Gas Meter

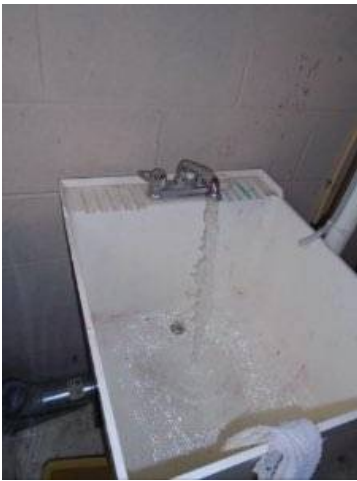
Photo 57-1

57) - Basement Utility Sink

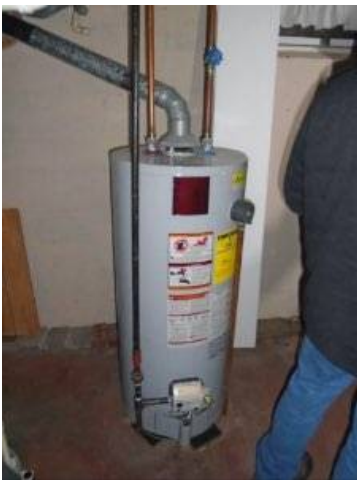
Photo 59-1

59) *Comment* - Water heater

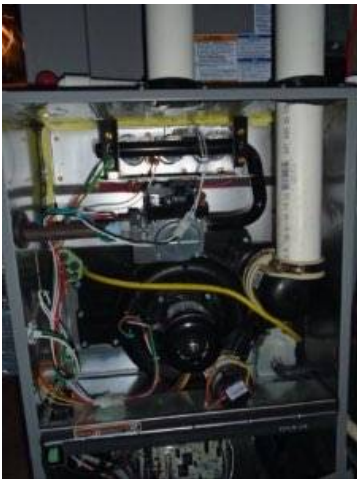
Photo 63-1

63) *Comment* - Furnace Interior

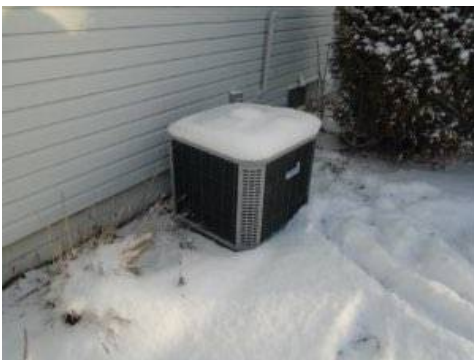
Photo 64-1

64) *Comment* - A/C Compressor/Condenser unit

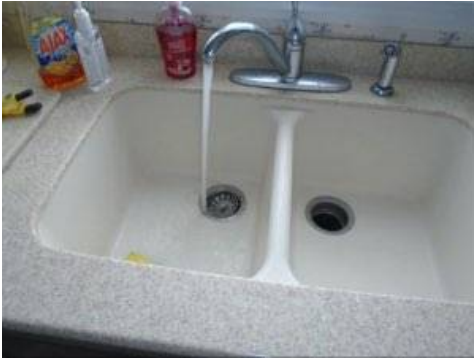
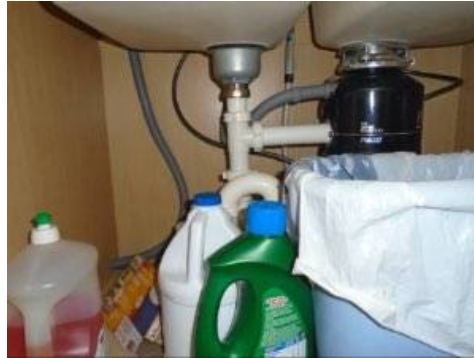
67) *Comment* - Kitchen Sink and under sink

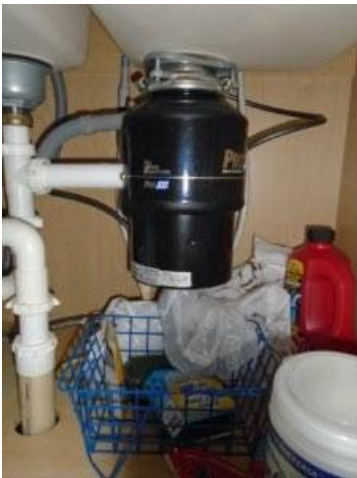
Photo 68-1

68) *Comment* - Garbage Disposal

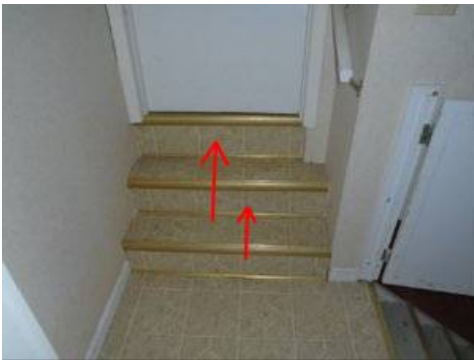
Photo 72-1

72) *Safety, Repair/Replace* - The risers for stairs at one or more locations varied in height and pose a fall or trip hazard. Risers within the same flight of stairs should vary by no more than 3/8 inch. At a minimum, be aware of this hazard, especially when guests who are not familiar with the stairs are present. Recommend that a qualified contractor repair per standard building practices.

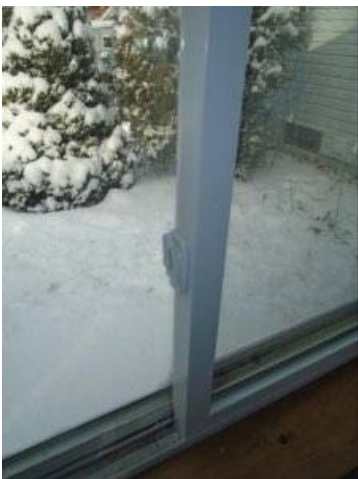
Photo 73-1

73) *Repair/Replace* - One or more windows that were designed to open and close were difficult to open and close. Recommend that a qualified person repair windows as necessary so they open and close easily.

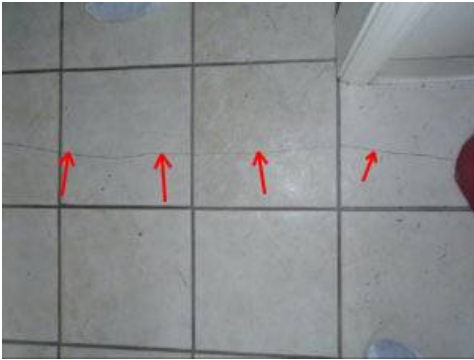
Photo 74-1

74) *Repair/Maintain* - Tile flooring in one or more areas was deteriorated (e.g. loose or cracked tiles, missing grout) or substandard. If in a wet area, water can damage the sub-floor. Recommend that a qualified contractor repair as necessary.

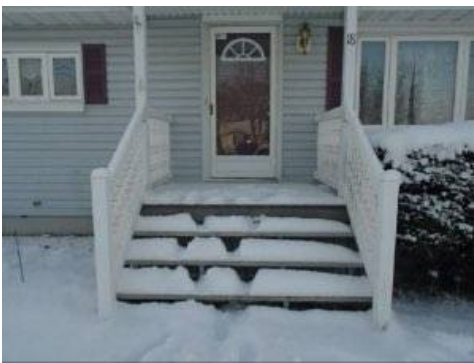
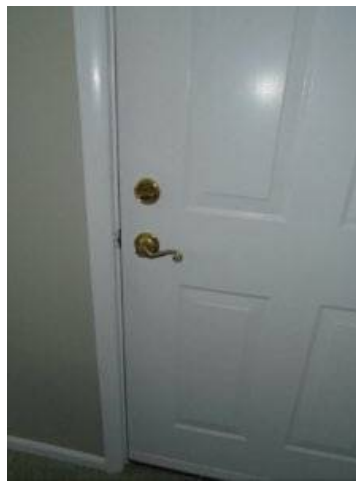
75) *Comment* - Front Door

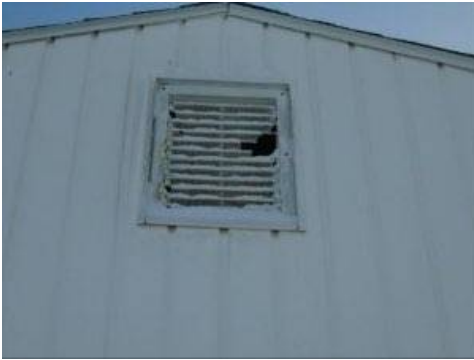
Photo 77-1

77) *Repair/Maintain* - One or more attic or roof vent screens were missing, deteriorated or substandard. Recommend that a qualified person replace or repair screens as necessary to prevent birds or vermin from entering the attic.

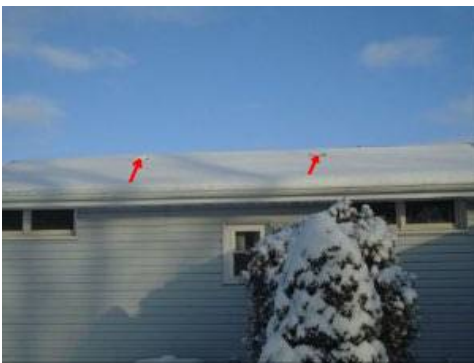
Photo 78-1

78) *Comment* - Roof Vents
