YOUR INSPECTION REPORT

Someplace
Northern, ON P3E Z1Z

Saturday, August 18, 2018

RE: Report No. 1061
Someplace
Northern, ON
P3E Z1Z

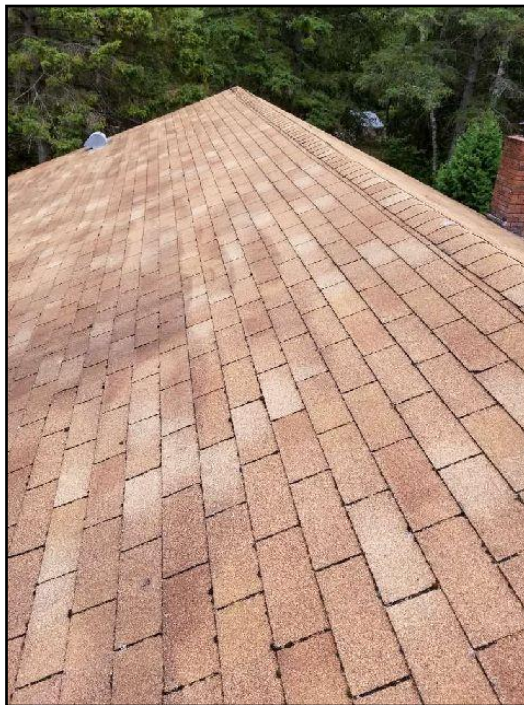
1. Asphalt shingles

Probability of leakage: • Low

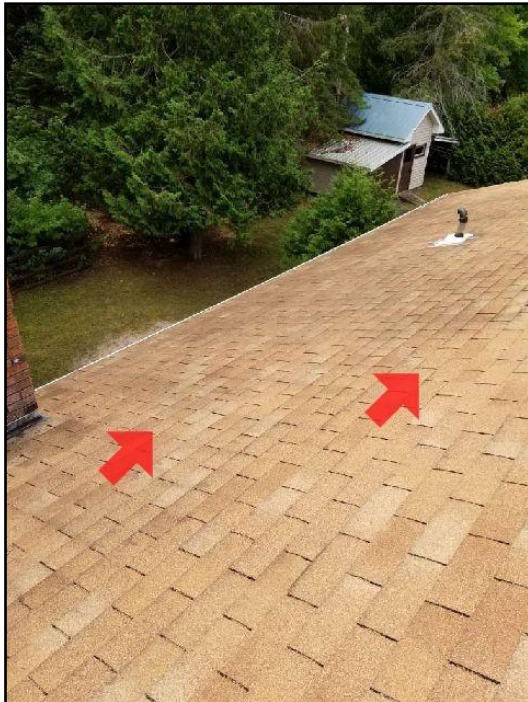
2. Condition: • [Damage](#)

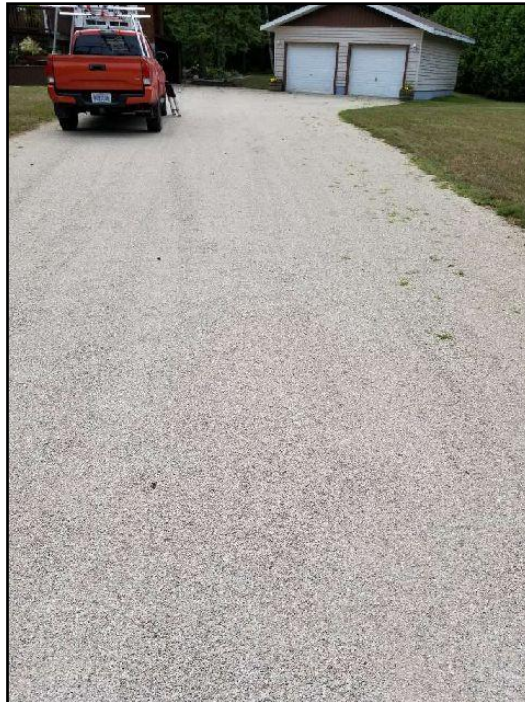
21. Gravel

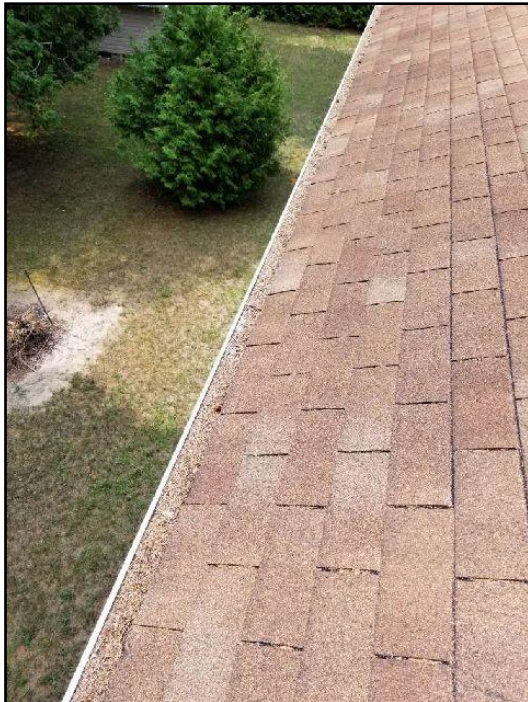
23. Clogged

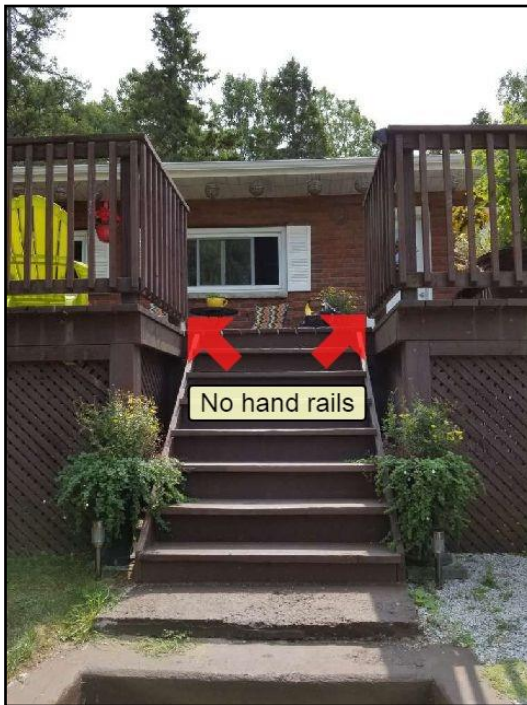
28. Poorly built

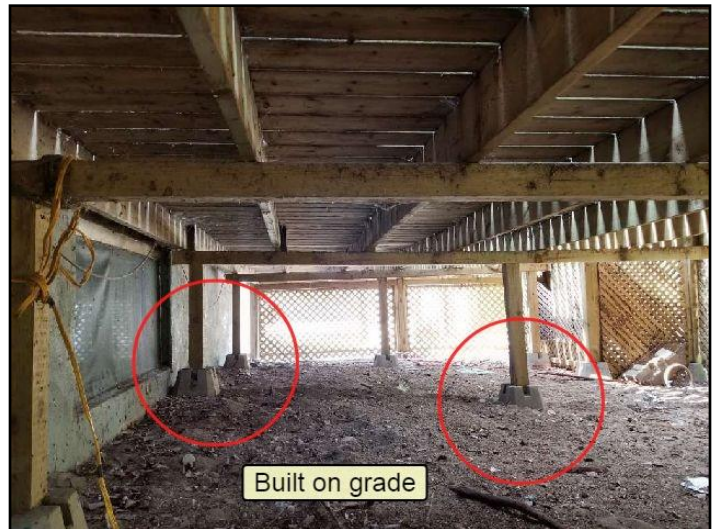
31. Poorly built

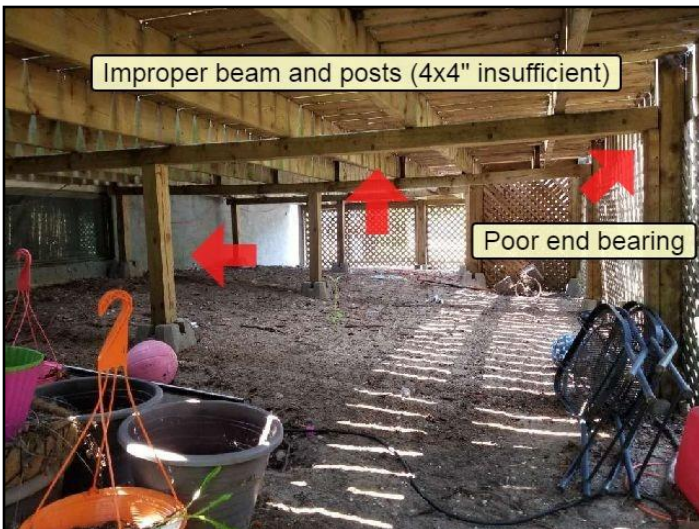
32. Poorly built

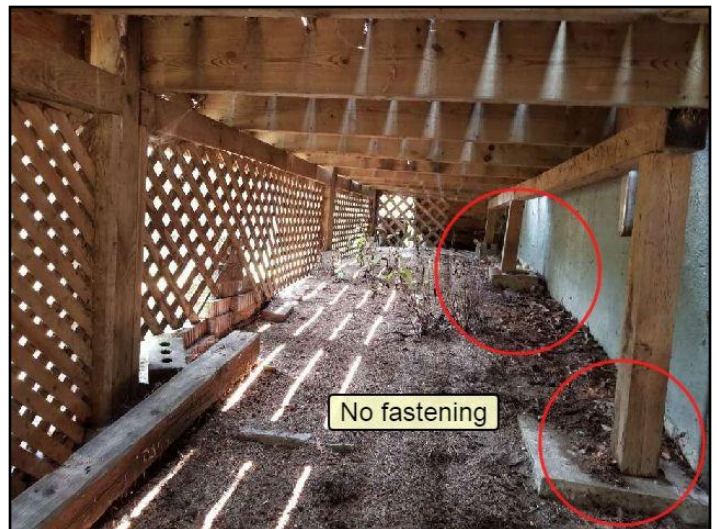
33. Poorly built

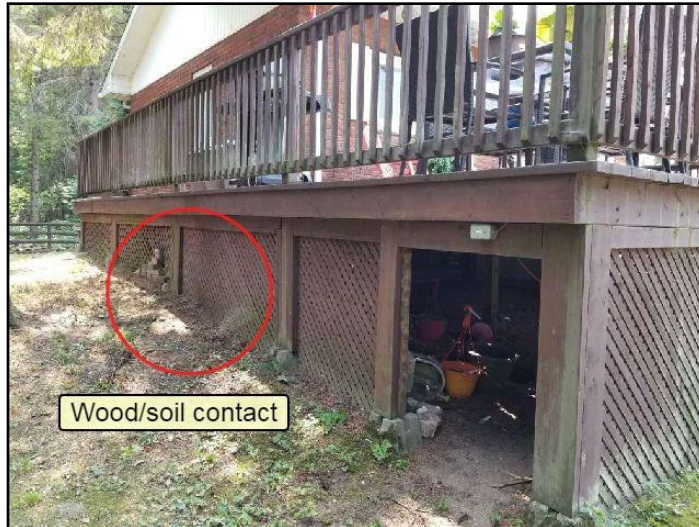
34. Poorly built

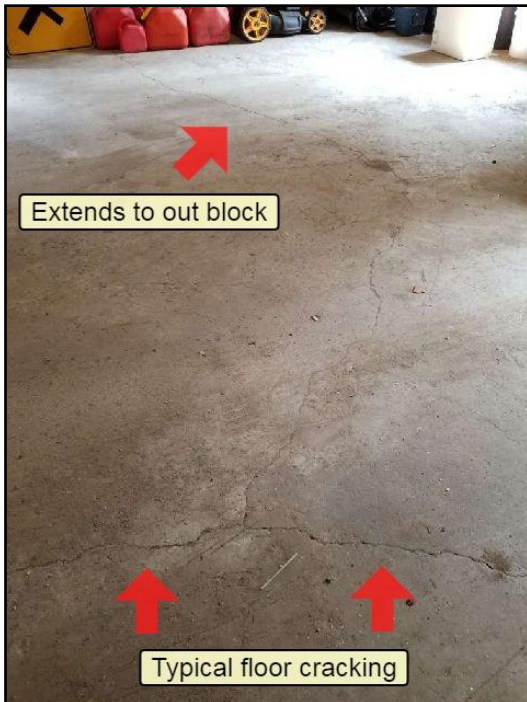
43. Disrepair

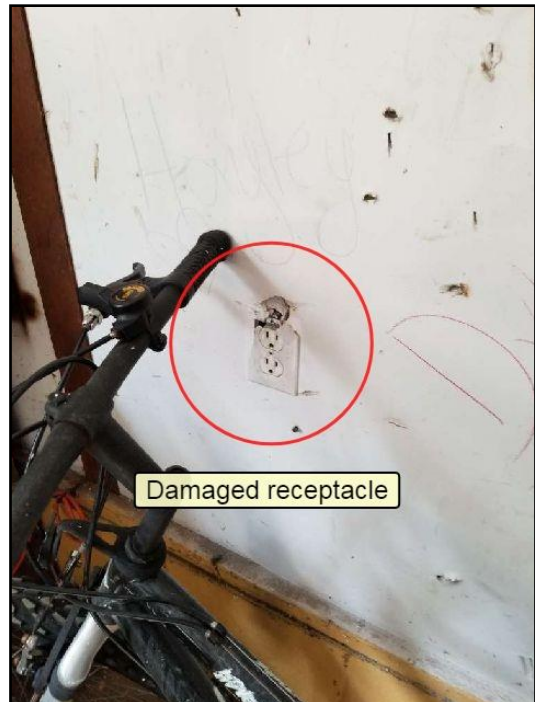
44. Disrepair

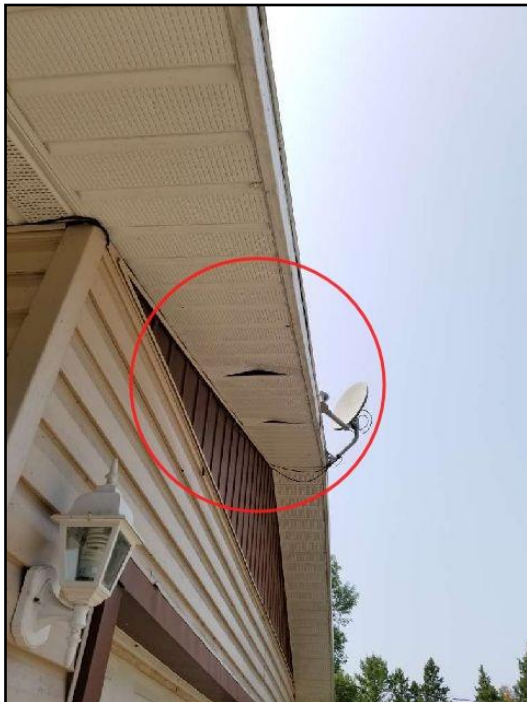
45. Disrepair

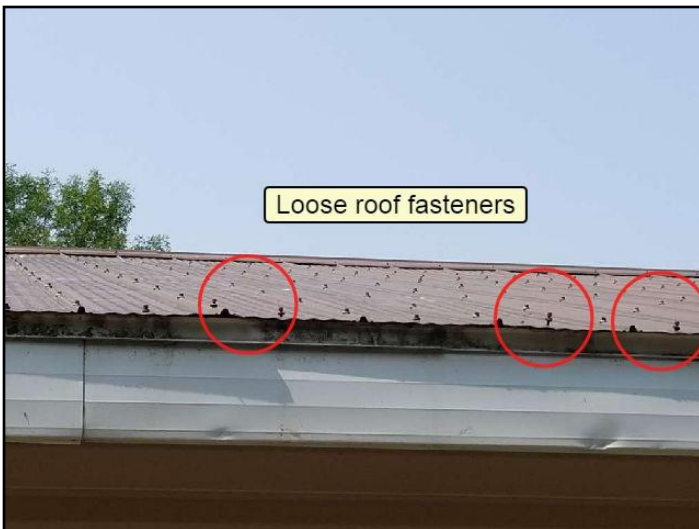
49. Disrepair

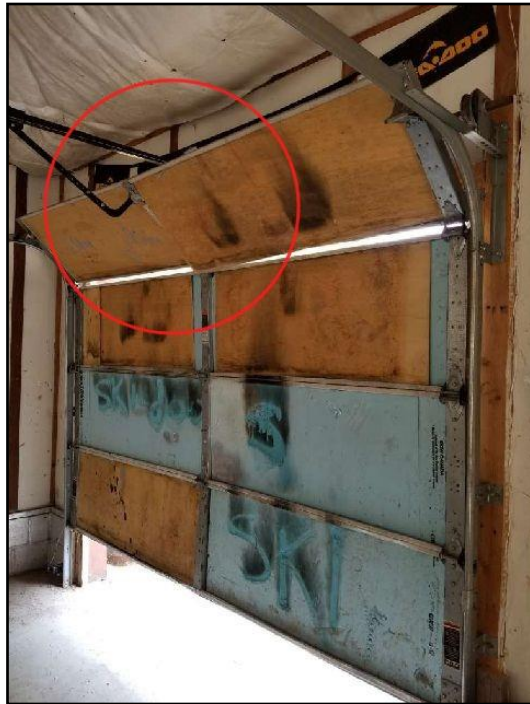
53. Disrepair

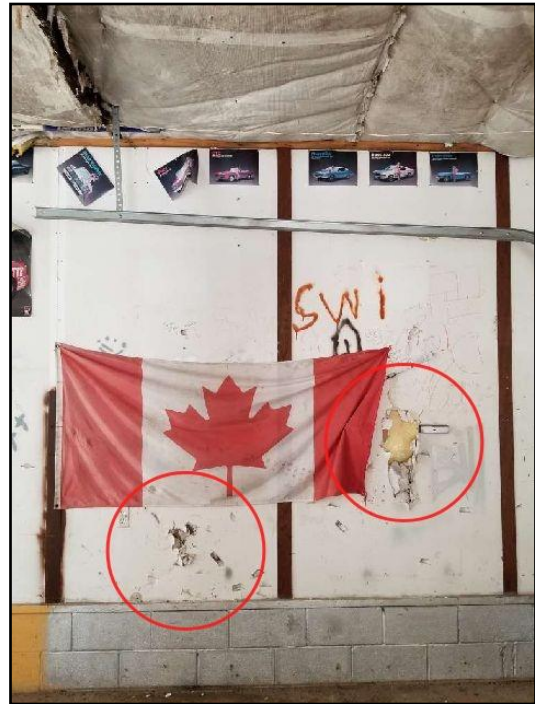
54. Disrepair

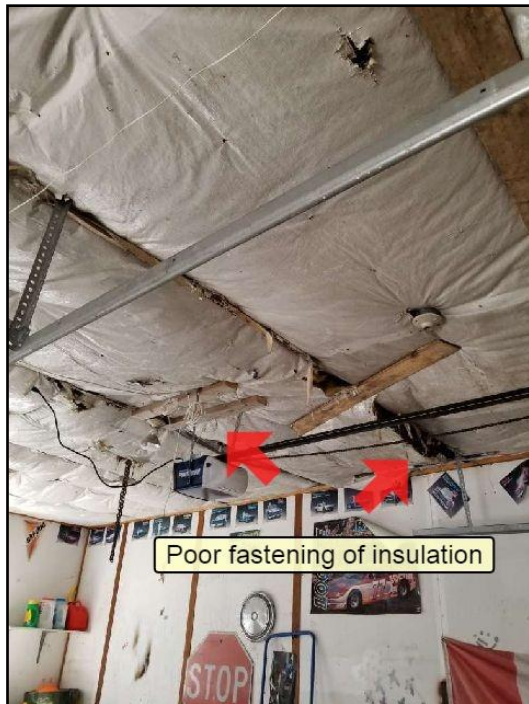
55. Disrepair

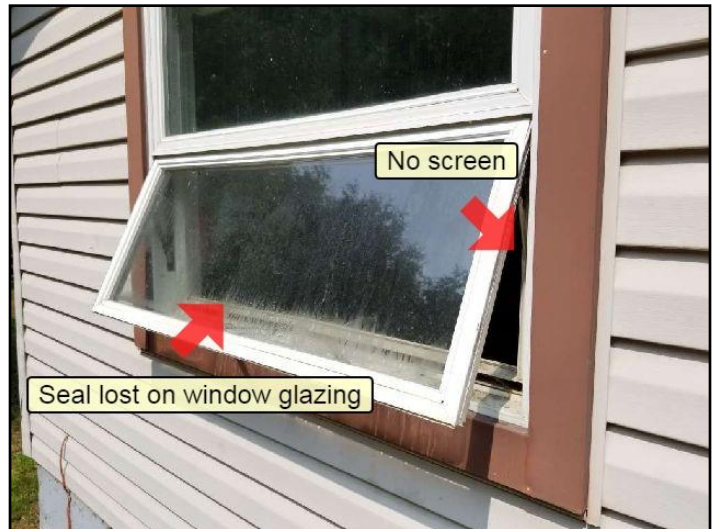
56. Disrepair

18. Condition: • Disrepair

Garage is generally in poor state of repair and shows lack of maintenance. Siding is damaged, interior insulation is in poor condition, right garage door upper panel is damaged and shows notable flex when actuated by opener, roof has a number of loose fasteners. See pictures for further details.

Implication(s): Chance of water damage to contents, finishes and/or structure | Reduced operability

Task: Repair

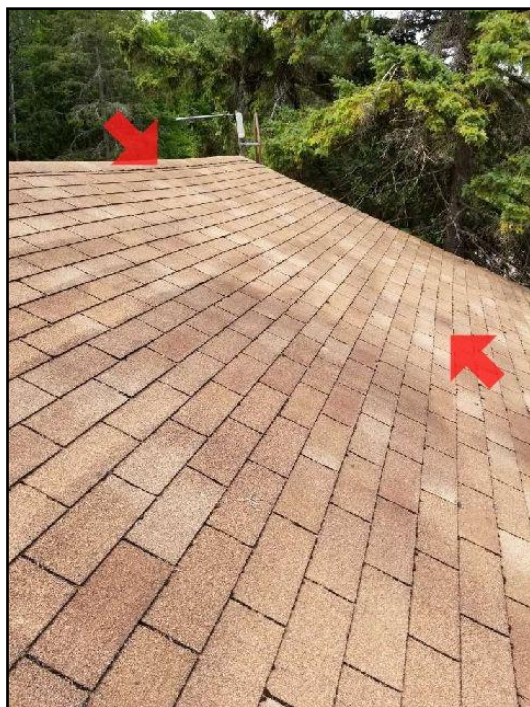
62. Sagging

21. Condition: • [Sagging](#)

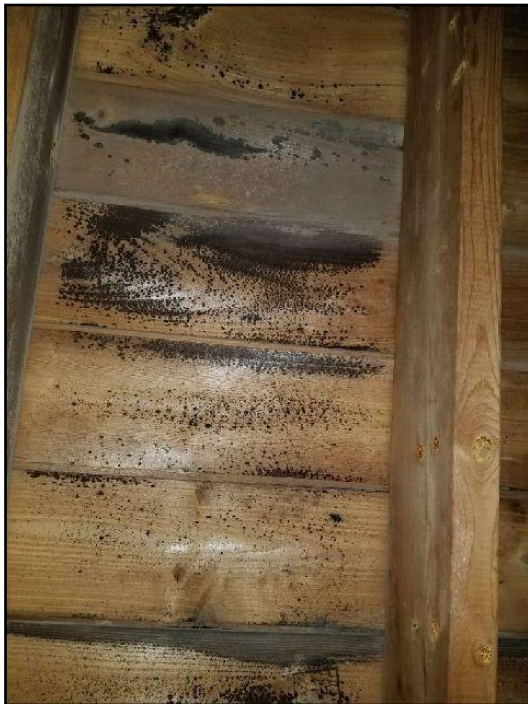
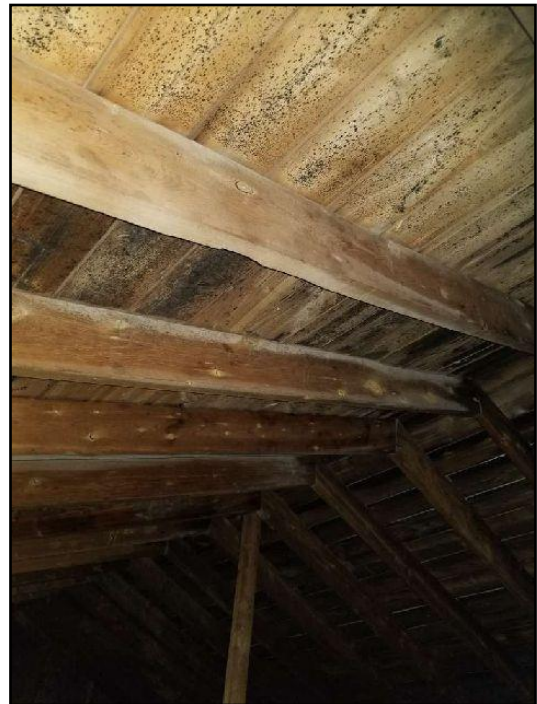
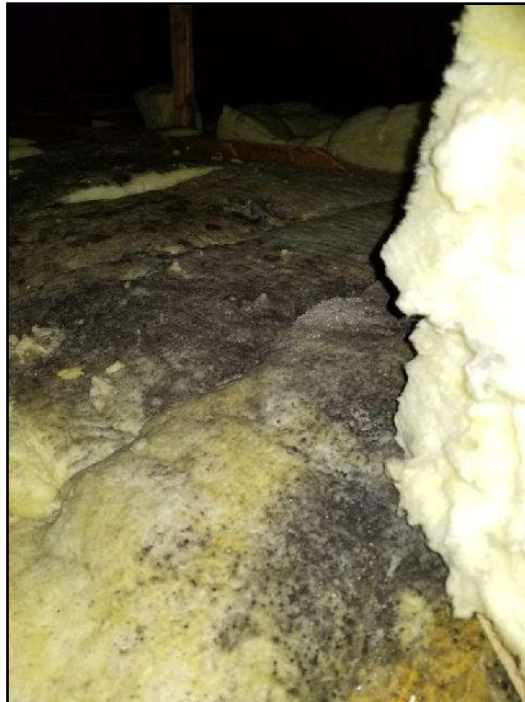
22. Condition: • [Mold](#)

Various signs of mold on underside of roof sheathing and some insulation. Consult a specialist for further evaluation and remediation. Likely cause is lack of ventilation in attic space resulting in excess condensation on roof structure. See related "venting" observation.

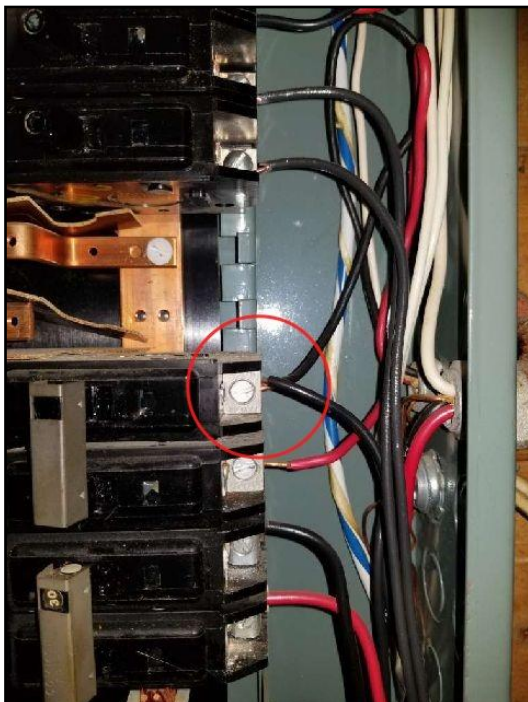
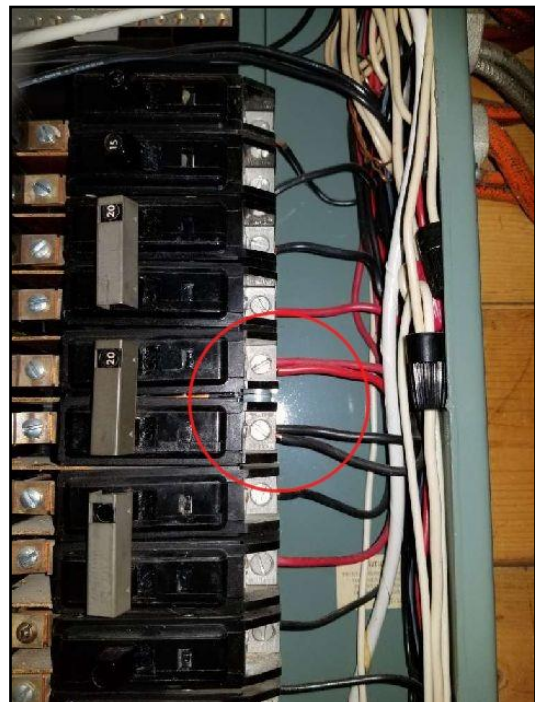
24. Condition: • [Double taps](#)

Implication(s): Fire hazard

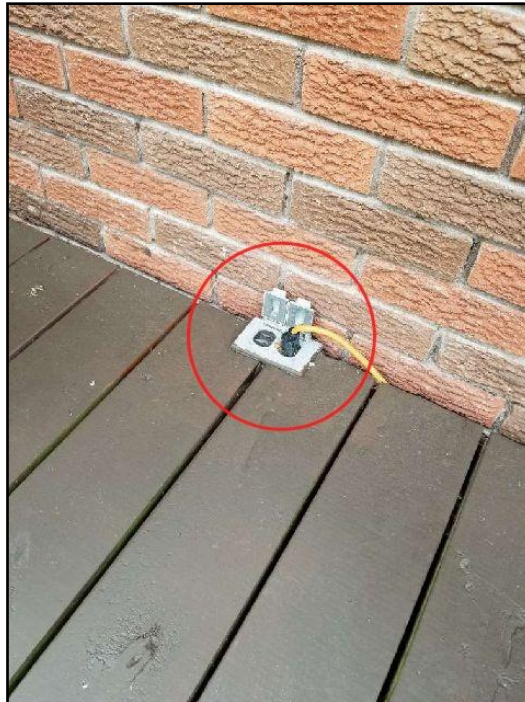
86. In floors or countertops

28. Condition: • [In floors or countertops](#)

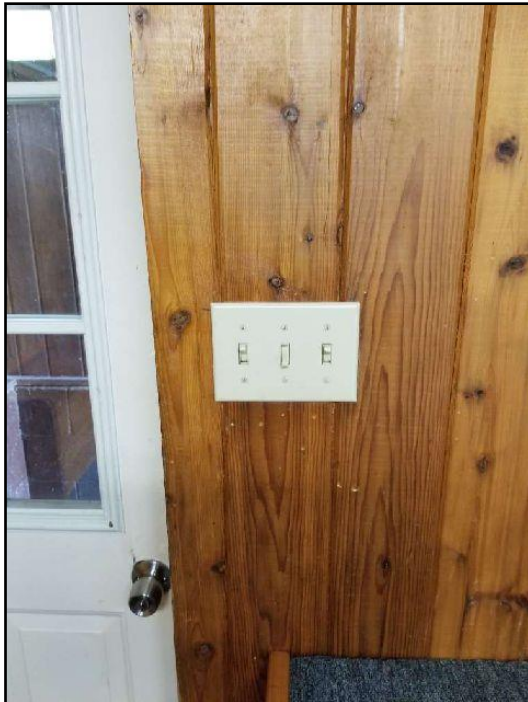
87. Inoperative

29. Condition: • [Inoperative](#)

Implication(s): Inadequate lighting

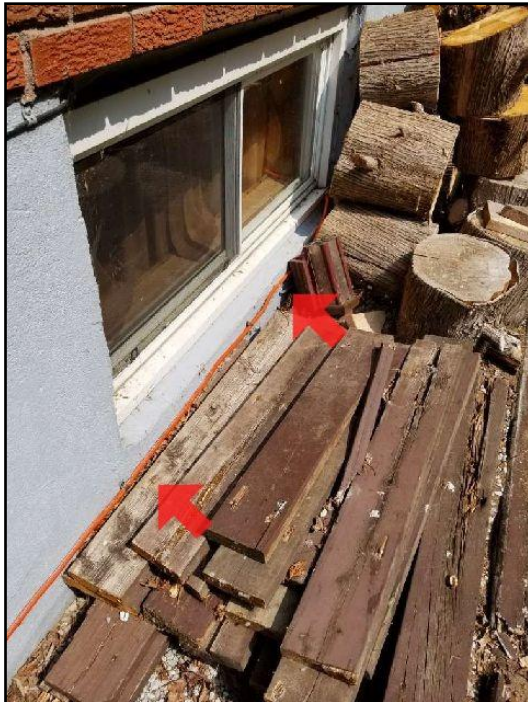
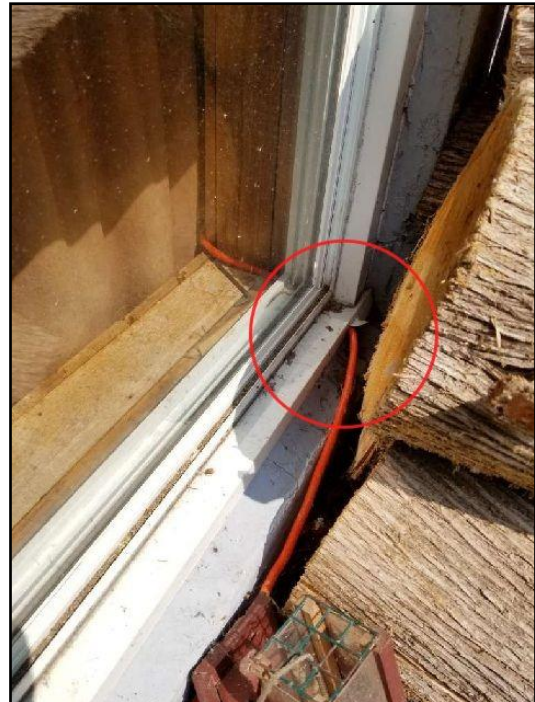
30. Condition: • Oil feed line exposed to possible damage.

Implication(s): Equipment damage, fuel leak.

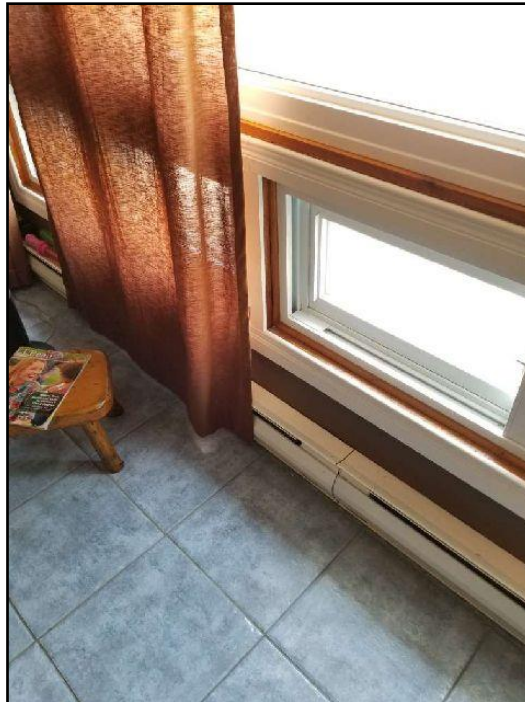
101. *Obstructed heaters*

31. Condition: • [Obstructed heaters](#)

Implication(s): Fire hazard | Reduced comfort

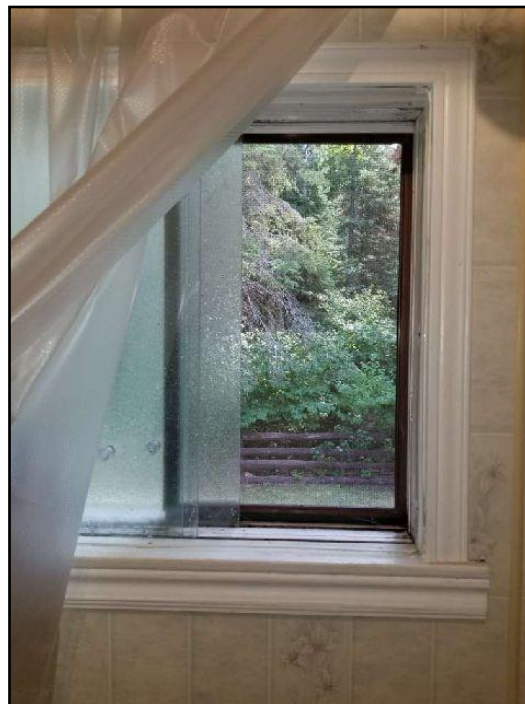
117. Unprotected window

38. Condition: • [Unprotected window](#)

Implication(s): Chance of damage to finishes and structure

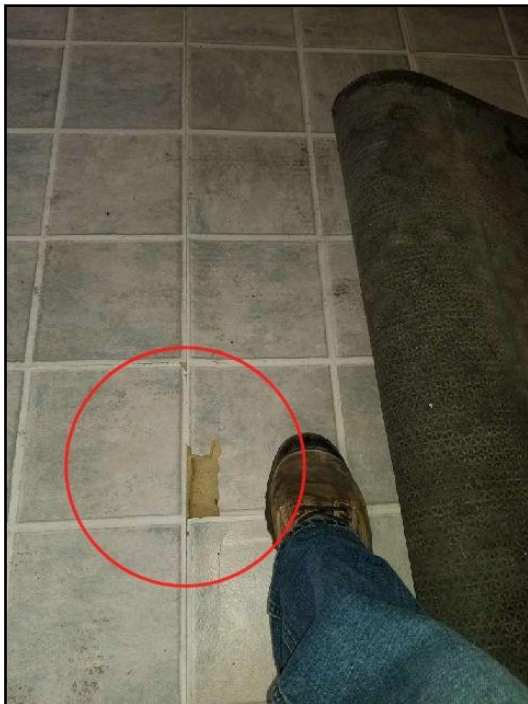
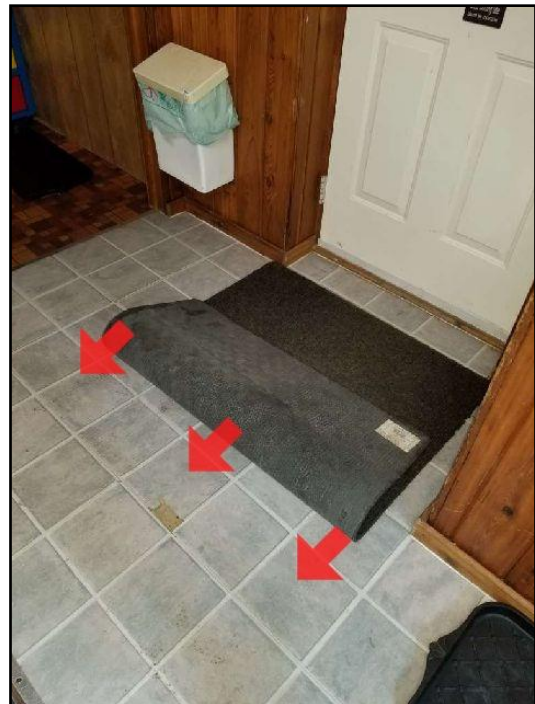
45. Condition: • [Swollen waferboard](#)

125. Swollen waferboard

126. Swollen waferboard

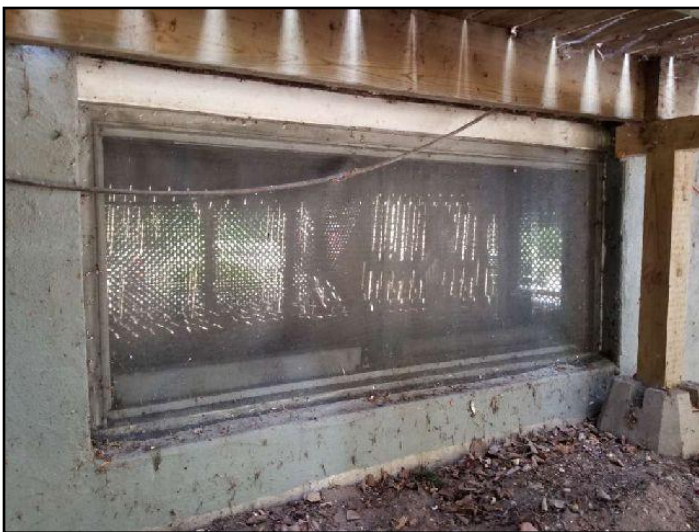
127. Original lower quality units

46. Condition: • [Original lower quality units](#)

Task: Replace
