PROPERTY INSPECTION  
**REPORT**

**12345 123rd St E, Puyallup, WA 98374**

DATE OF INSPECTION: 10/9/2026

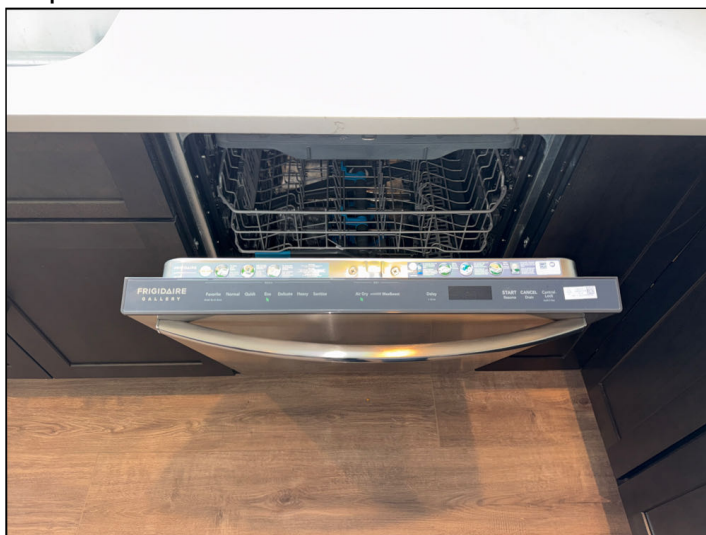
The dishwasher was not tested at the time of the inspection as it did not have power turned on.

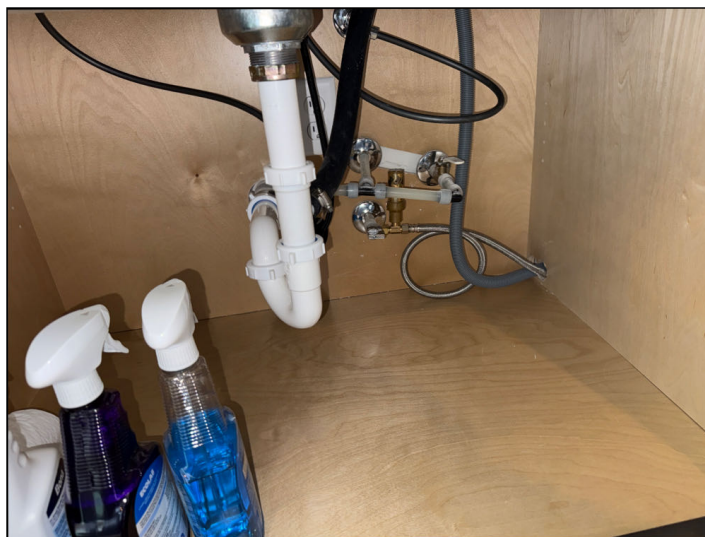
No leaks noted at the time of the inspection.

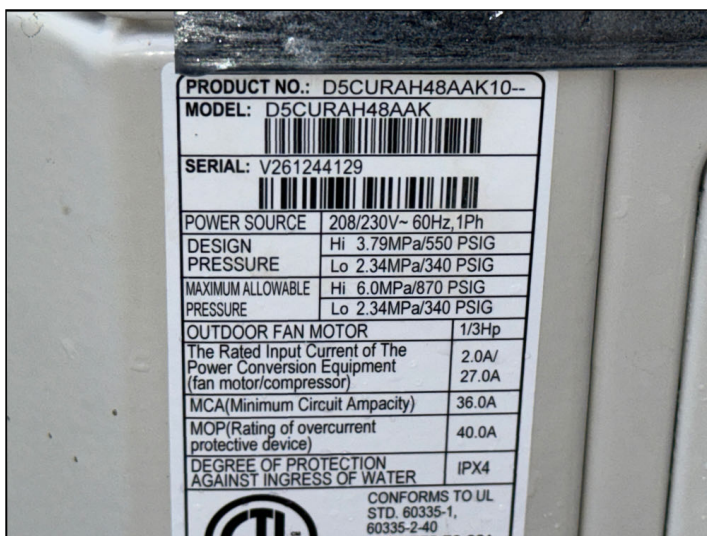
Appeared functional at the time of inspection.

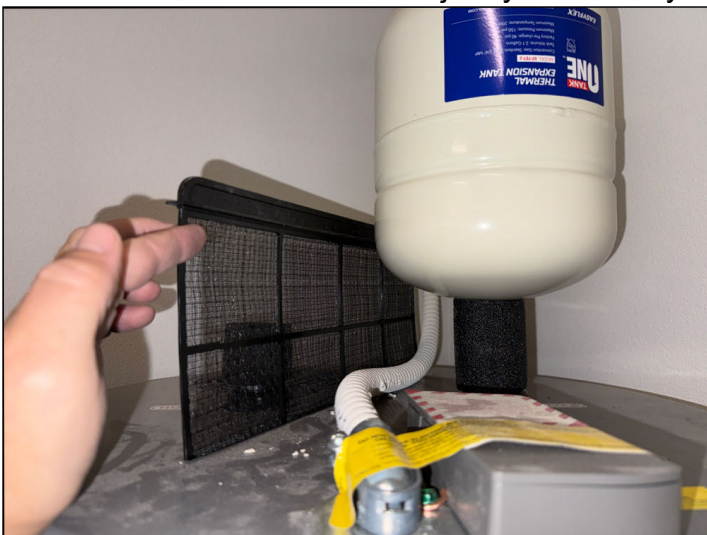
The filter noted at the top of the water heater is clean and should be checked annually or as needed.

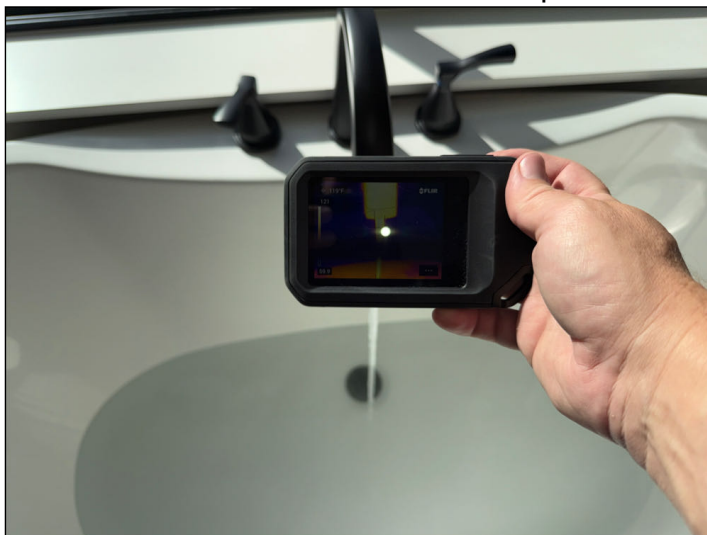
Hot water is tested to be inside normal safety range.

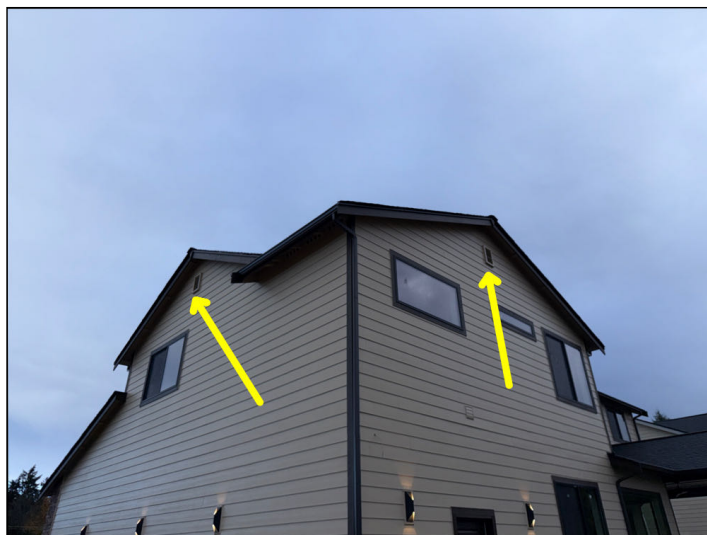
The gable vents appear to be decorative only and were not counted toward attic ventilation. This is appropriate for the apparent soffit-and-ridge ventilation system, as open gable vents can disrupt the intended airflow from the soffits to the ridge.

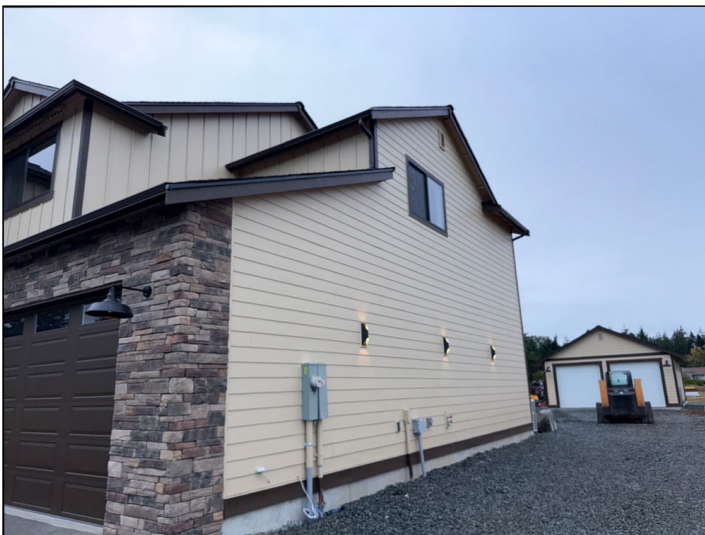
No major system safety or function concerns noted at time of inspection.

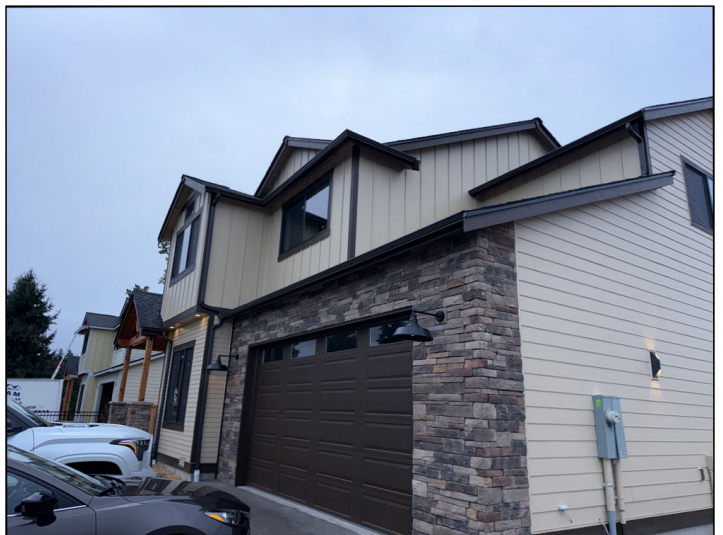
No major system safety or function concerns noted at time of inspection.

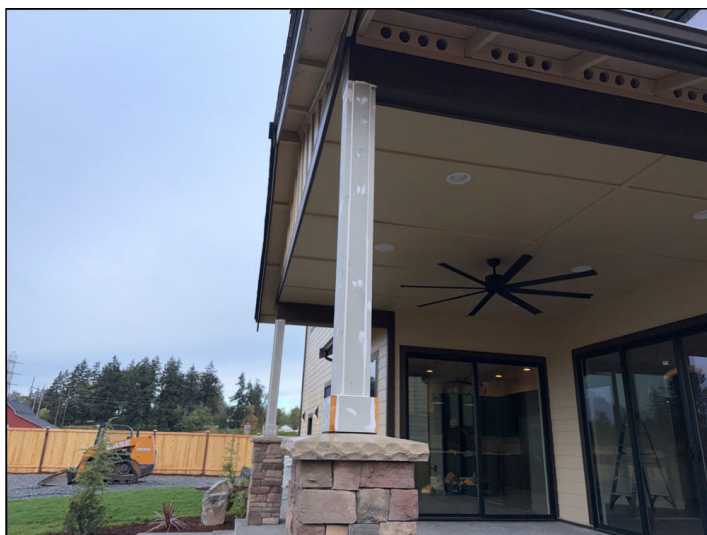
The back patio columns have not been painted.

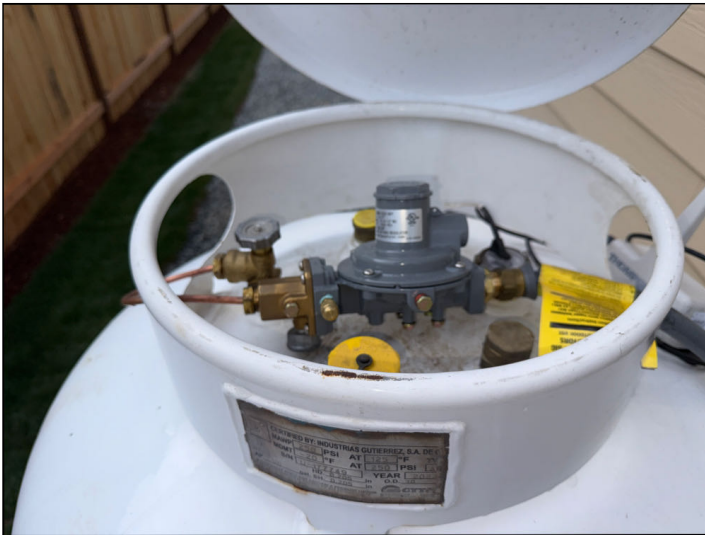
The propane tank was located on the east side of the home.

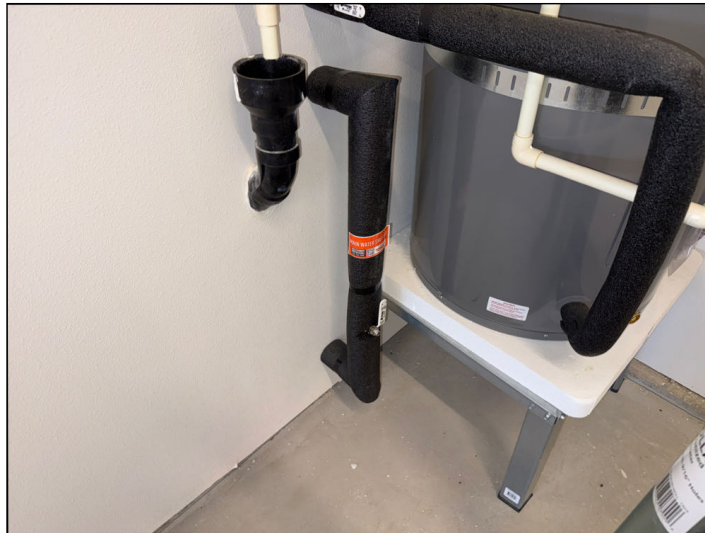
Main water shutoff was located in the garage on the east wall next to the water heater.

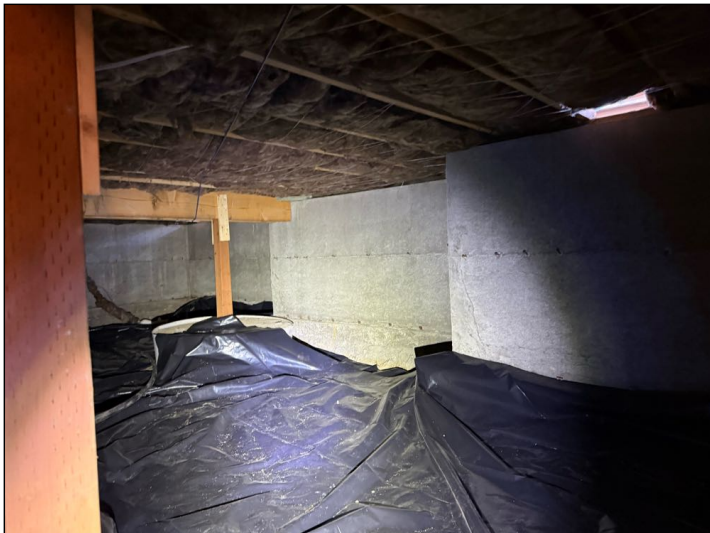
No deficiencies were observed at the visible portions of the structural components of the home.

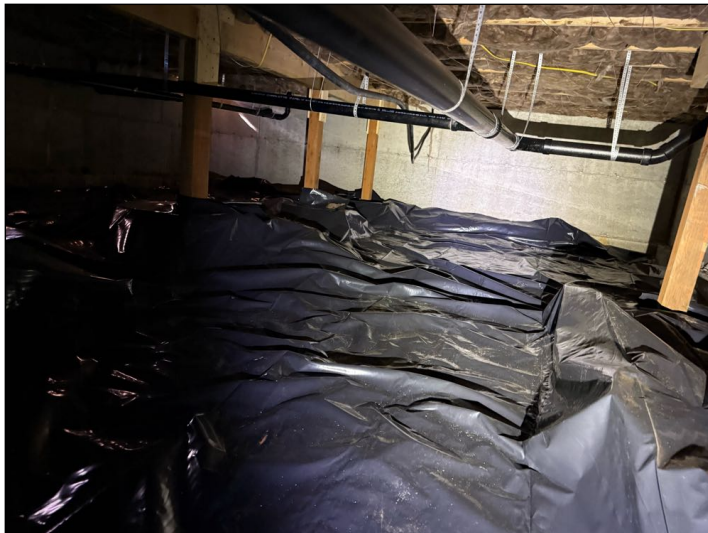
No deficiencies were observed at the visible portions of the structural components of the home.

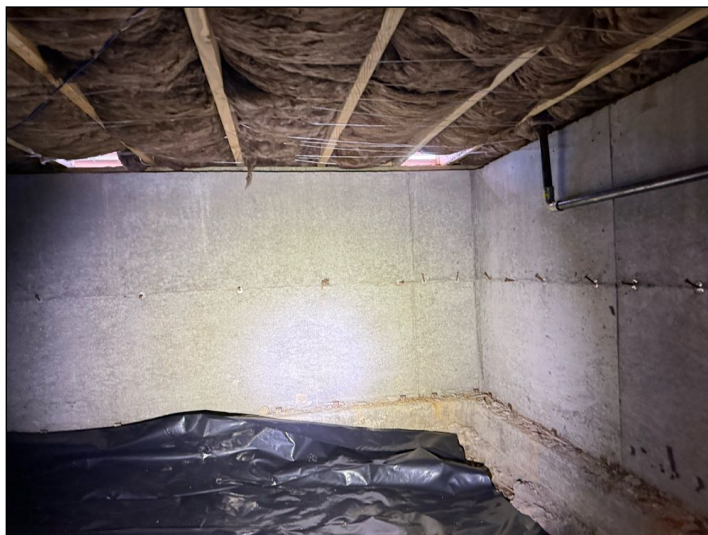
No deficiencies were observed at the visible portions of the structural components of the home.

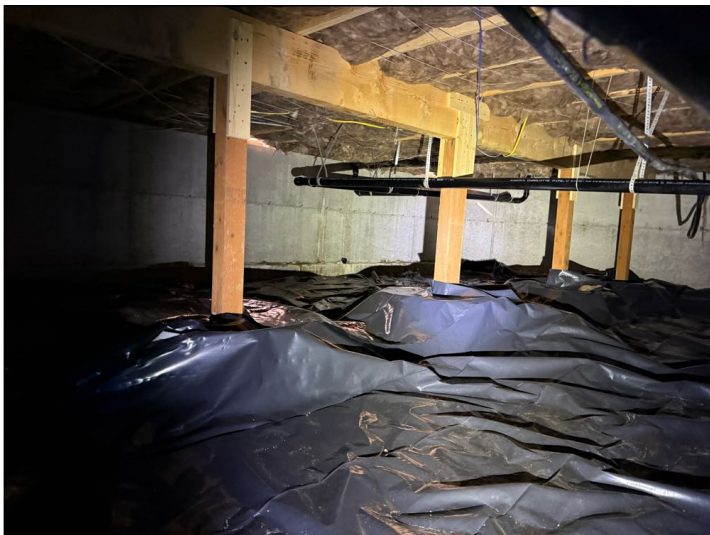
Vapor barrier present and appears to be properly installed.

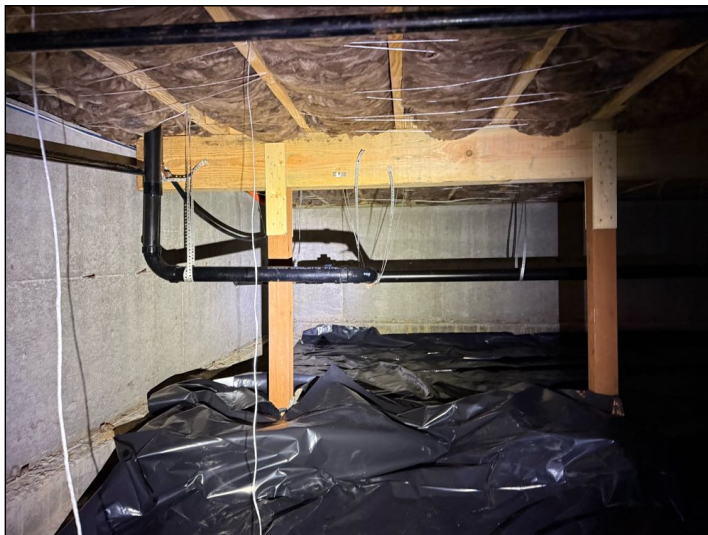
Vapor barrier present and appears to be properly installed.

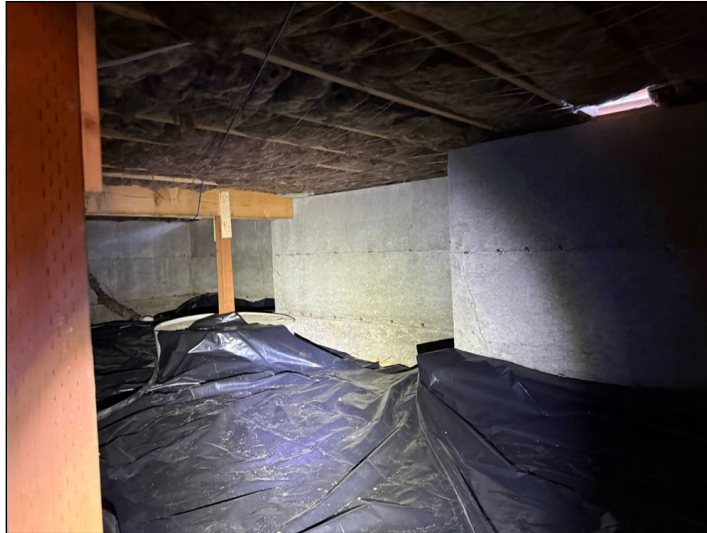
Vapor barrier present and appears to be properly installed.

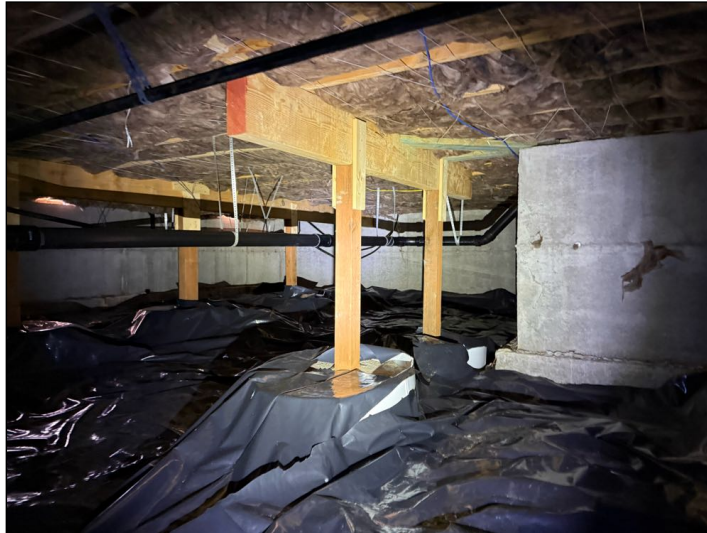
The crawlspace batt insulation was noted to be in place and in good condition.
