PERRY INSPECTIONS

PERRY INSPECTION REPORT

869 Estates Dr
Los Alamos, NM 87544

APRIL 3, 2024

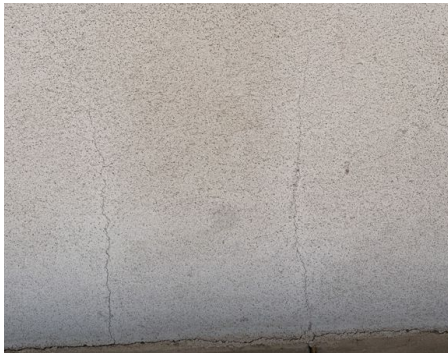
Coverings & Conditions: Typical Cracks (Monitor)

Hairline cracks were noted and are considered normal. If any crack opening become 1/8 inch or larger, it is recommended to have the crack repaired.

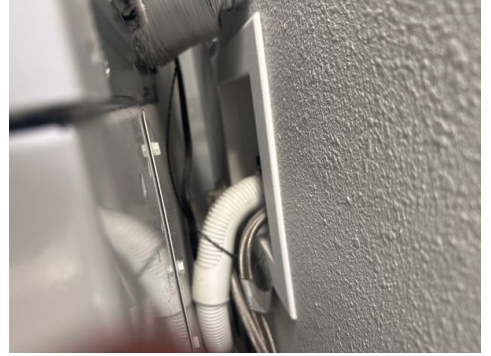
NOT VISIBLE

The connections to the clothes washing machine were not accessible. The connections could not be inspected.

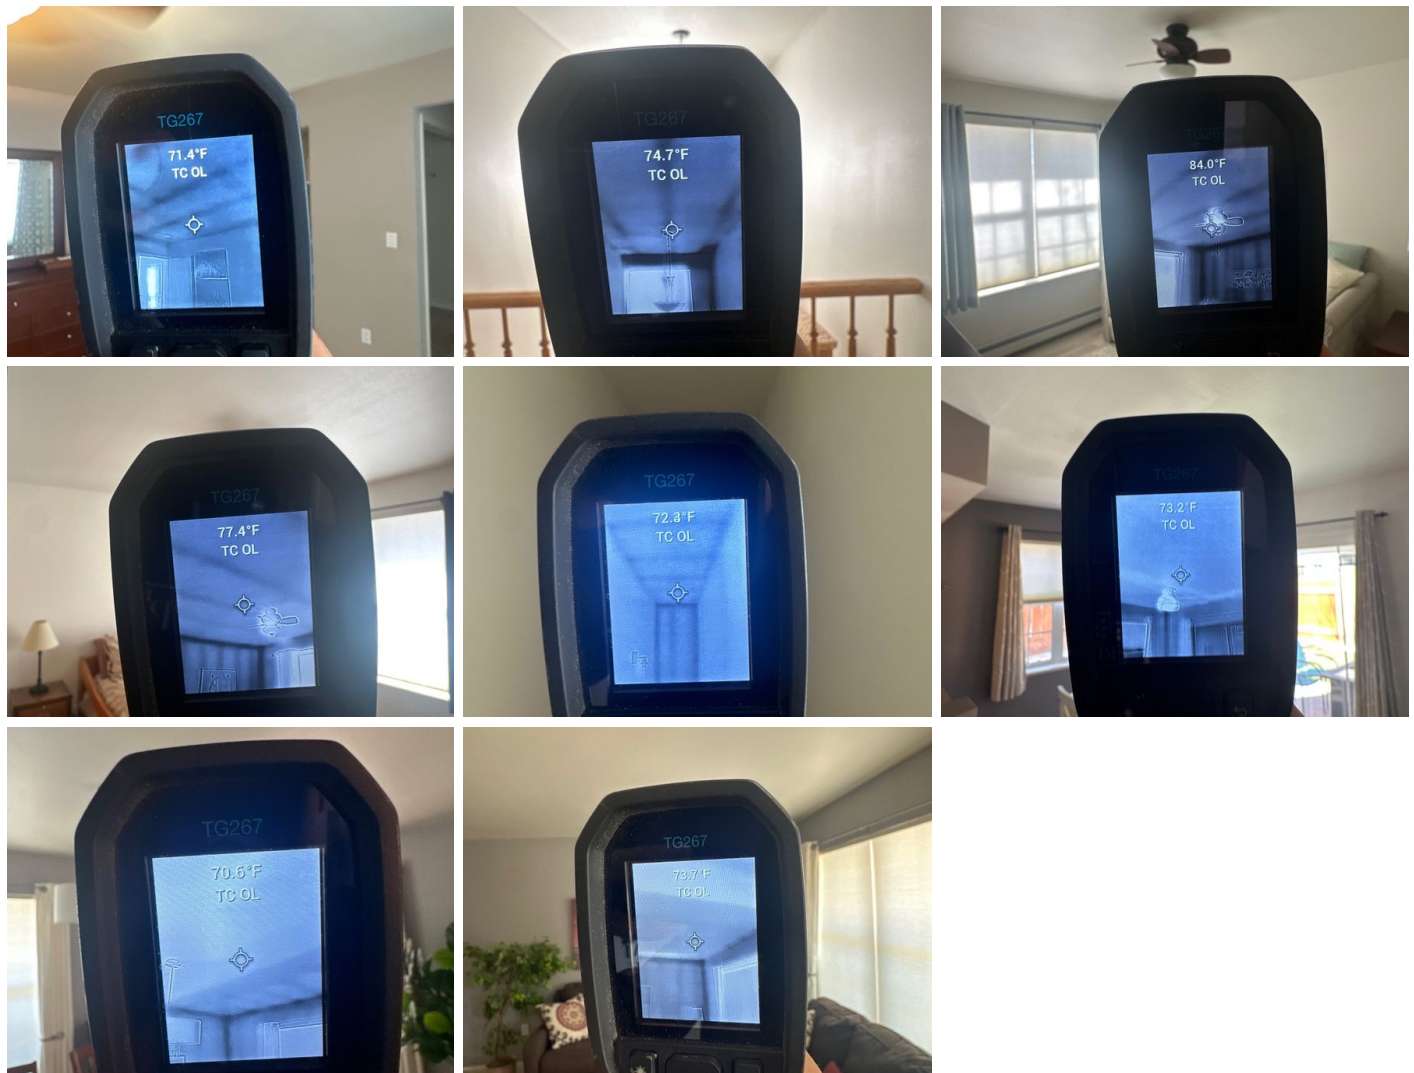
Thermography Scan: Infrared/Good

An Infrared Scan was performed at the time of the inspection. No conditions requiring repair were observed.

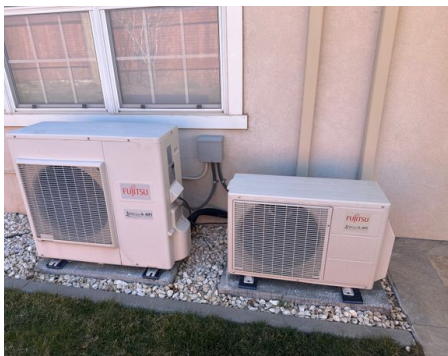
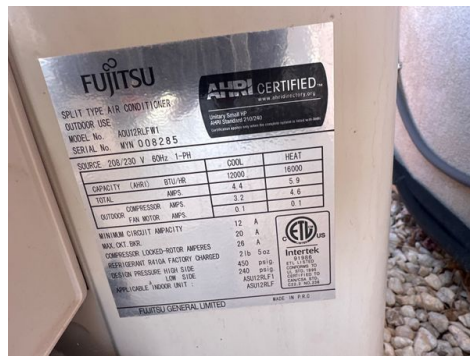
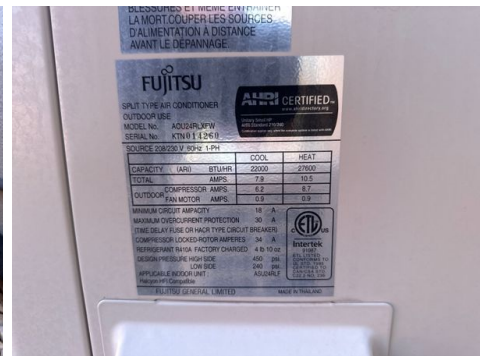
Heat Pump with Air Conditioning - Primary Type: Heat Pump/Air Conditioner (Location and Type)
 Ground, Multiple Compressors

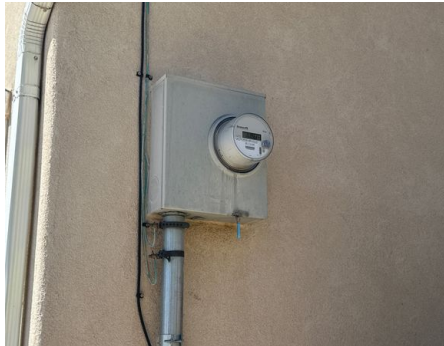
Electric Service - Location:
Electrical Service Location
Underground

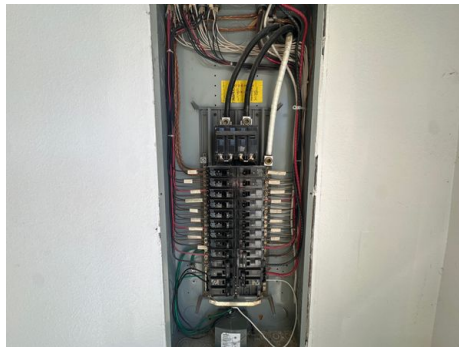
Main Panel Location: Main Panel Location
Garage

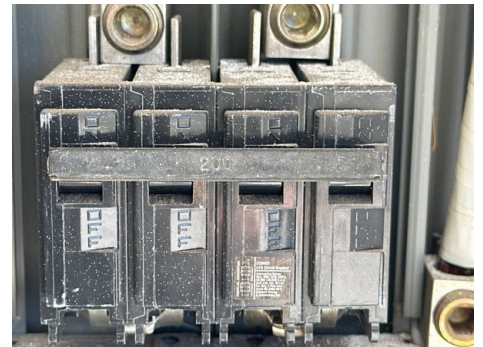
Main Panel Power: 200 amps
200 amps/ 240 Volt

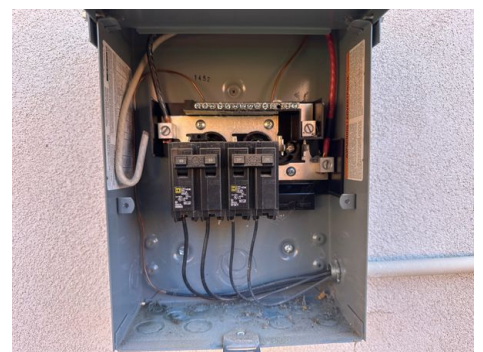
Electrical Subpanels - Location: Electrical Sub-Panel Locations
Exterior

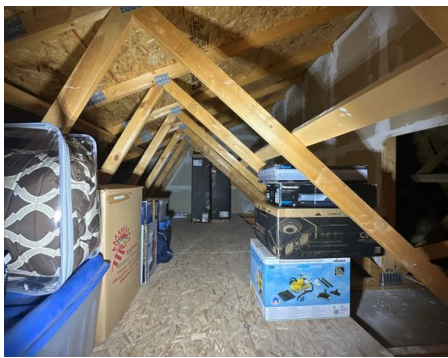
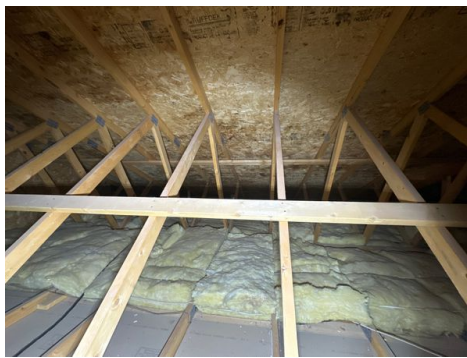
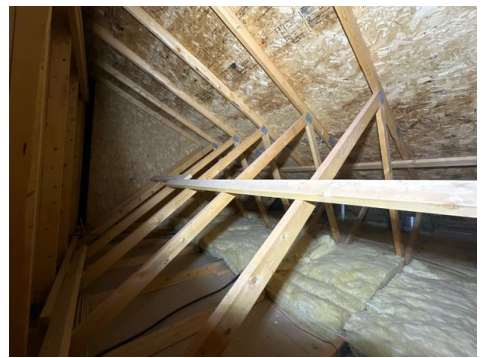
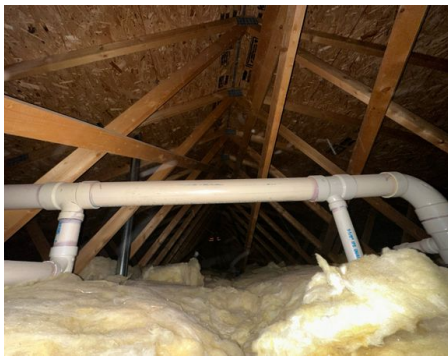
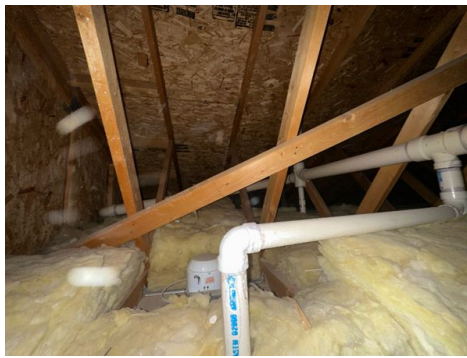
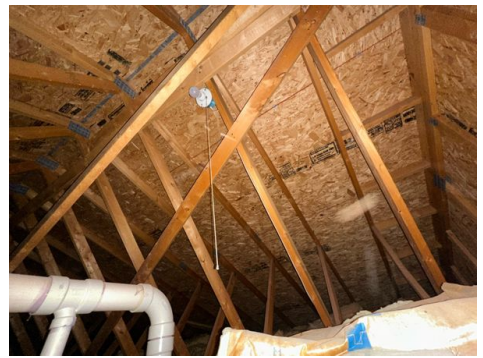
Attic & Insulation - Access: Attic Space - Access

Bedroom Closet, Garage Ceiling
