STANDARD PROPERTY & TIMBER PEST REPORT

Report number: **1637784963172**
Inspection date: **25-11-2021**
Client: **Sample**
Property address: **Sample Street, Gold coast**

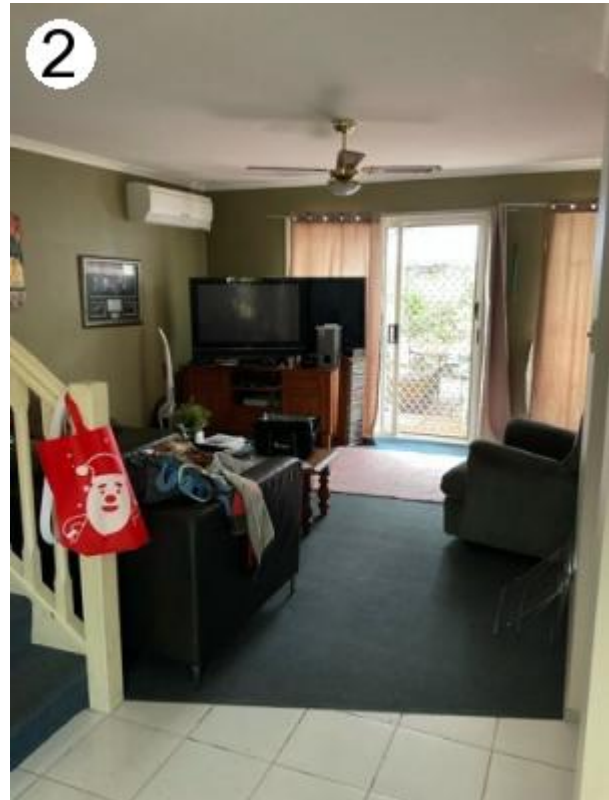
#2. Showing example of the furniture

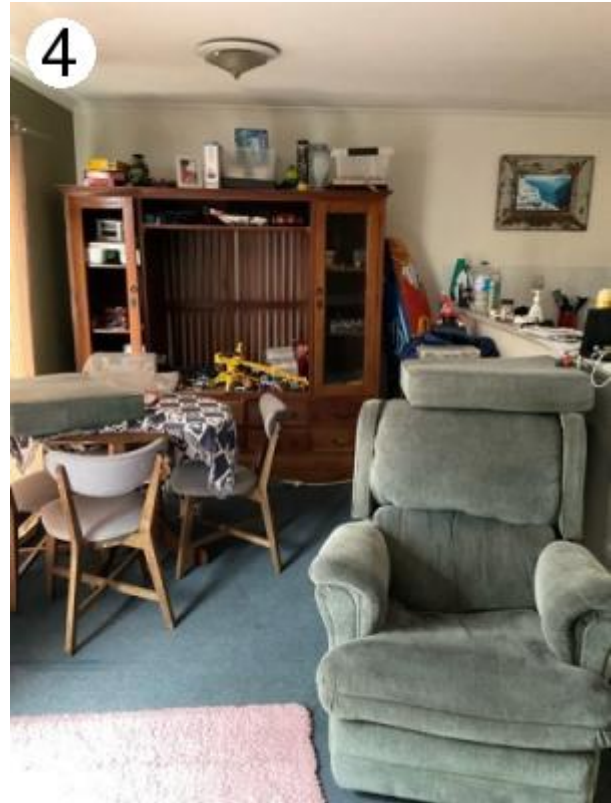
#4. Showing example of the furniture

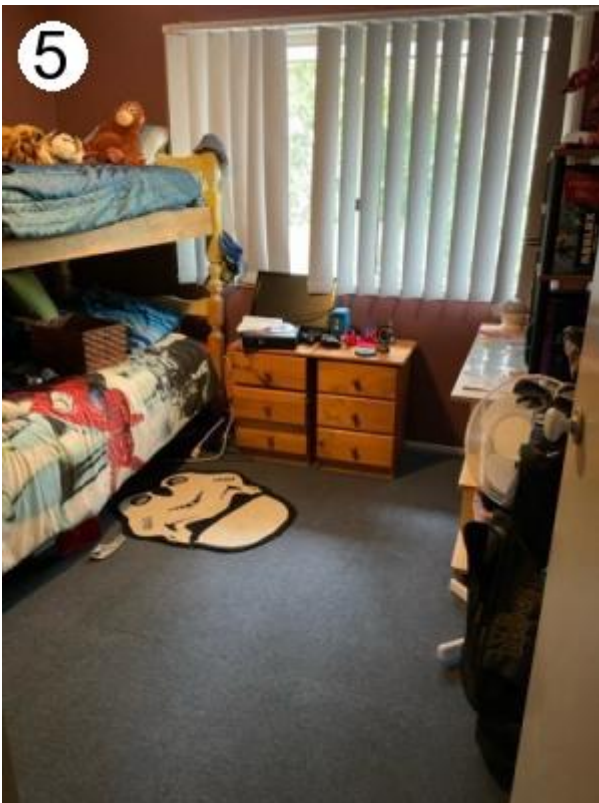
#5. Showing example of the furniture

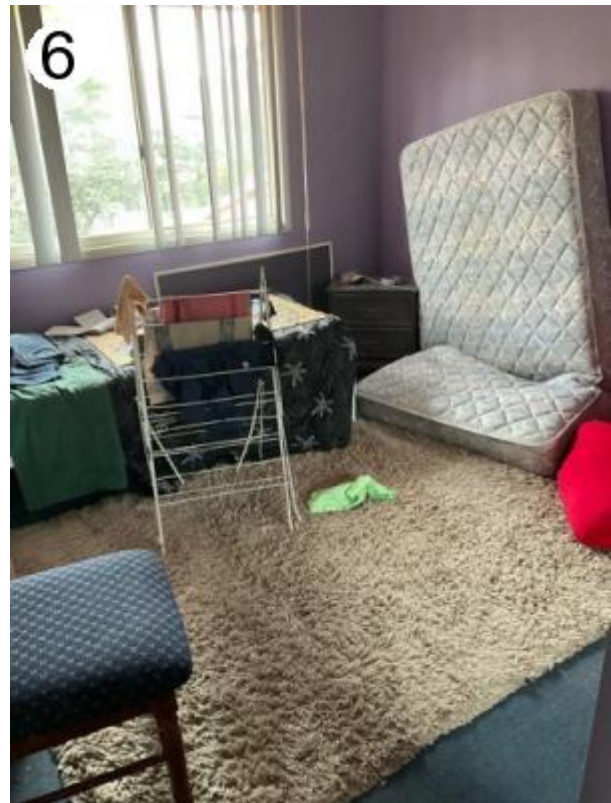
#6. Showing example of the furniture

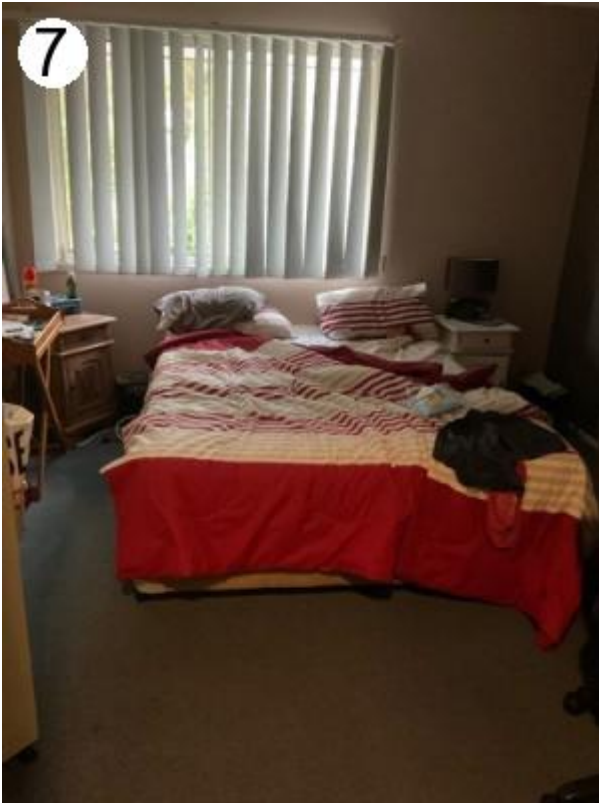
#7. Showing example of the furniture

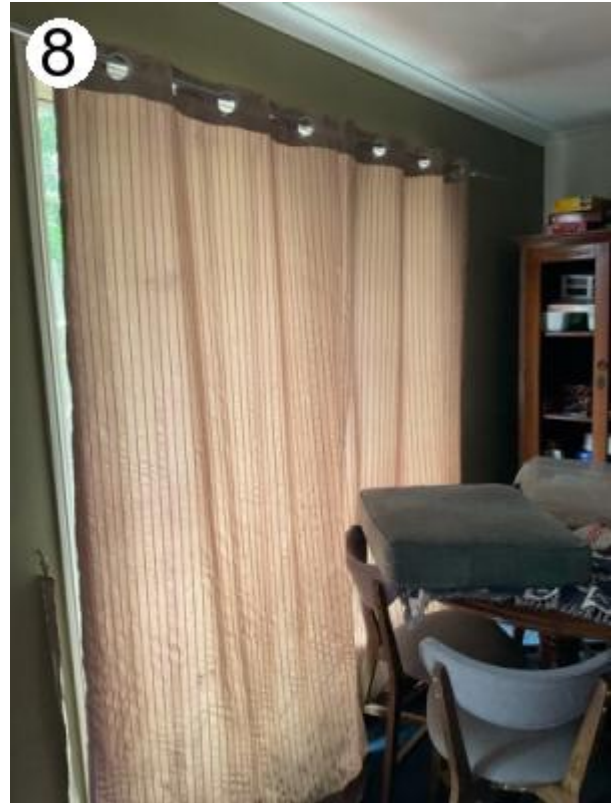
#8. Showing example of the window furnishings

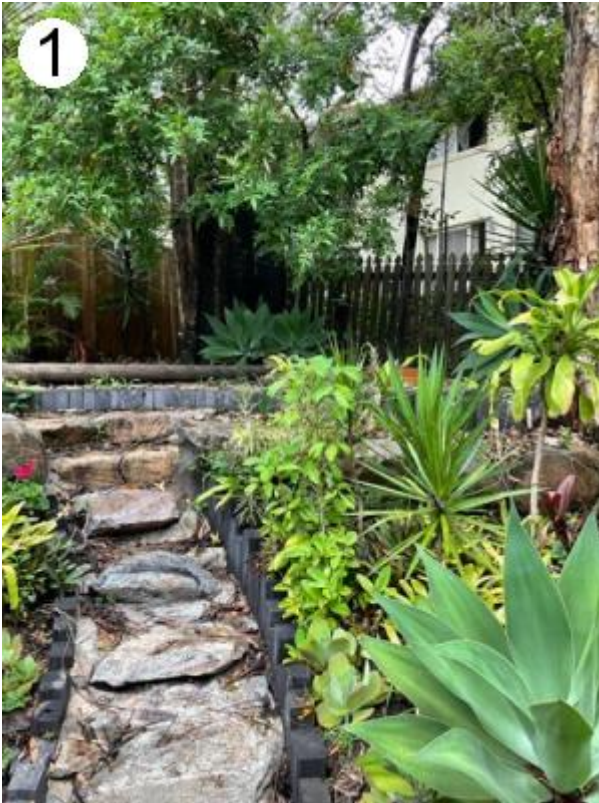
#1. Showing example of the vegetation

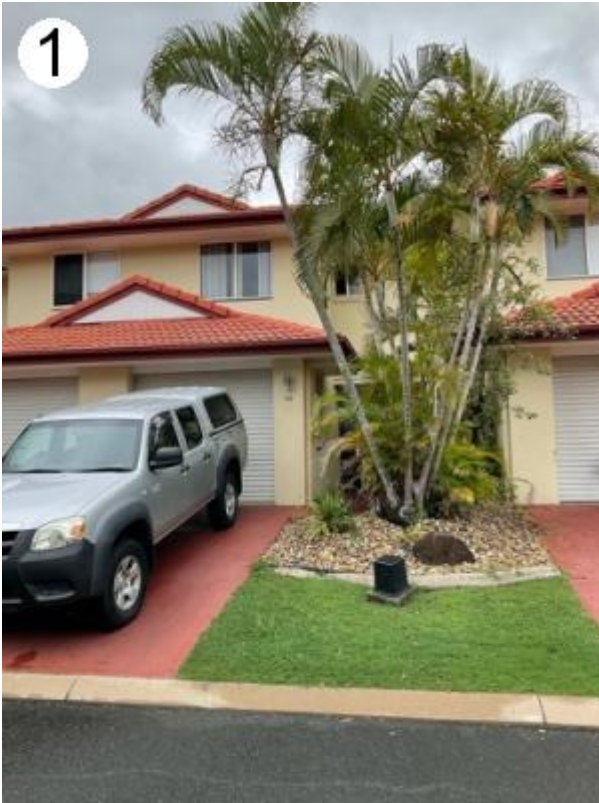
In inspecting the roof exterior, there was no inspection of the roof where the area of accessibility was more than 3.6 metres above ground or floor levels

#1. Showing example of upper roof height restrictions

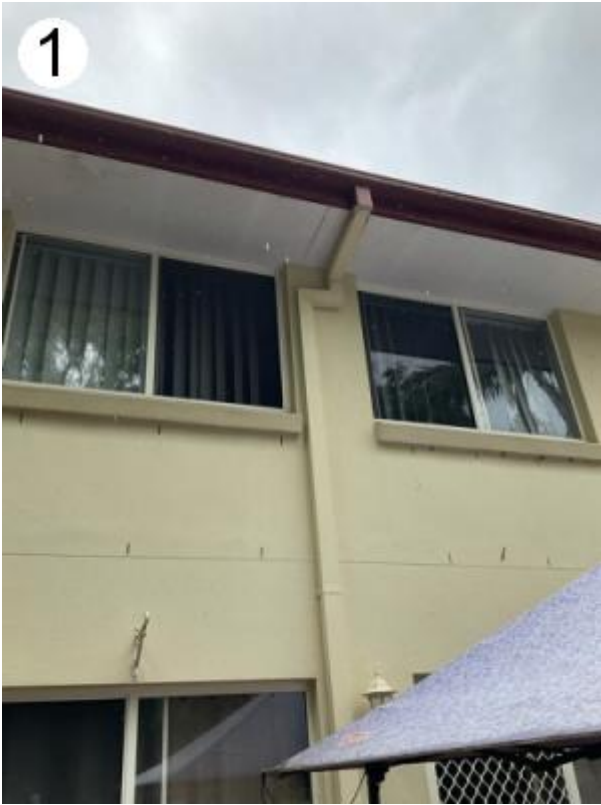
#1. Showing example of the windows

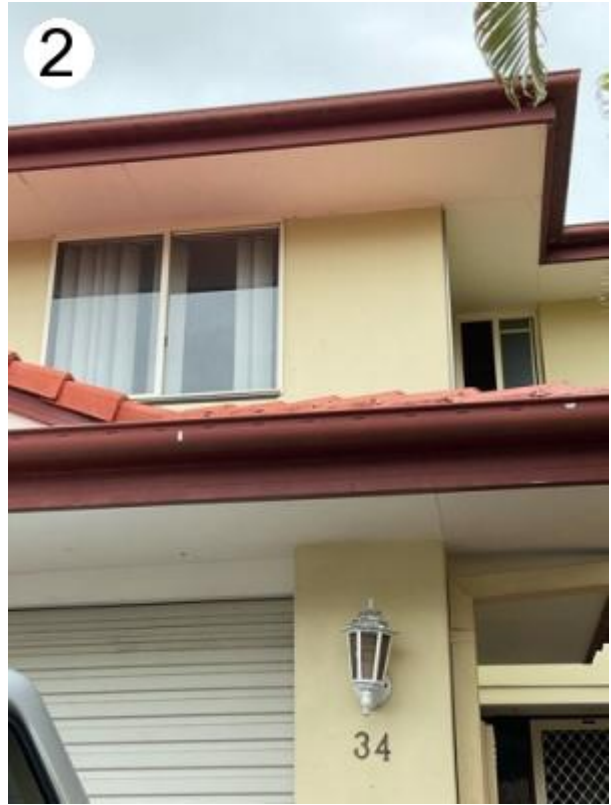
#2. Showing example of the windows
