Serenity Home Inspections LLC

Property Inspection Report

1290 W Spring St, Smyrna GA 30080

Commercial Inspection

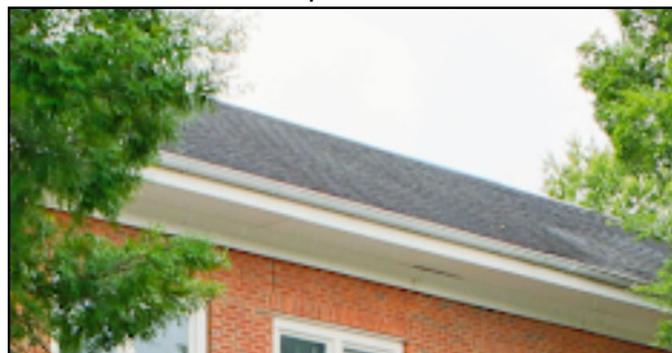
Billowing observed on roof covering. Recommend contacting a licensed roofing contractor to review repair options.

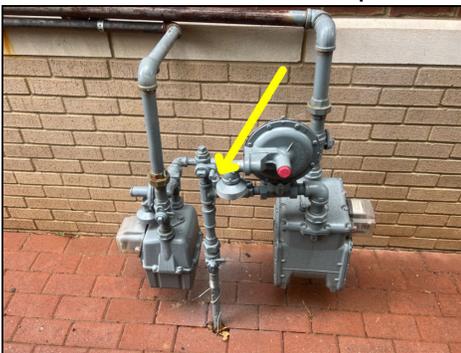
1.5. Gas meter for rooftop is not in use

Gas meter(s) at the left side

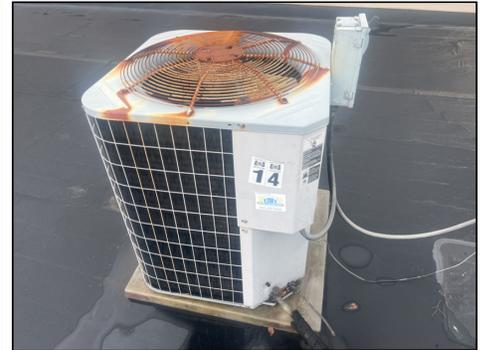
Exterior cooling unit compressor 14. Estimated age 20.

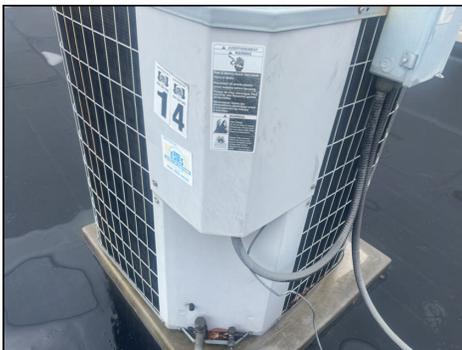
Exterior cooling unit compressor data tag was not present in unit 14.

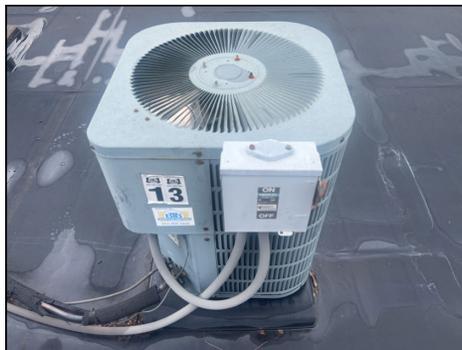
Rooftop exterior compressor number 13. Amana. Age 18.

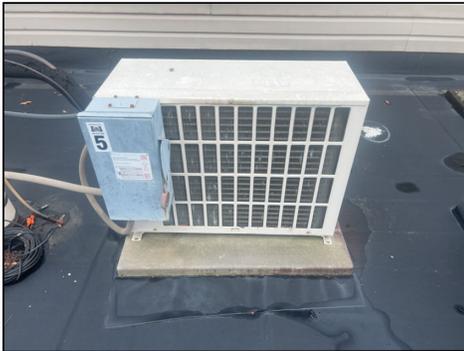
Exterior AC unit number five. Fujitsu mini split. Age unknown due to label not being legible.

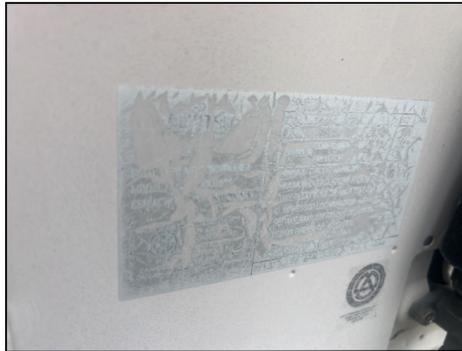
Exterior cooling unit 5 mini split data tag not legible. Estimated age based on professional opinion is 20 years.

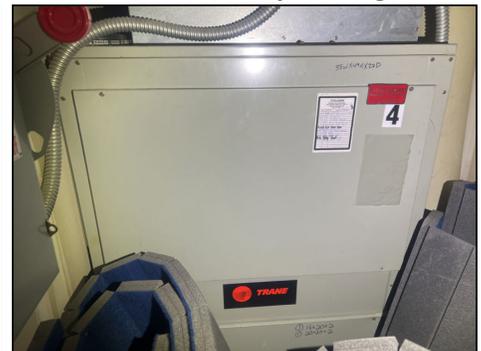
Air conditioning was not operating in Suite 100 rear area

Evaporator coil portion of the cooling system in rear area of suite 100

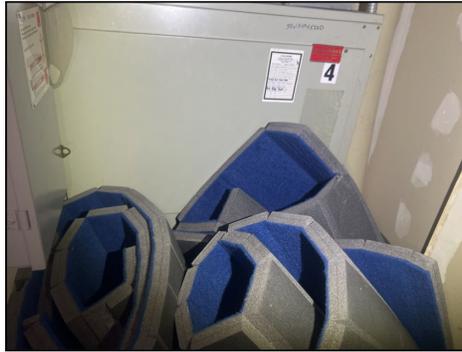
Evaporator coil portion of the cooling system in rear of suite 120 was obstructed by storage.

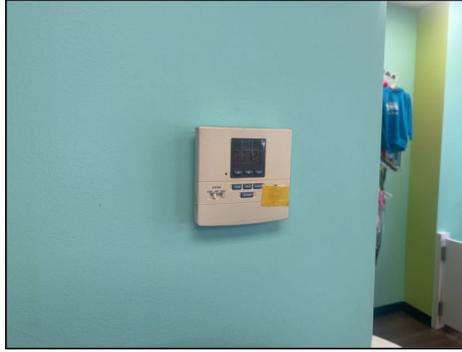
9.1. The cooling system in front portion of suite 100 was inoperable at the time of inspection using normal operating controls.

The cooling system in front portion of suite 100 was inoperable at the time of inspection using normal operating controls.

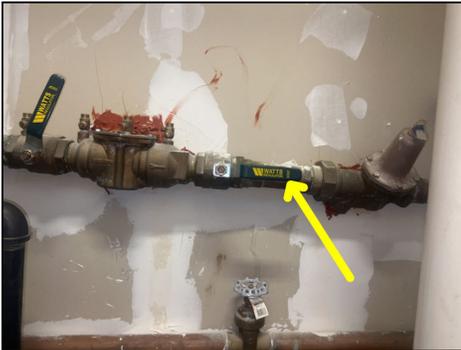
Main water shut off located in utility closet and main floor hallway

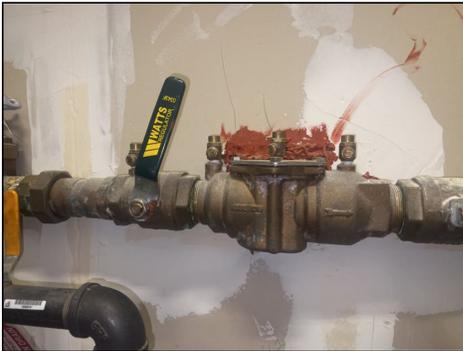
3.1. There was no visible inspection tag at the backflow preventer. Have inspected and tagged by licensed commercial plumber.

Backflow preventer noted in main floor utility closet

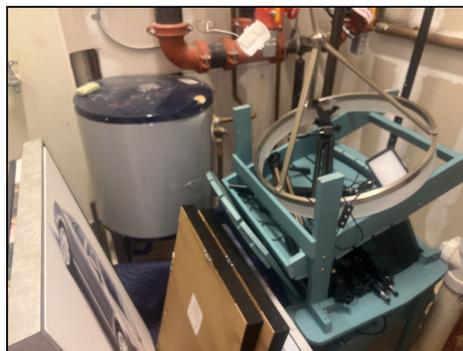
5.1. Water heater located in main floor. Utility closet was not fully accessible and not fully inspected.

Water heater located in main floor. Utility closet was not fully accessible and not fully inspected.

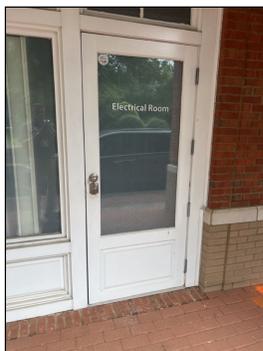
2.3. Electrical room door was not secure. Door should be locked with key provided to authorized personnel only.

Electrical room door was not secure. Door should be locked with key provided to authorized personnel only.

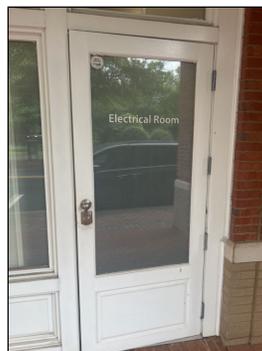
2.2. Electrical room not labeled "Authorized Personnel Only". Add signage for safety.

Electrical room not labeled "Authorized Personnel Only". Add signage for safety.

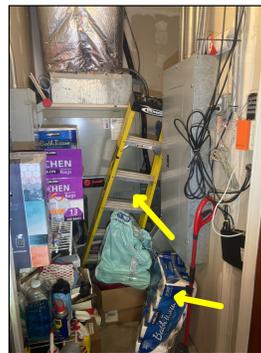
Storage noted on subpanel in Suite 120. No item should be stored on electrical panels.

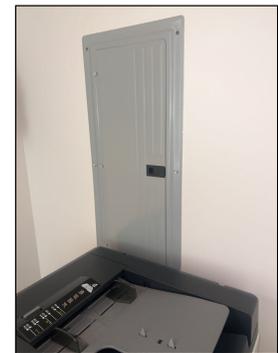
Sub panel in second floor main was obstructed. Not inspected. Sub panels should be accessible.

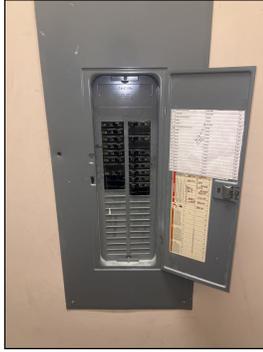
Sub panel data tag no fully visible

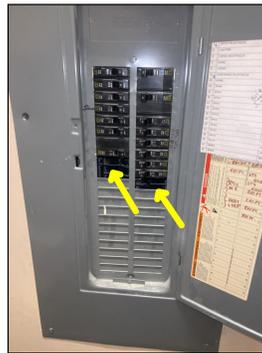
Open knockouts observed in second floor electrical room service panel cover.

- Missing screws noted at panel cover. Have replaced by licensed electrical contractor
- Inadequate panel access observed in second-floor data room.
- **Open knockouts observed in one or more service panel covers, suggest installing knockout plugs, as needed, for safety.**

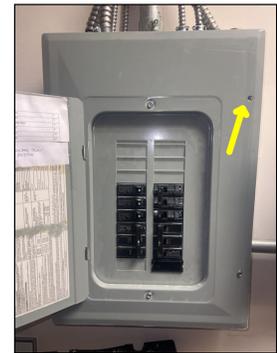
Missing screws noted at panel covers in suite 260

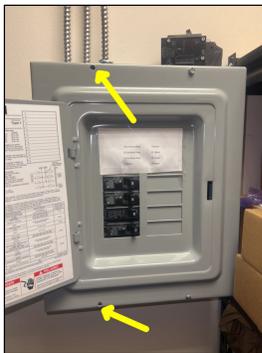
Missing screws noted at panel covers in suite 260

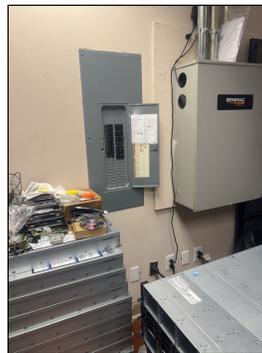
Inadequate panel access observed in second-floor data room.

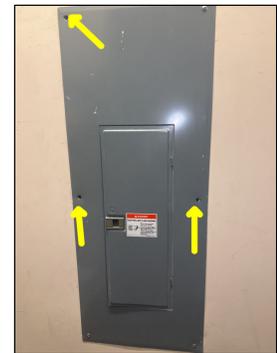
Missing screws noted at panel cover in second floor main suite electrical room.

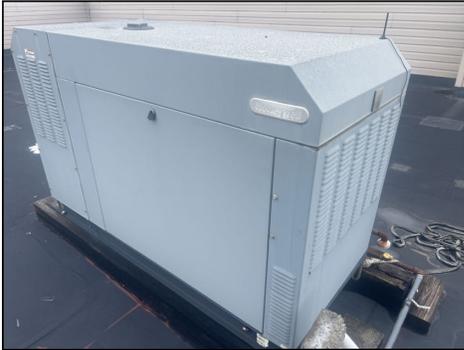
Back up generator was connected to a gas line. Gas line to roof is not in service. Generator is not available for use without gas.

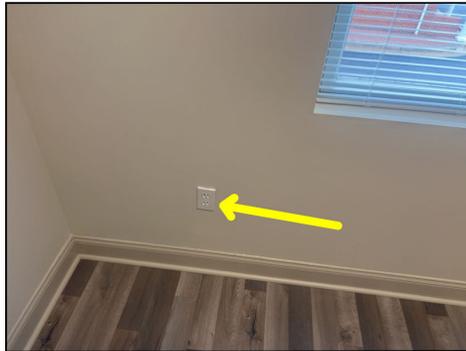
Non energized receptacle at back wall of Studio 325 office

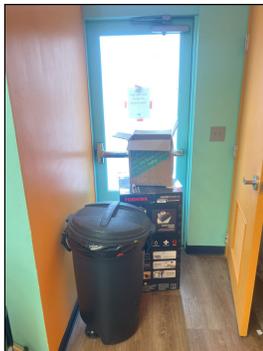
Blocked emergency exit observed in Suite 100

2.2. Exterior doors observed locked from the inside, chained, bolted, barred, latched or otherwise rendered unusable at the time of the inspection. This condition should be corrected. See photographs for locations and details.

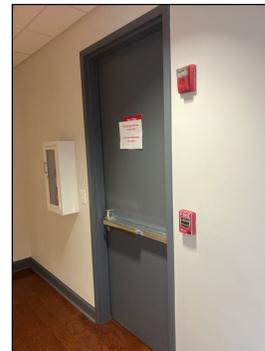
Emergency exit from second floor was connected to alarm, which would activate if opened. Not tested.

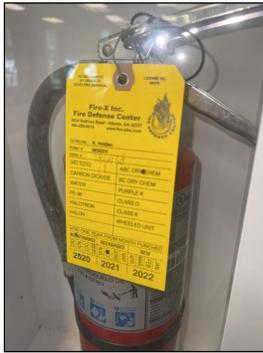
Expired fire extinguisher tag observed in suite 100.

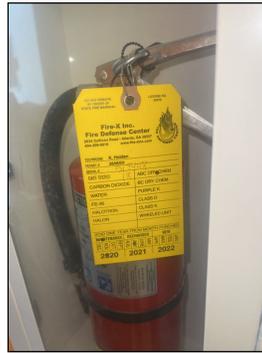
Expired fire extinguisher tag in suite 100.

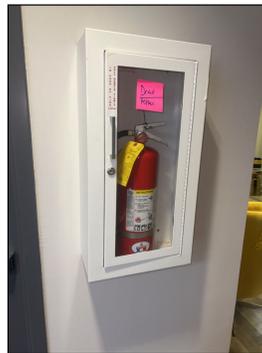
Fire extinguisher box near reception area on second floor was locked. This should be accessible in case of emergency.

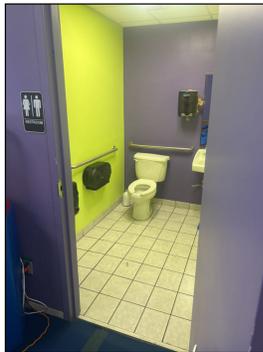
Suite 100

2.1. Loose towel dispensers observed. See photographs for locations.

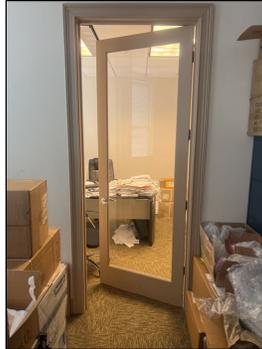
Rear office door in Suite 260 does not latch when closed
