# First Choice Inspection Services

## PROPERTY INSPECTION REPORT

**Concerning:** 1234 Any Street Sample  
Corpus Christi TX 78401  
(Address or Other Identification of Inspected Property)

**By:** Salvatore M Iacono TREC #7465.  
(Name and License Number of Inspector:) (Date)

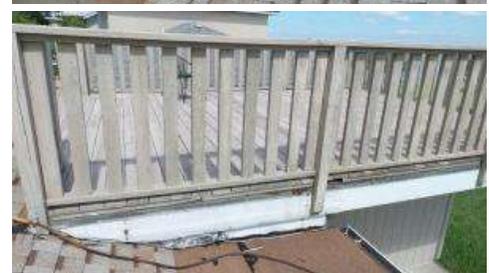
**Some of the rear flat roof is covered by wood deck is not inspected.**

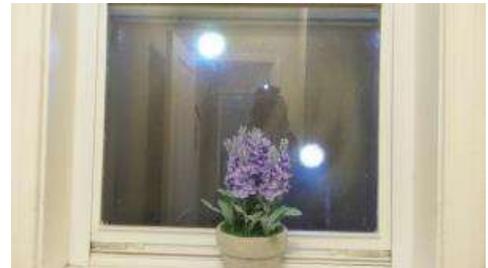
Downstairs master bathroom window at toilet was difficult to open and close. The window covering has not been removed.

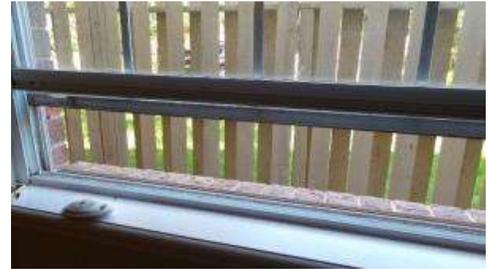
Installed storm windows in sleeping areas may hinder egress in an emergency such as a fire. An emergency escape plan is needed.

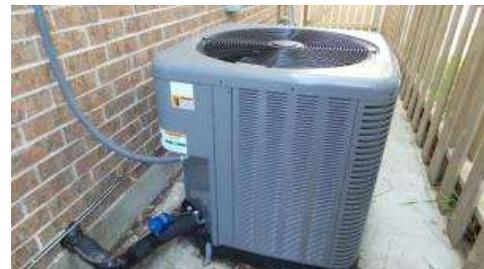
OBSERVATIONS- No problem observed during this inspection period.

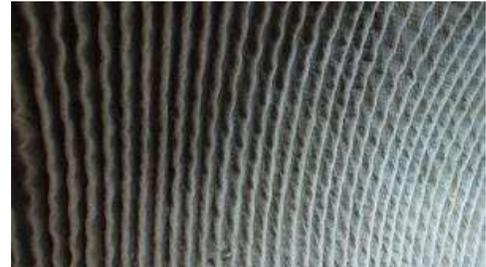
**Filter is dirty.**

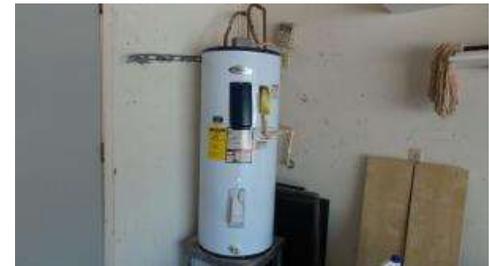
*Energy Sources:* Electrically operated.

*Capacity:* 50 Gallons, Appears to be a 2012 model.
